Archaeological watching brief at Stokesay Castle, Craven Arms, Shropshire

Worcestershire Archaeology

Archaeological watching brief report

Site name: CSO Improvement works at Stokesay Castle, Craven Arms
Site code: P5682
Local planning authority: SMC – Historic England
Planning reference: SMC S00218293
Central NGR: SO 43523 81606
Commissioning client: JN Bentley on behalf of Severn Trent Water
WA project number: P5682
WA report number: 2815
HER reference: SM 1003011
Oasis reference: fieldsec1-395402

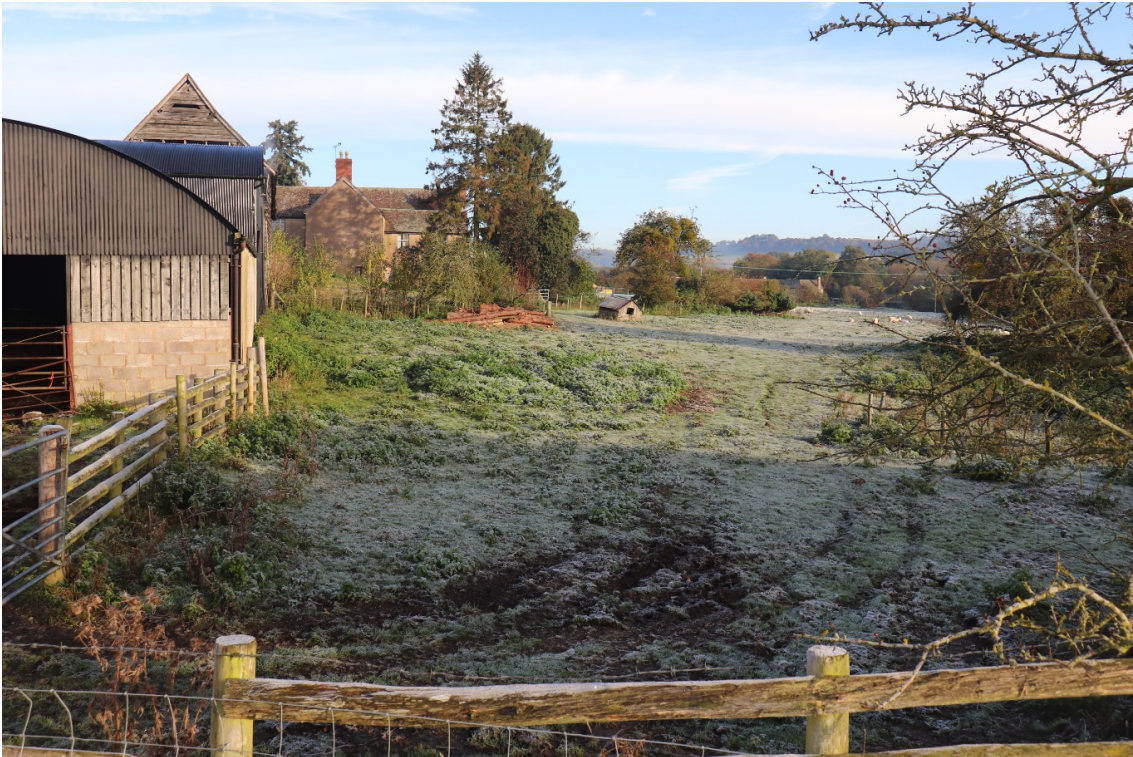
Plate 1: Scheduled Monument area of Stokesay Castle on initial site visit, prior to works commencing. From southern boundary looking north.

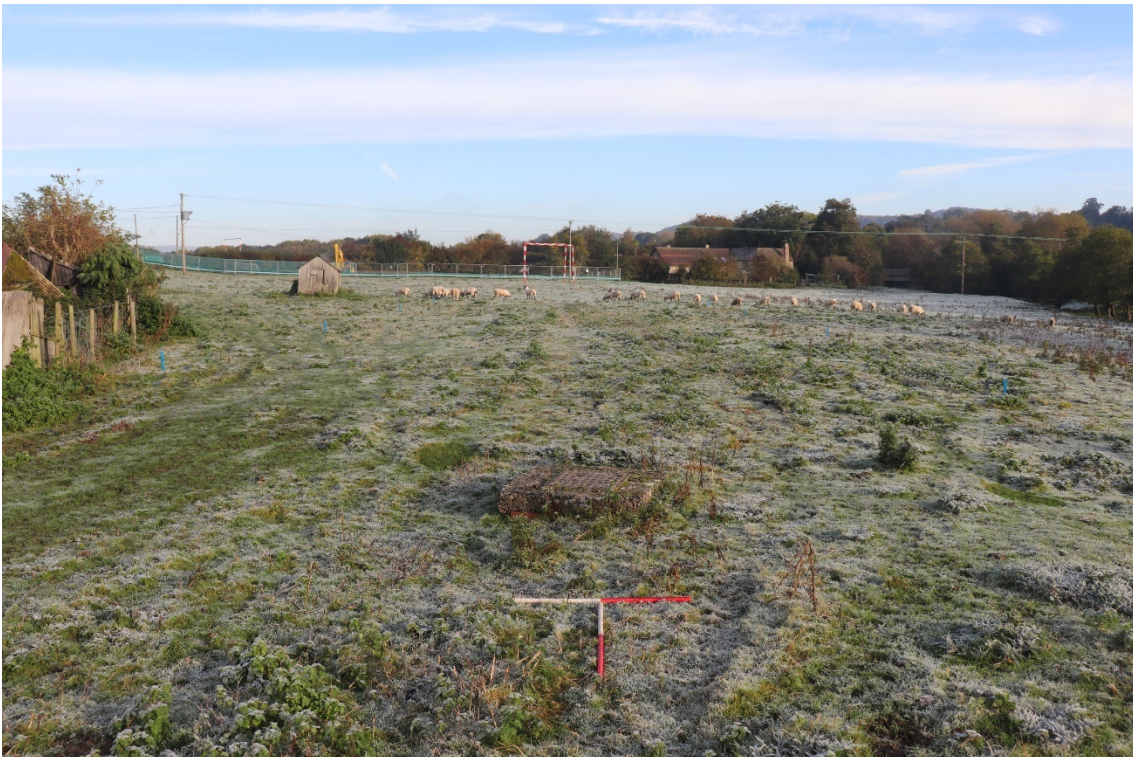
Plate 2: Scheduled Monument area of Stokesay Castle on initial site visit, prior to works commencing. Manhole in centre of field with 1m scales looking north.

The pipeline route runs through pasture fields of StokeCastle farm with occasional animal shelters and the site of the pipeline is generally flat at 114m -115m AOD with a slope at the southern end (Plate 2), assisting drainage and livestock movement from StokeCastle farm. The land slopes down on the east towards the river Onny and other tributaries and ox-bow lakes.

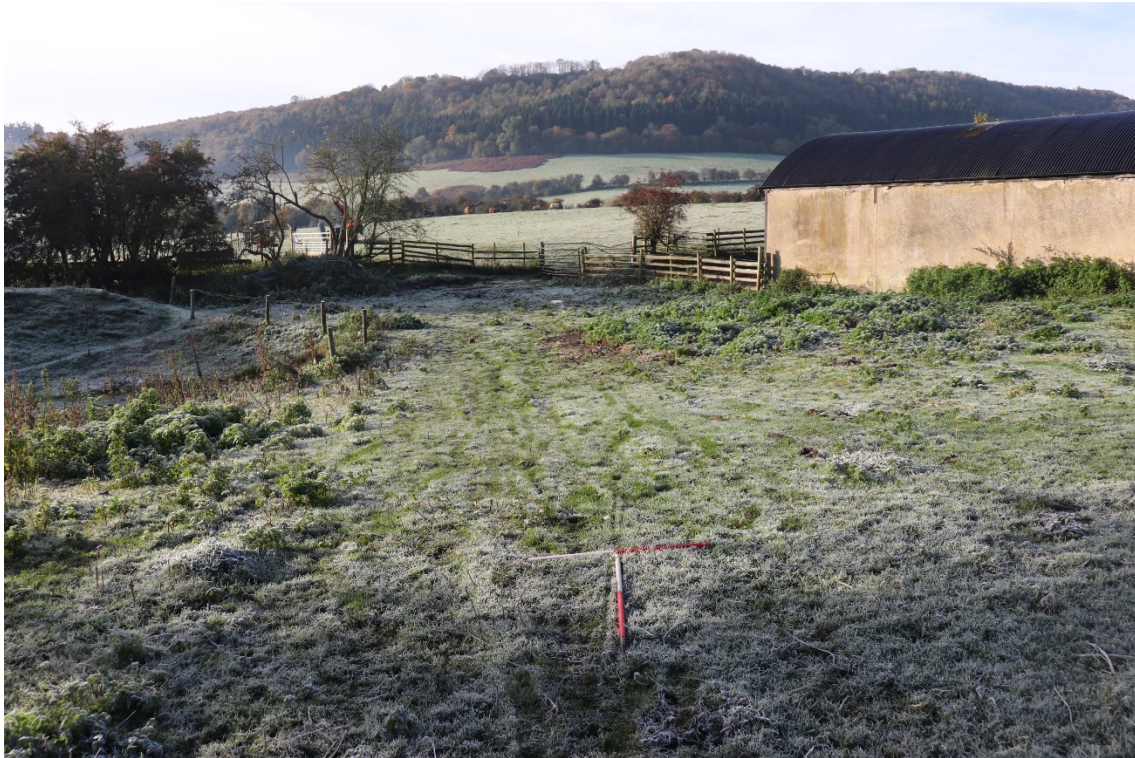
Plate 3: Scheduled Monument area of Stokesay Castle on initial site visit, prior to works commencing. Centre of field with 1m scales looking south.

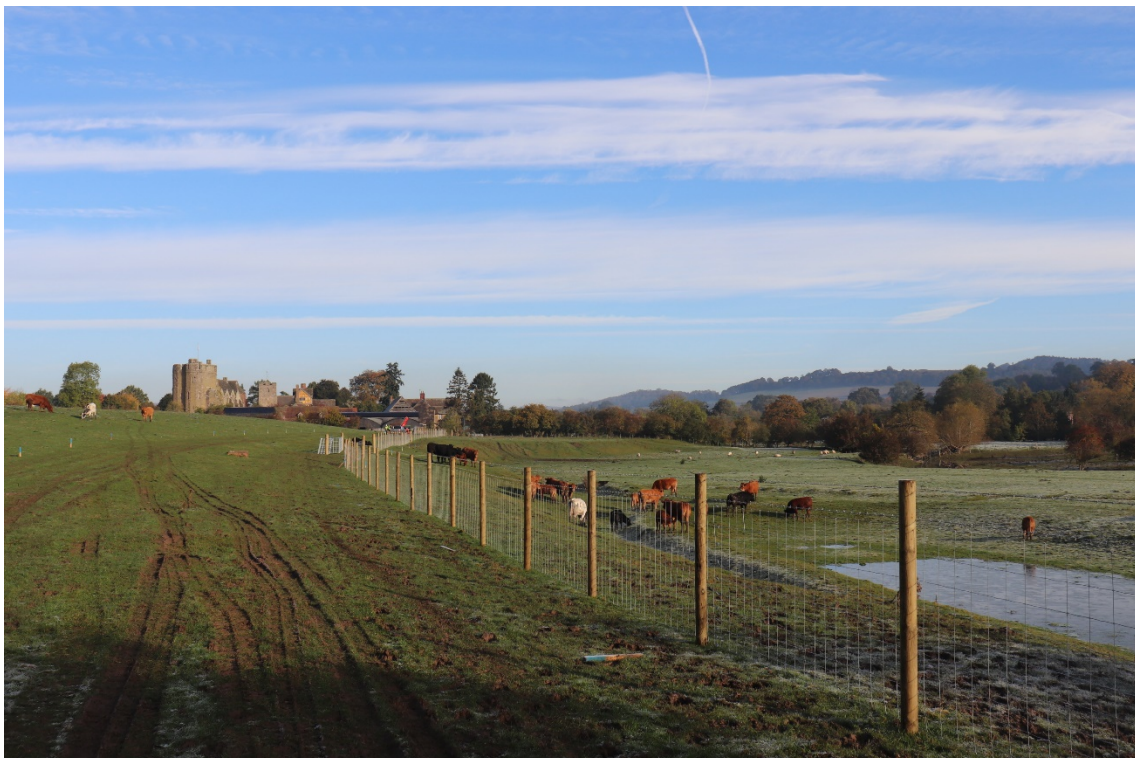
Plate 4: Stokesay Castle on initial site visit, prior to works commencing from proposed pipeline route south of the castle.

A site visit prior to the works was made in October 2019 to discuss the scheme and archaeological requirements (Plates 1 – 4).

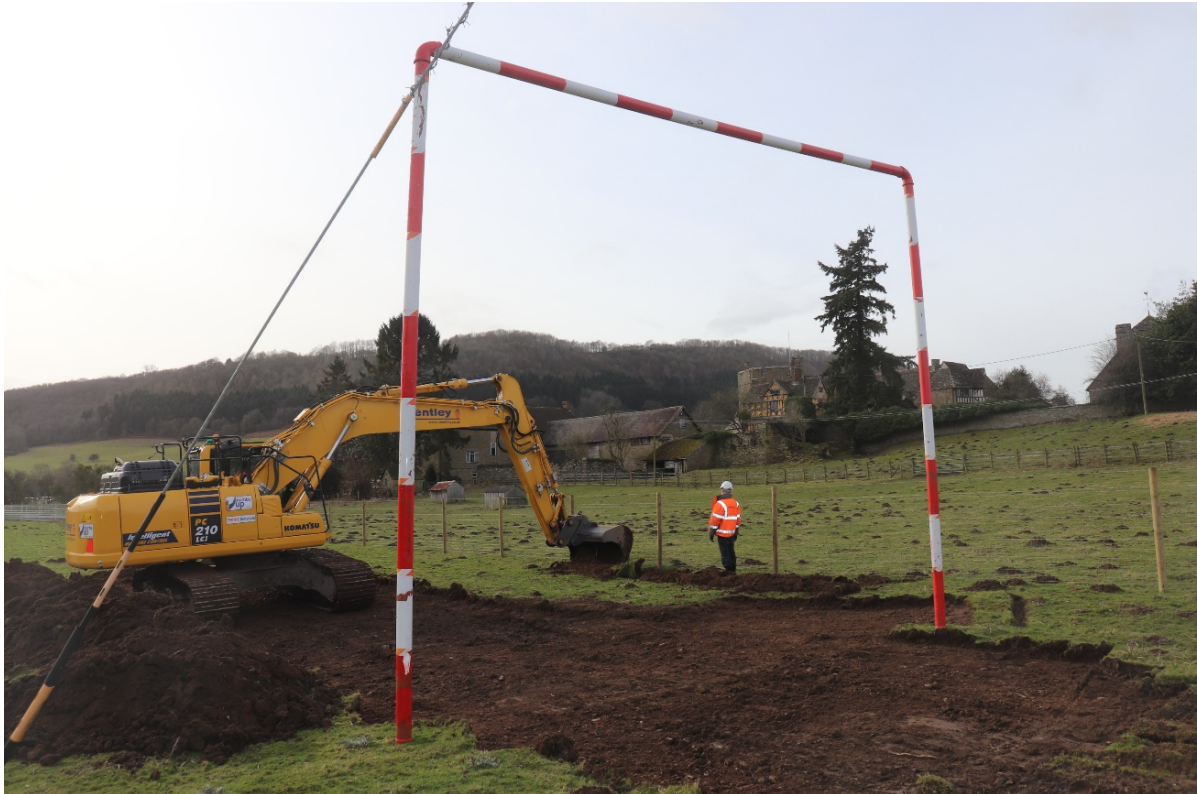
Plate 5: Easement topsoil strip with Stokesay Castle in background. looking southwest.

The initial topsoil strip and preparatory works were monitored in February 2020 over the footprint of the pipeline (Figures 3 - 4), a total easement width of 14m for access (Plates 5-8). The original cut for the existing pipe was visible and surveyed at 4m wide. Only topsoil with modern and post-medieval residual material was observed, together with modern backfill and disturbance from the original pipe installation in the mid-20th Century. The topsoil (100) overlaid a moderately compact mid orangey brown silty clay subsoil (101), with patches of orangey brown sand and gravel natural substrate visible (104) throughout the area.

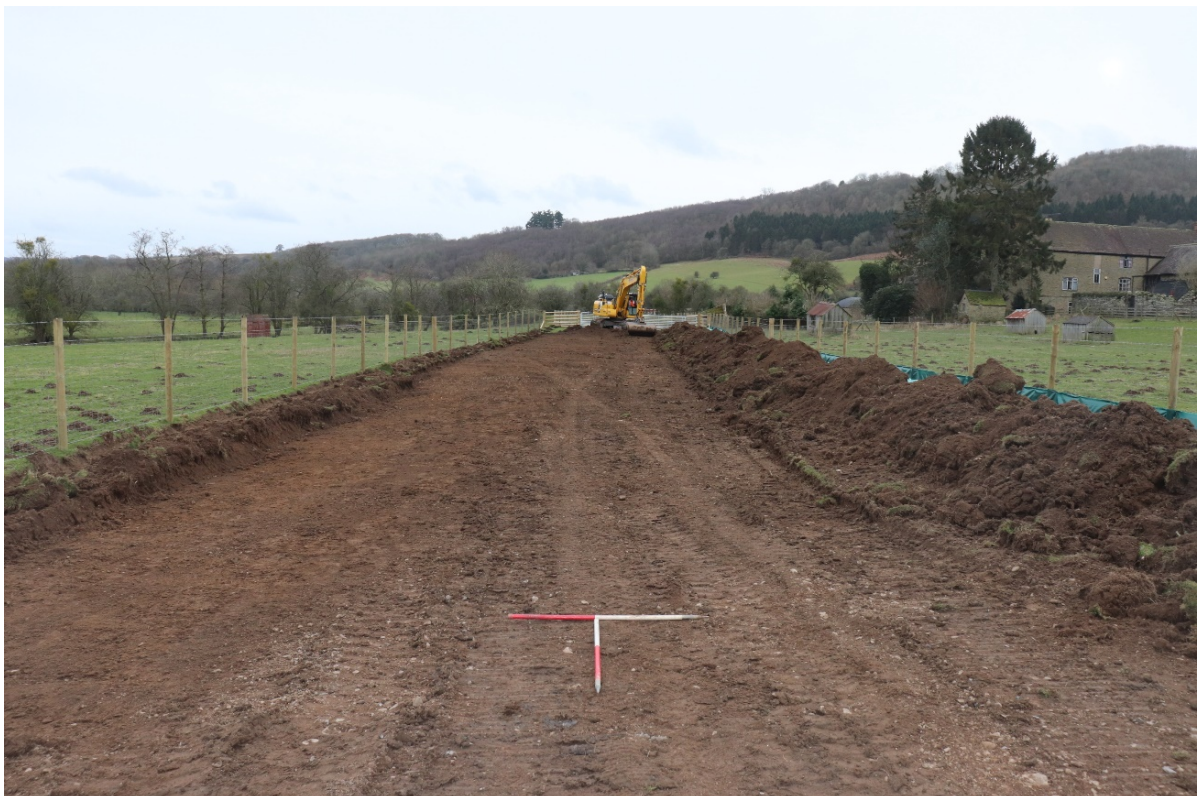
Plate 6: Easement topsoil strip looking south with 1m scales.

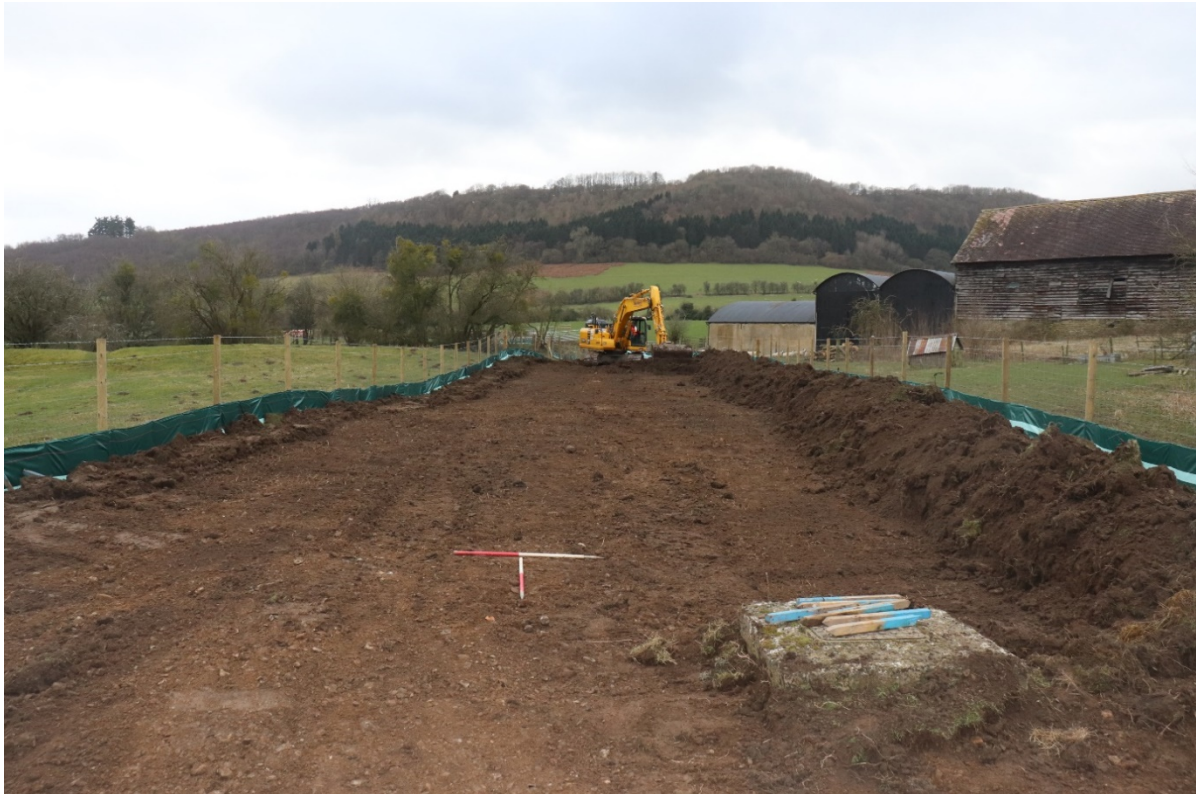
Plate 7: South end of Scheduled Monument area of Stokesay Castle following topsoil strip, with manhole in foreground. 1m scales looking south.

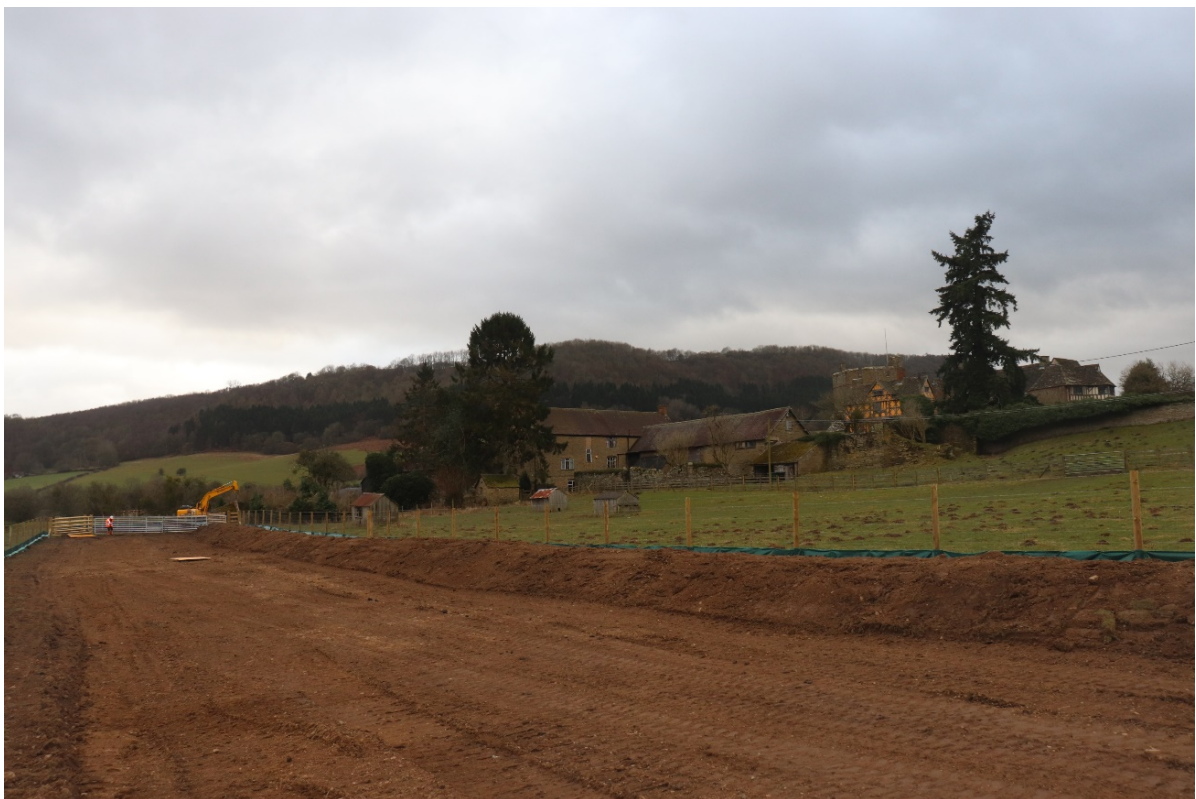
Plate 8: Easement topsoil strip with Stokesay Castle and StokeCastle farm in background, looking southwest.

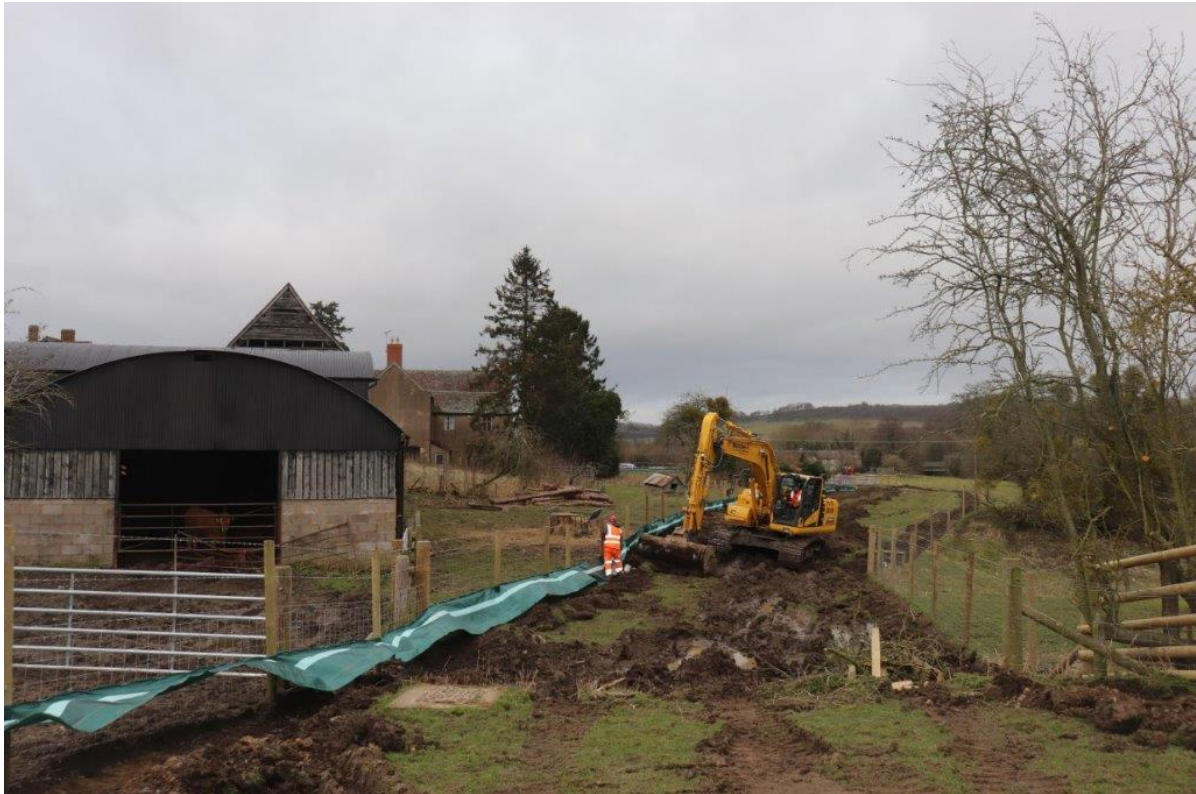
Plate 9: Location of trial hole for drain connection, during initial topsoil stripping in February. Looking north

A square excavation approximately 4m x 4m and up to 2.5m deep was excavated mechanically (Figures 3 - 4 and Plates 9 – 10). By the time the archaeologist was present, it was too deep and the sides not stable enough for the excavation to be entered and it was therefore recorded from above the cut. The excavations revealed a section across a U-shaped linear cut (105) which spanned the

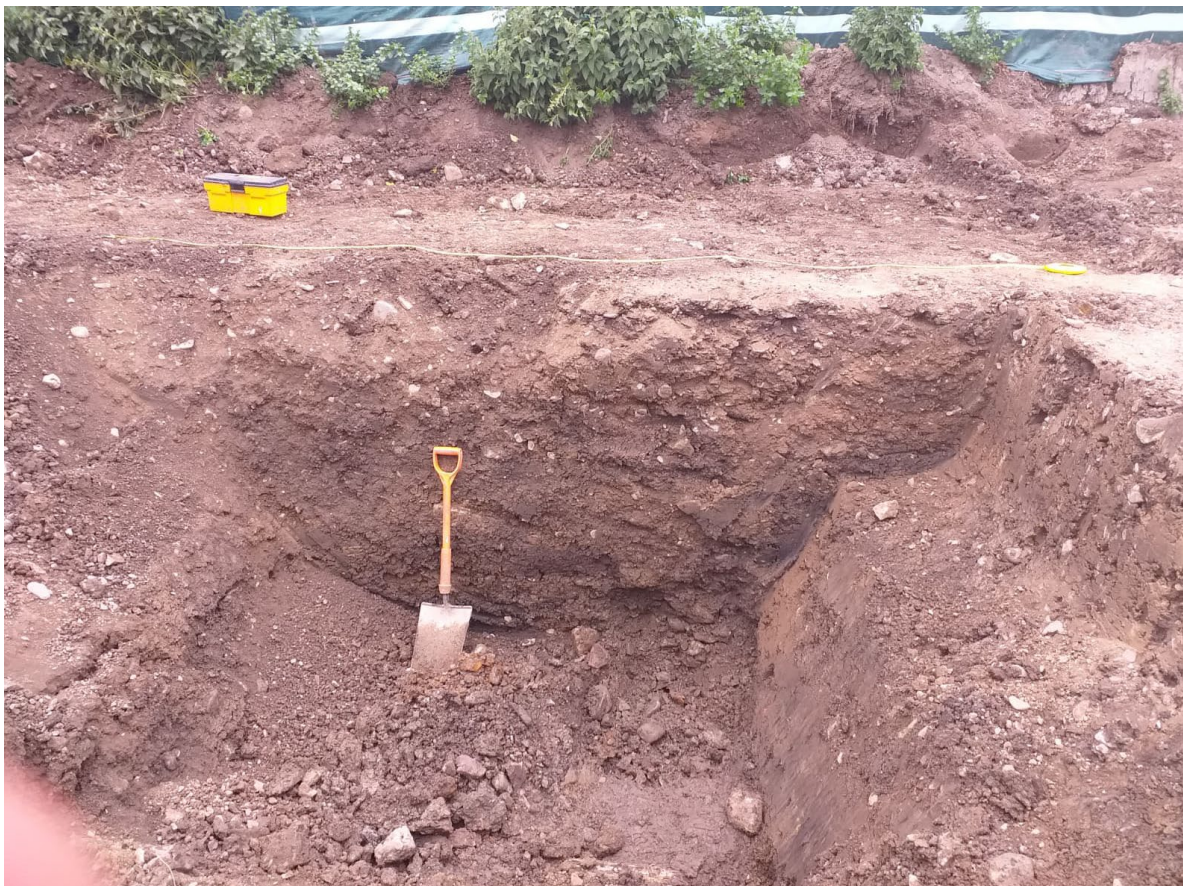
entire excavation. The upper layers comprised a topsoil similar to that recorded in the remainder of the easement (101) and below this a layer of loose mid brown silt (106). At the base of the cut was a dark brown/black silt with frequent animal bone, bottles, shoes and stoneware jars (107). Natural gravel (104) was revealed at an estimated depth of 2.5m.

It is thought that prior to the laying of the drain, a large open linear cut for drainage ran from the corner of the farm south-west towards the river Onny. This was subsequently used to dump waste from the farm and then deliberately infilled for to allow the track to cross this area. To the south-east there are earthwork banks which could well be the upcast from earlier excavation of this feature, although their date remains unclear.

Plate 10: Trial hole for drain connection showing U-shaped drainage channel and backfill. Looking northwest, no scale.

A further phase of monitoring was undertaken of excavations for a later connection to a drain. This revealed a substantial cut leading from the farm toward the river. Deposits present in the base of the cut demonstrate that this feature was extant during the 19th Century. A homogenous layer overlying is evidence that the feature was backfilled in a single episode, probably to facilitate the construction of a track to a farm gate to the south. Immediately to the east, the continuation of the cut is evident as an earthwork flanked by banks and it is thought likely it was the bank material which was used to backfill the cut adjacent to the farm.

It is likely that this feature acted as a drain from the farm but may also have been connected to water management features west of the farm and castle complex and may also have fed the mill pond known to have existed to the south east.
