Archaeological watching brief at Stone Cottage, 7 The High Road, Felmersham Bedfordshire

Worcestershire Archaeology
for Nichole Goodland

June 2020

Archaeological watching brief report

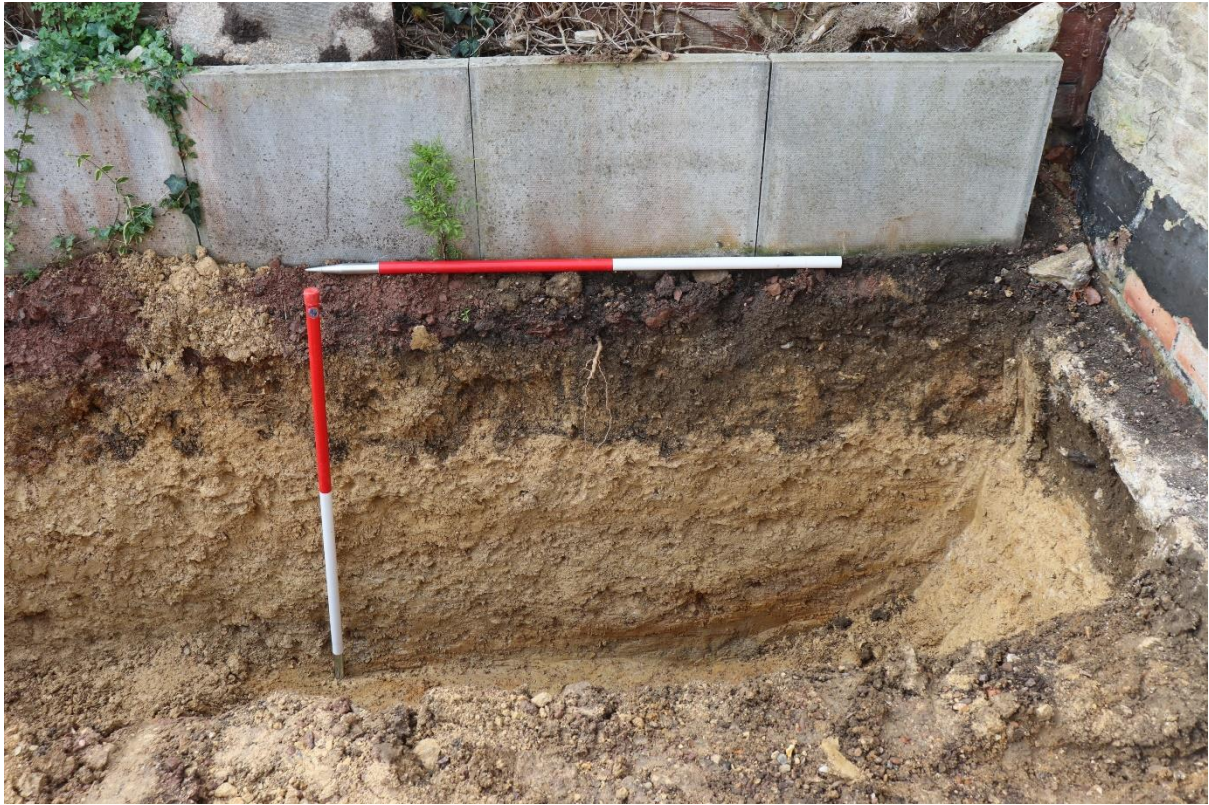
Plate 1: NW facing section of Trench 1 showing the original house foundations and disturbed ground layers 101 and 102. 2x1m scale, facing south east

Trench 1 had been heavily disturbed by the construction of previous foundations and the laying of a patio. Below this point the natural substrate appeared to be undisturbed.

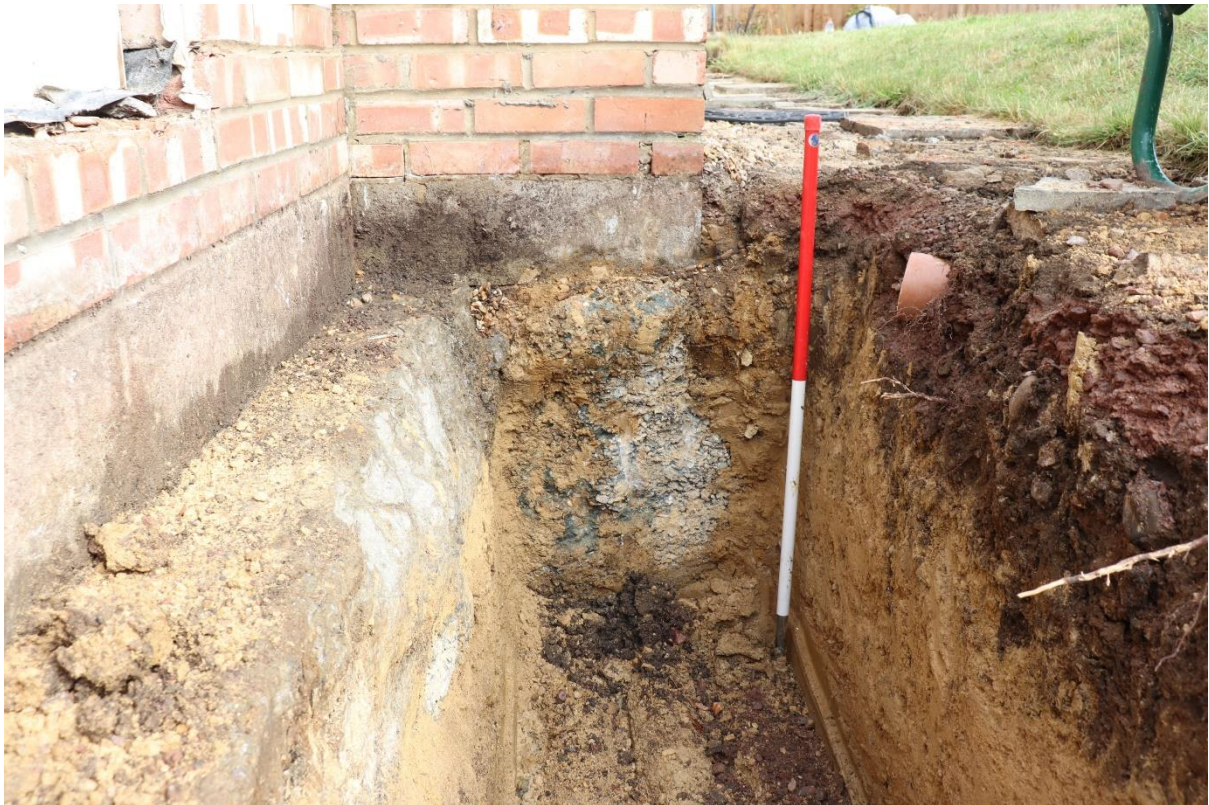
Plate 2: SE facing section of Trench 1 showing the foundations of the previous extension and conservatory. 1m scale, facing north west

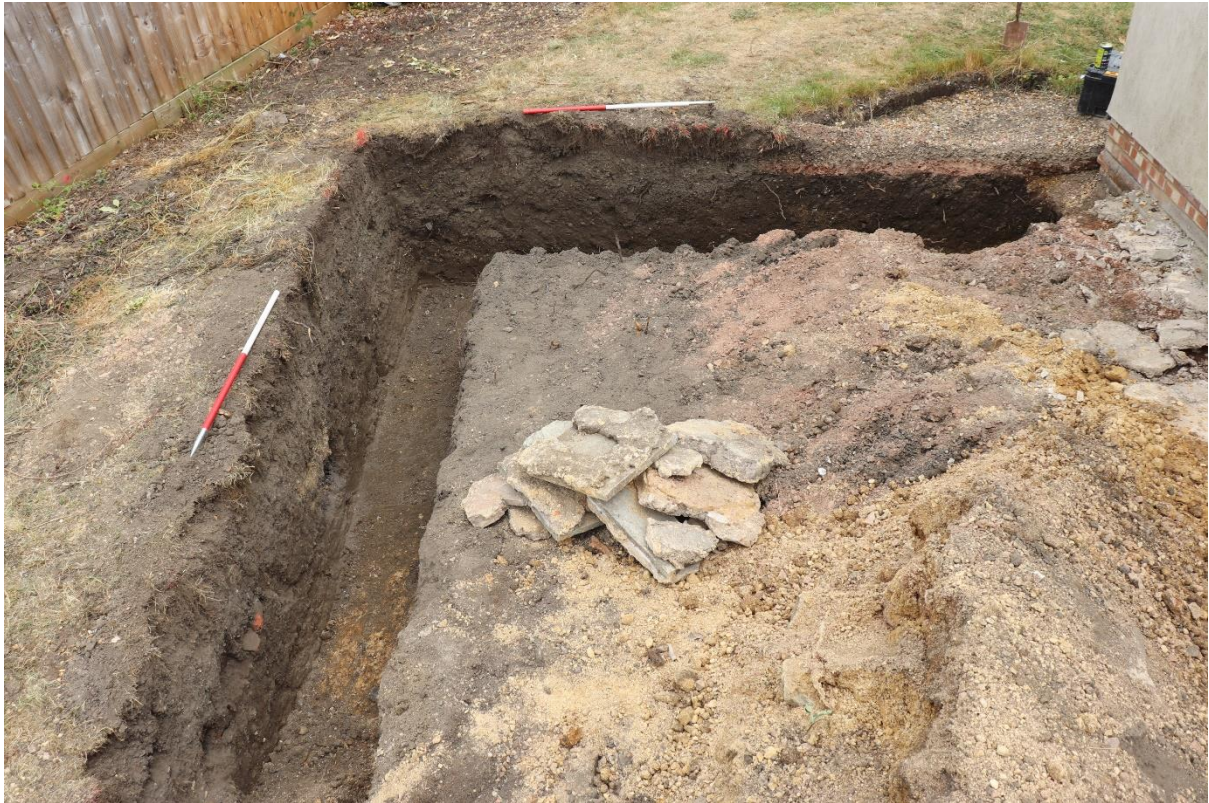
Plate 3: SE and SW facing sections of Trench 2 showing the made ground layer 202, the driveway 204, and the foundations of the previous extension. 2x1m scale, facing north east

Trench 2 consisted primarily of modern made ground related to previous development of the site. Where witnessed the natural contained no indication of further disturbance.
