Archaeological evaluation of
Land at Churchfields
Kidderminster
Worcestershire
Worcestershire Archaeology
for RPS Heritage

# LAND AT CHURCHFIELDS KIDDERMINSTER WORCESTERSHIRE

Archaeological evaluation report

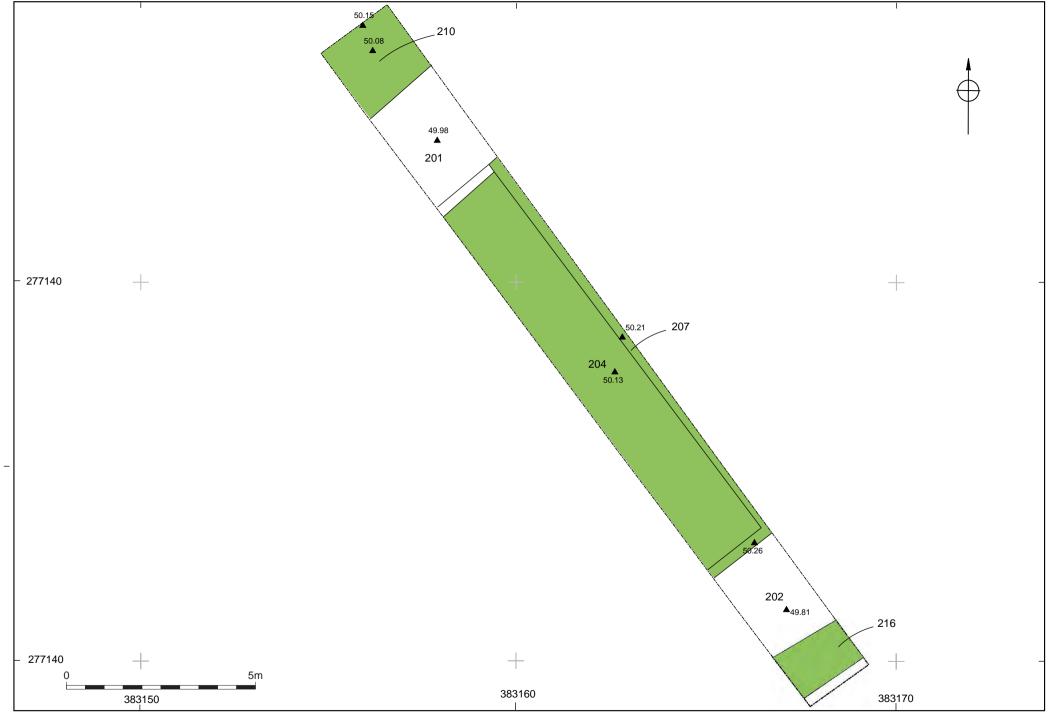
Figure 4

Made ground deposits were observed at the south-eastern end of the trench and towards the north-western end. The northern end of the trench was covered in a brick surface 210 (at 50.08mAOD), comprised of blue engineering bricks laid on edge. The bricks measure 9" x 4.5" x 3". The southern edge of the brick surface was truncated by an unknown event, though probably related to the later remodelling of the site. The middle of the trench was covered by a surface 204 constructed of blue engineering paver bricks measuring 10" x 5" x 2". It was 11.7m long and abutted wall 207 on its eastern and southern side, lying at 50.13mAOD. It continued beyond the trench on the western side. Wall 207 survived to three courses high, and was constructed of machine made bricks measuring 9" x 4.5" x 3". To the south of wall 207 was a series of cuts for old service pipes, through the made ground mentioned above. Covering the brick surface was a made ground layer, beneath tarmac.

Trench 2 (features and structures indicated in green)

The brick surface that was recorded in Trench 2 was probably the internal floor of a structure that was visible on both the 1885 and 1902 Ordnance Survey maps and the 1920 Fire Insurance plan (RPS 2011), with the wall along the northern and eastern edges of the surface representing the walls of that building. It was not present on the Broadfields map of 1859 (*ibid.*). Trench 3 also aligns with a building that is illustrated on the OS maps and the Fire Insurance plan. The various tanks and large pipes indicate an industrial function.

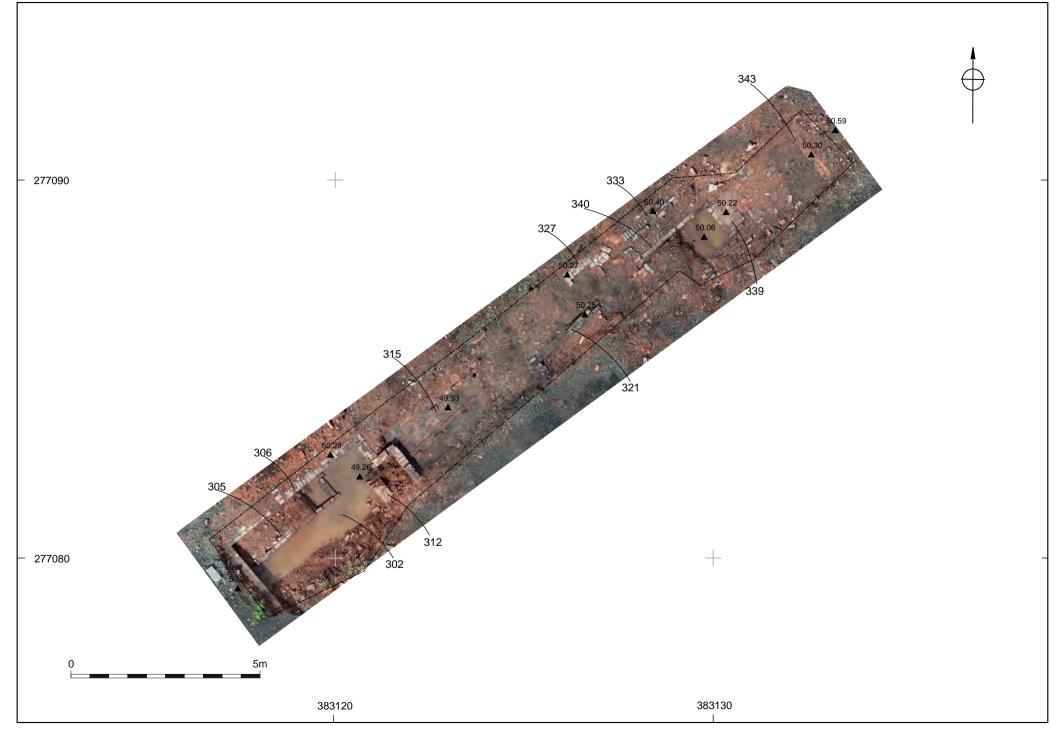
Trench 3 Figure 5

The south-western end of the trench was dominated by a large brick tank, constructed of brick surface 302 and surrounded by wall 306. Within the tank were walls 305 and 312. Surface 302 was constructed of blue paver bricks measuring 10" x 4.5", sitting at 49.18mAOD. The surrounding wall was 16 courses high and made of blue engineering bricks measuring 8" x 4" x 2.75". Wall 305 was constructed of the same brick type, and formed a 3m long rectangle in the northern half of the trench. The eastern end of the larger tank had several pipes feeding into it from trenches beyond the wall.

There were a number of smaller tanks constructed of blue engineering bricks along the trench, all surrounded by a demolition layer 301, around 50.30mAOD. The tanks contained potential asbestos and so were not fully excavated. Along the north-eastern end of the trench was wall 343, constructed of red bricks measuring 9" x 4.5" x 3".

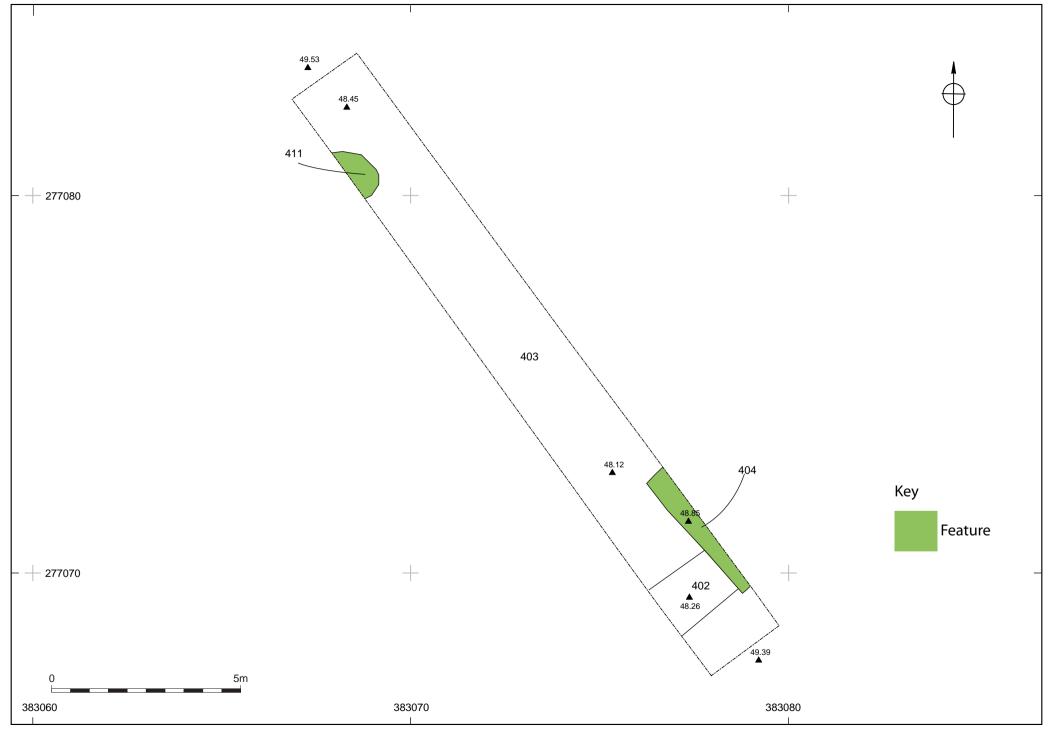
Trench 4 Figure 6

The natural gravel was encountered across the majority of the trench, with a series of demolition deposits above. At the southern end of the trench wall 404 was observed in the eastern edge, at 49.01mAOD. It was four courses high and made from red machine-made bricks measuring 9.5" x 4.5" x3".

Along the western edge of the trench was wall 407. This was nine courses high, with bricks measuring 9" x 4" x 2.5". It was seen only in the section.

At the western end of the trench a pit (411) was cut through the demolition layers and contained 20th century material.

The walls in Trench 4 relate to buildings illustrated on the Ordnance Survey maps of 1885 and 1902 though the trench only clips them so little can be determined as to their function other than what can be gleaned from the cartographic evidence.

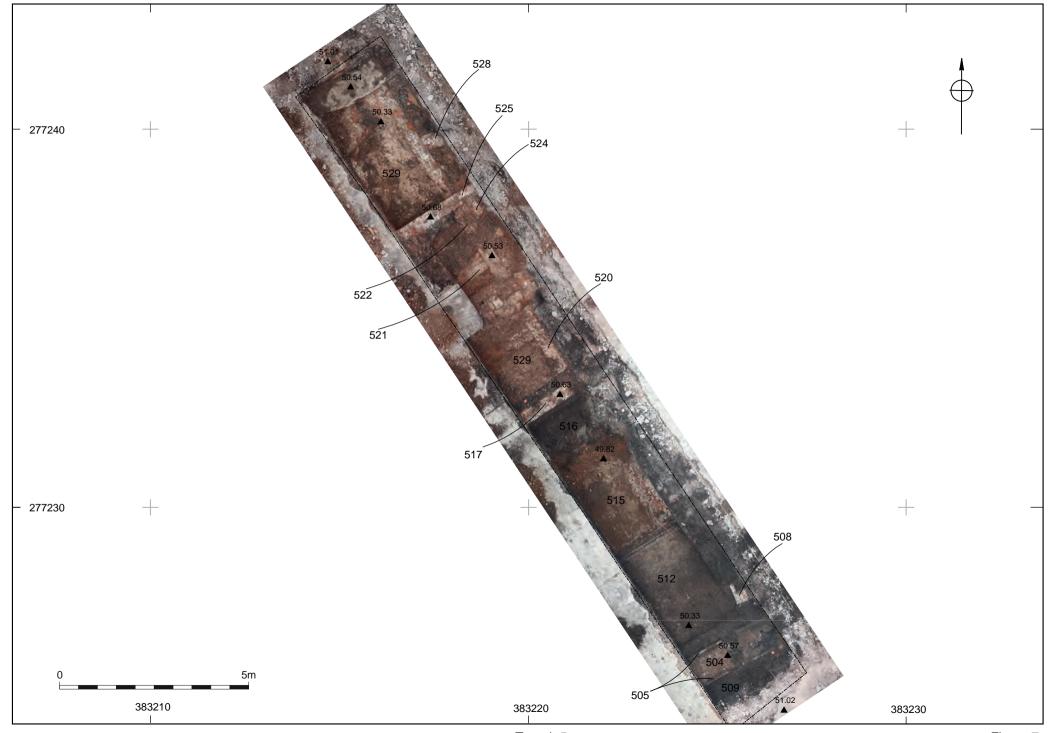
Trench 5 Figure 7

In the southern half of the trench was a possible subsoil 0.3m thick above the natural gravel in a machine-dug sondage. Overlying the possible subsoil was a probable garden soil 512, of later post-medieval date. Into this was cut a pit, 513, which contained a brick rubble fill, and a smaller pit, 510, containing 19th century ceramics (at 48.72mAOD). Above 512, and seemingly sealing the two pits, was a later garden soil 507. This had a garden path cut into it, formed of two lines of red bricks on edge, with a gravel deposit between. It was 0.36m wide.

In the northern half of the trench were a series of walls and demolition layers. Running across the trench was wall 517, constructed of handmade red bricks measuring 8.5" x 4.5" x 3". The construction

cut for this wall truncated earlier wall 520, which ran perpendicular to it. It was made of handmade red bricks measuring 9" x x4.5" x 2.75". Running perpendicular to this wall and bonded to it were two small walls, possibly acting as buttresses. A remnant of a possible brick surface was observed against wall 520 and wall 525, which ran perpendicular to 520. It seemed to be bonded with 520, which emerged to the north. Demolition material surrounded these walls.

The structures recorded in Trench 5 are of mid to late 19th century date, appearing between 1859 and 1885. The artefactual evidence confirms this. The features observed in the extramural area of the trench are indicative of backyard activity.

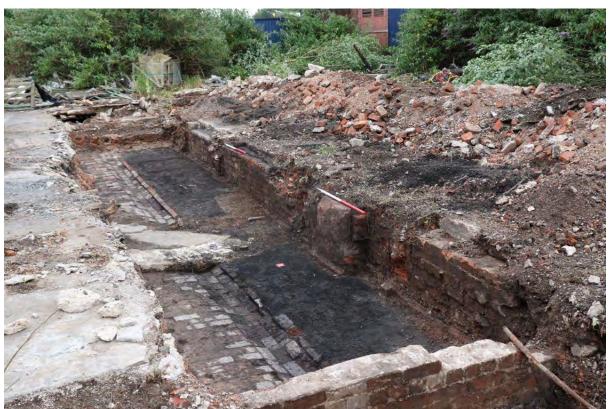
Directly above the natural ground was a possible subsoil, with brick rubble and charcoal throughout. Above that were a number of made ground layers, the uppermost of which was cut by the construction cut for wall 105. At the south-eastern end of the trench, a deeper 1m x 1m sondage was excavated, revealing two made ground layers. These were comparable to the made ground deposits seen at the northern end, though these northern deposits were not able to be thoroughly inspected due to health and safety constraints. Sealing the made ground was a dark grey black clinker layer 133 (at 50.20mAOD), that was truncated by brick surface 130. This was constructed of red bricks on bed, handmade, and measuring 9" x 4" x 2.5". It ran along the length of the trench from the south-eastern end, before terminating in a rounded end. The western side of the surface incorporated a drainage gully formed by the brickwork, and this led to a drain on the western edge of the trench.

This surface was truncated by various later walls and services. Wall 108 cut across the surface and appeared to have been originally bonded to wall 113 on the western edge of the trench. However,

later truncation to insert a metal pipe at the corner had obscured this. Both walls were constructed of bricks measuring 9" x 4.5" x 3", and stood eight courses high, surviving to just under the concrete floor slab. Wall 105 was constructed of similarly sized bricks. All were machine made. At the southern end of the trench was modern wall 126 enclosing concrete floor 127.

Plate 1 Trench 1 looking south (1m scales)

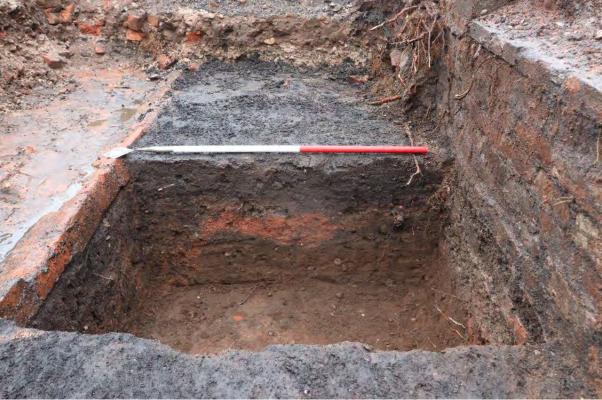
The natural geological stratum was observed in Trenches 1, 4, and 5 (Figure 8). This consisted of soft yellow sand with rounded cobbles and pebbles. In Trench 1 this was observed only in a sondage at the north-western end of the trench, at a depth of 1.24m below ground surface (49.50mAOD).

Plate 2 Sondage through layers in Trench 1. Looking south-east (1m scale)

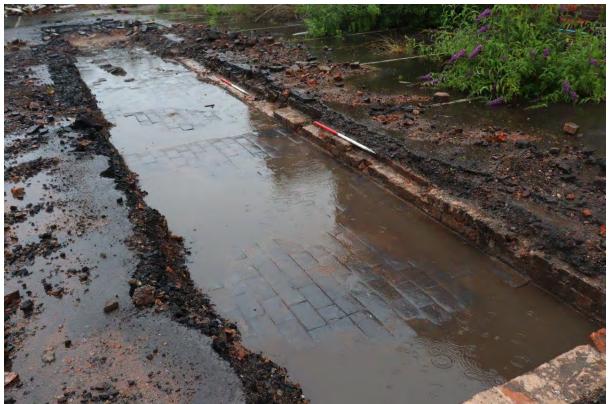
Plate 3 Trench 2 looking north (1m scales)

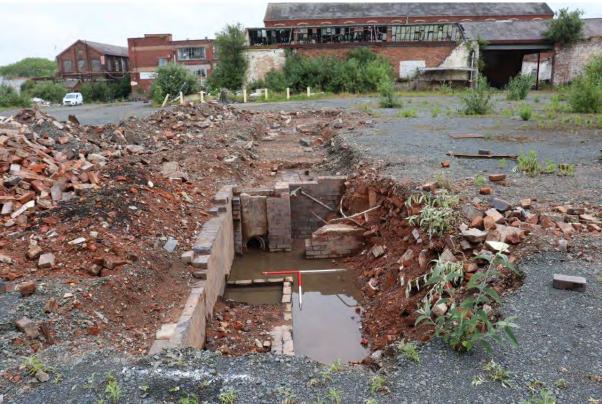
Plate 4 Trench 3 looking north-east (1m scales)

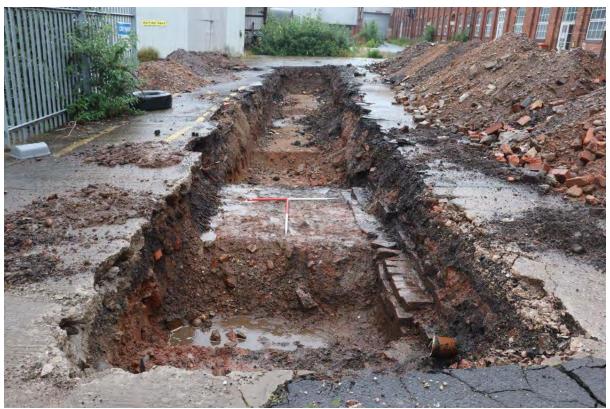
Plate 5 Trench 4 looking north-west (1m scales)

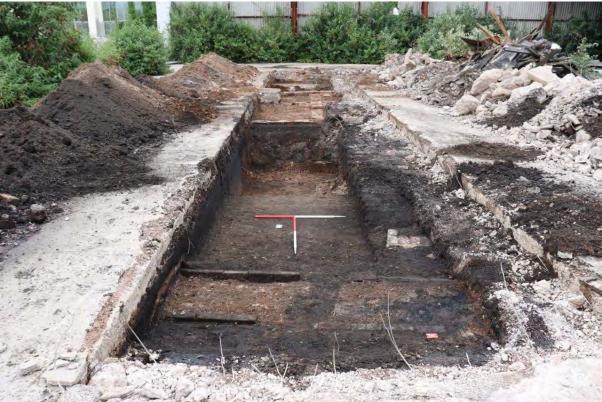
Plate 6 Trench 5 looking north-west (1m scales)
