ARCHAEOLOGICAL  
WATCHING BRIEF AT  
WITLEY COURT,  
GREAT WITLEY,  
WORCESTERSHIRE

SUPPLEMENT TO HEAS REPORT 1436

19 March 2010

Project 3469  
WSM 42112

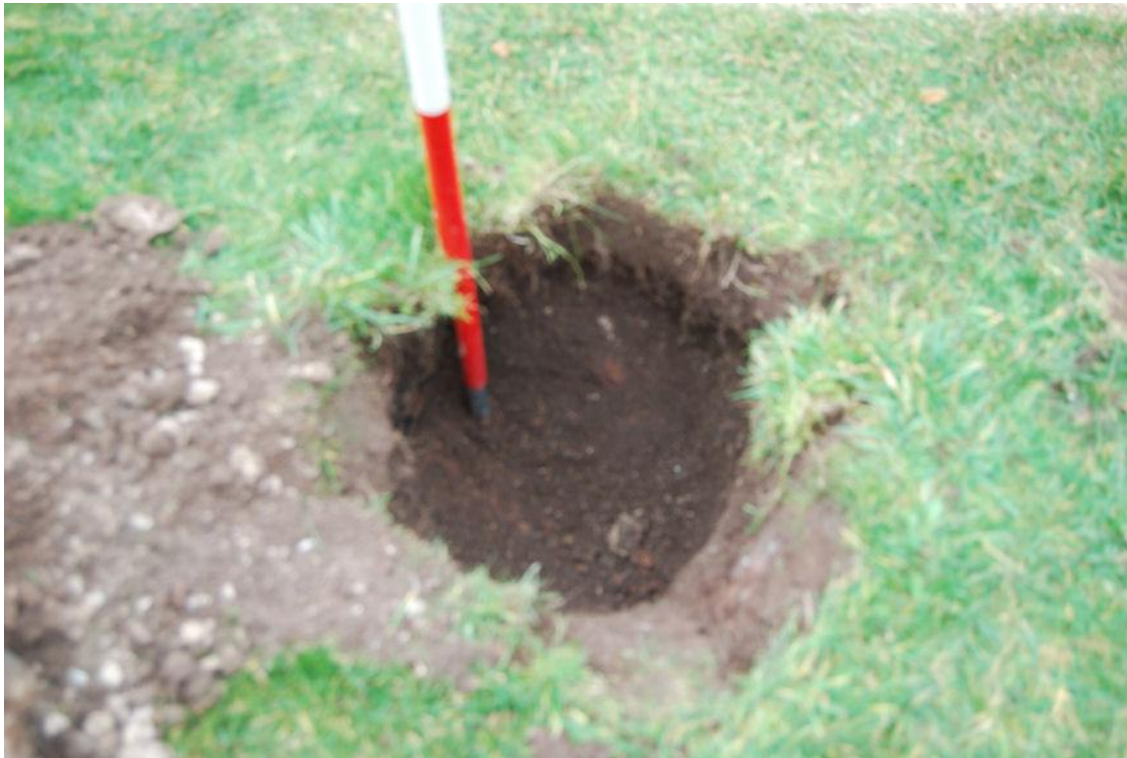
*Plate 1: Re-cut posthole for Panel 13, view north*

Panel 13 lies to the south-west of the Conservatory (Fig 5). The posthole opened for the reinstallation of the panel was wider than, but did not exceed the depth of, the previously excavated posthole (Plates 1 and 2; Potten and Templeton 2006, 5 and fig 2).

Deposit 1300, was considered to be disturbed topsoil, probably redeposited after the original excavation of the posthole in 2006. Once the concrete was removed from the hole a modern plastic sack was found, sealing fragments of brick and mortar (1302), which were left in situ as they continued beyond the edge of excavation. It is likely that this deposit is the same one observed in 2006 which was believed to be demolition debris relating to an earlier conservatory on the south west of the house (*ibid*).

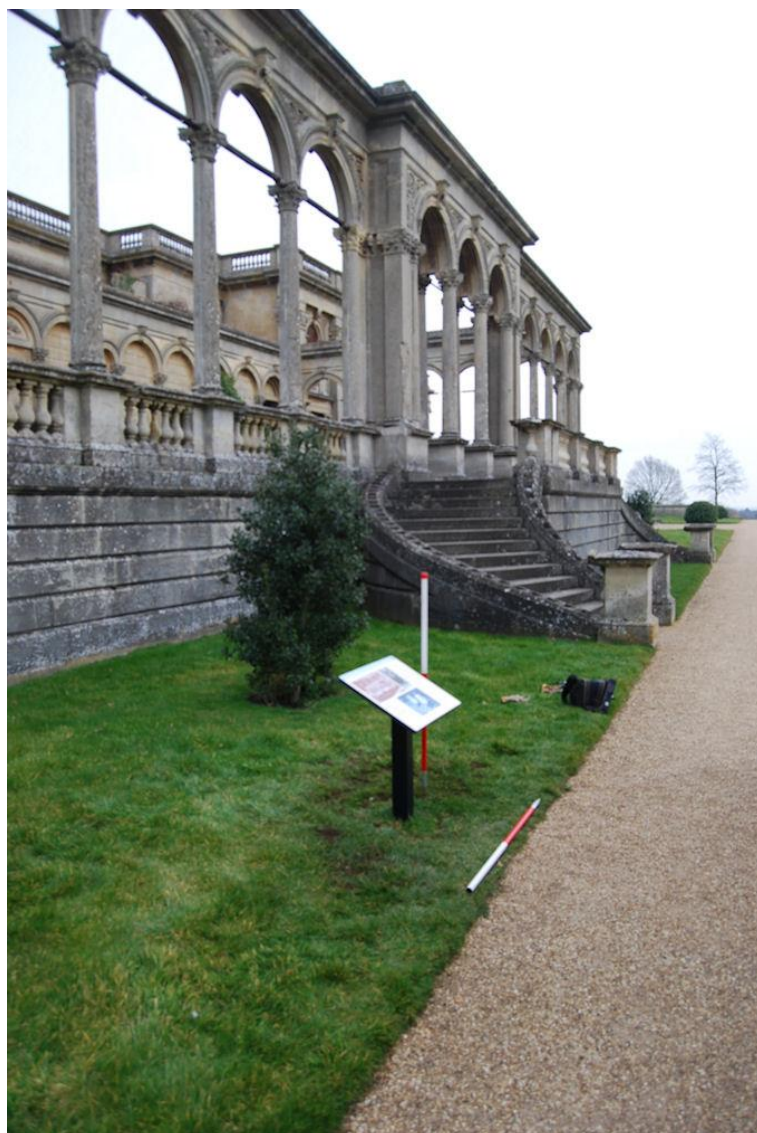
*Plate 2: Panel 13 re-installed, view east*

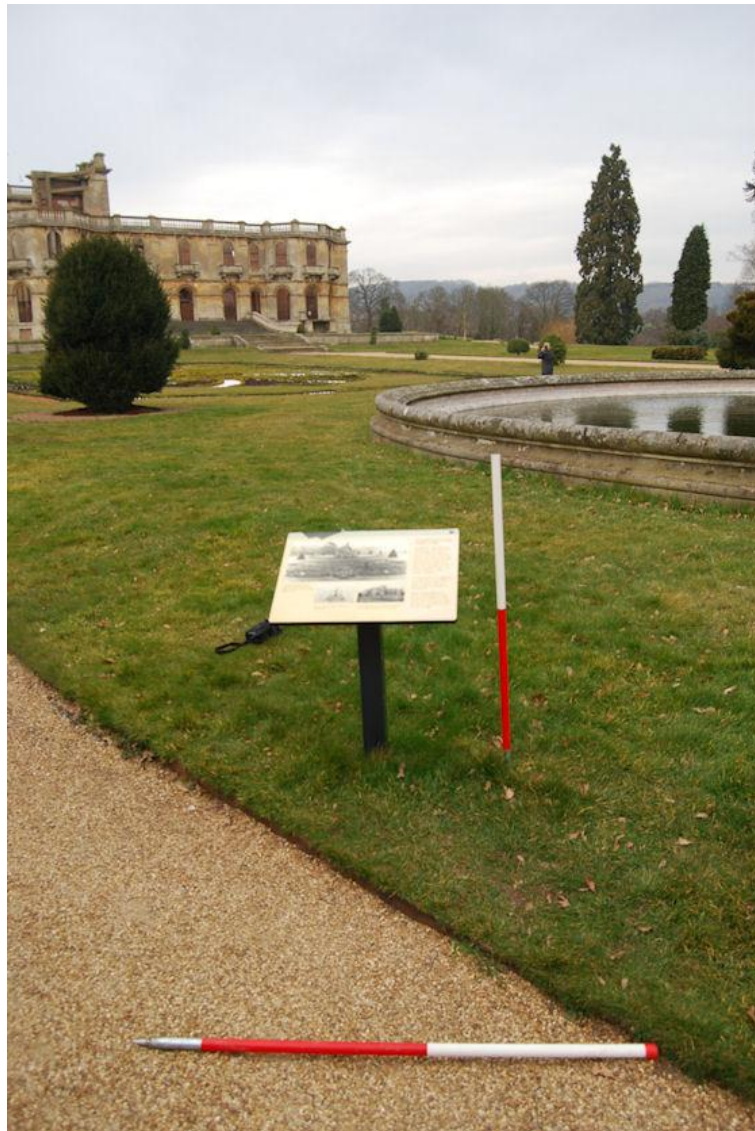
*Plate 3: Existing post for Panel 16, view north-west*

Panel 16 was moved from the south side of the East Parterre to the north-west side (Plates 3 and 4; Potten and Templeton 2006, 6 and fig 2).

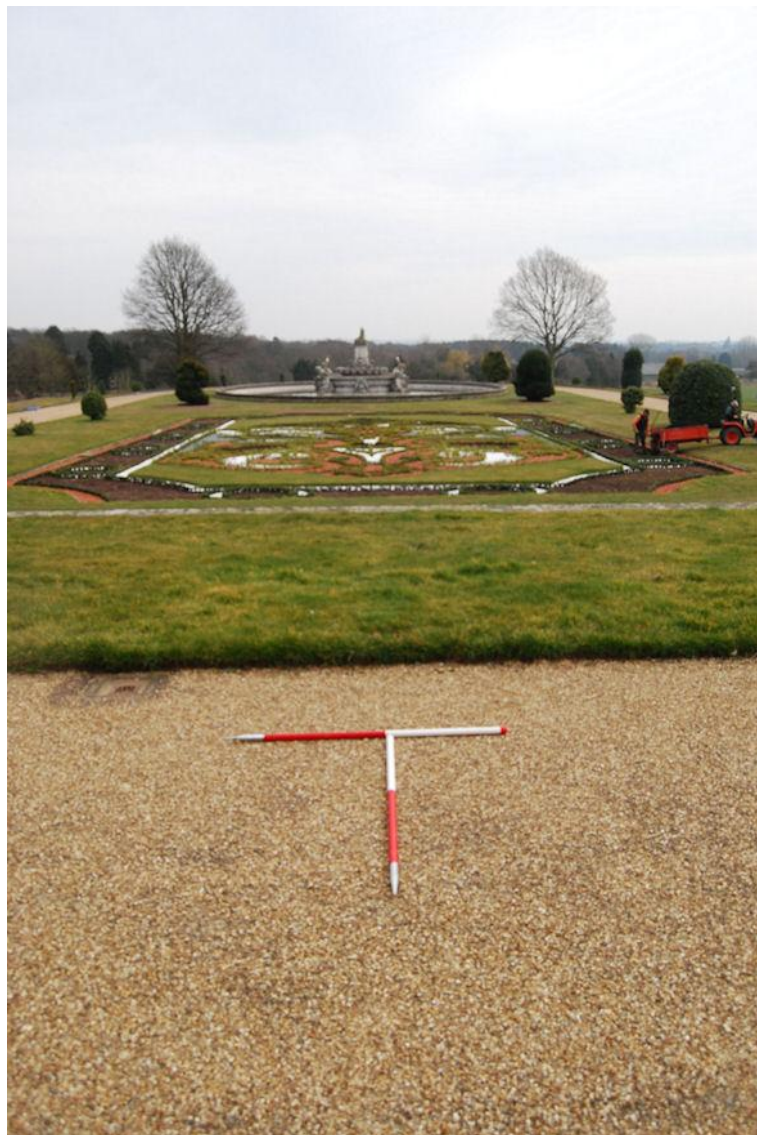
*Plate 4: New location of Panel 16 prior to excavation, view south-east*

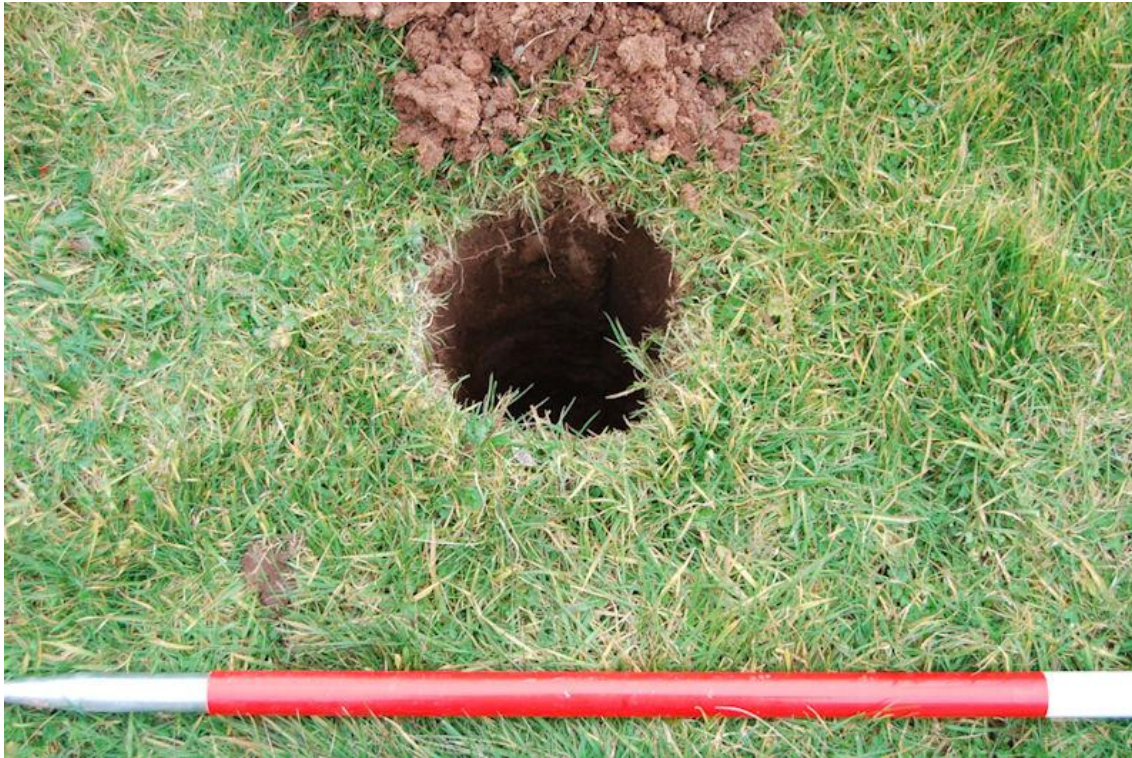
*Plate 5: Posthole cut for new location of Panel 16, view east*

Deposits 1600 and 1700 within both postholes were identified as disturbed topsoil, imported for the landscaping of the formal gardens to the south and east of the house in the 18<sup>th</sup> and 19<sup>th</sup> centuries. This reflects the findings of the previous watching briefs, which identified similar deposits within that area (Potten and Templeton 2006; Vaughan and Hughes 2009). As observed in 2006, the natural Triassic sandstone (1601 and 1701) was observed within the base, between 0.32 and 0.38m below the ground surface (Plate 5).

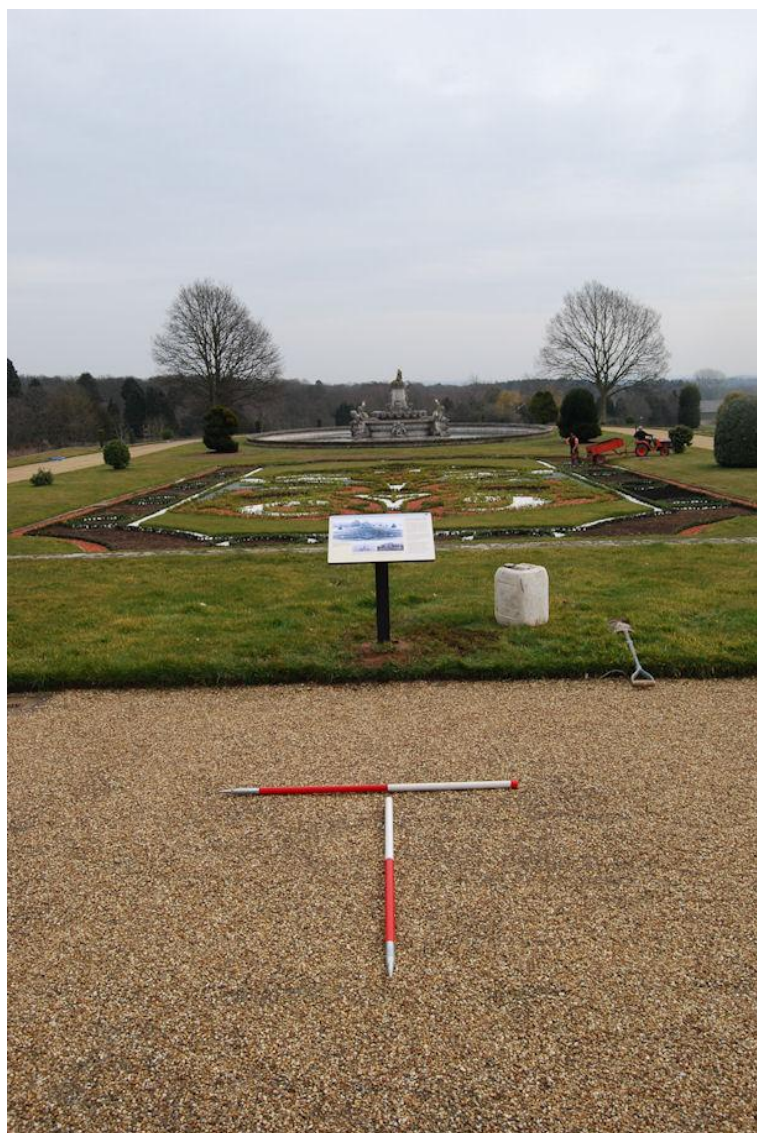
*Plate 6: Panel 16 in the new location, view south-east*
