ARCHAEOLOGICAL  
EXCAVATION OF A LATRINE  
AT  
CROOME PARK, CROOME  
D'ABITOT, WORCESTERSHIRE

Revised 4<sup>th</sup> August 2010

# Archaeological Excavation a latrine at Croome Park, Croome D'Abitot, Worcestershire

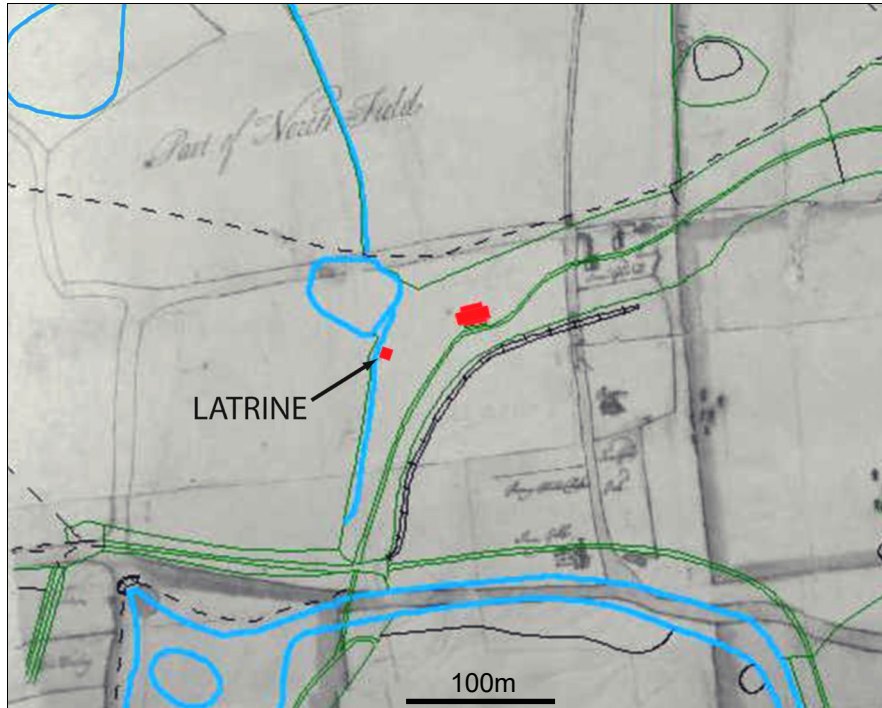
*Figure 4. Modern landscape park features superimposed on Doharty's map: Outlines of Croome River, lake, lagoons and watercourses in blue; Park boundary, paths and shrubberies in green; Latrine and Temple Greenhouse in red.*

In Figure 4, Doharty's map has been georeferenced to a modern map using points on unchanged features, e.g. the 'New Road' to High Green, and the road running northwards from the main park entrance at the London Arch. This comparison suggests that the demolished settlement would have been located within the confines of the present parkland, no more than 200m east of the latrine site.

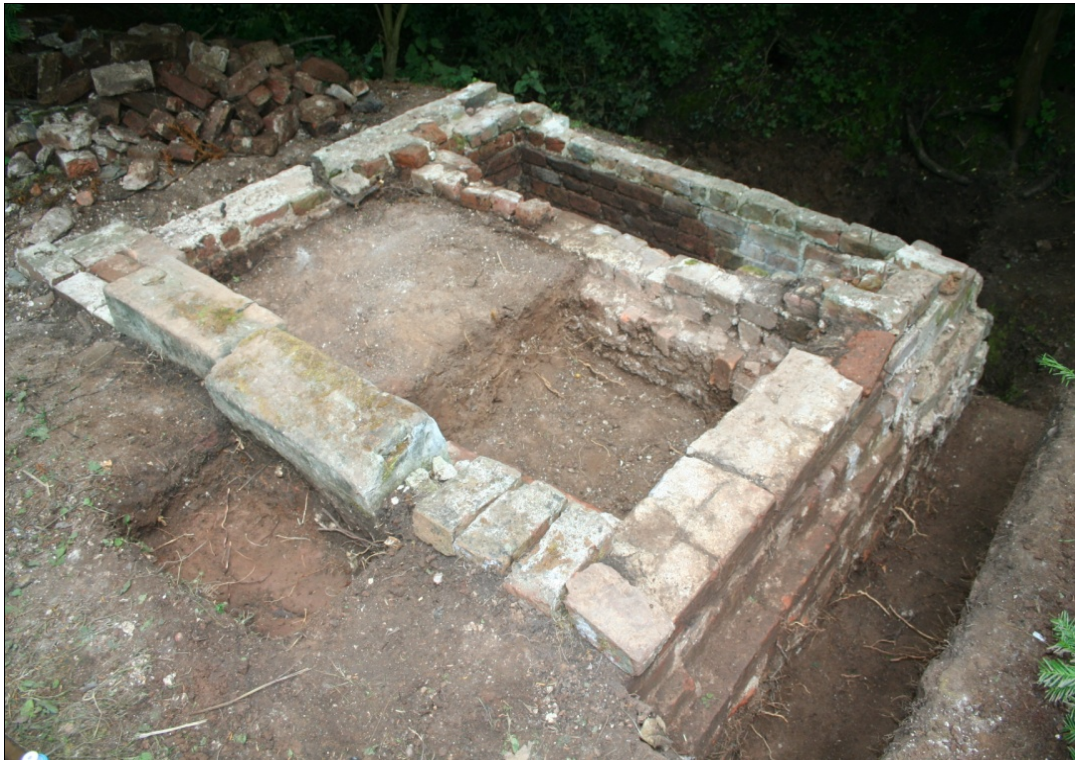
*Figure 8. General view of latrine structure, looking W. Trench on right-hand side is excavated down to the first course of bricks.*

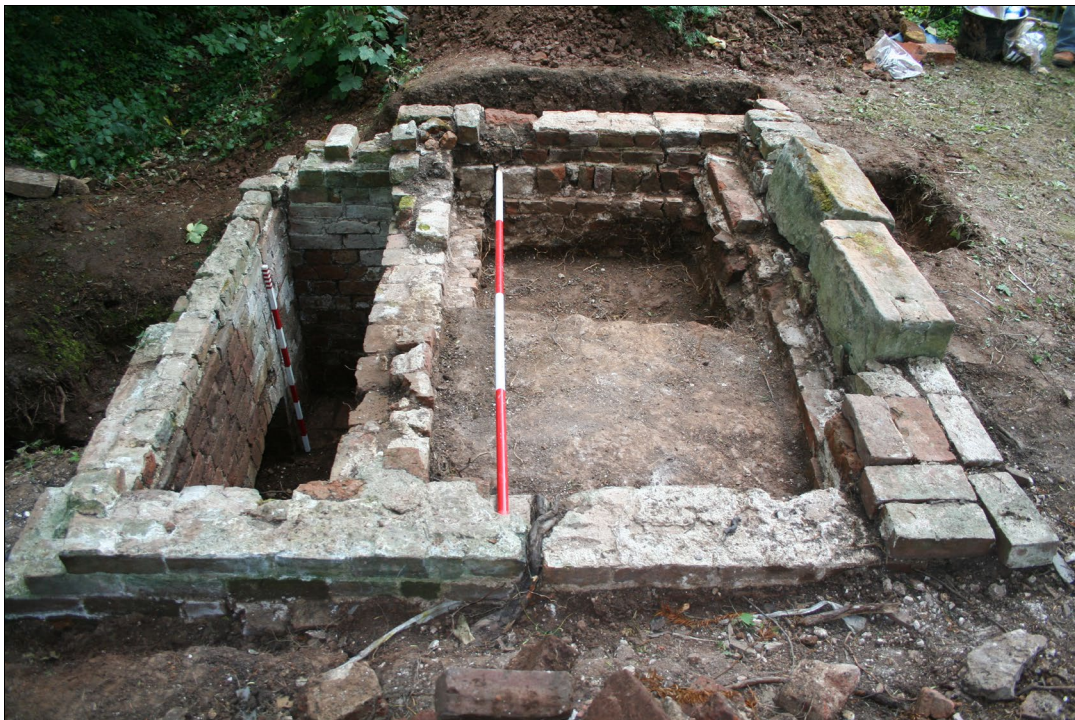
*Figure 9. Latrine, looking NE. Cess chamber is on left-hand side, with drainage ditch next to it.*

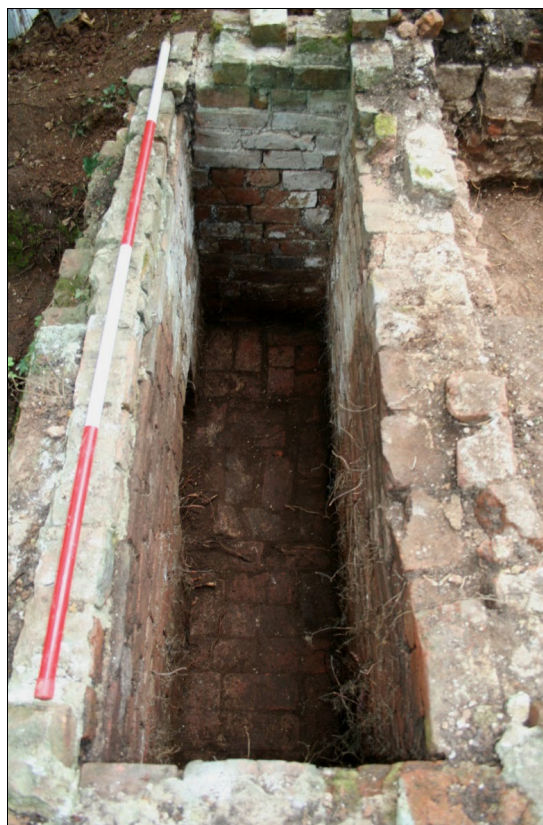
*Figure 10. Cess chamber, looking NE.*

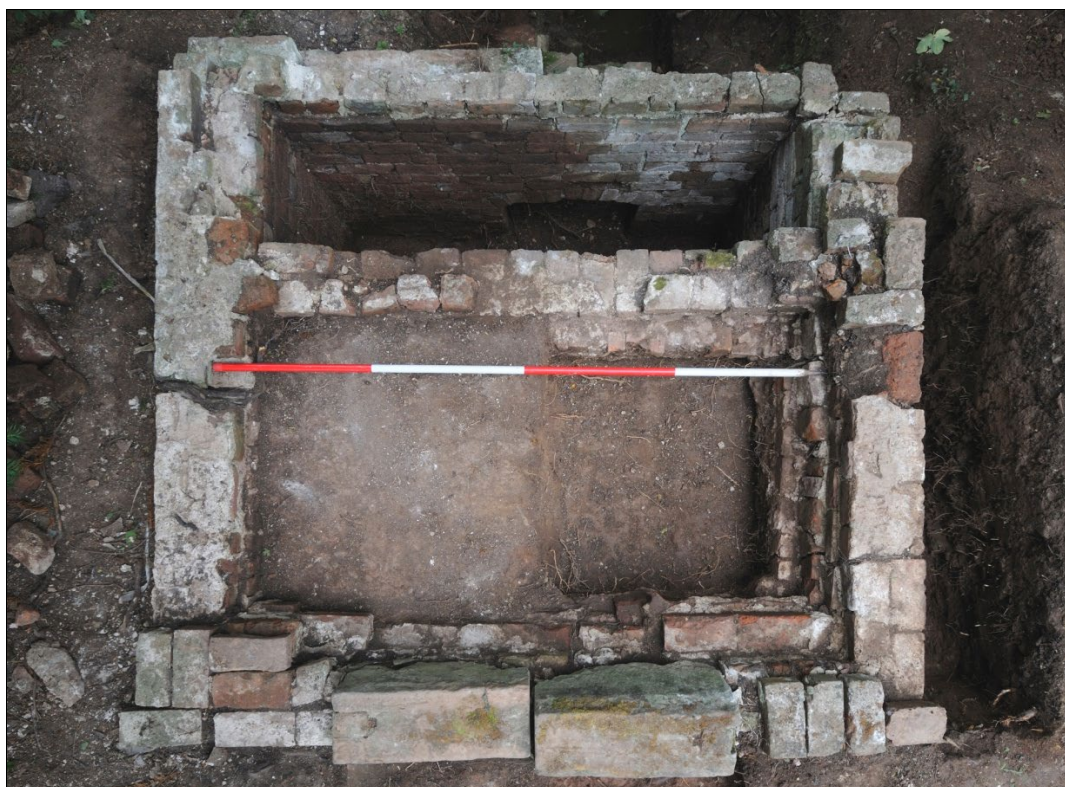
*Figure 11. Vertical view of latrine structure (NW at top).*

The excavation confirmed that the foundations visible behind the Temple Greenhouse were those of a latrine. This was almost square in plan, 2.1  $\times$  2.5m, and constructed of brick. At the front, there were two large stone doorsteps, which had inset hinge sockets for double doors. Between the back wall and an internal wall there was a cess chamber, its brick base lying approximately 1.2m below the estimated level of the main floor. The cess drained, via an arched aperture, into the ditch running behind the latrine. There would probably have been a wooden bench above the cess chamber, with room for up to three openings, although no trace of this survived.

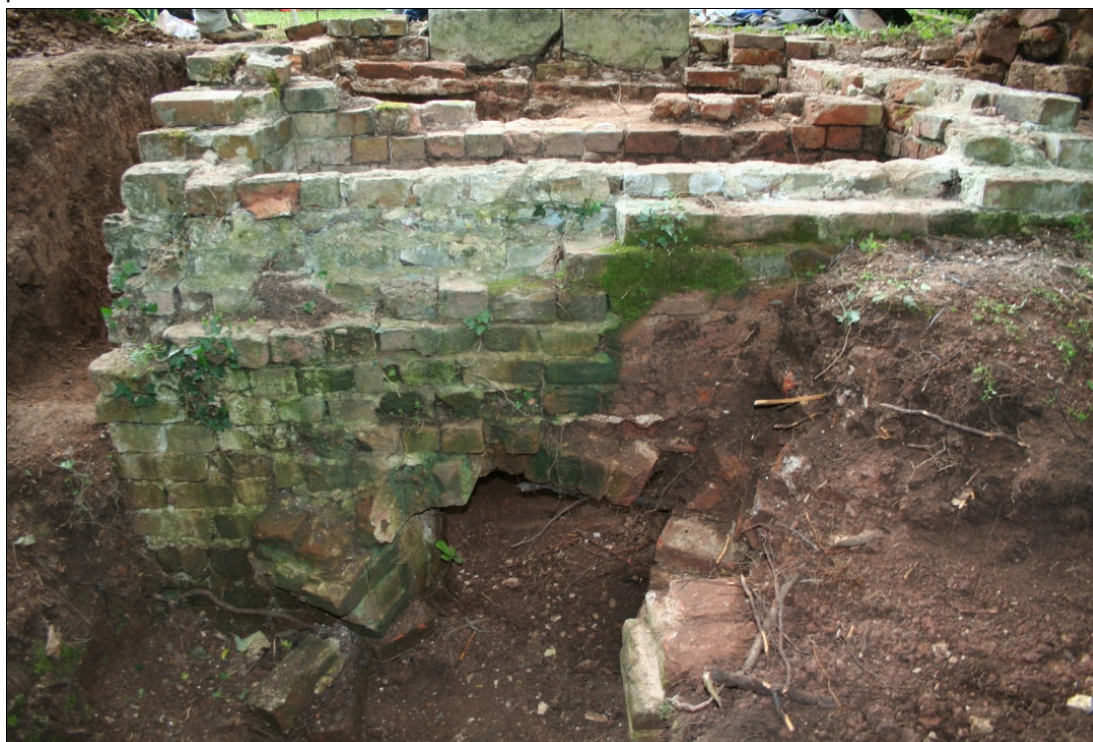
*Figure 12. NW wall, with arched discharge from cess chamber above the ditch.*

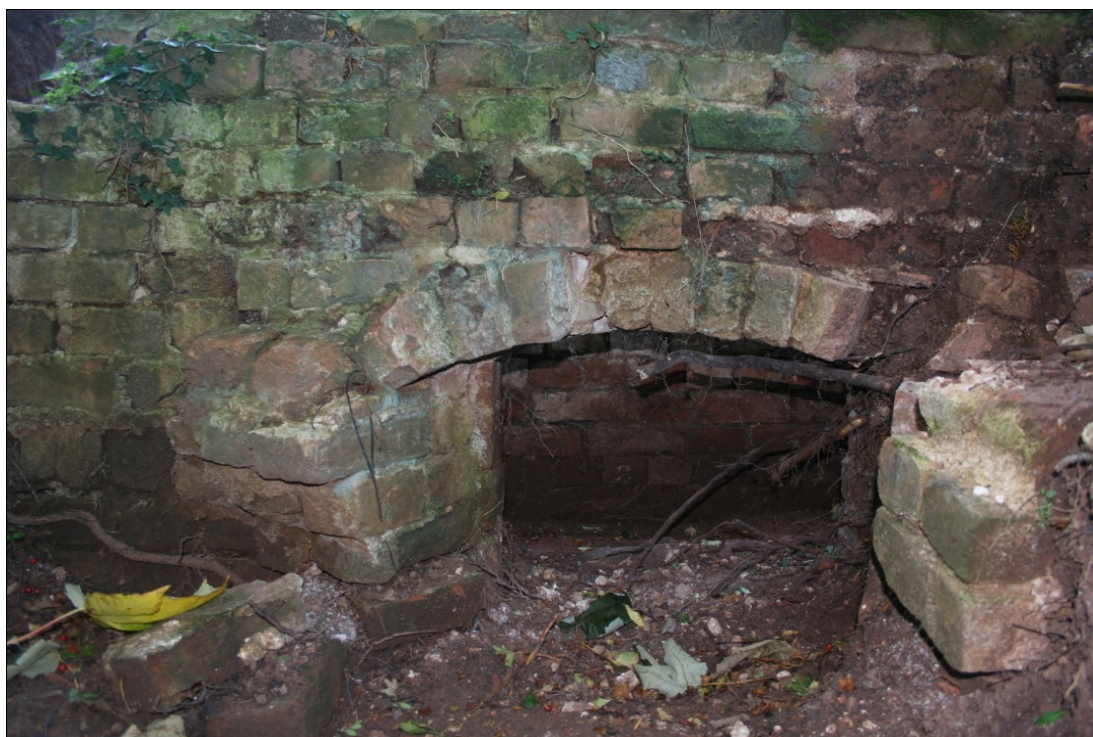
*Figure 13. Brickwork around discharge from cess chamber.*

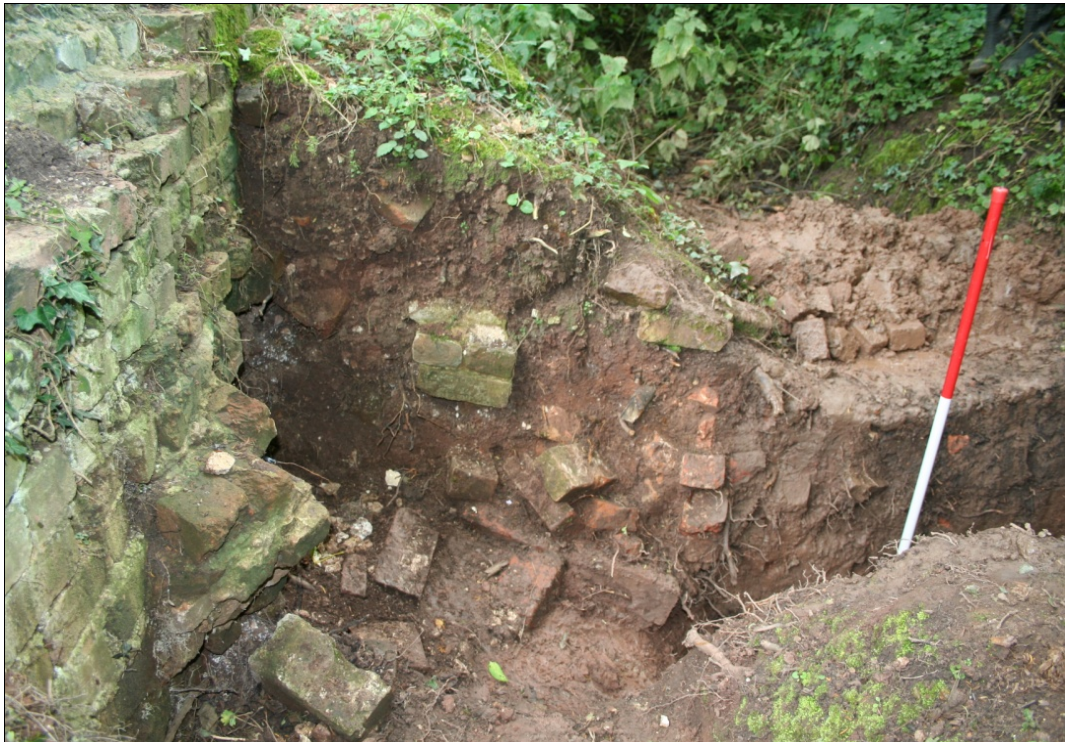
*Figure 14. NE facing section through bank of ditch, containing demolition rubble.*

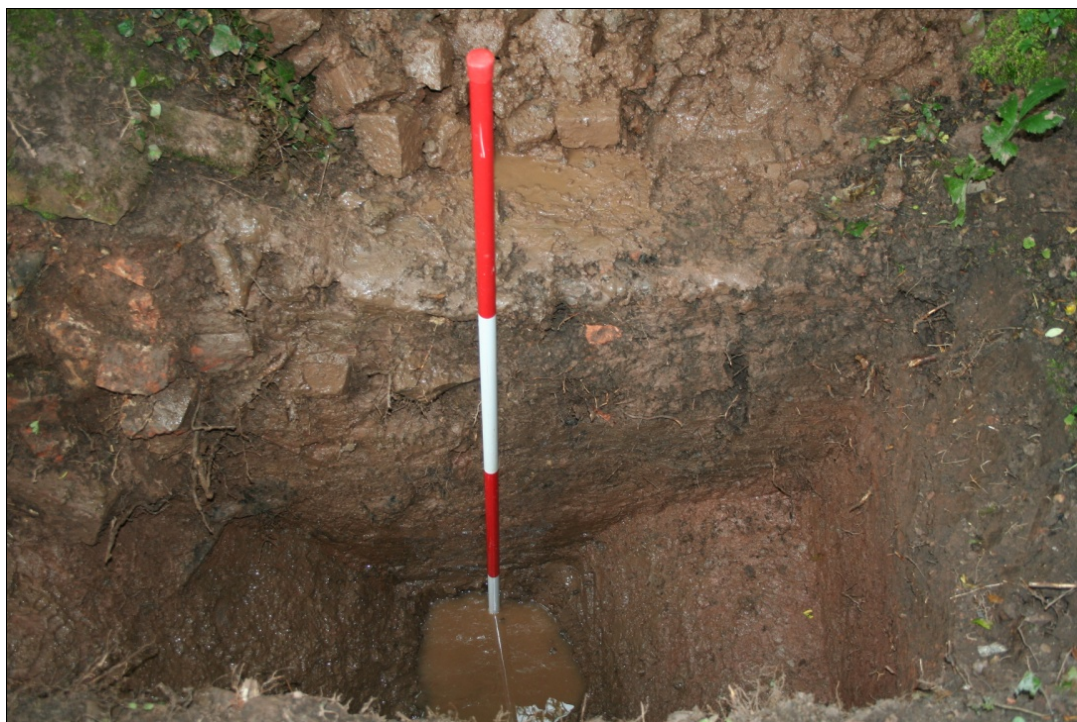
*Figure 15. NE facing section through deepest part of ditch.*

The ditch that acted as a drain for the latrine was over 2m deep and V-shaped. No dating evidence was recovered from its lower fills, but comparison of the Doharty and Snape estate maps shows that it was not present as a boundary before the creation of the landscape park. Though heavily silted up now, it would have also provided a passage for water between a small lagoon and a watercourse leading to the ornamental lake. The surprising depth and V-shape of the ditch could indicate that it also acted as a deer-leap at some point.

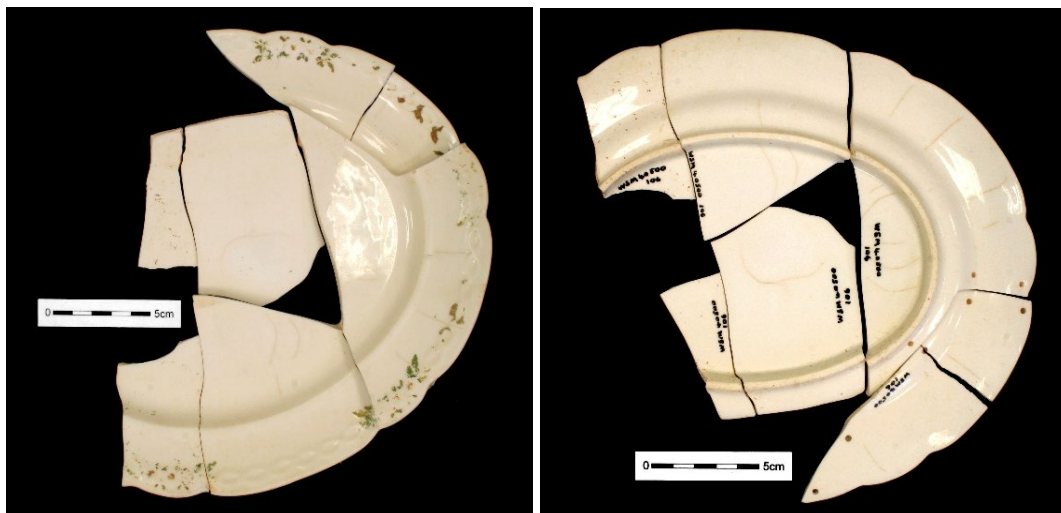
Figure 16. (a) Bone china platter, with repair holes (bottom right) drilled on underside.

In spite of its ignominious place of disposal, the value this bone china must have once had as a possession was evident from the trouble that had been taken to repair the oval platter, after a large rim segment had broken away. Blind holes had been carefully drilled either side of the break, to accept metal rivets or staples, though none of these small fasteners was recovered during the excavation (Figure 16).
