Archaeological watching brief of pylon installation works, Southern Link Road, Temeside Way, Worcester

*for
Western Power Distribution plc*

Worcestershire Archaeology

August 2018

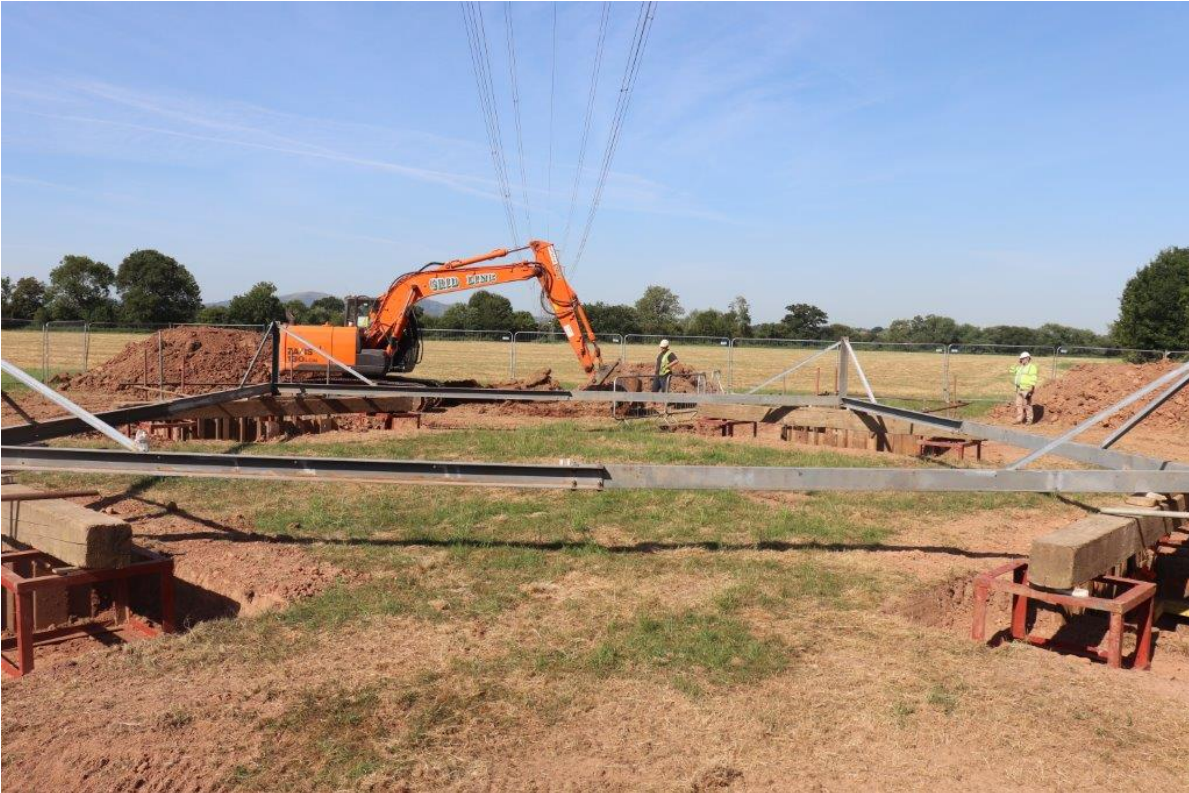
Plate 1 The pylon area showing machine in area of TP1 and existing works, view west

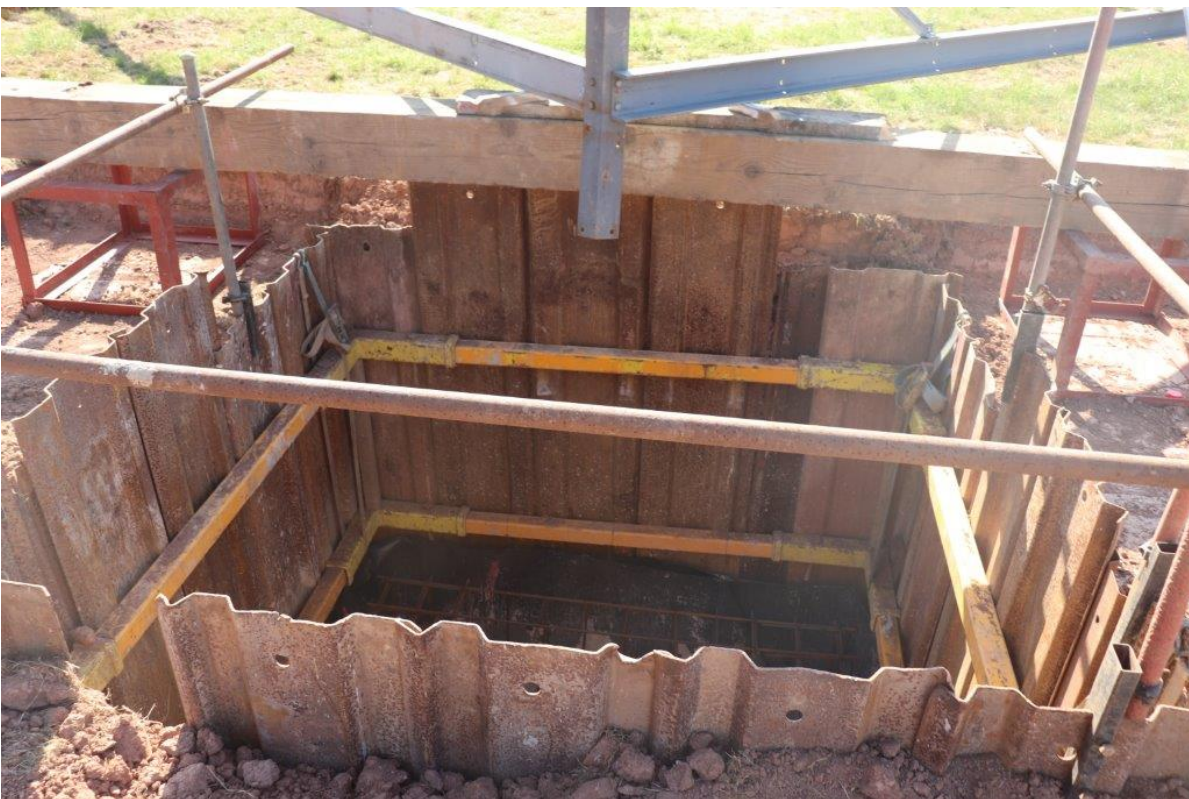
Plate 2 Example of one of pylon base pits shuttered and filled with concrete

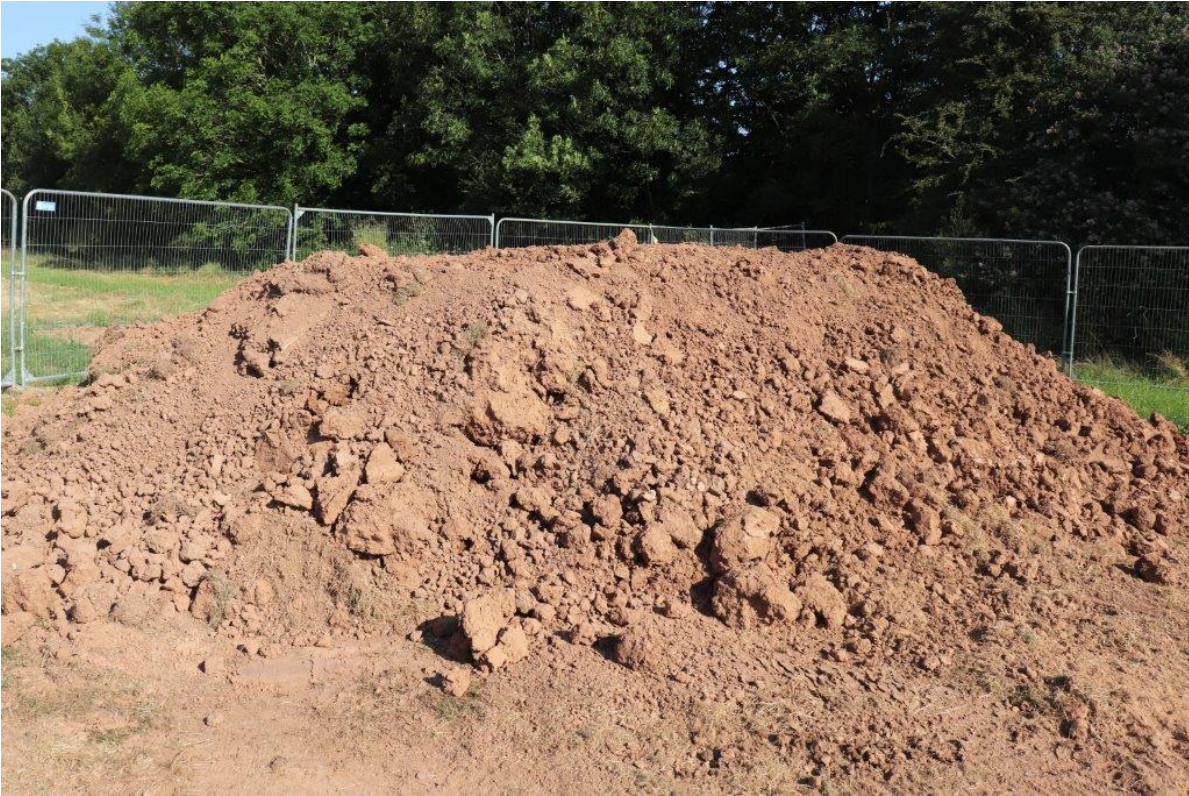
Plate 3 Example of one of the spoil heaps that was metal detected after flattening

In addition the spoil from all pits was scanned with a metal detector for artefacts.

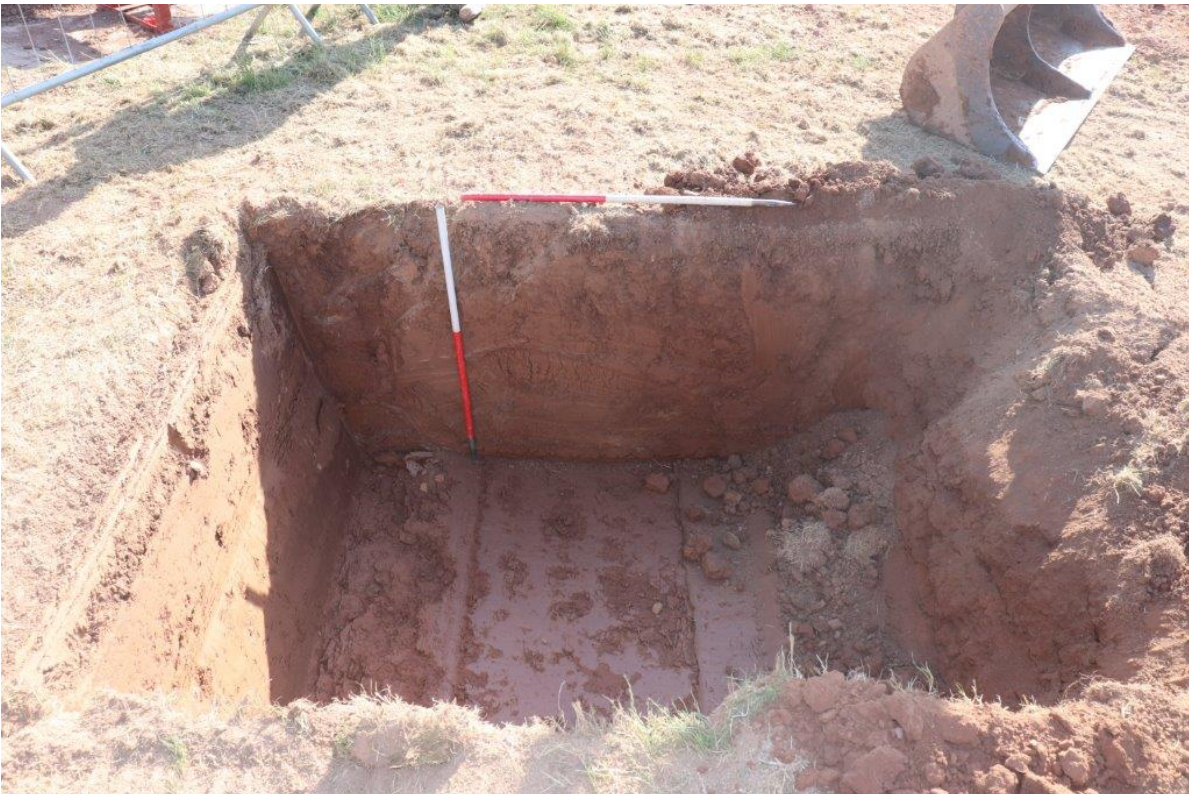
Plate 4 Test Pit 1 at 1.2m depth, view east, 2x 1m scales

The original four pits were not made available for monitoring. However full observation of the additional pit was undertaken during machine excavation. The exposed surfaces were sufficiently clean to observe well-differentiated archaeological deposits, though any less clear may not have been identified. The pit was not accessed beyond 1.20m depth, for reasons of health and safety.

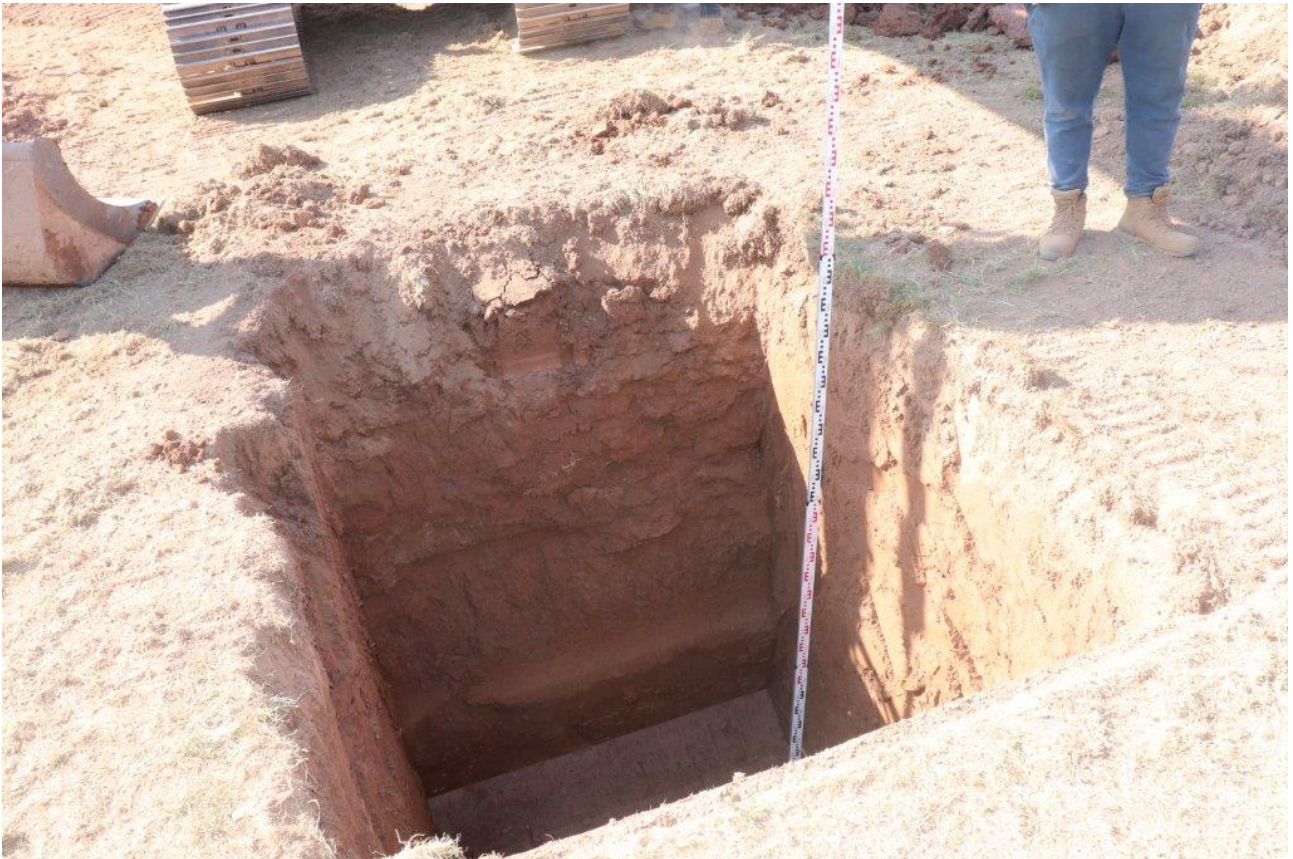
Plate 5 Test Pit 1 excavated to full depth of 3.00m showing sterile homogenous alluvial deposits above sand and gravel river terrace at base, measuring staff as scale, view south-west

Context	Classification	Description	Depth below ground surface (b.g.s) – top and bottom of deposits
100	Topsoil	Friable mid grey brown sandy clay silt	0.00–0.30m
101	Subsoil	Mod compact light yellowish orange brown clay silt	0.30-0.50m
102	Alluvium	Firm mid reddish brown clay silt	0.50-1.20m
103	Alluvium	Firm dark reddish brown clay silt with frequent manganese	1.20- 2.90m
104	Natural	Sand gravel river terrace	2.90m +

One test pit was opened up to record the stratigraphy in the area. A similar stratigraphic make up was found to the results during the evaluation stage of works (Bradley Arnold 2017). Evaluation Trench 6 was located to the north-west of the current works (Figure 2). This exposed the topsoil, subsoil and alluvial sequence above the natural strata. The natural river terrace sands and gravels were recorded at 2.90m and excavation stopped at 3.00m below ground level.
