# Building recording at Sharrow, Bidford Road, Cleeve Prior, Worcestershire

Building recording report

Site name: Sharrow, Bidford Road, Cleeve Prior, Worcestershire  
Local planning authority: Wychavon District Council  
Planning reference: 19/00283 and 19/00284  
Central NGR: SP 08902 49244  
Commissioning client: Douglas Carr  
WA project number: P5609  
WA report number: 2884  
HER reference: WSM71620  
Oasis reference: fieldsec1-412305

Building recording was undertaken of a former stable at Sharrow, Bidford Road, Cleeve Prior, Worcestershire (NGR SP 08902 49244). It was commissioned by Douglas Carr, in advance of proposed conversion of the existing building into a residential annexe. A planning application has been submitted.

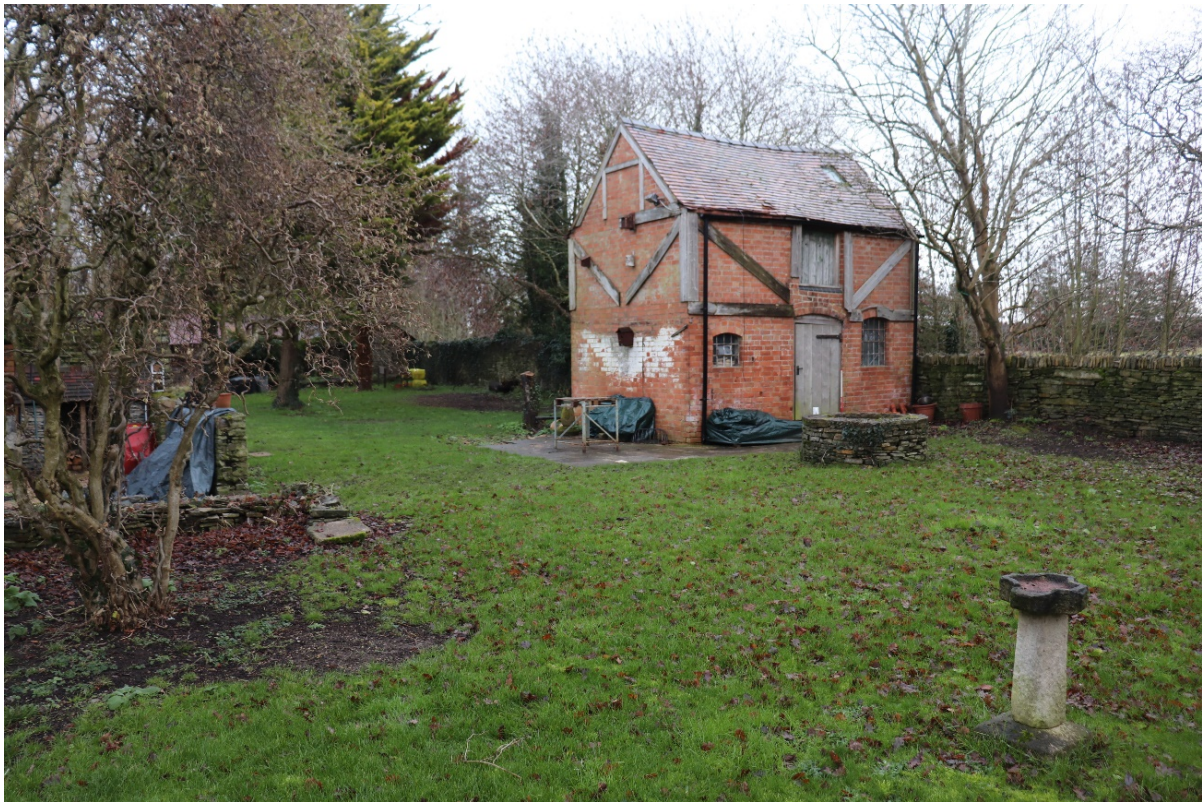
*Plate 1 The building, general view north-east, scale 1m*

The building (Plate 1 to Plate 2) comprises a small brick rectangular structure with decorative timber facings, aligned broadly east to west with gabled ends and a tiled roof. It has a single door on the ground floor facing to the south, flanked by two casement windows. Directly above the door was a hatch which opened into the first-floor space. The building is currently used as a storage space.

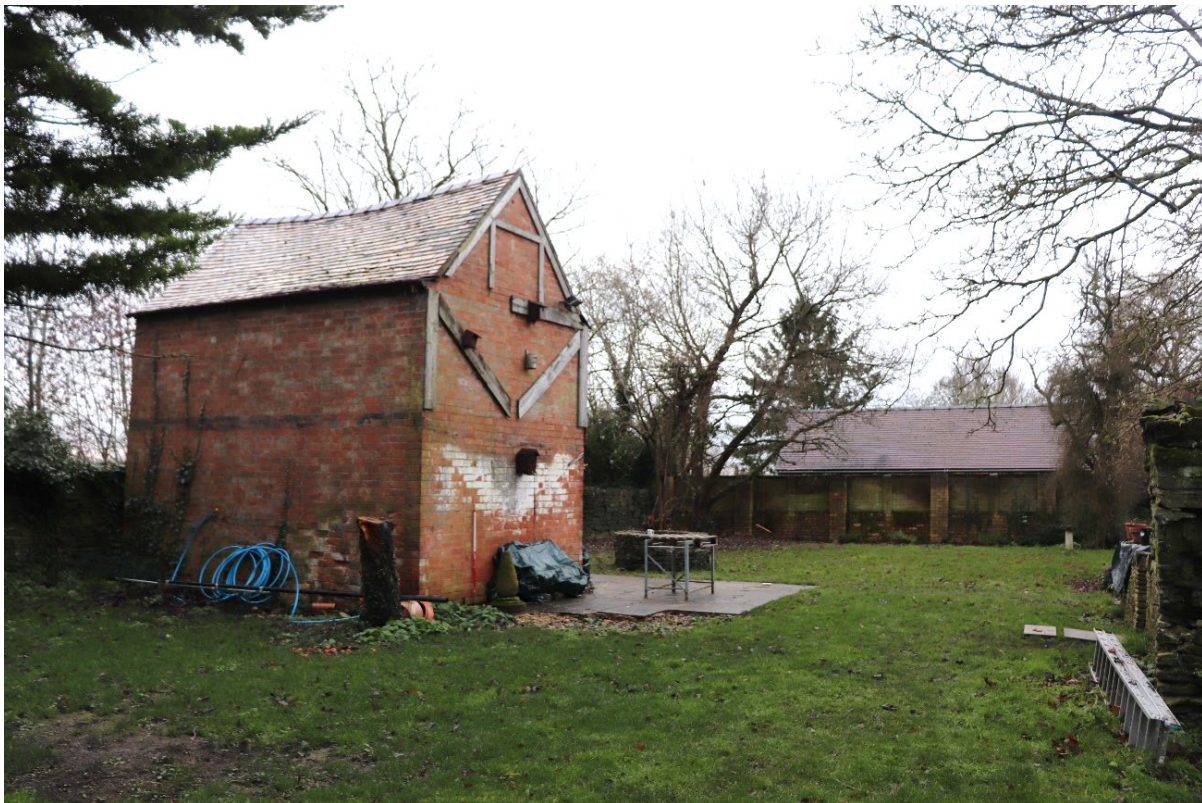
*Plate 2 The building, general view south-west, scale 1m*

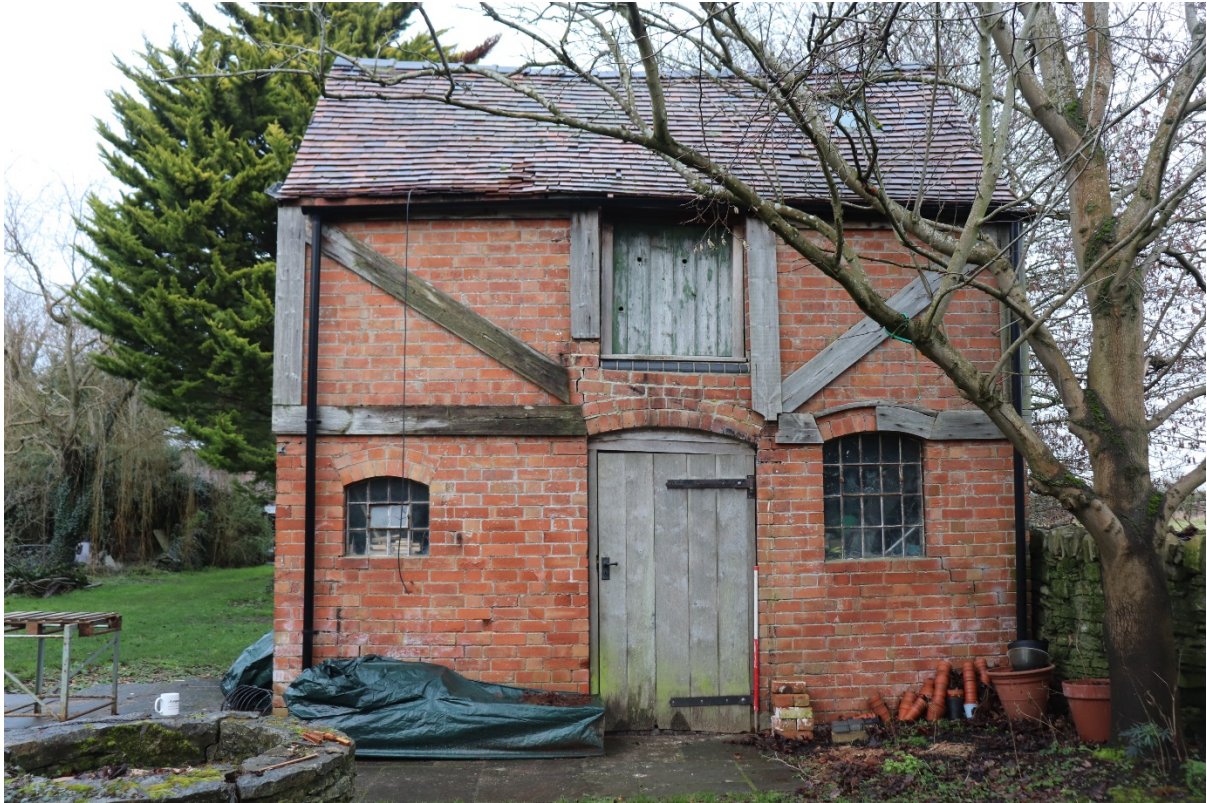
The basic layout of the building and majority of its fabric dated to this period. The door, window and hatch positions on the frontage on the south elevation are original. The metal window frames on the ground floor and the wood of the hatch on the first floor are original. The door appears to be later (Plate 3). It is unclear if the external timber frame effect planking on the south and west elevations is original.

*Plate 3 The building, south elevation, view north, scale 1m*

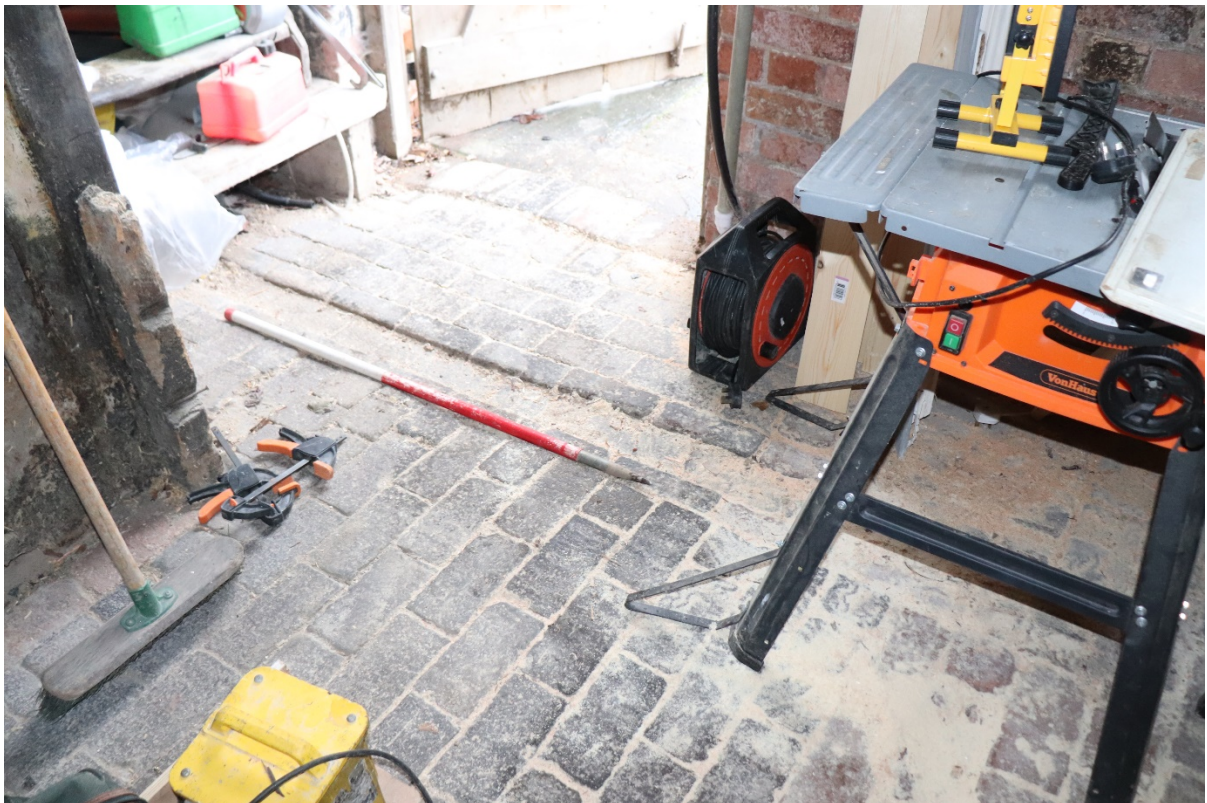
Internally, within the ground floor, a drain (Plate 4) extended for most of the length of the room, which was laid with purple engineering brick, excepting at the west end where a strip of red brick was used as flooring. This area corresponded with timbers sunk into the wall in the north-west corner (Plate 5), indicating a former internal division which corresponded with the smaller of the two exterior windows. A gap along the northern side of the first floor above was for dropping hay to a feeding rack below, though the remaining element was of Phase 2, indicated by a sawn off floor joist which was present in the north-west corner that was not present at the north-east corner. It is likely that the ground floor was spilt into a stable along with a small tack room.

*Plate 4 Internal drain, view south-east, scale 1m*

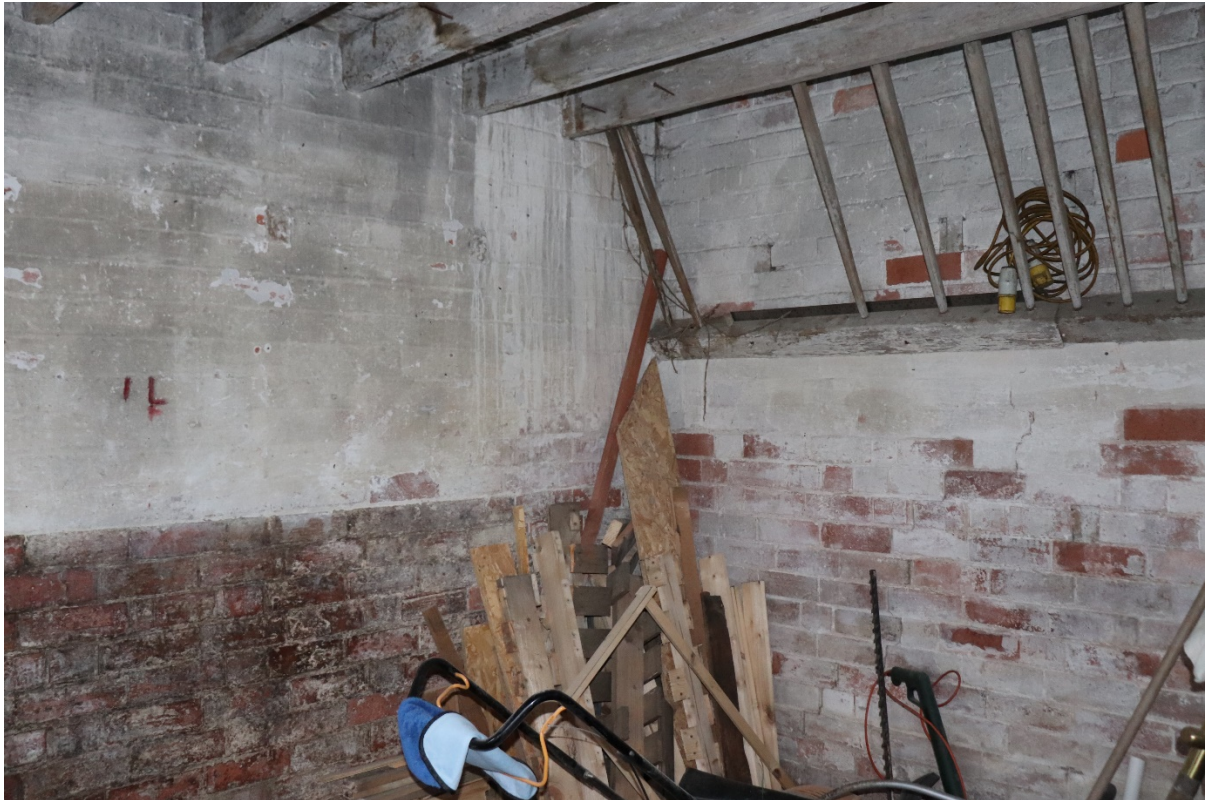
*Plate 5 Timbers set into the wall, view north-west, no scale*

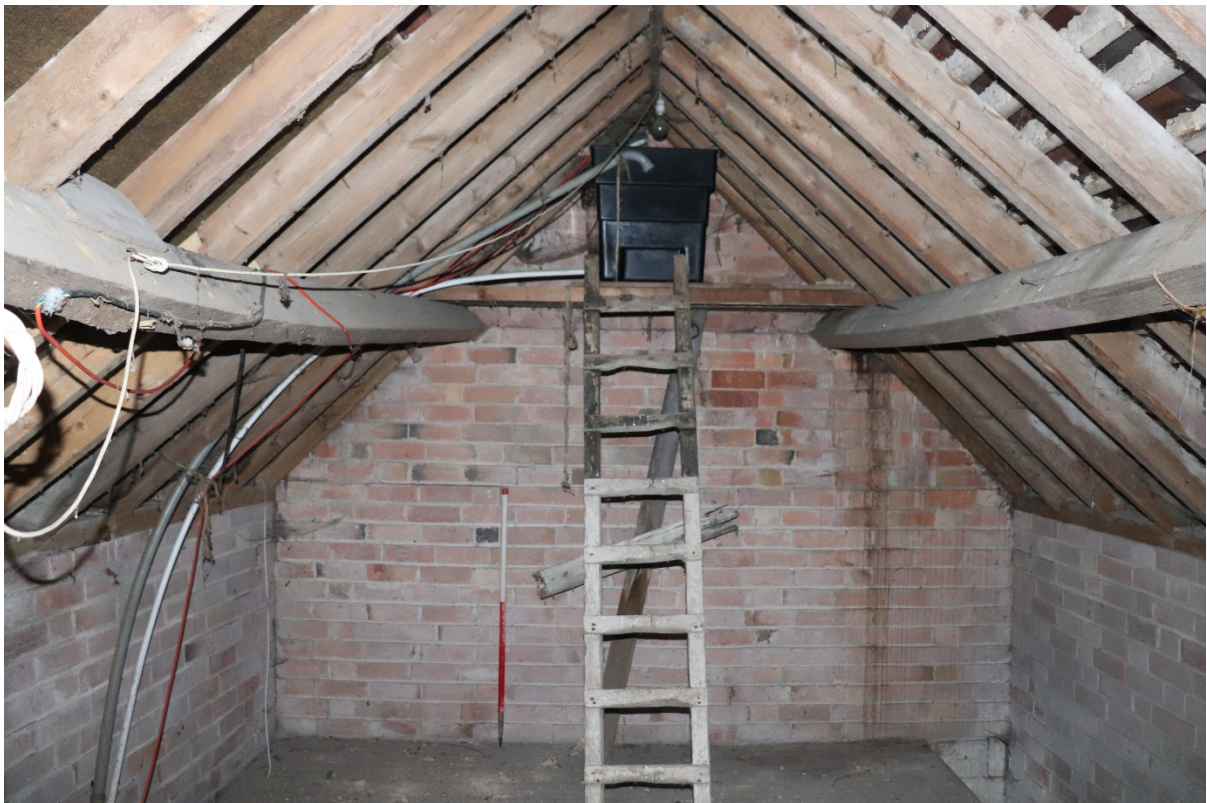
The first floor (Plates 6 and 7) was accessed by a ladder from behind the later staircase, as well as the external hatch above the door, from which hay would have been loaded.

The function as a stable ended once the reused staircase was added in the position of the earlier ladder access (Plate 9), as well as a water tank and associated plumbing at the top of the roof (Plate 6). Part of the roof was replaced at this time on the southern side.

*Plate 6 The first floor, view west, scale 1m*

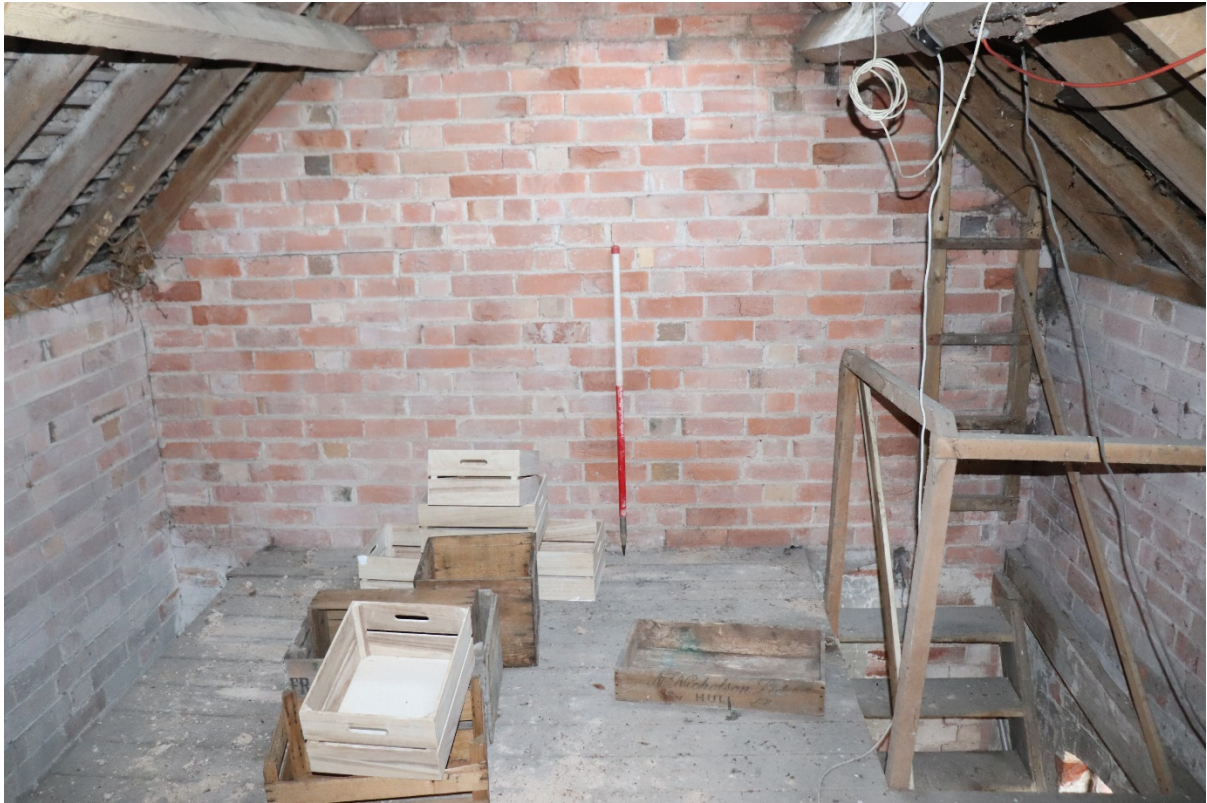
*Plate 7 The first floor, looking east, scale 1m*

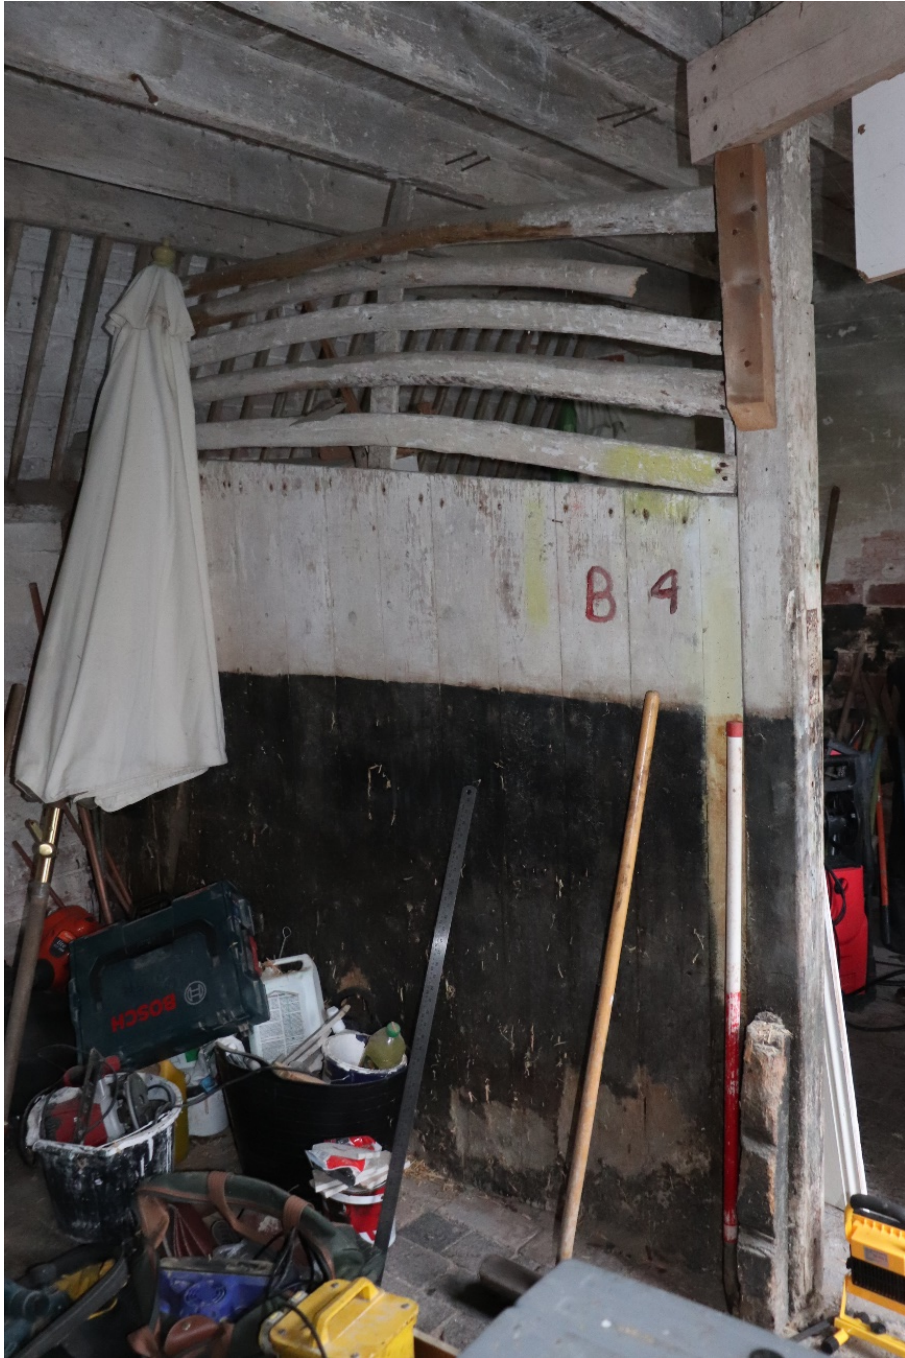
The possible tack room was removed, with the hay rack added and the ground floor split into two with the addition of a timber division (Plate 8), creating two stables.

*Plate 8 Phase 2 stable division and hay rack, view north-east, scale 1m*

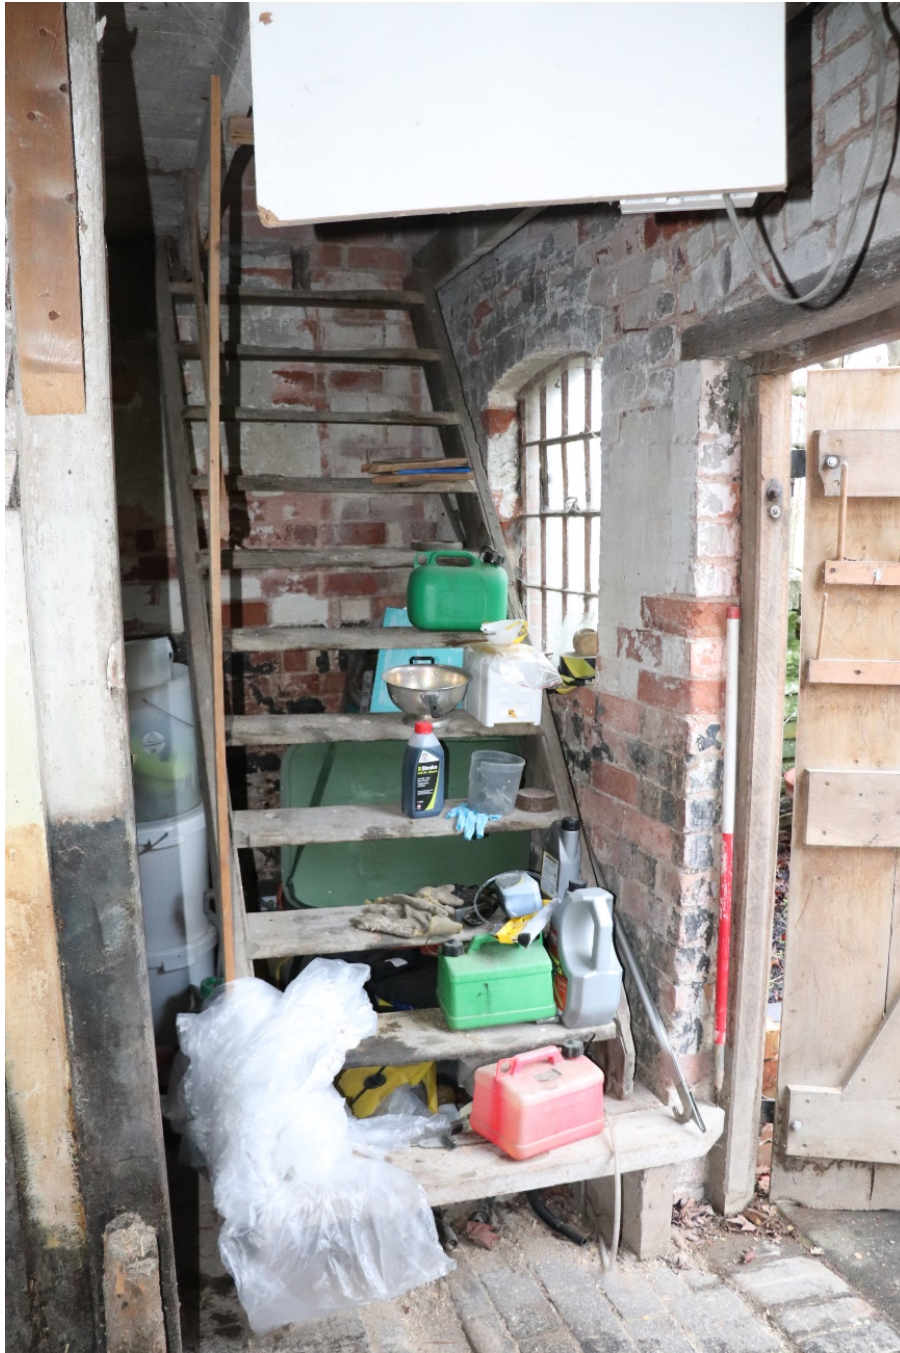
*Plate 9 Phase 3 stairs, view east, scale 1m*

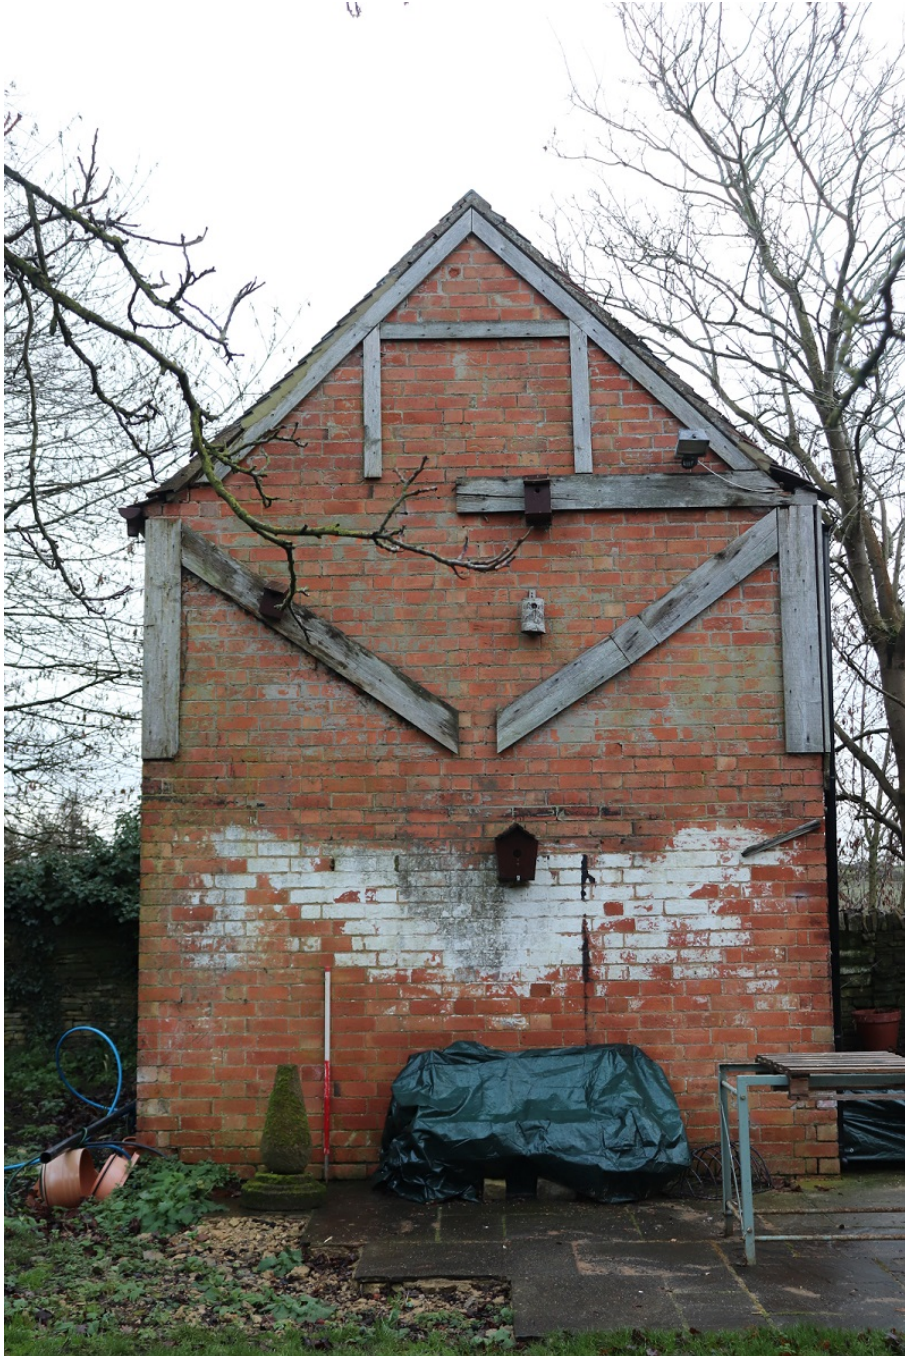
The extant white paint on the lower half of the external gable end wall of the building, along with the more weathered condition of the brickwork above, which also corresponds with the lower edge of the timber plank framing, indicates that the previously adjoining building to the east was of a single storey (Plate 10). Traces of black paint or bitumen across the wall indicate that at some stage the roof line sloped down from north to south. A horizontal line of black paint or bitumen across the external north

*Plate 10 The building, west gable elevation, view east, scale 1m*

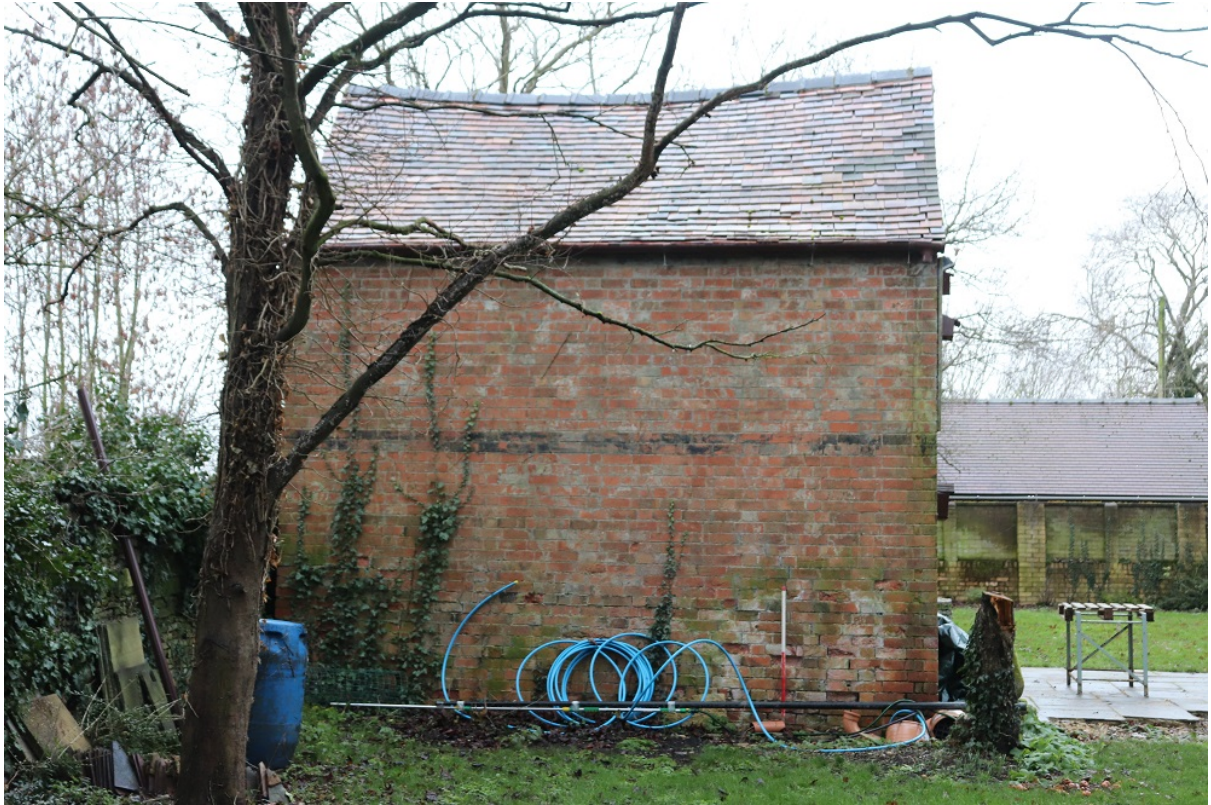
elevation corresponds with that on the west elevation (Plate 11). There is no other evidence of an adjoining structure on this elevation, so the line appears to be purely decorative.

*Plate 11, The building, north elevation, view south, scale 1m*
