Building recording at Pye Hill Farm, Hartlebury, Worcestershire

Worcestershire Archaeology
for Pieter van Zyl

February 2021

Building recording report

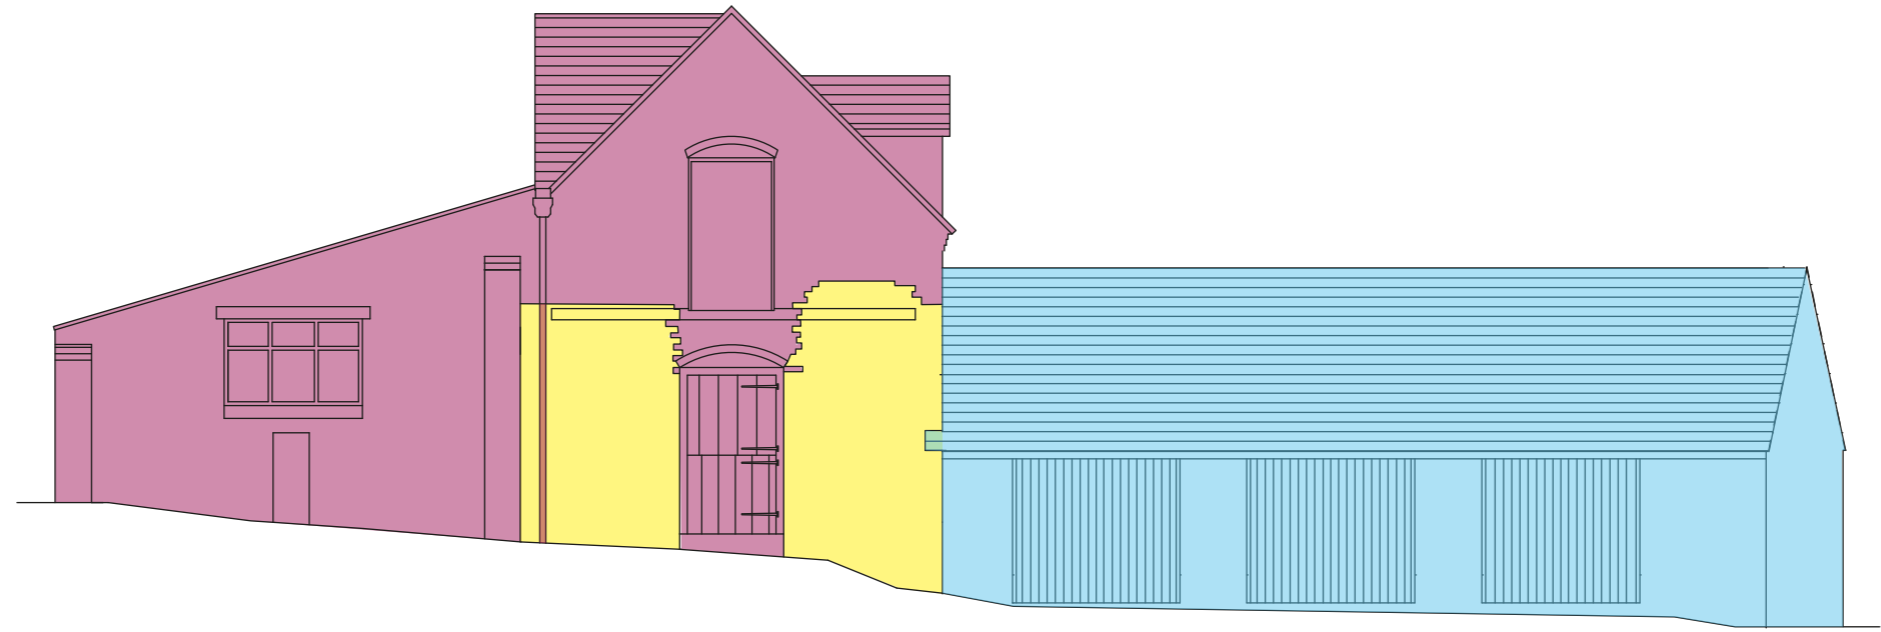
*Stable, coshed and garage phase plans with plate location and phasing
(after John Anthony Architechterural services drawings 789-6 and 789-10)*

A single storey structure was added to the north-east side of the likely dovecote at a slight angle (Plate 3, Plate 16 and Figures 8 and 9). It was sandstone built, though with a brick end gable above wall plate level. Internally it was split into four bays, as divided by three machine-converted softwood

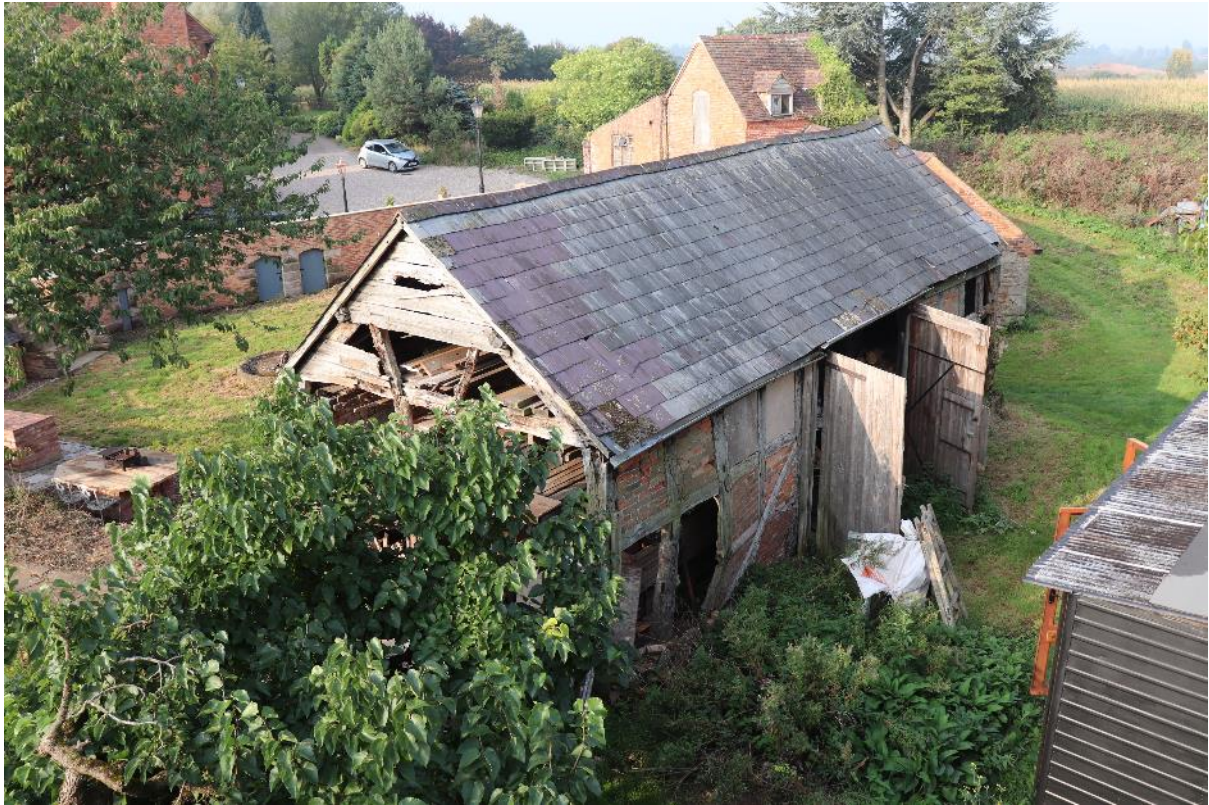
Plate 1 Phase 1 barn, looking south-west

The largest element is a broadly east to west three bay timber framed barn (Plate 1 and Plate 2) with brick infill panels, large central doors and tiled gabled roof. To the south-west of this was a single storey stone built range with tiled gabled roof aligned broadly north-east to south west with three double doors facing to the south-east (Plate 3). This was built at a slightly offset angle onto a further stone and brick built broadly square structure which again had a door facing to the south-east with a hatch door above (Plate 4). Its main gabled and tiled roof ran north-west to south-east, but with an extra smaller gable the south-west and two gabled windows to the north-east. On the south-west end of the this element was a brick built single storey lean-to structure with a single pitch corrugated metal roof (Plate 4 and Plate 5). To the south of these buildings was the three storey brick farmhouse with tile roof with and front facing towards the east along with a projecting wing to the rear. Historic information

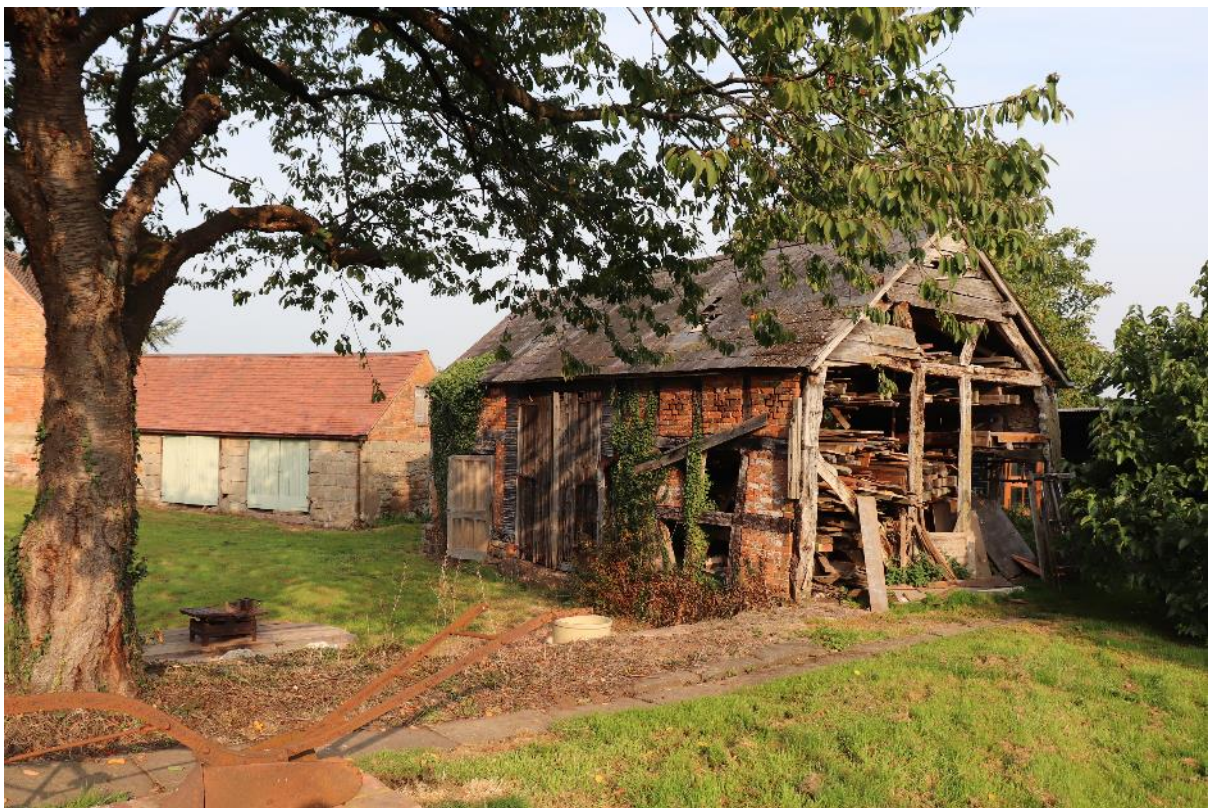
Plate 2 Phase 1 barn, looking north-west

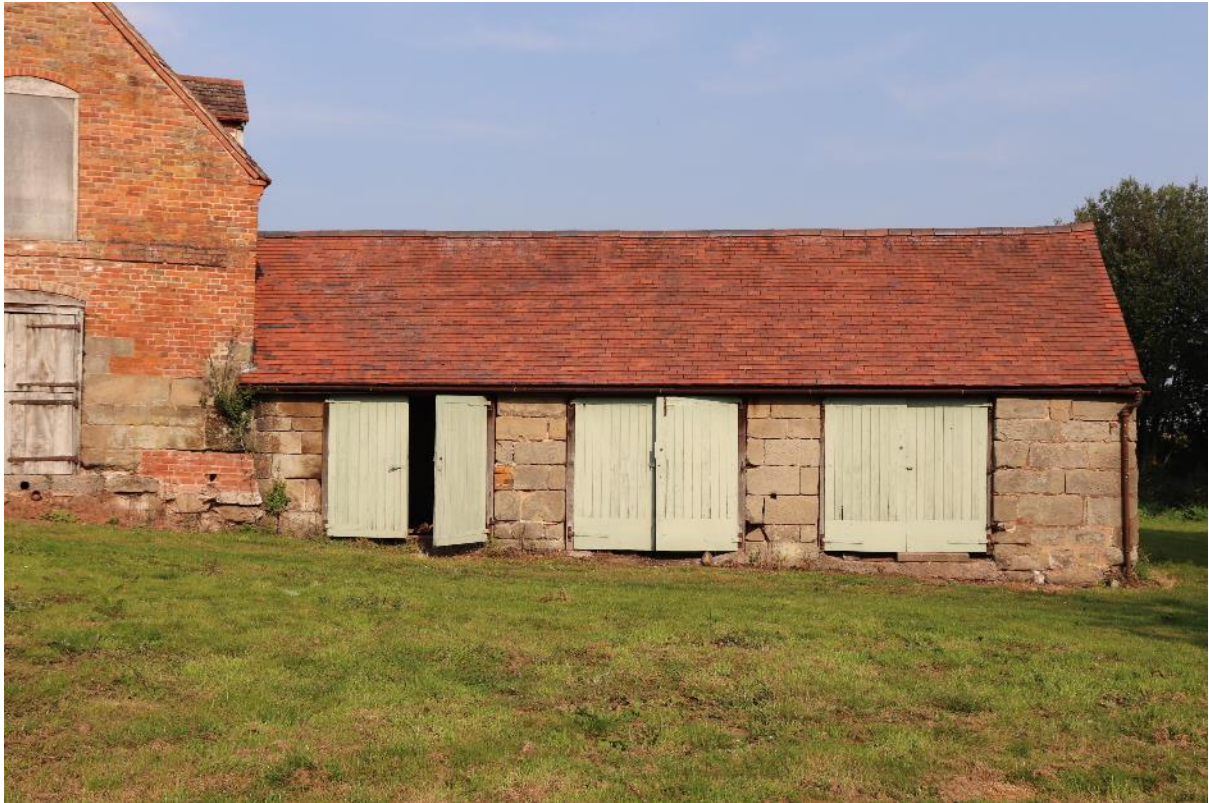
Plate 3 Phase 3b cow shed, looking north-west

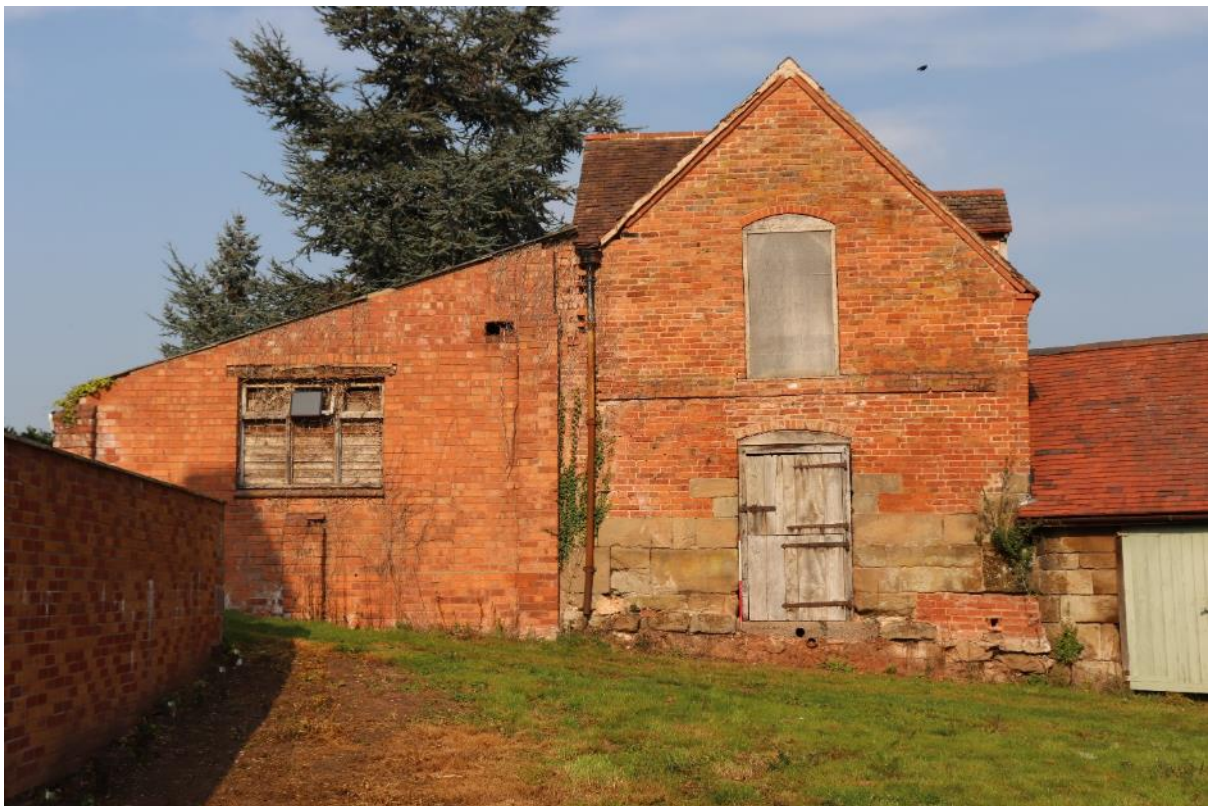
Plate 4 Phase 3a dovecote and Phase a garage, looking north-west, 1m scale

On the southern side of the newly converted stable was a single pitch brick structure (Plate 4 and Plate 5) which appears to be on the mapping of 1883, though this is not clear, and the style of the structure suggests a date within the first half of the 20th century. It is possible that this replaced an earlier structure within this location.

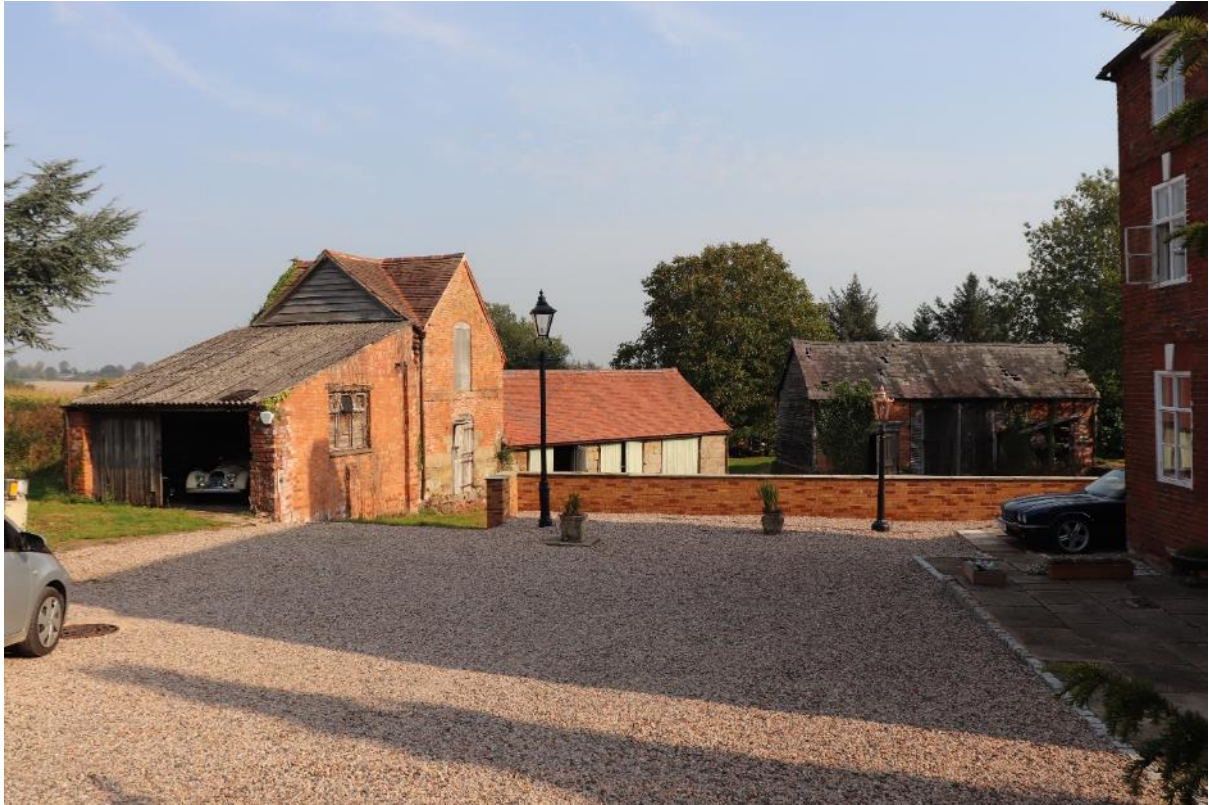
Plate 5 The buildings, looking north

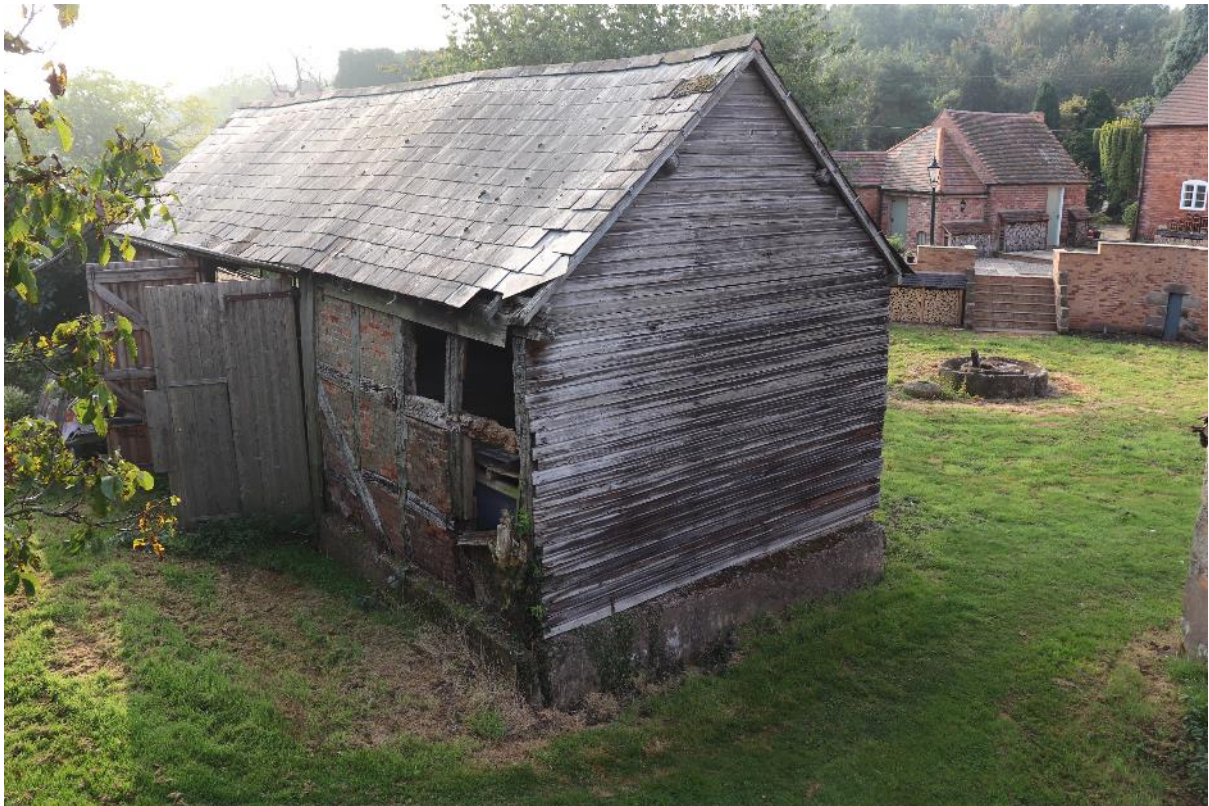
Plate 6 Phase 1 barn, looking south-east

Elements of a structure earlier than the house were evident within the fabric of the Phase 2 barn (Plate 6 and Plate 7). This was in the form of reused timbers. There was no clear indication that the structure that these timbers represent was within its original setting, it is possible that they were brought in from a redundant building.

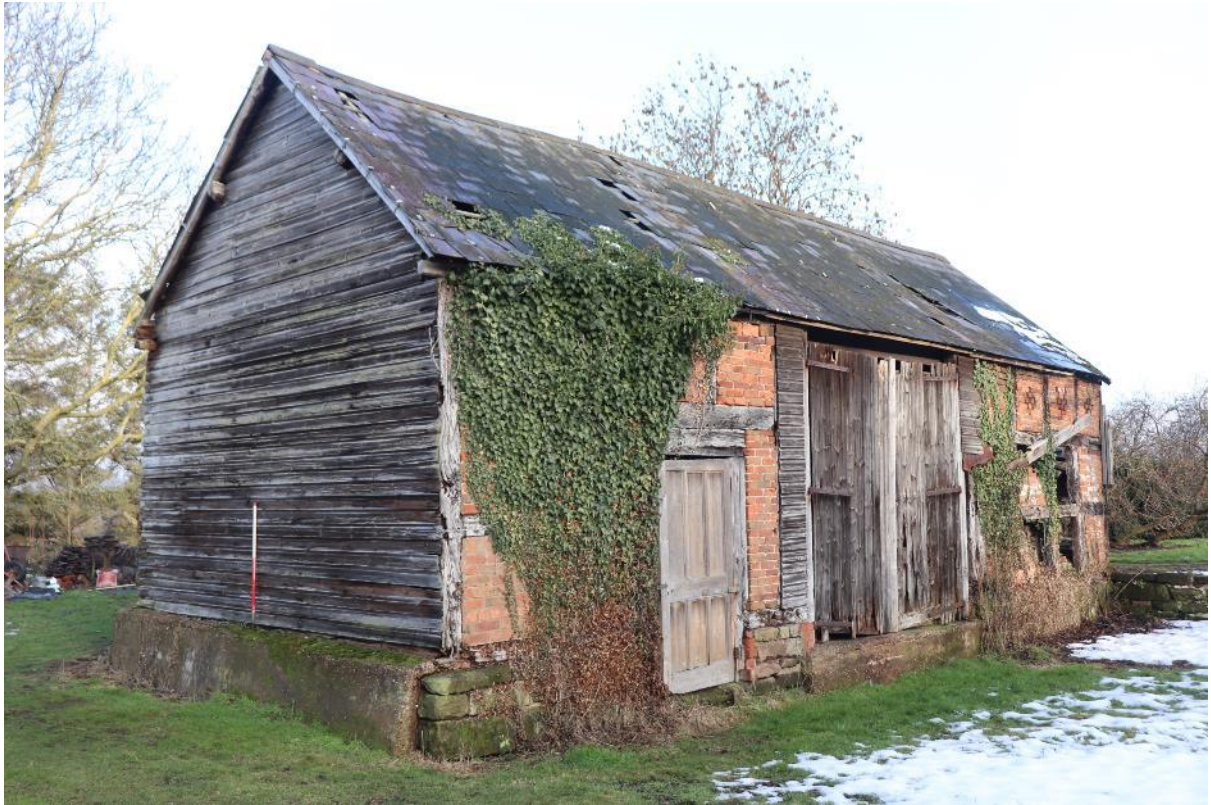
Plate 7 Phase 1 barn, looking north-east, scale 1m

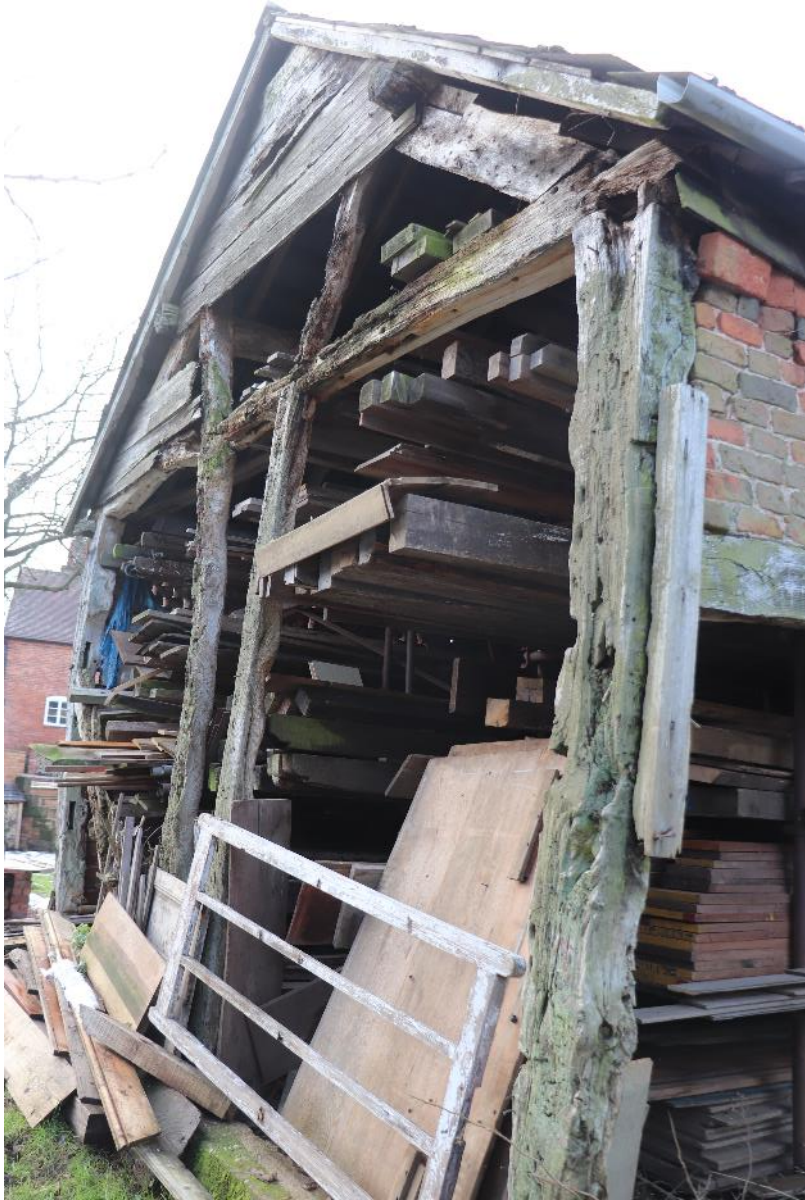
Plate 8 Phase 1 barn with empty mortice and stave holes under the tie beam, looking south-west

These timbers were primarily recognised by the presence of carpenters marks entirely separate from those of Phase 2 (Figure 4 Plate 8). The carpenters marks of this phase were cut using a race knife and were in the forms of lines and circles that did not make a pattern, due to the timbers having been moved out of original context in Phase 2. Most of these were visible on the northern elevation (Figure 4), along with the carpenters marks of Phase 2 which were chisel cut and numbered the posts consistently.

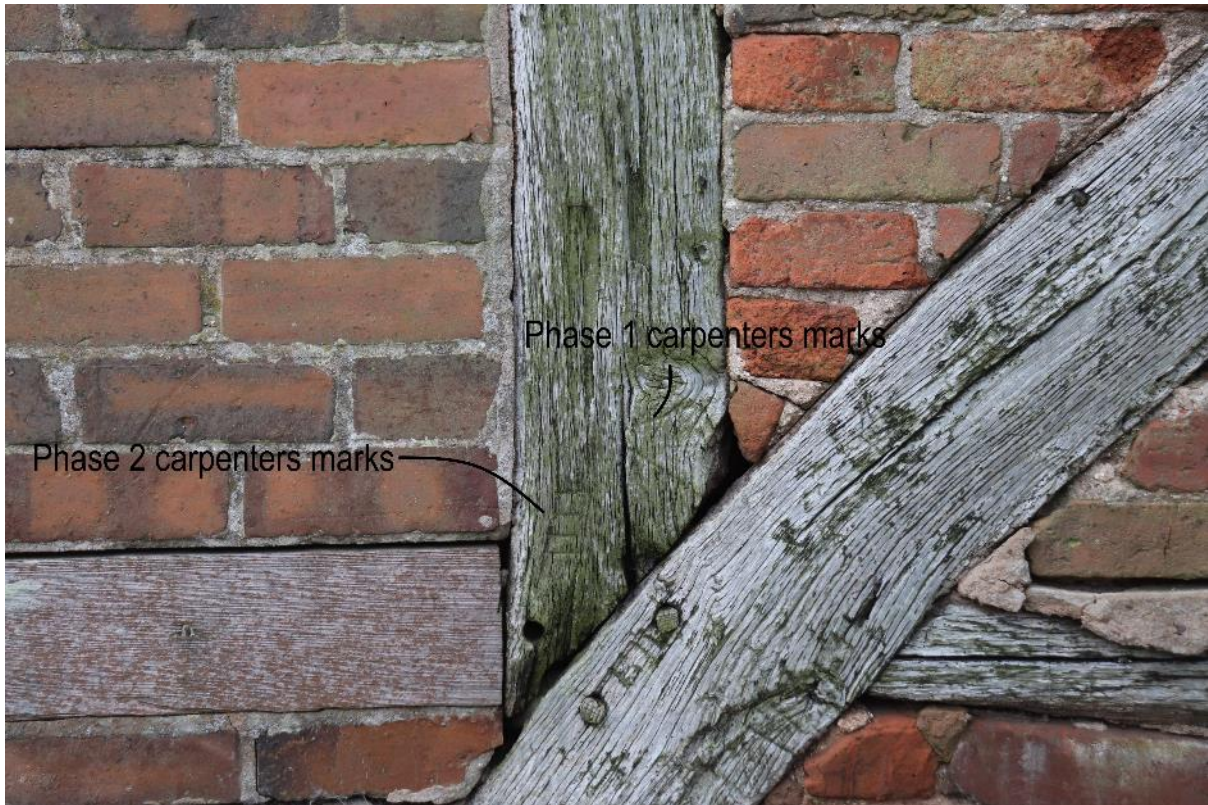
Plate 9 Phase 1 and 2 carpenters marks, looking south

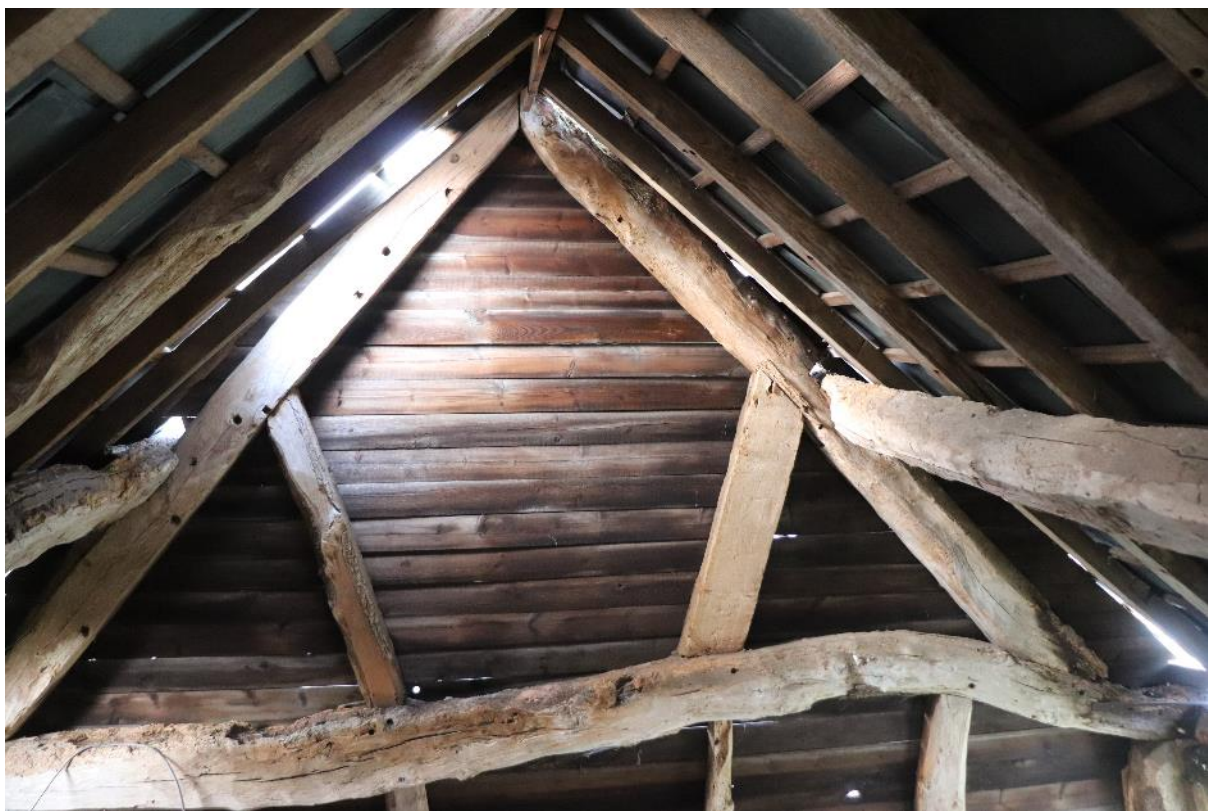
Plate 10 Phase 2 west end truss, looking west

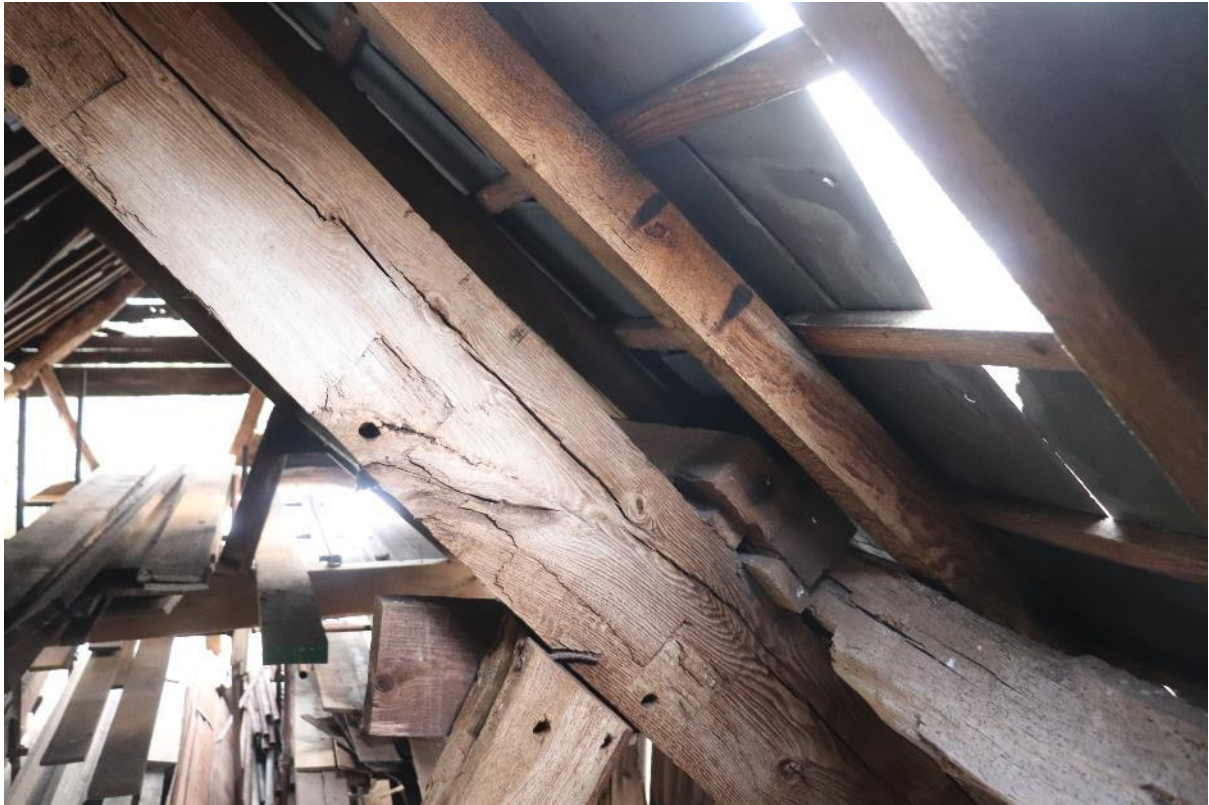
Plate 11 Phase 2 burn marks, looking east

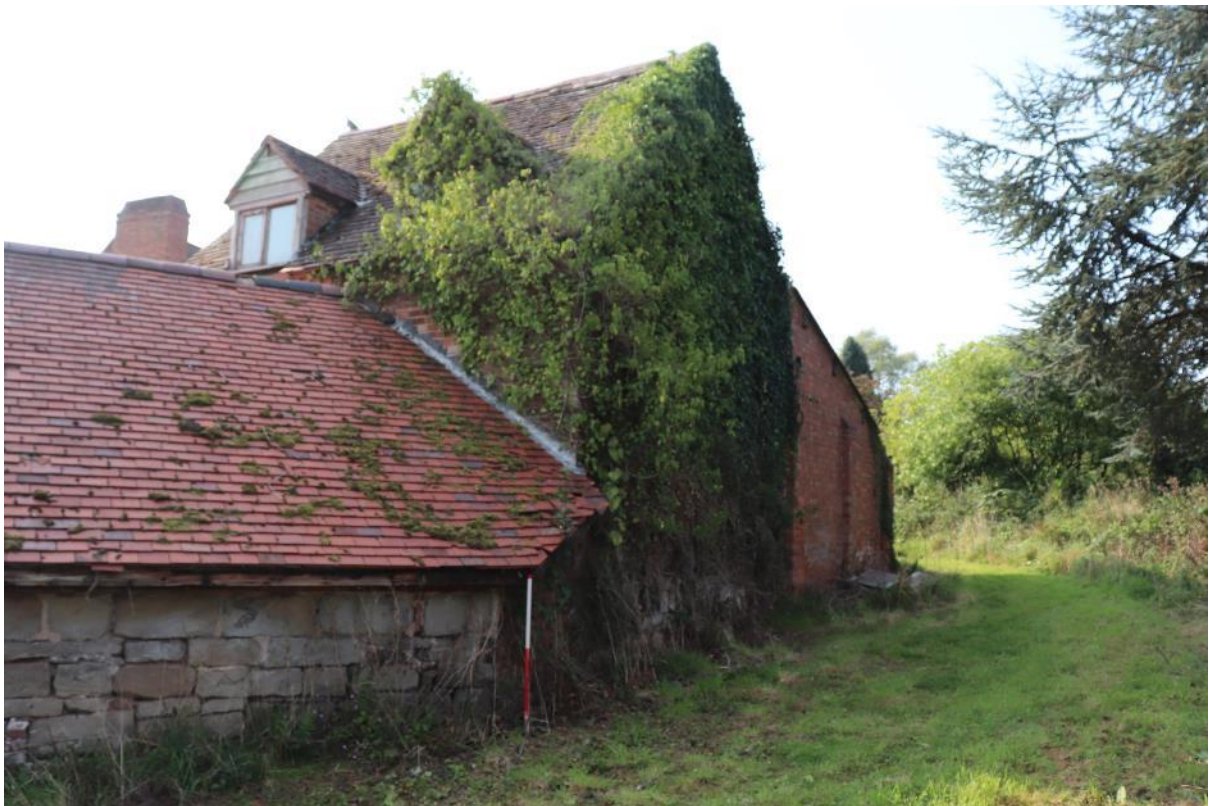
Plate 12 Phase 3 a dovecote, looking south, scale 1m

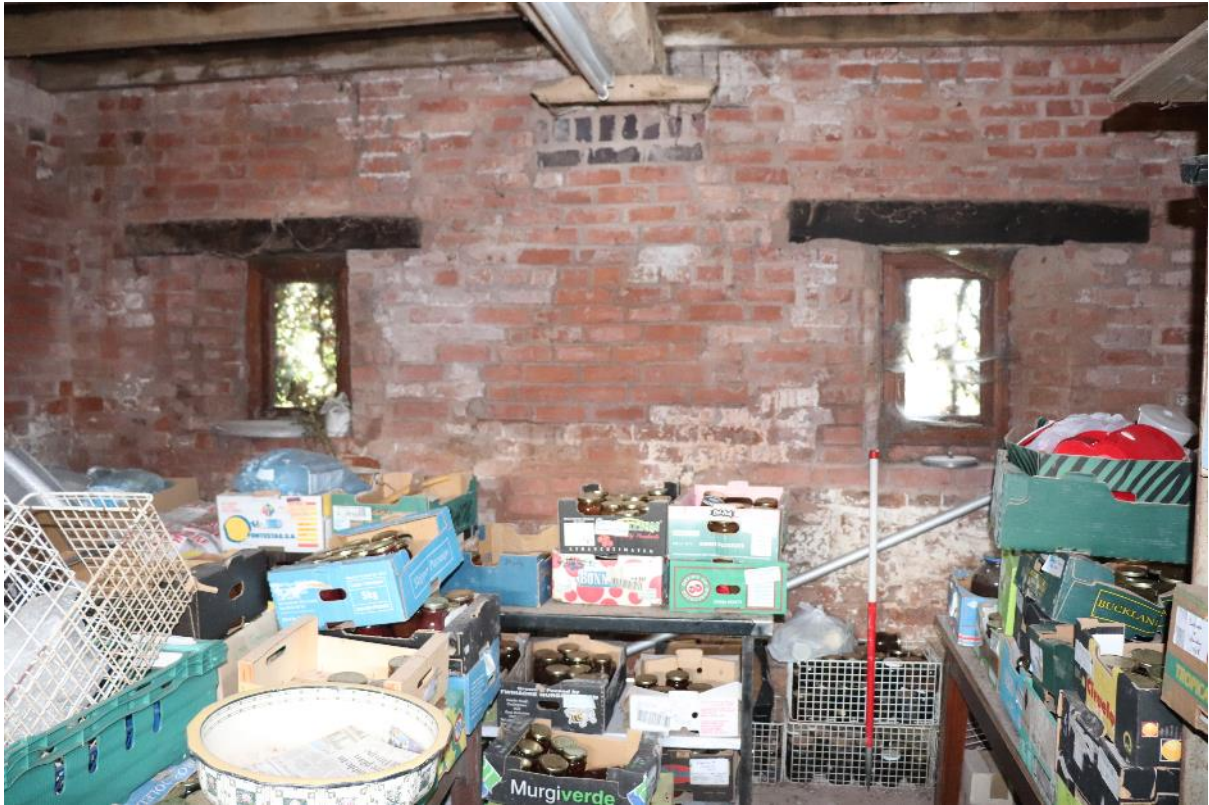
Plate 13 Phase 3a dovecote, looking north-west, scale 1m

The structure had a door on the south-east side and two small windows facing to the north-west (Plate 13). It possibly had further facing to the north-east and south-west, though these were not clear due to a high degree of internal rebuild. Within the walls were some empty holes suggesting that the floor was originally slightly lower than as remaining, along with evidence suggesting that the door was also slightly lower (Plate 14). The door and floor were heightened to convert the structure into a stable in Phase 3b or 3c, suggesting it was not a stable before this point. A suggestion as to its function was degradation in the brick work just above the height of the former floor position (Plate 15). This evidence was not present all the way around the structure due to it having been entirely rebuilt from above the height of the brick string course visible on the south-east facing elevation, including the removal of the roof. This degradation is typical of the presence of pigeon excrement, suggesting use as a dovecote.

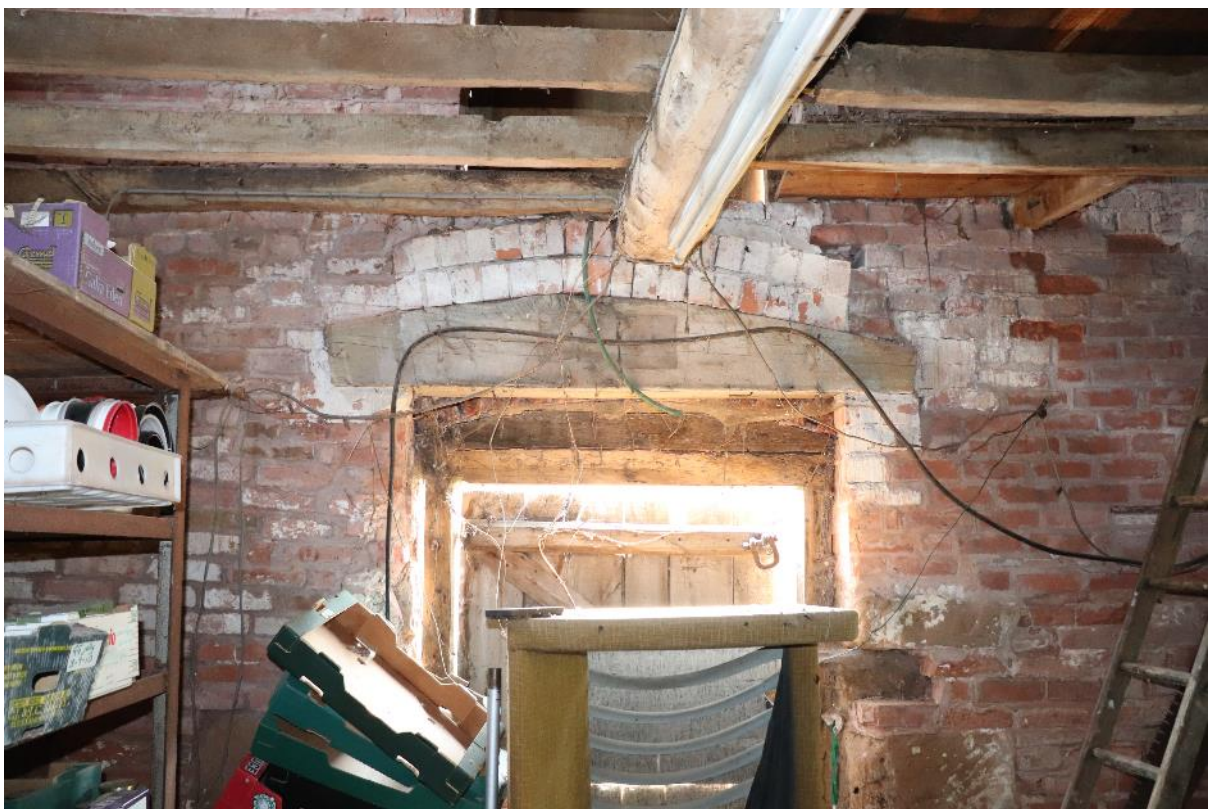
Plate 14 Phase 3a dovecote with evidence for the door and floor beam having been raised, looking south-east

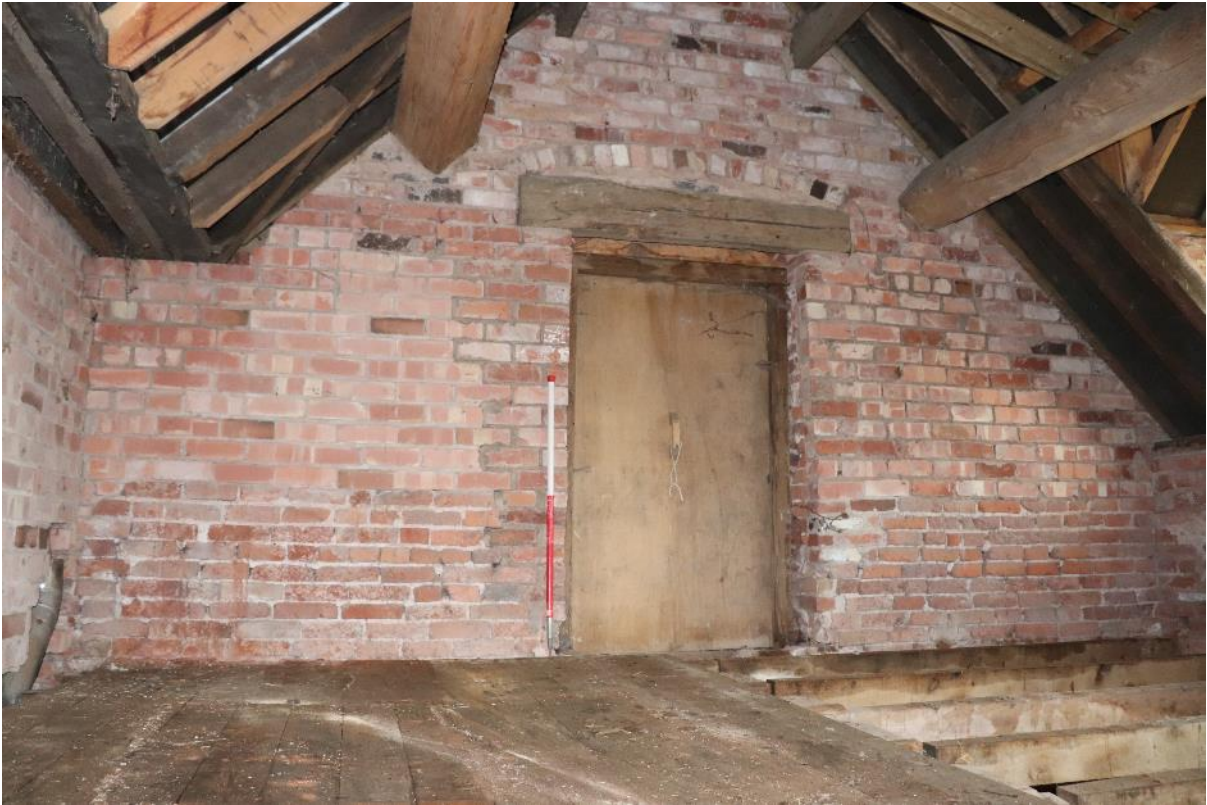
Plate 15 Phase 3a dovecote with floor level brick degradation , looking north-west, scale 1m

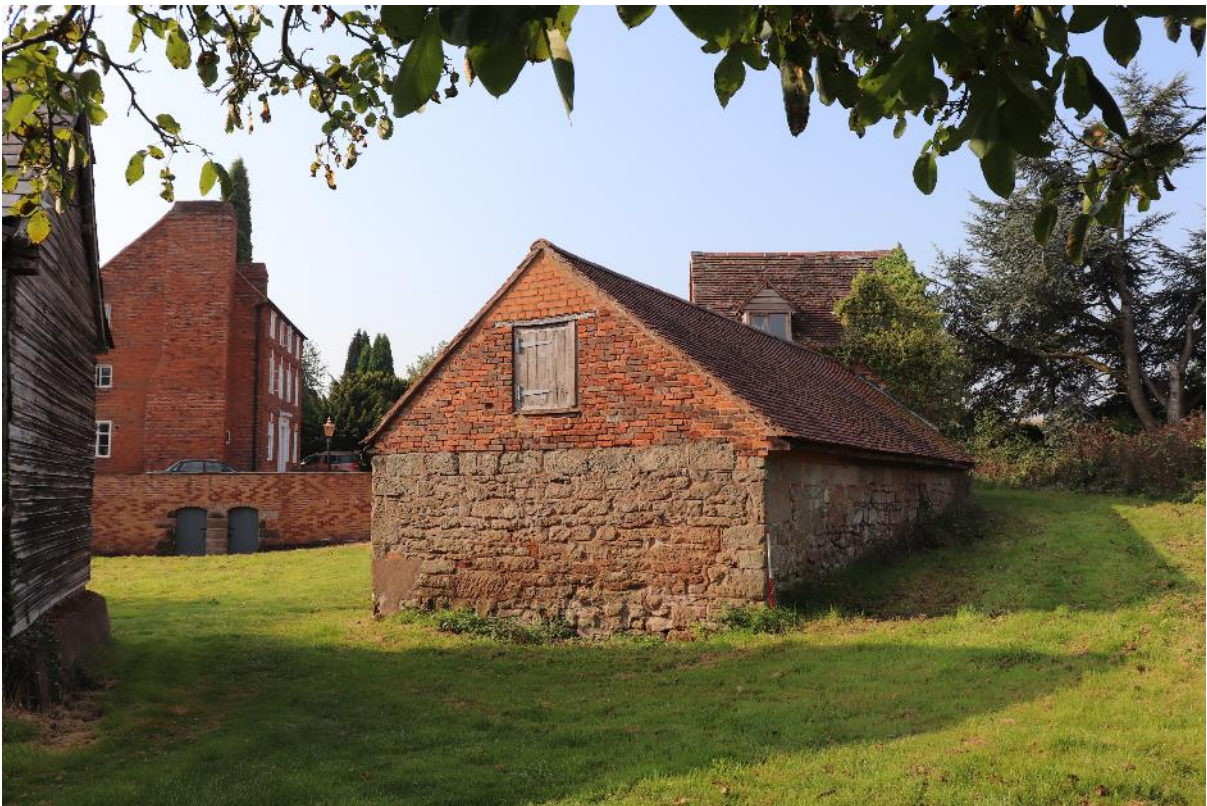
Plate 16 Phase 3b cow shed, looking south, scale 1m

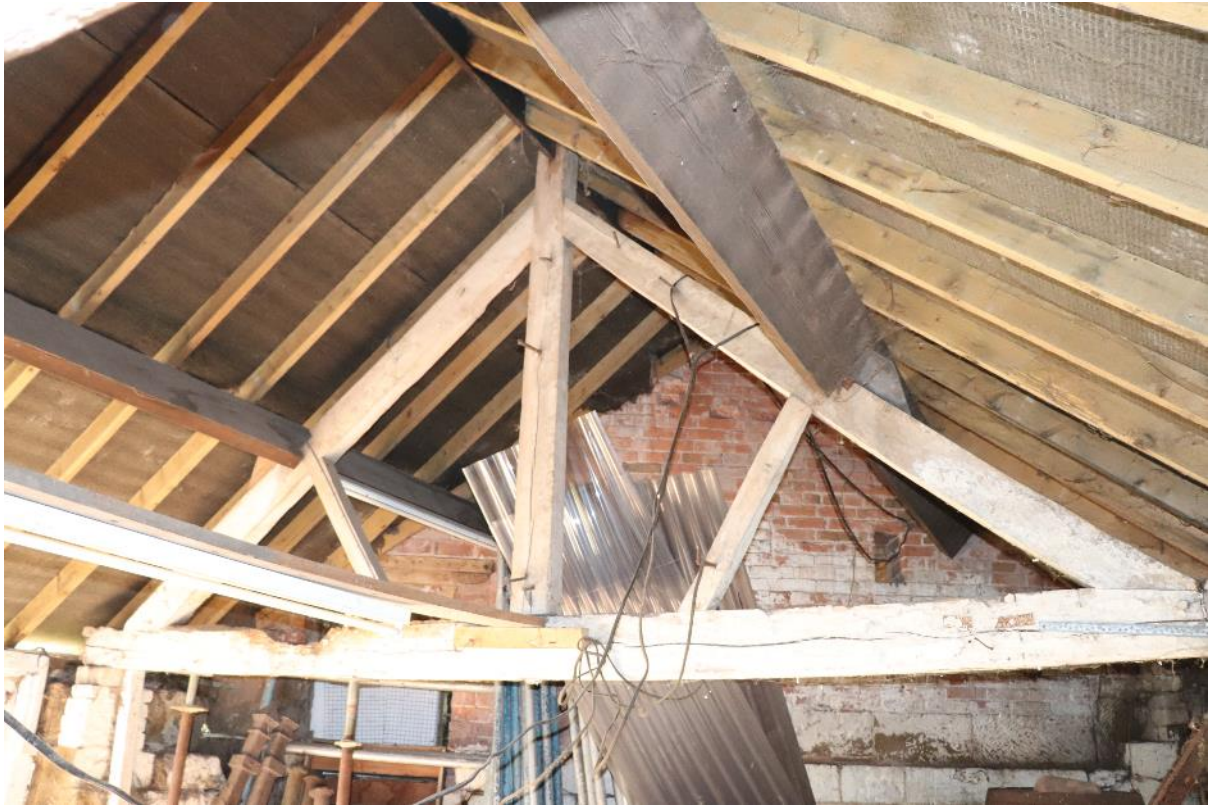
Plate 17 Phase 3b cow shed roof truss, looking south-west

king post trusses with the central post bolted to the tie beam and raking struts between the principal rafters and tie beam (Plate 17). Such trusses were typical of much of the 19th century, but more typical in the second half of the century.

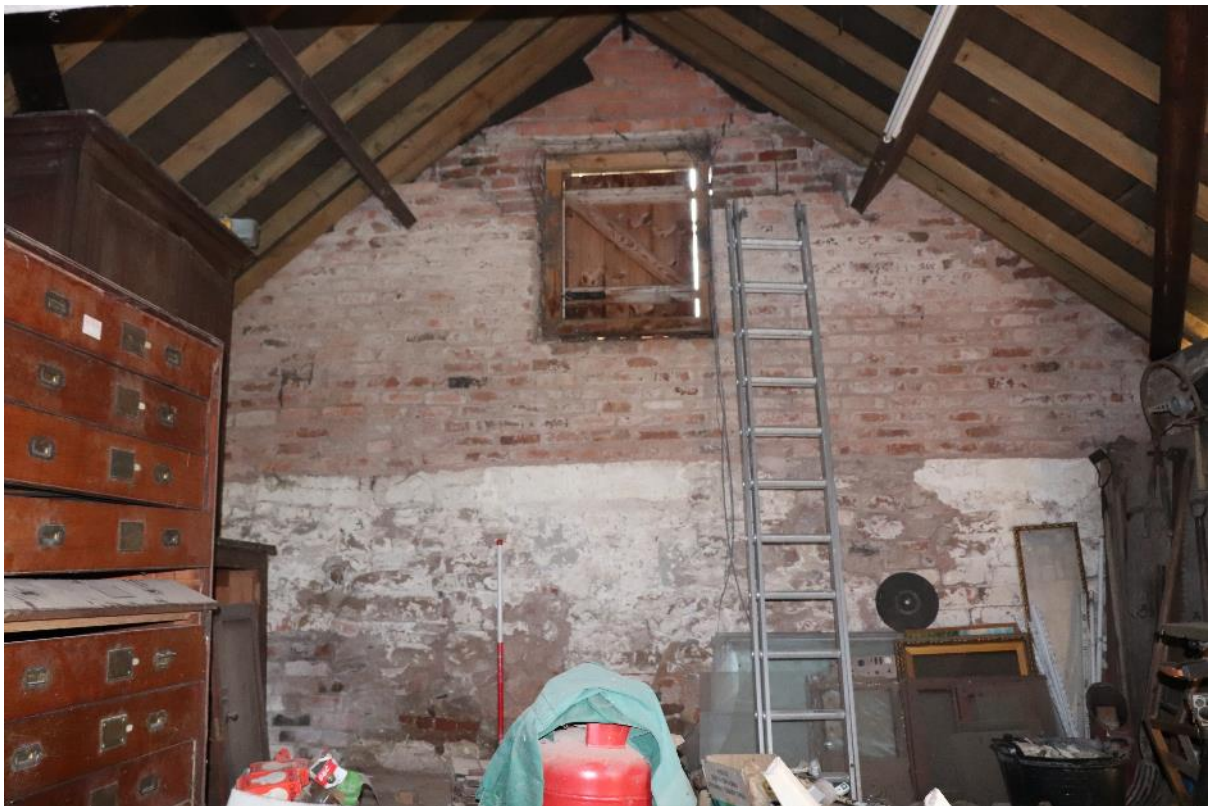
Plate 18 Phase 3b cow shed, looking north-east, scale 1m

It is possible that the brick of the gable (Plate 18) was a later rebuild as it had a hatch into which straw or hay could be added to a temporary floor above tie beam level internally, though no clear evidence of this remained. This may have represented a change of use as crop was not traditionally stored above cows due to their high level of perspiration.
