Archaeological watching brief at The Church of St Lawrence Evesham, Worcestershire

Worcestershire Archaeology
for Oliver Architecture Ltd

March 2021

Archaeological watching brief report

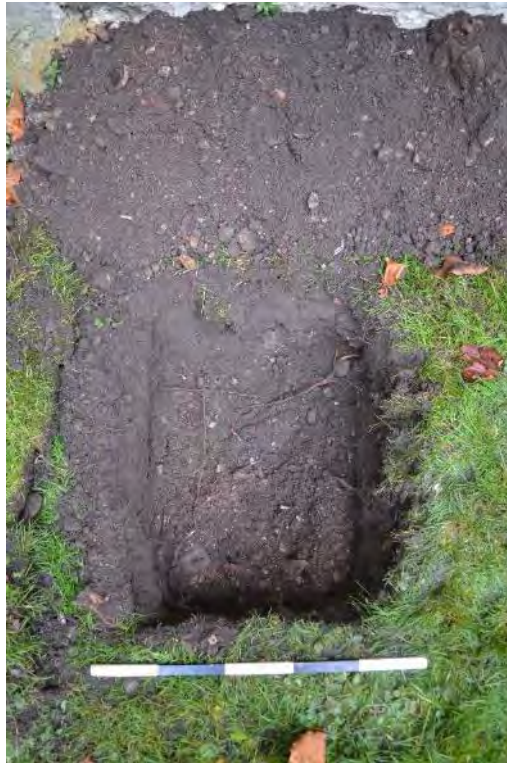
Test Pit No.	Dimensions in plan	Max Depth	Description
1	0.5m by 0.5m	0.25m	Topsoil (TP100), approx. 0.20m deep Brick/lime rubble (TP101), excavated to about 0.5m. Contained clay pipe stems.
2	1.3m (N-S) by 0.4m (E-W)	0.30m	Topsoil (TP200) Ceramic drainage pipe (TP201) Rubble/brick layer (TP202)
3	0.45m (E-W) by 0.55m (N-S)	0.25m	Topsoil (TP300) Compact gravel/concrete (TP301) possibly associated with adjacent pathway

Plate 1: Test Pit 1 from north-west

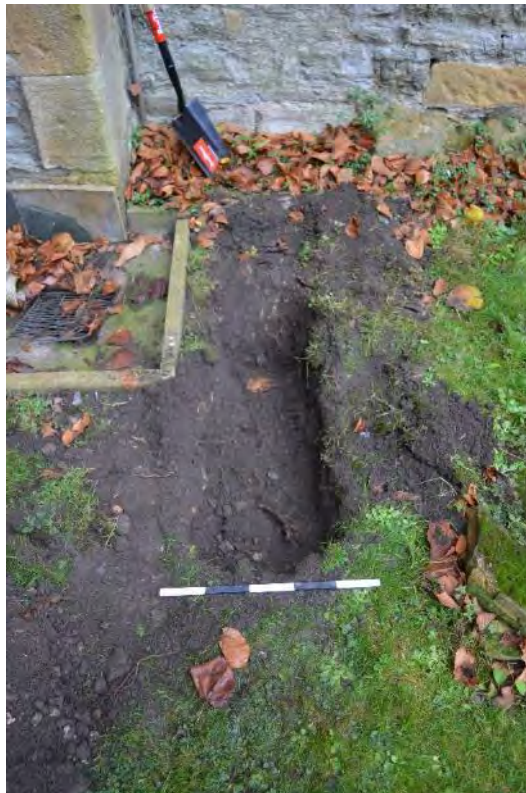
Plate 2: Test Pit 2 from north-west

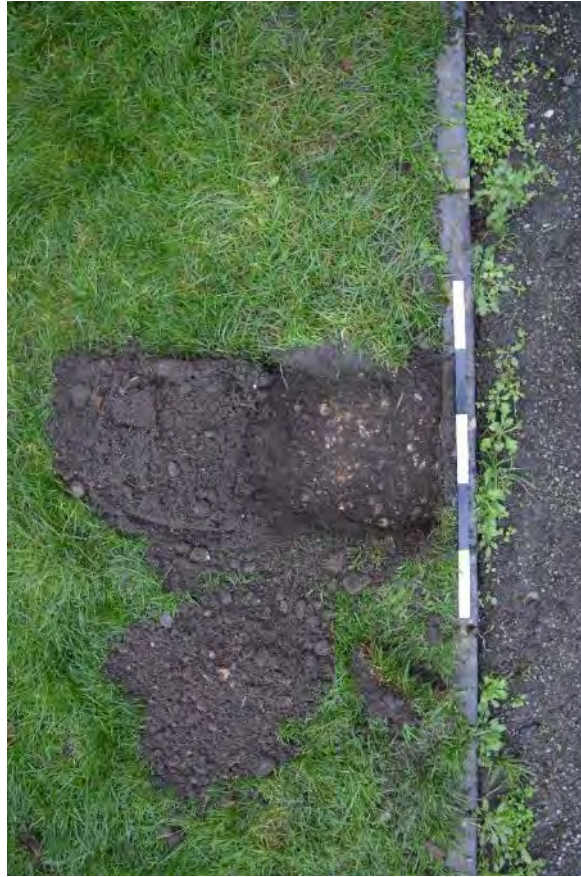
Plate 3: Test Pit 3 from north

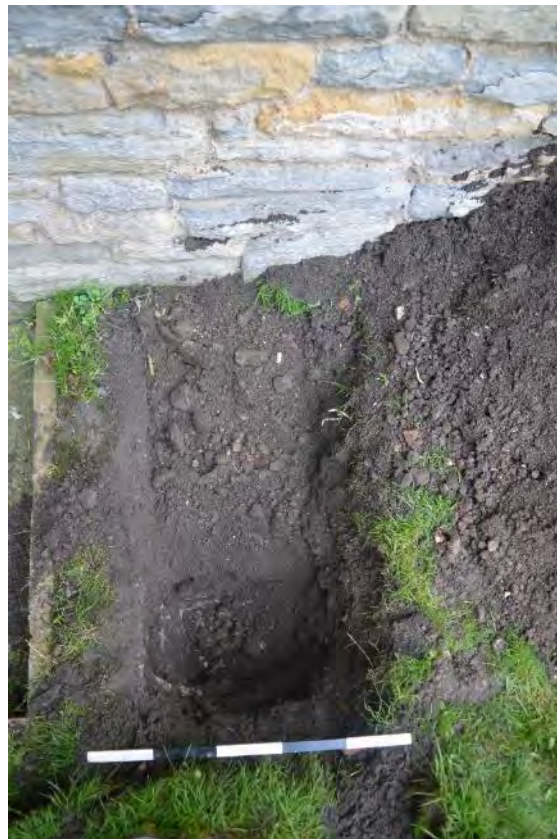
Test Pit No.	Dimensions in plan	Max Depth	Description
4	0.8m (E-W) by 0.5m (N-S)	c 0.4m	Topsoil (TP400) Drainage pipe (TP401) Mixed gravel/rubble (TP402)
5	0.6m (E-W) by 0.4m (N-S)	0.42m	Topsoil (TP500) Loose mixed gravel (TP501) containing modern pottery, metal and possibly human bone (reburied)
6	0.6m (E-W) by 0.4m (N-S)	0.4m	Topsoil (TP600) Loose gravel layer (TP601). Contained modern pottery, glass, possibly human bone (reburied)

Plate 4: Test Pit 4 from west

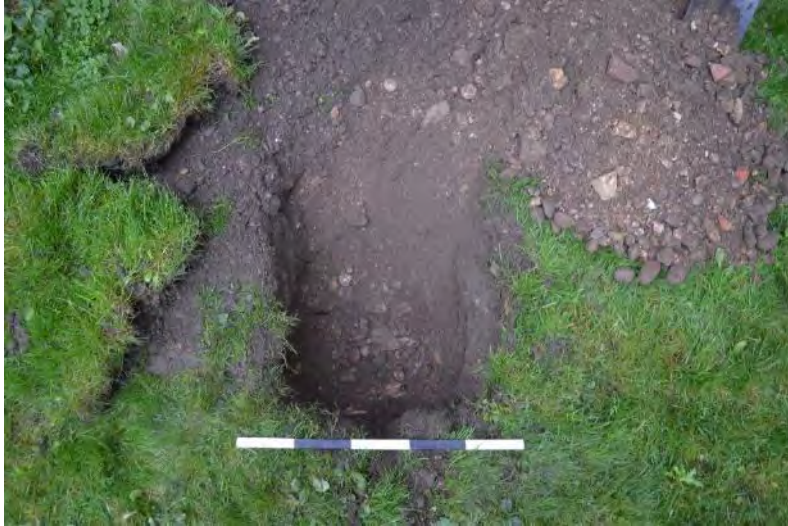
Plate 5: Test Pit 5 from south

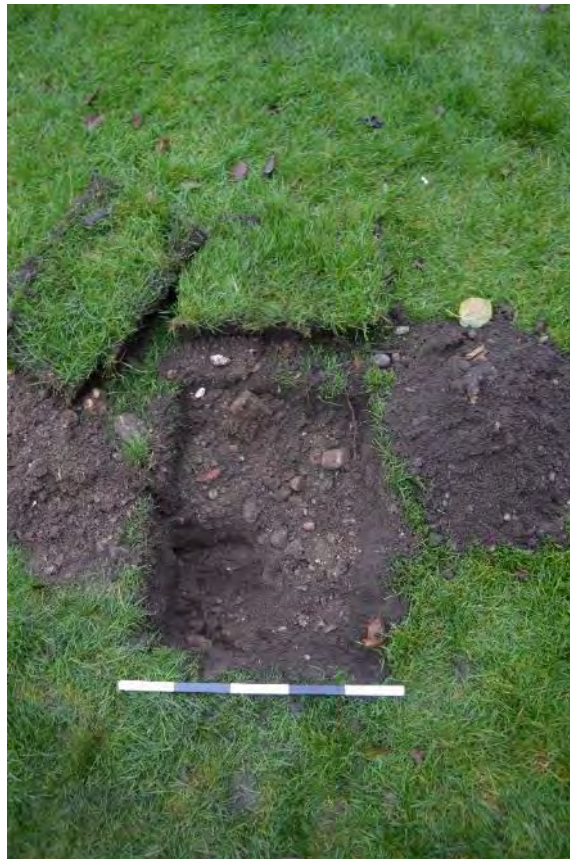
Plate 6: Test Pit 6 from west

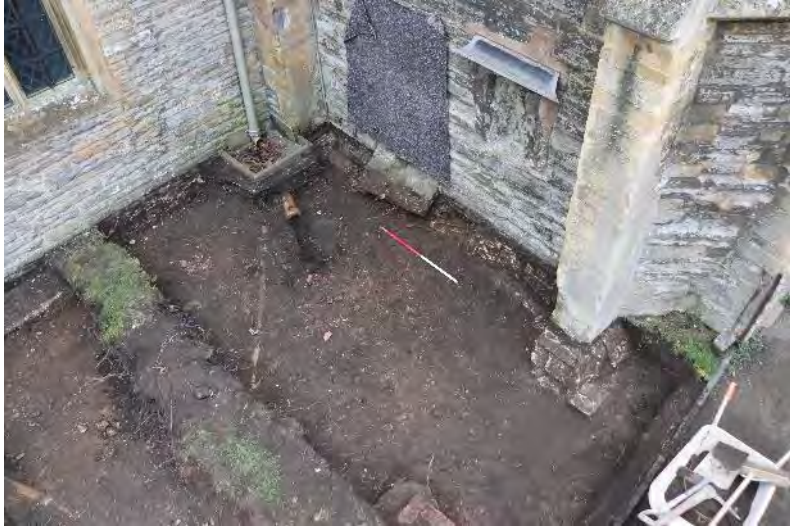
Two trenches (Plates 7 and 8) were opened after the test pits to the southern and northern sides of the church tower. These were excavated to a maximum depth of 0.55m below the surface. Each of these trenches was split by an unexcavated baulk but as the deposits were the same on either side of the baulk, separate trench numbers were not assigned

Both trenches revealed made ground deposits, as expected from the layers observed in the test pits. Drainage pipes were visible in both areas, along with a further modern brick manhole cover in Trench 1. In both trenches some disarticulated human bone was present. This was retained on site for reburial.

Within both trenches, a widening of the tower base was revealed in the form of a 45 degree chamfer. This feature did not continue around the later nave of the church, and was obscured by the doorway in Trench 2. The tower is considered to date to the early 15th century, and similar chamfers are present on upper stages

Context number	Max Depth	Description and interpretation
100	0.23m	Dark grey brown sandy silt- topsoil
101	0.13m	Mixed mid grey brown sandy silt with some small sub-rounded stones and modern material- made ground deposit
102	>0.10m	Mid to light pinkish grey sandy silt with frequent small rounded stones and occasional concentrations of lime- made ground deposit

Plate 7 Trench 1, looking south-east, scale 1m

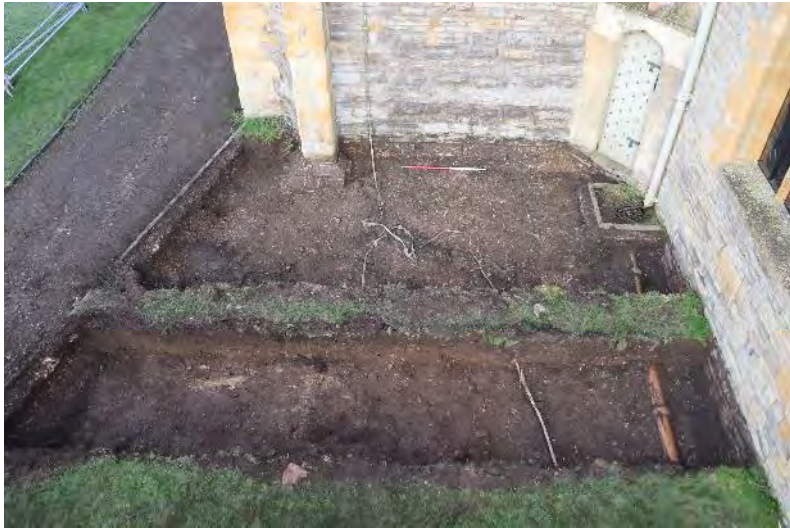
Context number	Max Depth	Description and interpretation
200	0.25m	Dark grey brown sandy silt- topsoil

Context number	Max Depth	Description and interpretation
201	>0.20m	Mixed mid grey brown sandy silt with some small sub-rounded stones and modern material- made ground deposit

Plate 8, trench 2, looking north, scale 1m
