# Building recording at The Old Barn, Crowle, Worcestershire

Worcestershire Archaeology  
*for Rob Pearce*

March 2021

Building recording report

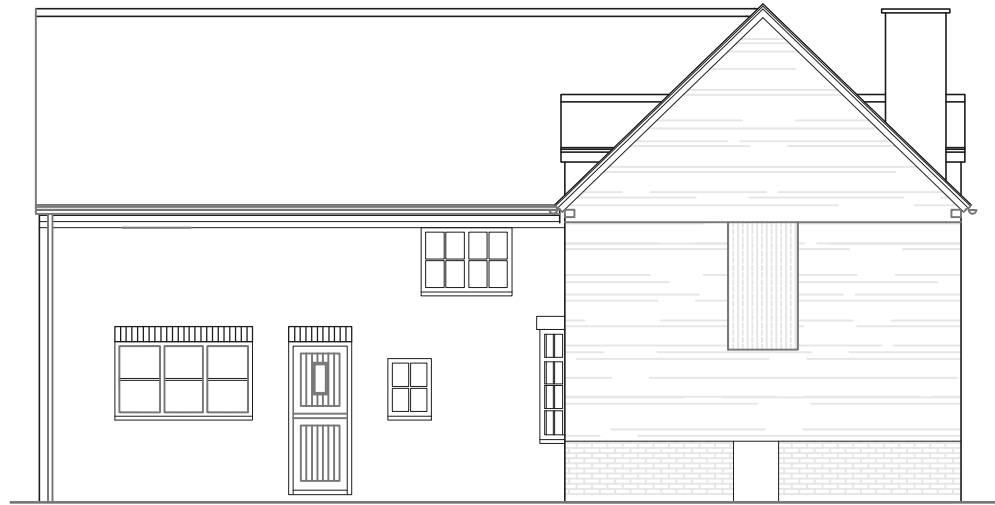
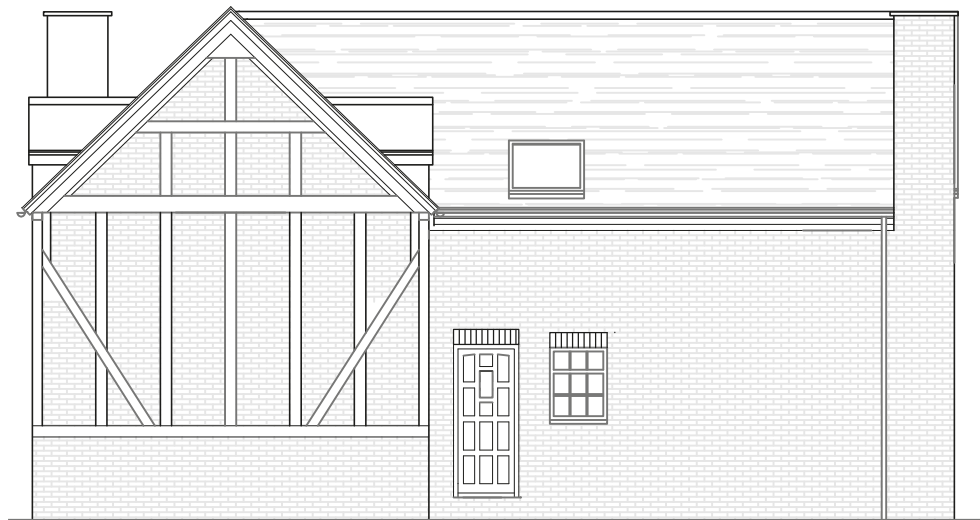
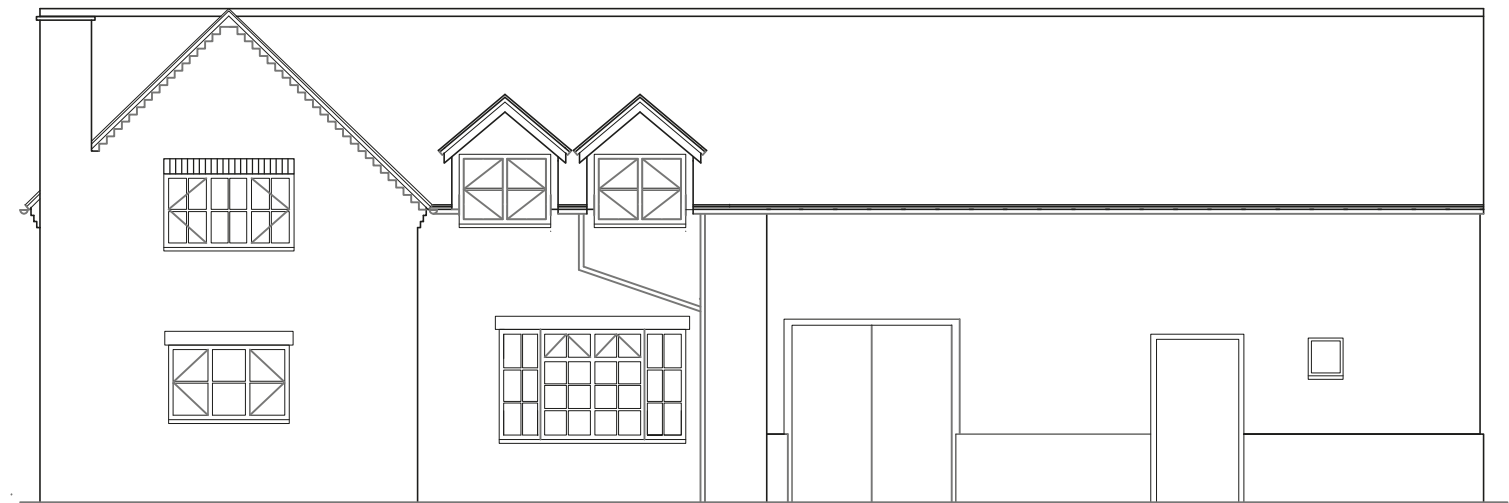
Figure 4

East elevation

North elevation

West elevation

South elevation

Elevations (after RDL Raxter Drawing number 10735-01)

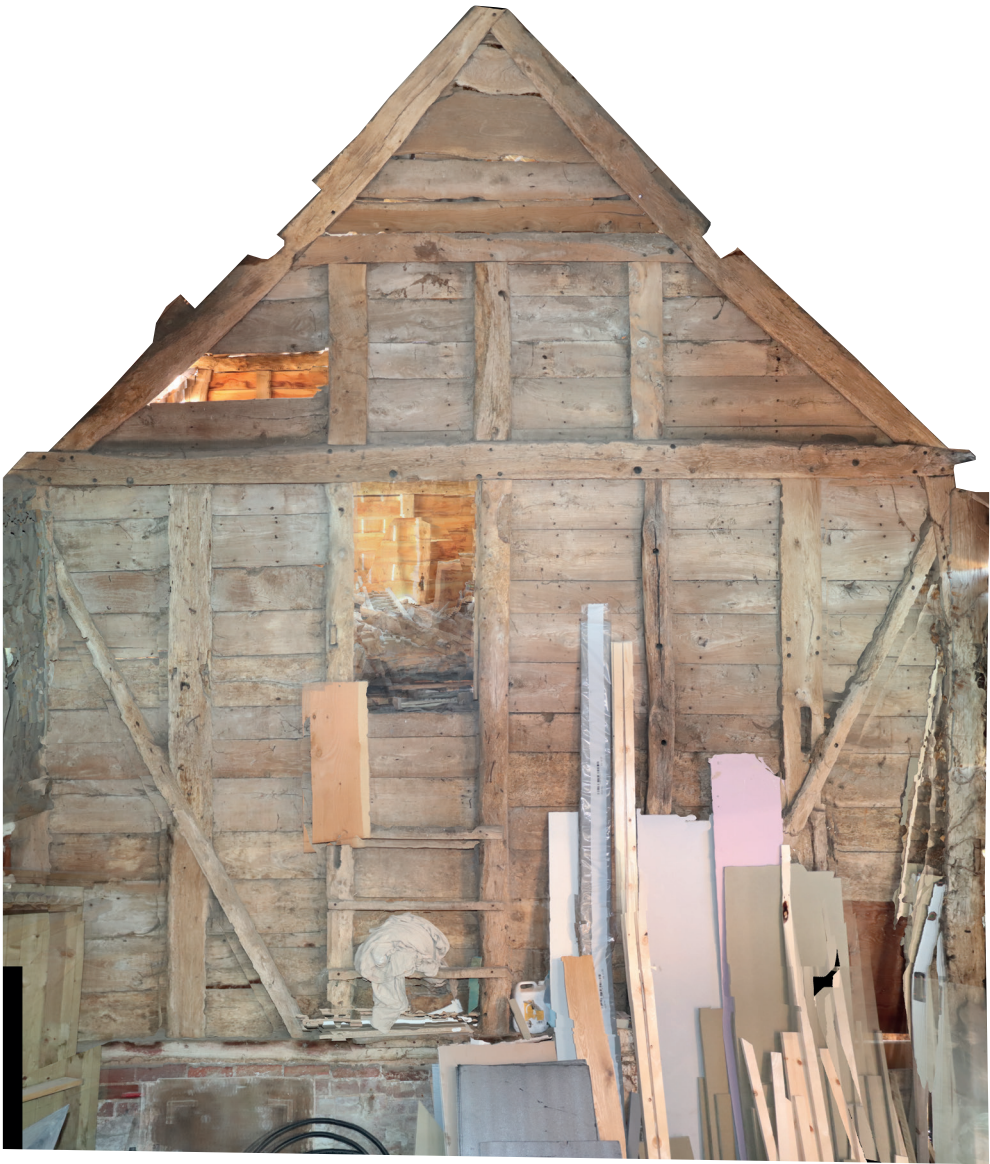
*Figure 5*

*West facing photogrammetric elevation  
of Phase 1 gable end frame*

This first phase consisted of a three bay barn structure aligned east to west, with its gable facing onto the road (Plate 4). Its western end frame consists of tall posts running full length from the tie beam to sill beam, with long straight braces running from the jowl posts to the sill beam. Three further posts run from the tie beam to collar and a further from collar to the apex of the principal rafters, which in turn support a ridge beam and purlins on each side. The setting out marks of the carpenters are visible, with the post base and sill beam joints numbered in Roman numerals I to V from north to south with a chisel (Plate 5).

Its eastern end frame is of broadly the same arrangement as that at the west, though without the central post running from the collar to apex (Figure 5). Some carpenters marks are visible on the former gable end and again in Roman numerals, but unusually this time cut with a race knife (Plate 6). A further difference is the numbering from I to VII from south to north, marking not only the post but also the brace joints. This difference of technique and tool may suggest different carpenters working on each truss. The use of a race knife for marking carpentry joints was normal in the medieval and early post medieval periods, but was highly unusual in the 18<sup>th</sup> century.

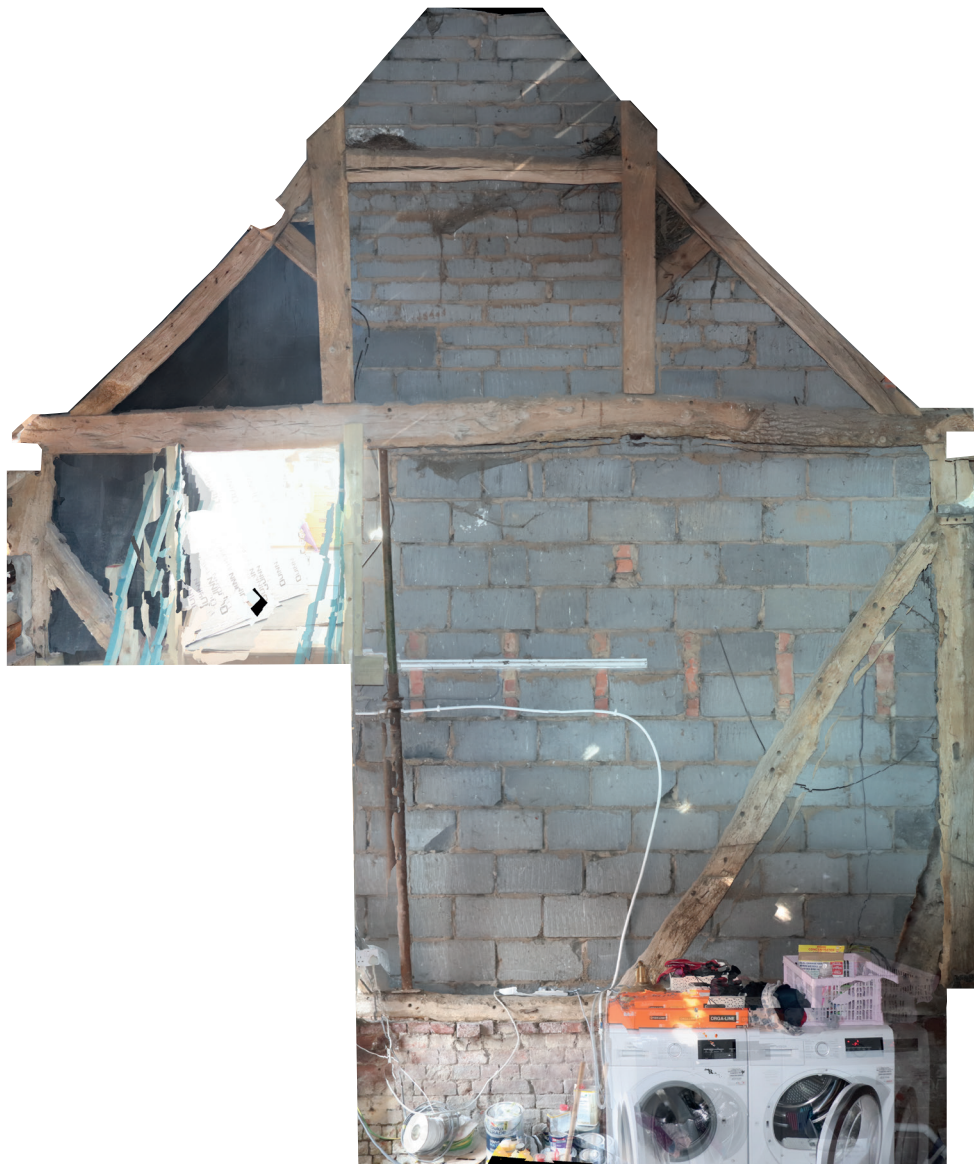
*Figure 6*

*East facing photogrammetric elevation  
of Phase 1 internal cross frame*

One interior truss remains largely complete (Figure 6) with its sill beam on a brick wall and long braces from it to the jowl posts. Above the tie beam, the principal rafters are interrupted by two vertical posts which have a collar running between and short angled braces between the posts and principal rafters. The carpentered face of this truss is on its western side, and faces the carpentered side of the next internal truss to the west, which is of the same configuration (Plate 8). It therefore seems highly likely that these open frames either side of a threshing floor, the large exterior doors of which were infilled during Phase 4. This would give the typical overall threshing barn arrangement of central threshing bay, with crop storage bays to its east and west which were open to the roof.

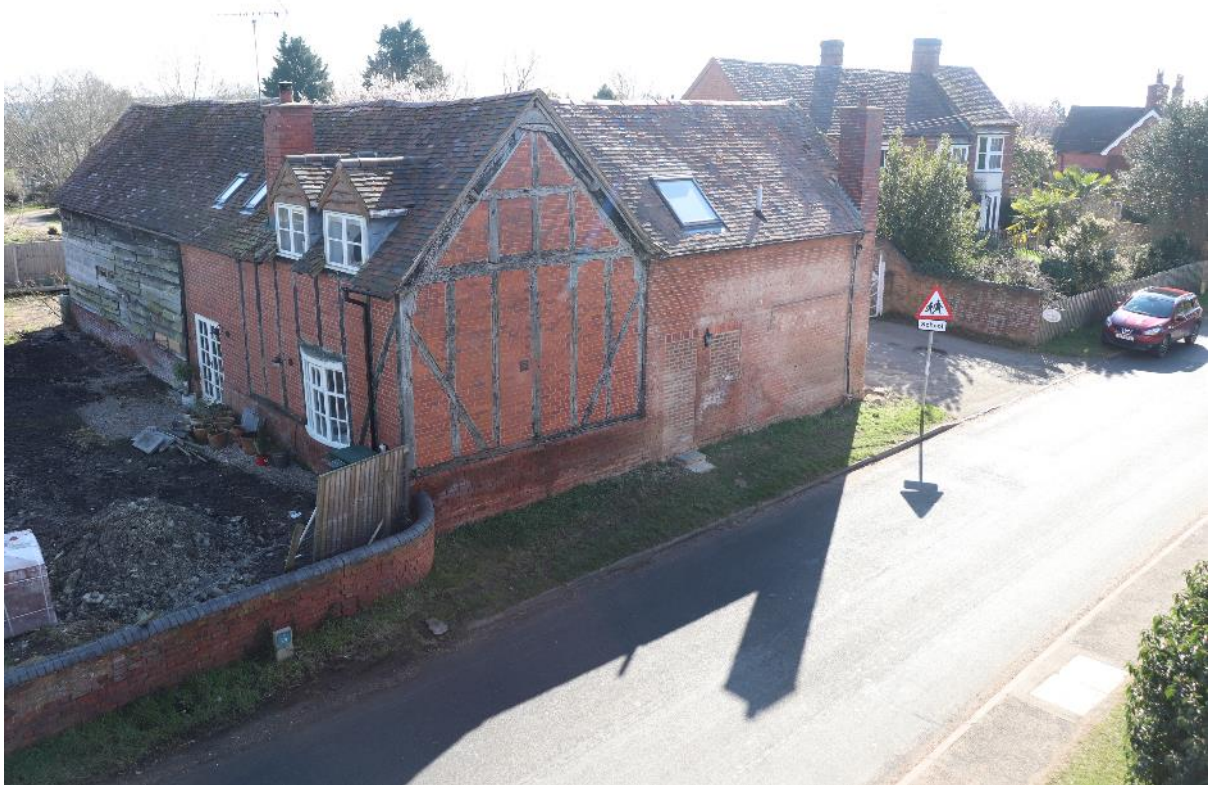
*Plate 1 The building, looking south east with Hyde Cottage behind.*

The building currently comprises an L shaped structure (Plate 1 to Plate 3). The main element is aligned east to west with a timber frame and brick structure at the western end and weather boarding at the eastern end with a brick only section between. A further north to south aligned brick element is present with a southern facing gable complete with a corner chimney stack. The roof of all these elements is ceramic tile covered. A three-dimensional model of the building can be accessed here <https://skfb.ly/6ZAZK>.

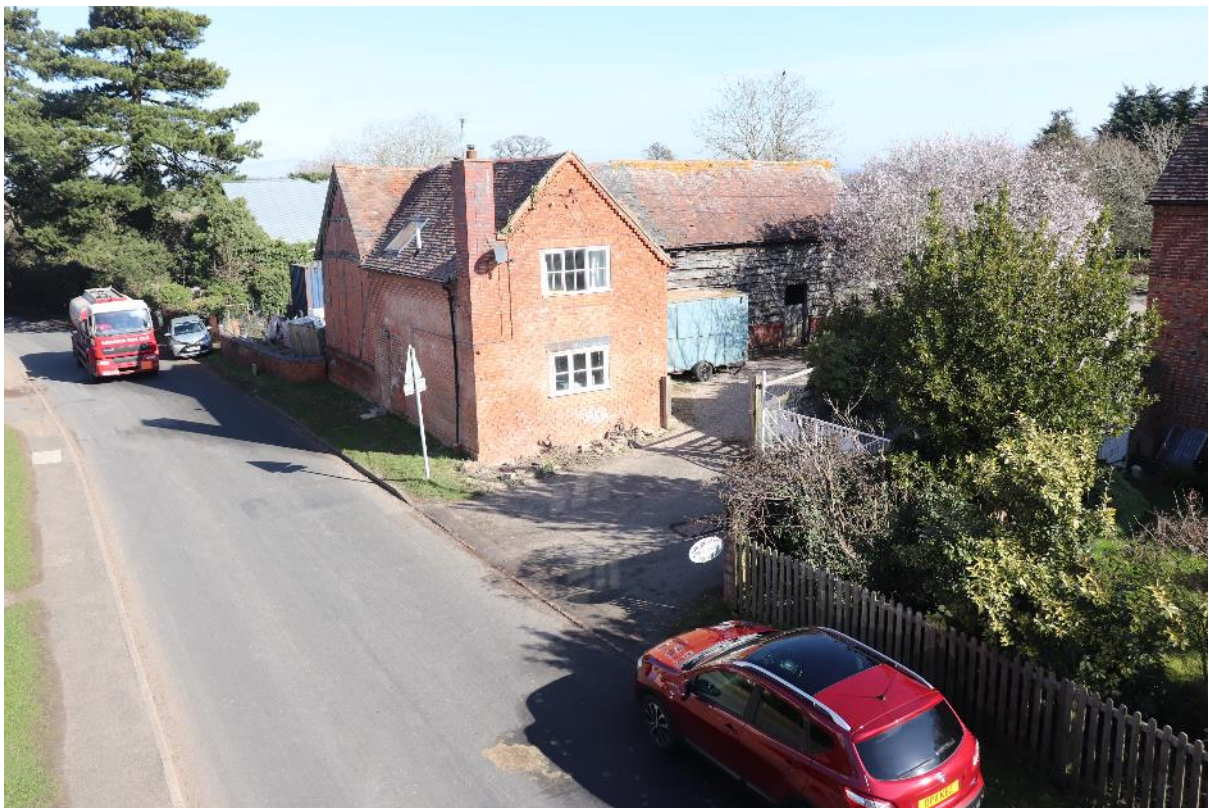
*Plate 2 The building, looking north east*

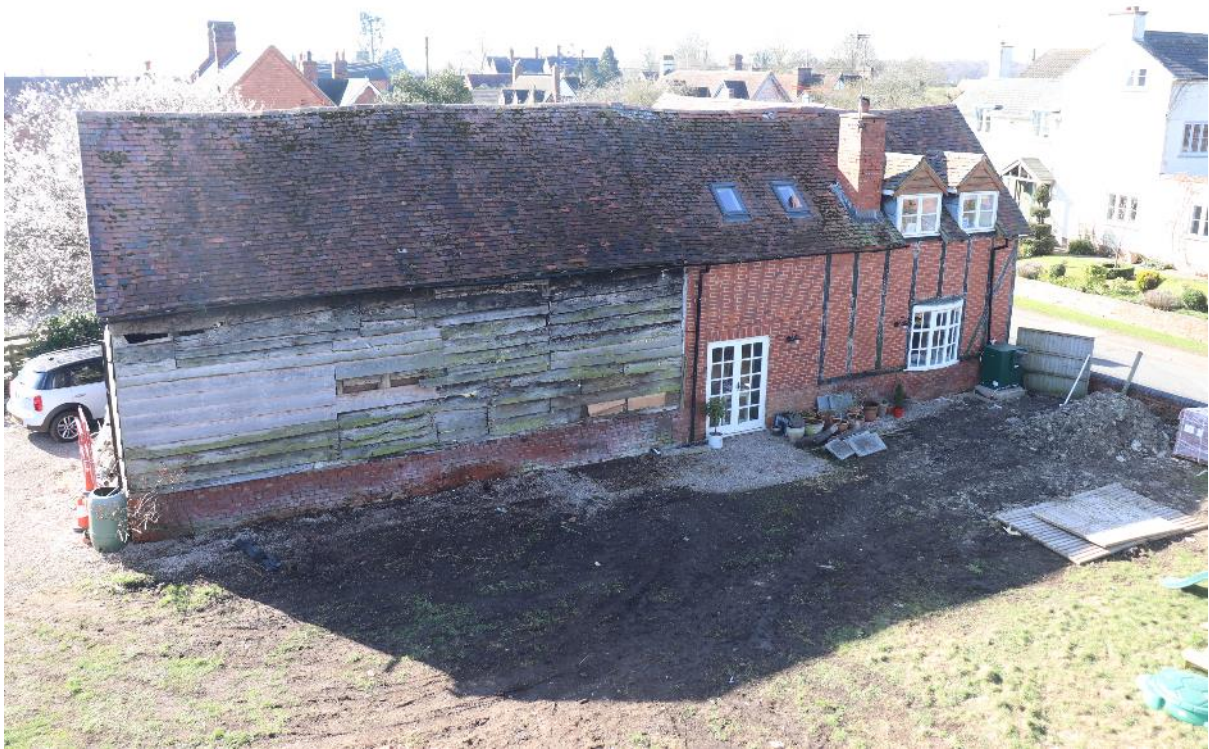
*Plate 3 The building, looking south west*

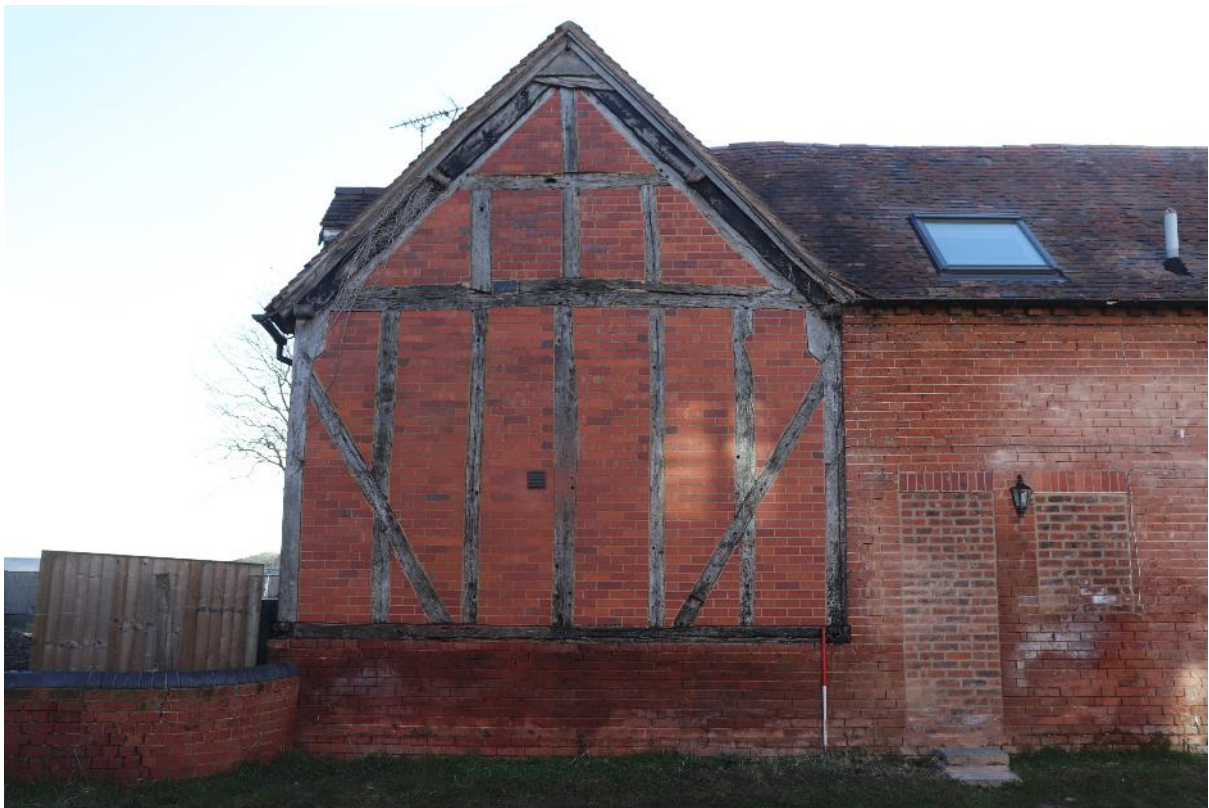
*Plate 4 Phase 1 gable end, looking east, scale 1m*

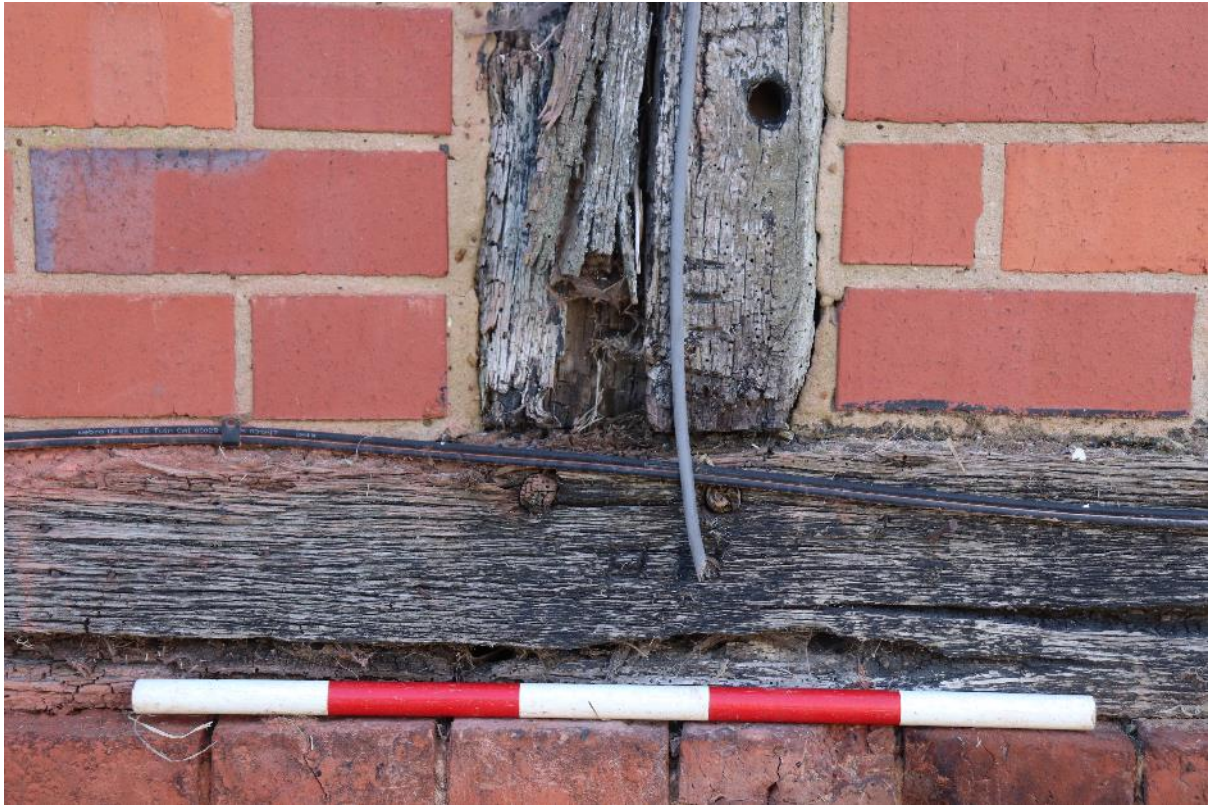
*Plate 5 An example of the carpenters marks on the Phase 1 gable end, looking east, scale 0.5m*

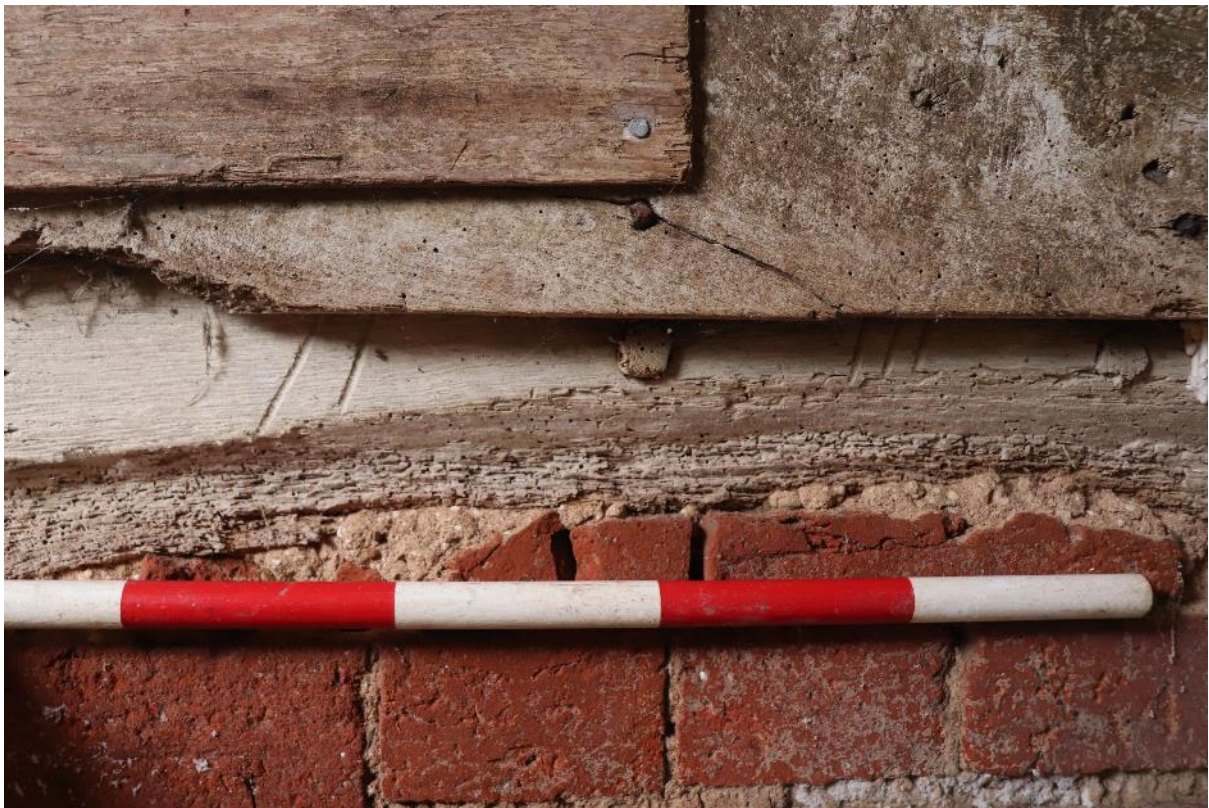
*Plate 6 An example of the carpenters marks on the Phase 1 gable end, looking west, scale 0.5m*

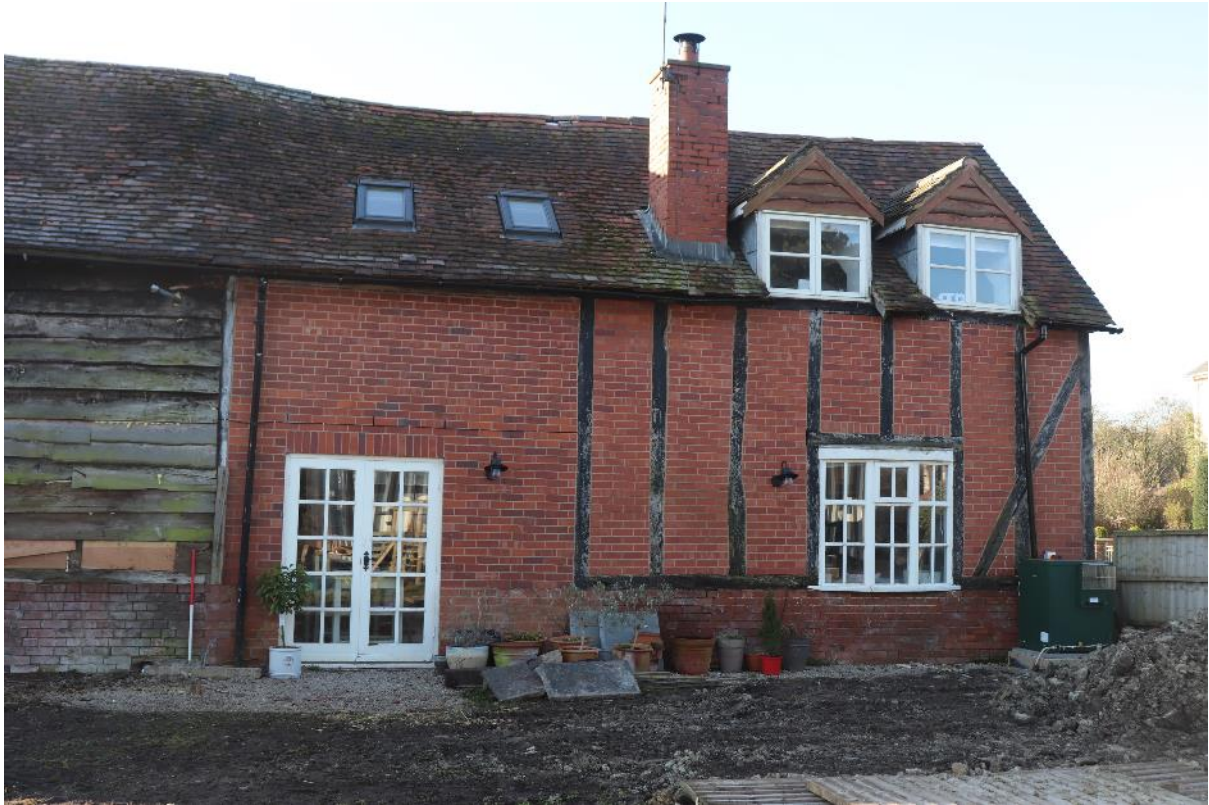
*Plate 7 Phase 1 walling, looking south, scale 1m*

The wall framing (Plate 7) remains most consistently on the northern side of the building and again consists of posts running from sill beam to wall plate. No consistent indication of infill between the posts is present, suggesting that the walling was weather boarded from the outset. It is probable that some of the extant weather boarding was original, as they were pit sawn and fixed with handmade nails. Their being hand sawn certainly suggest a pre circa 1850 date, after which timbers were predominantly machine sawn. Another feature visible on the building is the partial use of nails for fixing some joints, as opposed to oak pegging. This practice probably started to some degree in the later 17<sup>th</sup> century but was common throughout the 18<sup>th</sup> century in such agricultural buildings.

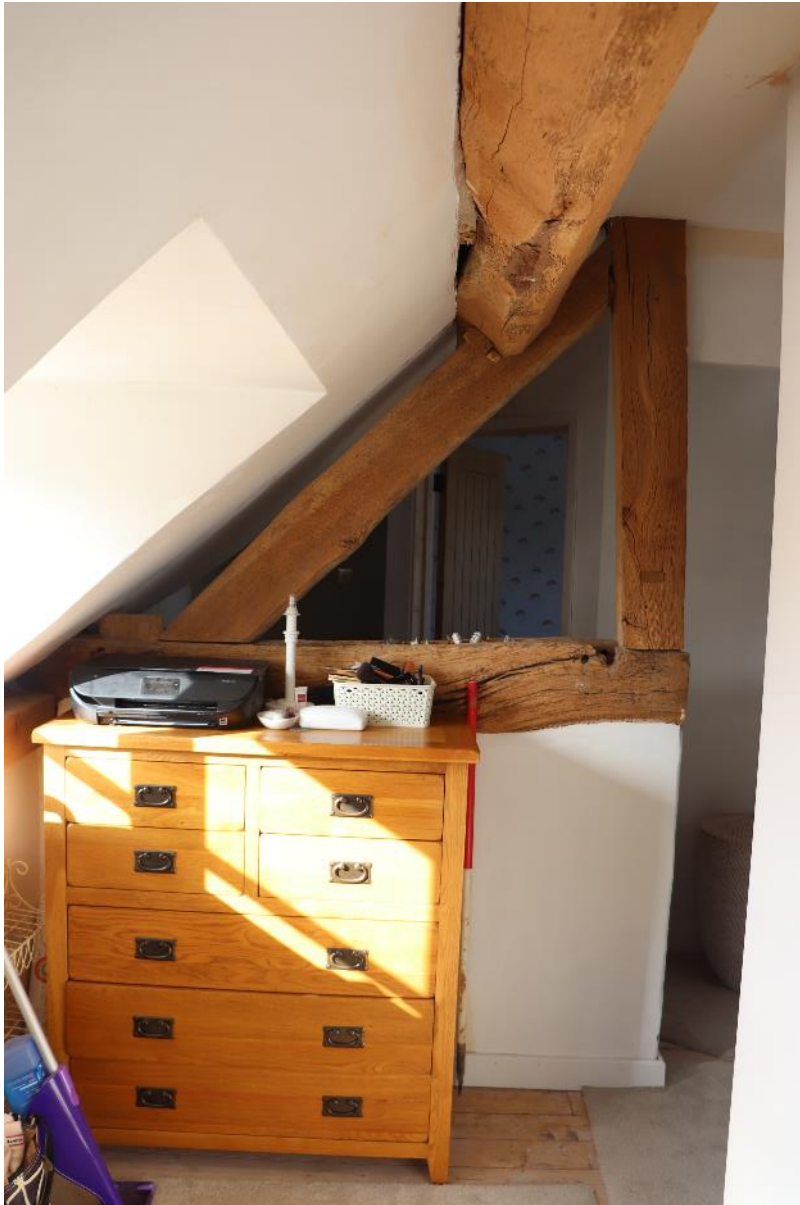
*Plate 8 Phase 1 internal cross frame truss, looking west, scale 1m*

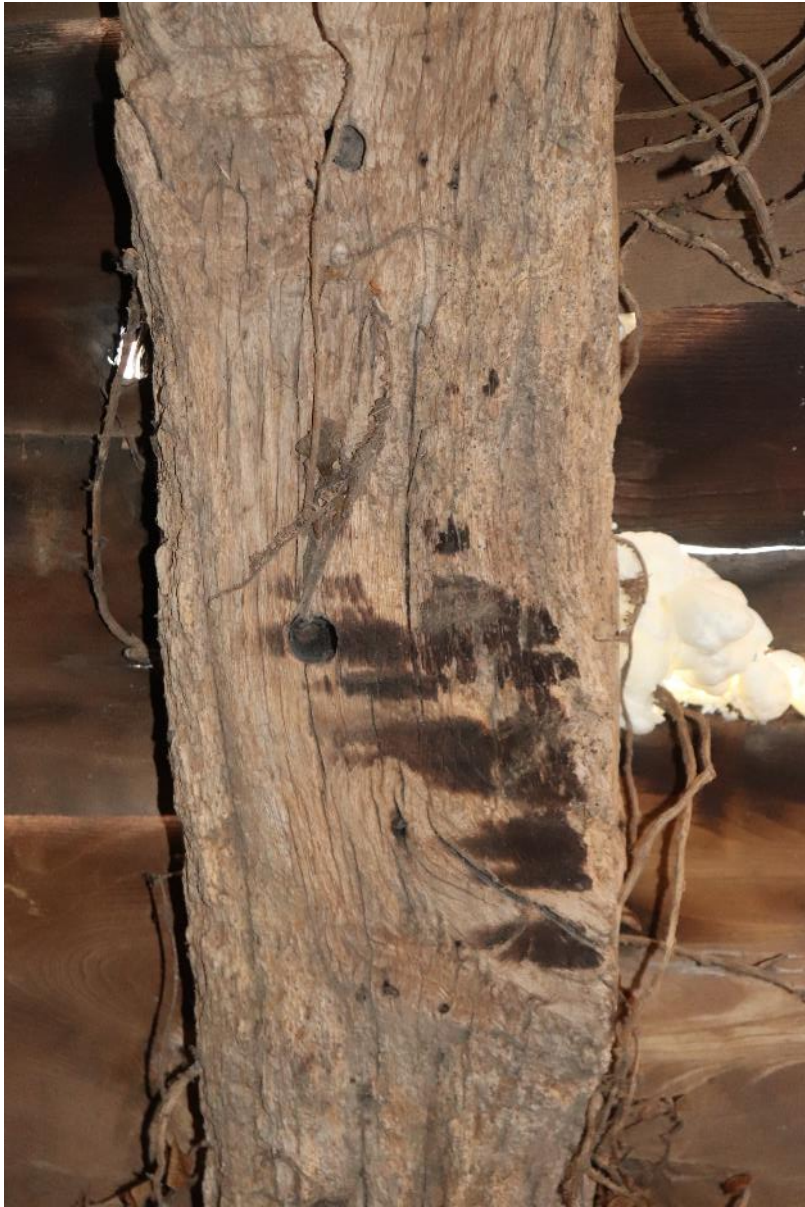
*Plate 9 Burn marks on a Phase 1 reused timber, looking south*

One further feature of one of the reused timbers was a concentration of burn marks orientated horizontally rather than vertically, indicating that they were made before the structure was erected (Plate 9). Such marks are widely considered to be apotropaic, perhaps specifically to ward off the devil and symbolically bringing light to the dark.

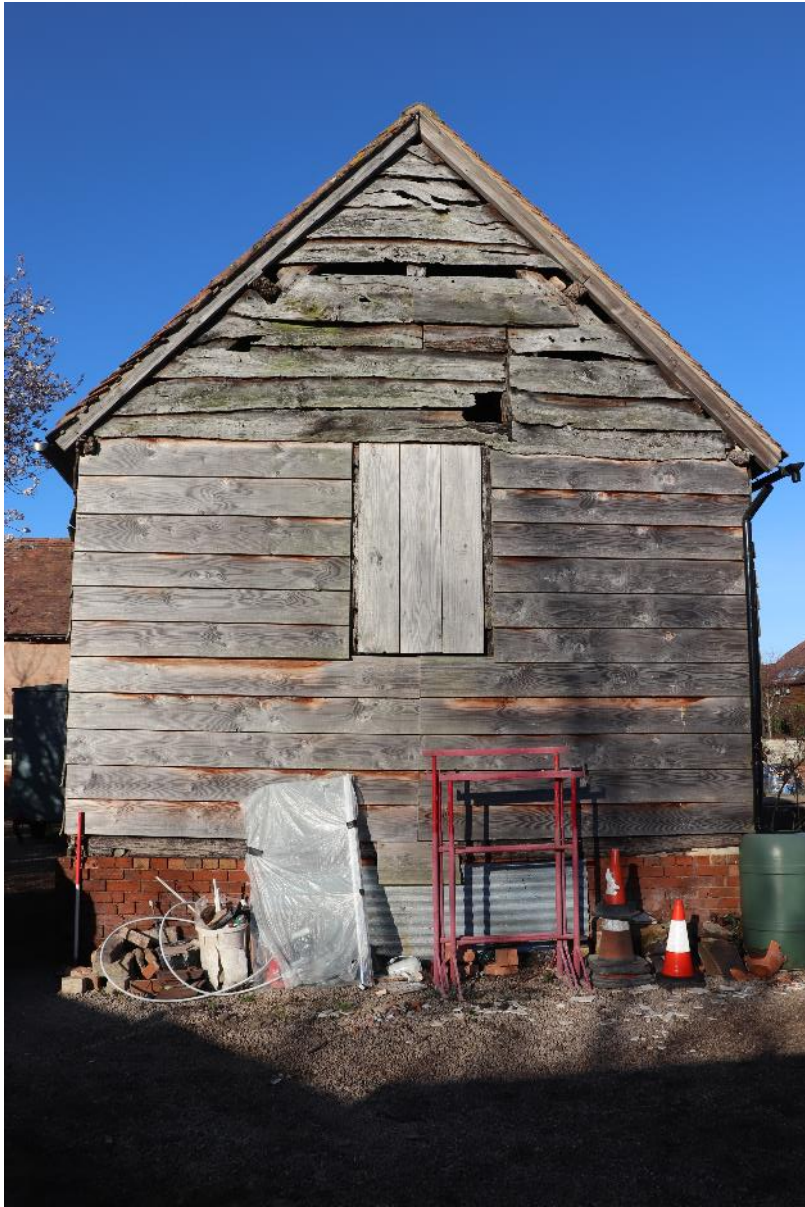
*Plate 10 Phase 2 gable end, looking west, scale 1m*

In this period, a single bay was added to the eastern end of the Phase 1 threshing barn (Plate 10 and Plate 11). Its style was similar with posts running from sill beam to wall plate and tie beam base, though with long braces running from sill beam to jowl posts on the end gable frame only. Above the

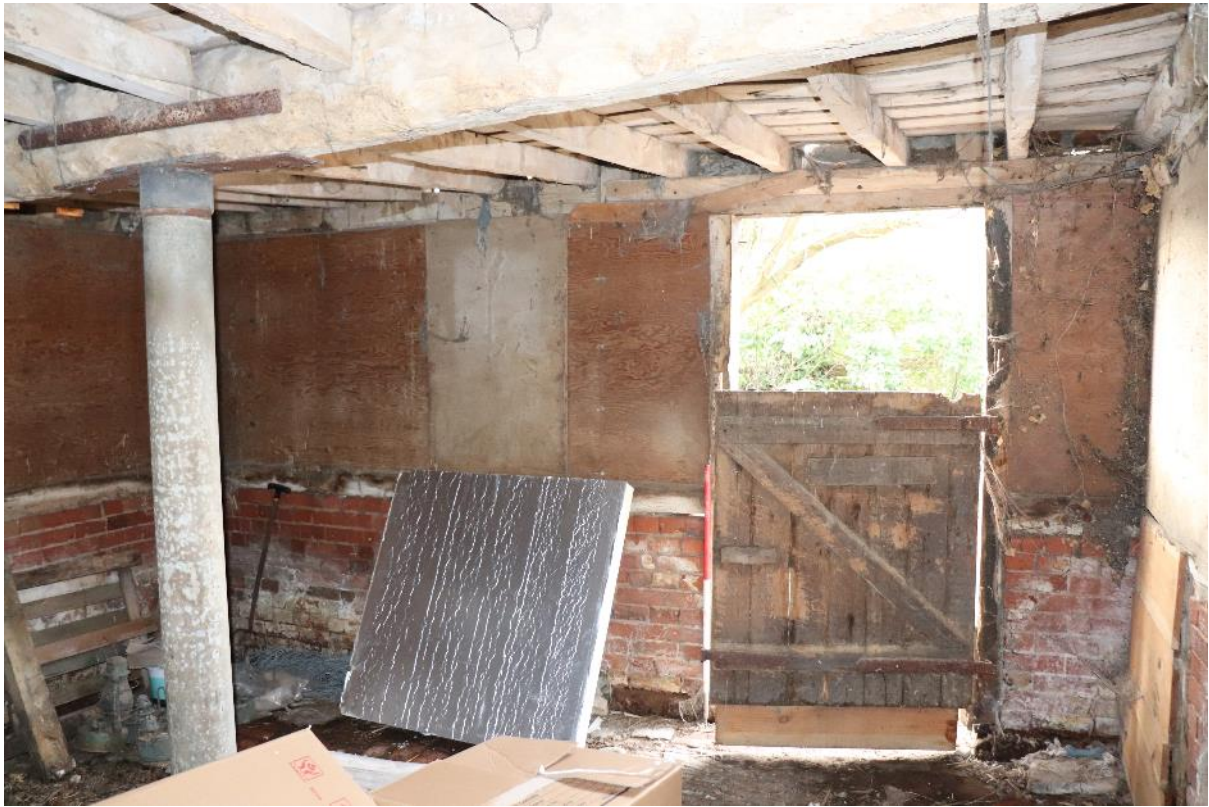
*Plate 11 Phase 2 interior ground floor, looking south east, scale 1m*

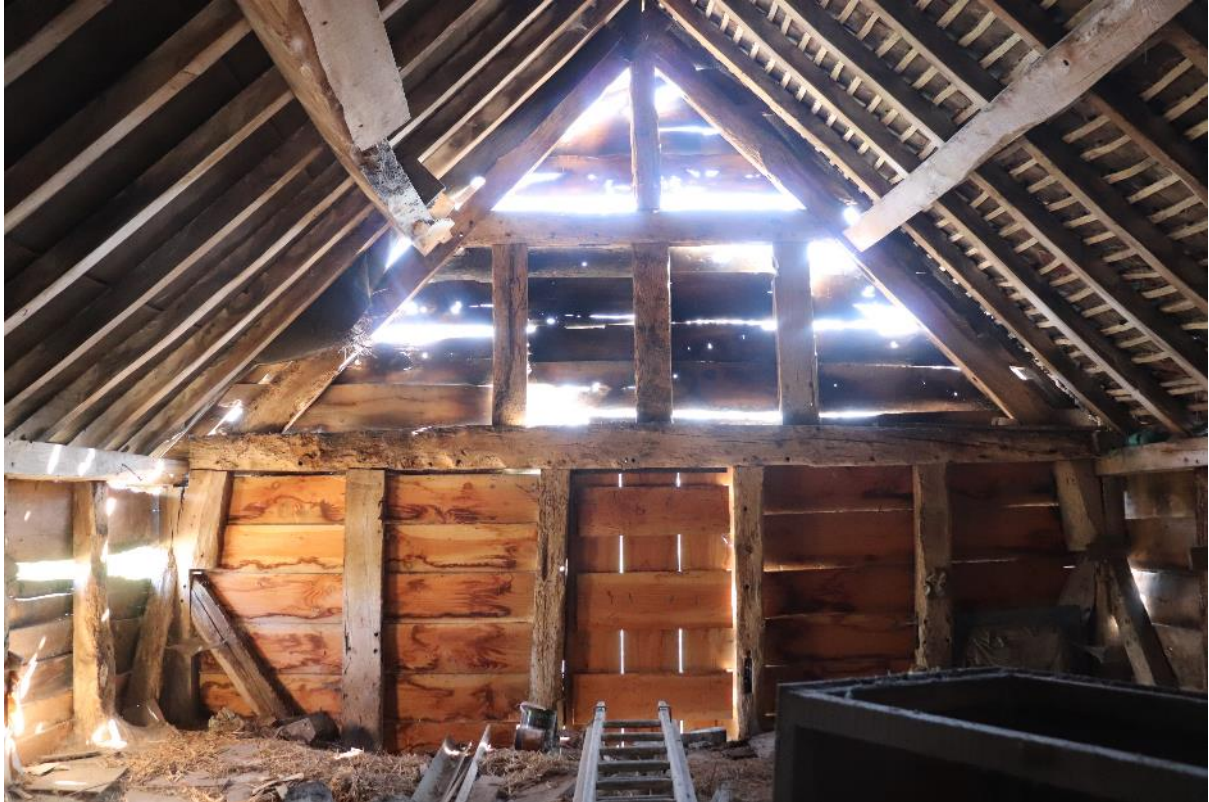
*Plate 12 Phase 2 interior inserted first floor, looking east*

tie beam (Plate 12) is the same arrangement as the western end of Phase 1 structure with three vertical posts to the collar and a further central post from the collar to apex. This similarity of style suggests a date for this extension not long after Phase 1.

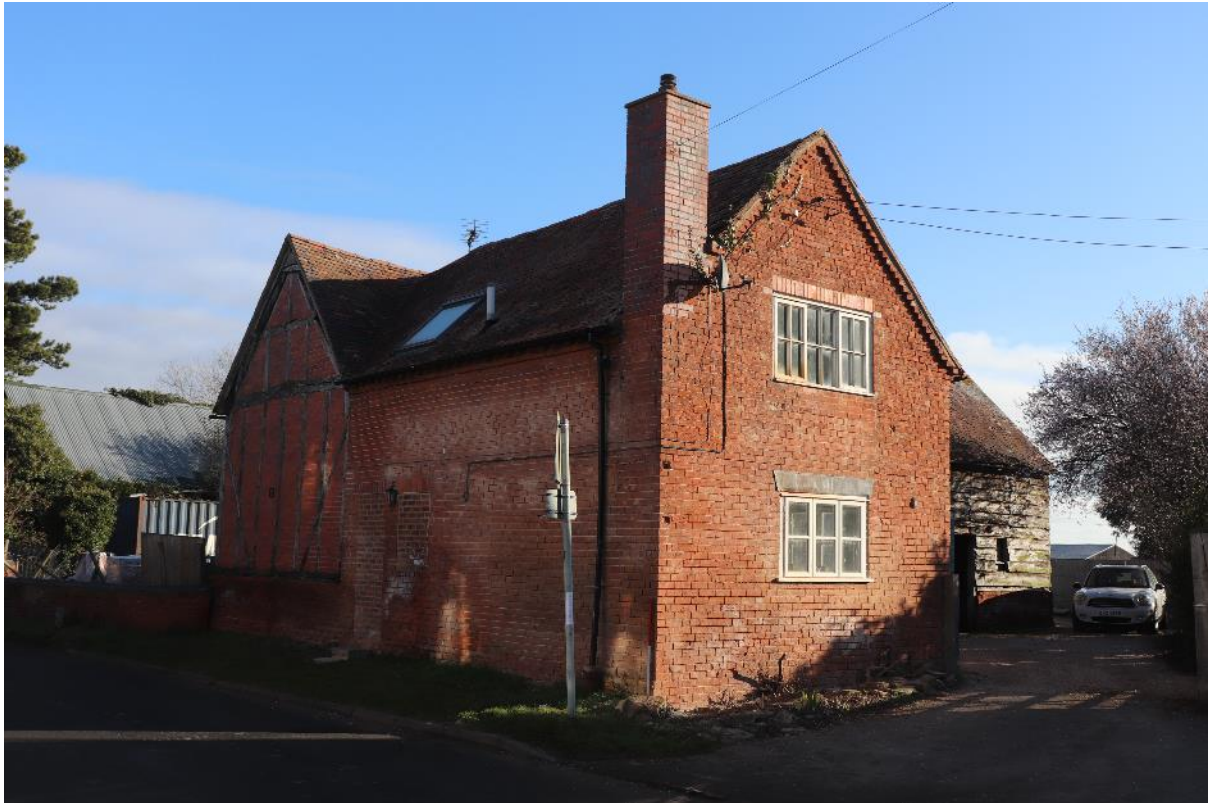
*Plate 13 Phase 3 addition, looking north east, scale 1m*

In this period a two bay brick extension was added to the southern side of the Phase 1 building, flush with its gable and parallel to the road (Plate 13 and Plate 14). The walling of this is of brick with dentilled eaves details, and stepped dentils running along the edge of the roof at its gable. Its brickwork is a variation of English Garden bond with three stretcher courses, followed by a course of alternating headers and stretchers. This bond and the same bricks continue around the Phase 1 and 2 plinth walls, excepting points of later rebuild, showing that their plinth walls were rebuilt at this time.

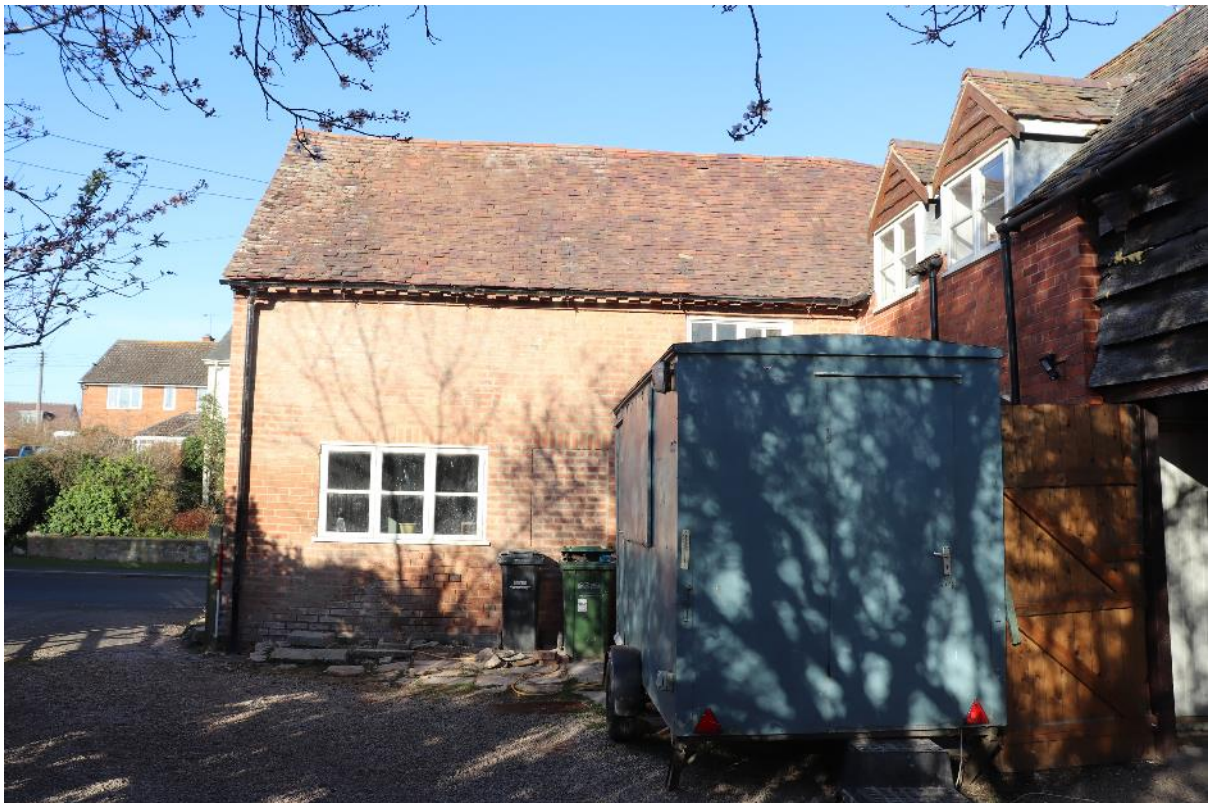
*Plate 14 Phase 3 addition, looking west, scale 1m*

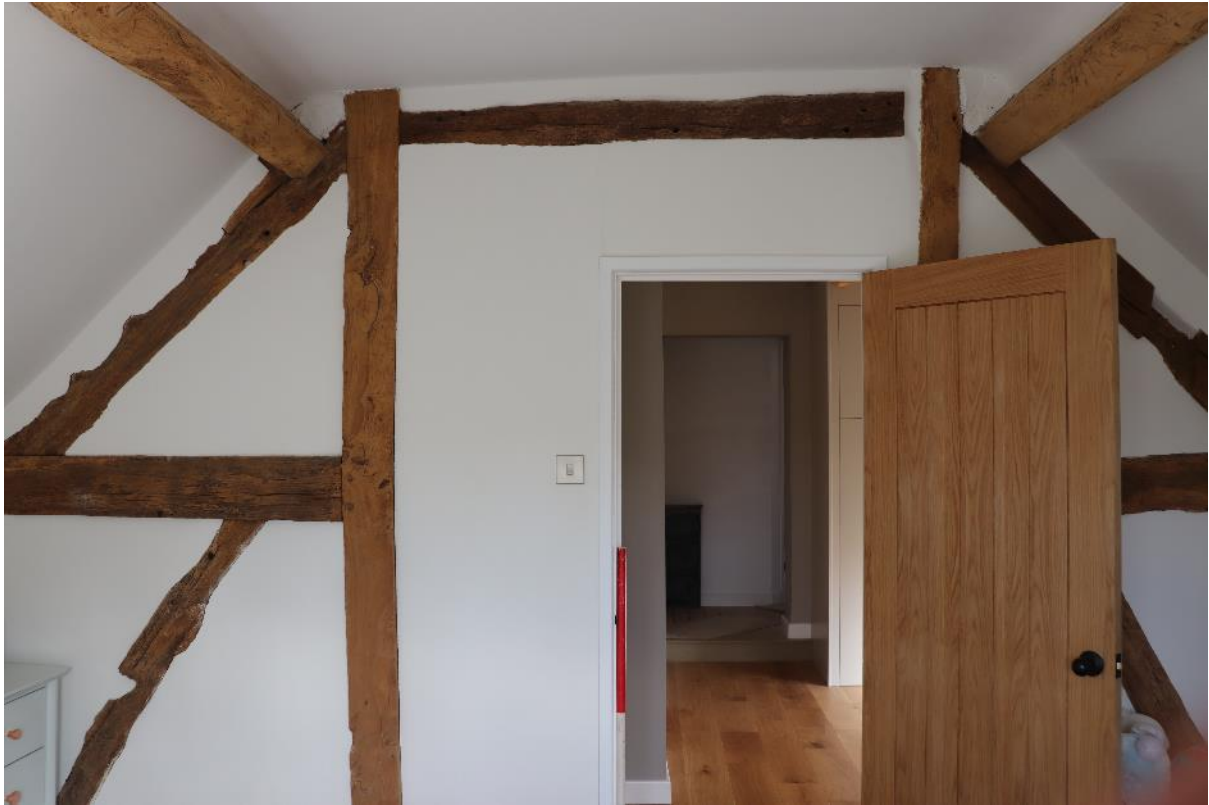
*Plate 15 Phase 3 addition first floor roof truss, looking north, scale 1m*

Internally the building was split over the ground and first floor, with a single truss dividing the first floor space (Plate 15). The tie beam and principal rafters of this truss are interrupted by two vertical posts which are linked by a collar, in manner similar to the Phase 1 internal trusses. The main differences are the interruption of the tie beam and the collar extending to a beam visible at just above head height level in the room below (Plate 16). This arrangement allowed easy access through the truss, effectively making a single two bay space on the first floor. No evidence of the ground floor beam is indicating a single ground floor space with no internal divisions.

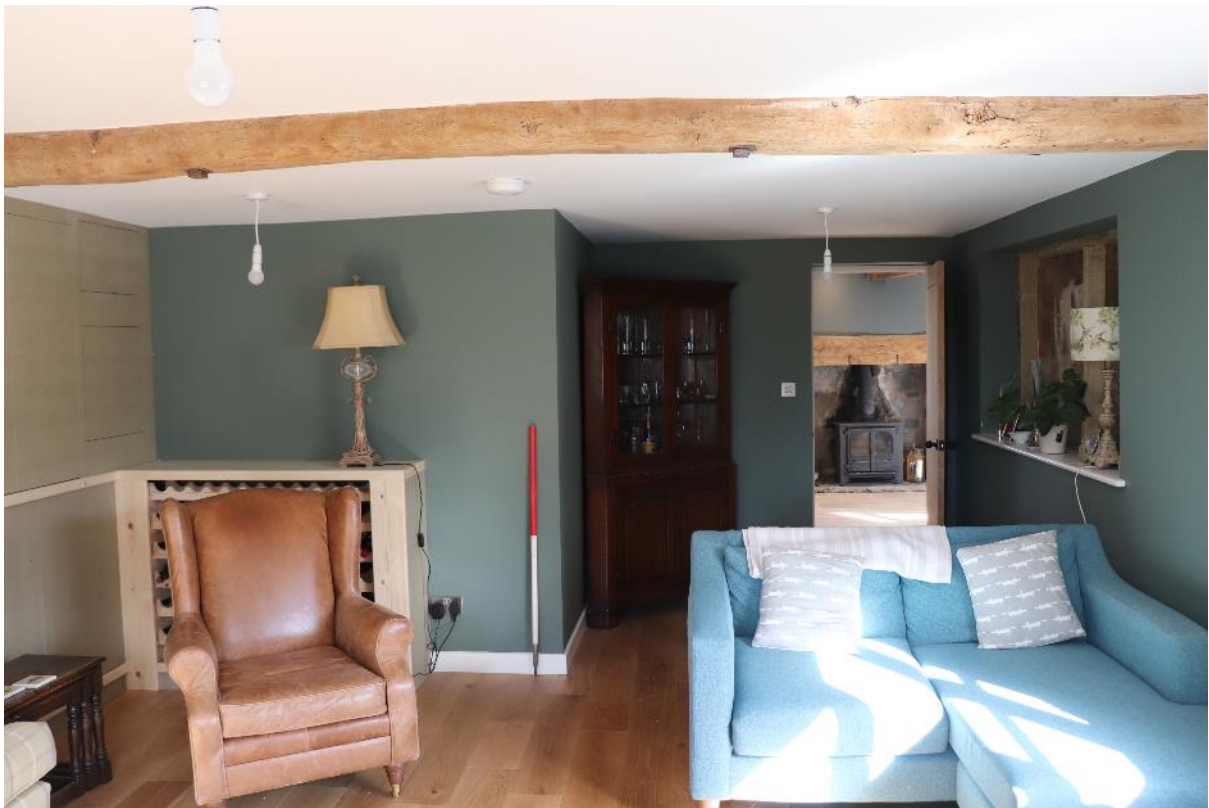
*Plate 16 Phase 3 addition ground floor, looking north, scale 1m*

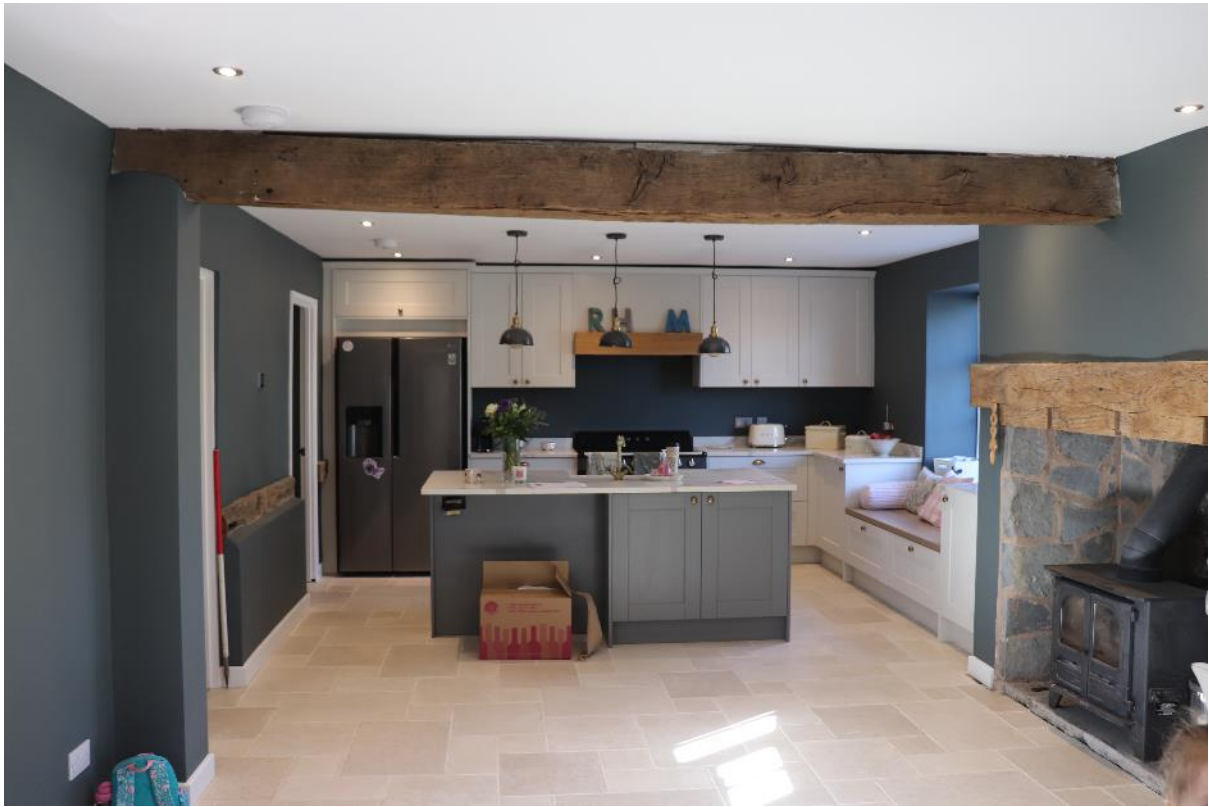
*Plate 17 Phase 1 ground floor with Phase 5 changes, looking west, scale 1m*

In the second half of the 20<sup>th</sup> century, part of the Phase 1 barn along with the Phase 3 brick building were converted for domestic use. Two fireplaces were added, one within the Phase 1 element and one with the south west corner of the Phase 3 building. The brickwork of the chimney stacks clearly shows their 20<sup>th</sup> century origin. 20<sup>th</sup> century brickwork is clear within the position of the Phase 1 threshing doors, as well as in between the posts of that phase. It is likely that the external weather boarding was removed at that point also. Four dormer windows were added to the roof of the Phase 1 building, likely highlighting the first time the western bay of the barn had a first floor. Stairs were added within the Phase 3 building, only to be moved into the Phase 1 barn. Various further divisions as drawn on (Figures 2 and 3) date to this phase.
