Building recording at Barn House Farm, Foxlydiate Lane Redditch

Worcestershire Archaeology
for Orion Heritage

July 2021

Building recording report

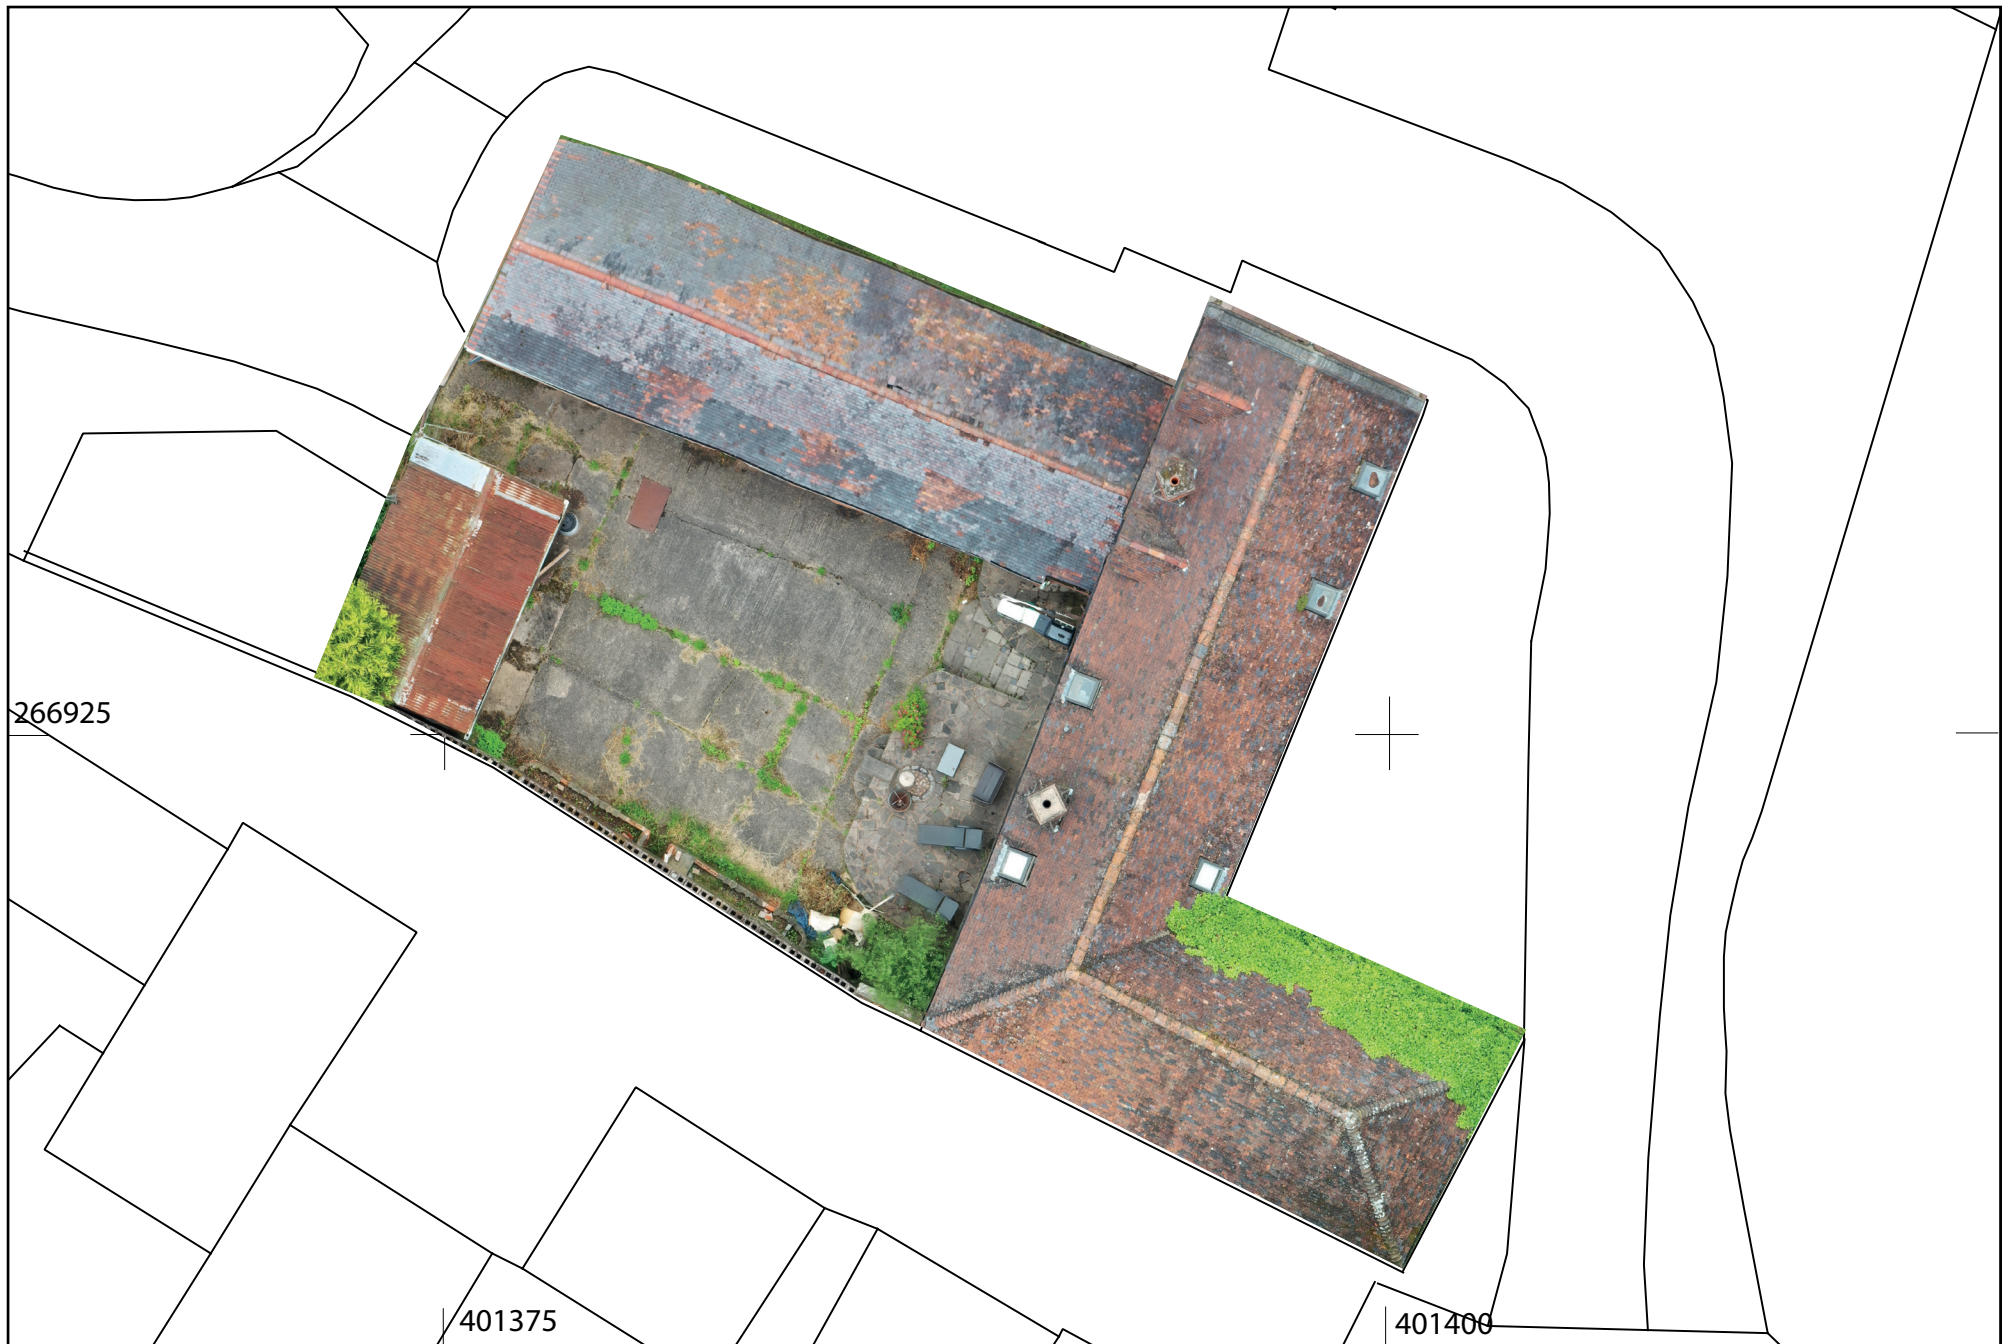
Figure 3

Site location with photogrammetric roof plan

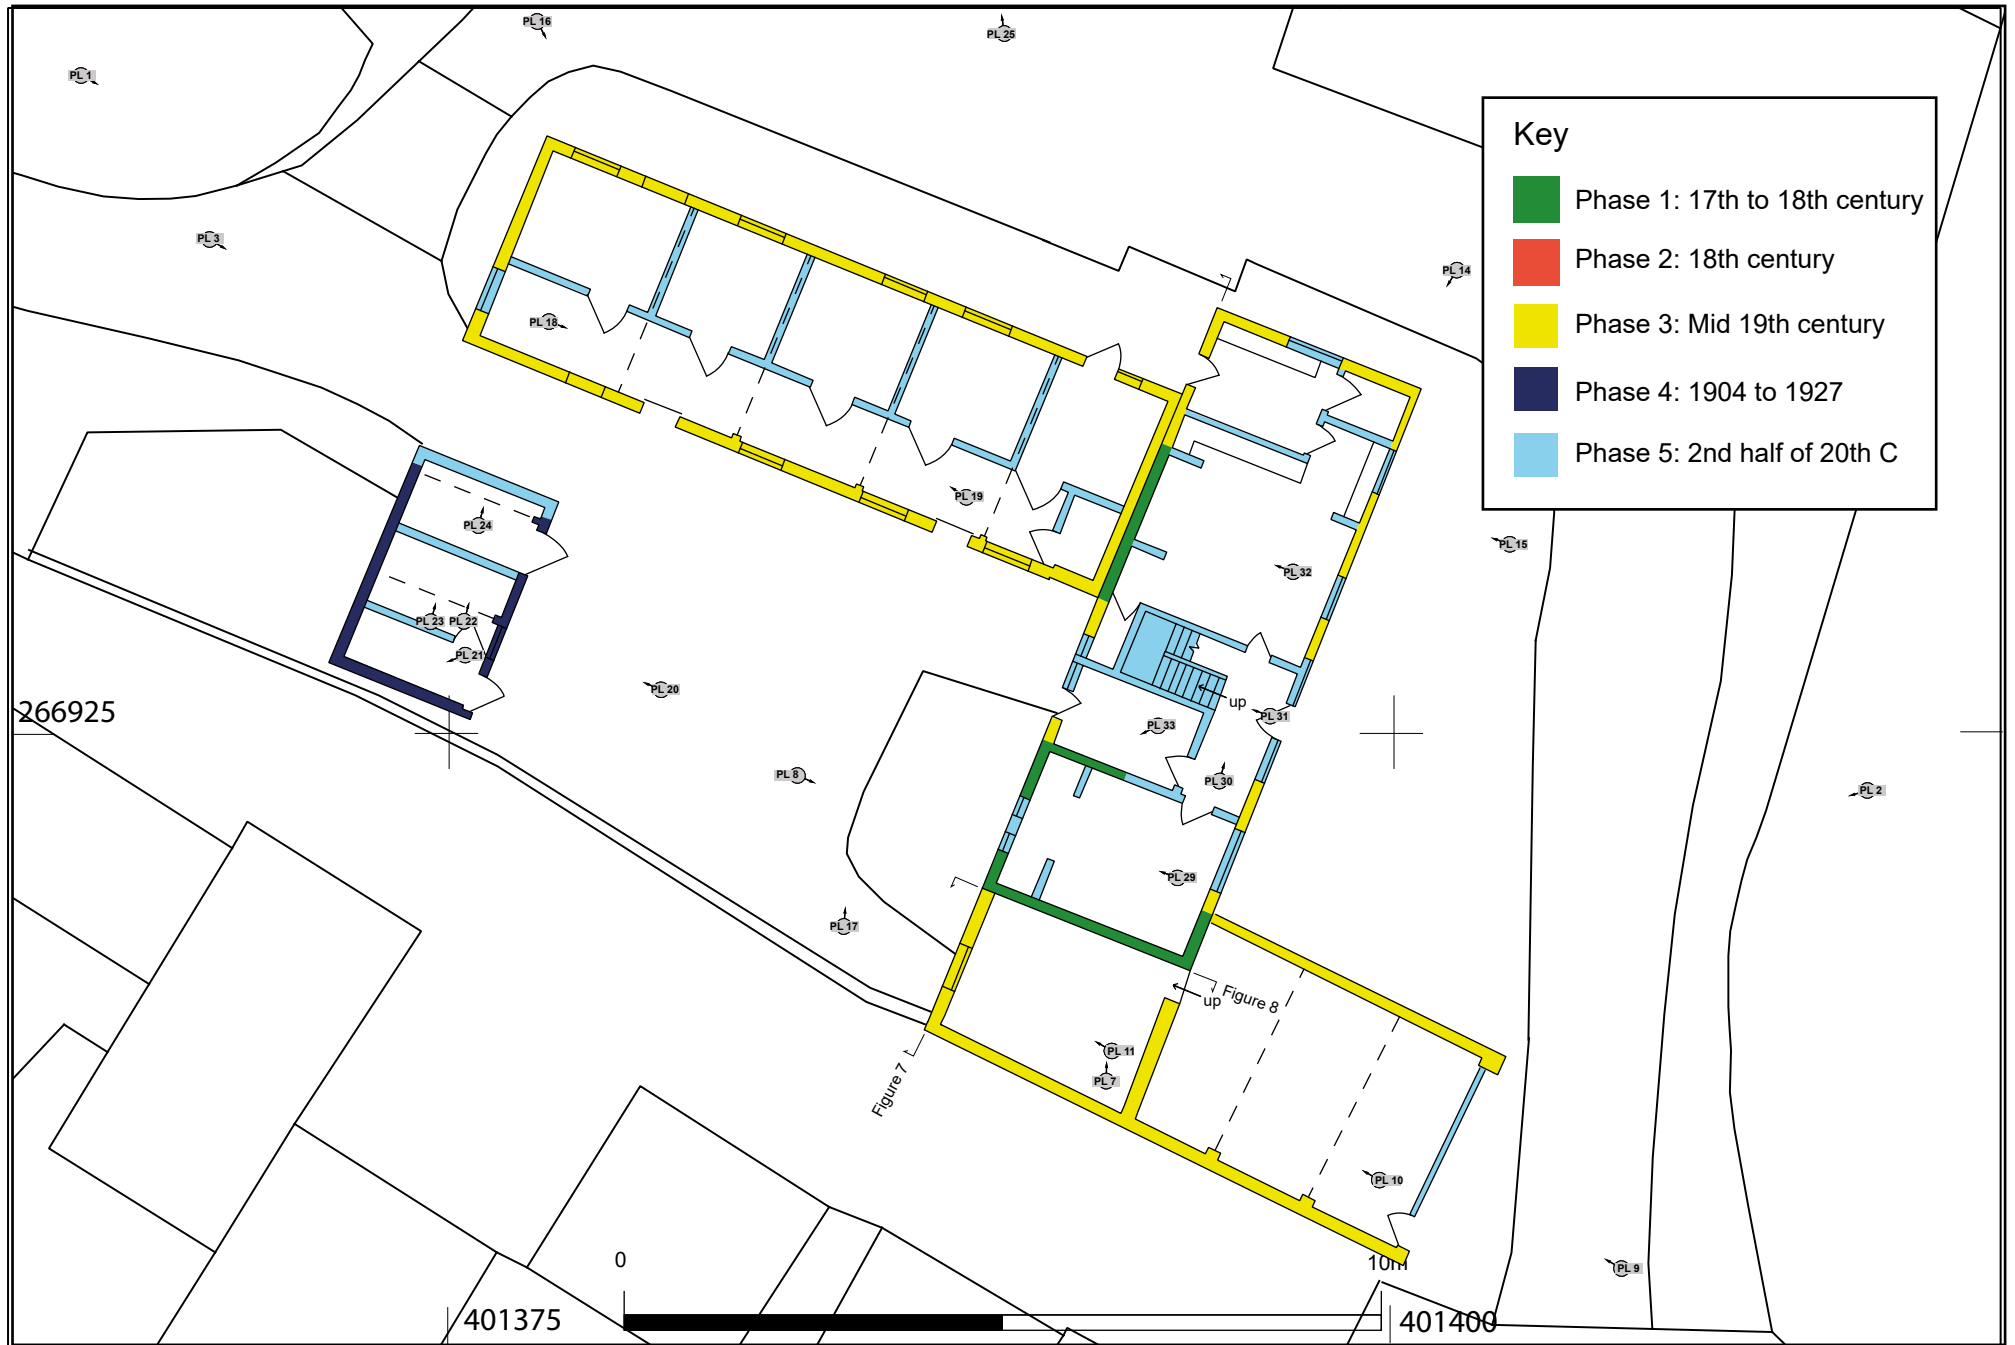
Key

- Phase 1: 17th to 18th century
- Phase 2: 18th century
- Phase 3: Mid 19th century
- Phase 4: 1904 to 1927
- Phase 5: 2nd half of 20th C

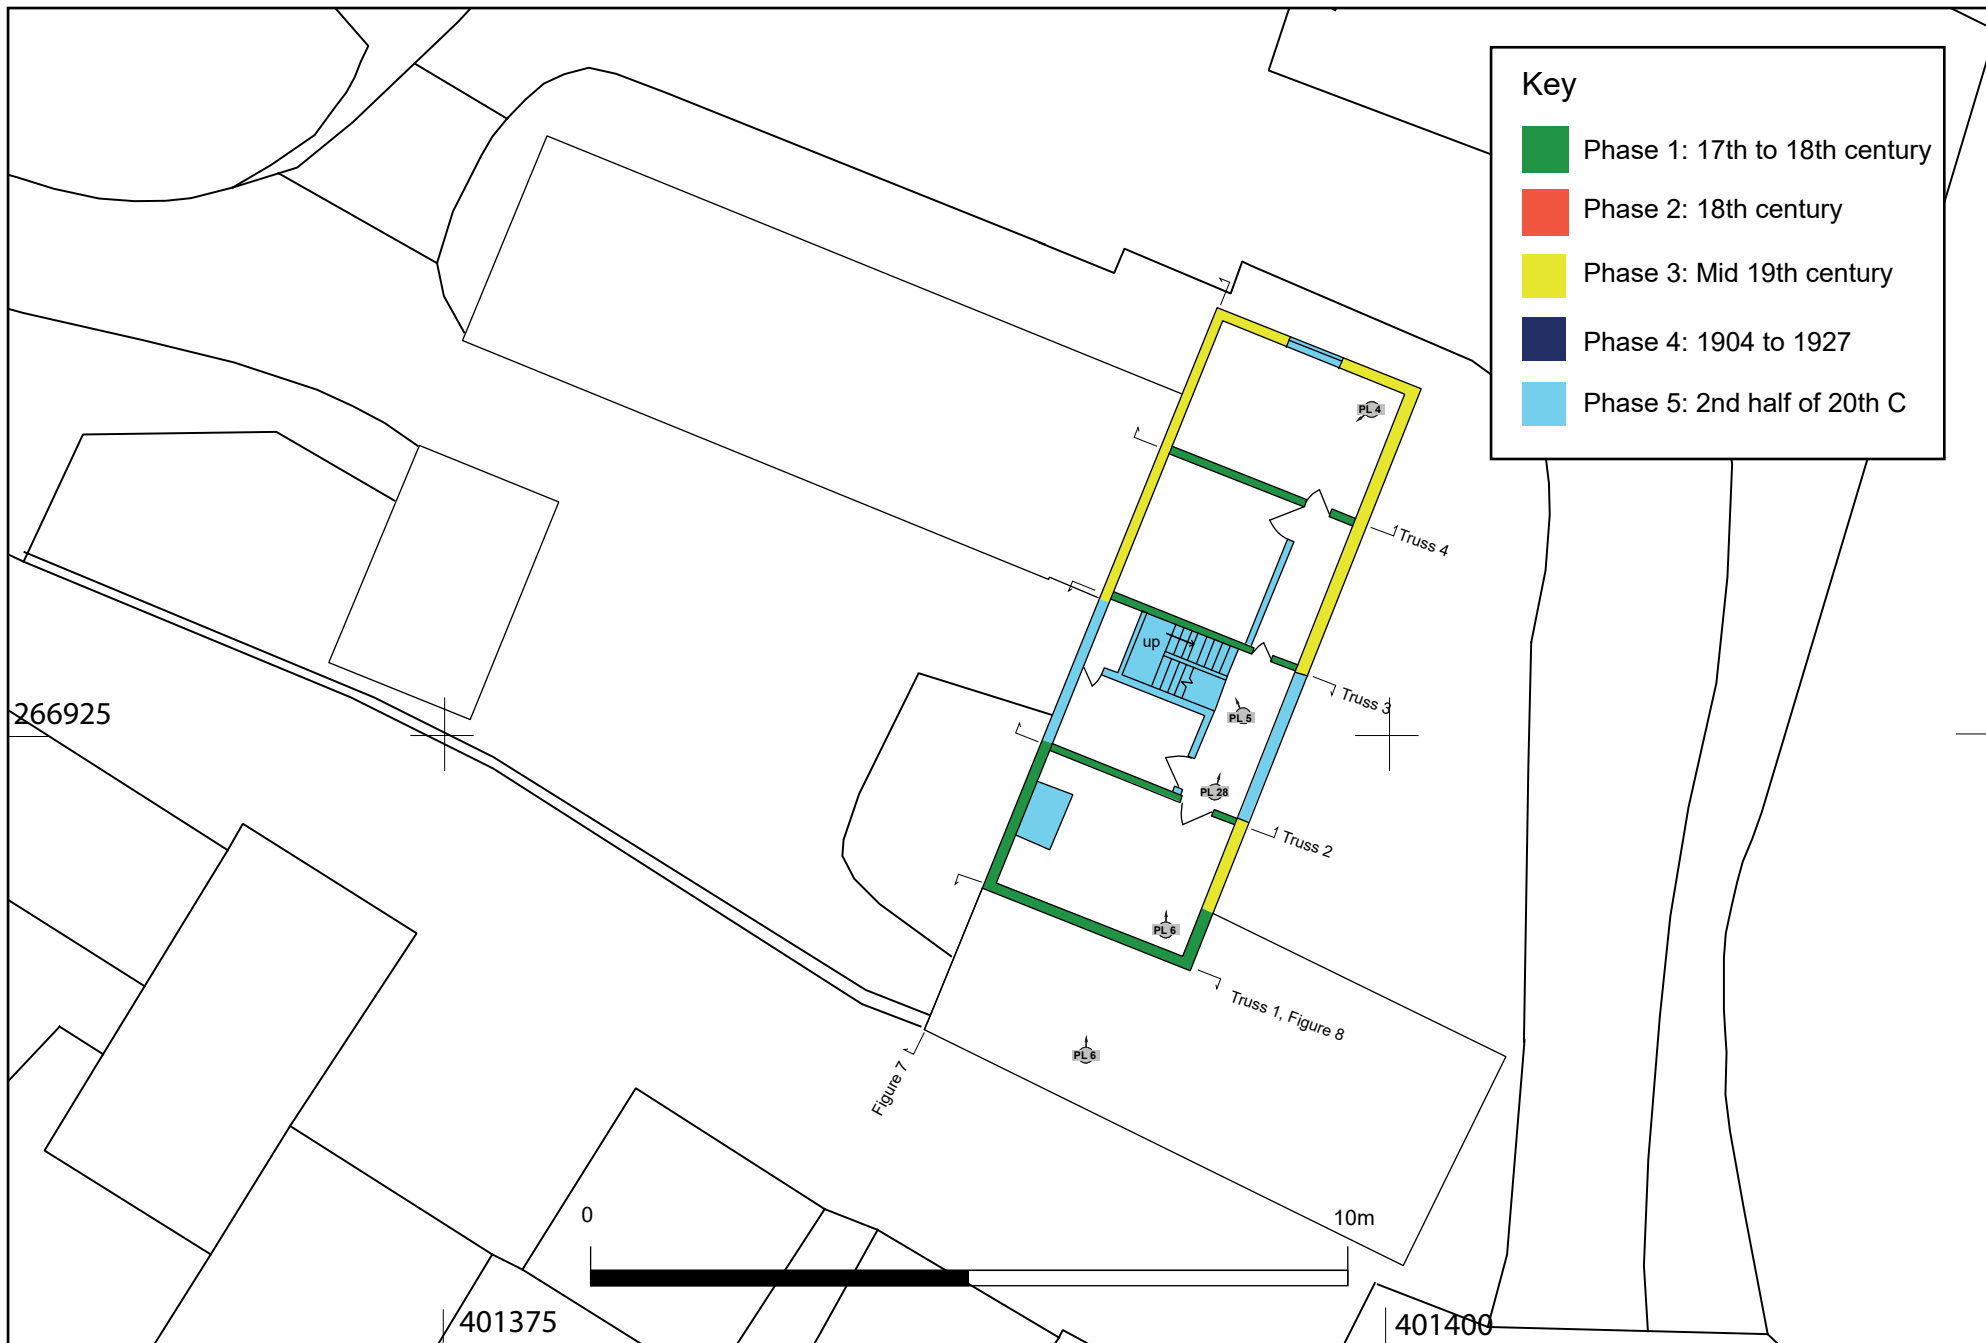
Figure 6

The first phase of the buildings on site consisted of a broadly north-east to south-west aligned three bay timber framed structure, now largely concealed within later phases. The primary evidence for the layout of this structure was in its roof trusses, all four of which remained (Plate 4 to Plate 7). The location of these four trusses is annotated on the first floor plan (Figure 6), as cross frames 1 to 4.

First floor plan with site mapping

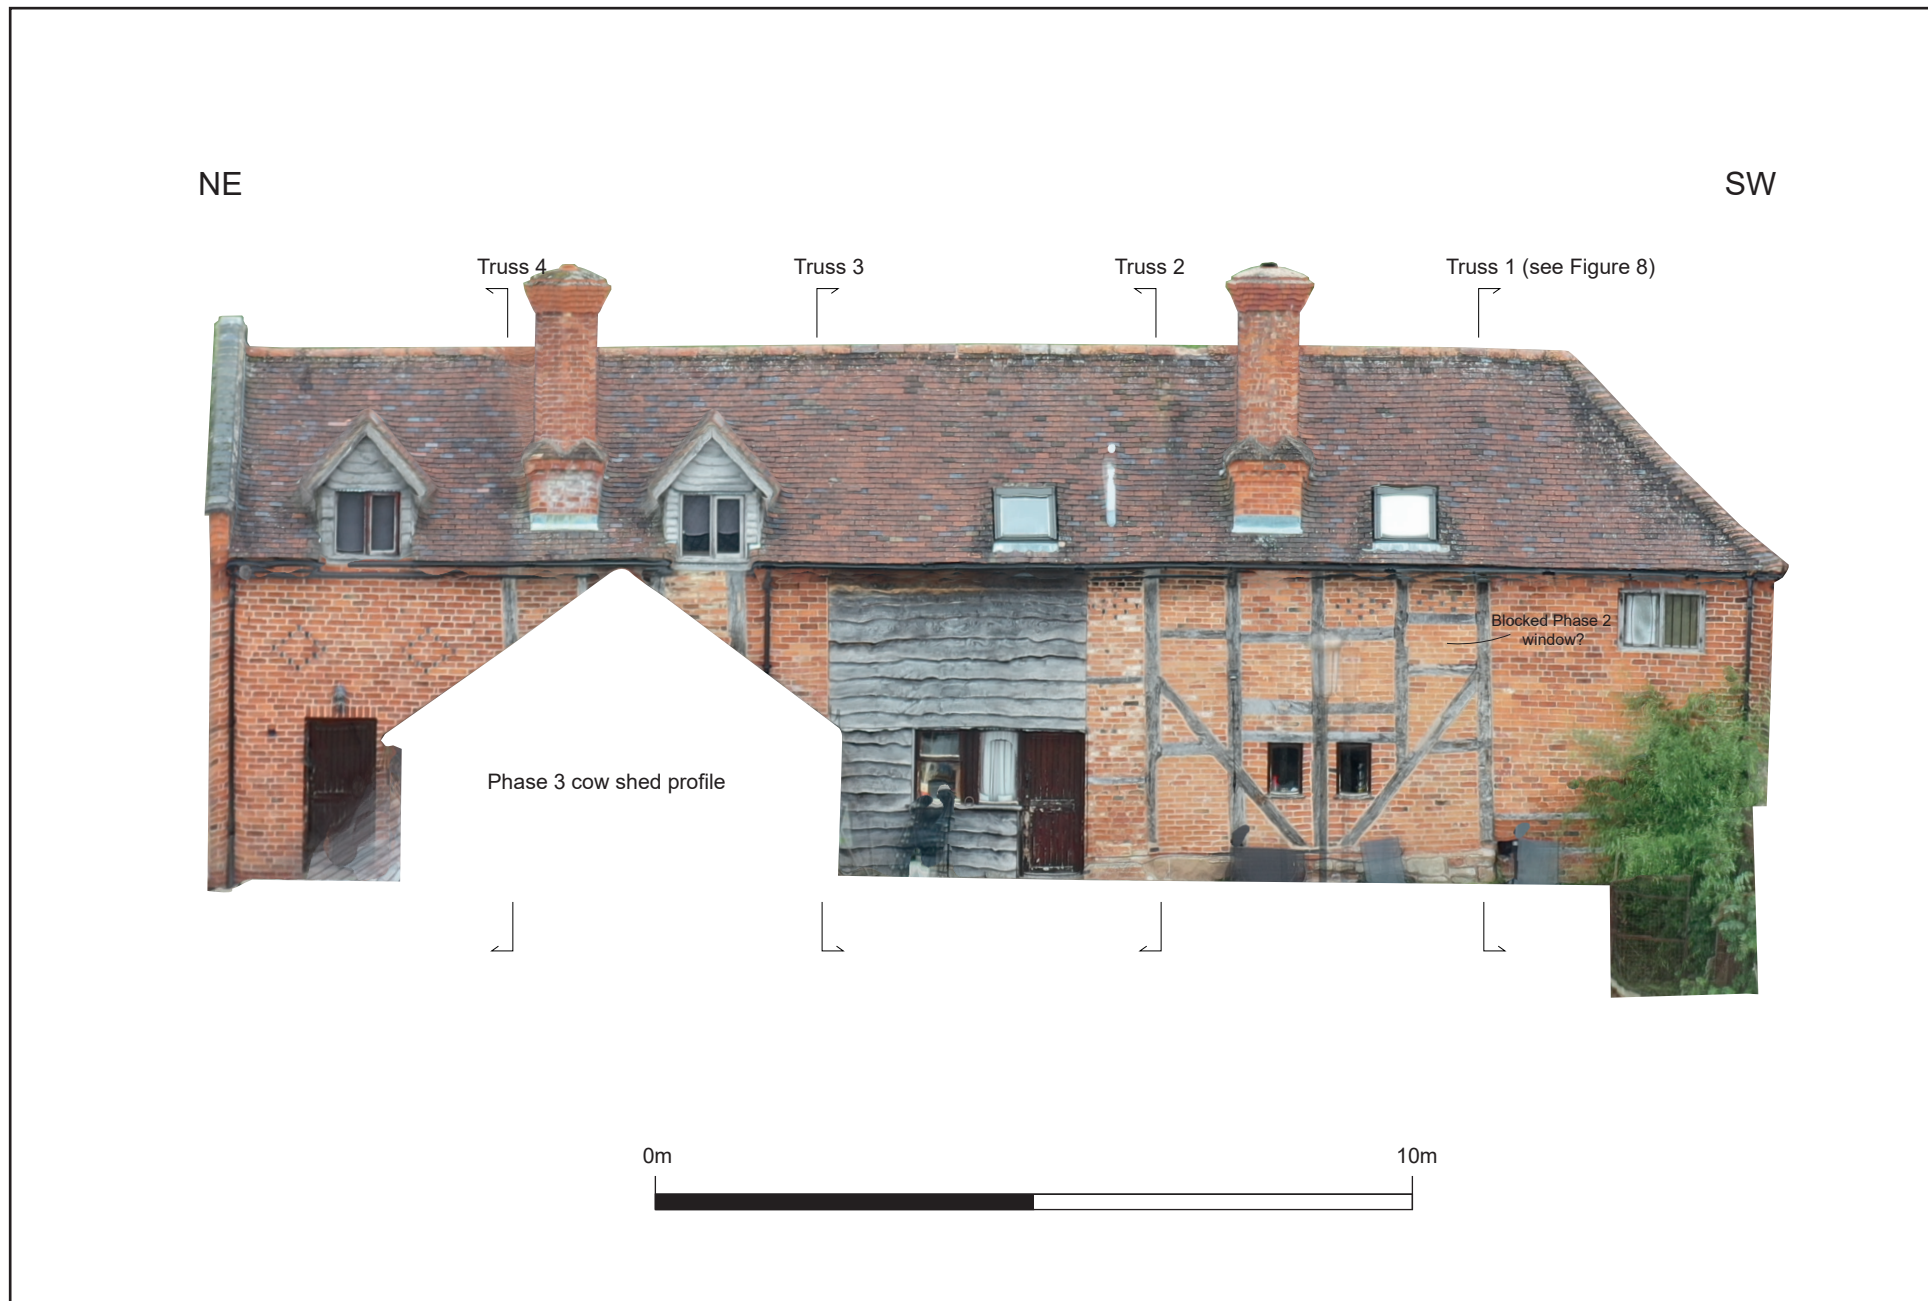
Figure 7

Some exterior area of wall framing remains, running between the jowl posts of cross frame 1 and 2 on the north west side of the building (Plate 8, Figure 7), as well as some further partially remaining studs between cross frames and 3 and 4, as visible above the roofline of the Phase 3 structure. Between the jowl posts of cross frames 1 and 2, the framing would have consisted of three high square panel framing, though this has been significantly altered later. As with cross frames 1 and 2, long braces ran between the sill beam and each jowl post.

North west facing photogrammetric elevation of the Phases 1 and 3 threshing barn with the location and facing of Phase 1 internal frames

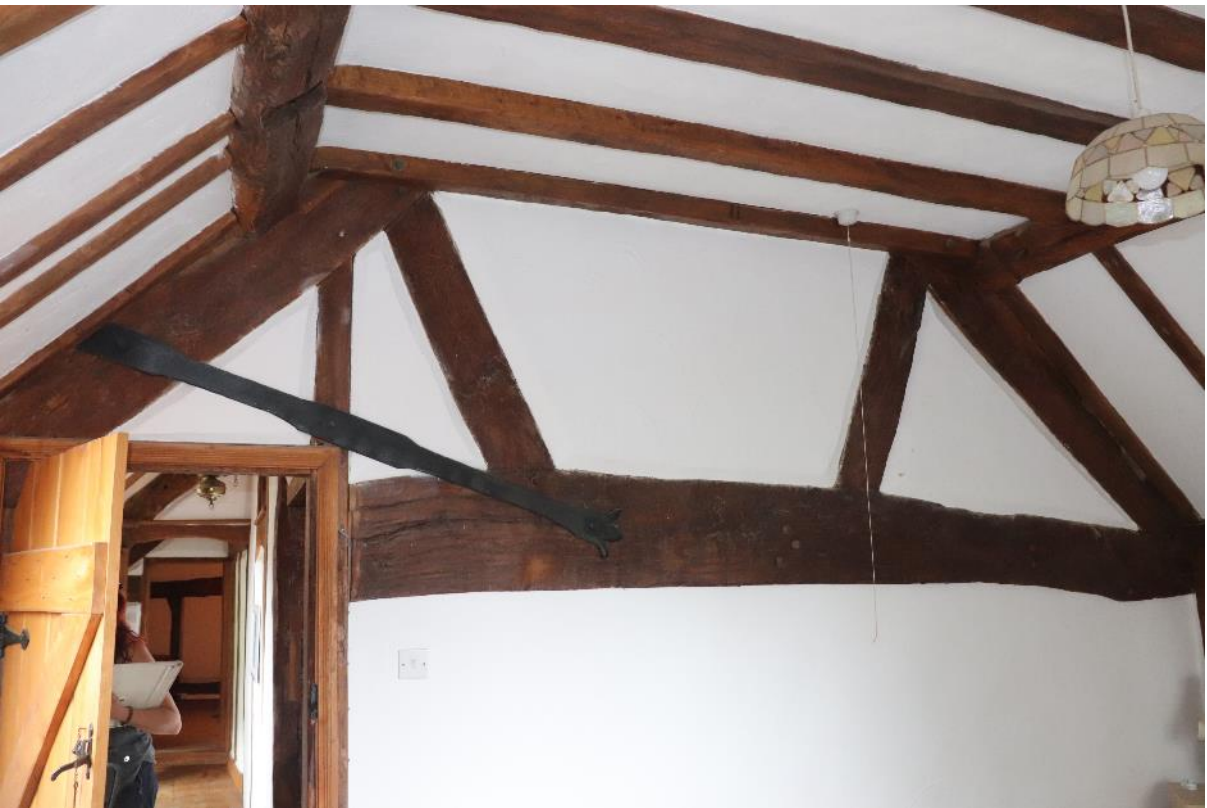
It is probable that cross frame 4 represented the former gable end of the building, though only the roof truss remains (Plate 4). The frame faces towards the north east, as would be expected of an exterior frame. No peg holes are present that would indicate timber infill on the under-side of the tie beam, potentially suggesting that this was open and that there was originally a further bay. This is not entirely conclusive as it is possible that this was largely brick infilled, though this would be of significantly different character to the opposing gable end, cross frame 1.

Plate 4 Phase 1 possible former gable end truss 4, looking south west

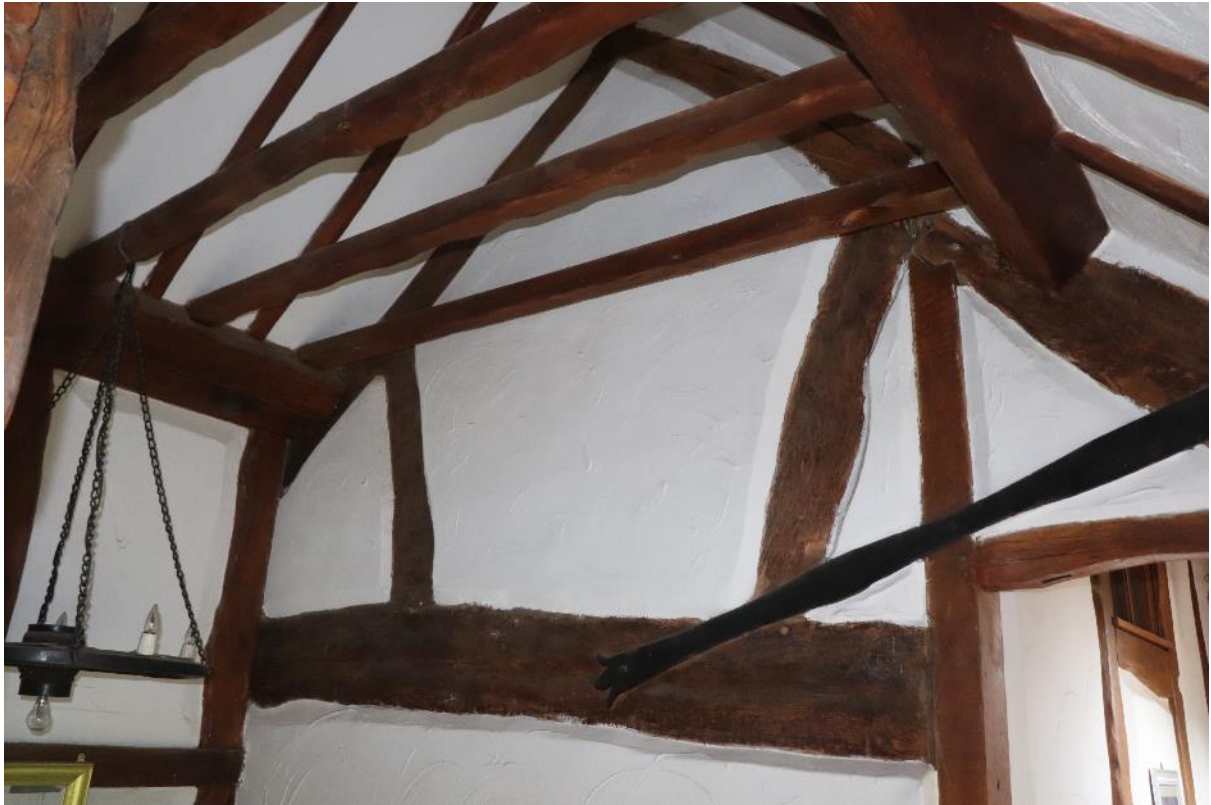
The carpenters faces of the two interior roof trusses, cross frames 2 to 3, were into the centre of the building, a configuration typical of threshing barns. This interpretation was supported by cross frame 2 having a sill beam remaining and a single surviving long brace from sill beam to jowl post (Plate 33), of which there would have been a further running to the opposing jowl post originally. No further framing evidence was present, indicating that this frame was originally open to the roof. It is likely that cross frame 3 was of the same arrangement. This would be entirely typical of 17th and 18th century threshing barns of the region, and these cross frames would have been either side of the threshing floor.

Plate 5 Phase 1 truss 3, looking north

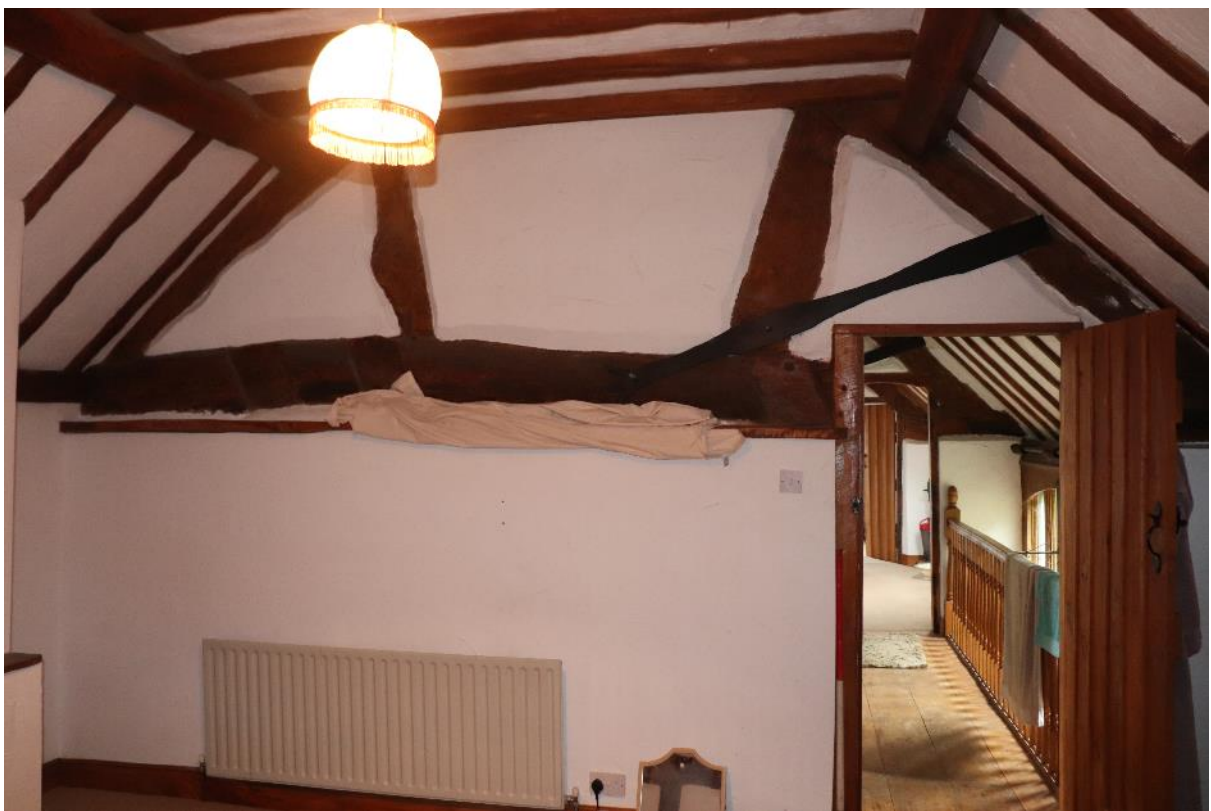
Plate 6 Phase 1 truss 2, looking north, scale 1m

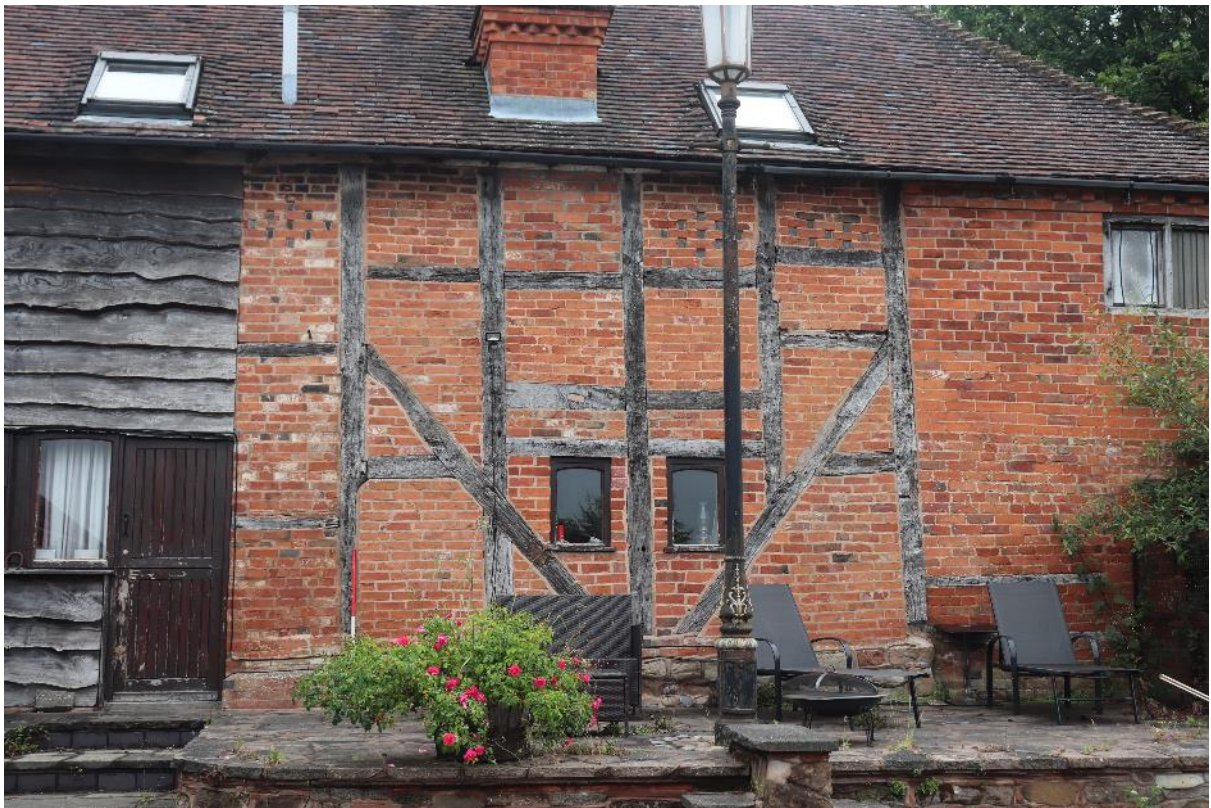
Plate 8 Phase 1 wall framing, looking south east, scale 1m

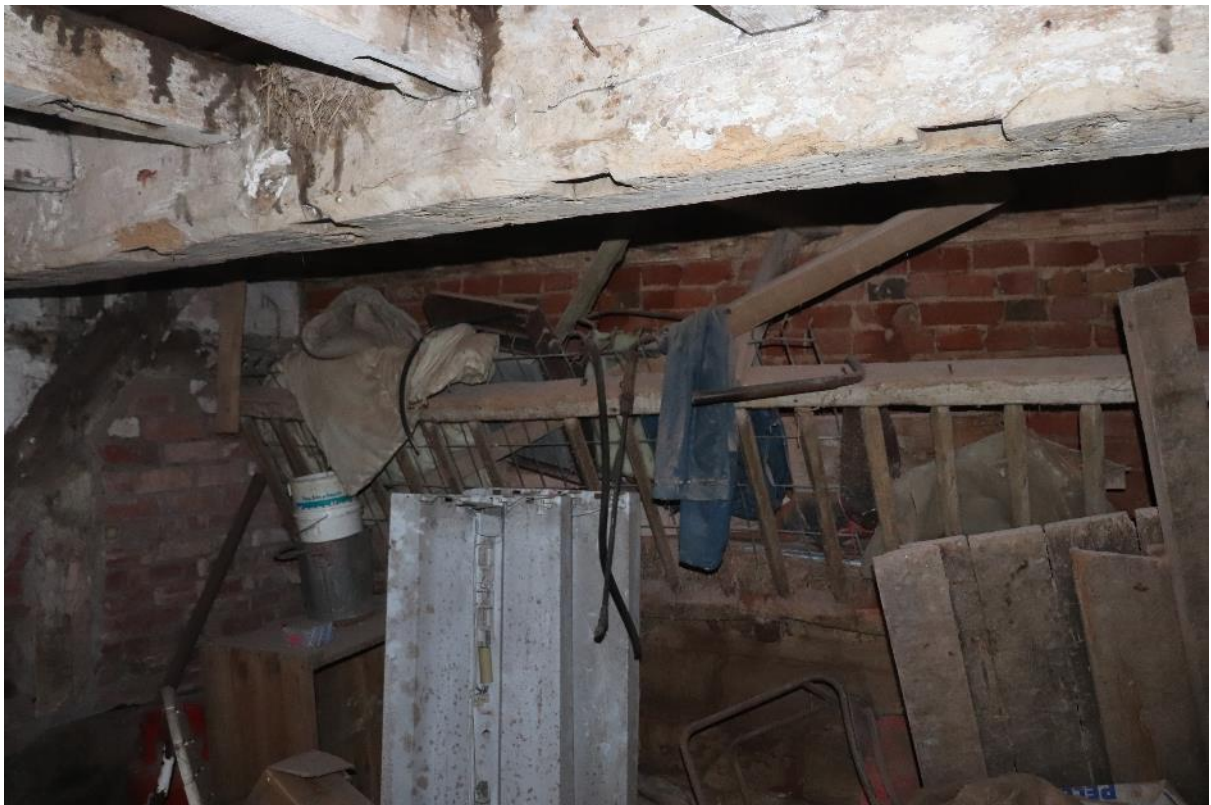
The dating of this phase is problematic, but given that the structure appears to have been largely timber framed, an 18th century date seems most likely. It is likely that some of the stone footings within the basement room date to this time (Plate 12).

The Phase 2 addition was largely removed at this point and replaced in brick with a hipped tile roof supported by the existing structure. An extension towards the south which consists of a single space spanned by two hardwood Kingpost trusses with single purlins each side that was hipped at its end and also tile covered (Plate 9 to Plate 10). This space has large opening at its south-east end, suggesting a former function as a cart shed. A single door accesses the space which replaced the Phase 2 structure. This room has a single window (Plate 11), though its function is likely to have been crop storage as the room below appears to have been a stable (Plate 12 and Plate 13).

Plate 12 Phase 3 addition, looking north east

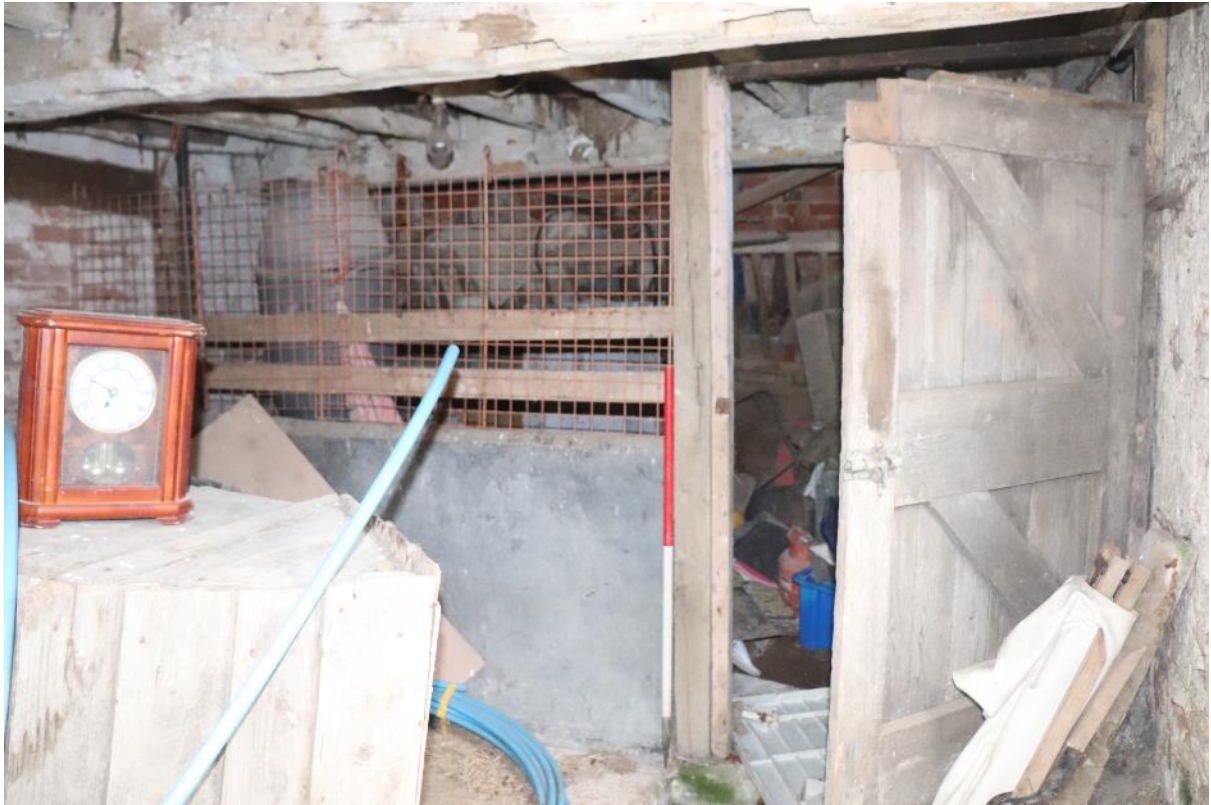
Plate 13 Phase 3 addition, looking north east, scale 1m

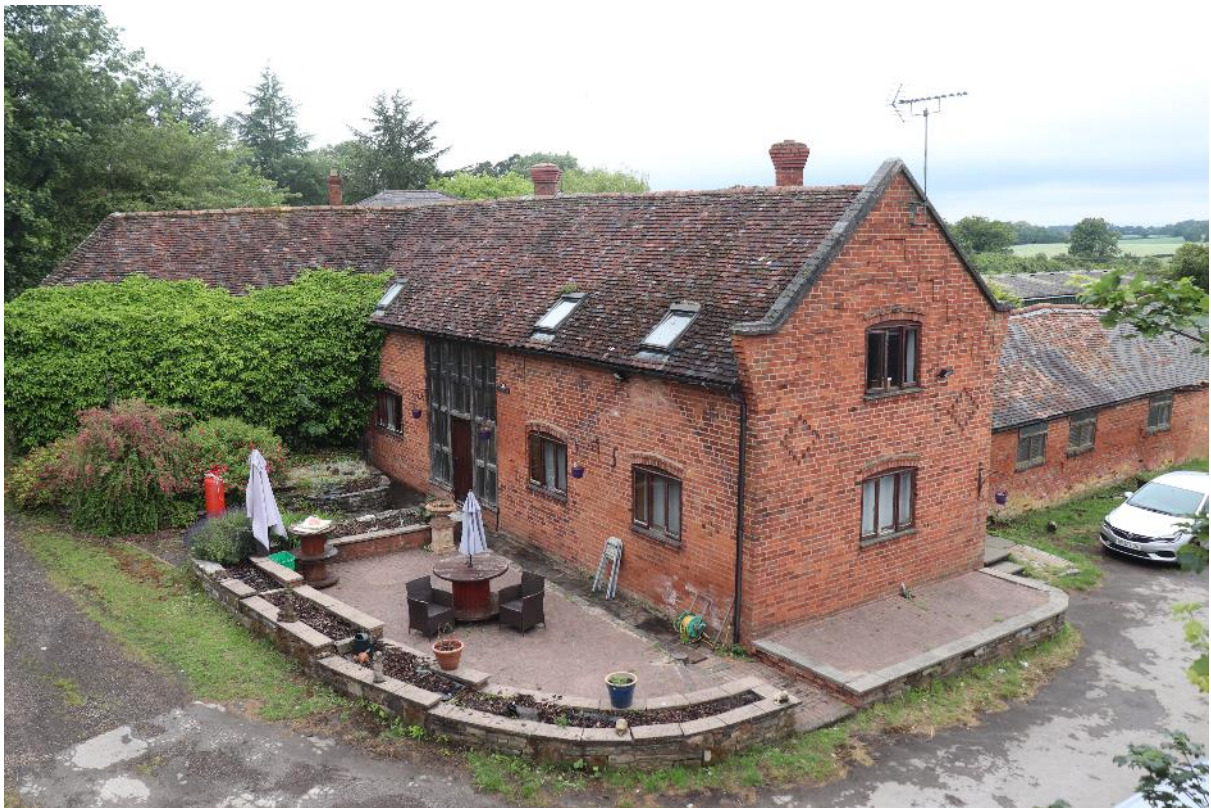
At broadly the same time, the Phase 1 threshing barn was extensively rebuilt in brick (Plate 14), most obviously on the south east side where the timber frame walls were entirely removed. A further bay was added onto its north-east end, though it is possible that this replaced a bay, as previously discussed. The character of the exterior of the existing building was established at this point the projecting cornices of gable end, and vent holes in the bricks. The latter, along with the retention of the Phase 1 threshing door positions, suggests the building was again being used as a threshing barn. Internally, it is likely that it retained a large degree of the Phase 1 layout, though this cannot be stated with certainty due to Phase 5 changes.

Plate 14 Phase 3 threshing barn, looking west

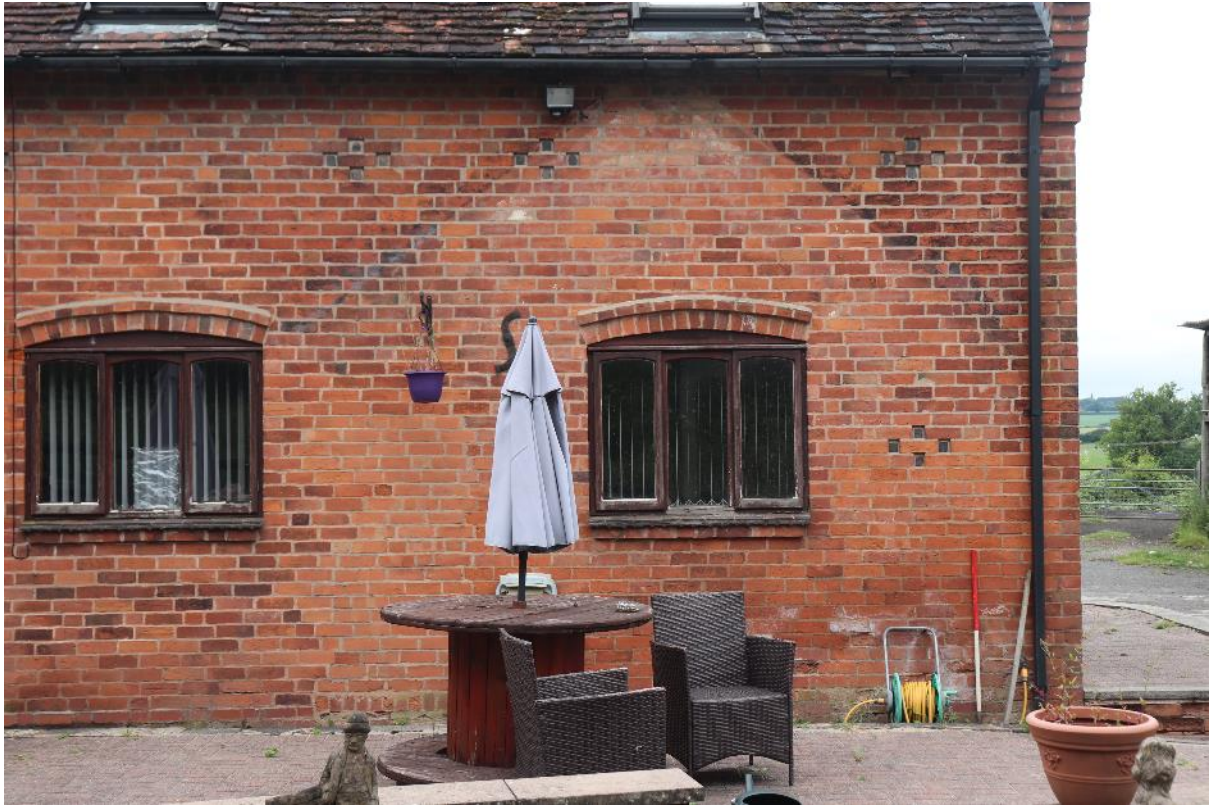
Sometime after this, two extensions were added. The evidence for one of these is simply an outline on the south east facing side of the building (Plate 15) which aligns closely with a structure on the 1885 mapping but has since been demolished.

Plate 15 Phase 3 addition, looking north west, scale 1m
