Building recording at Barn House Farm, Foxlydiate Lane Redditch

Worcestershire Archaeology
for Orion Heritage

July 2021

Building recording report

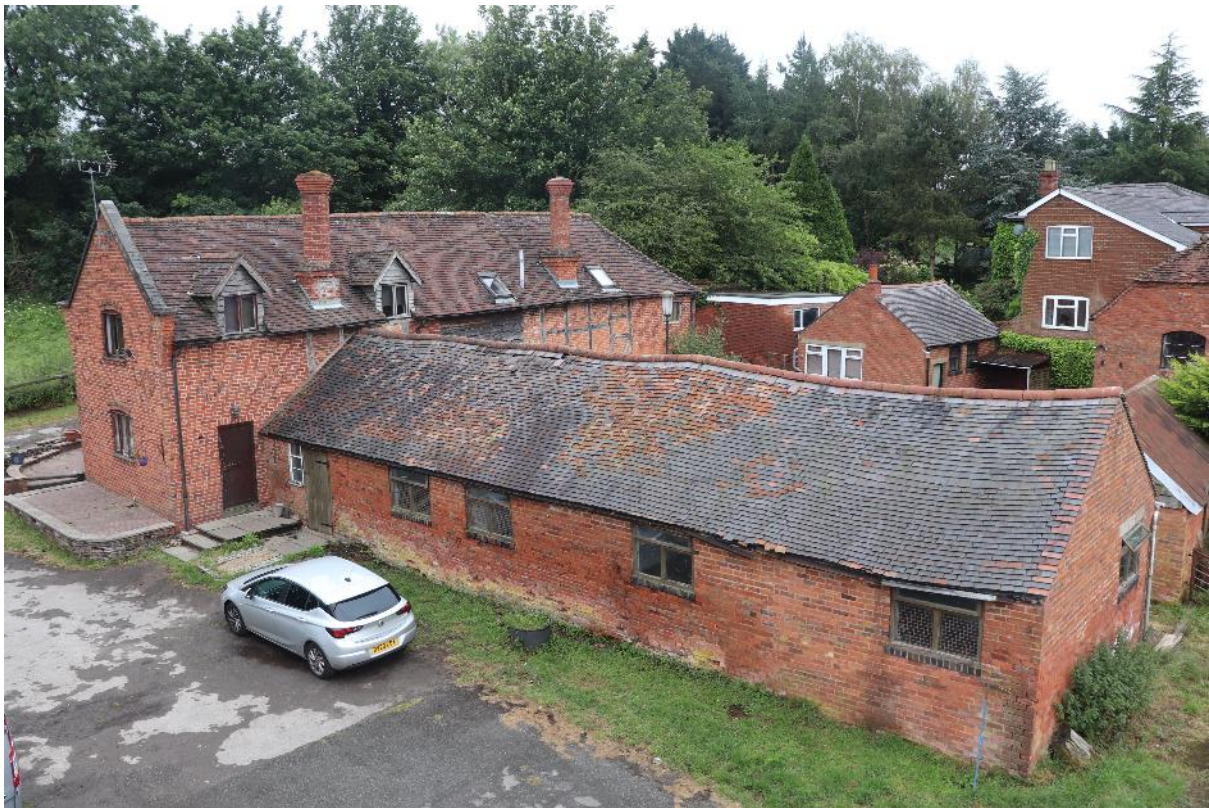
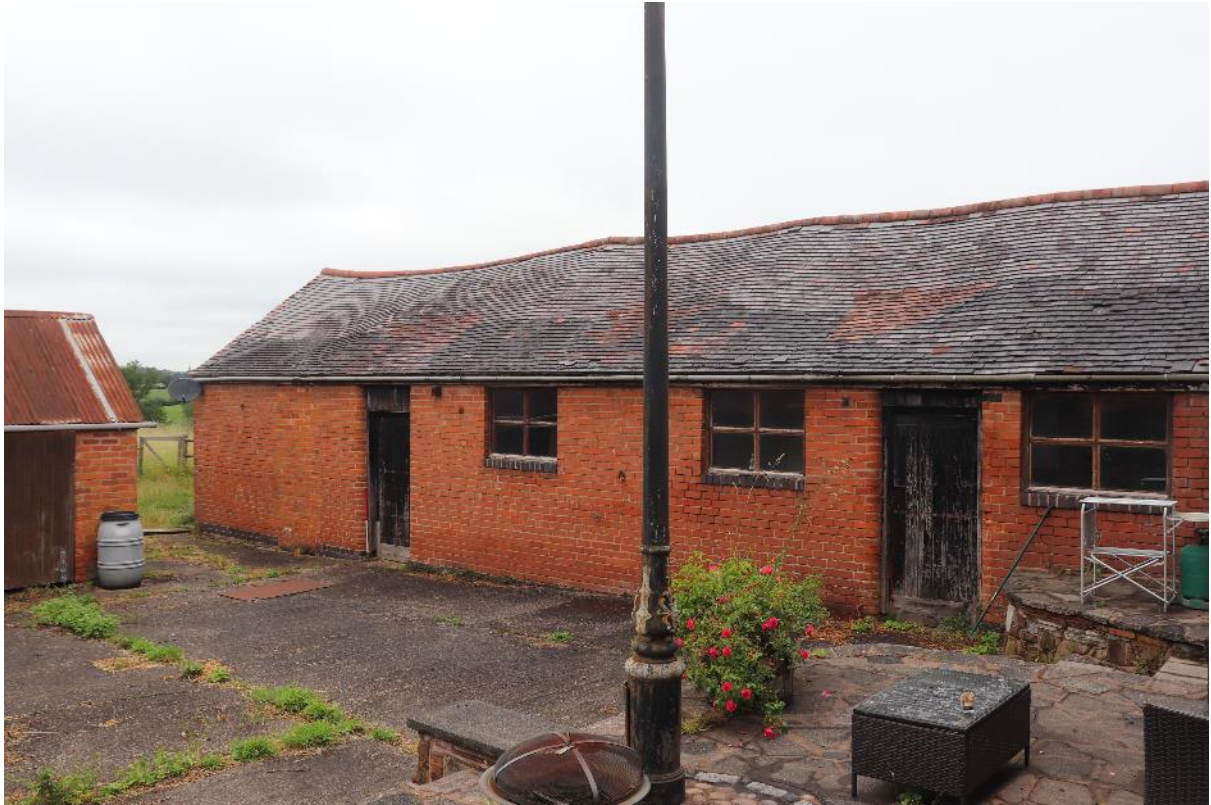
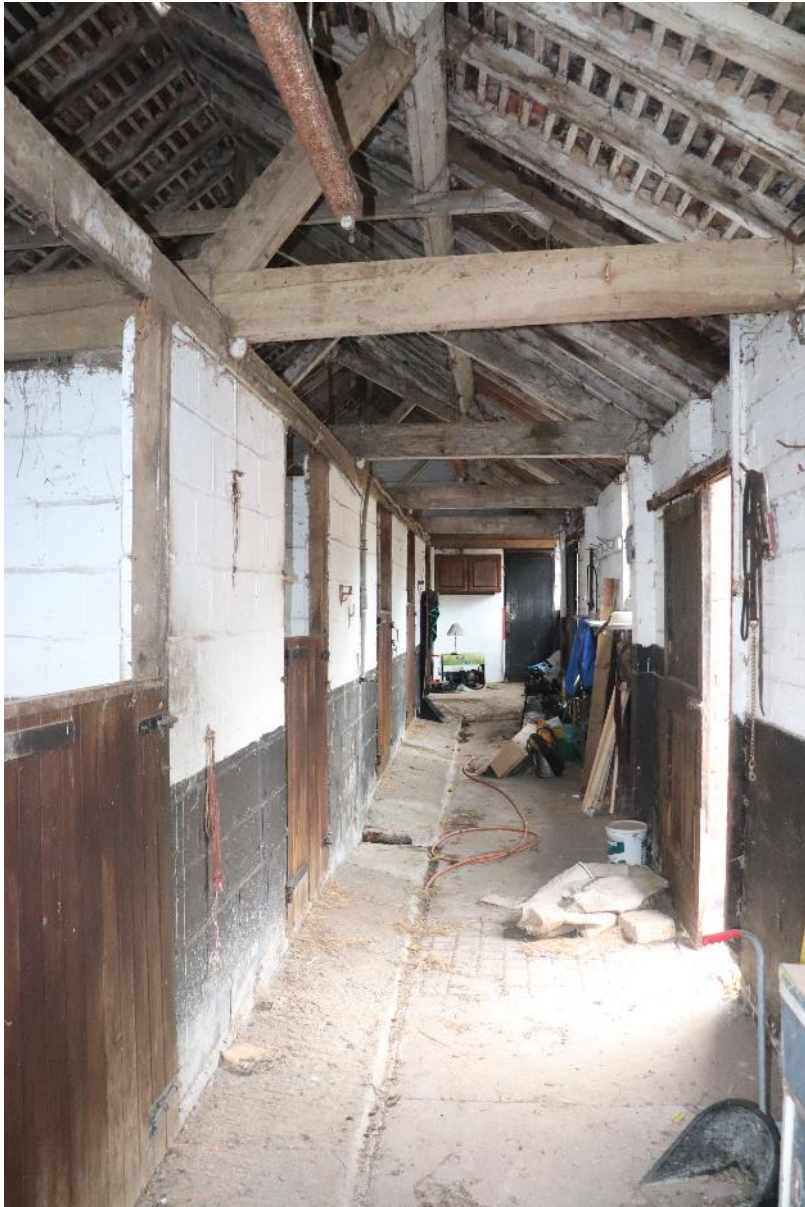
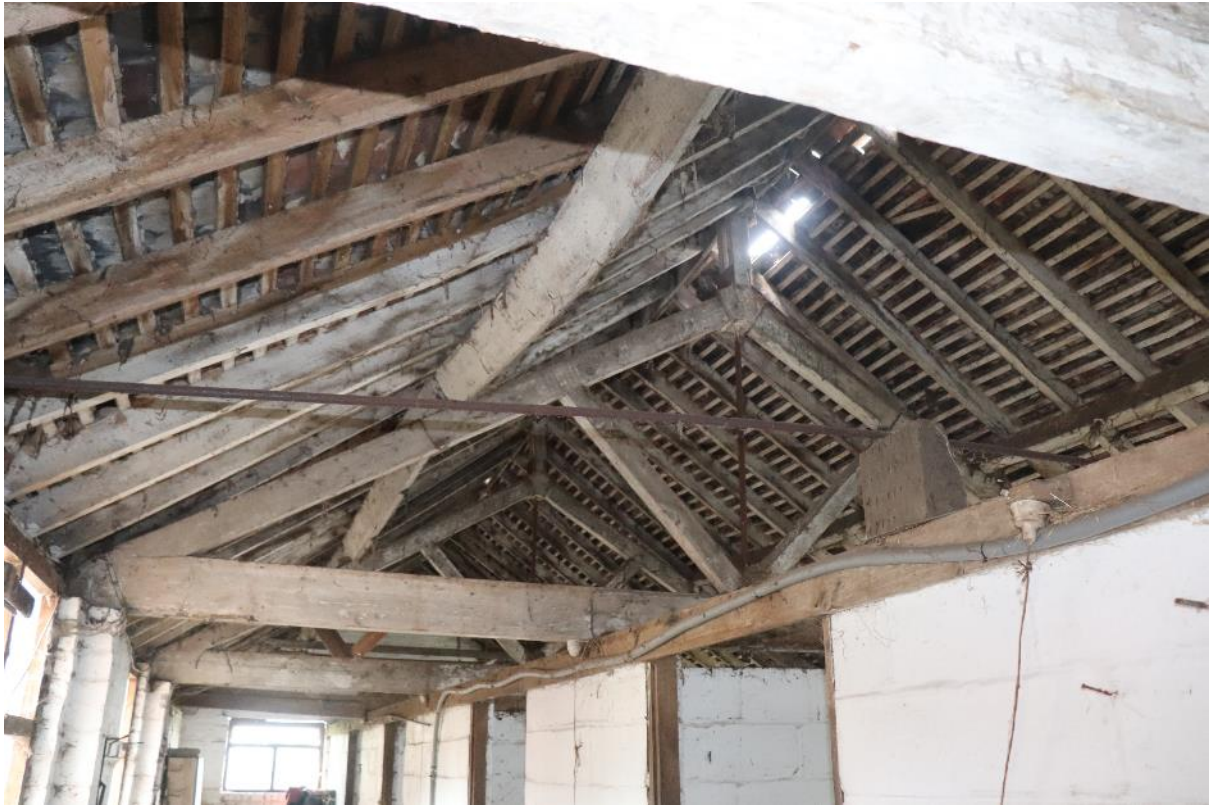
On the north west facing side, a long single storey brick structure remains, covered with a tile roof and forms a yard next to the barn (Plate 16 to Plate 19). This has three rectangular windows to the south east and four to the north west, though the actual windows are 20th century replacements. It has two original sliding doors facing into the yard, with a later door added to the north west as well as an added window on its gable. Evidence also remains for two blocked doors near its gable end on both sides of the structure.

Internally, the structure is of five bays defined by four soft wood king post trusses with raking struts, though with an iron central tension bar instead of a post. Originally, it would have been a single space for the housing of cattle.

Plate 16 Phase 3 cow shed, looking south east

Plate 17 Phase 3 cow shed, looking north, 1m scale

Plate 18 Phase 3 cow shed, looking south east, 1m scale

Plate 19 Phase 3 cow shed, looking north west

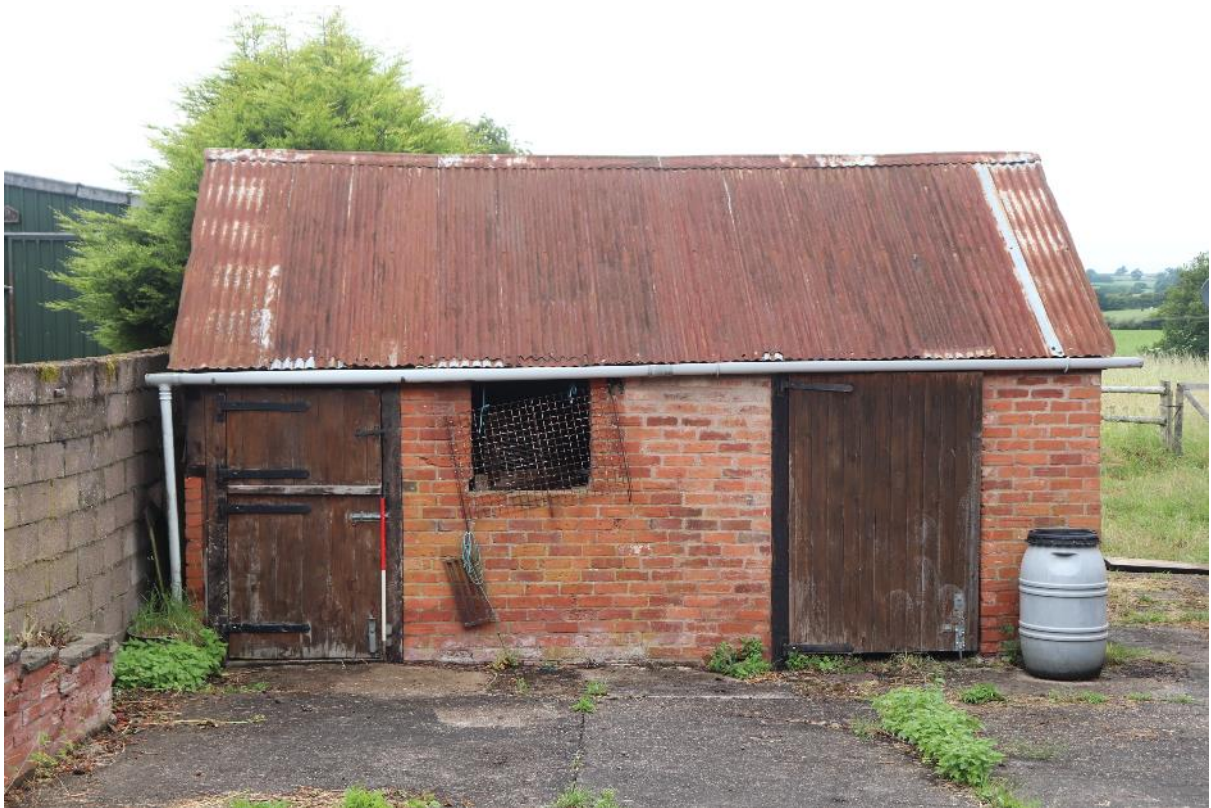
A small brick and weather boarded structure on the north west side of the yard was added during this phase (Plate 20) which is defined by the historic mapping. It is of brick with a corrugated iron roof supported by three roof trusses. Its gable end truss (Plate 21) has raking struts with four further vertical studs to which the weatherboarding is nailed. Its two internal roof trusses are simple softwood A frames with raking struts (Plate 22). The trusses in turn supports double purlins. The two internal trusses retain evidence of carpenters marks used in the traditional way, using a chisel on one truss with round tool with central point on the other. The latter is likely to have been a tool for the marking of peg holes (Plate 23 and Plate 24). These are very late example of a traditional roof carpentry method.

The building was internally of a single space originally and would have extended as far the Phase 3 cow shed but was truncated in Phase 5. It is probable that this was a further cow shed.

Plate 20 Phase 4 cow shed, looking north west, scale 1m

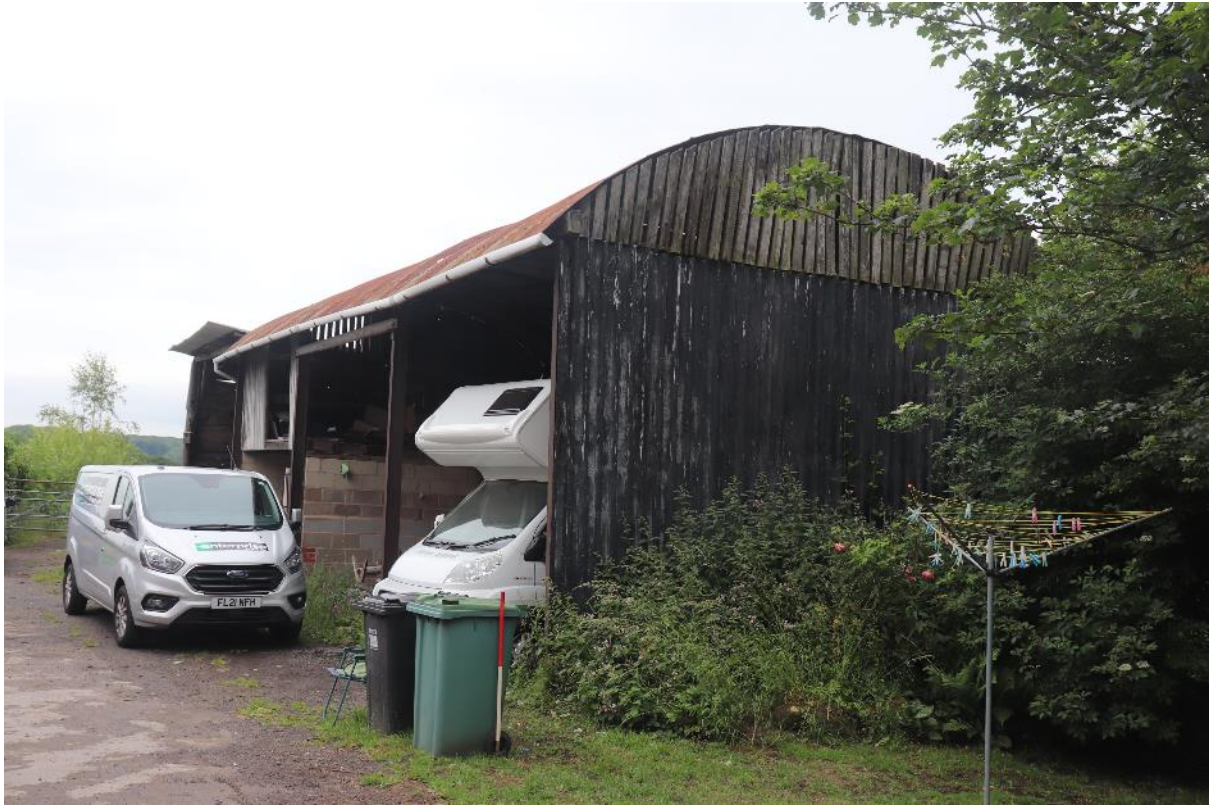
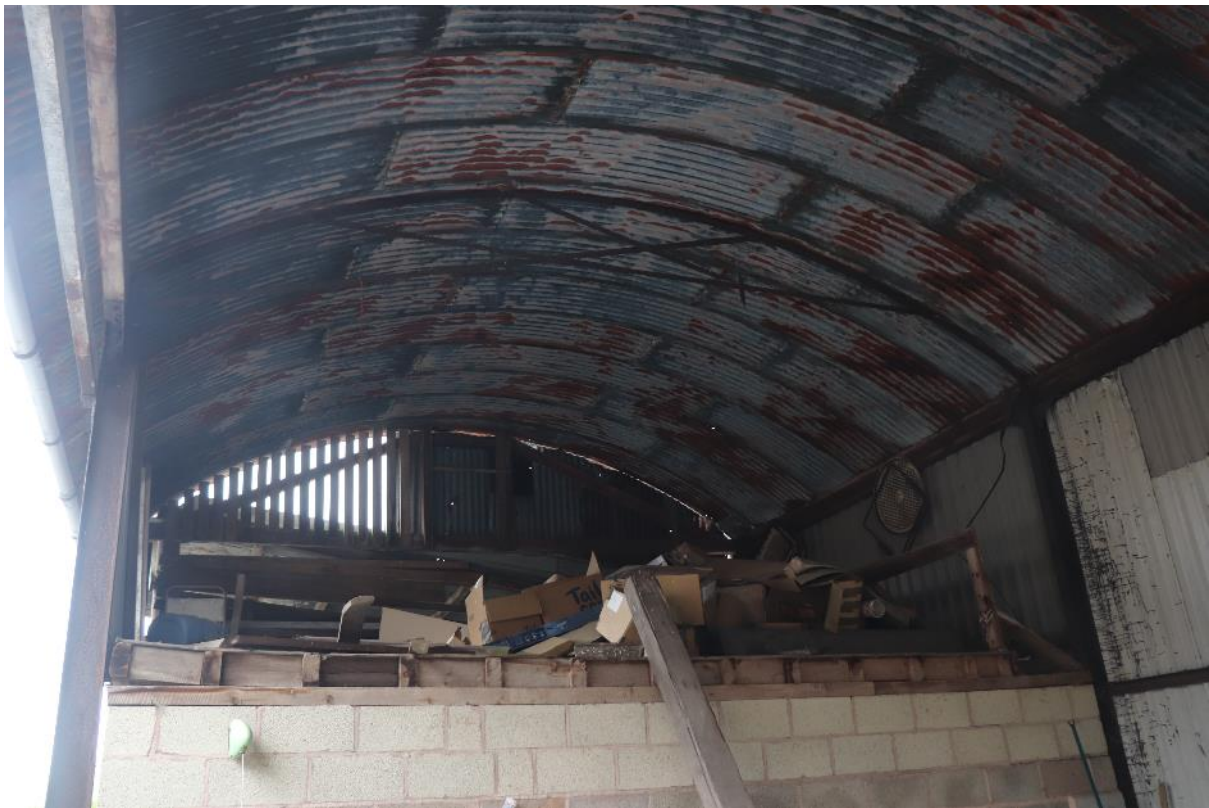
Also of this phase is a metal frame structure to the north of the buildings with domed corrugated roof supported by simple lattice trusses (Plate 25 and Plate 26) that would have been for crop stem storage such as hay and straw. This was further extended in Phase 5 on its north west end (Plate 27).

Plate 25 Phase 4 hay barn, looking north, scale 1m

Plate 26 Phase 4 hay barn, looking north

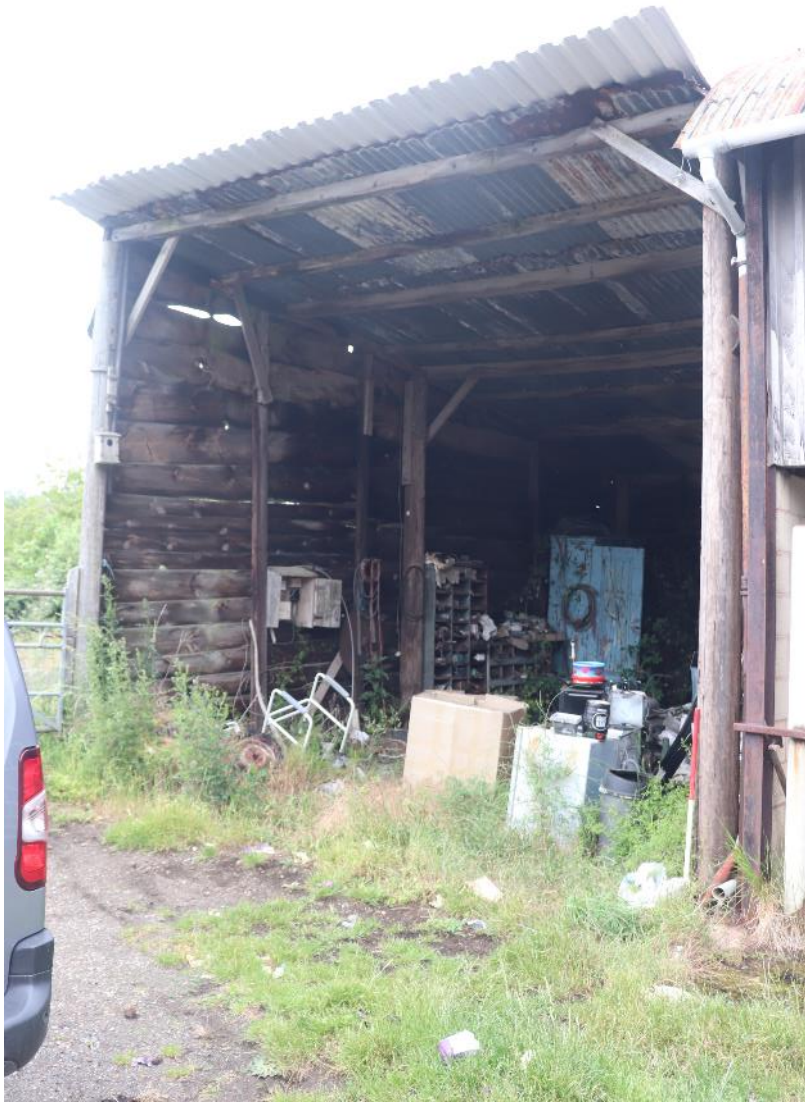
Plate 27 Phase 4 hay barn addition, looking north, scale 1m
