Archaeological investigations of the Biomass Boiler works, Hanbury Hall, School Lane, Hanbury, Worcestershire

Worcestershire Archaeology
For the National Trust

April 2022

Archaeological watching brief report

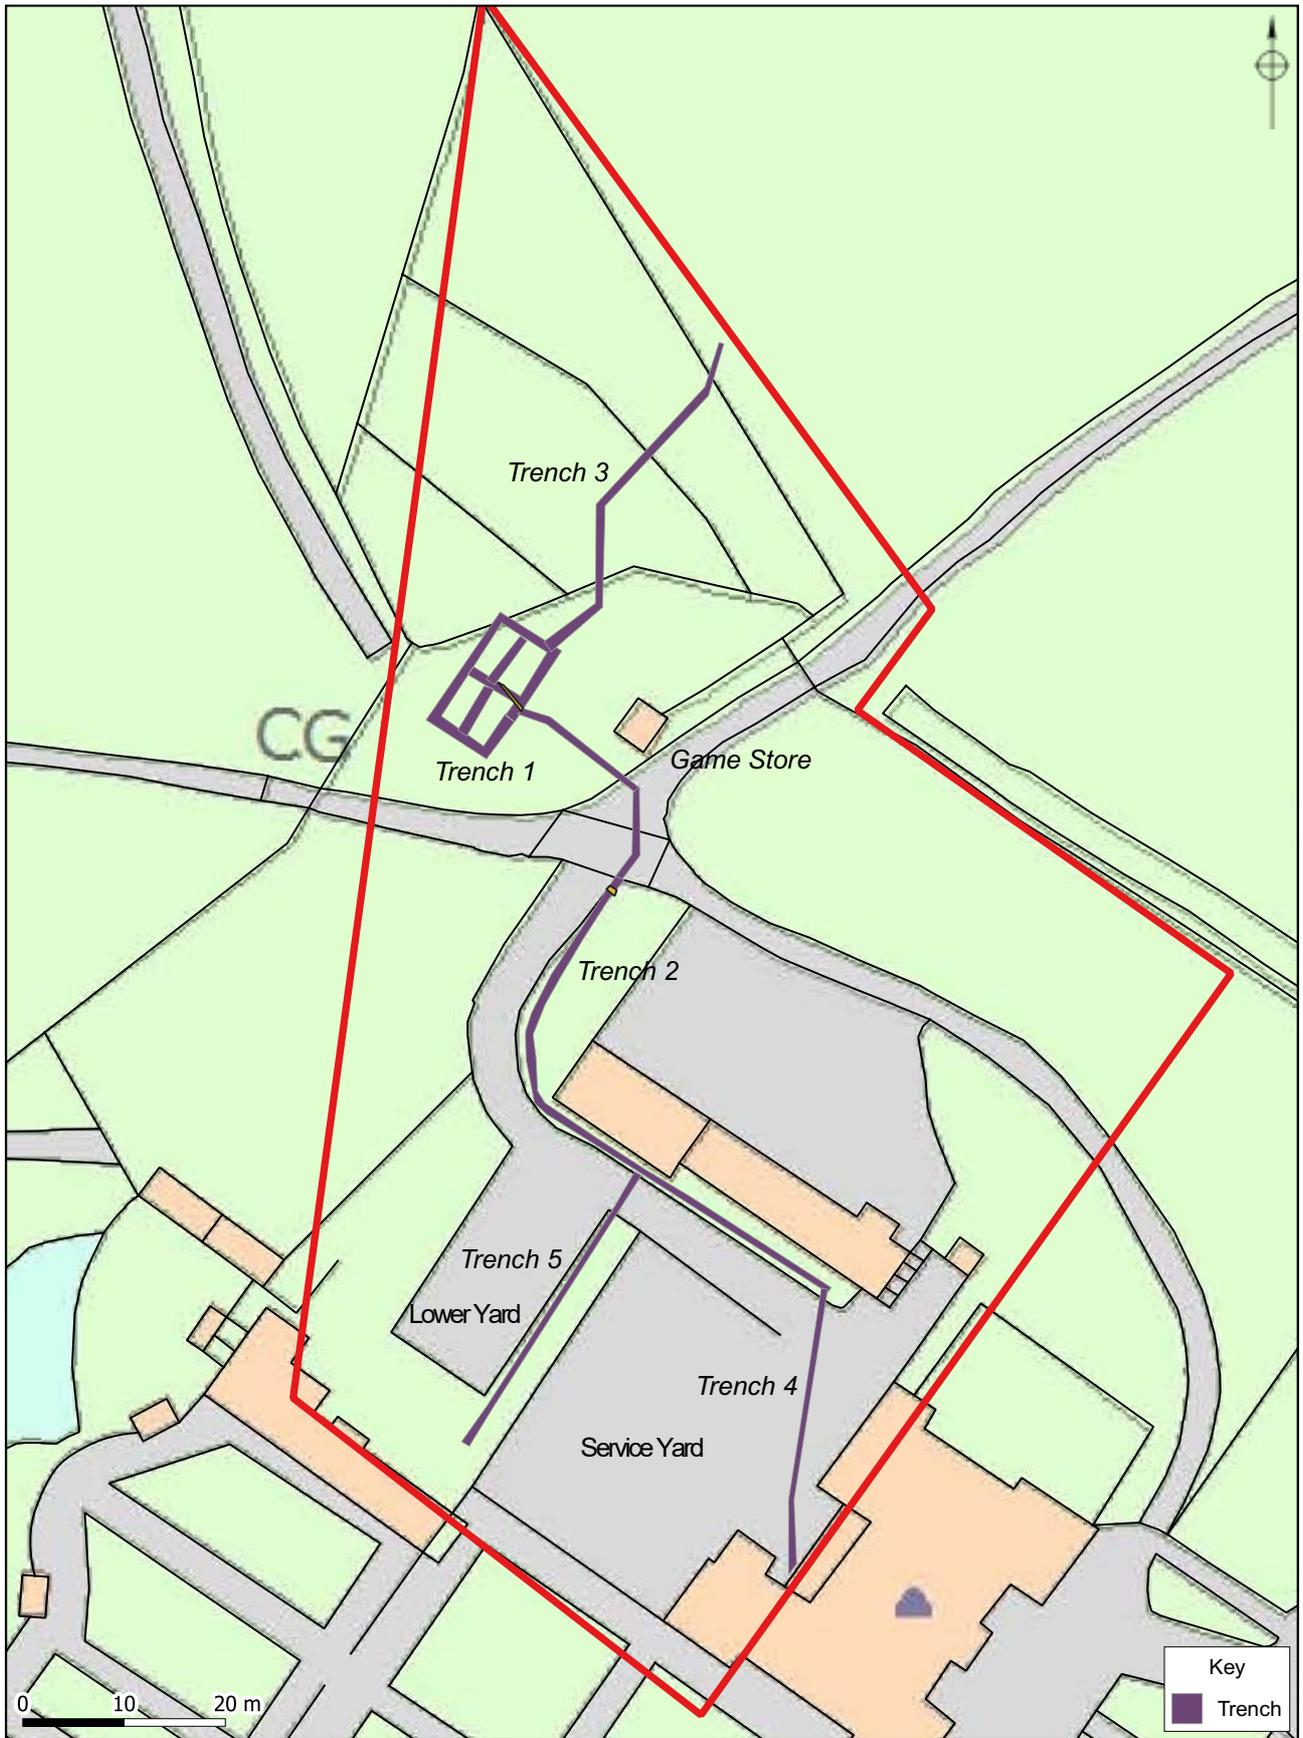
Figure 2

Trench location plan

The groundworks observed included the footprint of the biomass boiler and landscaping of the surrounding area (Trench 1) amounting to 170m² in area in total, and associated service trenches (Trenches 2 - 5), 0.50m wide and 0.80m deep, amounting to 169m² in total length, excavated across the site. Trenches 1-3 and 5 were observed under standard watching brief conditions. Trench 4 across the Service Yard was undertaken as a formal excavation under the supervision and control of WA. The location of the trenches is indicated in Figure 2.

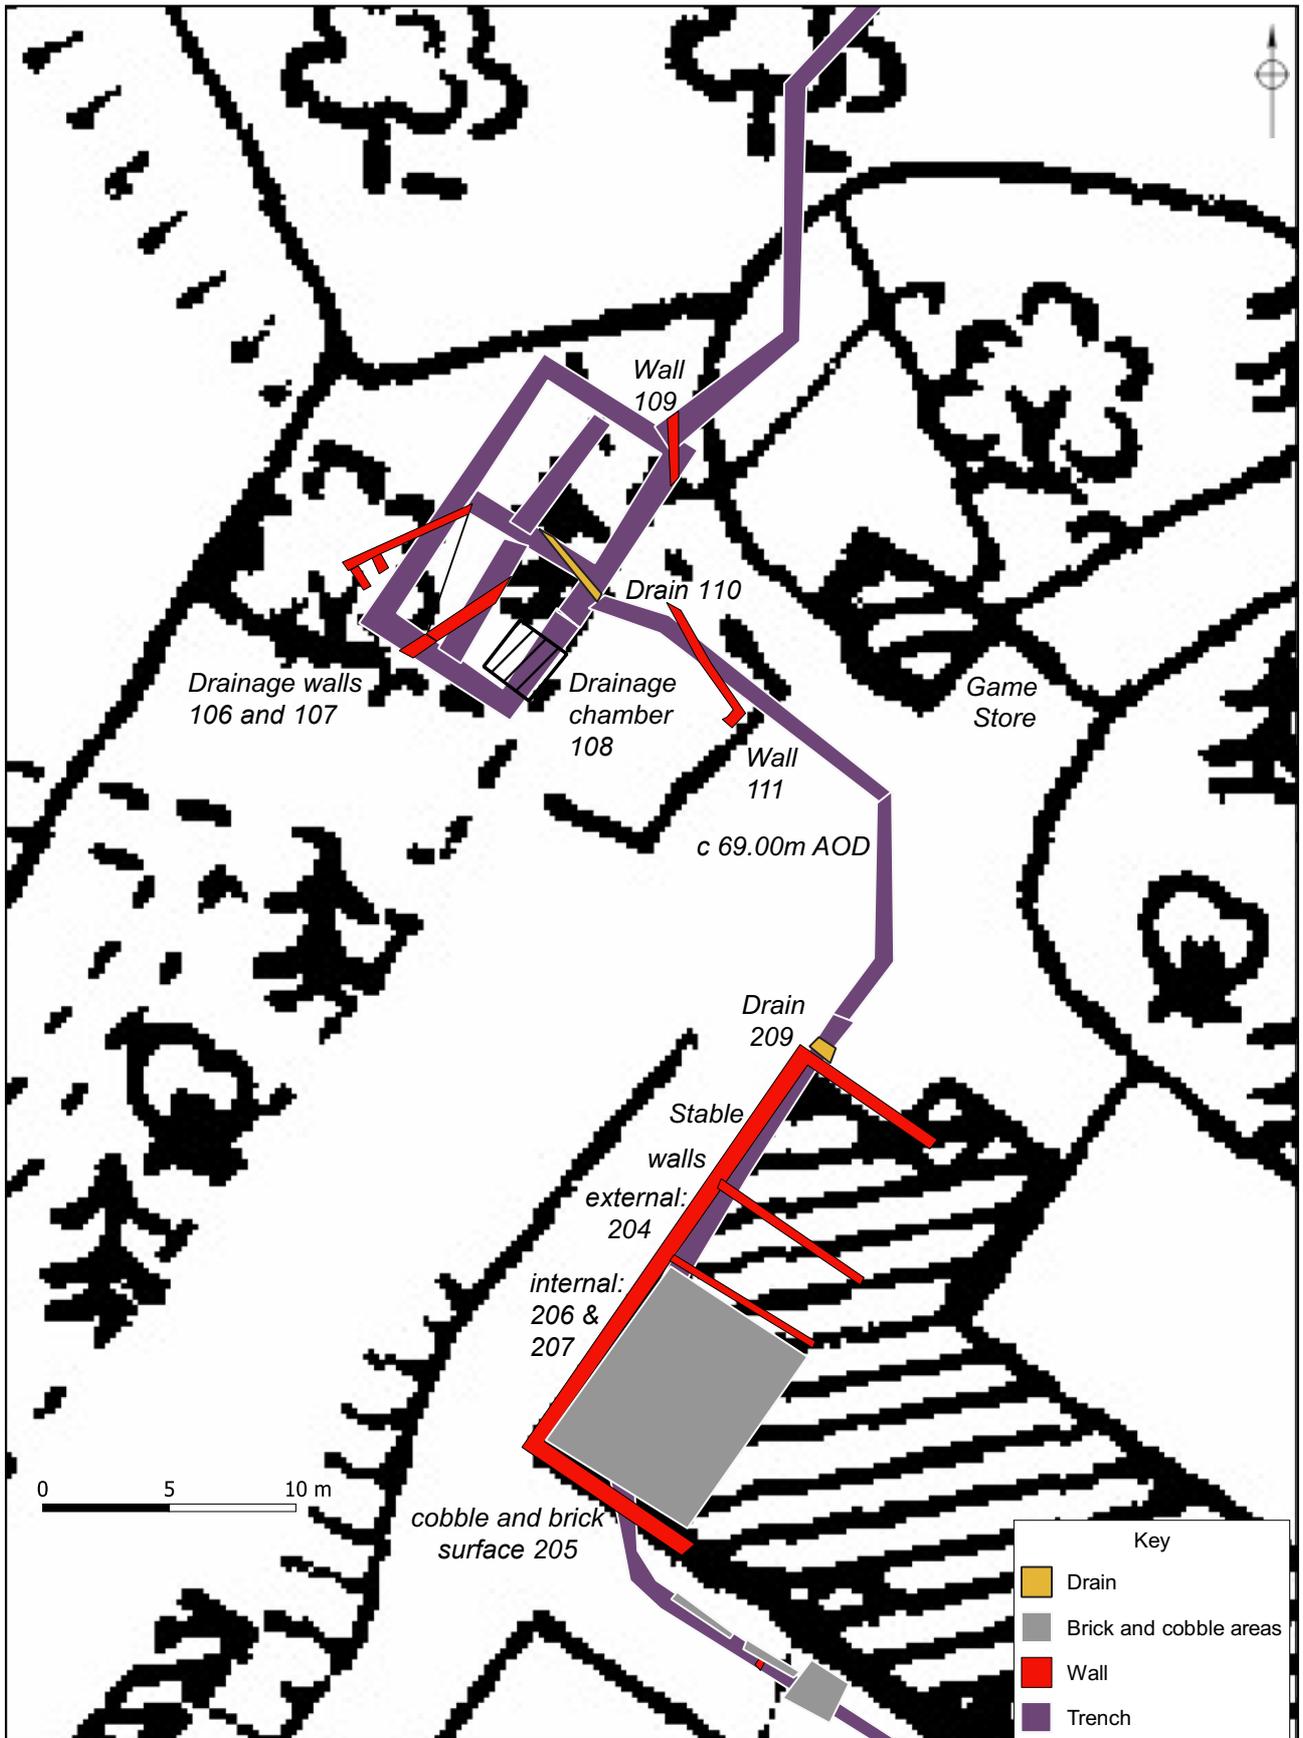
Figure 3

Trenches 1, 2 and 3 overlaid on 2nd edition OS map (features indicated in colour were visible in trenches, at the surface or after vegetation clearance)

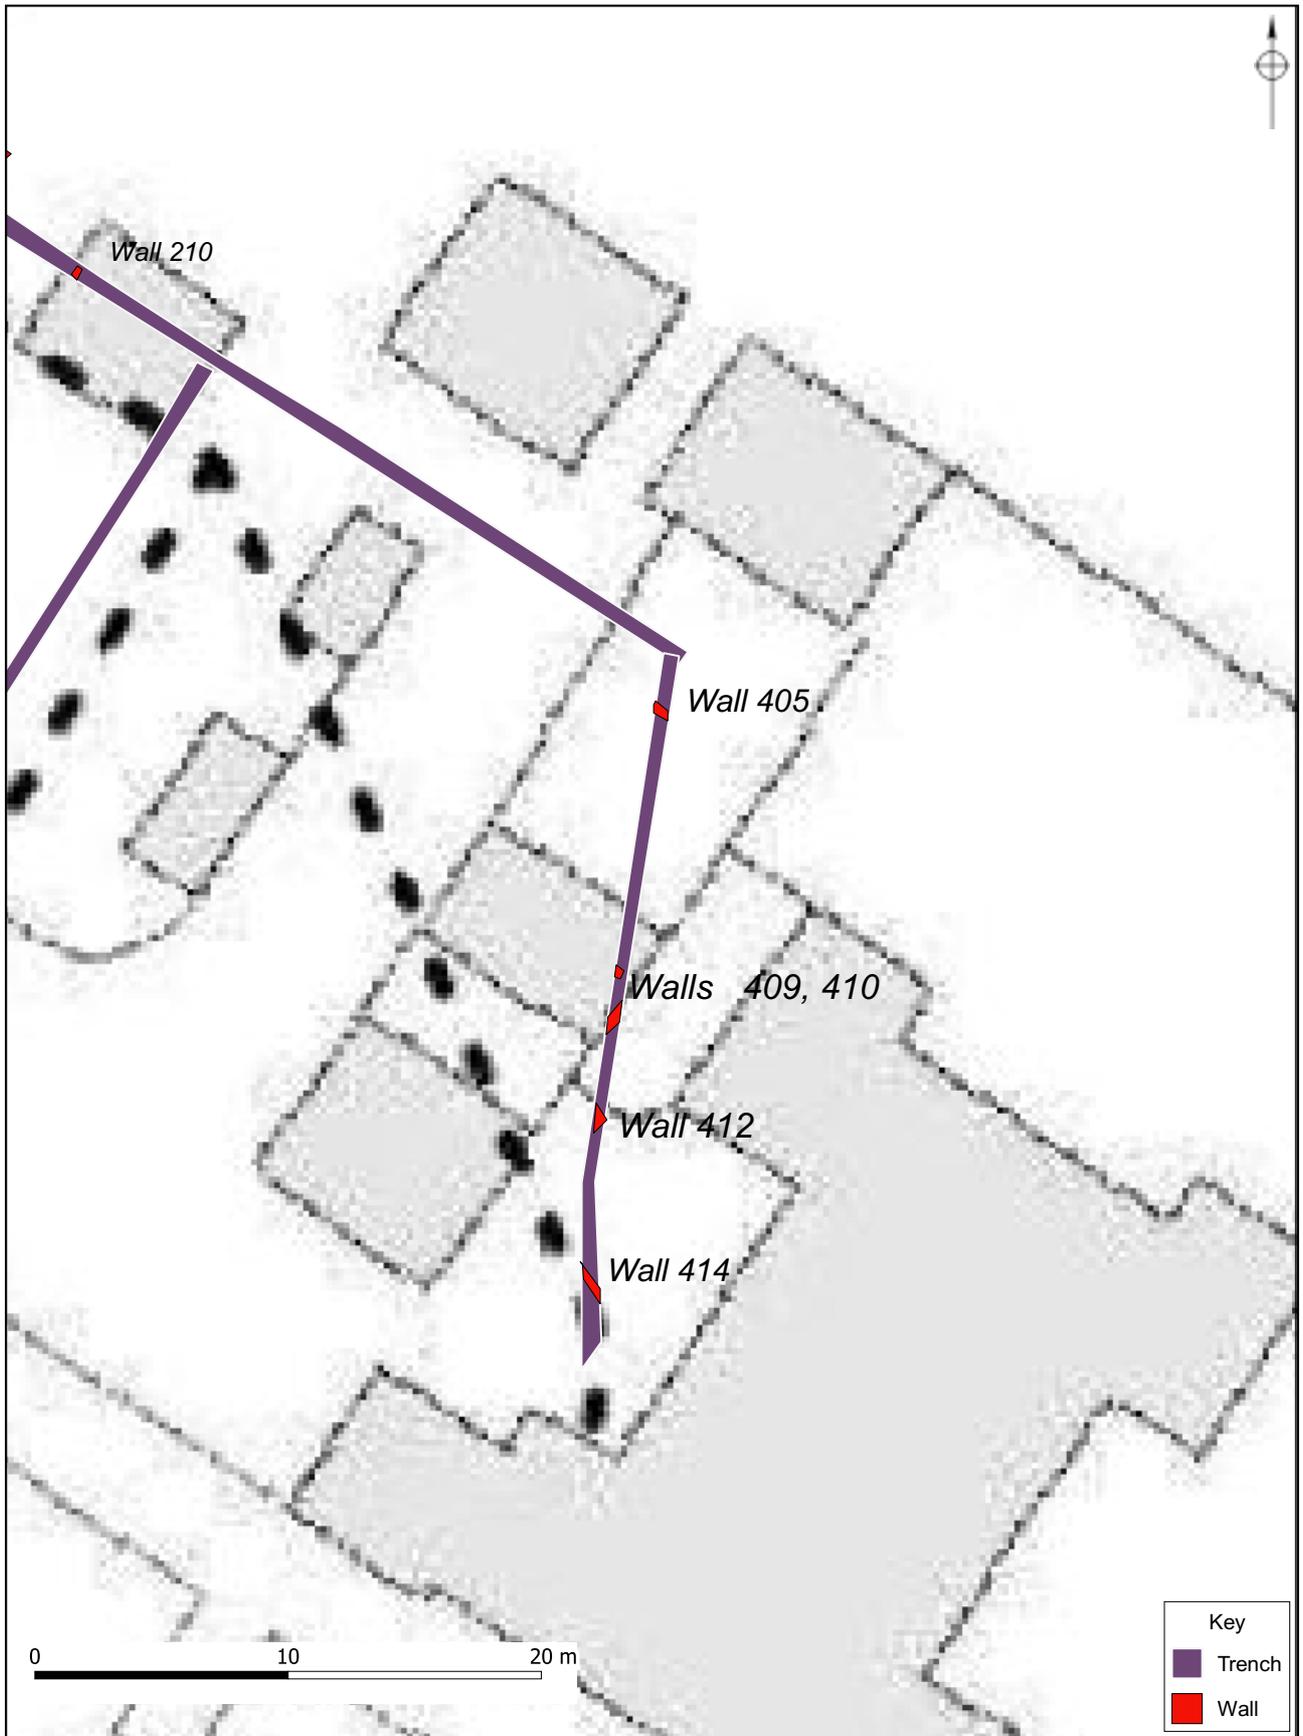
Trenches 2 and 4 in the Service Yard overlaid onto Donald Insall's projected 1706 plan Figure 4

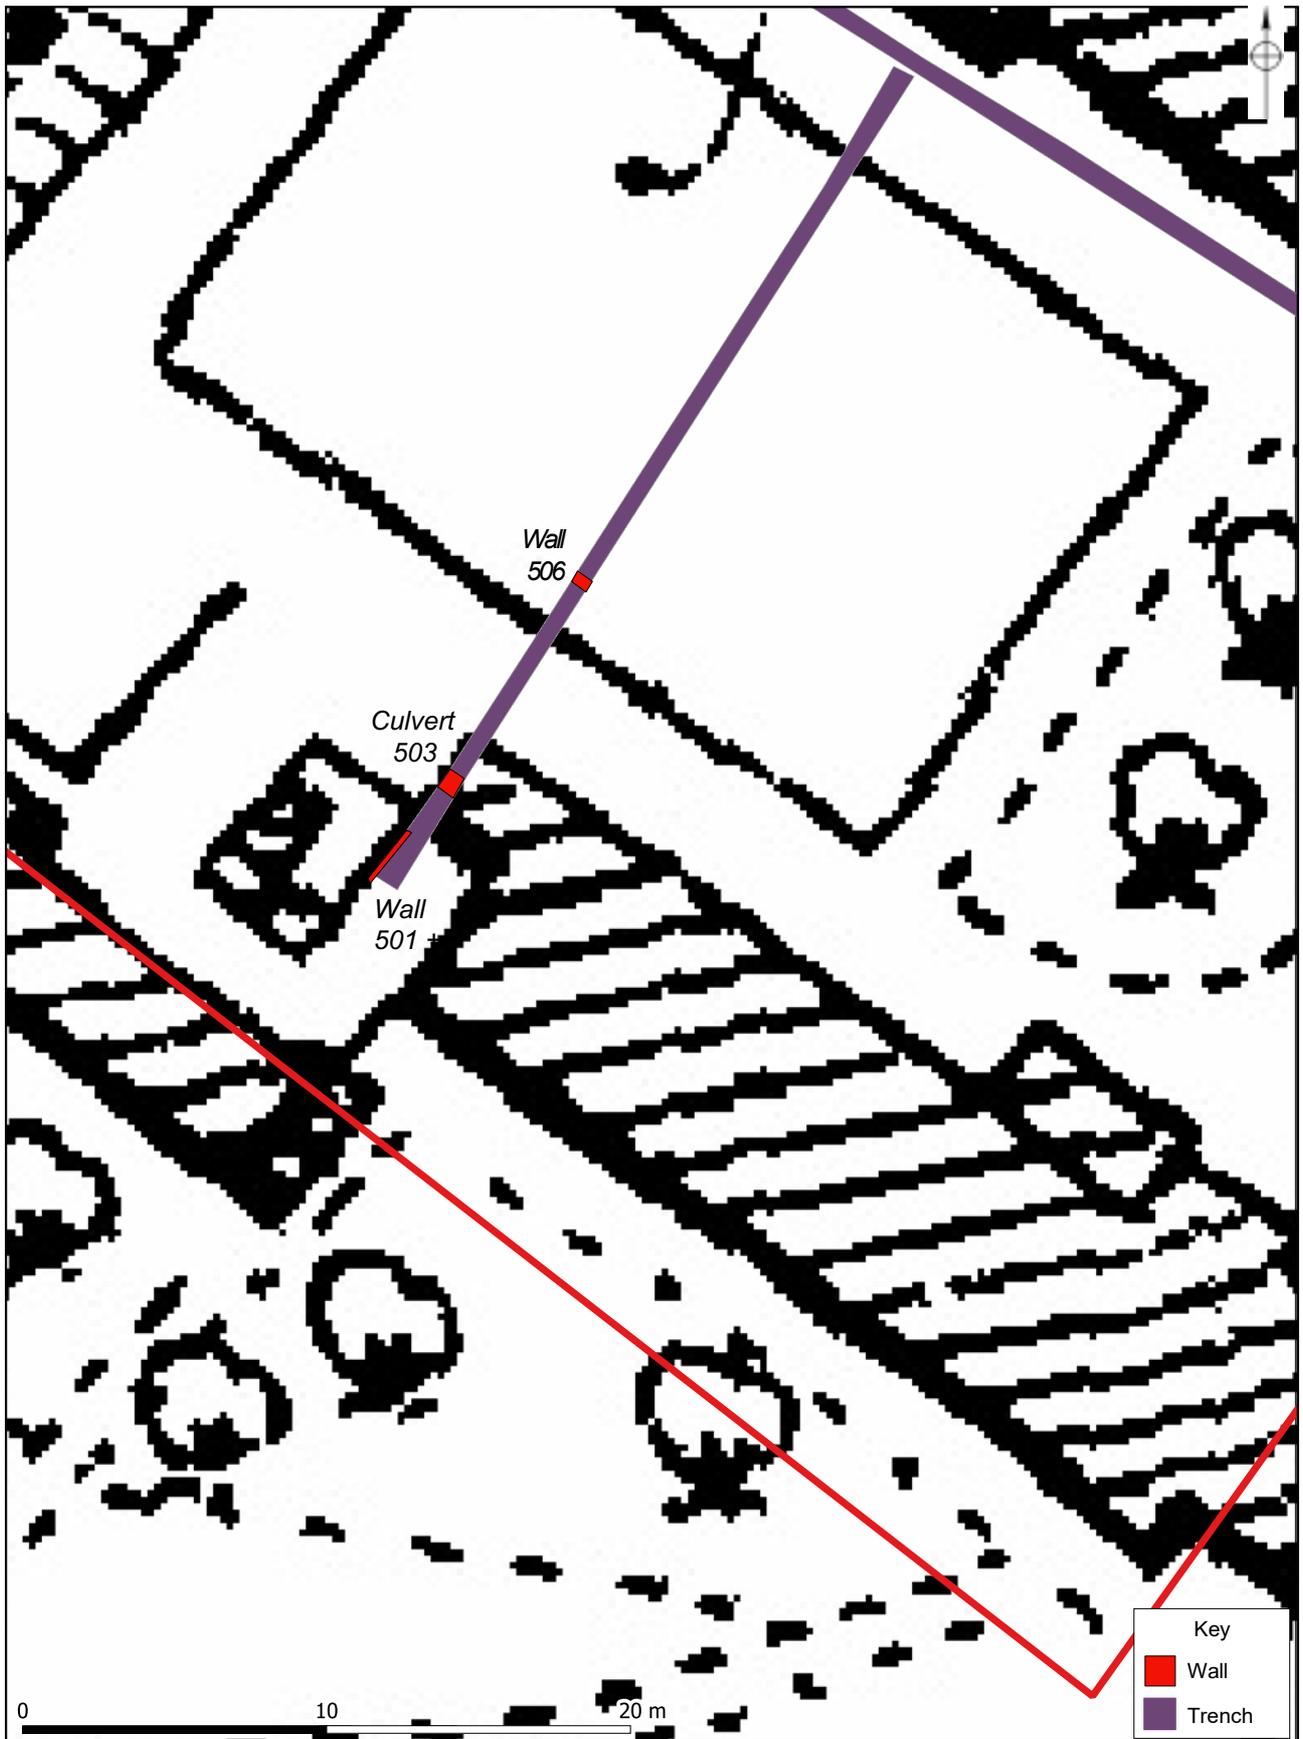
Figure 5

Trench 5 overlaid onto the 2nd edition Ordnance Survey map

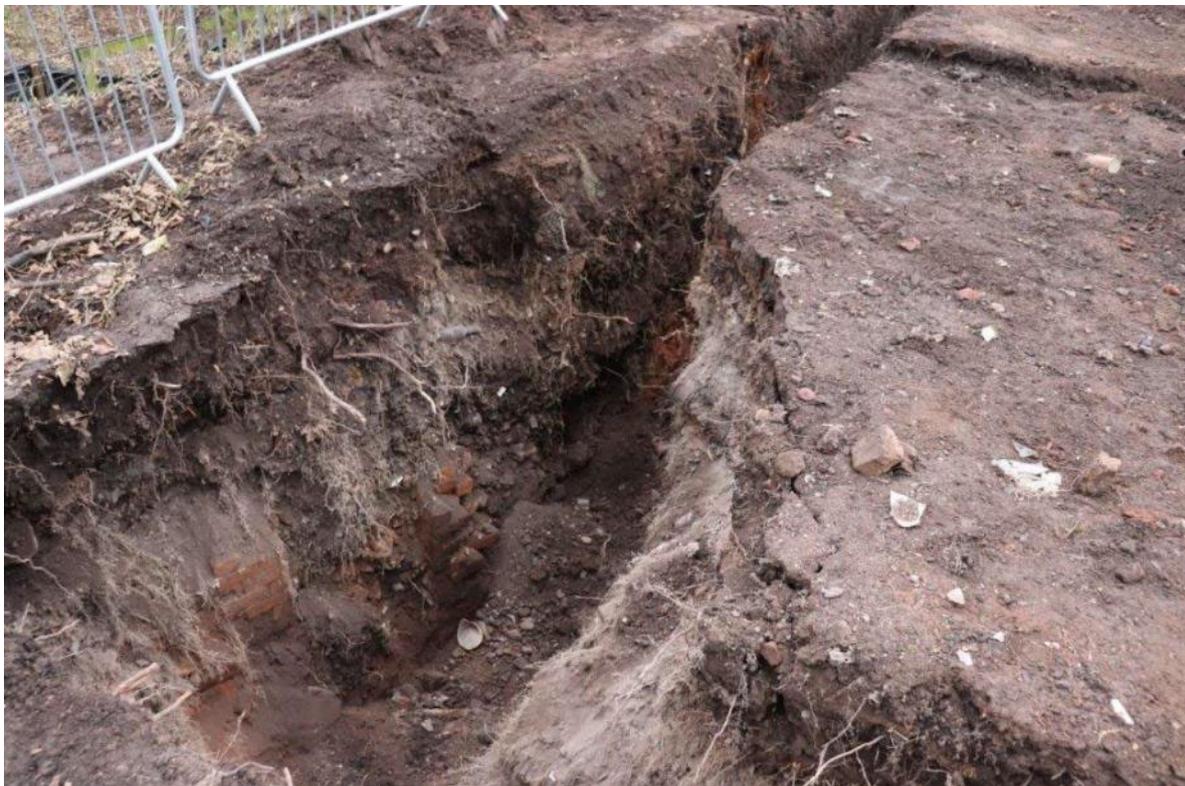
Plate 2: Trench 1 drainage walls and loose ash dump deposits with 20th century refuse, glass bottles and jars; no scale

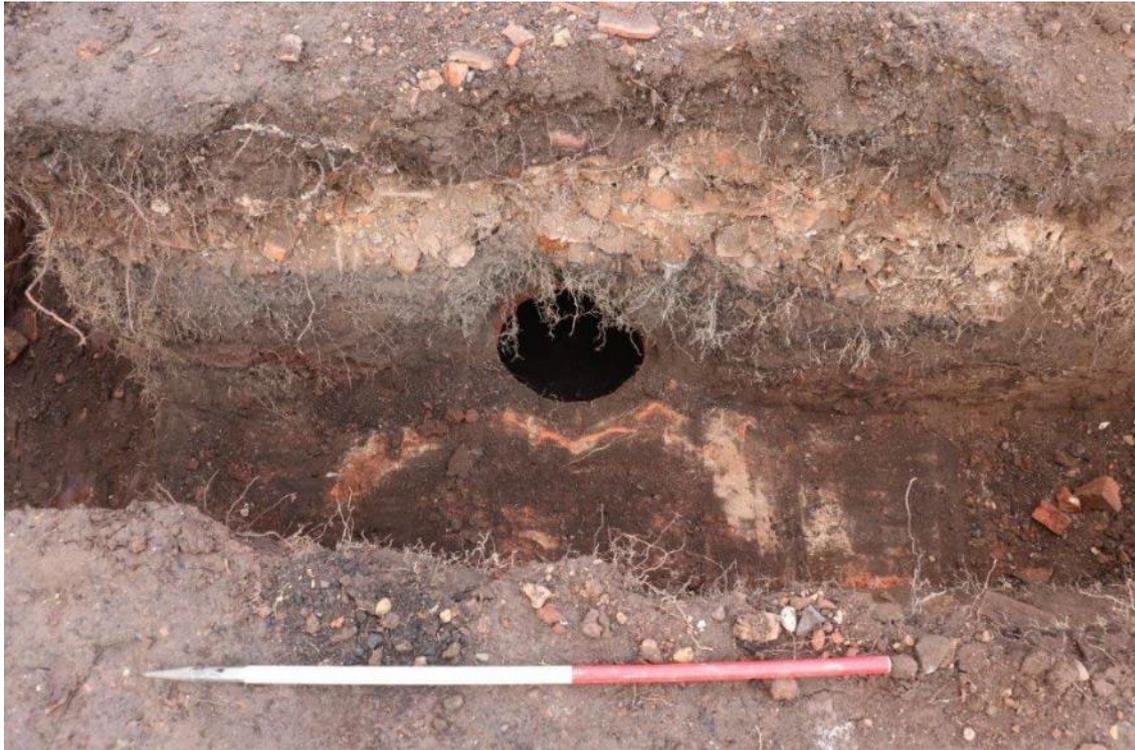
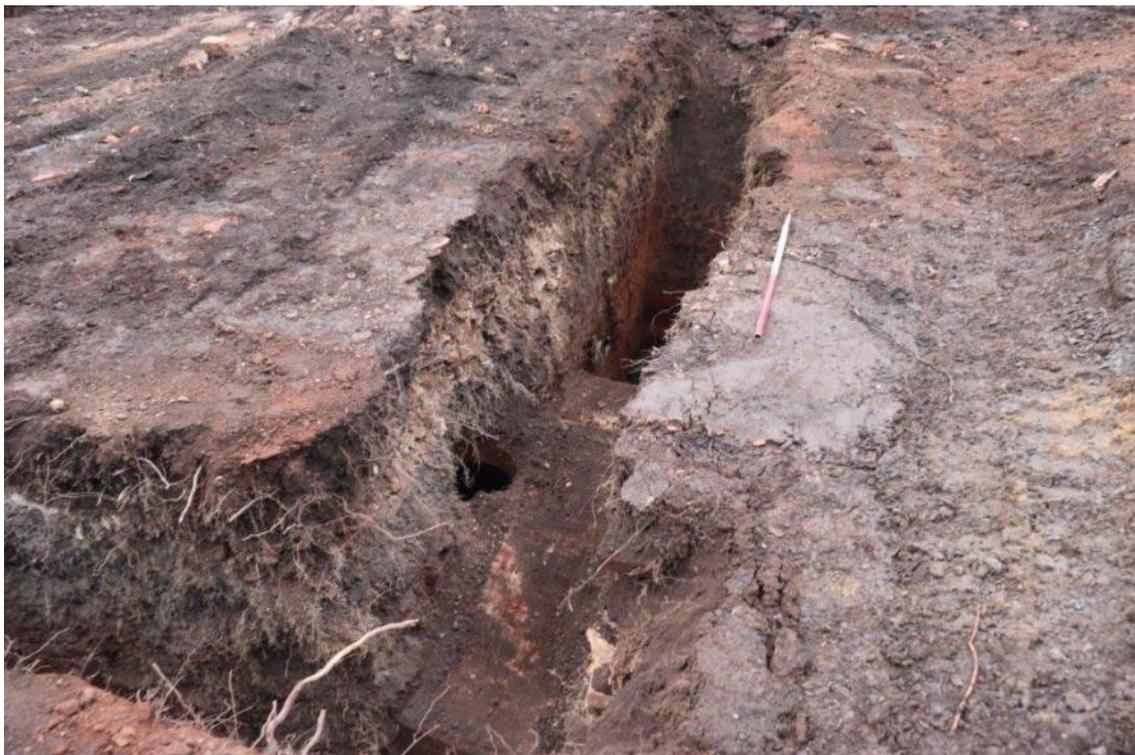
Plate 3: Trench 1, drainage chamber (109) in south-west corner; 1m scale

Plate 4: Trench 1, drainage chamber (109) in south-west corner; 1m scale

The Biomass boiler building was located in an area that had been subject to dumping of ash and waste from the house for a long time, so the ground level had been made up and consisted of a series of ash rich deposits, redeposited clay and turf. The Biomass Boiler footprint measured 12.50m x 6m. The trenches were between 1.00m BGL at the north-east end and 2.20m BGL at the west corner, with deeper sections of up to 4m BGL in the south corner to span a brick-built drainage chamber (108; Plates 3 and 4), 2.4m square, 0.60m BGL and backfilled with rubble.

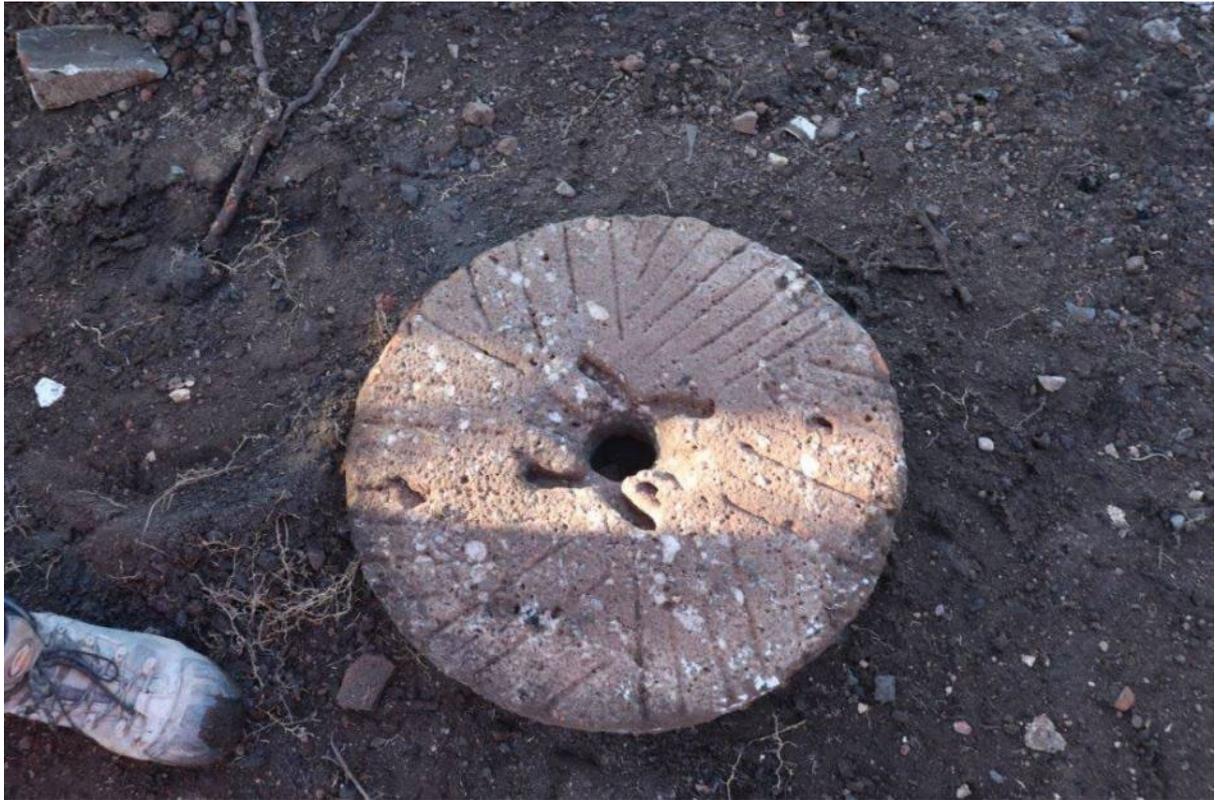
Plate 5: Trench 1, quern stone capping drainage chamber (109); no scale

The circular drainage chamber entrance had been capped with a quern stone (Plate 5), reused from elsewhere on site. A series of associated walls were visible to the west aligned north-east to south-west, surviving at between 1.20m and 1.50m, extending down to 2.20m BGL, with 9" x 4" x 3" bricks (106 and 107; Plate 2). These structures are considered to be contemporary with the late 19th century stable block marked on the 1st edition Ordnance Survey map.

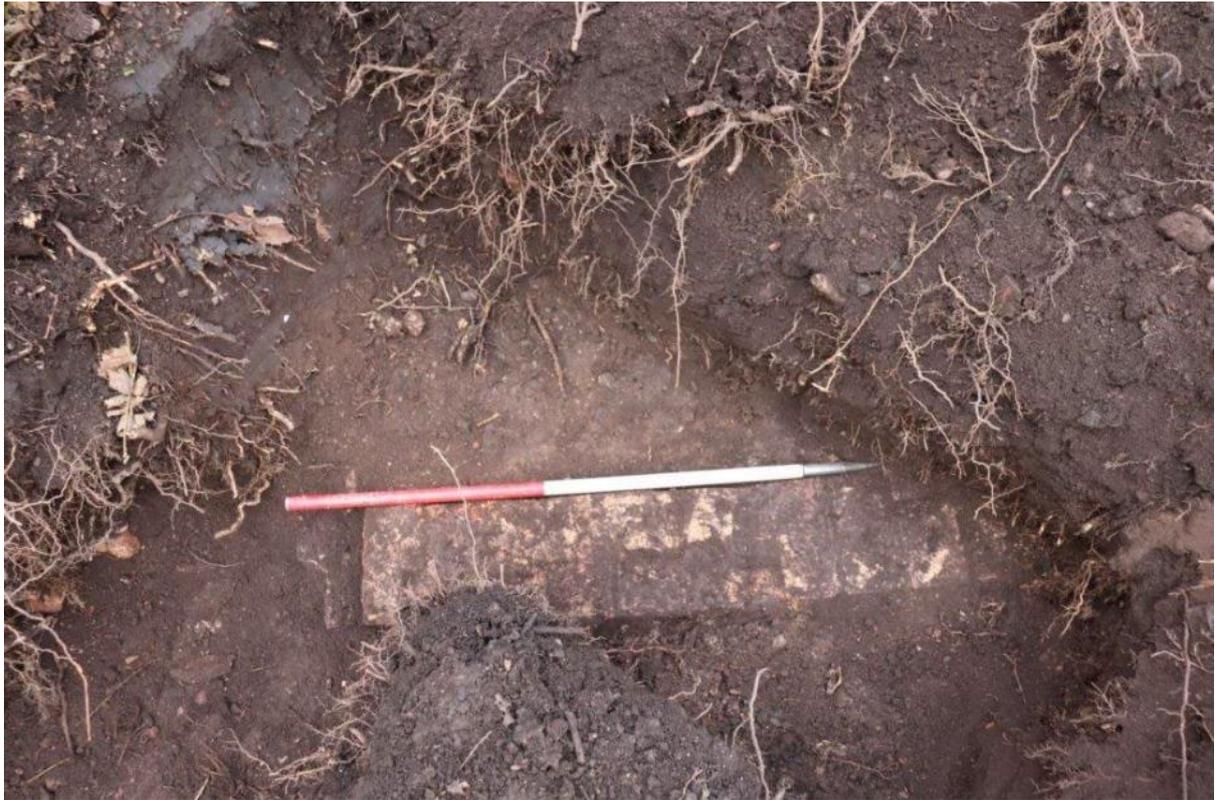
Plate 7: Trench 1, boundary wall of game store area (109) in north-east corner, view north; 1m scale

A double-skin brick wall was recorded in the north-east corner of the site (109) on a north to south alignment, with similar bricks and mortar. This is recorded on the 1st 2nd and 3rd edition Ordnance Survey maps as a boundary wall for the adjacent Game Larder to the east. During the groundworks, another boundary wall (111, Plate 8) was exposed to the south, aligned north-east to south-west and recorded on the 2nd edition OS map. This was further exposed and recorded to a depth of 0.80m+ in Trench 2.

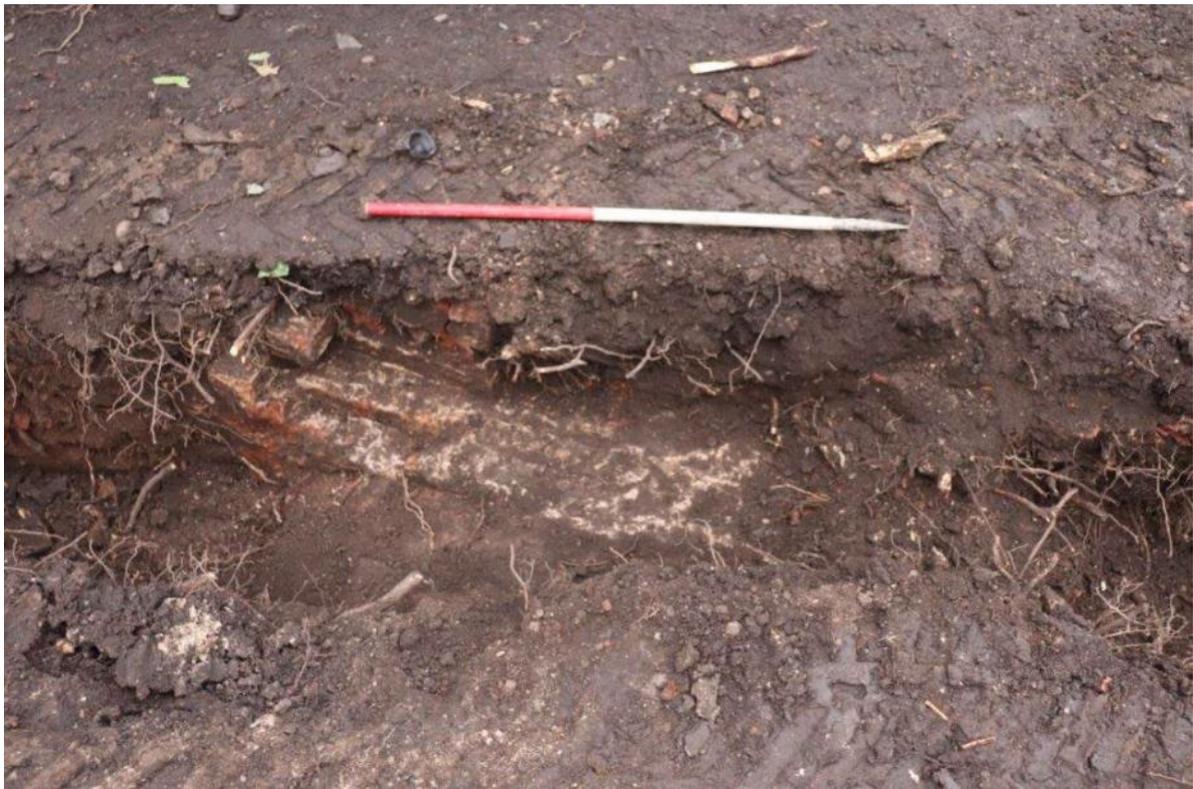
Plate 8: Trench 1, boundary wall of game store area (111) at entrance close to game store, view west; 1m scale

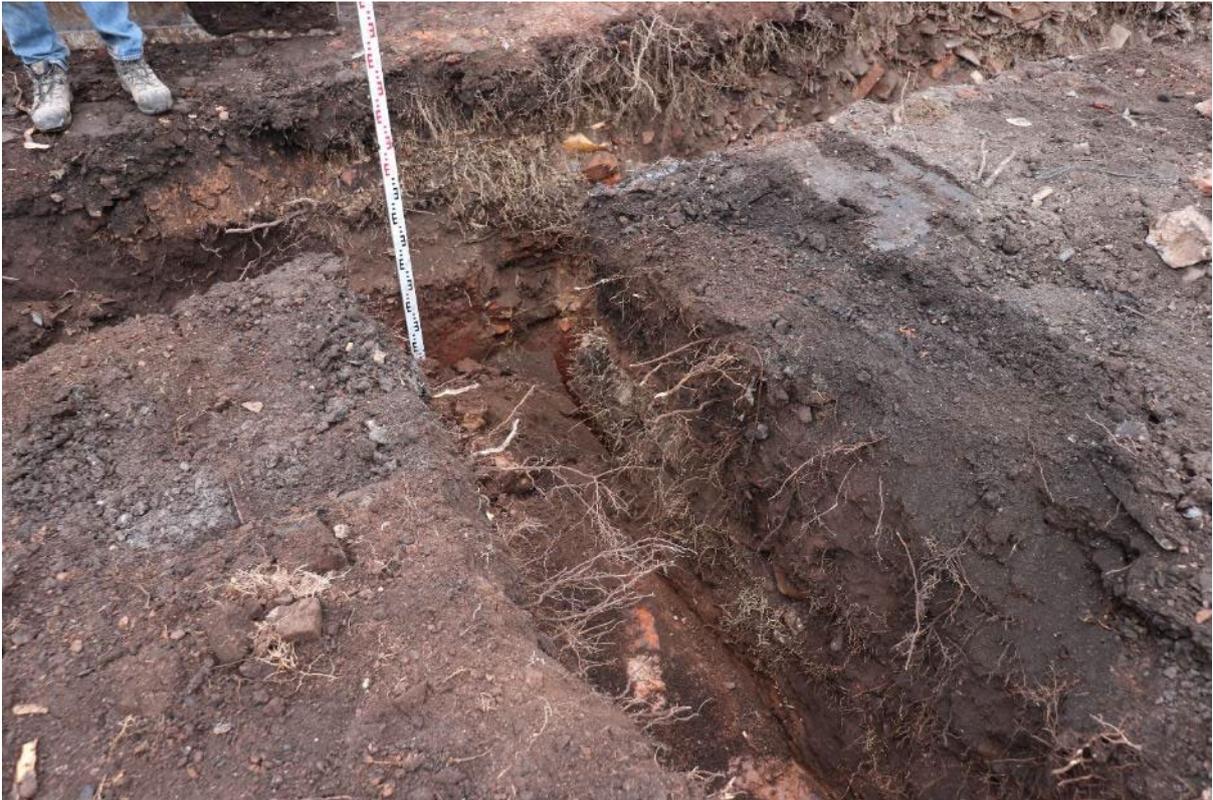
Plate 9: Trench 1, brick drain (110) aligned north-west to south-east, at 1m depth, view north; no scale

A brick and tile drain was recorded at a depth of 1m BGL north of 106-8 and recorded in plan (110 Plate 9), which may be associated with drain (209) towards the former stable block to the south-east.

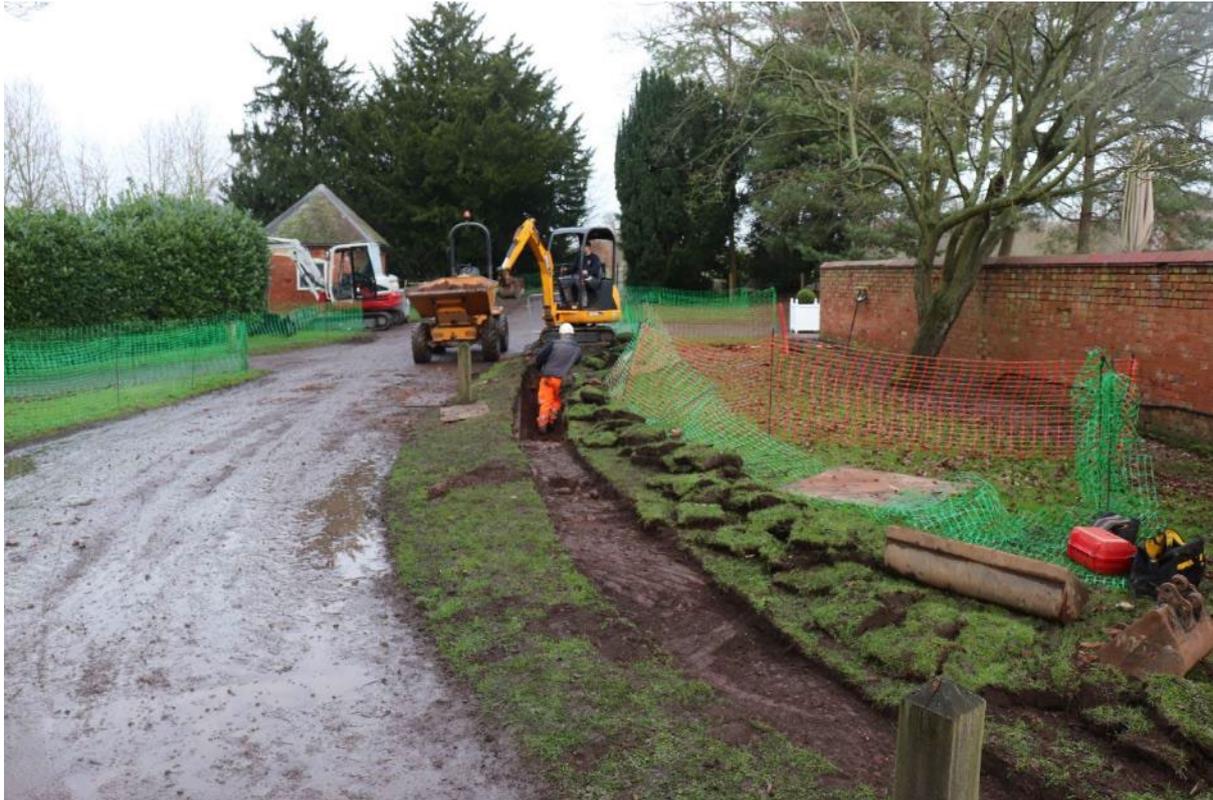
Plate 11: Trench 2, brick and cobble yard surfacing at west end of former stable block, view north-east towards game larder; no scale

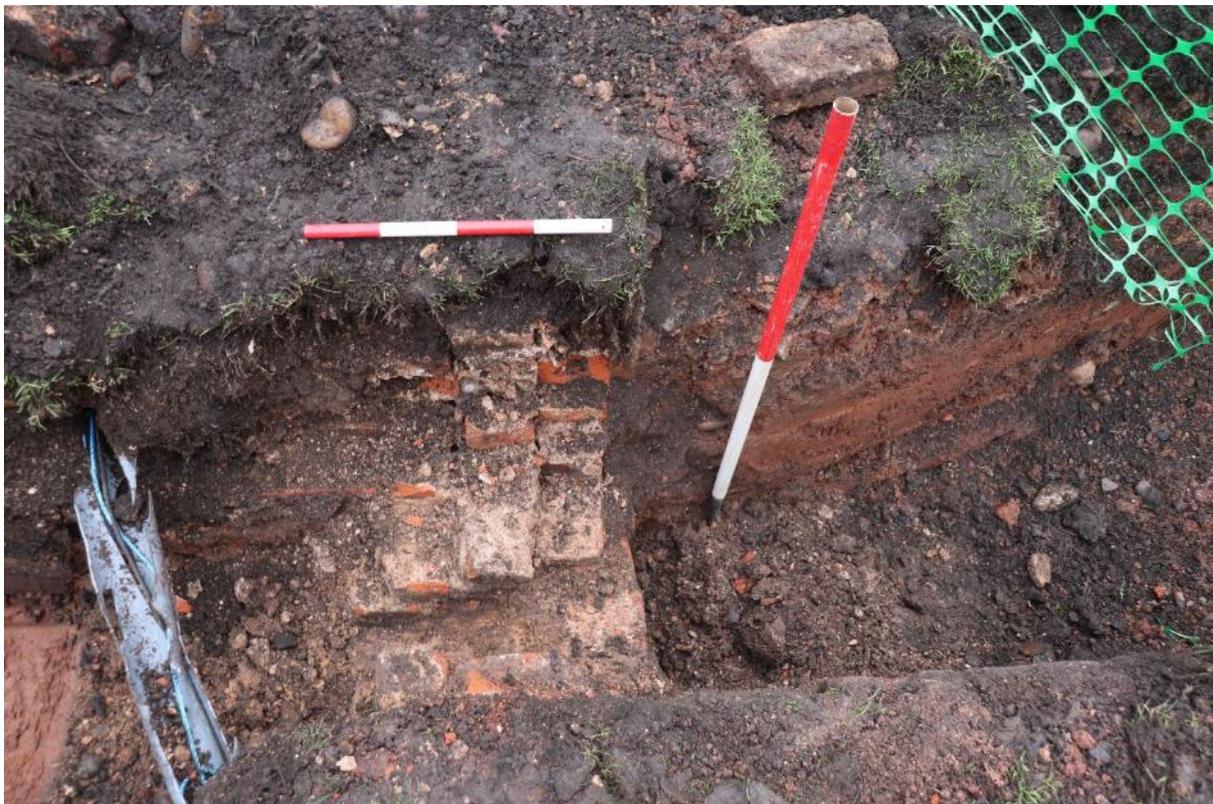
Plate 12: Trench 2, brick wall (204) at north-east corner of former stable block, partially removed, and drainage channel that ran into drain (209), heavily truncated by modern BT cable services; view south-east; 0.40m and 1m scales

This trench uncovered the footings of the former stables (204), on the north-west side of the current stable block. This measured 20m in length and 8m wide. The footings and features were visible on the ground surface adjacent to the current stables, with a section of cobbling and brick surfacing 8m in length (205), two internal brick walls (206 and 207) and the outer wall of the stables. A clinker deposit 0.40m below the ground surface also demonstrated the original ground surface of the stables, underlying the cobbles (205) and running along the length of the stable block. There was also a brick and tile drain (209) recorded in the north of the trench, 0.60m below ground level aligned north-west to south-east towards the drainage chamber. This was of similar construction as the drain (110) observed in Trench 1.

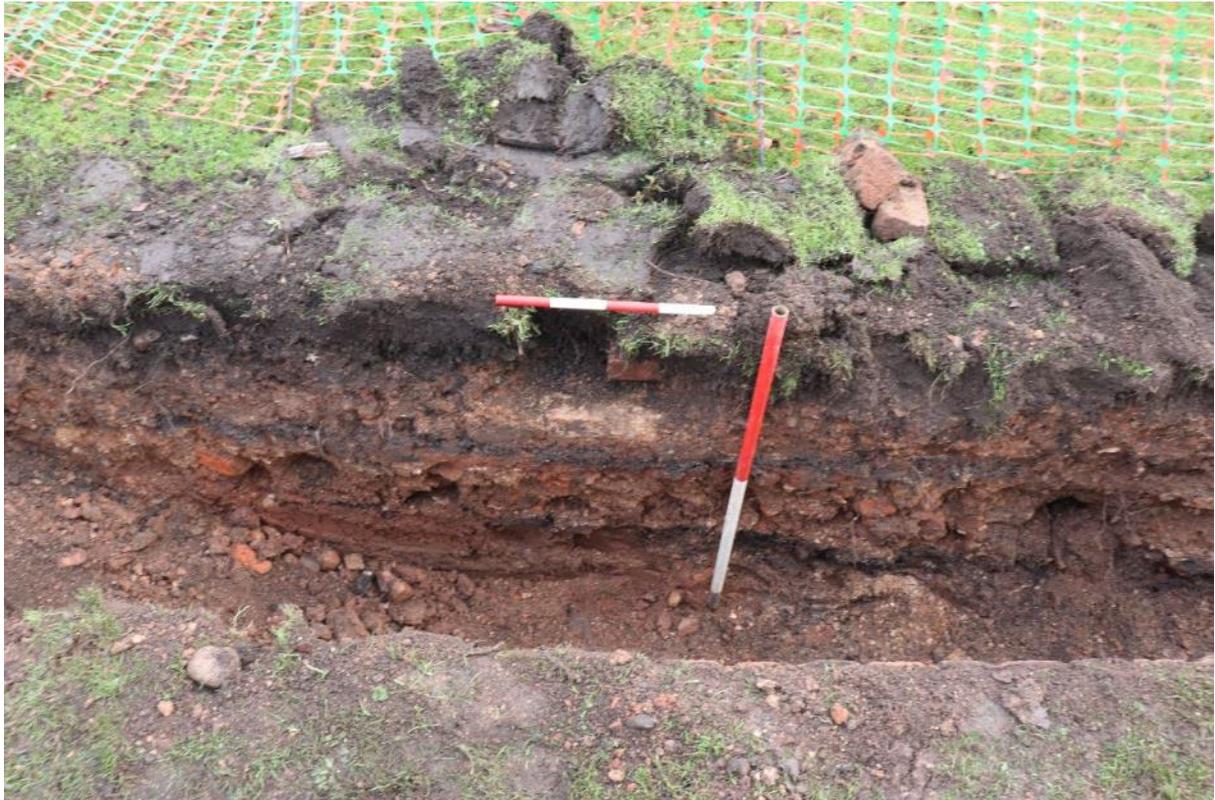
Plate 13: Trench 2, internal wall (206) within stable block and black clinker former surface in northwest facing section following removal, view south-east; 0.40m and 1m scales

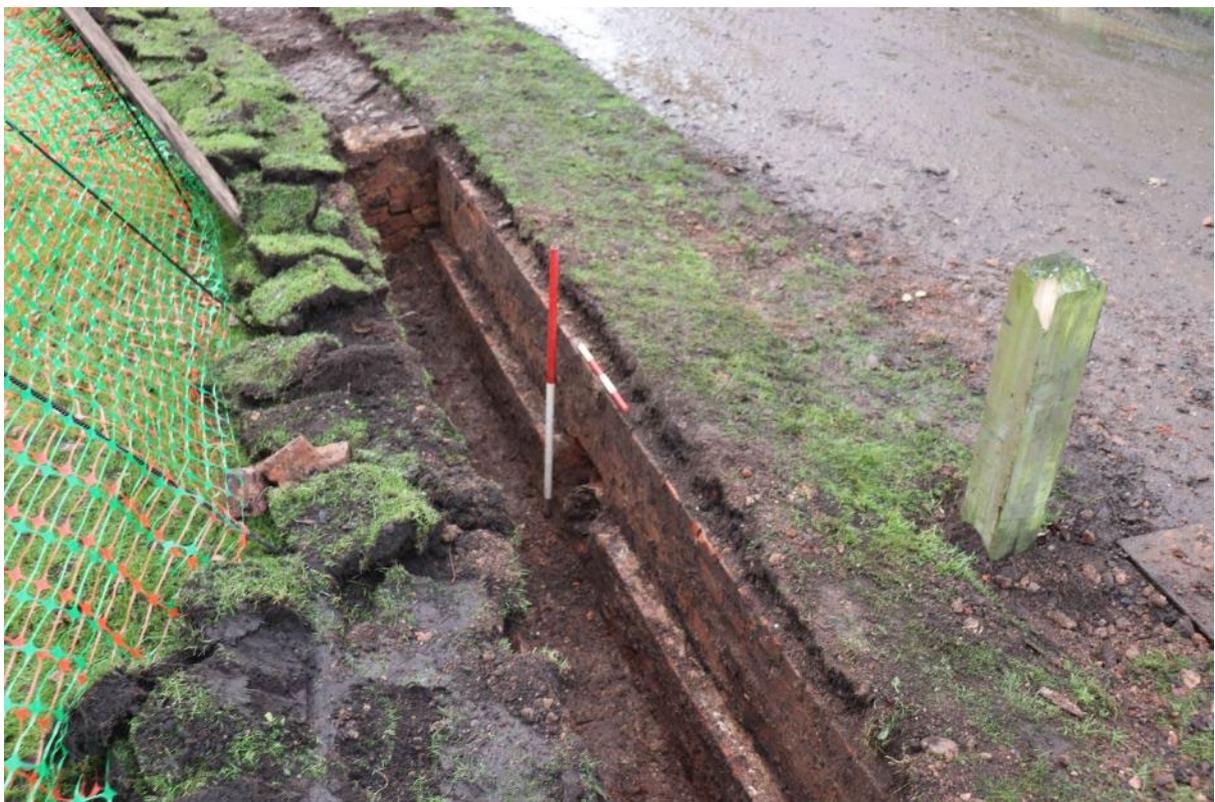
Plate 14: External wall and footing (204) of former stable block, cut by modern drain, with internal wall (206), brick and cobble surface (205) in background, view south-west; 1m scale

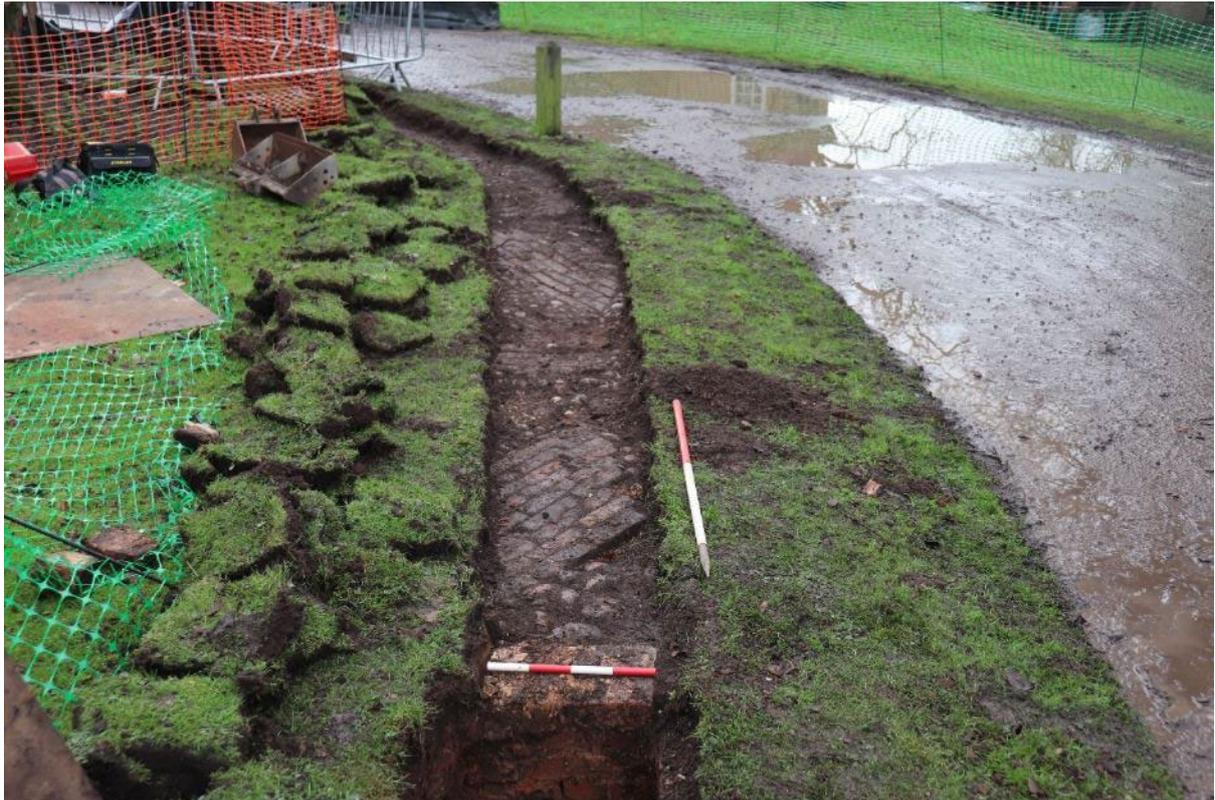
Plate 15: Trench 2, brick and cobble yard surface (205) at west end of former stable block, viewsouth; 0.40m and 1m scales

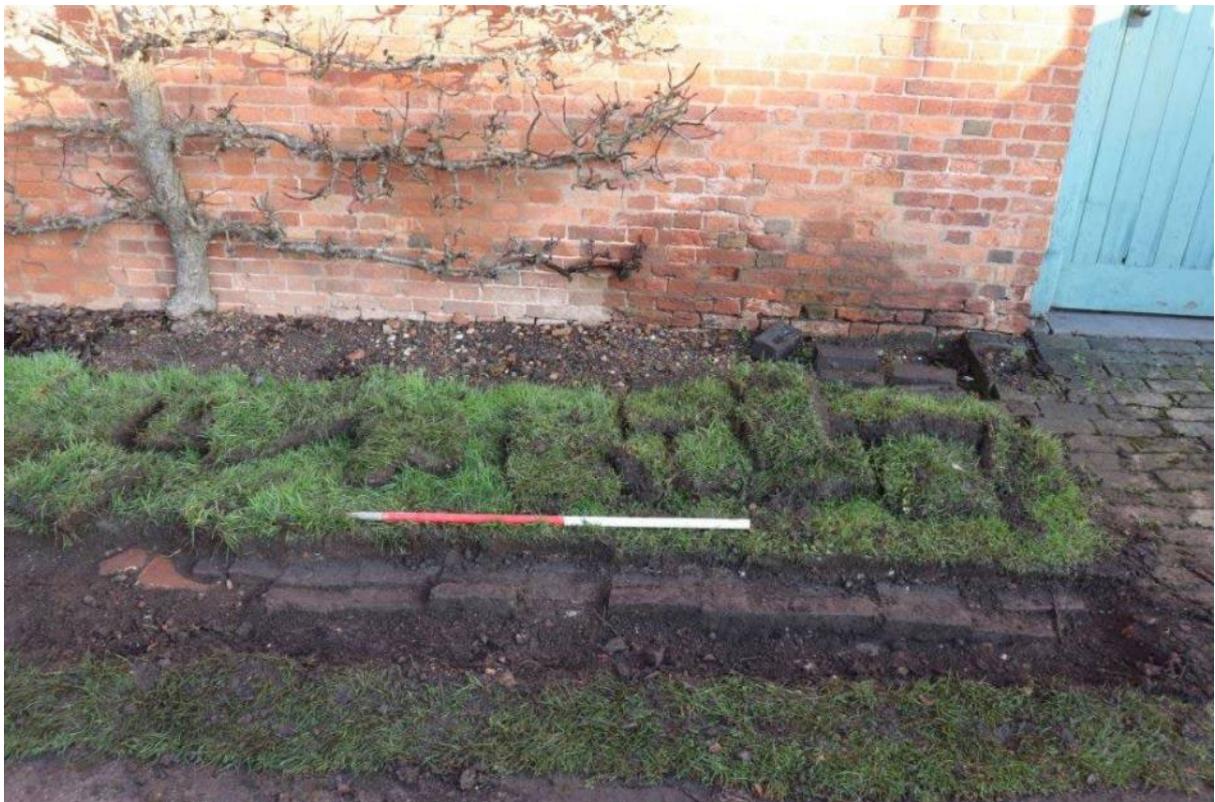
Plate 16: Trench 2, brick surface of blacksmiths path, view north-east; 1m scale
