Archaeological investigations of the Biomass Boiler works, Hanbury Hall, School Lane, Hanbury, Worcestershire

Worcestershire Archaeology
For the National Trust

April 2022

Archaeological watching brief report

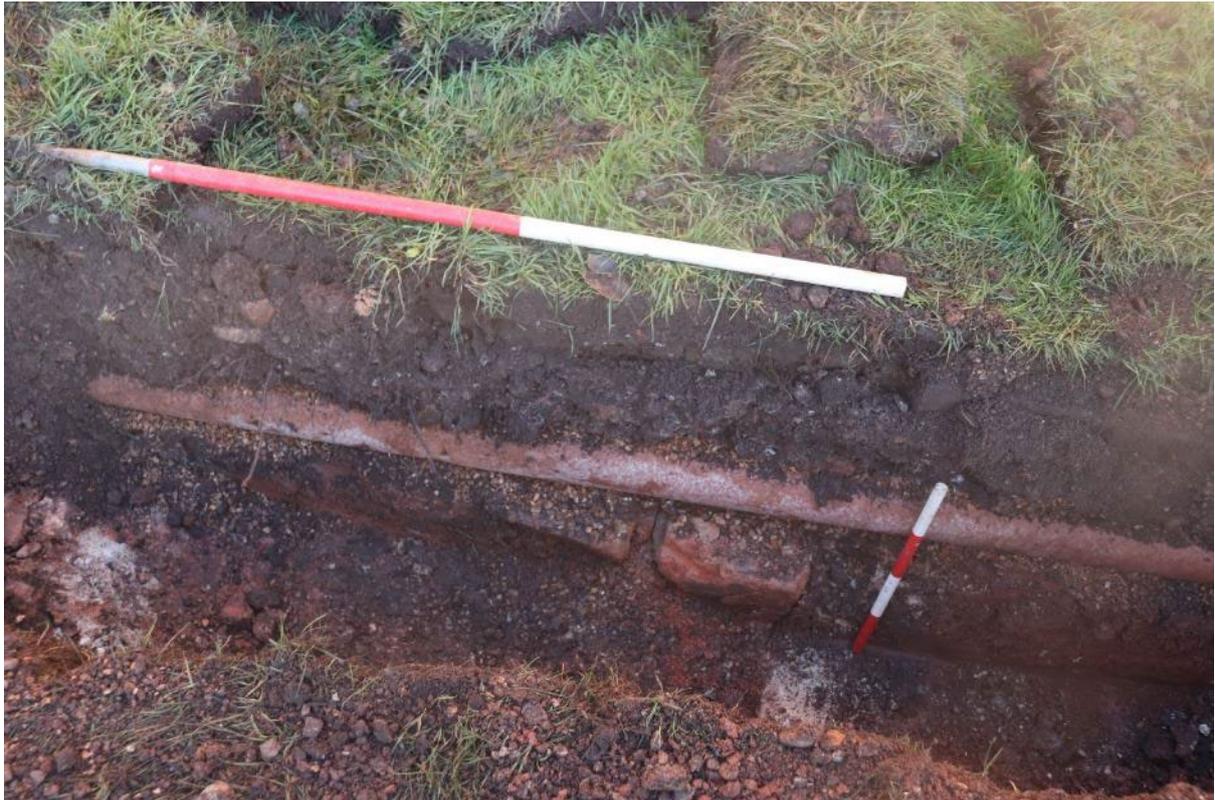
Plate 17: Trench 2, brick wall (210), with lime mortar and sandstone footings, truncated by modern drainage, view north-east; 0.40m and 1m scales

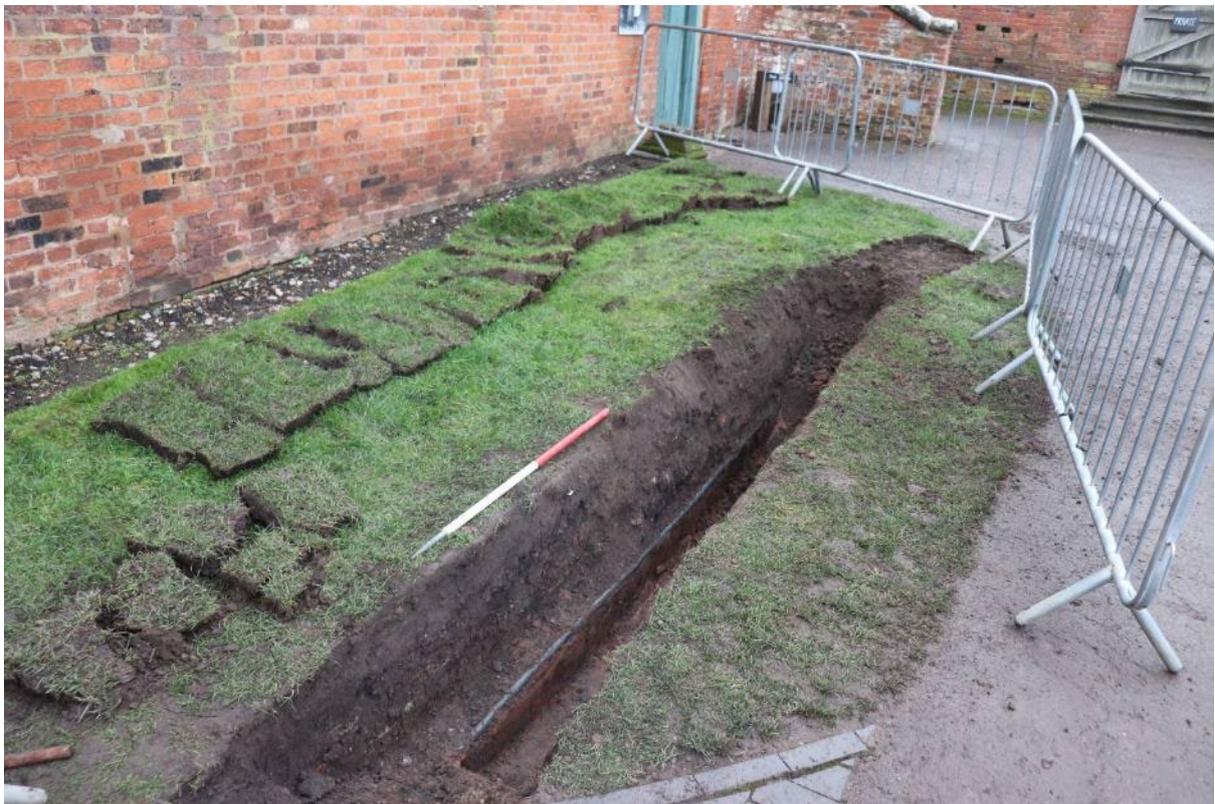
Plate 18: Trench 4 along north-east side of Service Yard with modern water pipe and disturbed ground, view east; 1m scale

The trench followed an existing modern water pipe and drainage along the stables verge, until turning and running diagonally across the Service Yard to the Hall. A series of three wall footings (409, 410, 412), were revealed at between 0.35m and 0.70m BGL. They comprised bricks 9" x 4-4 1/2" x 2 1/2" laid in lime mortar, cut into the natural. They had been previously truncated by the modern water pipe which lay a 0.70m BGL.

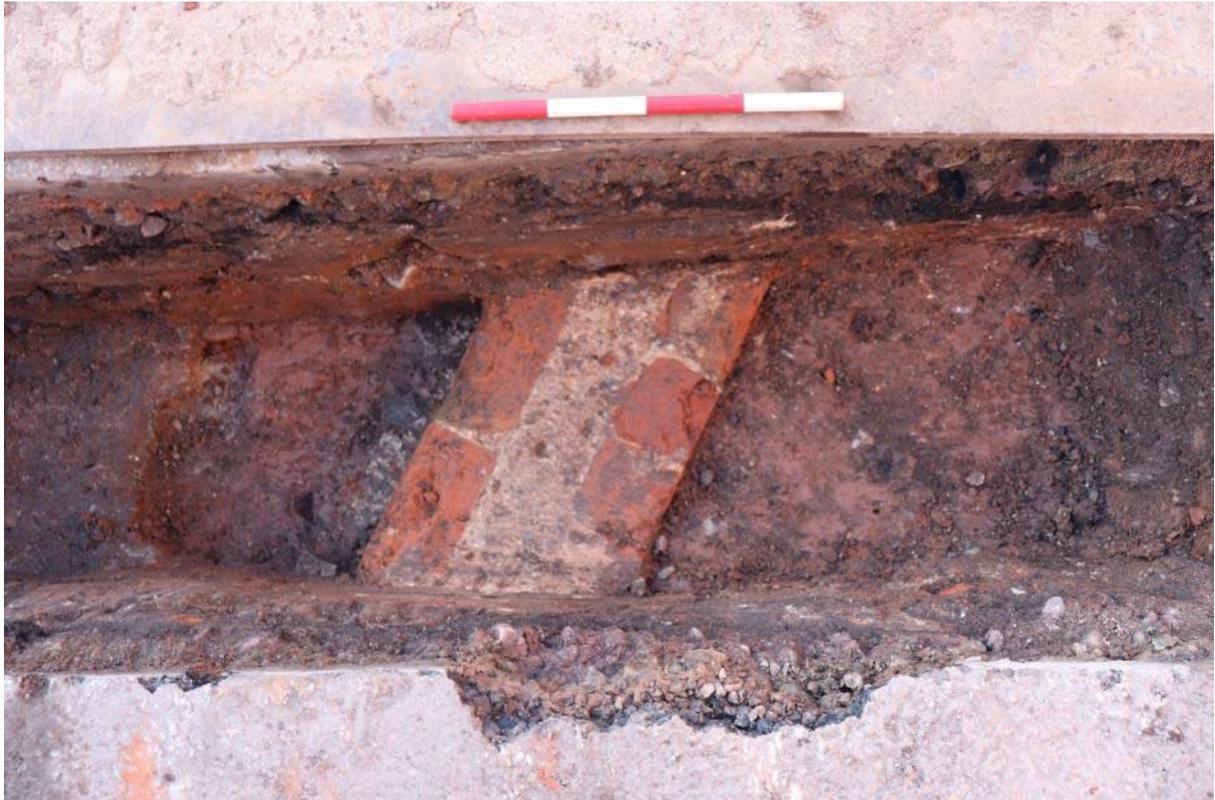
Plate 19: Trench 4 across Service Yard, boundary wall of drain (405), view west; 0.40m scale

A brick drain or boundary wall (405), 0.40m wide, with lime mortar at the centre, two brick courses deep, parallel to the existing stable block was also recorded at a depth of 0.35m BGL towards the northern end of the trench.

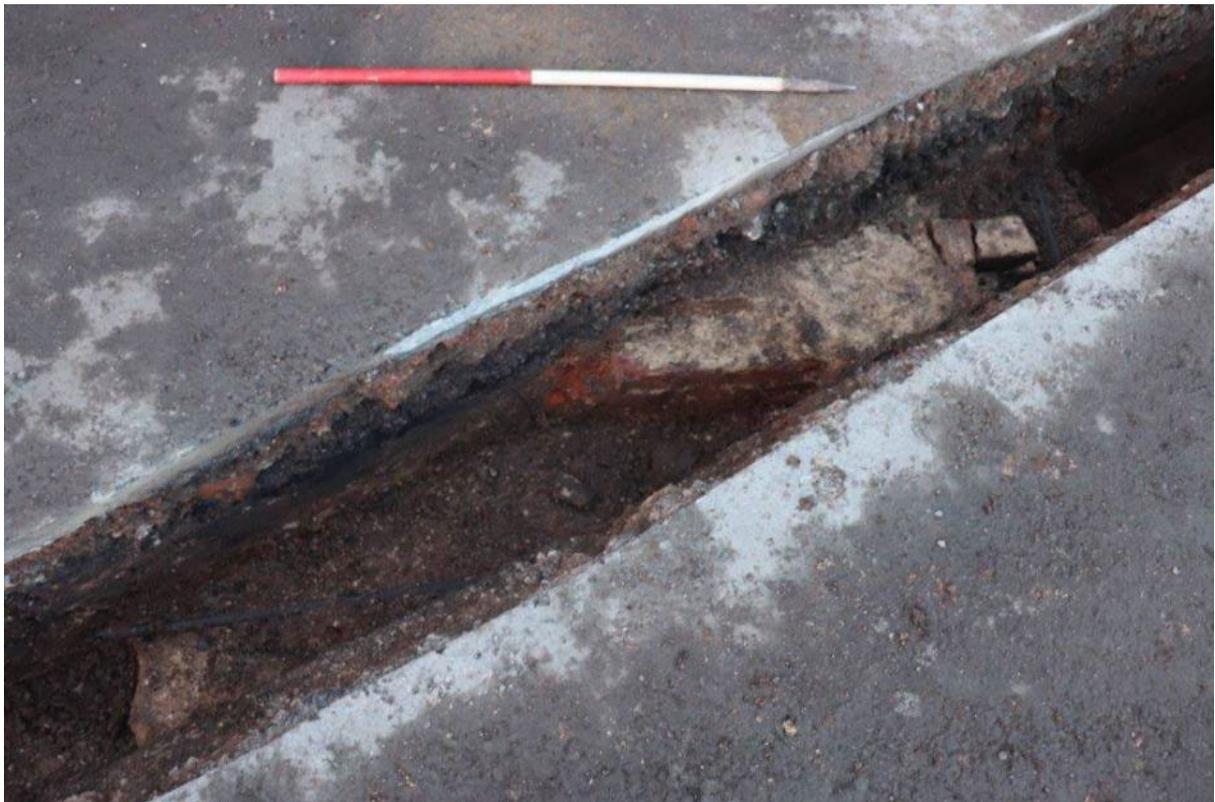
Plate 20: Trench 4 across Service Yard, wall footings (409) and (410) cut by modern water pipe, view south-east; 1m scale

Walls (409, 410 and 412) appear to relate to the former 1706 buildings indicated on the 1732 plan, whilst the drain or boundary wall 405 is considered to be of late 19th century date.

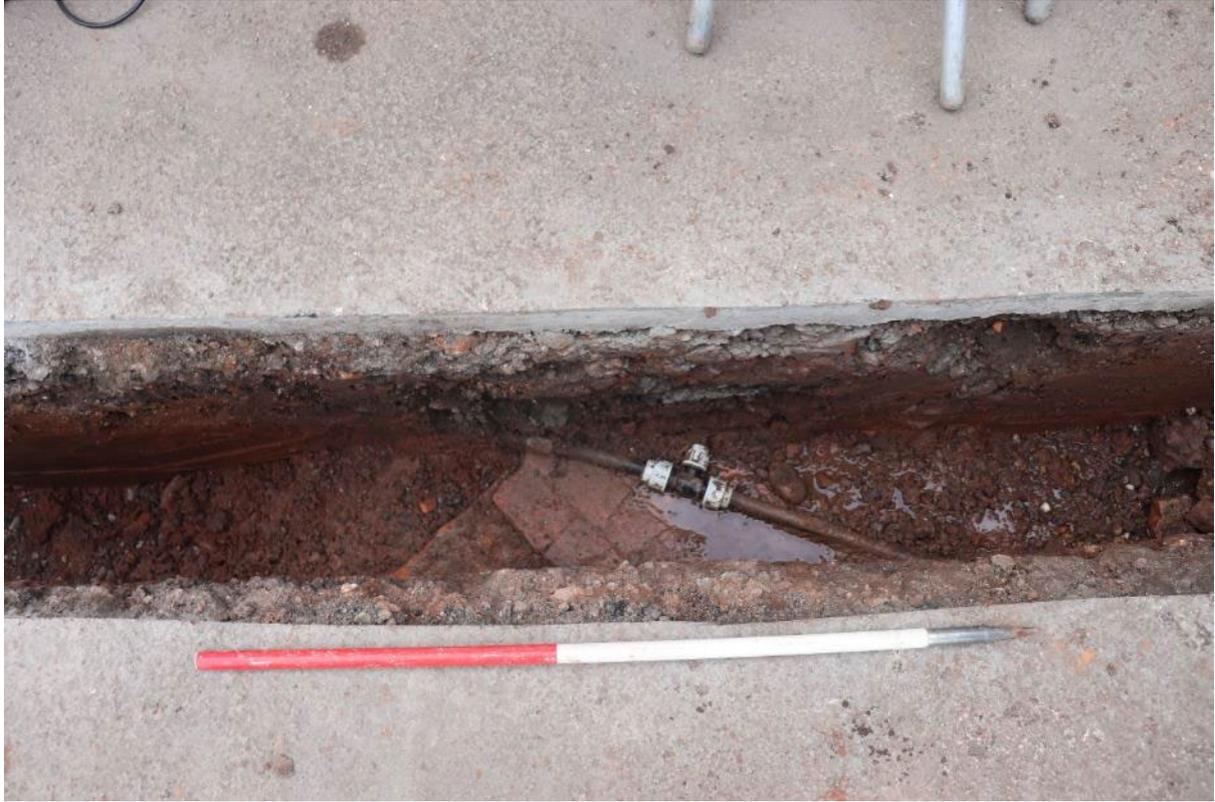
Plate 21: Trench 4 across Service Yard, wall (412) overlaid by modern water pipe, view south; 1m scale

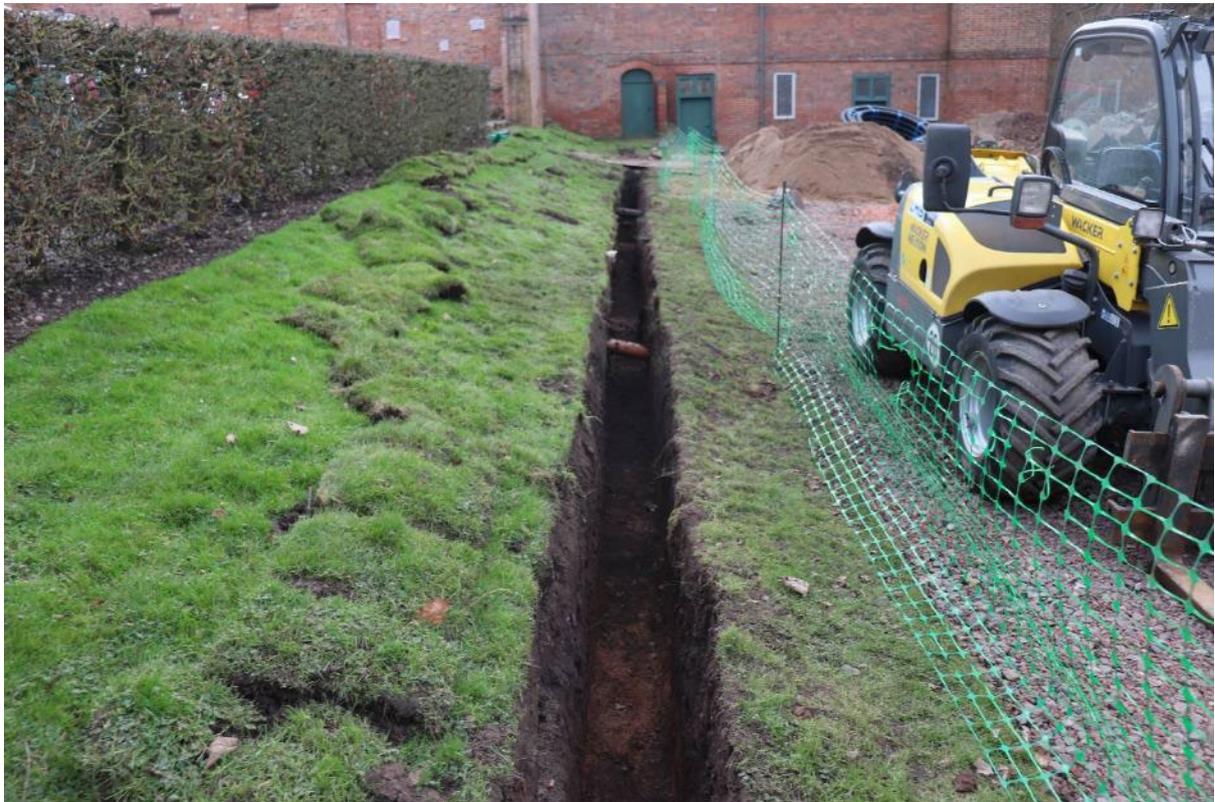
Plate 22: Trench 5 adjacent to hedge between Service yard and Lower Yard, view south-west; no scale

This trench ran parallel to the existing hedge between the Service Yard and Lower Yard towards the Long Gallery to the south-west. It was dug to a maximum depth of 0.80m. This revealed that the bank between the two yards consisted of modern made ground and landscaped topsoil, overlying mixed rubble from the mid-20th century above the natural at 0.60m BGL (Plate 22).

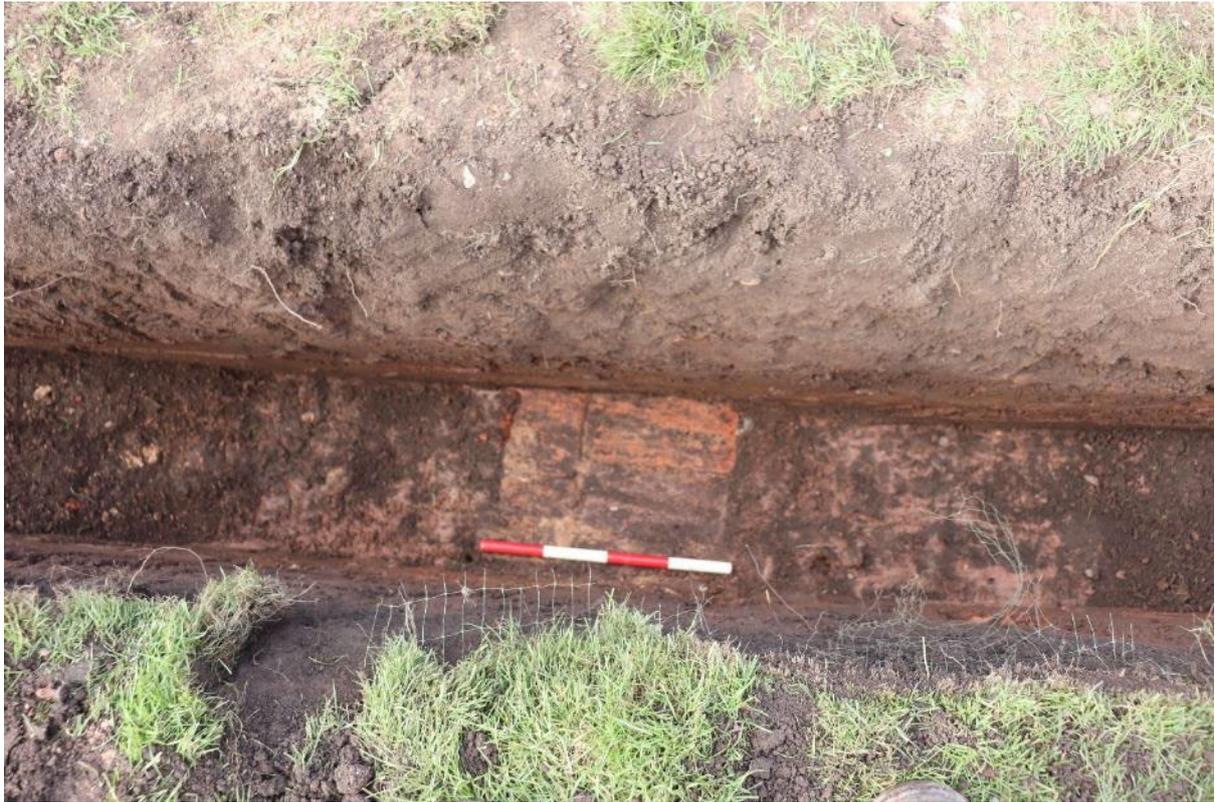
Plate 23: Trench 5, wall footing (506) 0.80m below ground level, cut into natural clay mudstone, view south-east; 0.4m scale

Within the middle of the trench one further brick structure was observed in the trench base at 0.80m BGL (506; Plate 23). This comprised a wall footing, aligned north-west to south-east, c 0.35m and three bricks wide, laid directly onto the natural. It was sealed by modern dump deposits. It appears to relate to a boundary wall within the Service Yard recorded on Donald Insall's projected 1706 plan, the 1st, 2nd and 3rd edition Ordnance Survey maps.

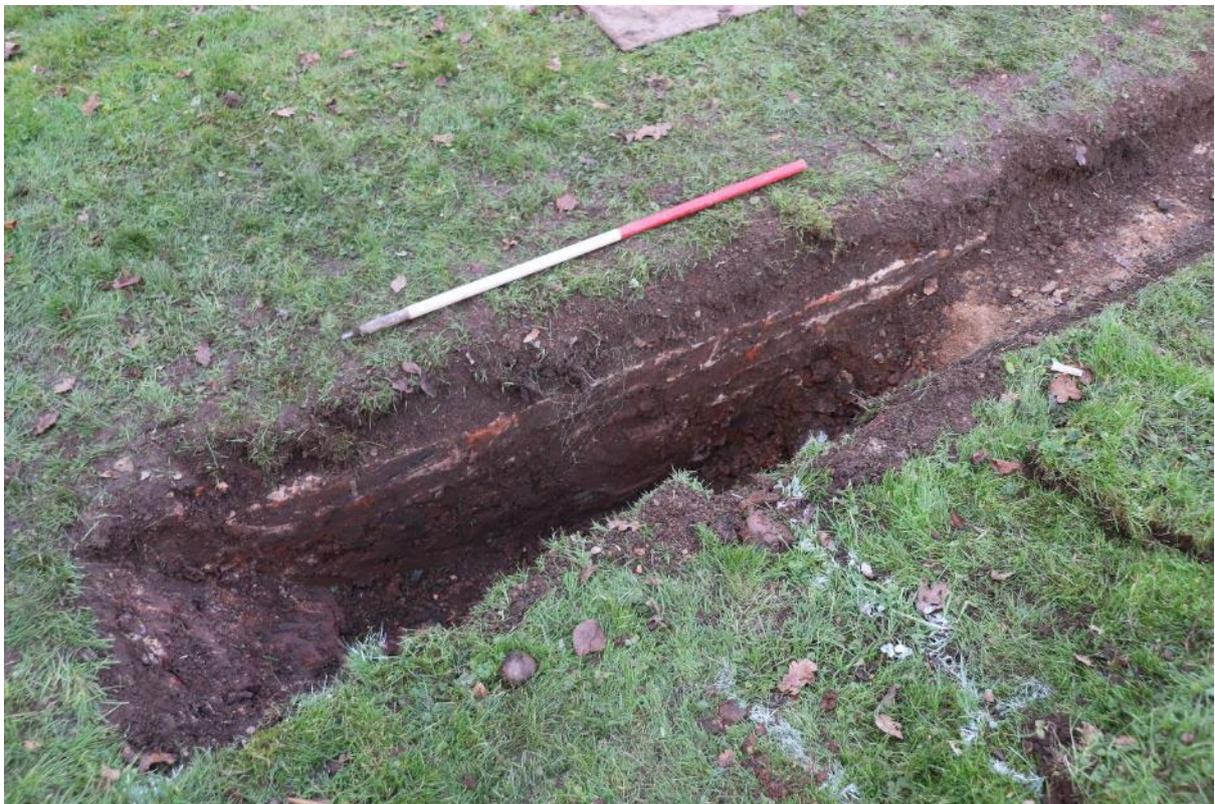
Plate 24: Trench 5, brick wall of service block (501) directly under turf, cut by modern drainage to the south-west, view north-west; 1m scale

At the south end of the trench a wall footing was noted in the north-west section (501; Plate 24). The footing was 2m in length, of 9" x 4" x 2 3/4" bricks, laid into the natural with at least 5 extant courses. It appears to relate to a small building off the north-west side of the late 19th century service block.

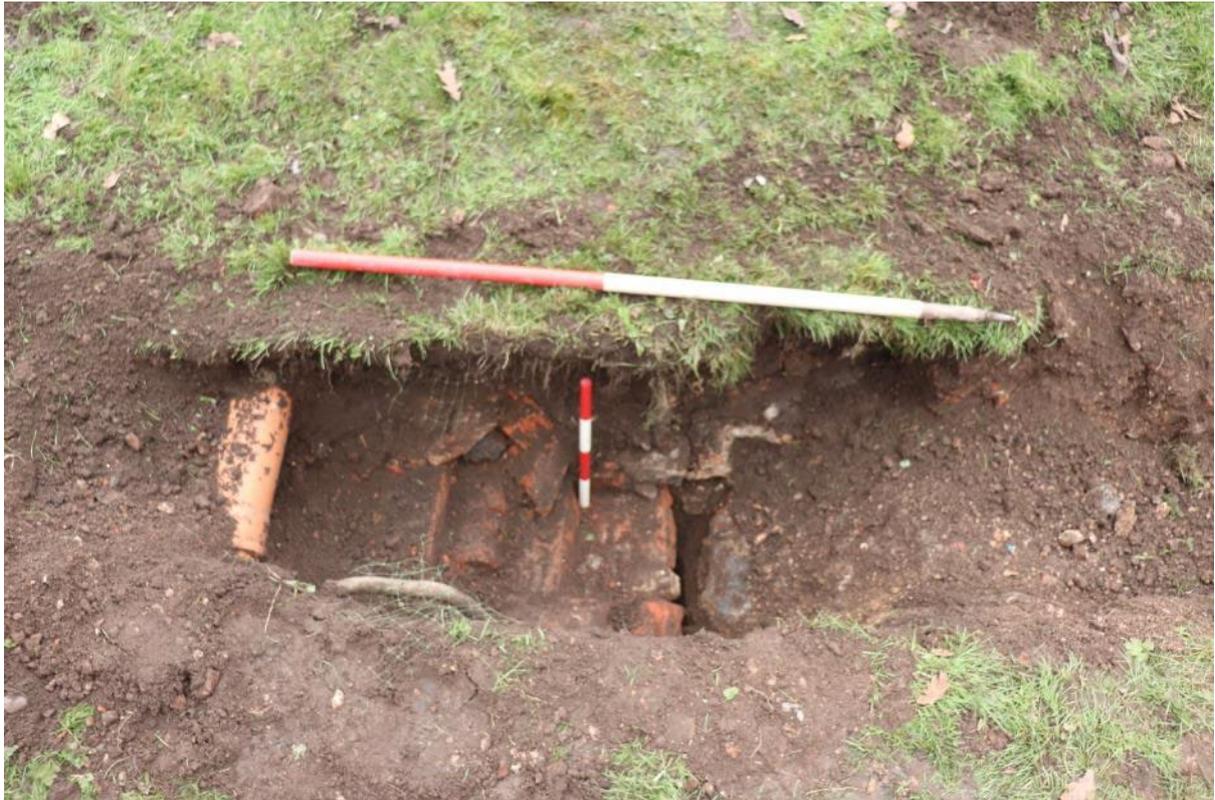
Plate 25: Trench 5, top of brick culvert arch (503), overlain by modern drainage and turf, view south-east; 0.40m and 1m scales

Towards the south-west end of the trench a brick culvert (503; Plates 25-28) was exposed at 0.35m BGL, overlain by a modern concrete drain. A camera revealed that the culvert had been bricked up immediately to the north-west, possibly due to modern drainage in the vicinity, but was intact to the south-east (Plate 26). The culvert was 0.60m wide and 1.20m deep internally, and c 1.00m wide externally. It had an arched top, constructed of a double skin of bricks, in cement mortar. The base was lined with slate. This structure had been identified in the 2019 evaluation (BA 2019) and was again in the excavation of the service block by Worcestershire Archaeology which ran concurrently with the Biomass watching brief (Graham and Vaughan forthcoming). The drainage culvert was mapped and its outflow is visible to the north-west, bricked up with a pipe (Plate 28).

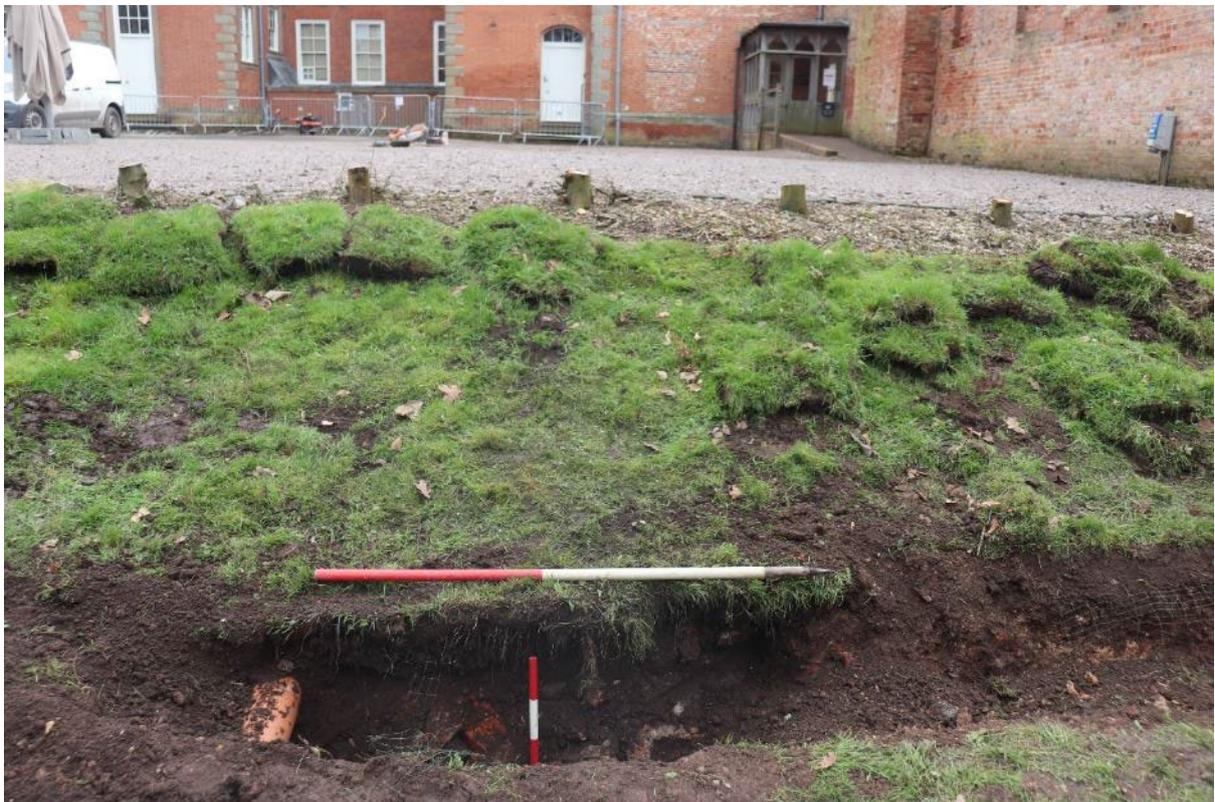
Plate 26: Trench 5, location of brick culvert (503), view south-east towards Service Yard and Hanbury Hall

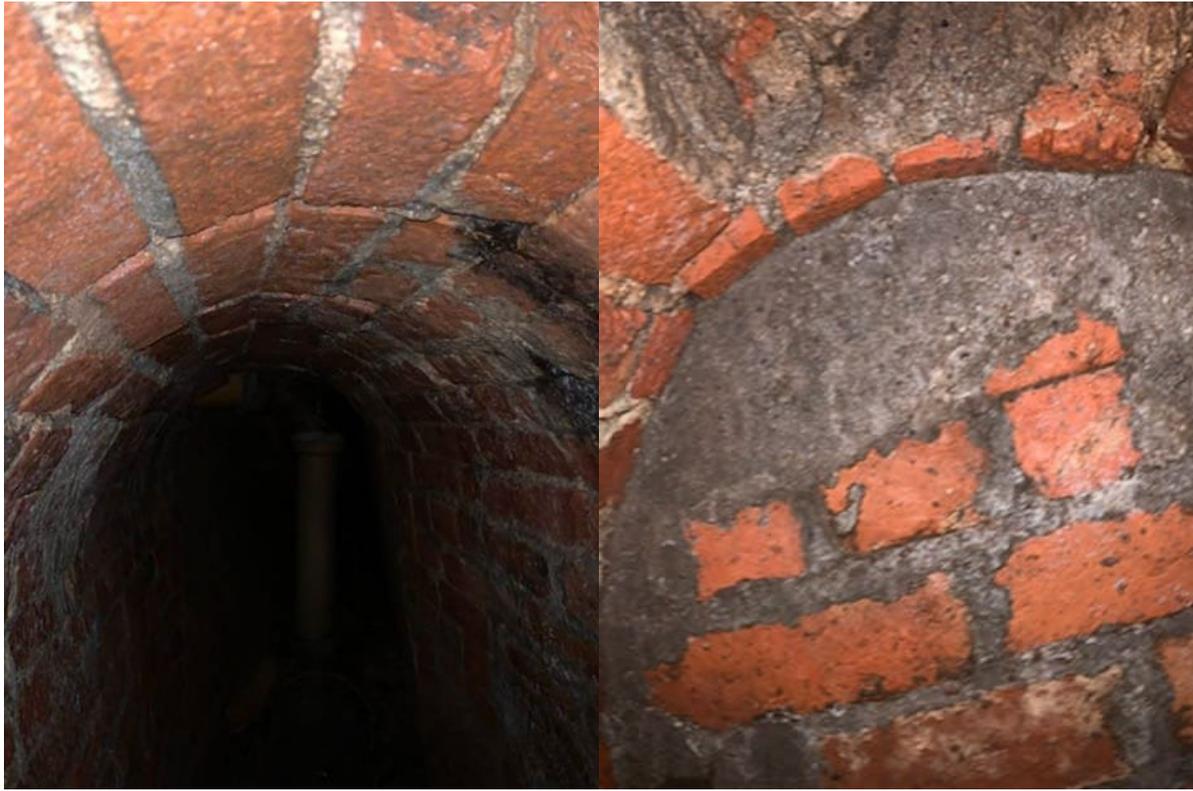
Plates 27a and b: Views inside brick culvert (503) from Trench 5, showing (a) pipes and intact condition to south-east; (b) bricked up to north-west, possibly due to modern drainage (502); no scale

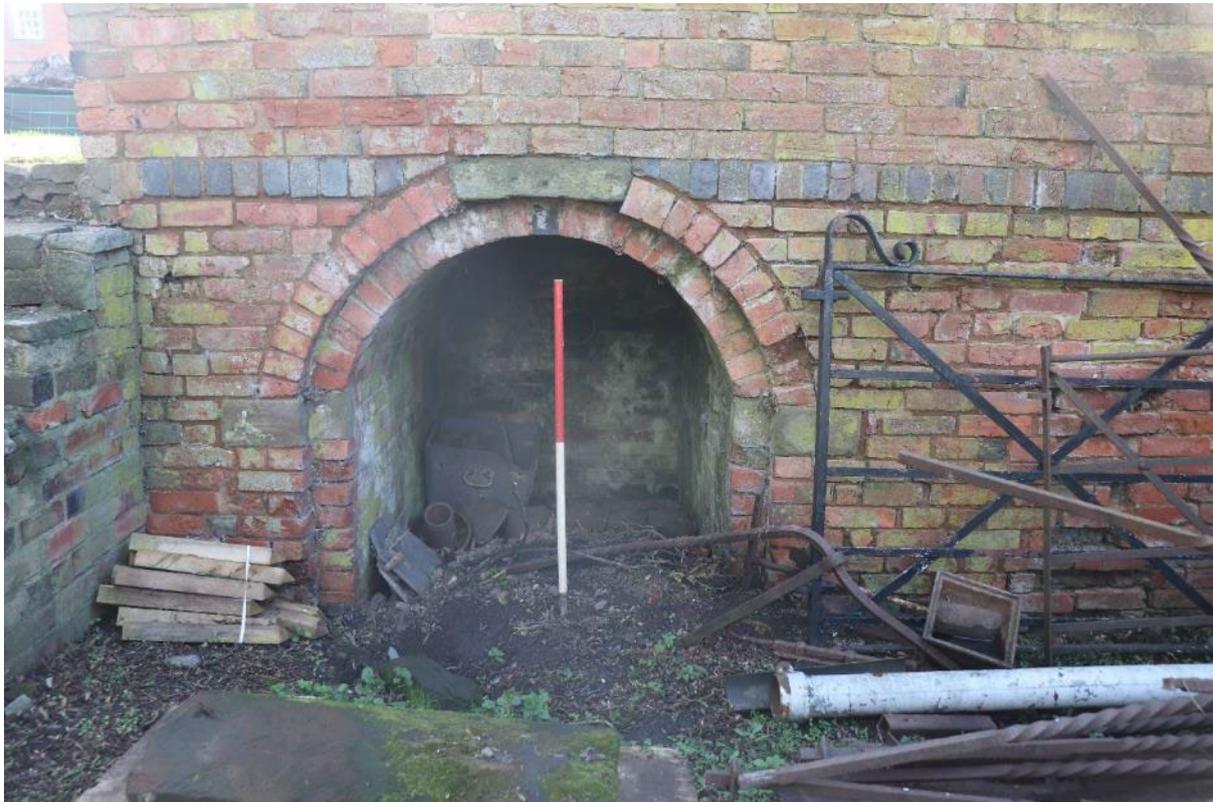
Plate 28: Outlet of brick culvert (503) at north-west edge of Lower Yard, view south-east; 1m scale
