ARCHAEOLOGICAL WATCHING
BRIEF AT
MOLINEUX HOTEL,
MOLINEUX STREET,
WOLVERHAMPTON

Project 3057
Report 1597
EBL 812

Archaeological watching brief at Molineux Hotel, Molineux Street, Wolverhampton

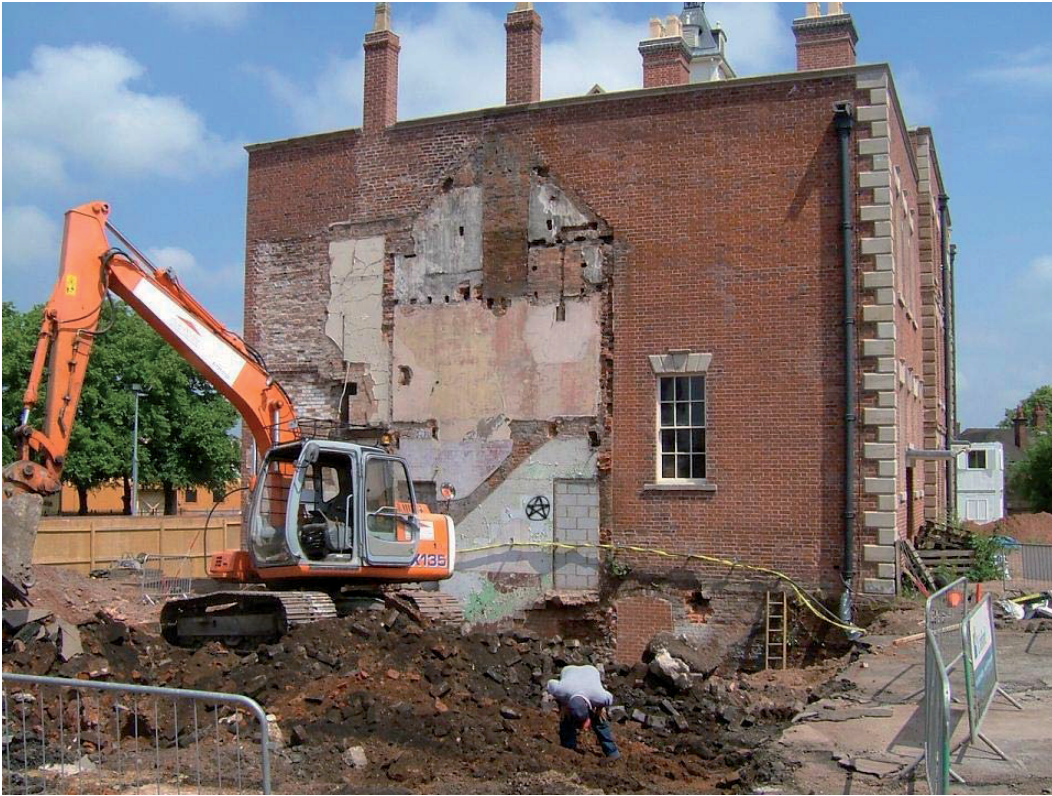
Plate 1, West elevation of West Range after demolition of North-West Range, view north northeast

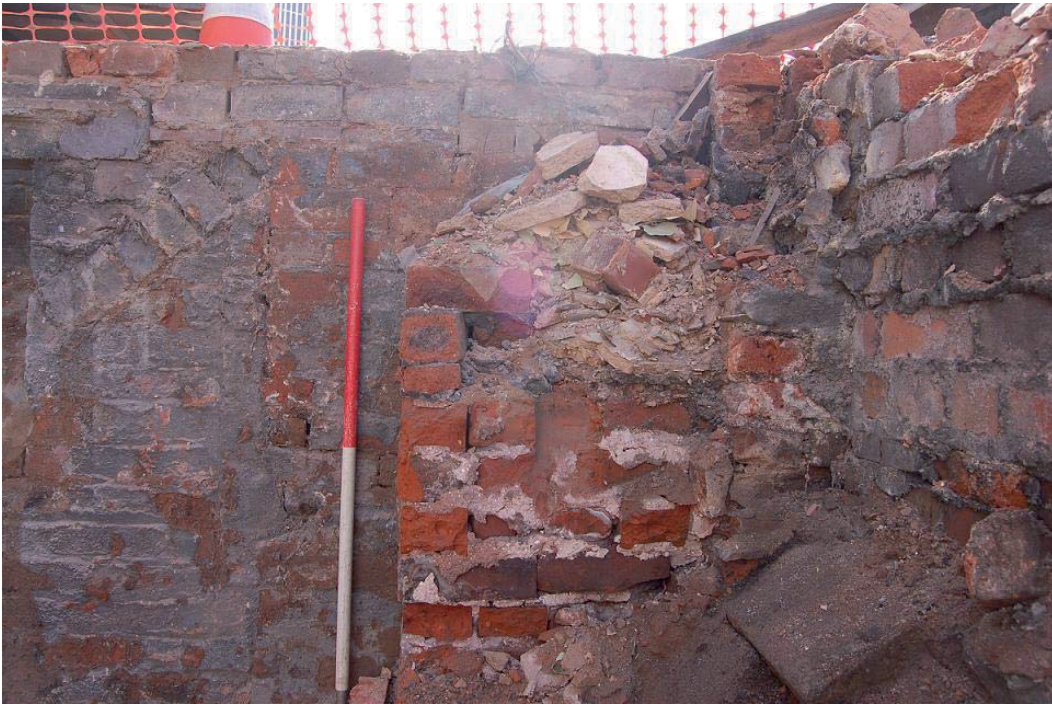
The foundations of the southwest wall comprised handmade red bricks, 109, bedded on a single course of sandstone blocks, 110, with buttresses protruding toward the cellar wall, 108, which lay approximately 1m to the northeast (Plates 2 and 3). The double-skin cellar wall comprised thinner handmade bricks of similar fabric bedded in a lime mortar, cut into the natural, 105, at a lower level than the outer foundation wall (Plate 4).

Plate 2, Wall and buttress 109 in south corner of North-West Range cellar, view southeast

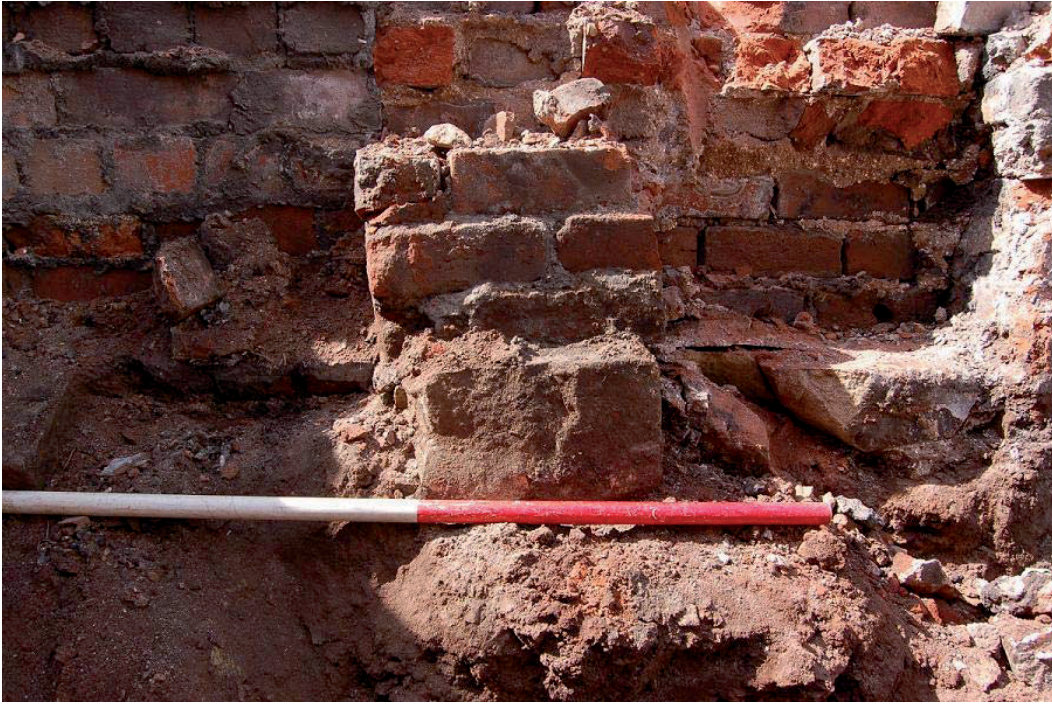
Plate 3, Southwest foundation wall and buttress, 109 and 110, below North-West Range, view southwest

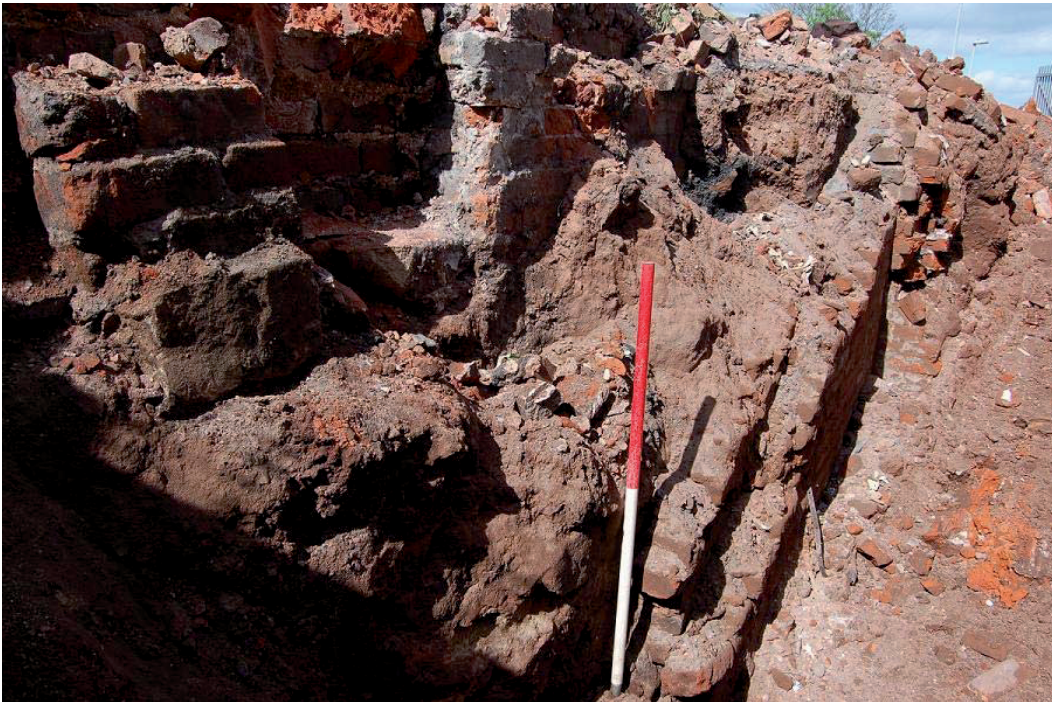
The southwest cellar wall, 108, below the North-West Range, comprised bricks of probable 18th century date and therefore appears to relate to the original construction of this wing. It lay approximately 1m to the northeast (and inside) the southwest foundation wall, 109/110 for the North-West Range, which comprised bricks of probable 19th century date set on a single course of sandstone blocks. This indicates that the range was indeed rebuilt and enlarged in the 19th century. The cartographic sources reveal that this took place before 1841-2 (*ibid*, Figs 3 and 4).

Plate 4, Southwest cellar wall, 108, below North-West Range, view north northwest

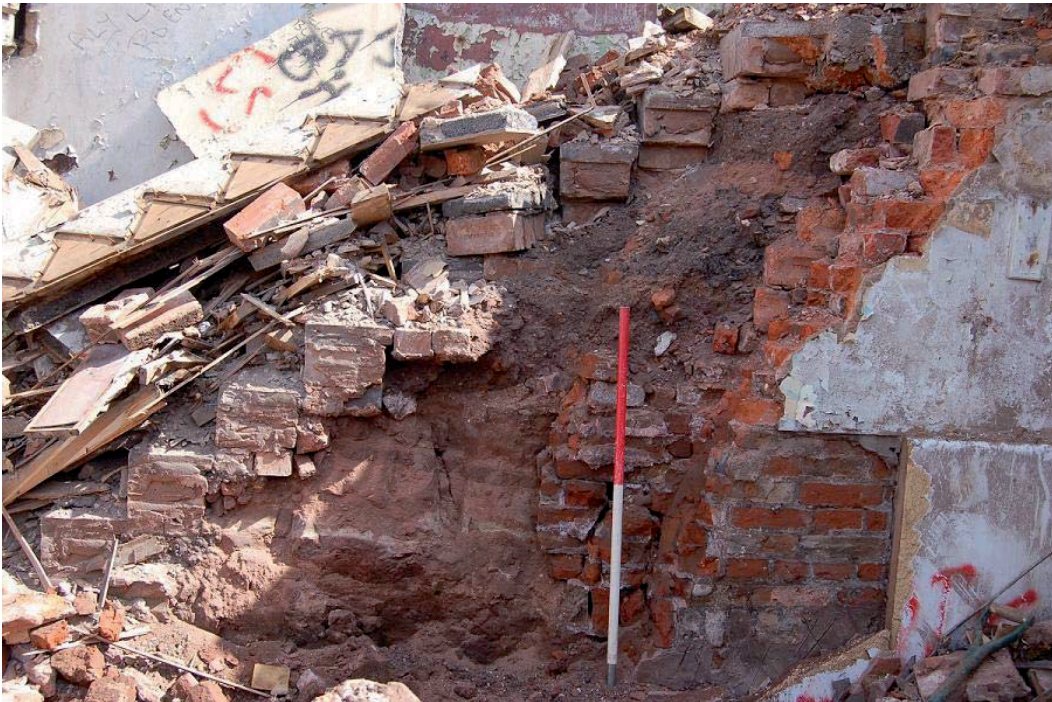
The staircase down into the cellar was recorded on the northeast side of the range. It comprised machine made blue engineering brick steps bedded over frogged red bricks, 106. The lower half of the flight was cut into the natural sand, 105, while the upper half lay over a sequence of make up layers, comprising mixed clay with building debris, 100, 102, 103 and 104, and a redeposited band of red sand, 101. These layers butted an adjacent cellar wall, 107. This was double-skin and heavily rendered, of hand made red bricks, bedded in lime mortar (Plate 6).

It is unclear if the dump deposits, 100-104, below the cellar stairs, 106, in the North-West Range were deliberately deposited during construction to raise this area, or were already there and hence were truncated during excavation for the cellar in the mid/late 19th century. They contained generic blue and white china of late 19th/20th century date. The cellar wall, 107 appears to date from the early/mid 19th century rebuilding. The lower steps date to the mid/late 19th century. The engineering brick steps appear to be replacements, of late 19th/early 20th century date.

Plate 6, Cellar stairs, 106, and wall, 107, below North-West Range, view northeast

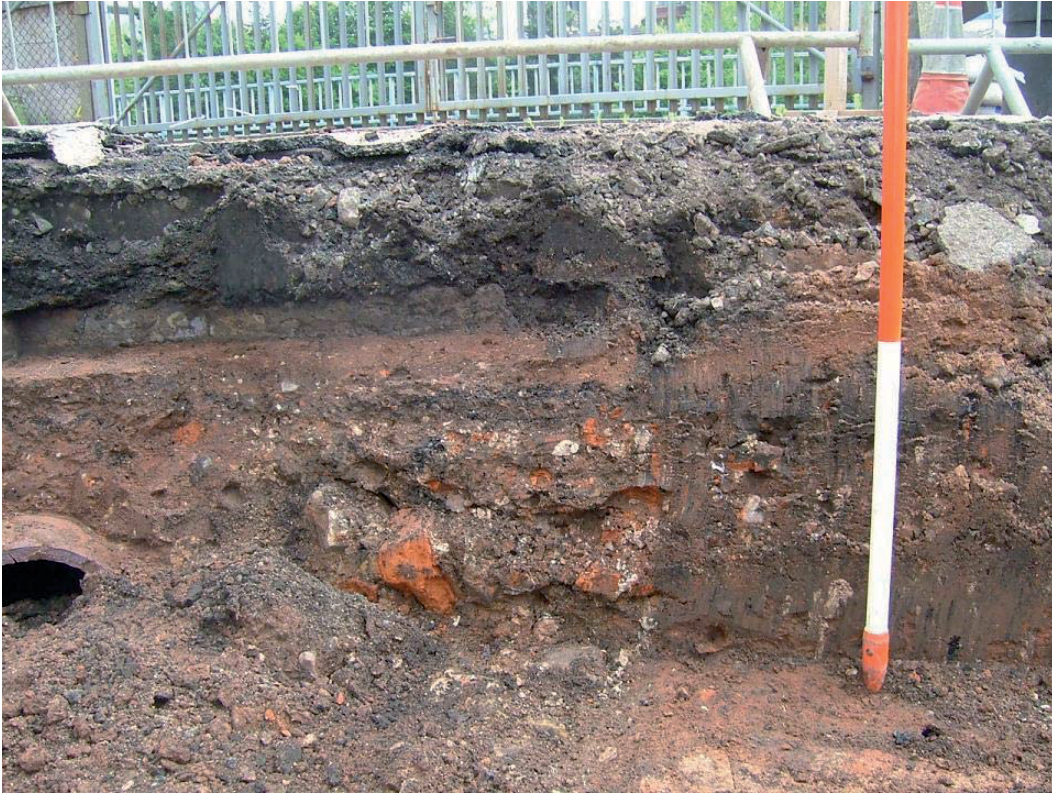
The excavation of the footprint of the new Archival Storage building exposed a sequence of layers to the south of the North-West Range (Plate 9). A surface comprised of machine made blue engineering bricks bedded on sand, 119, lay directly below the modern tarmac surface, 118. This sealed a mixed deposit of sandy clay with variable building rubble, to 0.85m depth, which had been disturbed by frequent services and lay over the natural matrix 117.

The surface of engineering bricks, 119, observed directly below the modern tarmac surface, immediately to the south of the North-West Range is considered to date from the later 19th or early 20th century. It formed part of the wider hardstanding on this side of the Hotel which covered the entirety of Molineux Fold yard until the area was tarmaced over in the last decades of the 20th century.

Plate 9, Brick surface, 119, to southeast of North-West Range, view southeast

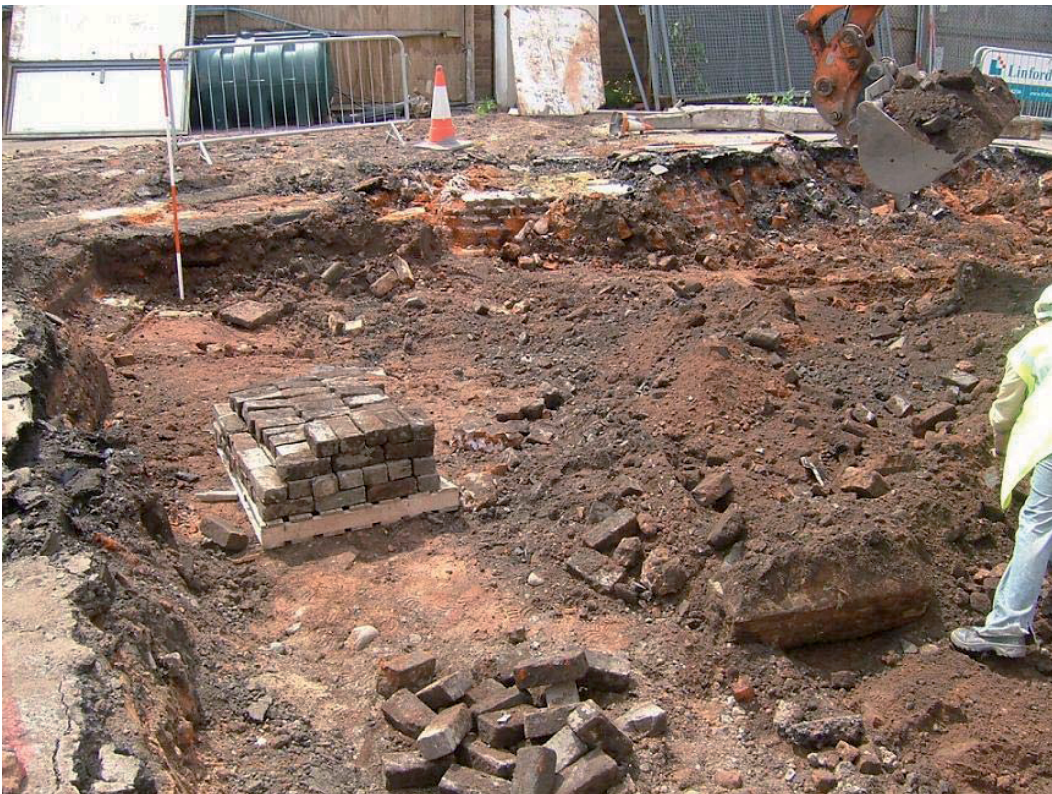
A substantial brick buttress or foundation, 121, was recorded to the southwest of the North-West Range. Unfortunately, it was not possible to record it fully, although it comprised bright red bricks bedded in lime mortar (Plate 10).

The substantial brick buttress, 121, on the southwest side of the excavations for the new Archive Storage building, appears to be part of the range of buildings alongside Molineux Alley. They are first recorded on the Godson map of 1788 (*ibid*, Fig 3), which were utilised as garages in the mid 20th century and had been demolished by 1971 (*ibid*, Fig 14). It is unclear if the structure relates to the late 18th century building or to a later rebuilding or alteration.

Plate 10, Brick buttress, 121, and excavation of footing for new Archive Store, view west

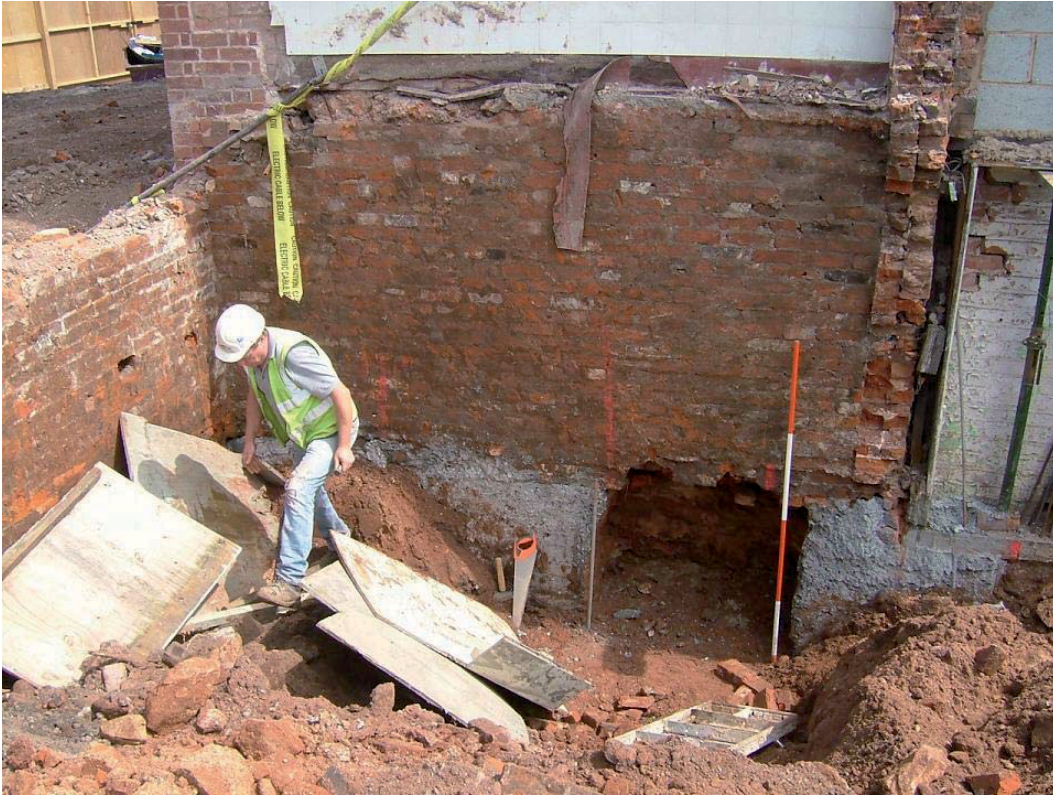
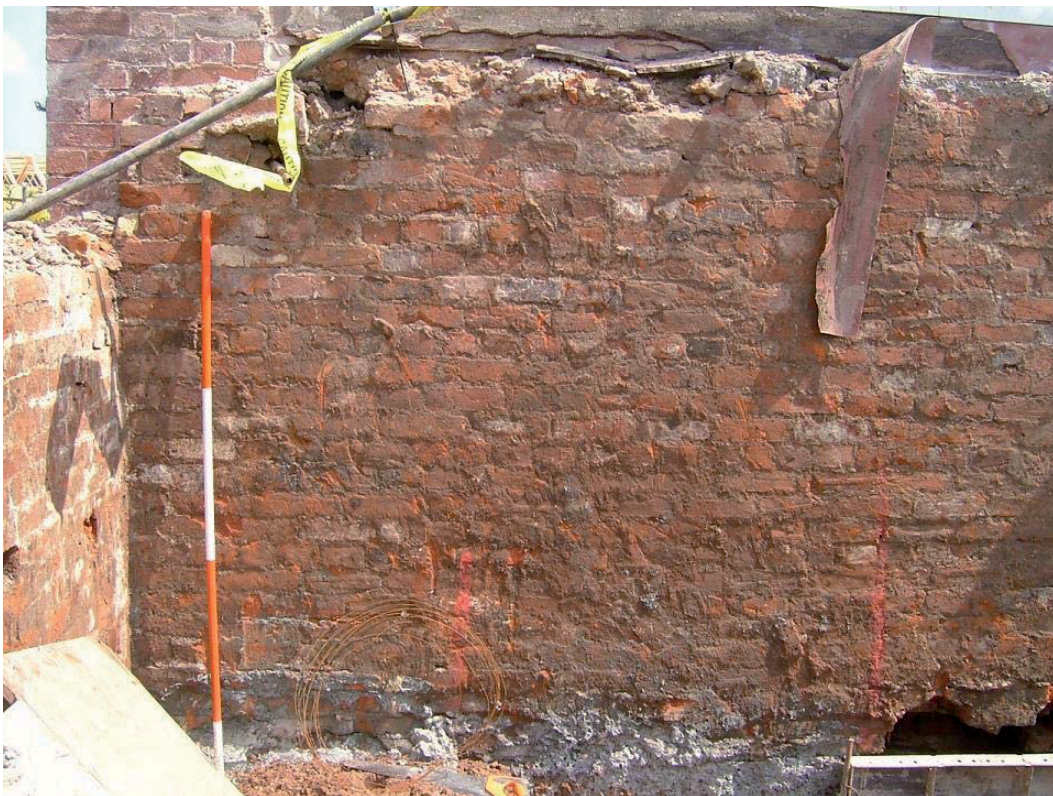
The foundation wall, 112, at the west corner of the West Range was observed (Plates 11 and 12). It comprised approximately 21 courses of late 19th century bricks, laid in English Garden Wall Bond, flush with the main wall above and bedded directly onto the natural matrix, 105.

The foundations for the west wall of the West Range, 112, date to the late 19th century. This indicates that the wing was altered later after the North-West Range (see below).

Plate 11, Foundation wall, 112, below southwest wall of West Range, view northeast

Plate 12, Foundation wall, 112, below southwest wall of West Range, view northeast

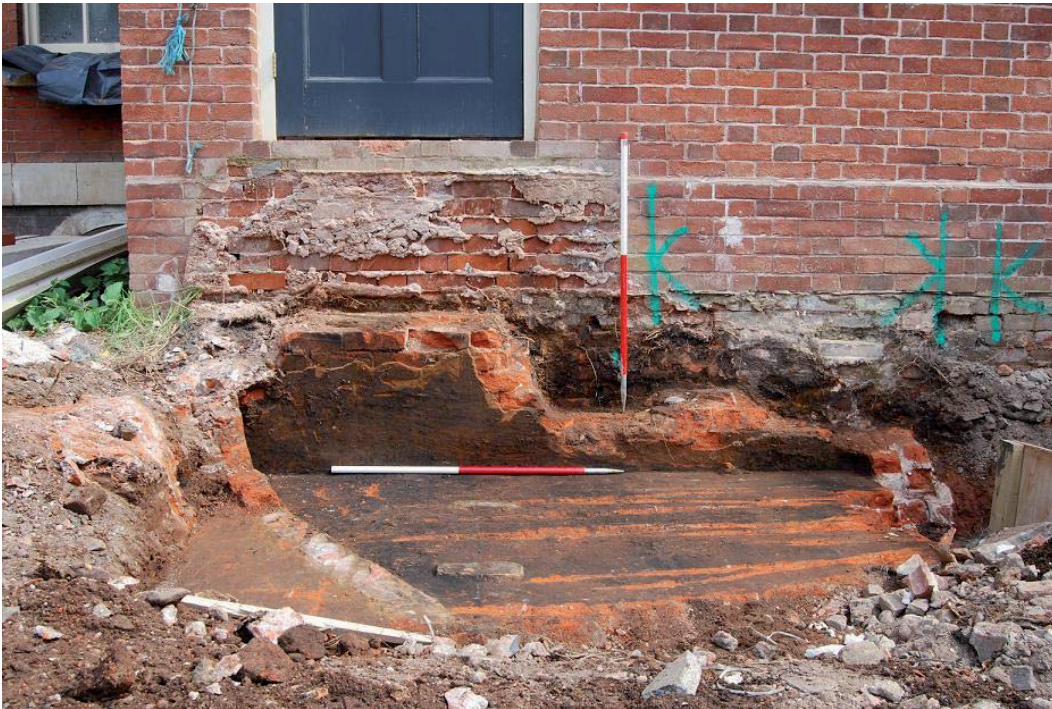
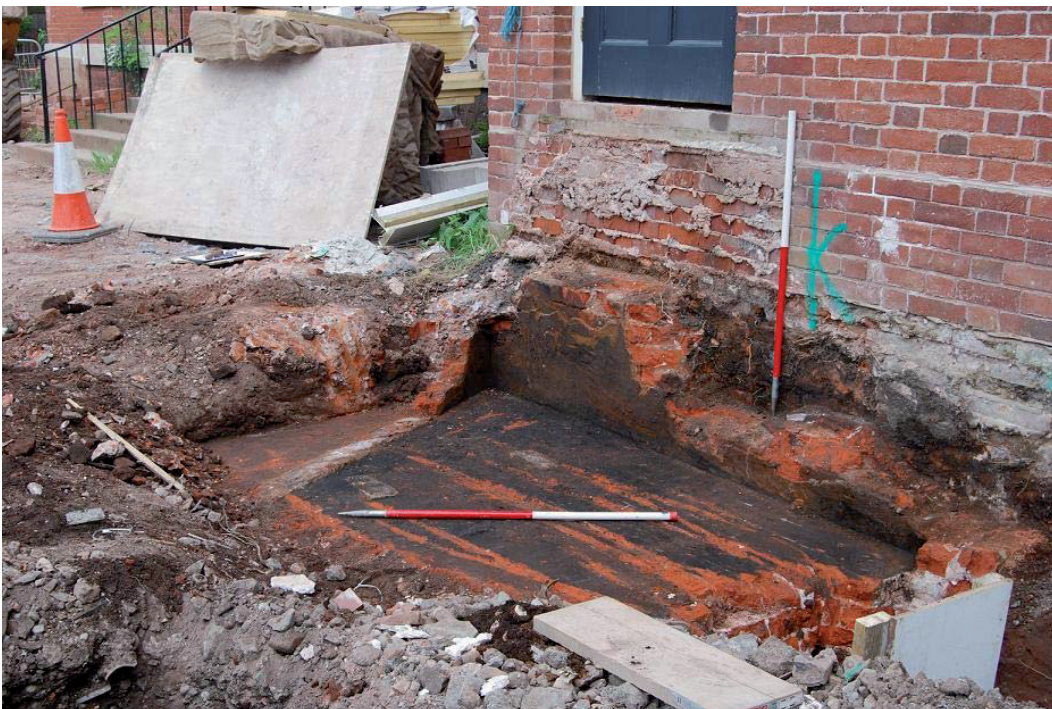
A red brick foundation base, 114, with adjoining walls, one of which had traces of a thick dark orangey brown render, was recorded butting the north corner of the West Range. The bricks were of 19th century date (Plates 13 and 14). It lay directly over the natural matrix, 117 and was sealed by dump deposit, 116. This latter comprised 19th century bricks, brick rubble, soil and modern gravel hardcore.

The red brick structure, 114, butting the north wall of the West Range appears to be the foundation for steps depicted on the 1852 Board of Health map (Vaughan 2007, Fig 5). It is not indicated on any earlier maps, although the only one to show the grounds in great detail is Isaac Taylor's map of 1750-1 (*ibid*, Fig 2). This foundation must then date from the first half of the 19th century and was thus not an original feature of the house. It does not appear to relate to the long narrow staircase shown on the 1st edition OS map of 1886, which appears to be an alteration (*ibid*, Fig 7). This narrow flight is indicated on the edition of 1889 (*ibid*, Fig 8), but not on the map of 1902 (*ibid*, Fig 9), or any subsequent plans, which suggests that it had been removed around the turn of the 19th/20th century. It is distinct from the later 20th century concrete flight in the same location (*ibid*, Plate 28; Fig 4).

Plate 13, Brick foundation, 114, for staircase, north corner of West Range, view southeast

Plate 14, Brick foundation, 114, for staircase, north corner of West Range, view east

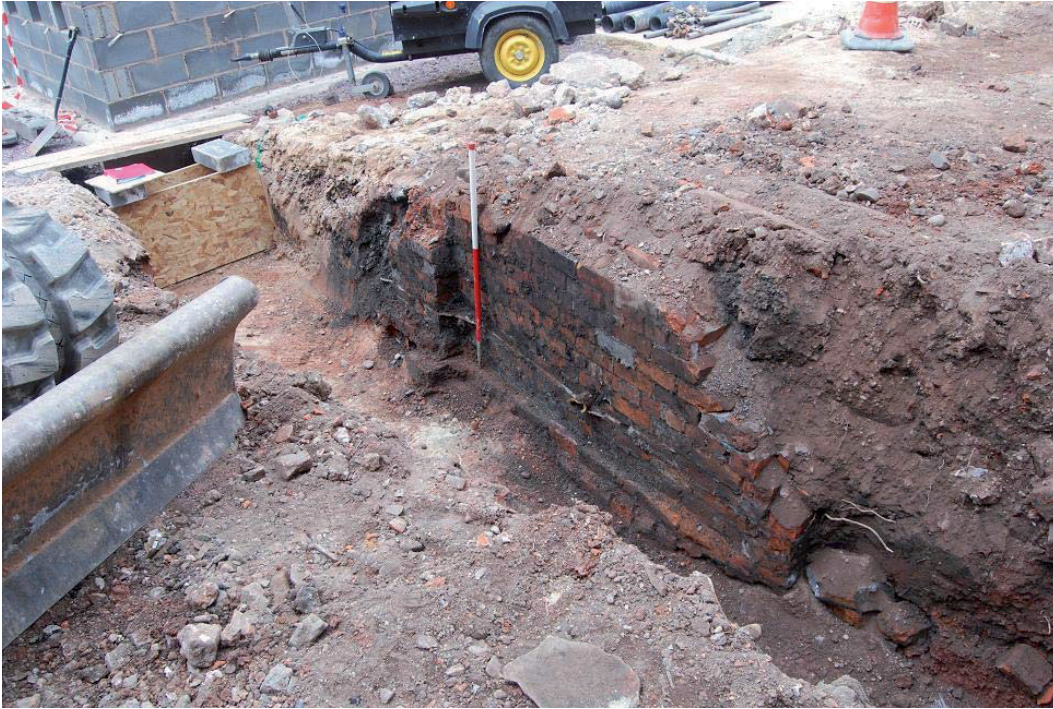
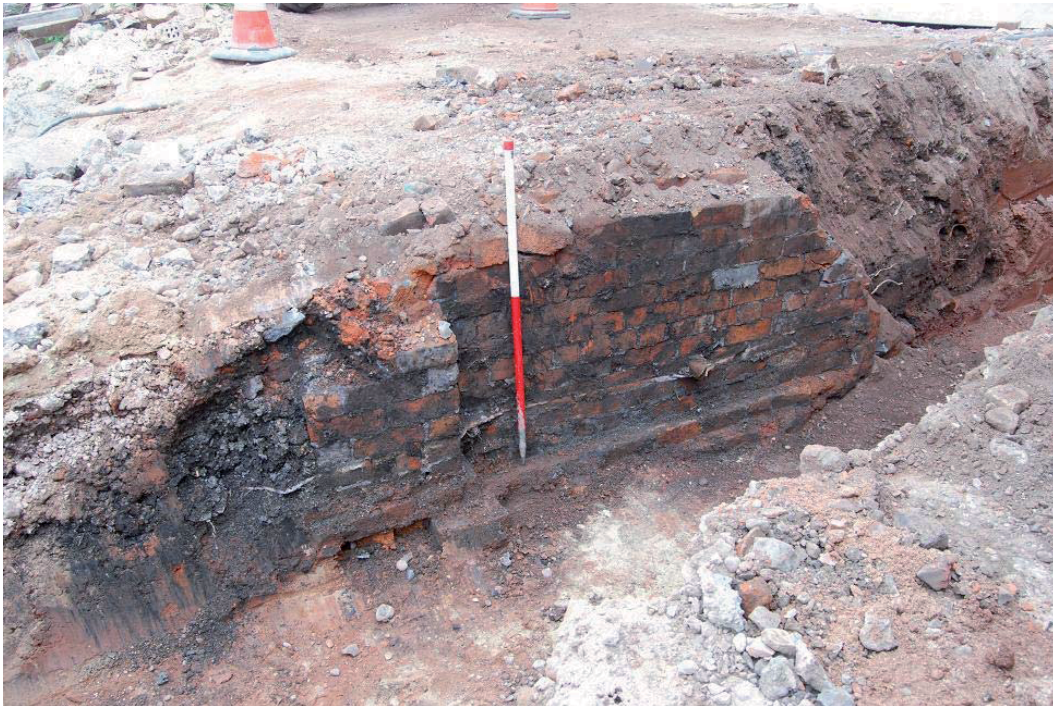
An adjacent wall, 115, aligned northwest to southeast, extended toward the north corner of the West Range (Plate 15 and 16). The relationship with the house and the base, 114, was unclear. The bricks were of later 19th or early 20th century origin, bedded in English Garden Wall Bond. The wall was double-skin. It was also sealed by deposit 116.

Wall 115 also observed off the north corner of the West Range, is that which is first indicated on the OS map of 1919 (*ibid*, Fig 10), when in the first decades of the 20th century the grounds were undergoing alterations associated with the development of the public and sporting facilities. The wall appears to form part of a phase of realignment of the bank and terracing to the immediate north of the Hotel.

Plate 15, Wall, 115, north of West Range, view north

Plate 16, Wall, 115, north of West Range, view east
