ARCHAEOLOGICAL WATCHING
BRIEF AT
MIDDLEPORT PRIMARY CARE
CENTRE SITE,
STOKE-ON-TRENT,
STAFFORDSHIRE

19 June 2009

Project 3324
Report 1696

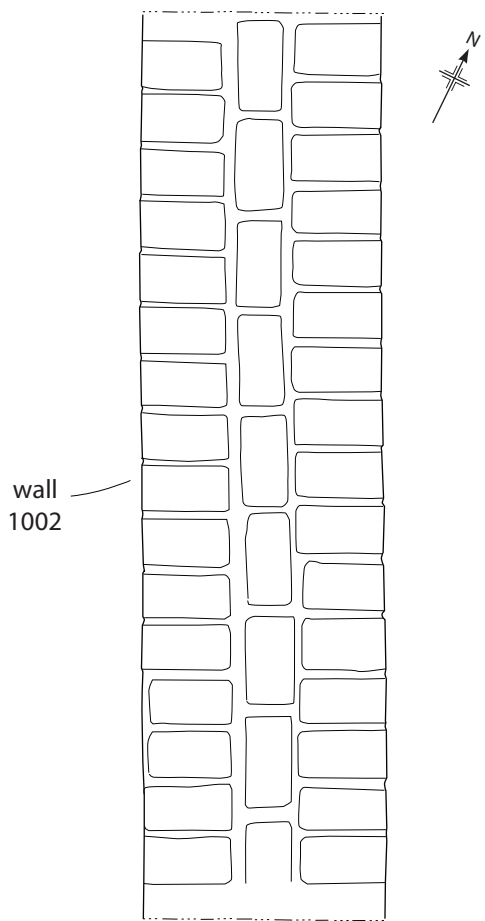
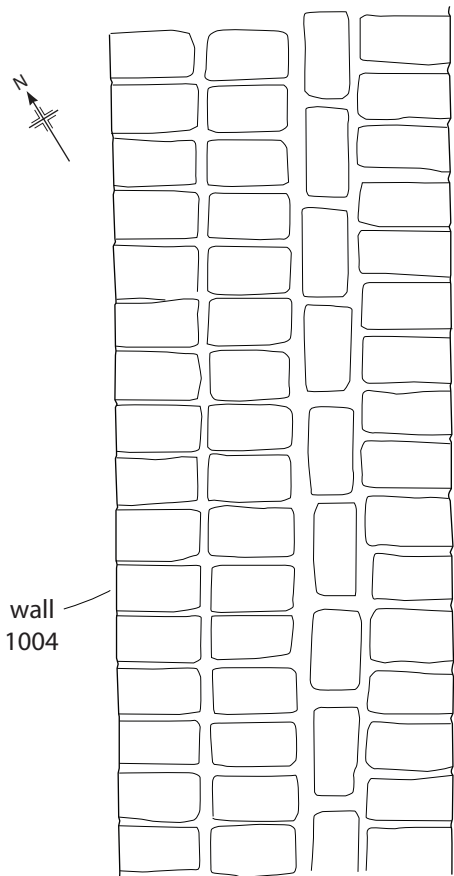
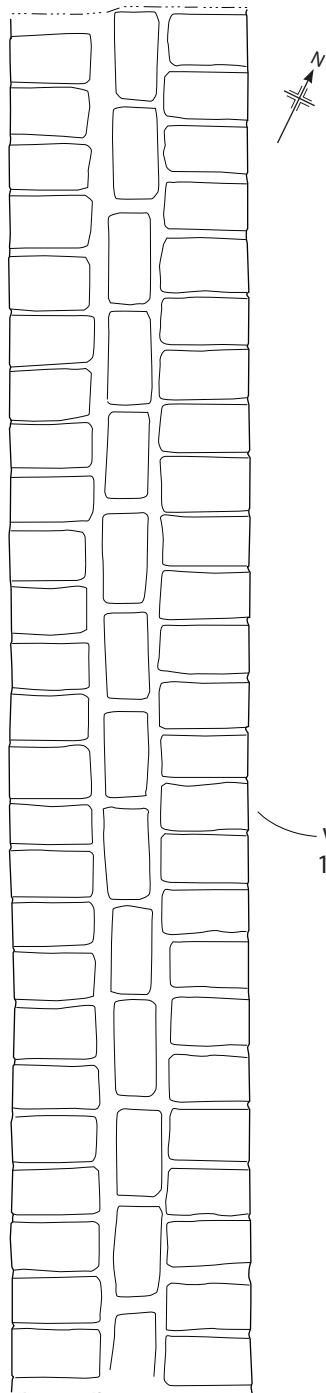
Figure 3

wall 1002

wall 1004

Plan of walls 1002 and 1004

Wall 1002 ran north-west to south-east; it was 16.50m long and two brick courses thick (0.20m) above deposit 1008 with no obvious foundation cut. As only 2 courses of the wall's face remained there is no evidence to suggest the type of bonding used, nor the purpose of the wall.

Wall 1004 was exposed 37m to the north-east of 1002. It was of identical bricks as 1002. The wall was two brick courses thick and 23m long, aligned north-west to south-east, with a right angle to the south-west.

The dimensions of the brick used in structures 1002 and 1004 dates their construction to the late 19th to early 20th century. These walls fit within external footprint of the 1900 building (Fig 6), however it is possible that these walls also relate to the original 1877 building. With only 2 courses of 1002 and 1004 remaining, the depth of the walls being 0.15m below the ground surface, there is no evidence to confirm the wall's load bearing capacity and function from the type of bonding used.

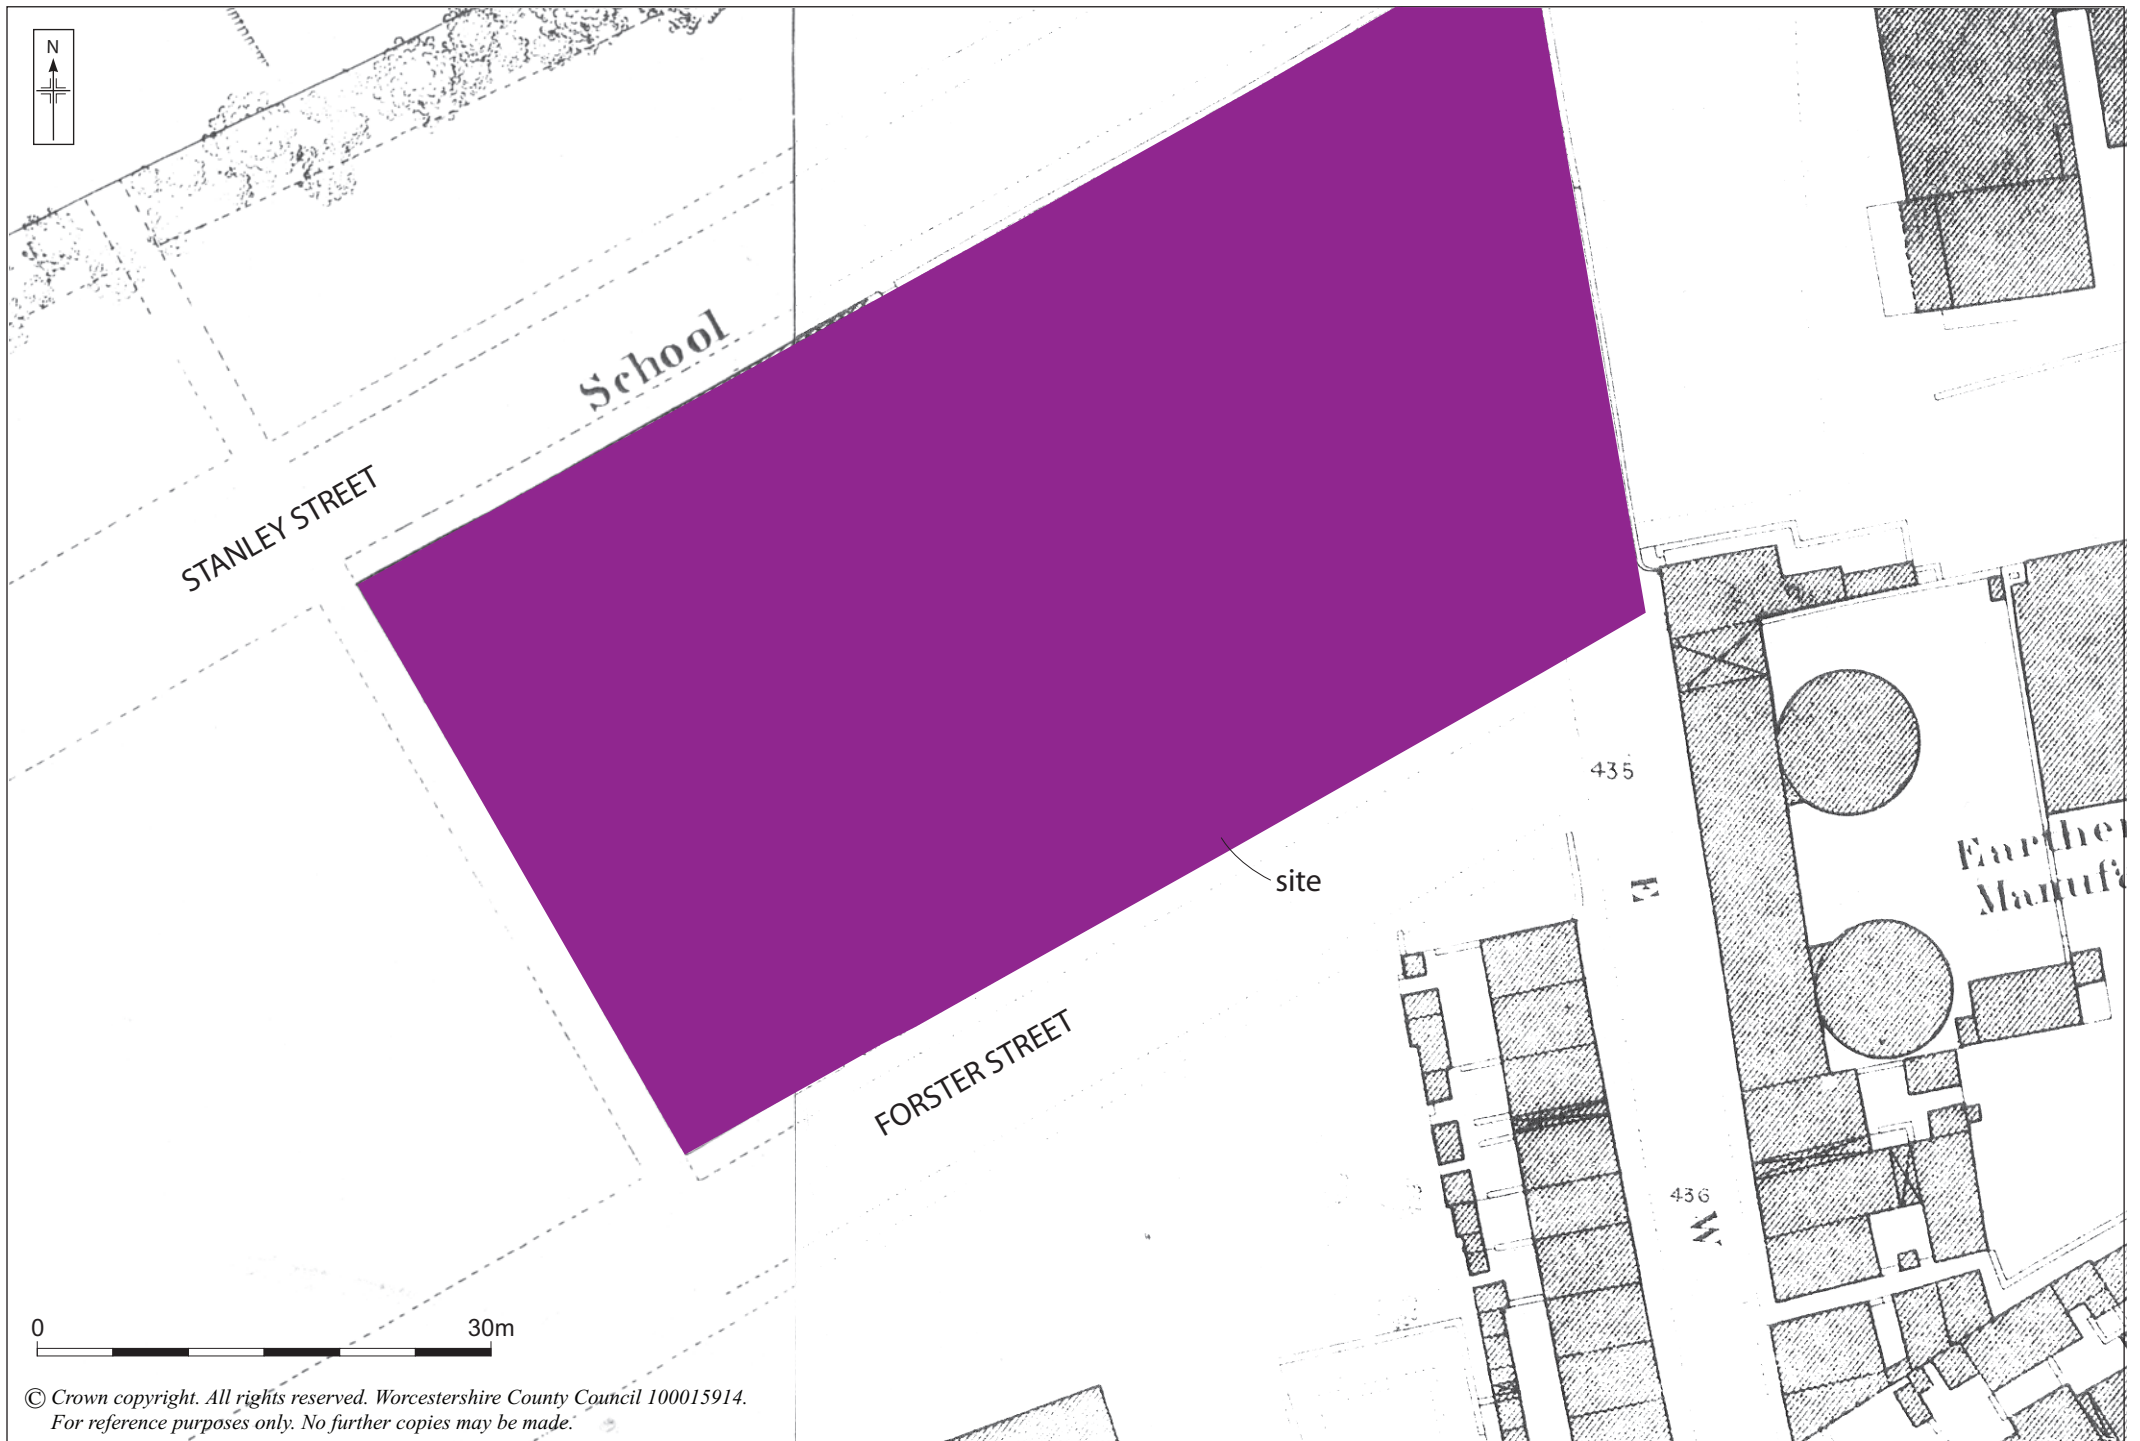
Figure 5

Extract from 1878 OS map of Staffordshire (Northern Division) Sheet Nos XI.12.15 and XII.9.11

The Stoke-on-Trent Ordnance Survey map of 1878 (Fig 5) depicts the site containing two buildings. Middleport County Infants School occupies the west side of the site and the other, along the west frontage of Newport Lane appears to have been under commercial (or industrial) use. The Ordnance Survey map of 1900 (Fig 6) reveals that the original school building had been extended to the south and west. The commercial building that occupied the east side of the site was replaced with terraced housing. The land between the housing and the school appears to have been under grass and was largely unoccupied. Incidentally Woolrich Street was then known as Forester Street, while Morton Street was named Stanley Street. Later Ordnance Survey maps indicate the building layout as unchanged until 1950 when part of the school building to the south-southeast has altered (Fig 7).

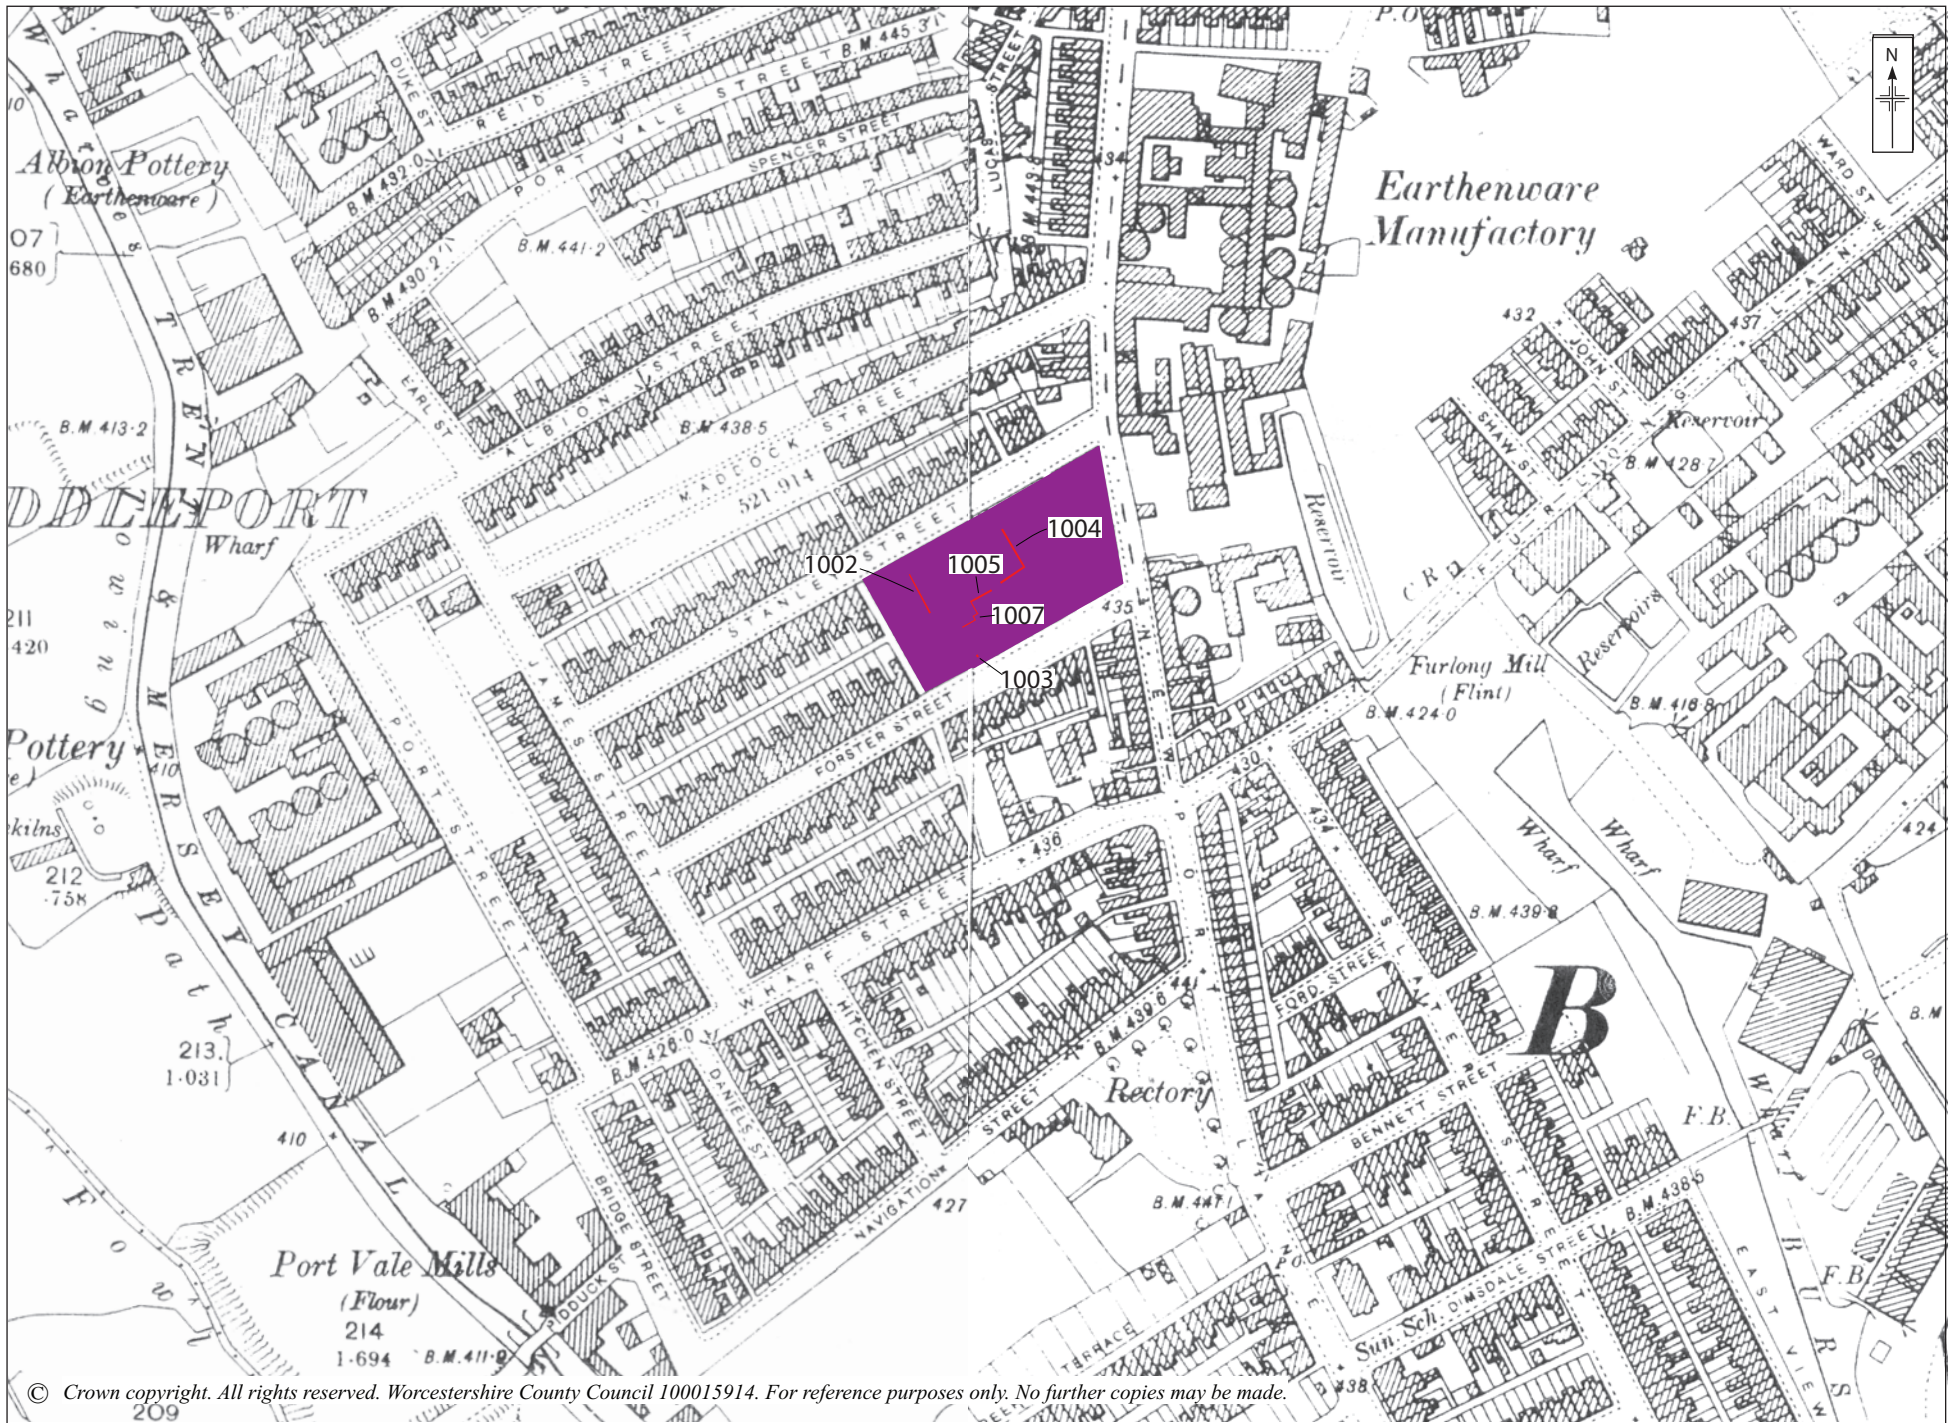
Figure 6

Extract from 1900 OS map, showing approximate location of walls (see Fig 2)

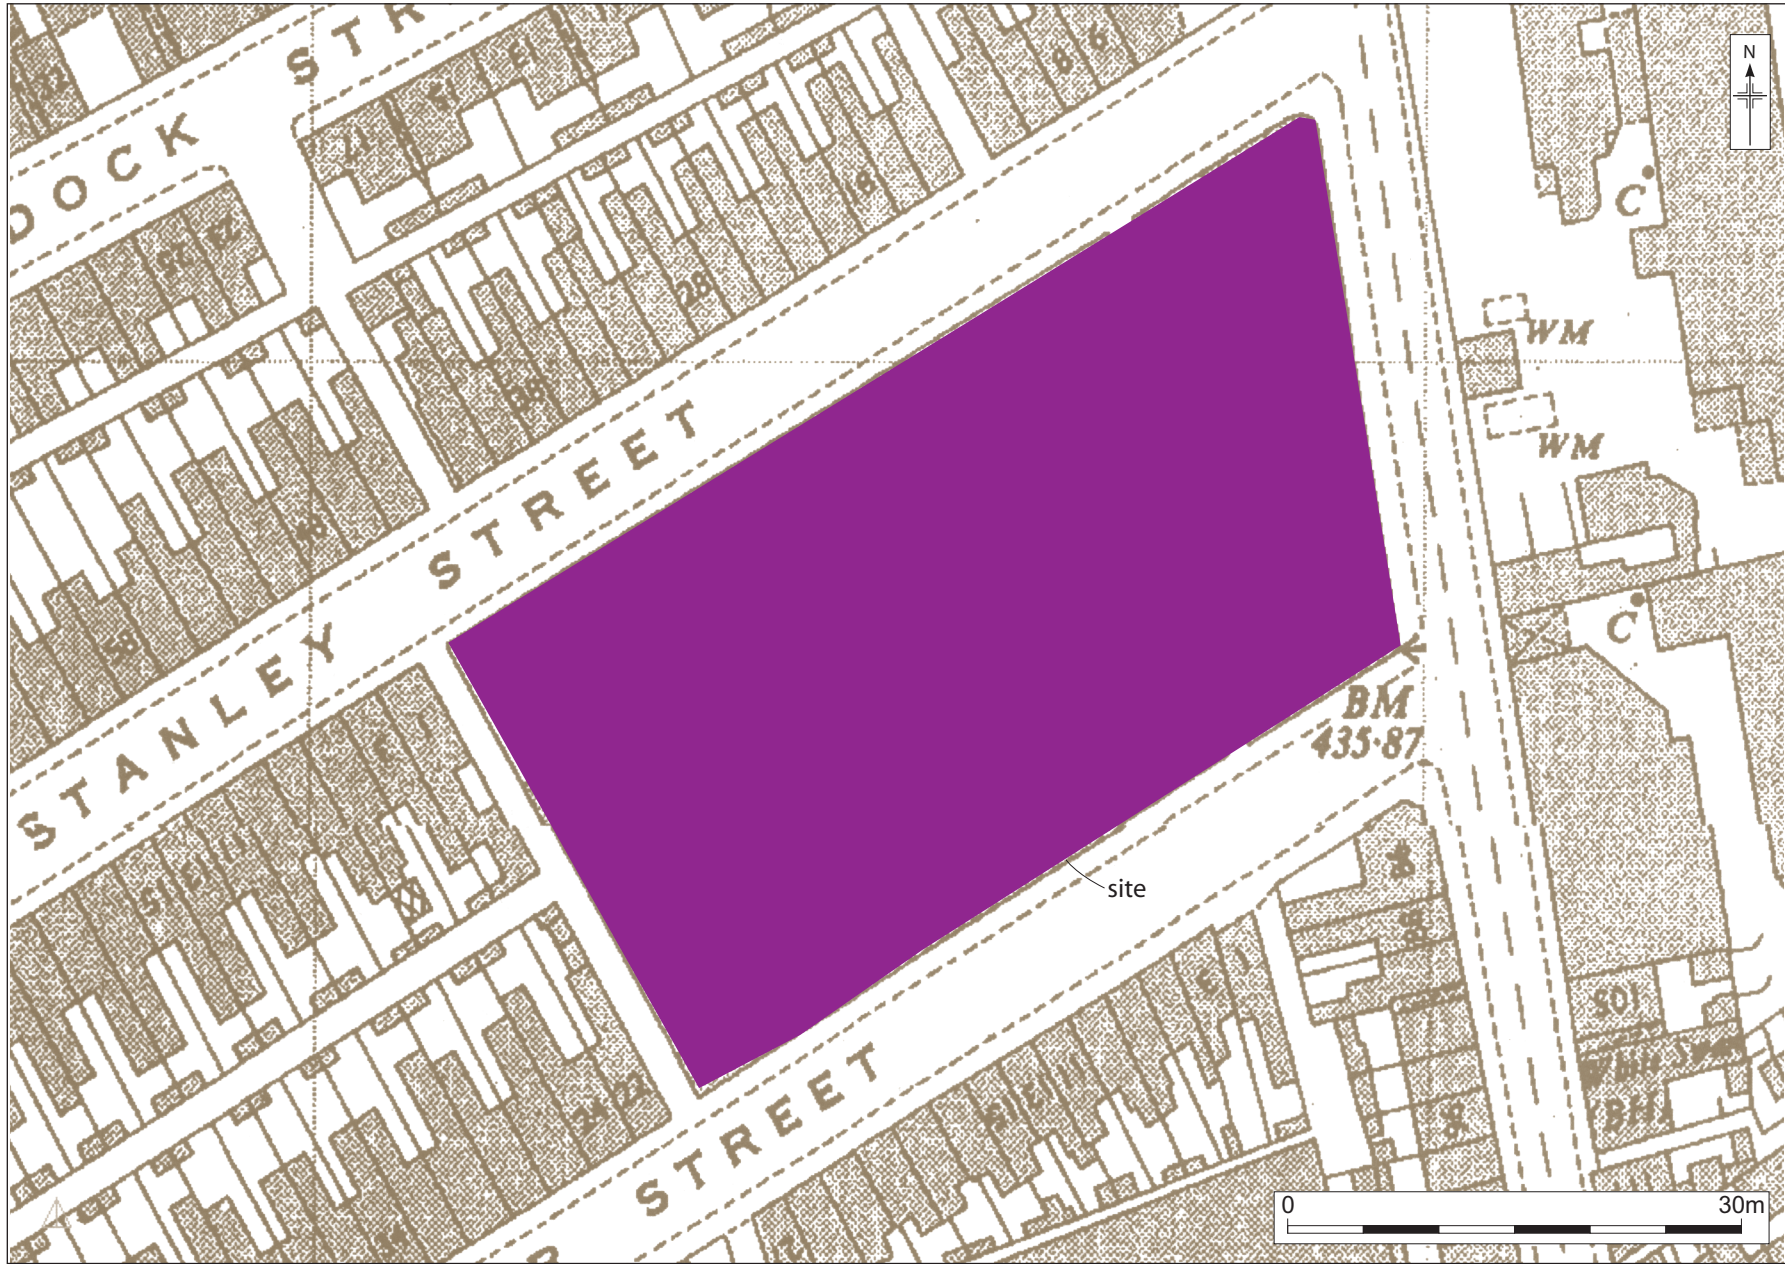
Figure 7

Extract from 1950 OS map

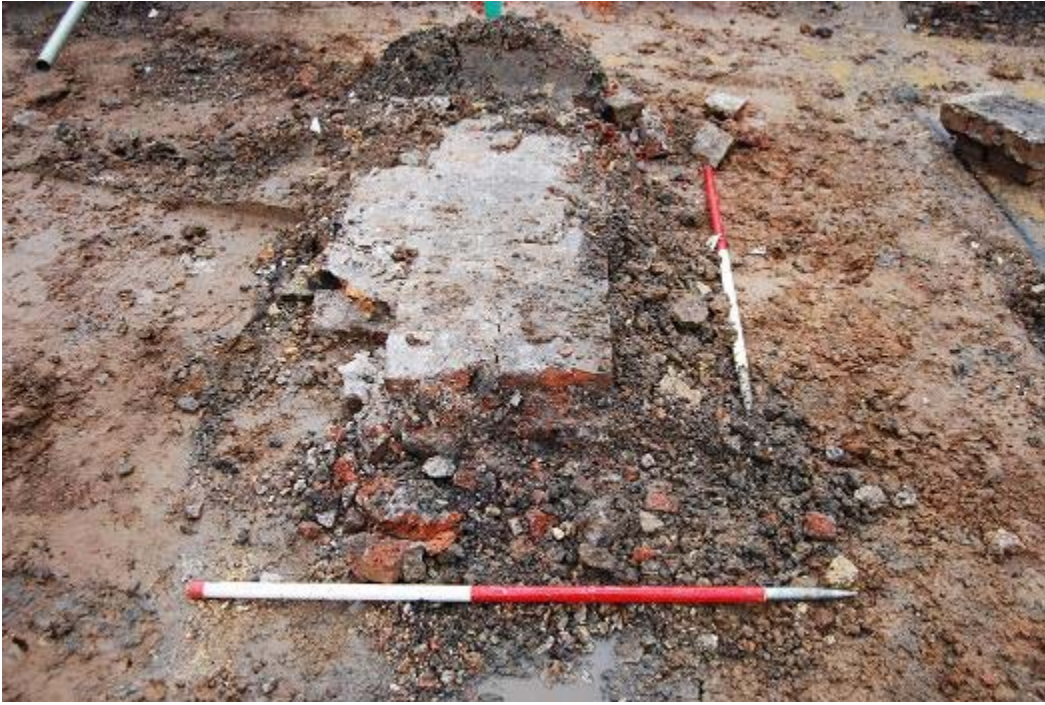
A small remnant of a wall (1003) was exposed in the south-east of the site, 1m long and three courses (0.60m) wide.

Plate 4: Wall 1003, view south-east

The wall 1003 lies outside the footprint of the original 1877 building, but may relate to the external south south-west elevation of the 1900 building. However exact phasing was not possible and it cannot be determined whether it was constructed as part of the extensions of 1877/8 and 1883 or the alterations of 1893 and 1900.

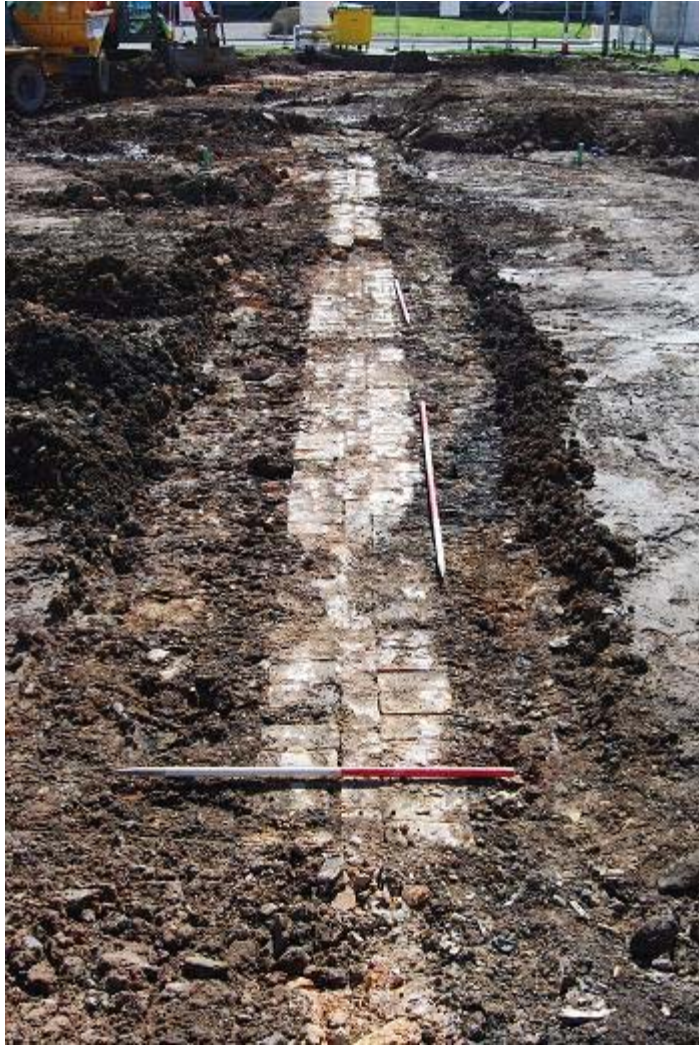
Plate 5: Wall 1002, view south-east

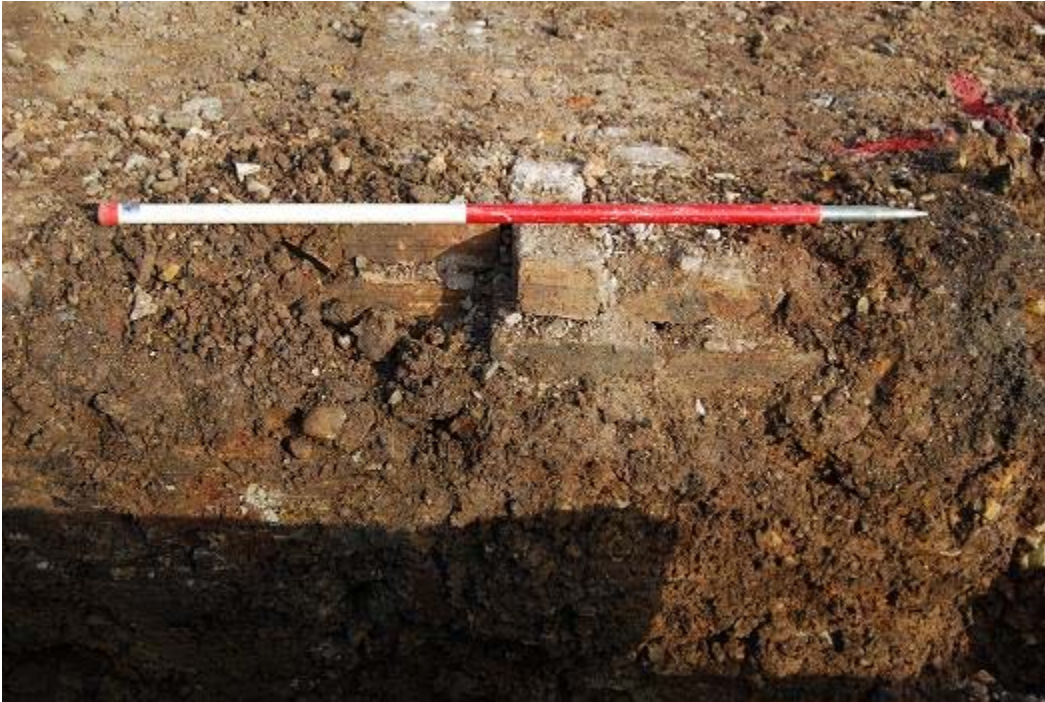
Plate 6: North-west elevation of wall 1002

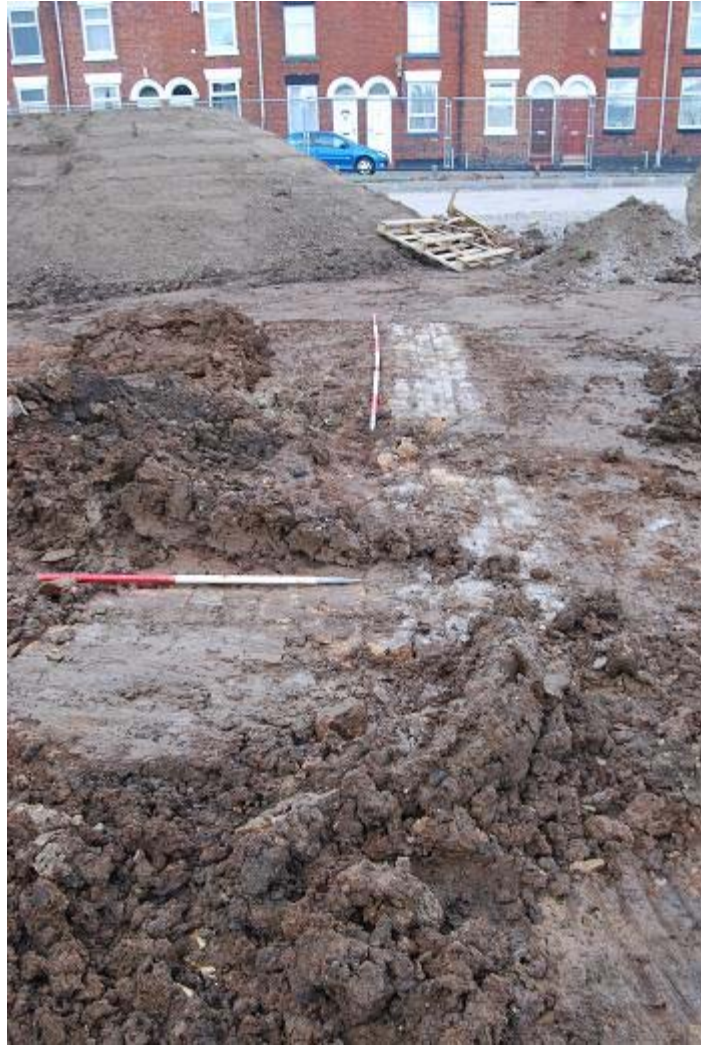
Plate 7: Wall 1004, aligned north-west to south-east, with a right angle to the south-west, view north-west

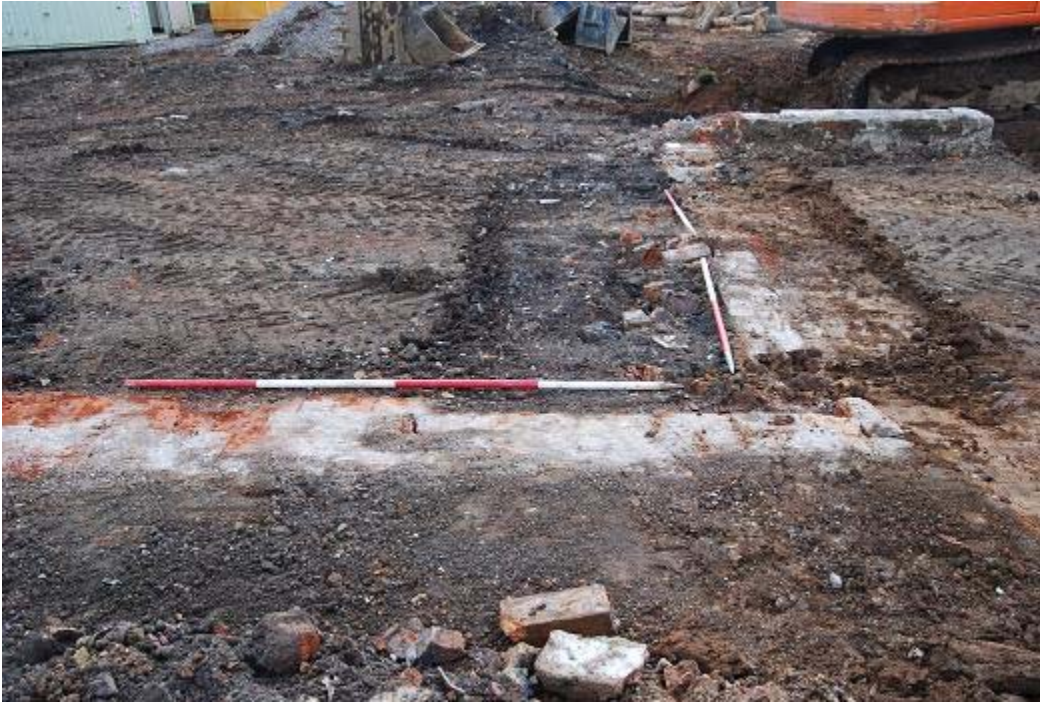
During the reduced level dig wall 1005 was revealed, and unlike the other walls it had not been completely demolished. This structure survived to 0.46m high and was 8.90m long. Abutting this was another structure, 1007. During the excavation of the foundation trenches 1007 was observed to continue below the full depth of excavation at 1.50m. Viewed in the south-west section of the trench the corner elevation of the wall showed the brick coursing was laid in Flemish Stretcher bond, with the bricks measuring 230 × 114 × 75mm

Plate 8: Wall 1007 in foreground and 1005 in right of shot, view north-west

The location of wall 1005 suggests it relates to the external wall of the northern wing of the 1900 building, while structure 1007 relates to the adjacent external wall of the southern wing (Fig 8). This part of the building is also present on the 1878 OS map therefore these walls may date to the first building phase of the school. The substantial depth of 1007 is interpreted to represent a cellar within the school, from its association with walls 1009 and 1010.

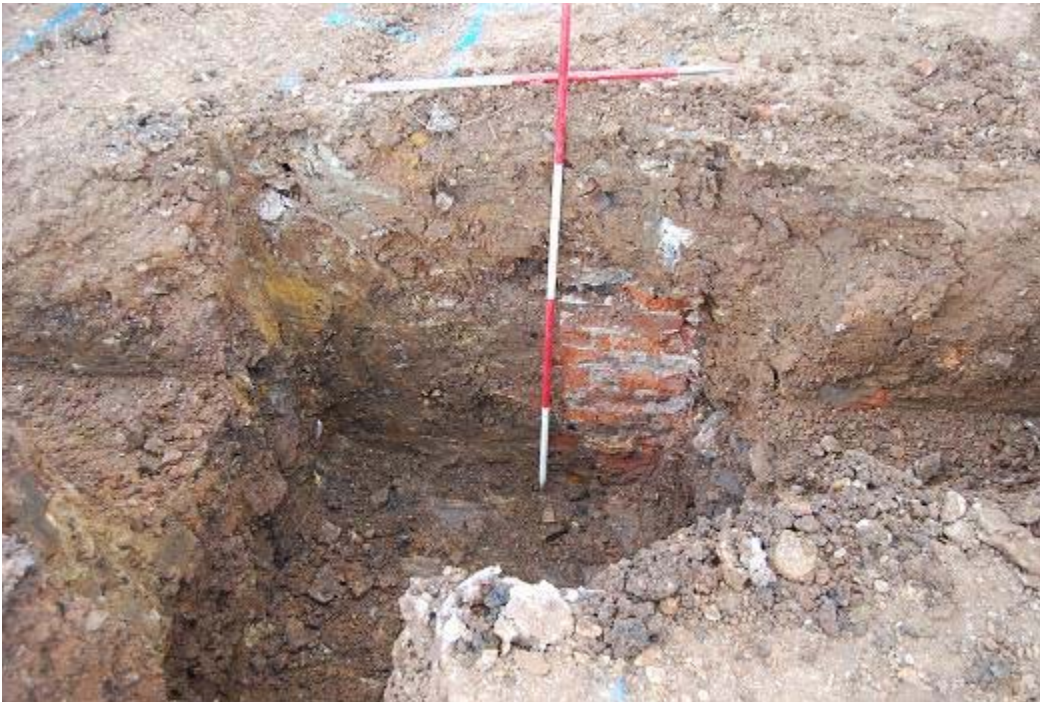
Plate 9: North-east facing section of foundation trench including wall 1007

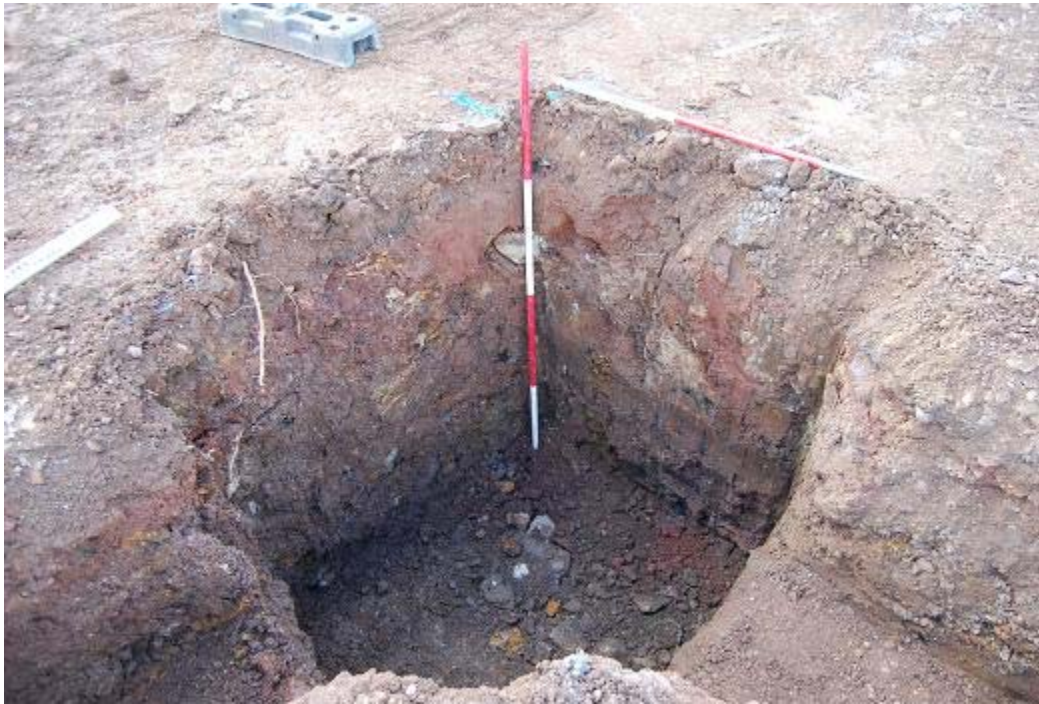
Sealed by 1008 and abutting 1009 and 1010 was deposit 1006, 0.70m below 1008. The deposit contained ash and charcoal with frequent fragments of brick, wood, plastic, iron and concrete fragments.

Plate 10: Trench 25 including deposit 1008 and 1006, view south

Deposit 1006 was observed in the south eastern area of the site, below 1008. The deposit is considered to be the result of the demolition of the school, which was used to backfill the cellar (1005, 1007 and 1009) and raise the ground level. The fire at the school in 2002 may explain the presence of burnt material within this deposit.

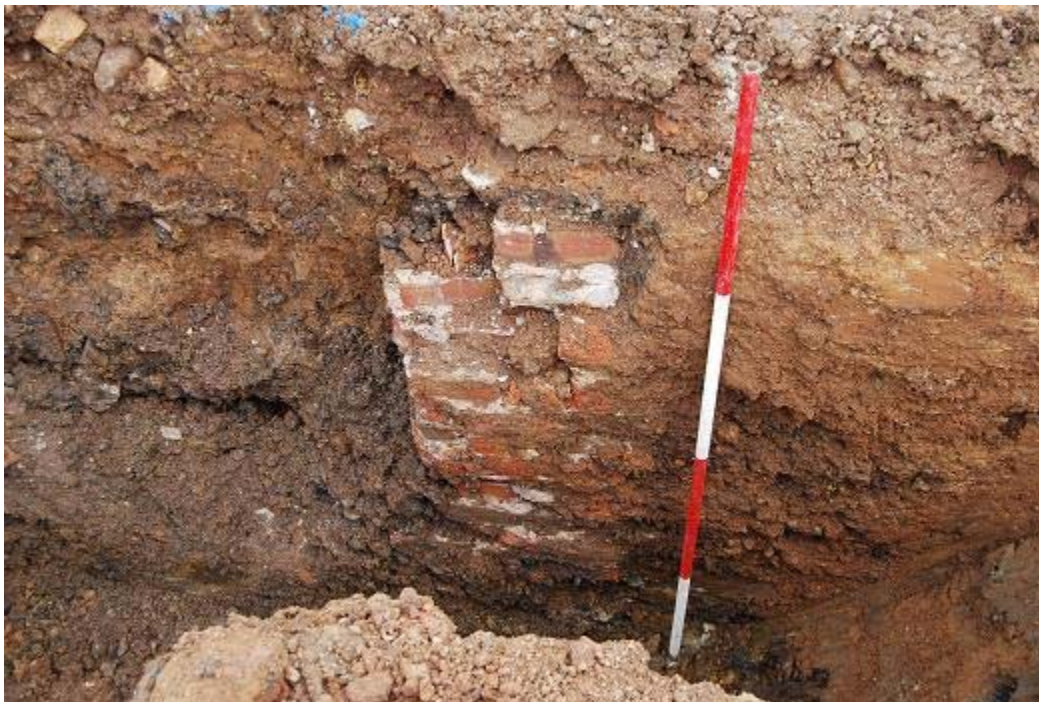
Wall 1009 was exposed 0.23m beneath deposit 1008. The wall was bonded with lime mortar and ran north-east to south-west. No associated foundation cut for the wall was visible. 2m to the north-west a further wall, 1010, was revealed 0.50m beneath deposit 1008. The south-east face of the wall had been painted grey. Both walls extended beyond the width of the trench and continued below the depth of excavation at 1.50m. Due to the limits of excavation a relationship between these structures could not be ascertained.

Plate 11: South-west face of section with wall 1009, deposit 1006 to left

Walls 1009 and 1010 appear to have been constructed from bricks of similar size and fabrics, suggesting they are broadly contemporary, however from the limited proportions uncovered it was not possible to establish their exact relationship to each other. The substantial depth of these walls below ground suggests they are likely to relate to a cellar within the school. They lie outside the building present on the 1878 OS map, but inside that denoted on the 1900 OS map. 1009 and 1010 appears to be present by 1900, although there is no evidence to establish whether a cellar was constructed as part of the extensions of 1877/8 and 1883 or the alterations of 1893 and 1900.

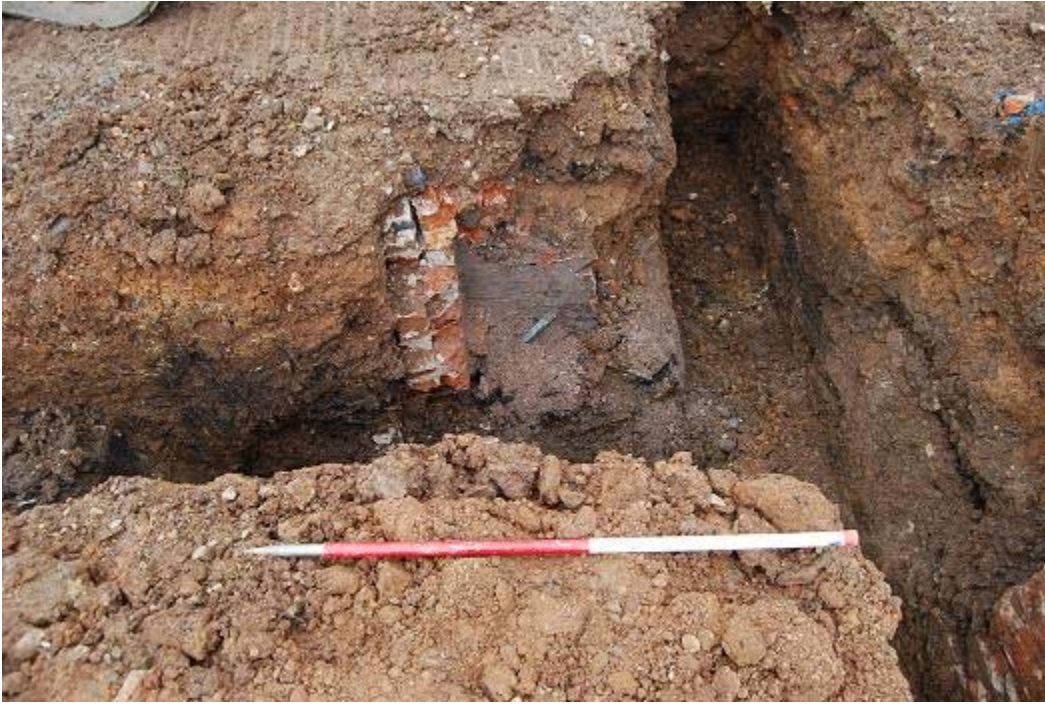
Plate 12: Wall 1010, view north-west
