ARCHAEOLOGICAL  
WATCHING BRIEF AT  
DODDERHILL SCHOOL,  
DROITWICH SPA,  
WORCESTERSHIRE

Project 3124  
Report 1566  
WSM 37555

## Archaeological watching brief at Dodderhill School, Droitwich Spa, Worcestershire

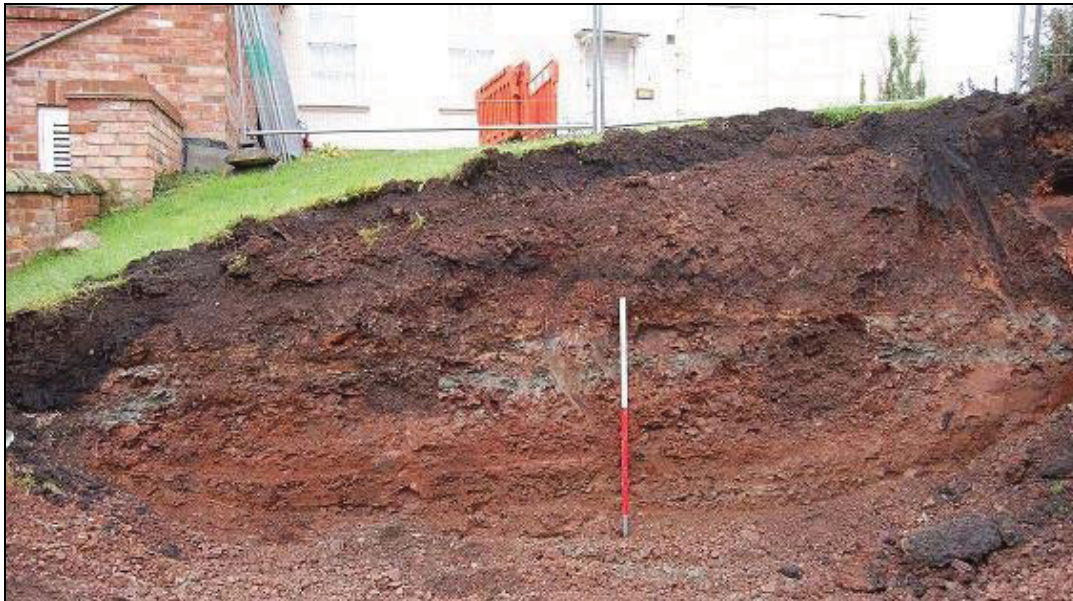
*Plate 1: North-east facing section through bank material*

The excavation showed the bank to consist of a series of post-medieval make-up layers (101, 102, 103, 104, 114; Fig 5; Plate 1). The made ground lay directly above heavily truncated natural Mercian mudstone. Mercian mudstone generally consists of an upper, weathered portion, which is cohesive and malleable, and a lower, un-weathered portion with a 'blocky' structure and a friable nature. No evidence of the upper portion was observed during the watching brief, indicating truncation down to the un-weathered parent material. Further, the sharp interface between the natural geology and the make-up layers above it suggests rapid deposition of material after the ground surface had been reduced. This landscaping was probably associated with the construction buildings during the 18<sup>th</sup> and 19<sup>th</sup> centuries. Earlier archaeological work to the west and south of the present trench also revealed widespread horizontal truncation of the natural geology (Edwards 1991, 4; Stone 1998; Dawkes 1999a; Dawkes 1999b).

Despite the truncation of the natural geology, two features were observed cutting into the Mercian mudstone, both in the western half of the trench and both also heavily truncated. First, a pit containing tile fragments only datable to a broad period (13<sup>th</sup>-18<sup>th</sup> century; pit 108) and, second, a possible, undated, linear feature running approximately north to south (106=115?). Both are possibly indicative of activity on the site prior to the 18<sup>th</sup> century but, in the absence of more precise dating, this cannot be stated with certainty (Fig 5; Plates 1 to 3).

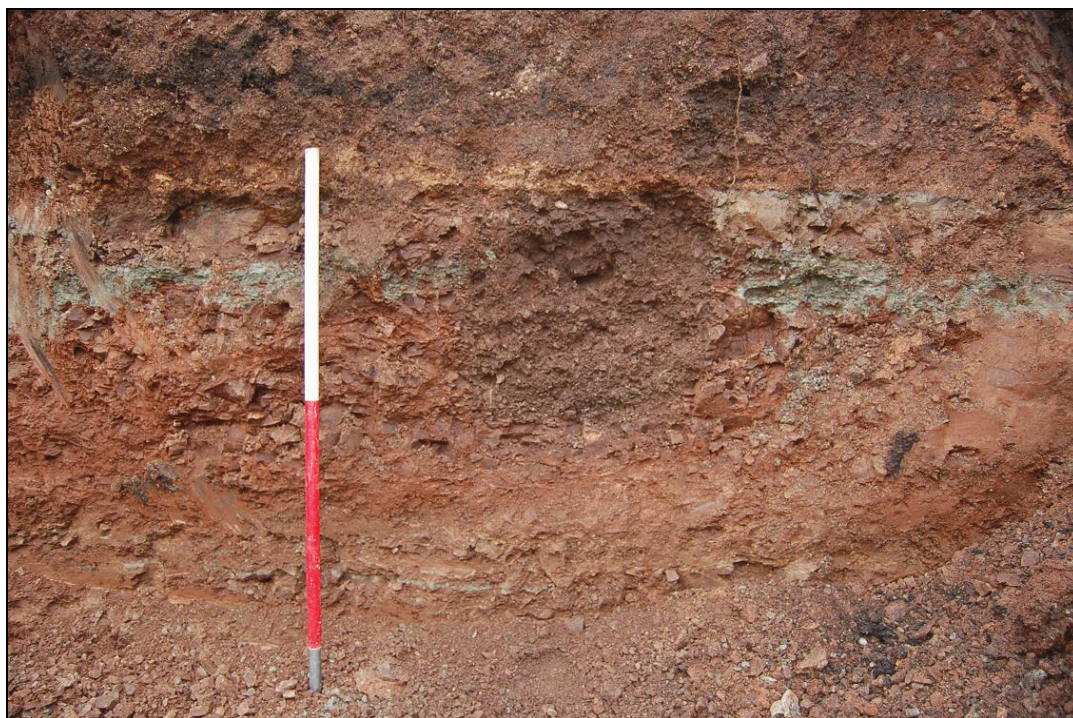
*Plate 3: Cut feature 108*

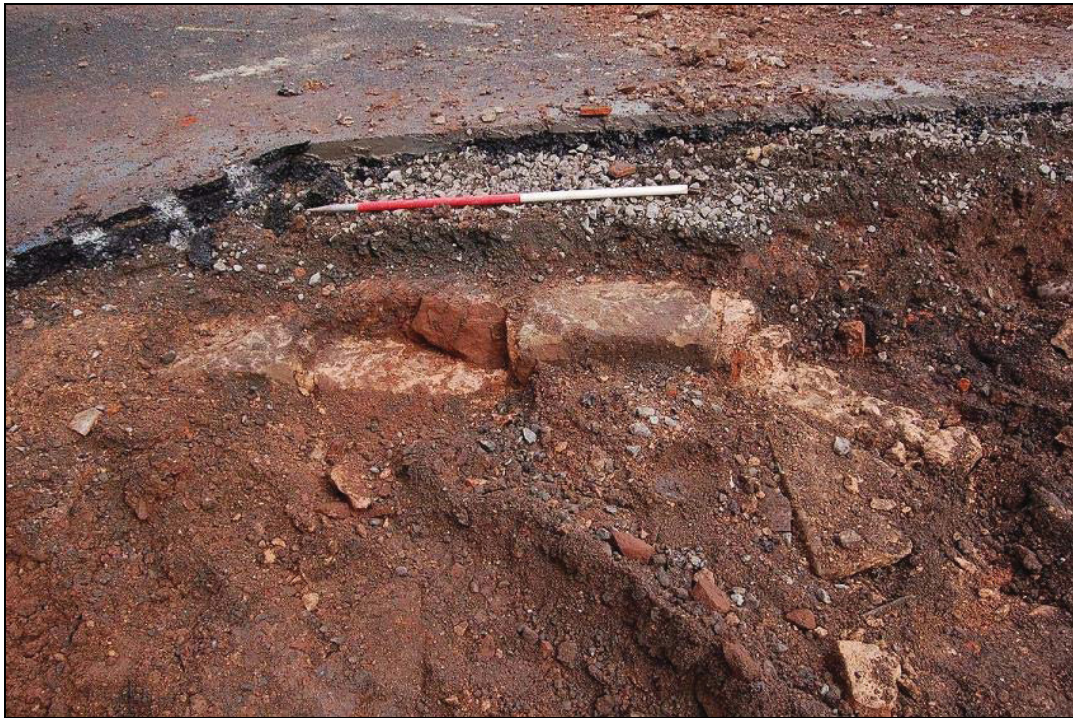
*Plate 4: Sandstone wall 125/126*

The eastern portion of the trench revealed the remains of three brick- and stone-built structures, all of post-medieval date and all sealed by tarmac (119), hardcore (120) and made ground (121; Fig 4). First, a circular brick-built feature with evidence of a hard, concreted lining in places (as if it had been intended to retain water; structure 111). This was initially interpreted as a well but proved not to have any great depth. The bricks from which it was constructed are of 19<sup>th</sup> century date (pers comm Angus Crawford) and it is probably best interpreted as a drainage feature of some sort, possibly associated with the coach house, or a garden feature. Second, a short stretch of sandstone wall located immediately south of the coach house, to which had been added a curved, much truncated brick wall (structures 125 and 126; Plate 4). Both walls were bonded with the same mortar and were probably contemporary. The bricks are broadly datable to the late 17<sup>th</sup> and 18<sup>th</sup> century, more probably the latter (pers comm Angus Crawford). The sandstone wall was in alignment with the eastern wall of the existing coach house and this structure may therefore represent an extension to the coach house, which has been demolished (the coach house is a brick-built building resting on sandstone foundations). Indeed, the 1<sup>st</sup> edition Ordnance Survey map (1885) shows subsidiary buildings in exactly this location (Fig 3). Third, a heavily truncated section of brick and sandstone wall located on the southern edge of the trench (structure 117; Plate 5). This structure was crudely built and contained an ashy, charcoal rich deposit containing pottery of 18<sup>th</sup> to 20<sup>th</sup> century date. Its function is unclear.

The remains of structures 125/126 and 117 give some indication of earlier buildings on the site but both were significantly truncated: any other structural remains in the area are likely to be fragmentary. The survival of masonry probably derived from the church is instructive, both for what it tells us about the re-use of material and the light it may shed on the history and development of the church.

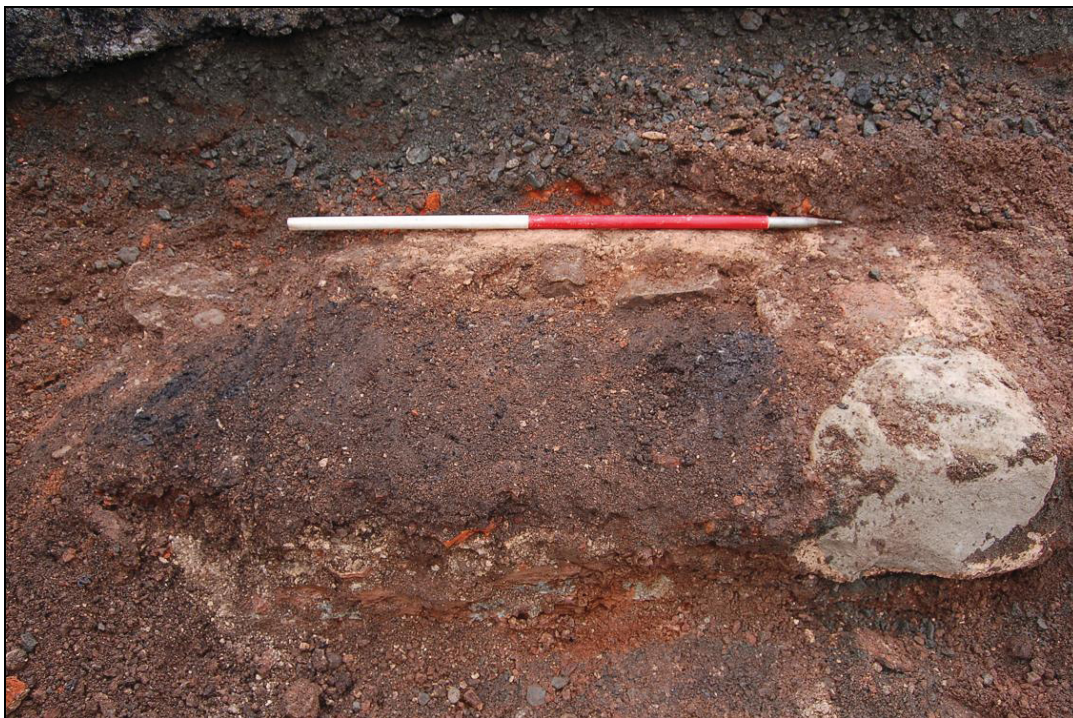
*Plate 5: Sandstone structure 117*

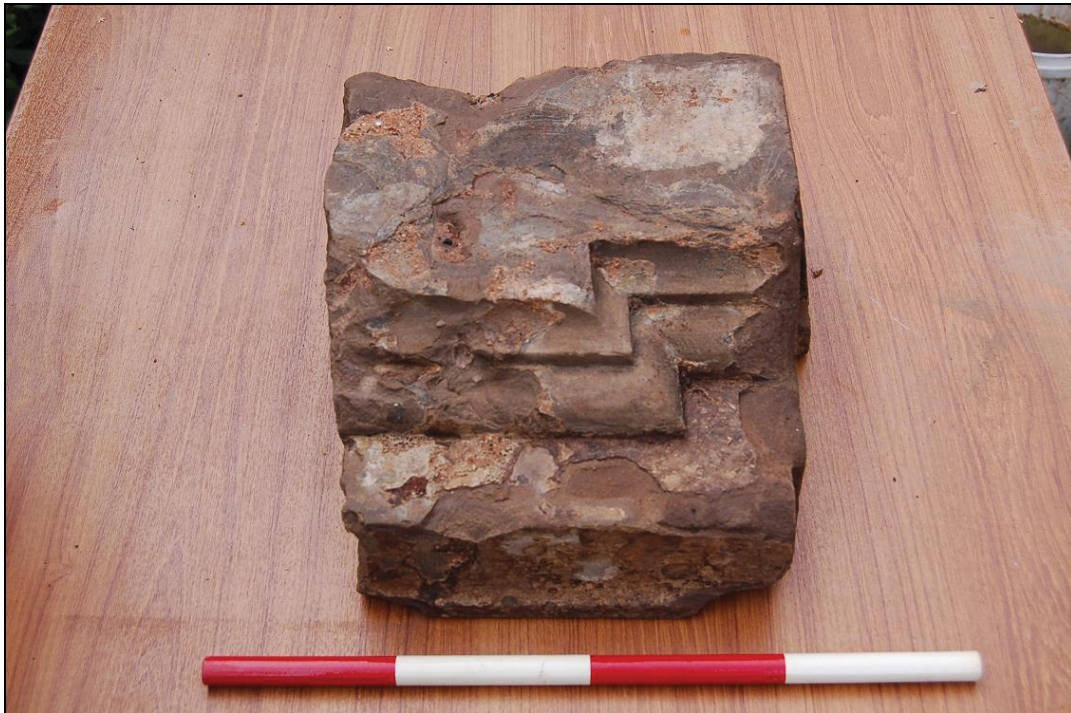
*Plate 6: Fragment of 17<sup>th</sup> century monument base*

Within the post-medieval make-up layer 121 several fragments of moulded, green sandstone were recovered, some showing evidence of re-use in a secondary context (a pinkish mortar is found on some surfaces that would not originally have been bonded). These included two fragments of masonry, possibly of medieval date, designed to divert water away from the walls of a building ('drip stones') and two fragments that may have been part of the base of a 17<sup>th</sup> century church monument (pers comm Chris Guy, Worcester Cathedral Archaeologist; Plates 6 and 7). Several parts of St Augustine's church are known to have been demolished during its long history and the church is the most likely source for these items. Notably, the tower was demolished during the Civil War after being heavily damaged; it is likely that other monuments were damaged and removed at the same time.

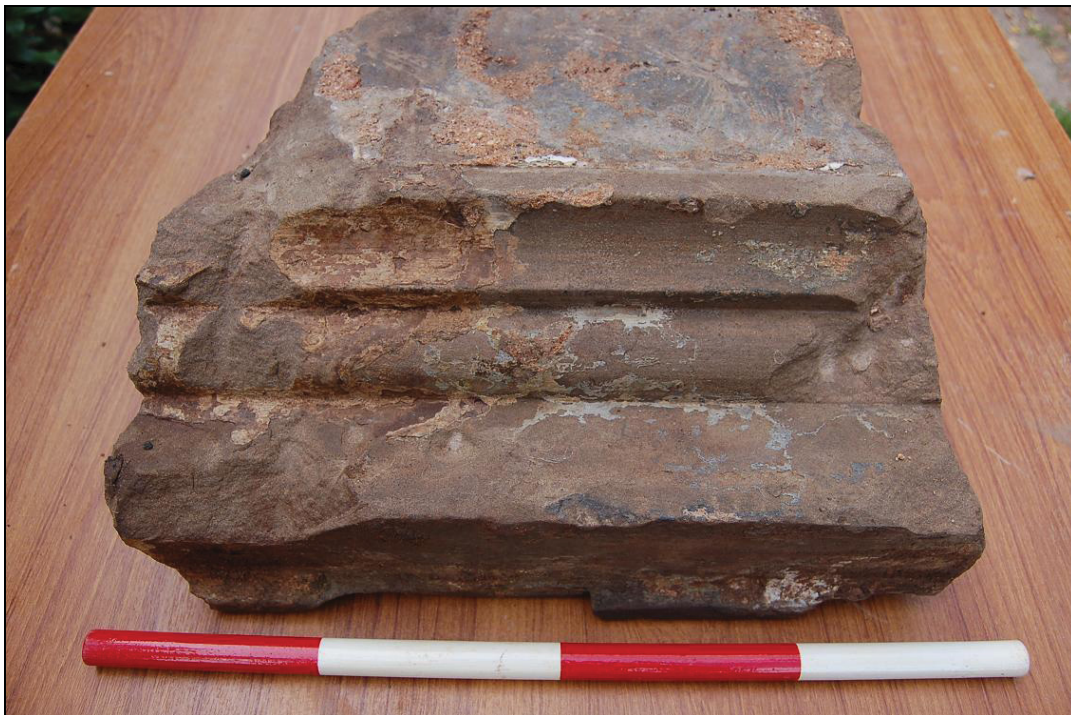
*Plate 7: Fragment of 17<sup>th</sup> century monument base*
