ARCHAEOLOGICAL
MONITORING AND RECORDING
AT
ST HELEN'S SCHOOL HOUSE,
FISH STREET,
WORCESTER

Project 3038
Report 1528
WCM 101510

Archaeological monitoring and recording at St Helen's School House, Fish Street, Worcester

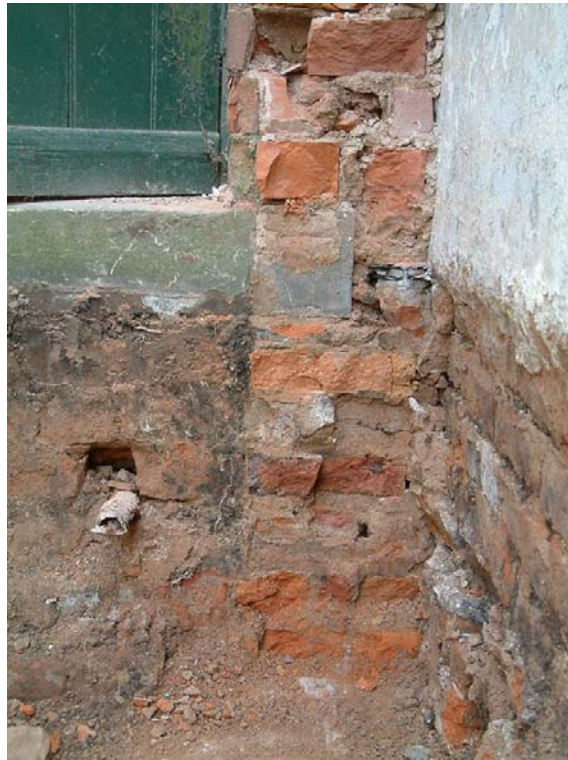
Plate 5, Area 2: Brick wall, 107, along west boundary below former School House lean-to, view south

2½” bricks, 107, dating to c 1650-1784 (pers comm Angus Crawford) were identified within the foundations for the west wall of School House, alongside the existing west boundary wall (Area 2; Plate 5).

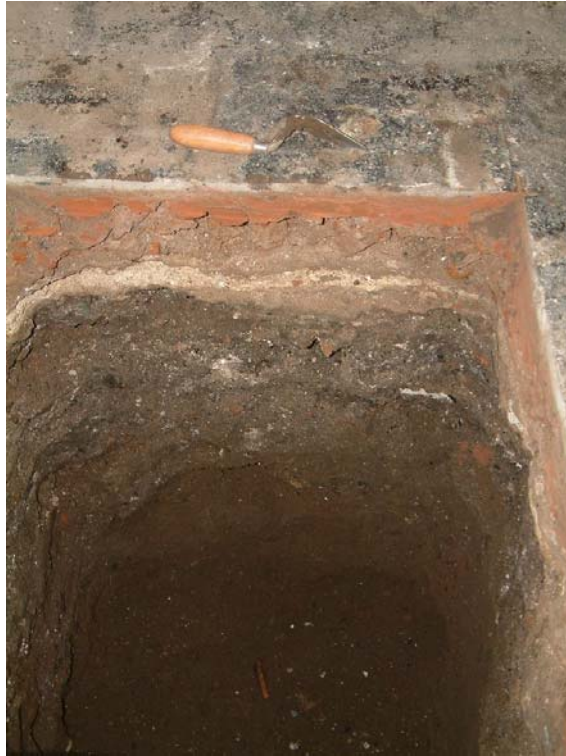
Plate 7, Area 3: north section, view north

A possible disturbed subsoil, 310, was recorded within the existing School House building at a depth of 0.66m (Pit 3; Plate 7). It comprised a dark brown silty sand, with occasional mortar flecks. It was not part of a soil sequence, but was overlain by a post-medieval dump deposit 309.

The subsoil 310, at a depth of 0.66m+ below the School House (Pit 3; Plate 7) contained medieval pottery and tile fragments, although an 18th century brick was also recovered. It lay below a dump deposit, 309, containing 16th-19th/20th century material, and was cut by a 19th century posthole, 311.

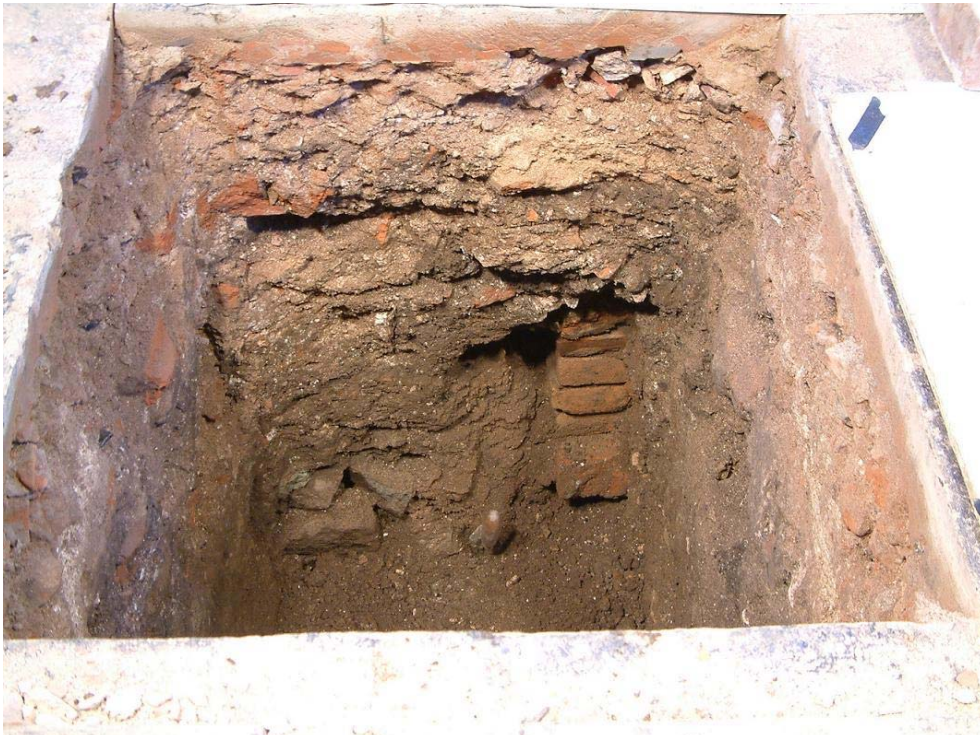
Plate 8, Area 4: brick wall, 408, in north section, view north

Layer 406, from 0.68m+ below the School House floor (Pit 4; Plate 8) may equate with subsoil 310 as described above, although it contained material of late 15th-18th century date. A number of rough-hewn stone blocks and fragments, 407, were recorded at a depth of >0.75m + within this layer, along with a carved mullion fragment (Area 4). This was considered to be a loose dump of stone rather than a structural feature.

A brick structure, 408, with an associated void, 409 (Pit 4; Plate 8), was observed within the existing School House building adjacent to the stone 407. It comprised at least seven courses of un-frogged handmade bricks (c 1650-1784) laid without mortar, at a depth of c 0.50-0.90m below the existing surface, cut into a mixed clayey sand deposit, 406, of late 15th-18th century date.

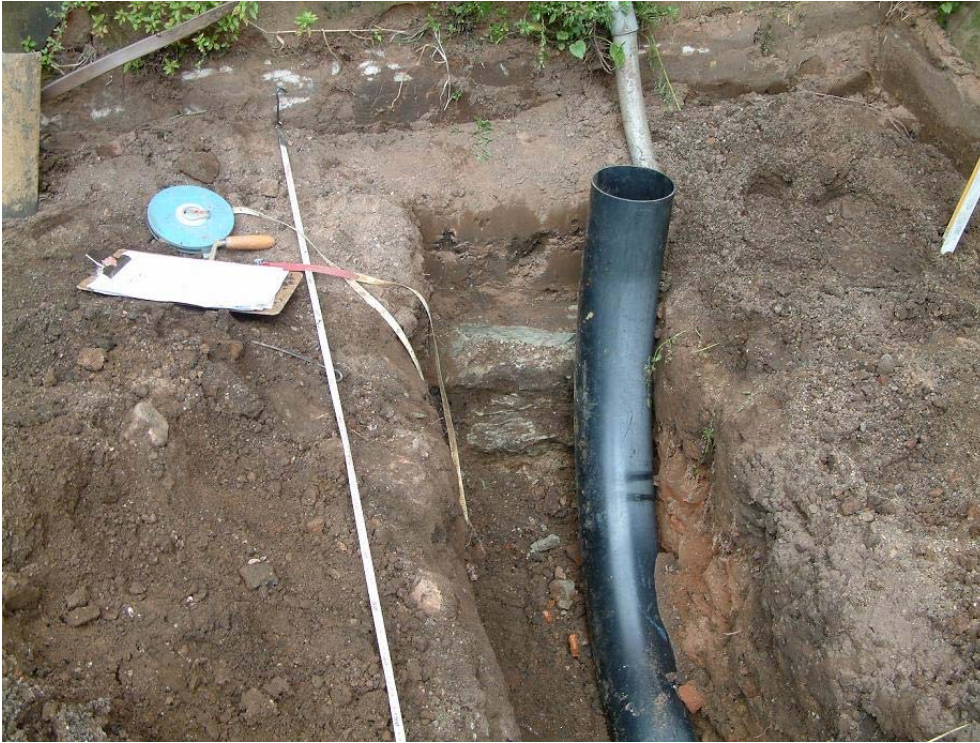
Plate 13, Area 7: sandstone foundation, 702, for south wall of church west tower, view north

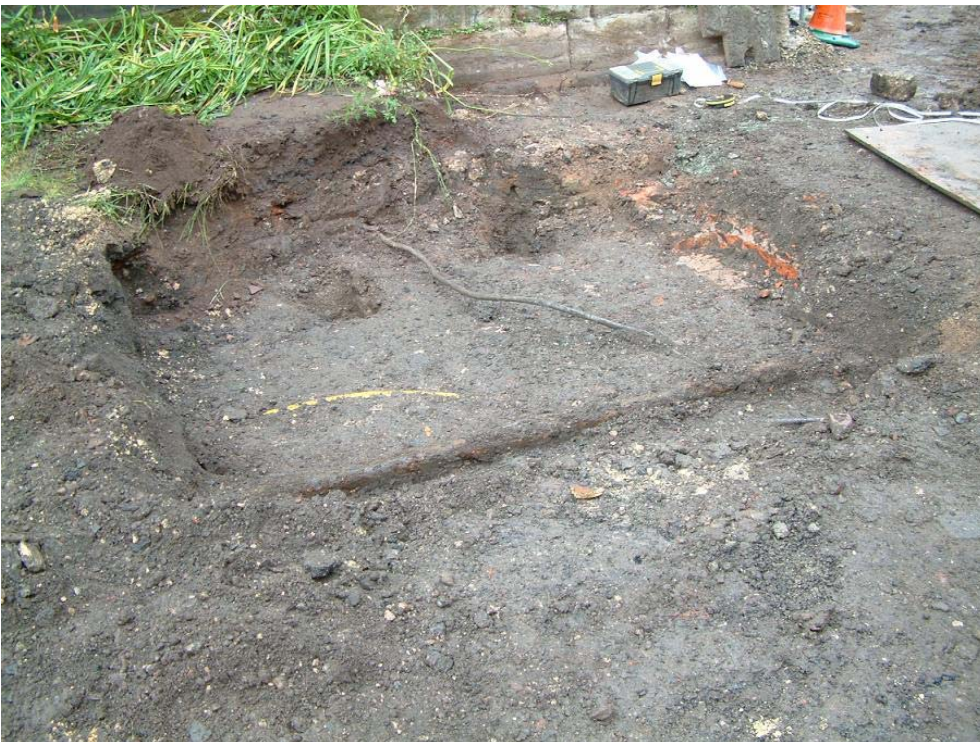
Plate 16, Area 8: general view over north brick vault, 806; brick wall 805 to south, view south-east

Two adjacent brick burial vaults, 806 and 900, were observed, butting the west wall of St Helen’s church tower (Areas 8 and 9). Neither was fully excavated or investigated. Both had shallow vaulted brick roofs, springing from brick walls, aligned east-west. To the north, 806, was a single occupancy structure, with rough mortared access in the west end. It contained a quantity of soil, which appeared to have fallen in following damage to the south side of the vault (Plates 15-18). To the south, 900, was double width. It had been previously cut through and entirely filled with gravel during excavation for a service pipe in the last decades of the 20th century. This latter may be the same vault as that exposed in 1987 (WCM 10083). It appears to have been disturbed during excavation of a service trench across the former churchyard to a brick boiler house to the rear of the church. No coffin remains or human bone was identified associated with either vault (Plates 19-20).

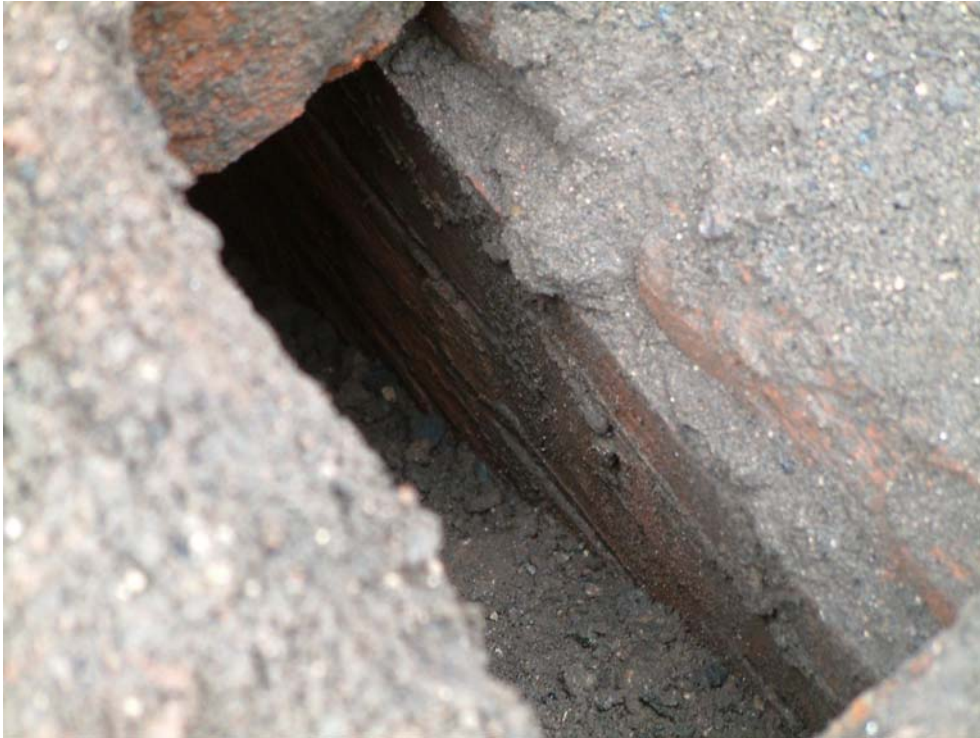
Plate 17, Area 8: south wall of north brick vault, 806, as broken through, view south-east

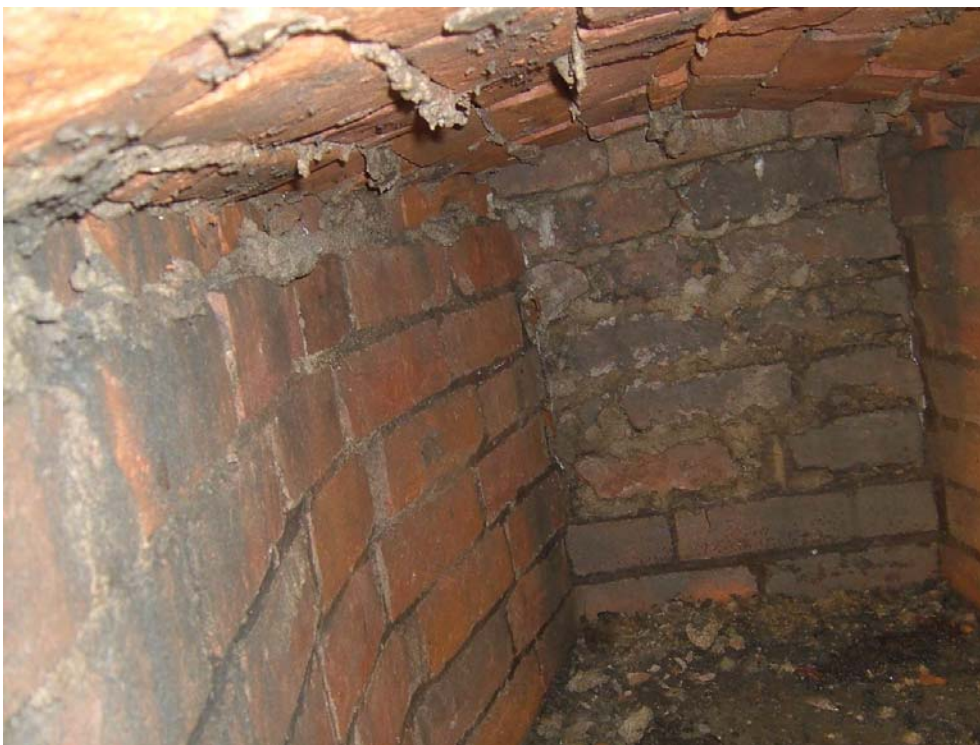
Plate 18, Area 8: brick vault, 806, interior, west end with rough mortared access

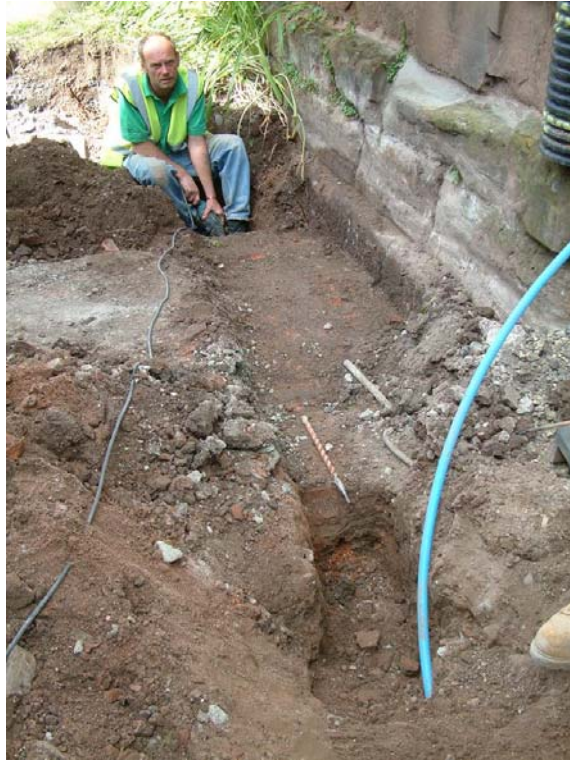
Plate 19, Area 9: south brick vault, 900, as exposed, view north

The upper foundations for the church were recorded toward the corner of the nave and tower (Area 7). Below the west wall of the nave this comprised a course of red sandstone, 703, stepped out some 0.85m from main wall at a depth of 0.30m. Below the south wall of the west tower it comprised three courses of green and yellow sandstone blocks, 702, stepped out 0.50m from the main wall, 0.30-0.65m below the present surface, over a thin band of silty sand, 706 (Area 7; Plate 13). The foundations on the west side of the tower stepped out twice, 0.15m and 0.09m respectively, and comprised red sandstone blocks as in the main wall above (Area 9; Plates 19 & 20).

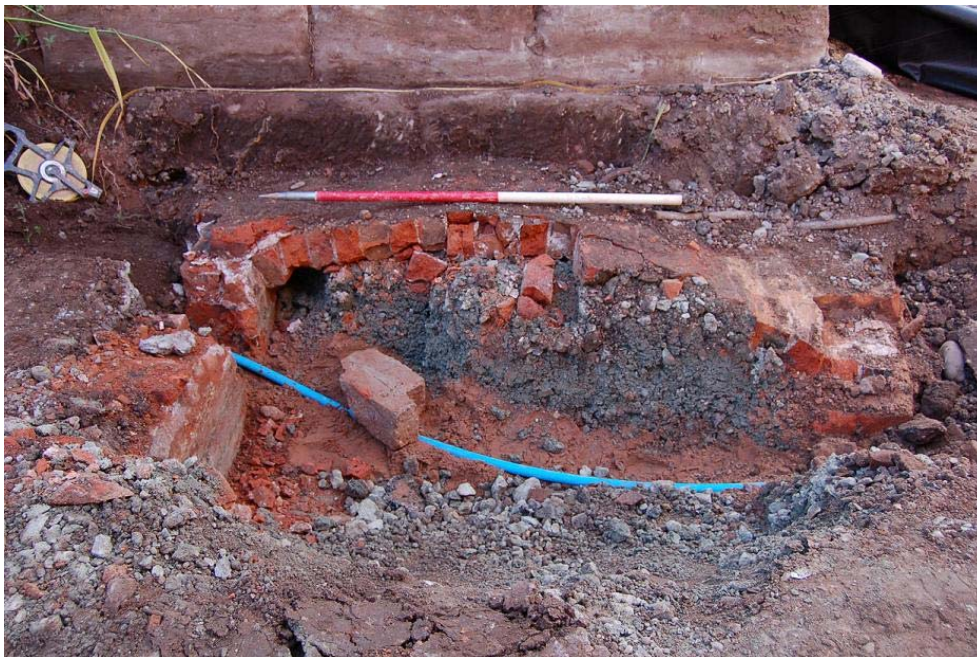
Plate 20, Area 9: south brick vault, 900, as excavated for service pipe, view east

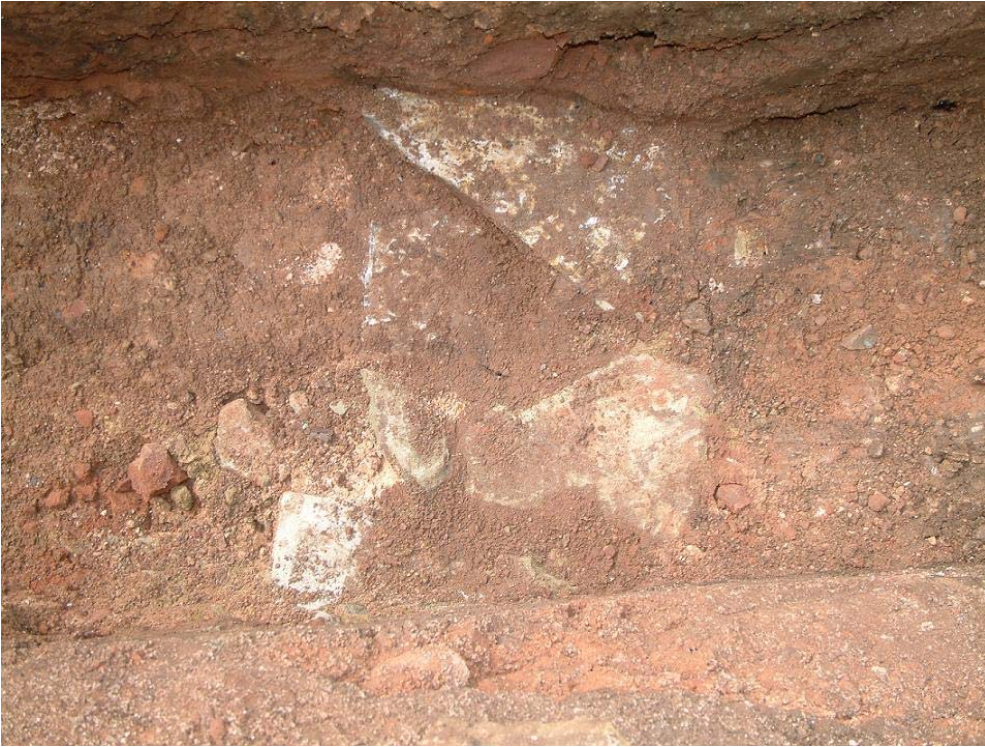
Plate 21, Area 9: Sandstone wall foundation, 901, associated with 1102?, view west

A sandstone wall or foundation, 901, was recorded to the south-west of the church tower (Area 9; Plate 21), comprised of rough flat green sandstone blocks bedded in a cream-white sandy lime mortar. Although its exact location and depth was unrecorded (pers comm Adam Lee), it appears to be aligned approximately WNW/ESE and may be associated with mortar layer, 1102, recorded at the north-east corner of the School House (Pit 11D; Plate 24). This latter appeared to continue under the present building to the south and comprised a layer of yellowish cream lime mortar at a depth of 0.45m. It is unclear if it overlay stone coursing below.

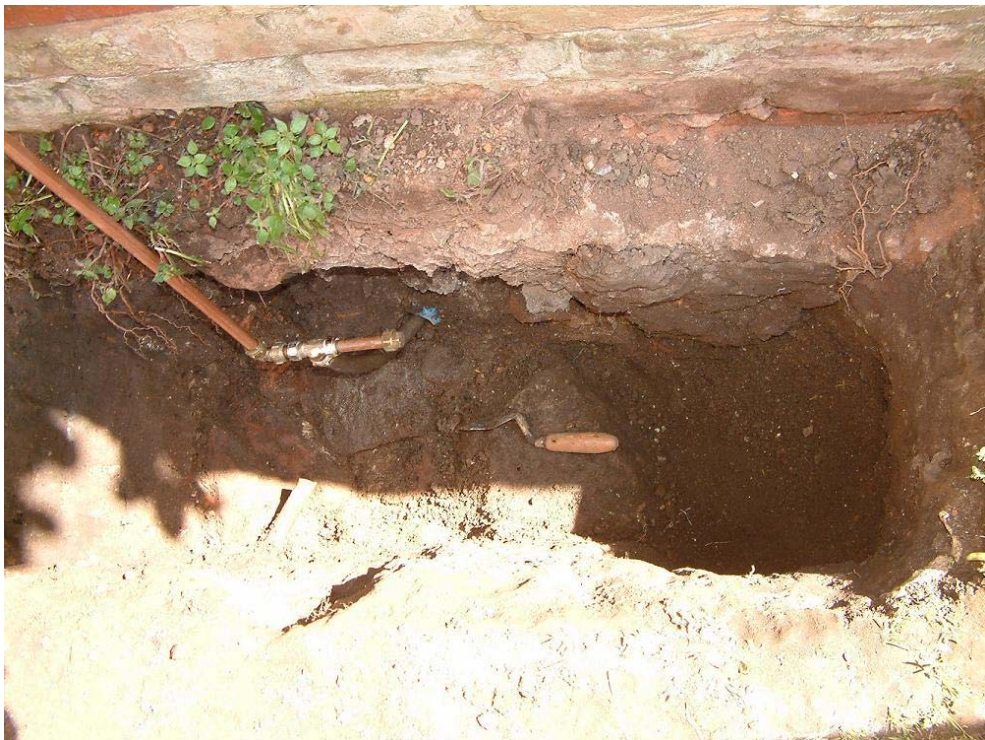
Plate 22, Area 10: Sandstone wall foundation 1001, same as 707?, view north-east

Three courses of a red sandstone wall or foundation, 707 and 1001, were recorded adjacent to the existing south-east boundary of the churchyard at a depth of c 0.40-0.80m (Trenches 7 & 10; Plate 22). They appear to represent an earlier wall, either wider than, or recessed from the existing brick wall.

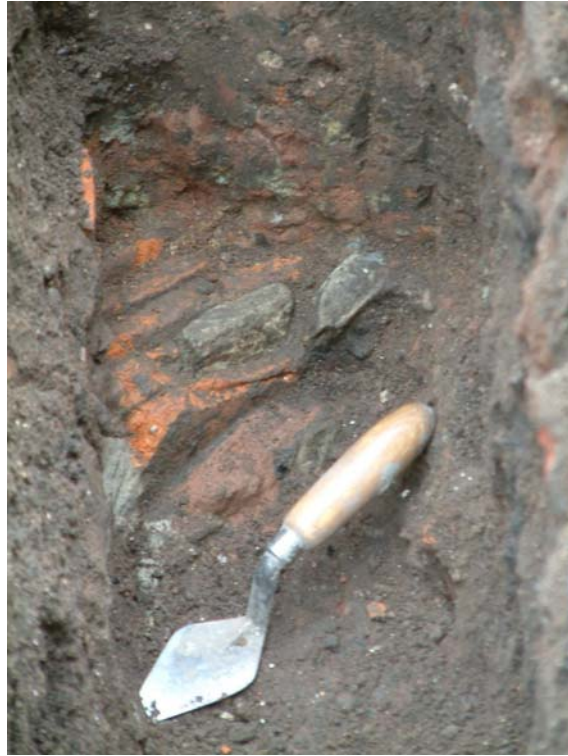
Plate 23, Area 11 C: Tile hearth 1101, view south-east

The north edge of a tile structure, 1101, was observed to the south-east of School House entrance (Pit 11C; Plate 23). It comprised red roof tiles and a few thin green sandstone blocks laid on edge. It is interpreted to be a hearth or the edge of a floor. Unfortunately it was not identified during subsequent trenching across the same area (Trench 5), nor were deep excavations undertaken to the south where it appeared to continue.

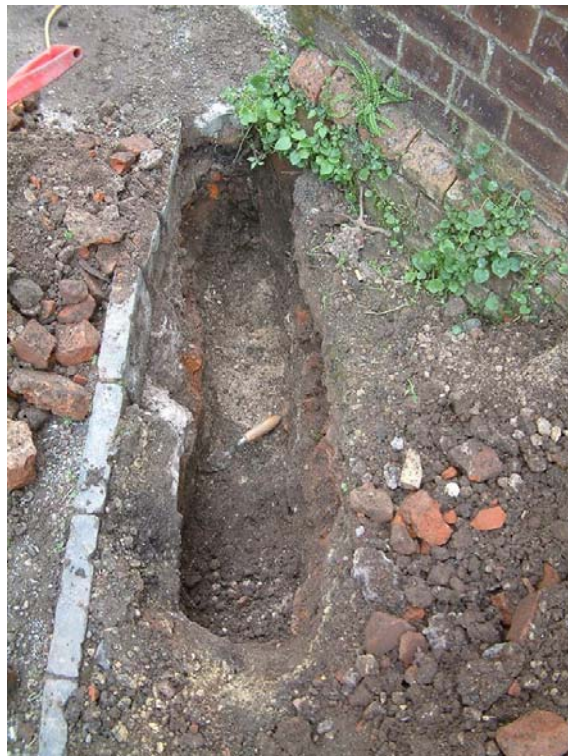
Plate 24, Area 11 D: Mortar layer 1102, associated with 901?, view south-east
