ARCHAEOLOGICAL WATCHING
BRIEF AT
THE SCALA THEATRE,
CROWN PASSAGE,
WORCESTER

19th December 2007

Project 3008
Report 1581
WCM 101522

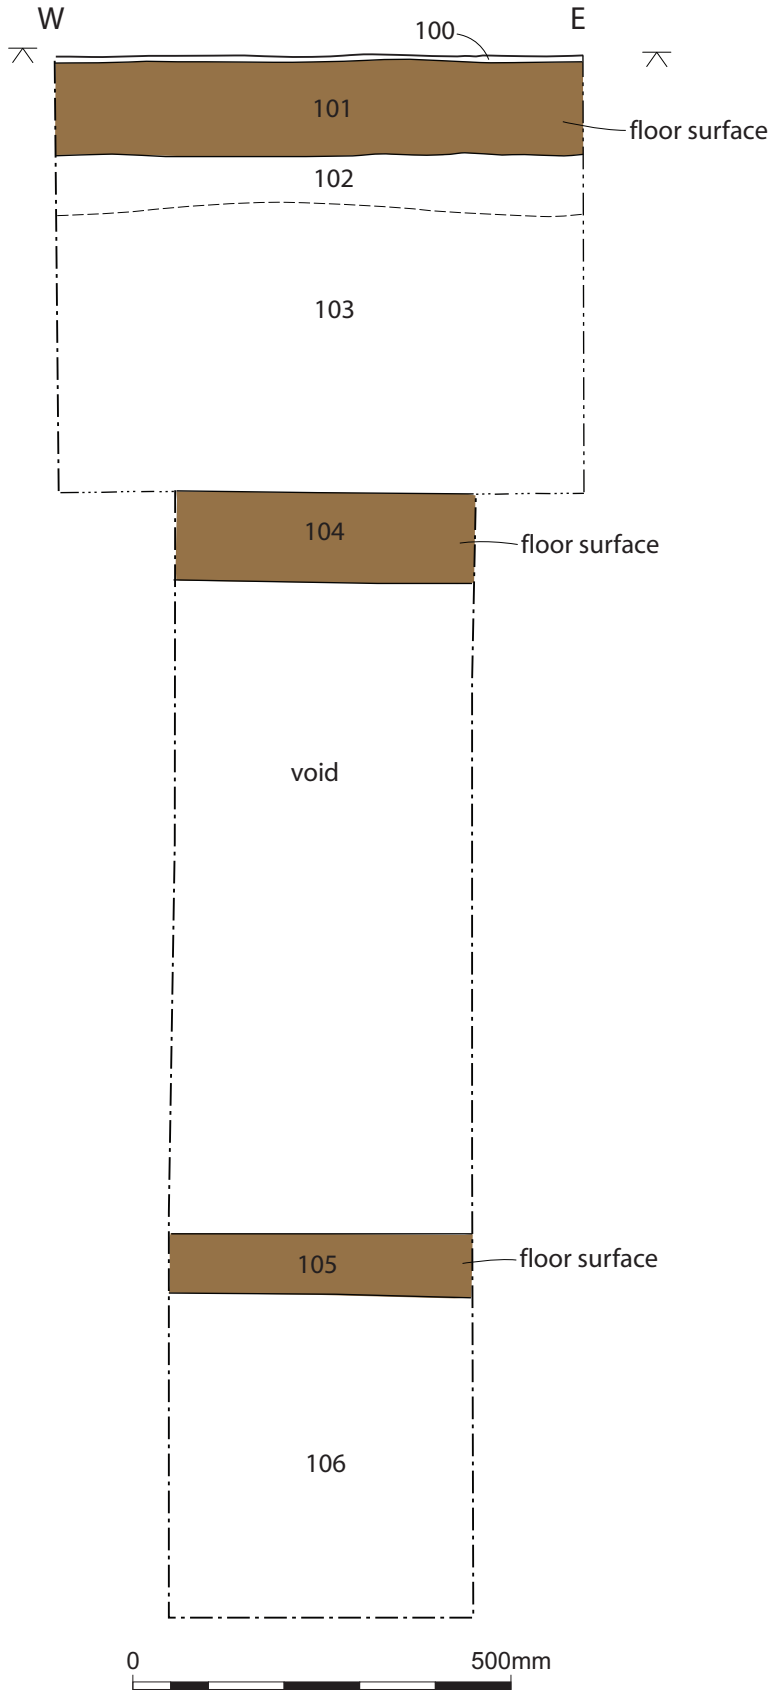
Figure 3

The removal of floor surface 104=204=704 in test pits 1, 2 and 7 revealed a service duct aligned north-south along the eastern edge of the building (Figs 2 and 3; Plate 2). The duct is c. 0.90m deep and 1.23m wide (east-west); it is bounded to the east by the existing eastern wall of the theatre and to the west by a continuous brick wall below floor surface 104=204=704. The base of the duct consisted of a third concreted floor surface (105=206=706) which, when broken out, revealed a dark brown loamy fine sand with inclusions of brick, mortar and charcoal (106=207=707). In test pit 1 this deposit (106) was investigated via a narrow sondage but access was limited and no artefactual material was recovered. It had a depth of at least 0.42m but continued beyond the limit of excavation (c.2.14m below current ground level in test pit 1). At this level the brick courses of the eastern wall of the theatre were stepped out to broaden the overall width of the wall (Plate 3); these broader, stepped courses appear to be the foundation courses of the wall. Deposit 106 may be backfill material relating to the construction of the east wall but this could not be proved conclusively.

TEST PIT 1: SECTION

Test Pit 1: section and sondage

Test pit 1 showed that the eastern wall of the theatre has surprisingly deep foundations (over 2 metres below ground level) and it is likely that when the Scala Theatre was constructed during the 1920s it was built up on top of an existing wall along its eastern edge, though this is conjecture.

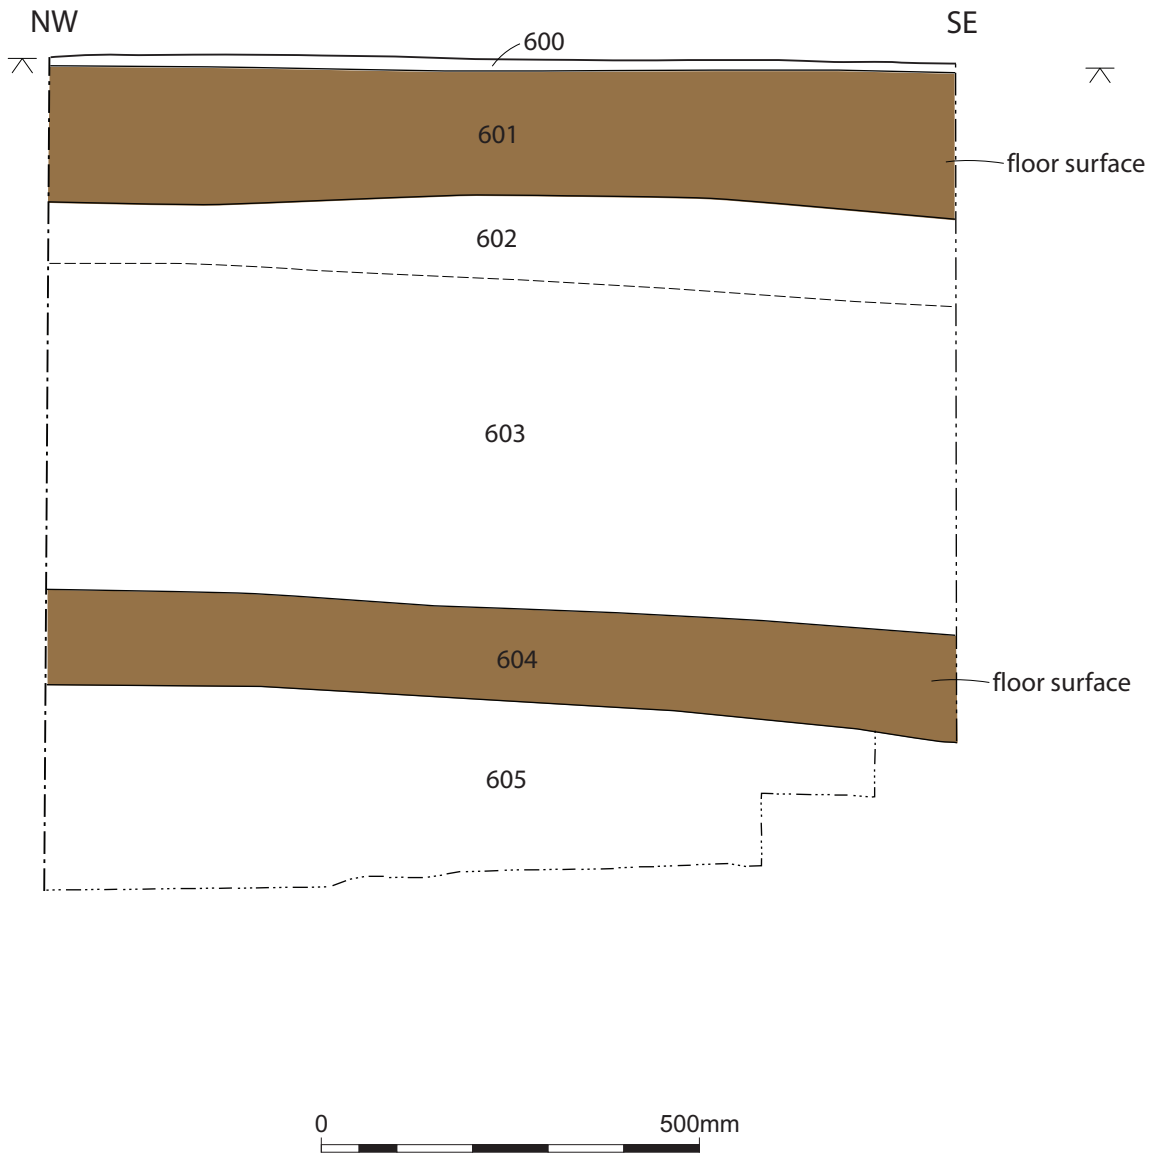
Figure 4

All the test pits revealed substantially the same profile in section down to a depth of c. 0.65-0.80m below current ground level (Figs 3 and 4; Plate 1), with only test pits 5 and 8 showing any significant variation (see below). The existing tile and concrete floor surface within the building sealed a layer of mixed silty sand and rubble containing much building/construction debris (103=203=303=403=503=603=703). The artefacts recovered from this deposit all dated from the 19th century but 20th century material was also noted during excavation. This deposit varied in depth from c. 0.40-0.50m and sealed an earlier floor surface constructed of concrete with brick inclusions (104=204=304=404=504=604=704). When this floor surface was broken out in test pits 4 and 6 a dark brown loamy fine sand with much building/construction debris was revealed (405=605). This layer had a depth of 0.27m+ in test pit 6 and 0.60m+ in test pit 4; in both cases it continued beyond the limit of excavation (c. 1.45m below current ground level in test pit 4). Deposit 605 contained pottery sherds of 17th and 18th century date and occasional fragments of dressed red sandstone. It is unclear whether this deposit represents an 18th century soil or mixed, re-deposited levelling material; the latter is perhaps more likely.

TEST PIT 6: SECTION

Test Pit 6: section

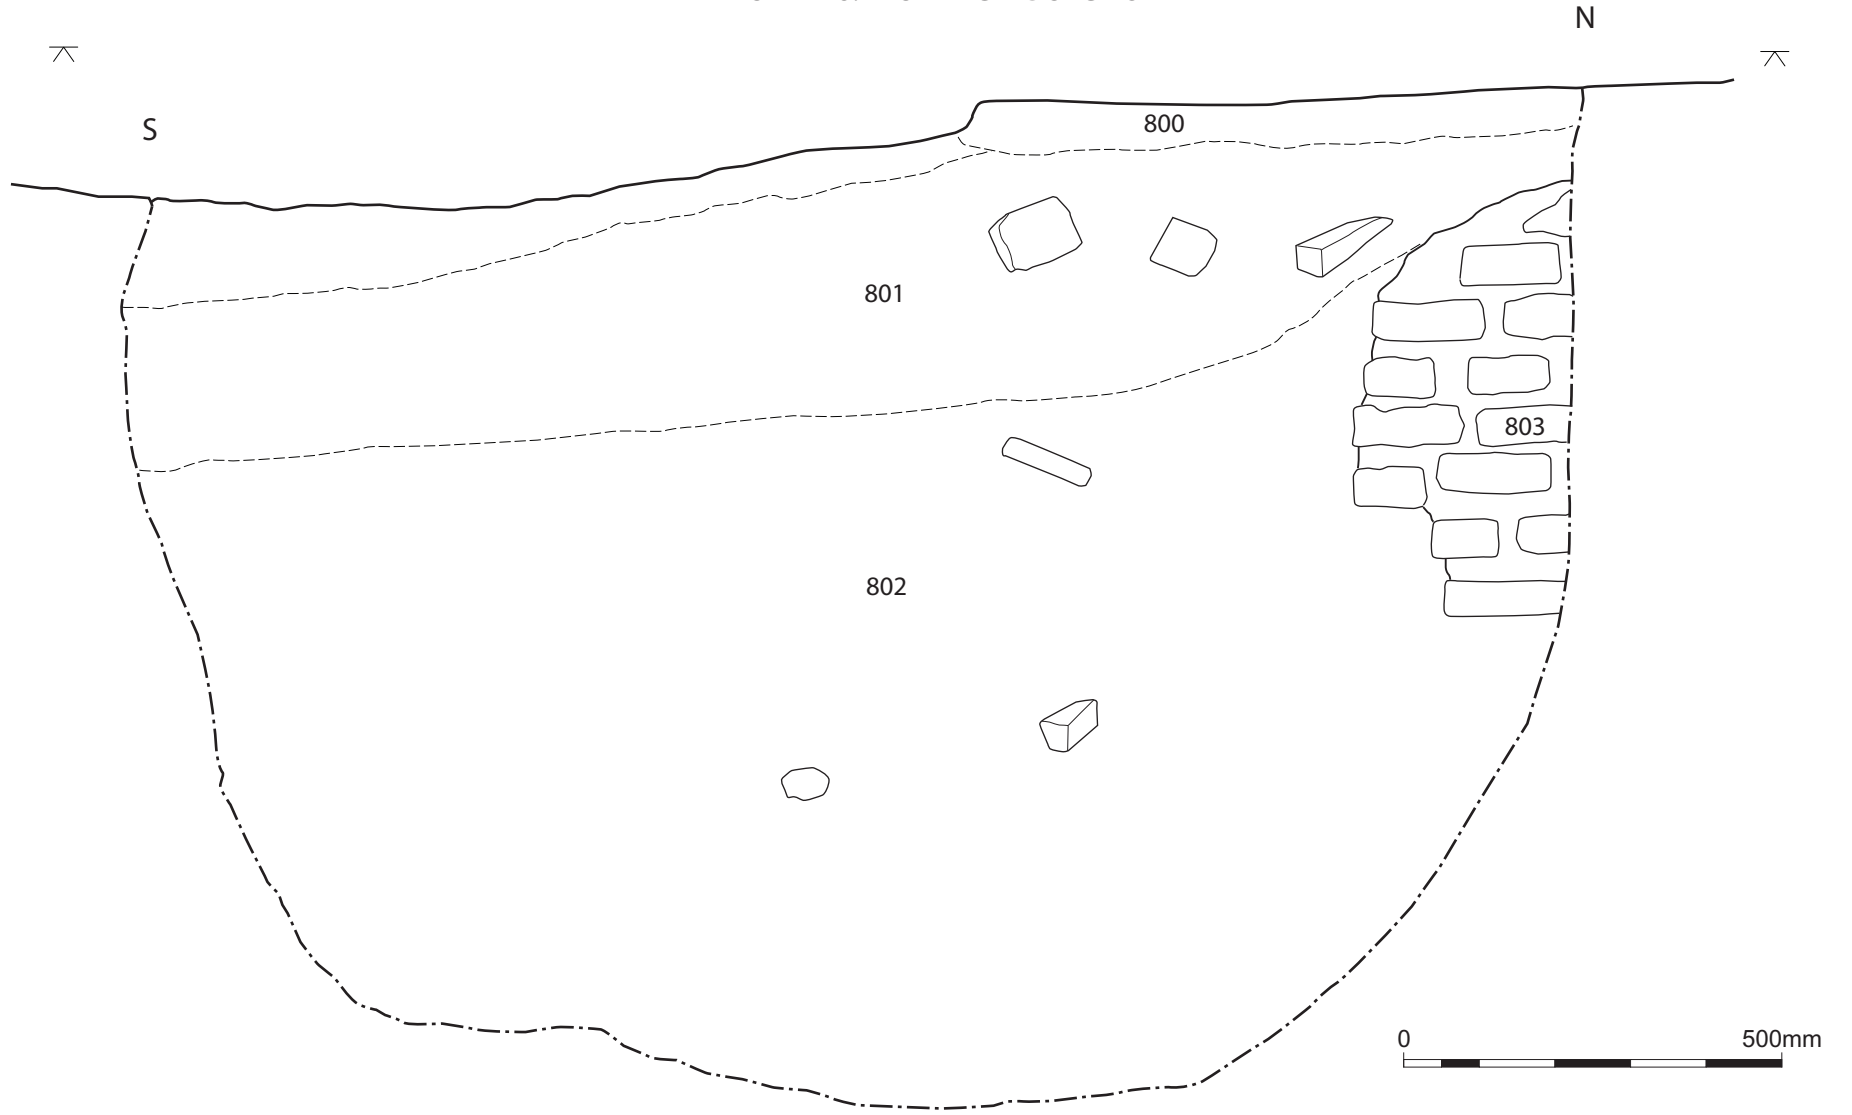
Figure 5

Test pit 8 was located within a separate retail unit and revealed a slightly different profile. Below the existing concrete floor and a layer of hardcore (800 and 801) were the remains of a brick wall aligned east-west (803; Plate 5; Figs 2 and 5). The dimensions of the bricks in wall 803 are indicative of 17th century manufacture (pers. comm., Angus Crawford, WHEAS). The wall was abutted by a deep deposit of dark brown loamy silt (802) containing

TEST PIT 8: EAST-FACING SECTION

Test Pit 8: section

The two brick walls located in test pits 5 and 8 are of interest (506, 803). They are likely to date from the late 17th or 18th century: the dimensions of the bricks used in their construction are consistent with this dating and they are both abutted by deposits containing discarded

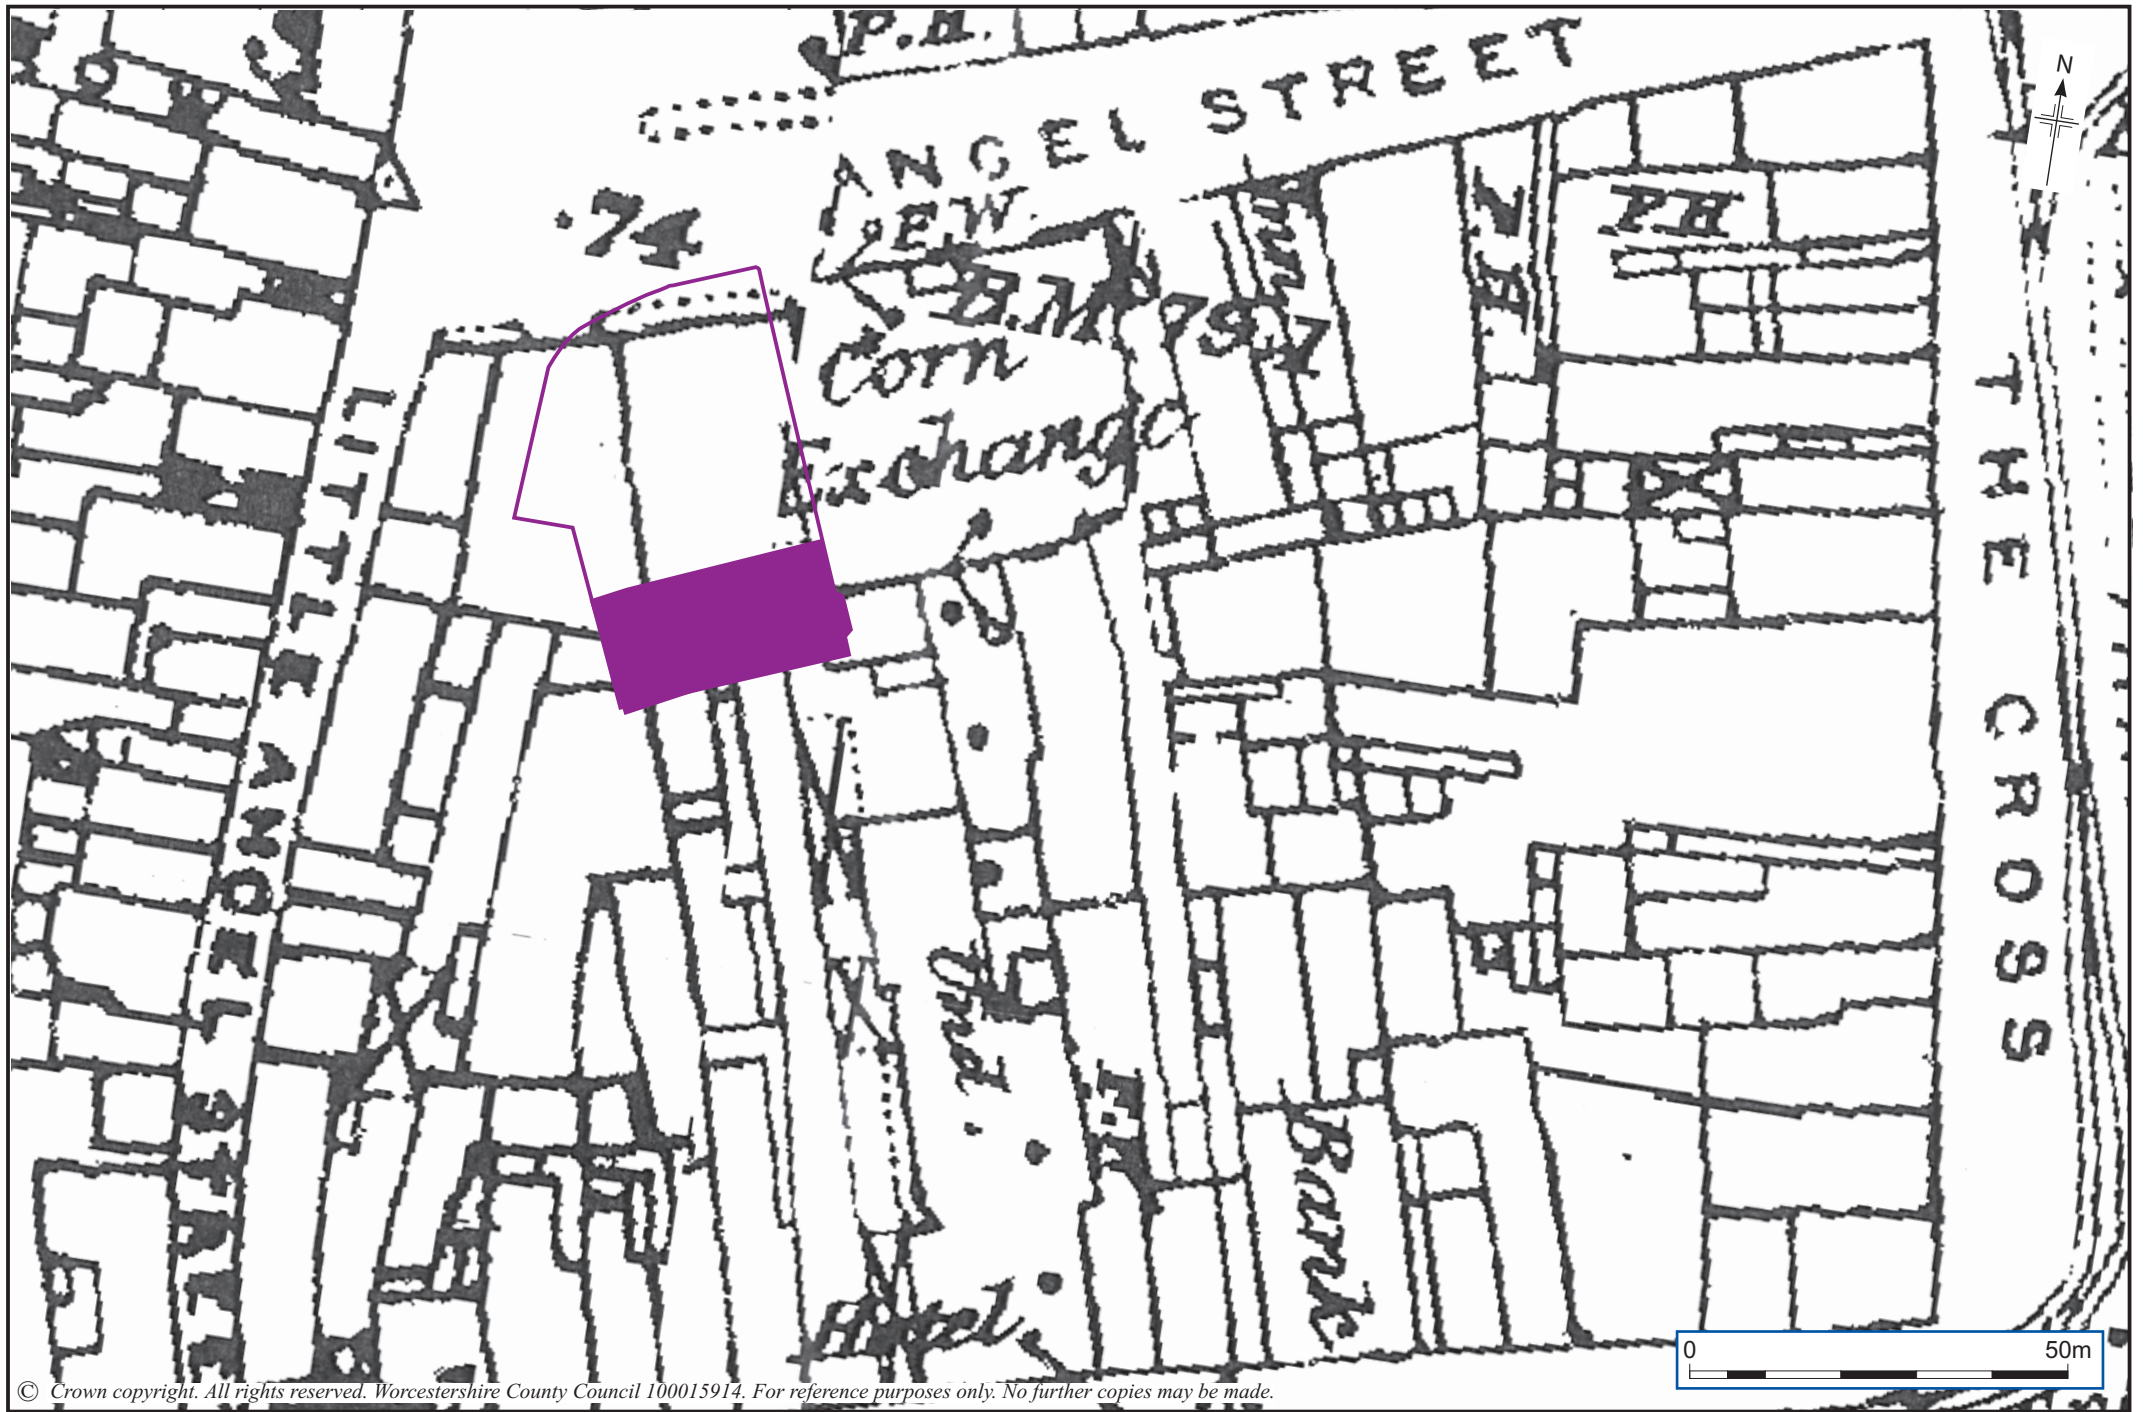
Figure 6

cultural material of 18th century date (505, 507, 508, 509, 802). They clearly pertain to earlier structures on the site and appear to align well with buildings depicted on the first edition Ordnance Survey map (Fig 6). Both, however, have been significantly truncated and their extent beyond the test pits is unknown.

1st edition Ordnance Survey map with modern overlay

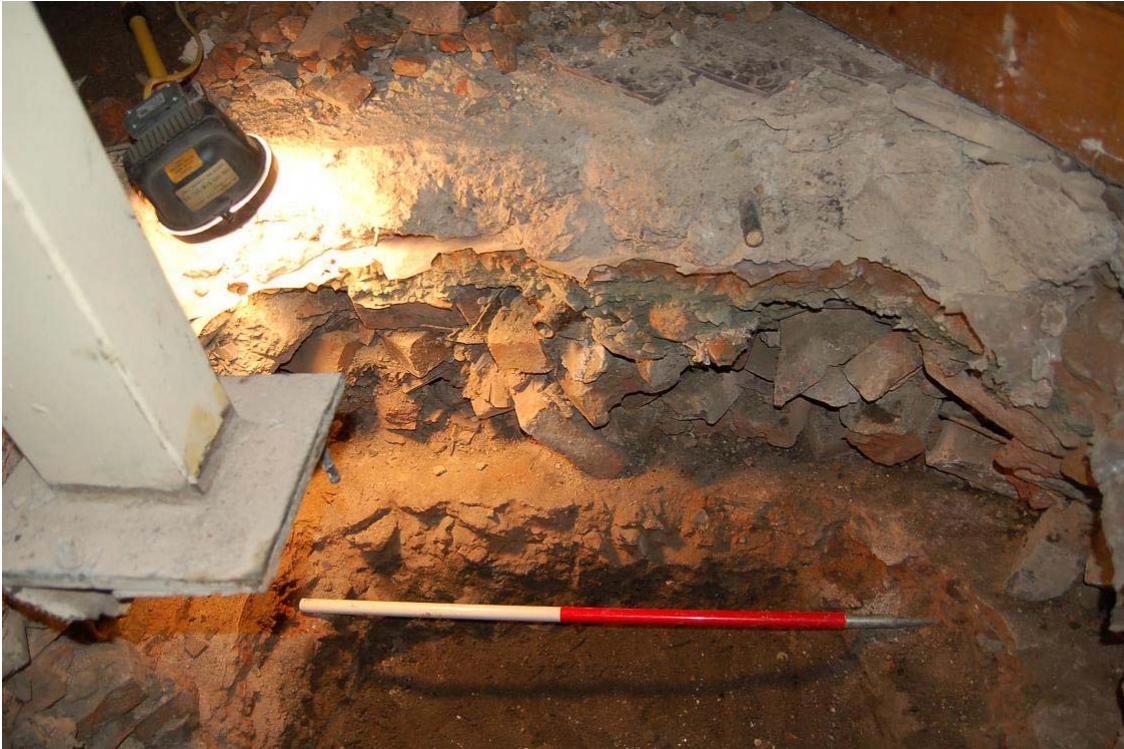
Plate 1 West facing section, test pit 6, showing modern floor surface, rubble layer 603, second floor surface 604 and deposit 605

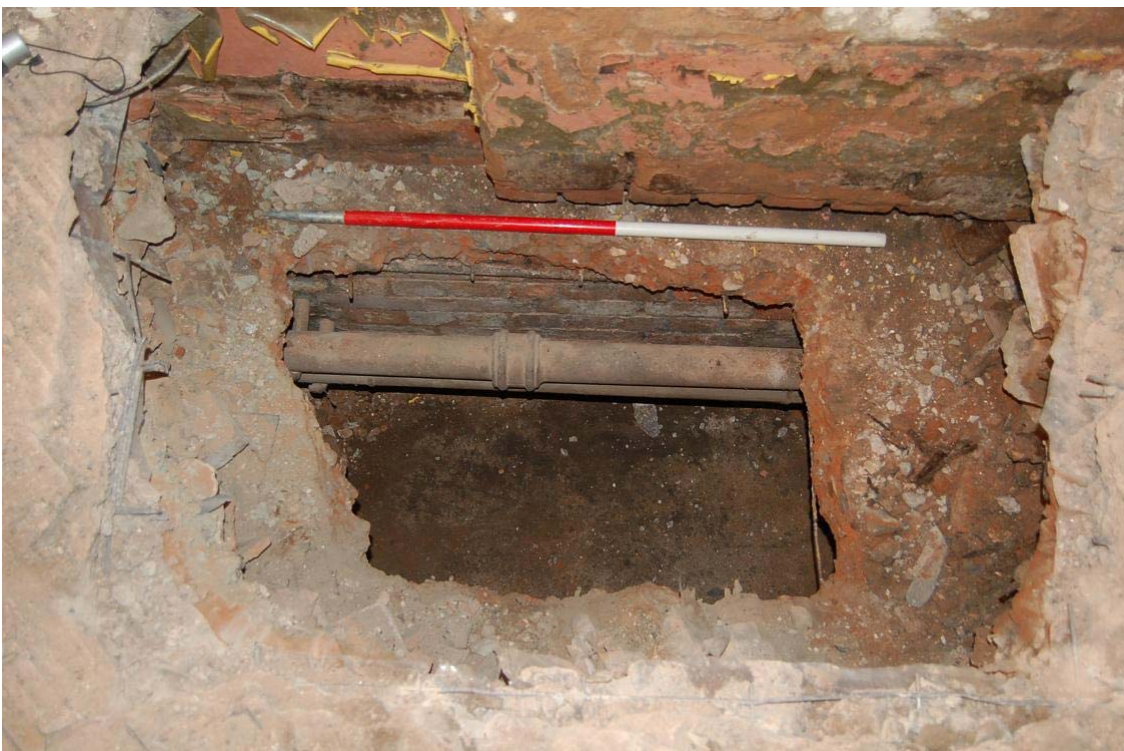
Plate 2 Service duct, test pit 1

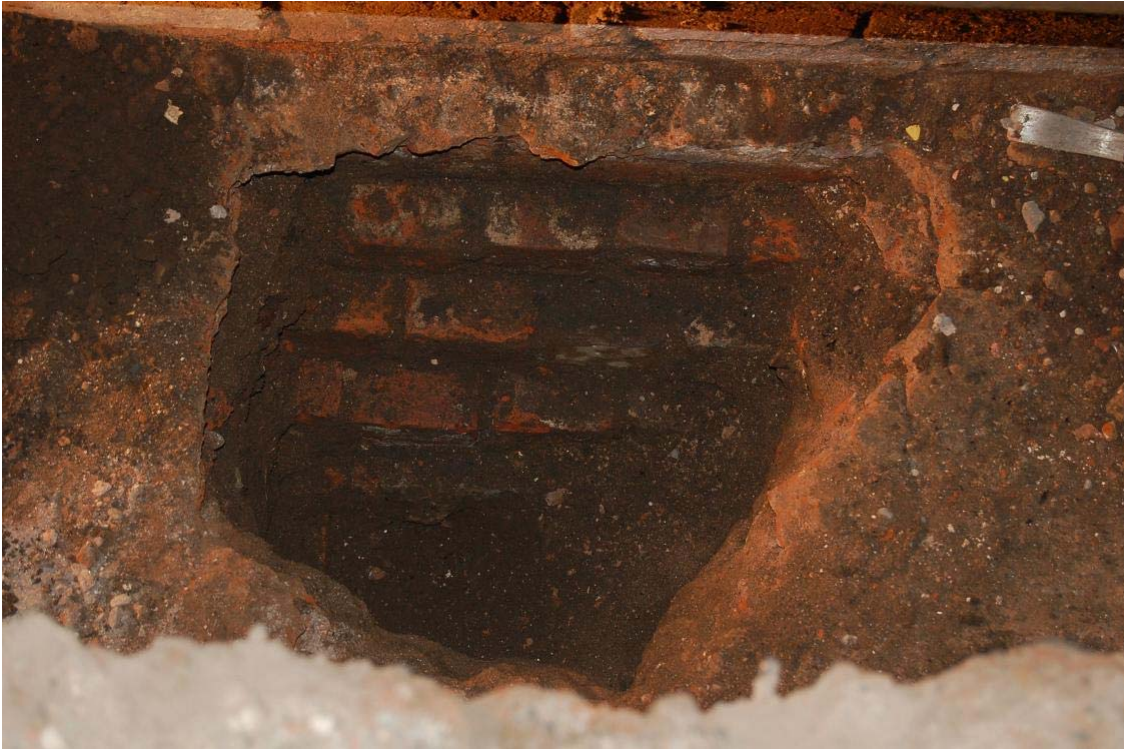
Plate 3 Sondage in test pit 1 showing stepped foundations of the east wall of the Scala Theatre

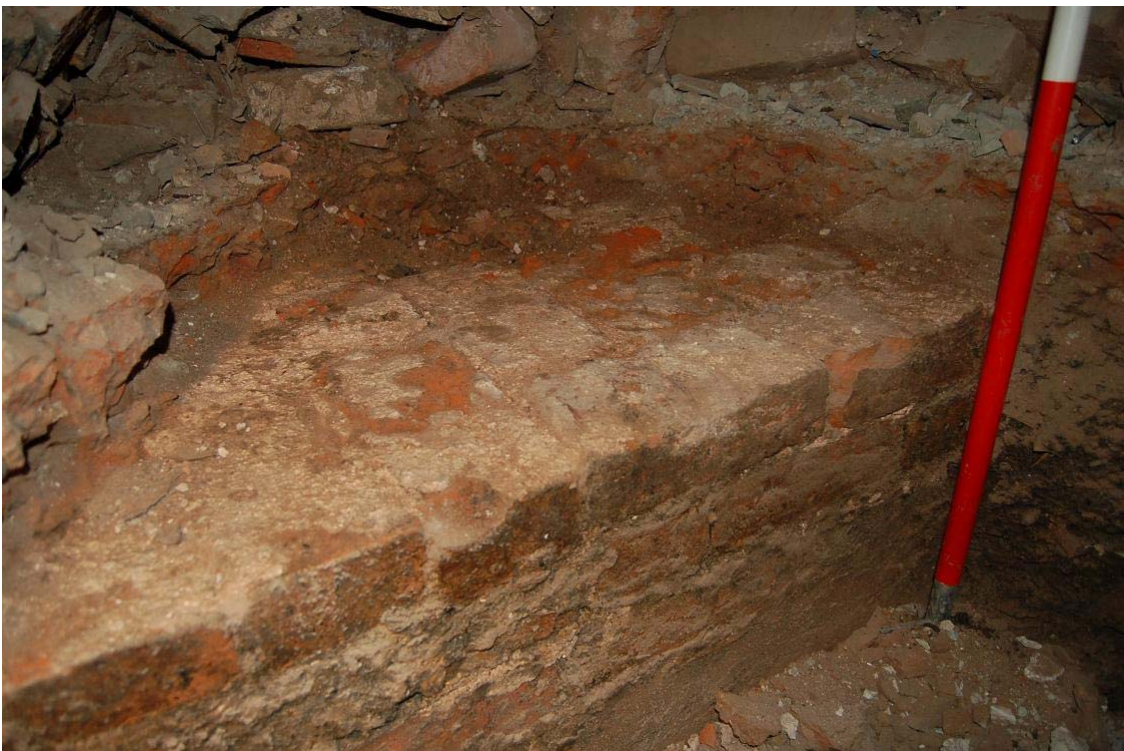
In test pit 5 the removal of floor surface 504 revealed the truncated remains of a brick wall aligned approximately east-west (506; Plate 4; Fig 2). This wall was partially demolished by the contractors, revealing a short extension to the south, possibly the truncated base of a drain. The dimensions of the bricks used to construct wall 506 indicate that they were probably made during the mid-17th to 18th century (pers. comm. Angus Crawford, WHEAS). The wall was abutted by four similar deposits (505, 507, 508 and 509) all of which were loamy soils containing building debris and artefacts of 18th century date. Deposit 508 also contained two fragments of dressed sandstone and one fragment of dressed limestone, possibly deriving from earlier structures. All these deposits appear to be dumped levelling material.

Plate 4 Wall 506, test pit 5

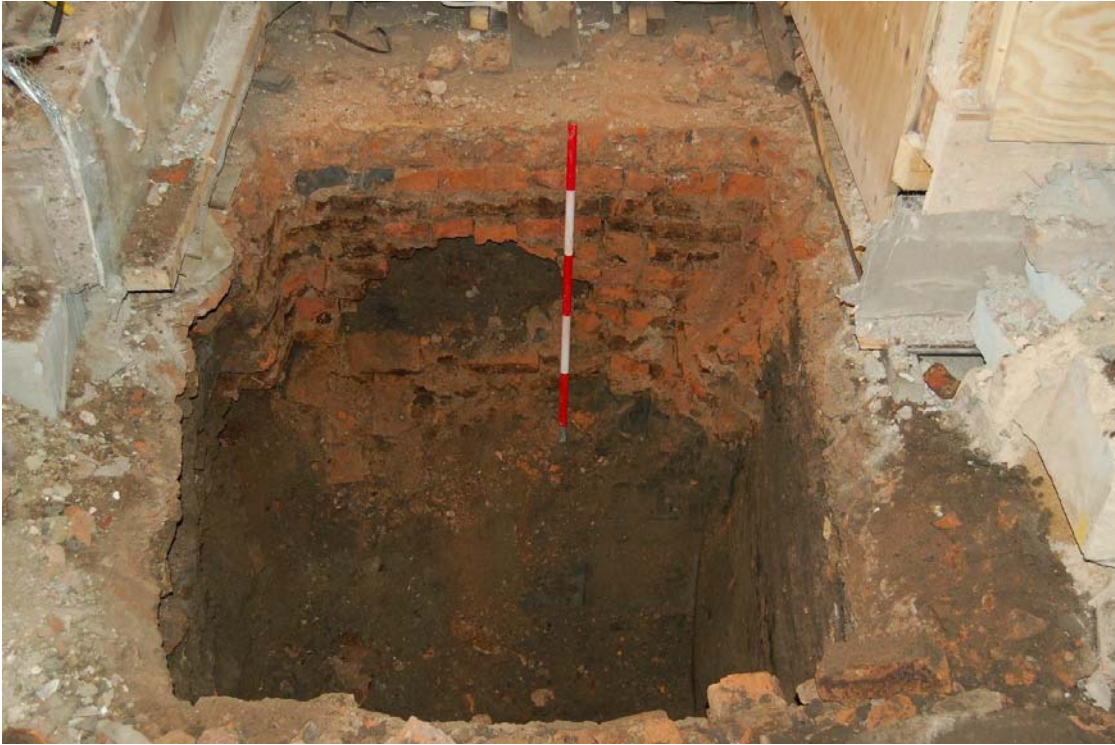
Plate 5 Wall 803, test pit 8
