ARCHAEOLOGICAL
INVESTIGATIONS
AT
BRICKWALLS FARM,
GILBERTS LANE,
HANLEY SWAN,
WORCESTERSHIRE

Project 3119
Report 1571
WSM 37563

Archaeological investigations at Brickwalls Farm, Gilberts Lane, Hanley Swan, Worcestershire

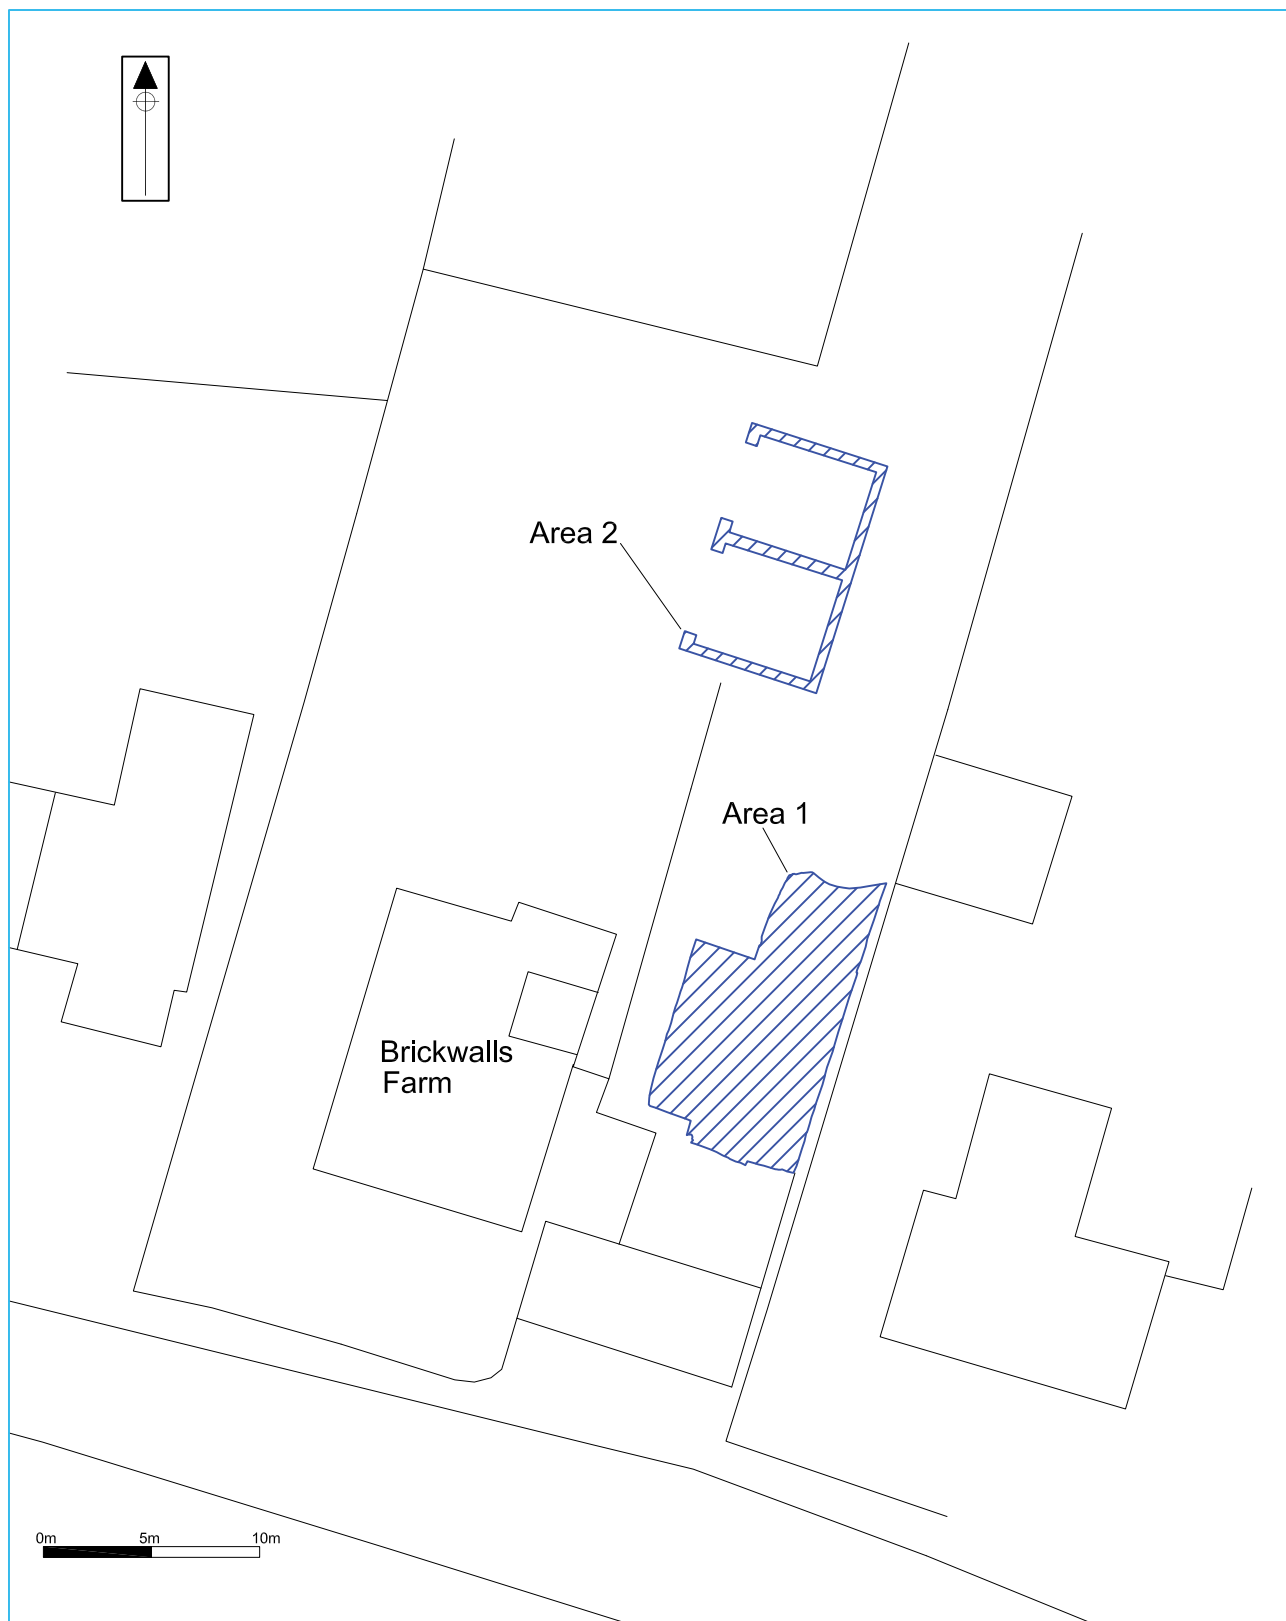
Figure 2 Location of areas

ditching bucket. Mechanical excavation covered a total area of approximately 71.88m² for the new house on the frontage and 31.25m of trenching were excavated to the rear for the garage (Fig 2; Plates 1, 2 and 7). Subsequent excavation was undertaken by hand. Clean surfaces were inspected and selected deposits were excavated to determine their nature, to retrieve artefactual material and environmental samples. Deposits were recorded according to standard Service practice (CAS 1995).

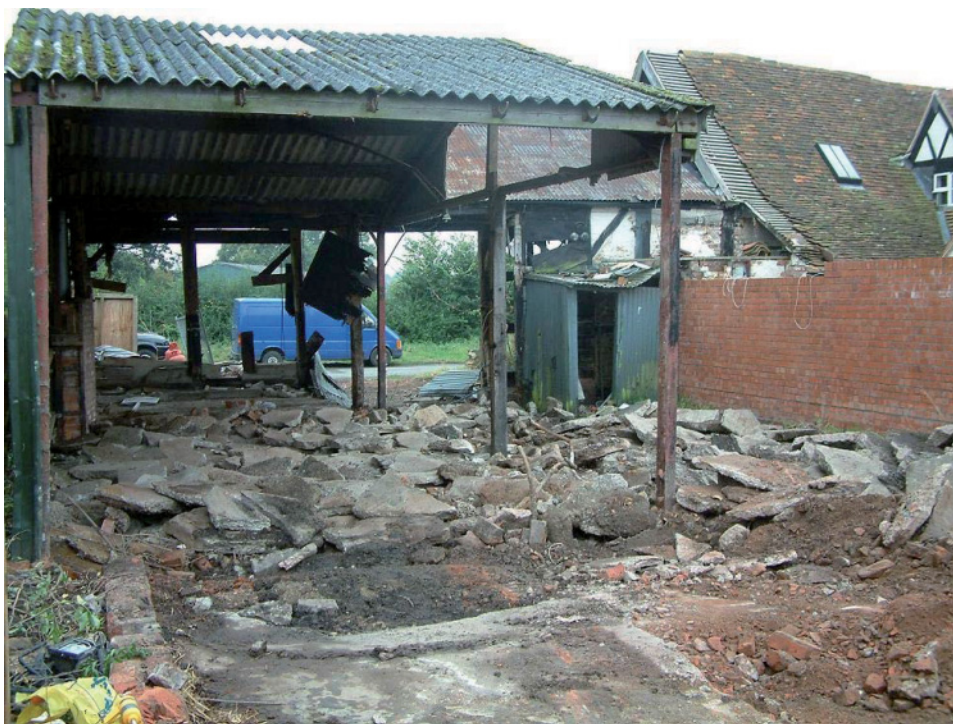
Observation of the excavated areas was undertaken after removal of the concrete slab foundation of the modern barn immediately to the rear of the 17th century barn and subsequent machine excavation, using a 360° tracked excavator, employing a smooth-bladed

Plate 1: Area 1, general shot after breaking up of concrete slab, view south-south-west

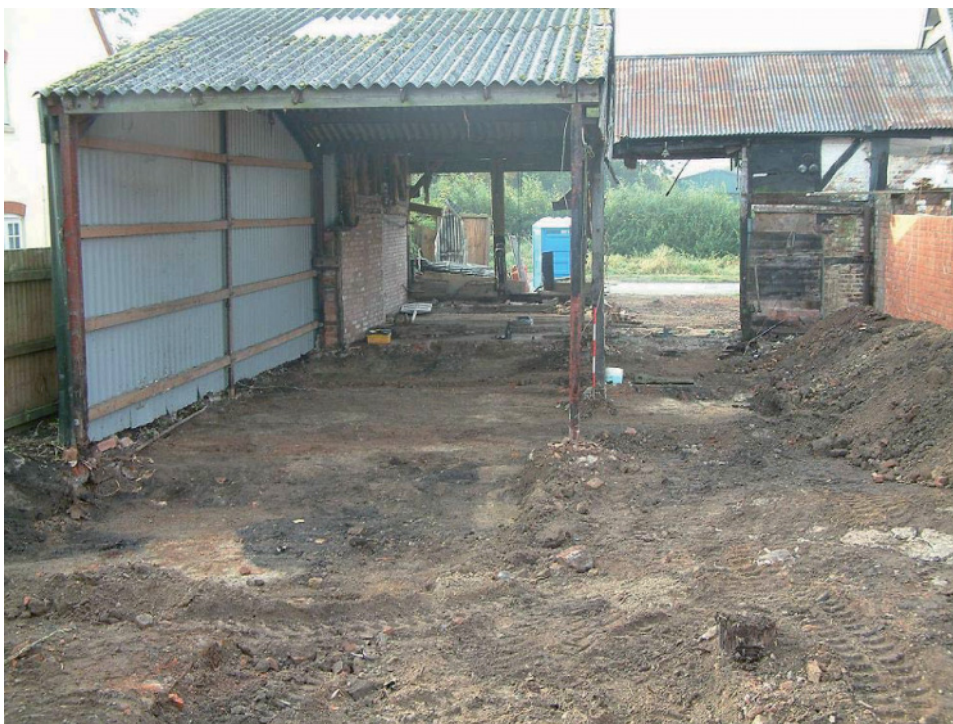
The natural matrix consisted of sub-angular and angular yellowish grey gravel and clay, with frequent patches of blue-grey clay, observed at a shallow depth toward the frontage (Plate 2) and at 0.60m below the present ground surface, toward the rear of the plot (Plate 8).

Plate 2: Area 1, general shot after soil strip, view south

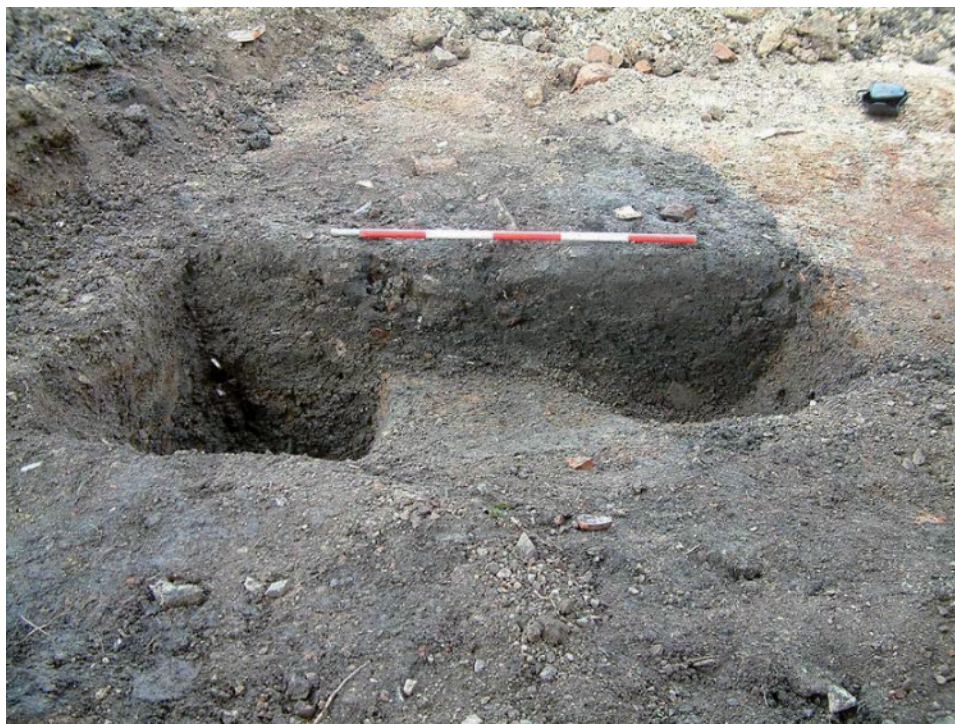
The only features identified, consisted of a small number of pits, within Area 1 toward the frontage: two shallow oval pits, 102 and 110 (Plate 6); a deeper sub-oval pit, 106; a sub-rectangular vertical sided cess pit, 108 (Plate 3); and a shallow linear ditch, aligned west-north-west to east-south-east (in parallel with the road), with a deeper gulley to its north side, 104 (Plates 4 and 5).

Plate 3: Area 1, pits 106 and 108, view north

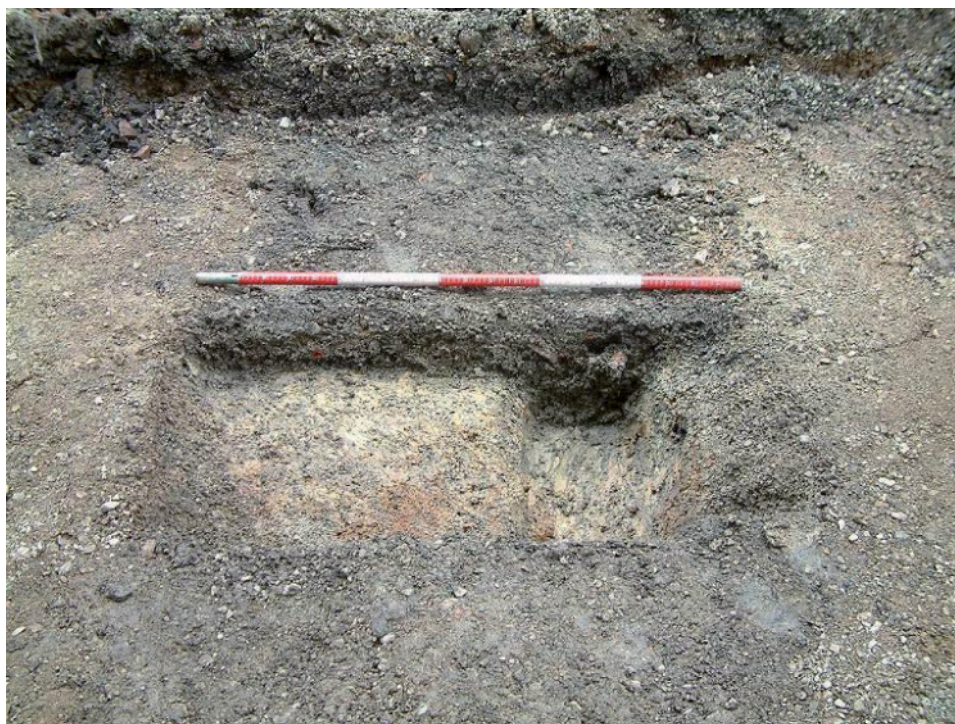
Plate 4: Area 1 linear 104, view west-north-west

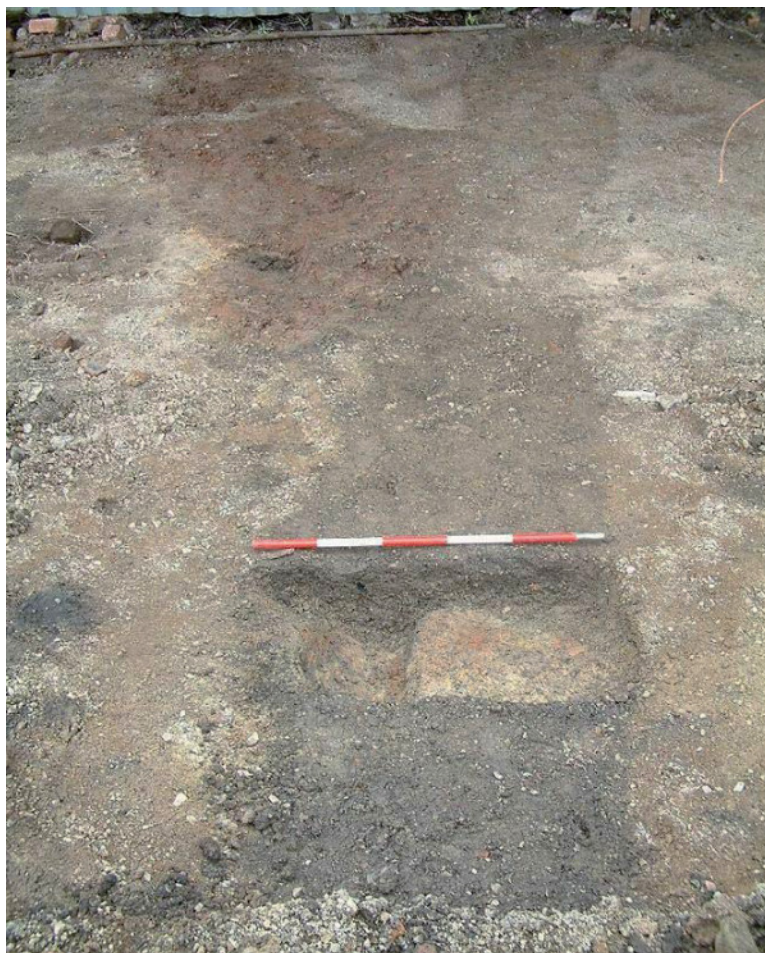
Plate 5: Area 1, linear 104, view east-south-east

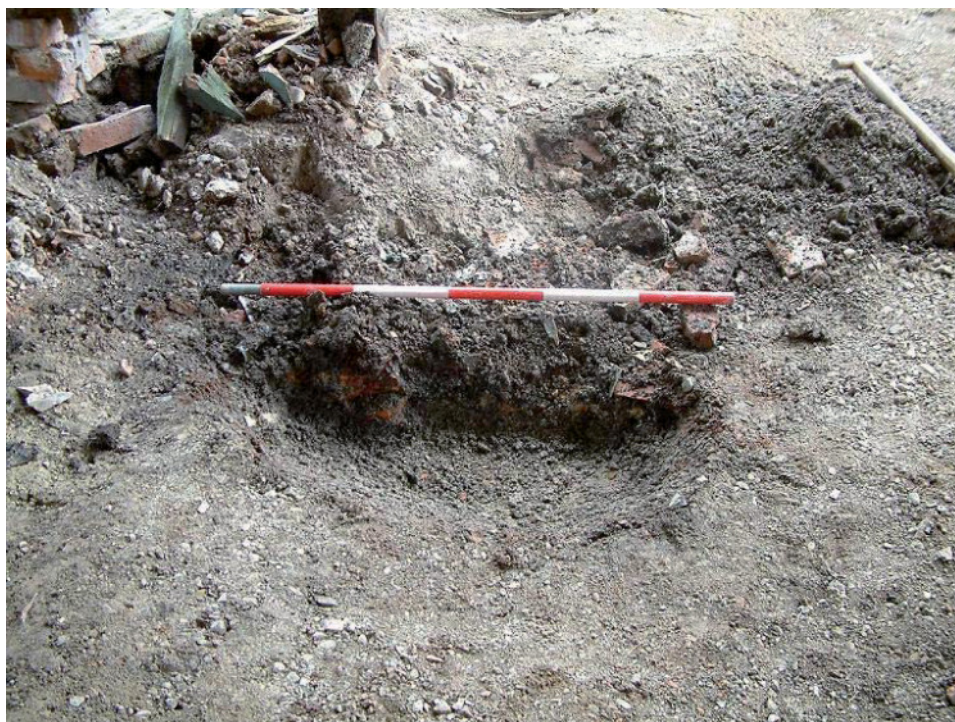
Plate 6: Area 1, pit 102, view west

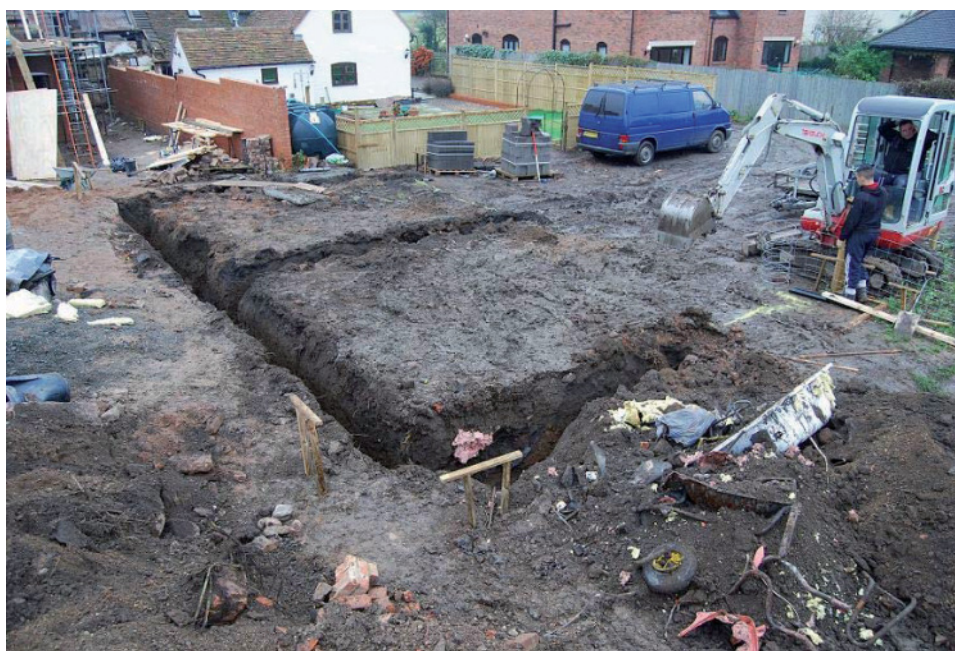
Plate 7: Area 2, general shot, view west-south-west

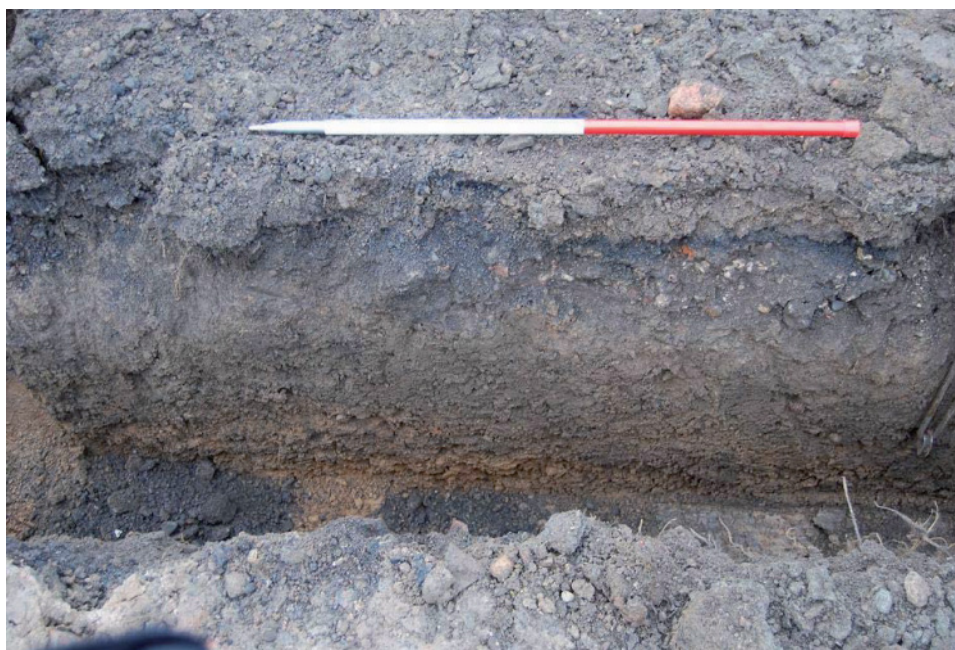
The overlying soil sequence was identified in Area 2 to the rear of the site (Plate 8). It comprised a shallow dark grey gravelly silt topsoil, with frequent brick and mortar inclusions, over mid brown clayey silt with moderate angular stones. The soil sequence was not visible toward the frontage, within Area 1, where a modern barn with a concrete floor slab had previously existed.

Plate 8: Area 2, sample section
