ARCHAEOLOGICAL
EVALUATION
AND WATCHING BRIEF
AT
TOLLADINE GOODS YARD,
WORCESTER

Revision 1
22nd May 2008

Project 3180
Report 1620
WCM 101624

Archaeological Evaluation and Watching Brief at Tolladine Road Goods Yard, Worcester

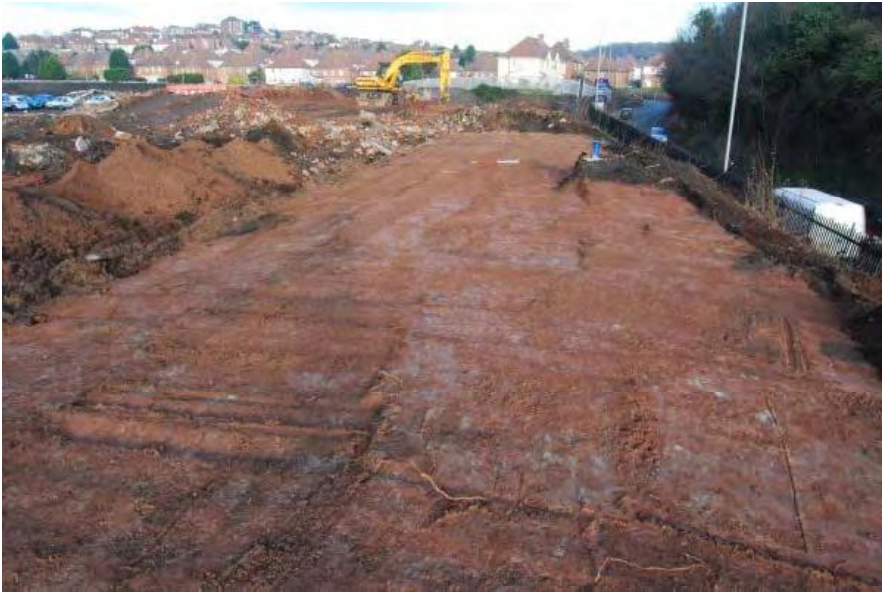
Plate 1. The area subject to watching brief looking north

In the area of the watching brief a layer of mixed, disturbed soil (1100) similar to those encountered in Phase 1 of the evaluation overlay the natural deposits. Artefacts recovered from this deposit indicate that it is of relatively modern origin. One modern ceramic pipe crossed the northern part of the area from north-south.

Context	Classification	Description	Depth below ground surface (b.g.s) – top and bottom of deposits
1100	Layer	Mixed dark brown sandy silt and mid brown clay with ash, clinker, brick and services. Very disturbed layer. Overlies (1101)	0.00 - 0.40m
1101	Natural	Mid orange brown clay with patches of green clay	0.40m+

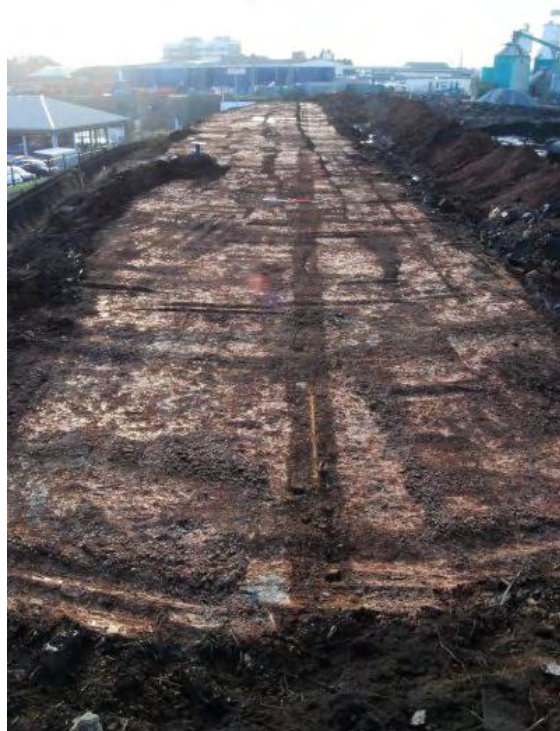
Plate 2. The area stripped prior to the watching brief, looking south

approximately 1200m² (Figure 2) was monitored over four days in December 2007. Unfortunately prior to the commencement of the watching brief, an area of approximately 1100m² slightly to the north-east of this area had already been stripped to natural levels by the on-site contractor in the footprint of the proposed Unit 300. This area was inspected and no archaeological features were apparent cut into the exposed natural stratum, however no information is available relating overlying strata or structures.

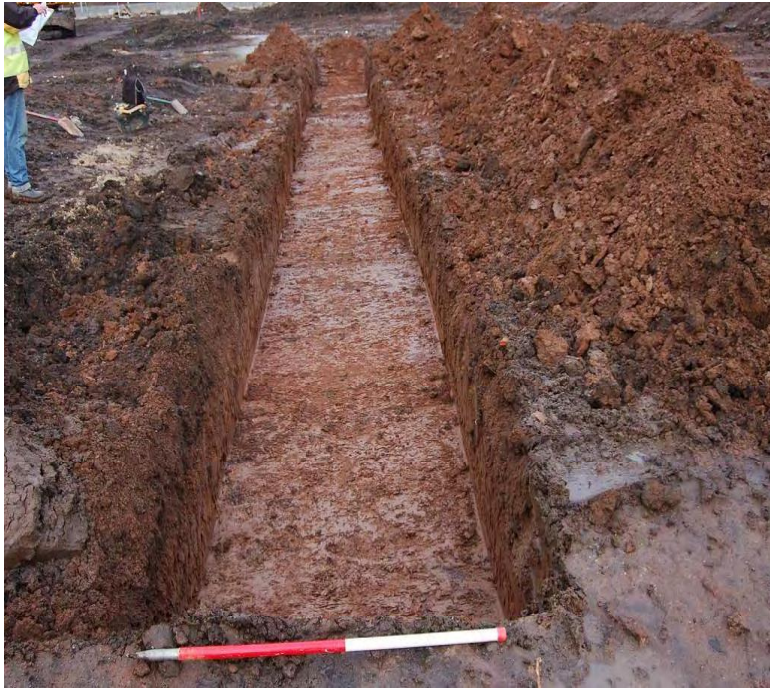
Plate 3 Trench 1 looking north-west

Maximum dimensions: Length: 22m Width: 1.70m Depth: 0.73m (max)

Context	Classification	Description	Depth below ground surface (b.g.s) – top and bottom of deposits
100	Topsoil	Mid greyish brown sandy/silty clay, friable with occasional charcoal flecks, rare bone fragments, occasional to abundant root disturbance and rare to occasional modern brick and tile.	0.00 – 0.27m
101	Subsoil	Mid-light yellow-orange brown compact plastic clay, with rare modern tile.	0.27 – 0.73m (max)
102	Natural	Light greyish pink brown, compact plastic clay, rare sub-rounded medium pebbles.	0.67 – 0.73m

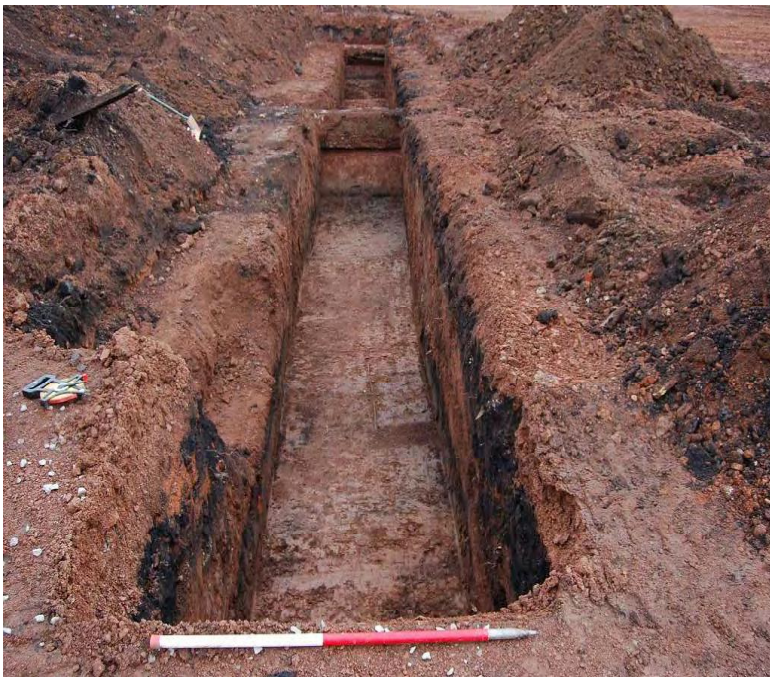
Plate 4. Trench 2 looking east

Maximum dimensions: Length: 25m Width: 1.60m Depth: 1.50m (max)

Context	Classification	Description	Depth below ground surface (b.g.s) – top and bottom of deposits
200	Surface	Mid red-orange brown, friable gravely clay. Landscaping base for the proposed development.	0.00 – 0.12m
201	Layer	Black ash and cinder layer with occasional modern brick, rare modern pot and occasional to abundant root disturbance.	0.12 - 0.32m (max)
202	Layer	Mid pinkish grey brown compact silty clay, occasional mortar, rare modern brick and occasional sub-rounded medium pebbles.	0.28 – 0.62m (max)
203	Layer	Mid-orange pink friable plastic clay with green-grey flecks and abundant root disturbance.	0.56 – 1.20m (max)
204	Layer	Mid grey-brown compact-friable clay, abundant charcoal flecks, occasional tile	1.15 – 1.50m
205	Layer	Mid-grey brown compact clay, below context 208	0.85 – 1.50m

Context	Classification	Description	Depth below ground surface (b.g.s) – top and bottom of deposits
206	Layer	Black ash and cinder layer below context 203 at NW end of trench only	Not drawn
207	Layer	Same as 204 but darker grey-brown hue with occasional brick, below context 206, at NW end of trench only	Not drawn
208	Layer	Mid blue-grey compact plastic clay, above context 205	0.90 – 1.35m (max)
209	Natural	Mid pink-red brown to grey-brown friable silty clay, truncated.	1.35 – 1.50m

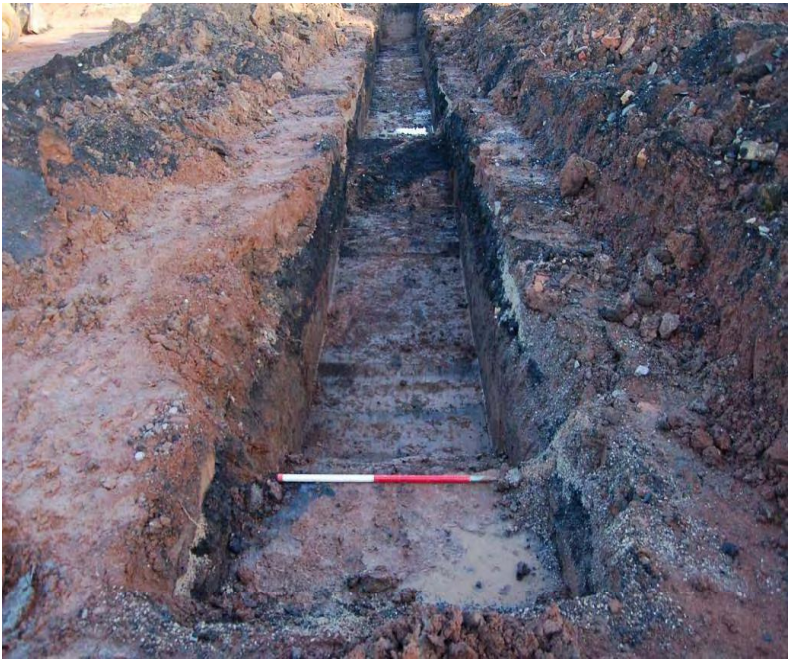
Plate 5. Trench 3 looking north-east

In Phase 1 (trenches 1-4), the general stratigraphy was a sequence of layers of re-deposited natural, mixed soil deposits and clinker deposits overlying natural. Several services crossed the trenches including a brick culvert (306) in Trench 3. Trench 4 contained modern machine cut features.

Maximum dimensions: Length: 24.50m Width: 1.70m Depth: 1.20m (max)

Context	Classification	Description	Depth below ground surface (b.g.s) – top and bottom of deposits
300	Surface	Mid red-orange brown, friable gravelly clay. Landscaping base for the proposed development.	0.00 – 0.11m
301	Layer	Black ash and cinder layer abundant root disturbance, rare copper slag.	0.11 - 0.73m (max)
302	Layer	Mid-light orange-yellow to brown-green glass and iron slag, dumped, modern material, contained by context 301	0.34 – 0.42m (max)
303	Layer	Mortar layer, contained by 301	0.50 – 0.54m (max)
304	Layer	Mid grey brown compact clay with abundant charcoal flecks, occasional modern brick and root disturbance	0.68 – 1.12m
305	Layer	Light yellow-white gravel, contained by 301	Not drawn
306	Structure	Brick culvert running W-E across the trench, roof capping slightly damaged by machine, mainly intact.	2.10m wide
307	Layer	Same as 301 but with occasional modern brick and root disturbance.	Not drawn

308	Layer	Mid-dark orange to red brown loose gravel, occasional modern pot and brick	Not drawn
309	Natural	Mid pink-red brown to grey-brown friable silty clay, truncated.	1.20m+
310	Layer	Mid grey blue compact silty clay, occasional modern brick, bone and glass slag	Not drawn

Context	Classification	Description	Depth below ground surface (b.g.s) – top and bottom of deposits
311	Layer	Mid grey blue compact silty clay, occasional modern brick, bone and glass slag, same as 310	Not drawn
312	Layer	Mid grey blue compact silty clay, occasional modern brick, bone and glass slag, same as 310	Not drawn

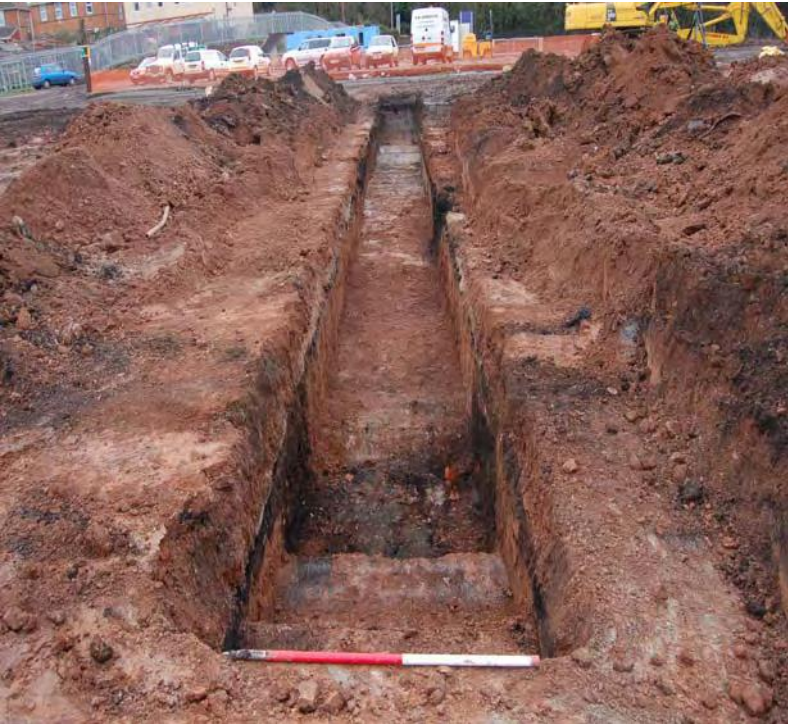
Plate 6. Trench 4 looking east

Maximum dimensions: Length: 23m Width: 1.60m Depth: 1.70m (max)

Context	Classification	Description	Depth below ground surface (b.g.s) – top and bottom of deposits
401	Surface	Mid red-orange brown, friable gravely clay. Landscaping base for the proposed development.	0.00 – 0.20m
402	Layer	Black ash and cinder layer, some root disturbance.	0.20 - 0.38m (max)
403	Layer	Re-deposited compact orange clay, occasional CBM fragments.	0.38 – 0.70m (max)
404	Layer	Same as 403, grey lenses within a sandy clay matrix, re-deposited material.	0.38 – 0.76m (max)
405	Fill	Black ash and cinder, fill of context 406	0.20 – 1.00m
406	Cut	Pit filled with modern, dumped burnt material, machine-excavated but apparent in south trench section.	Not drawn
407	Fill	Black ash and cinder, fill of context 408	1.60m wide (min)
408	Cut	Ditch, possibly equivalent to context 306, runs N-S across trench, disused culvert?	1.60m (min)
409	Layer	Re-deposited orange-grey clay with occasional charcoal flecks and CBM frags. NB. Natural not identified, heavy truncation probable across this area of the site.	1.20m+

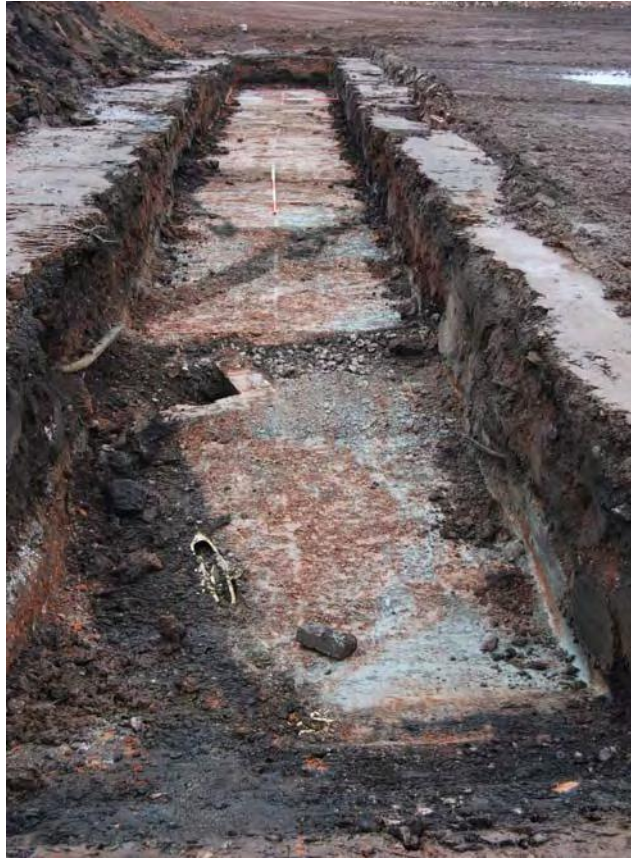
Plate 7 Trench 5 looking east

Maximum dimensions: Length: 23m Width: 2m Depth: 1.20m

Context	Classification	Description	Depth below ground surface (b.g.s) – top and bottom of deposits
500	Re-deposited topsoil	Mixed grey brown loam with much disturbance. Lenses of cleaner clay and darker material. Moderate bricks and pebbles. Overlies (501)	0.00 - 0.32m
501	Layer	Pink re-deposited clay with grey mottling and hardcore. Overlies (502)	0.32 - 0.52m
502	Layer	Black clinker and ash. Overlies (503)	0.52 – 0.73m
503	Natural	Pink clay with grey mottling	0.73m+
504	Drain	Ceramic drain pipe and cut. Fill of mixed material. Cuts (502)	0.52m+
505	Manhole	Brick manhole. Cuts (502)	0.52m+
506	Drain	Drain run cut with hardcore backfill. Cuts (502)	0.52m+
507	Service trench	Service trench backfilled with mixed material. Cuts (502)	0.52m+
508	Layer	Crushed brick concrete seen to north of service trench (504)	0.52m+

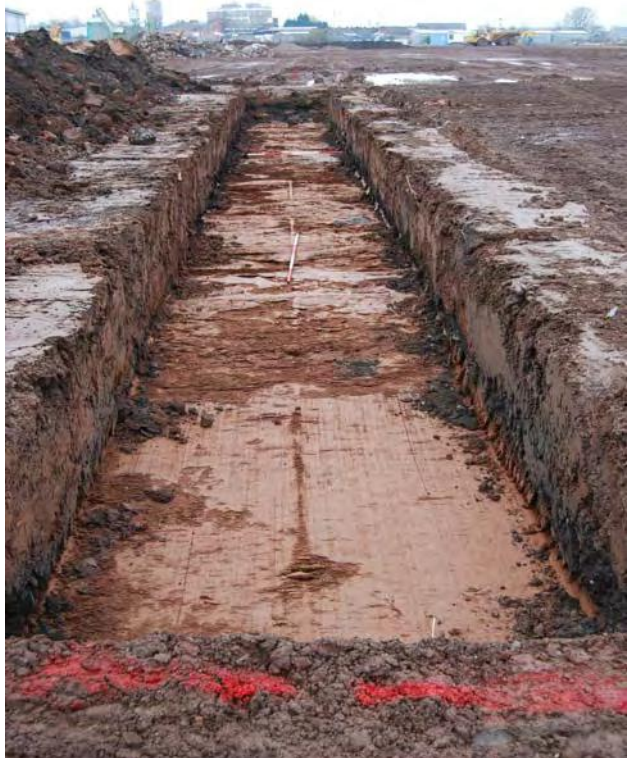
Plate 8 Trench 6 looking south

Maximum dimensions: Length: 24.50m Width: 2m Depth: 1.10m

Context	Classification	Description	Depth below ground surface (b.g.s) – top and bottom of deposits
600	Re-deposited topsoil	Mixed pinky brown clay loam with much disturbance. Lenses of cleaner clay and darker material. Moderate bricks and pebbles. Overlies (601)	0.00 - 0.25m
601	Layer	Mixed pinky brown clay with moderate bricks and pebbles. Overlies (602)	0.25 - 0.60m
602	Layer	Mixture of dark brown black clinker, coal and ash. Very frequent hardcore and occasional lenses of yellow beige small	0.60 – 0.95m

Context	Classification	Description	Depth below ground surface (b.g.s) – top and bottom of deposits
		pebbles and sand. Overlies (603)	
603	Natural	Pink clay	0.95m+

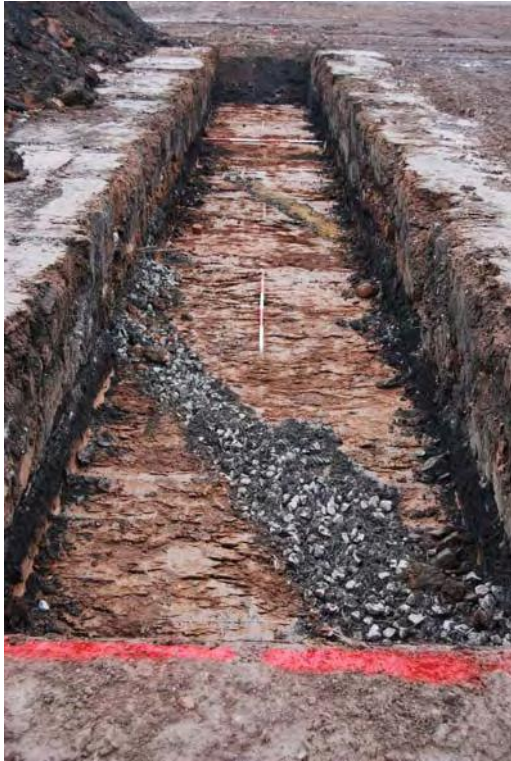
Plate 9 Trench 7 looking south

Maximum dimensions: Length: 23.60m Width: 2m Depth: 1.30m

Context	Classification	Description	Depth below ground surface (b.g.s) – top and bottom of deposits
700	Re-deposited topsoil	Mixed grey brown loam with much disturbance. Lenses of cleaner clay and darker material. Moderate bricks and pebbles. Overlies (701)	0.00 - 0.36m
701	Layer	Dark grey brown clay loam with very frequent bricks, stones and lens of cleaner clay. Overlies (702)	0.36 - 0.78m
702	Layer	Layer of grey hardcore of varying thickness. Overlies (703)	0.78 – 0.88m
703	Layer	Clinker and coal within a black loam. Overlies (704)	0.88 – 1.10m
704	Natural	Pink clay	1.10m+

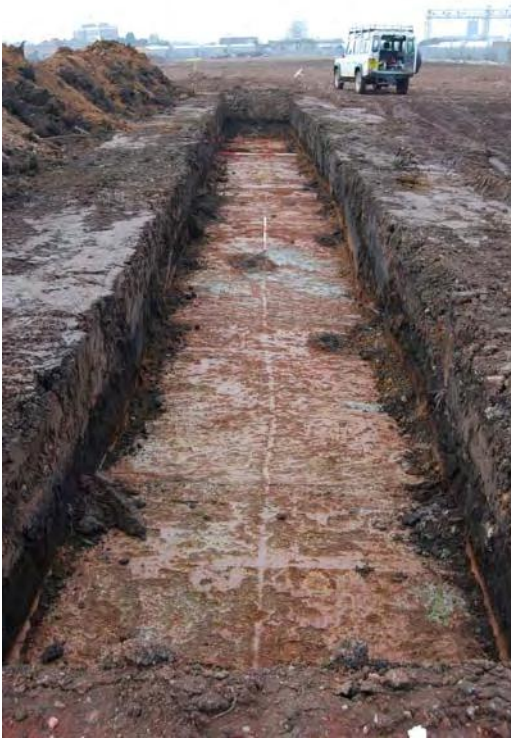
Plate 10 Trench 8 looking south

Maximum dimensions: Length: 25m Width: 2m Depth: 1.10m

Context	Classification	Description	Depth below ground surface (b.g.s) – top and bottom of deposits
800	Re-deposited topsoil	Mixed grey brown clay loam with much disturbance. Lenses of cleaner clay and darker material. Frequent bricks and stone. Overlies (801)	0.00 - 0.60m
801	Layer	Dark grey black clinker, pebbles and coal in a dark loam matrix. Overlies (802)	0.60 - 0.80m

Context	Classification	Description	Depth below ground surface (b.g.s) – top and bottom of deposits
802	Layer	Orange yellow coarse sand and pebbles. Overlies (803)	0.80 – 0.90m
803	Natural	Pink clay with grey mottling	0.90m+
804	Post-hole?	Sub-square cut filled with mixture of (802) and (803). Cuts (801)?	?0.60m+
805	Post-hole?	Sub-square cut filled with mixture of (802) and (803). Cuts (801)?	?0.60m+

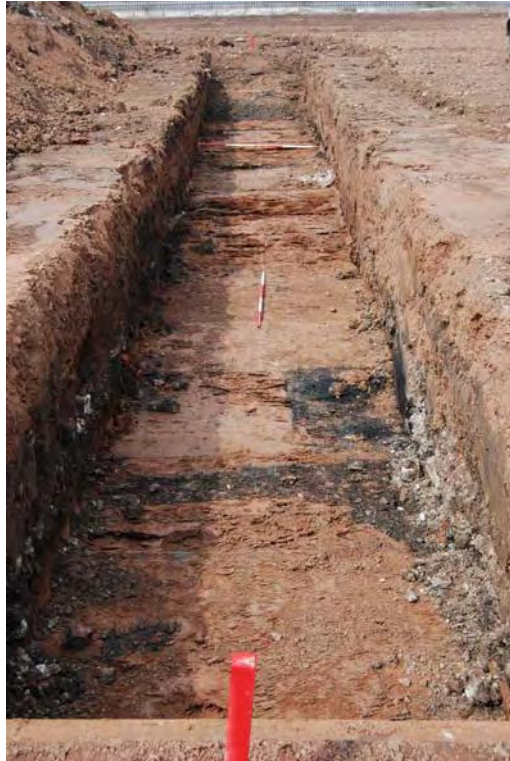
Plate 11 Trench 9 looking west

Maximum dimensions: Length: 23.20m Width: 2m Depth: 1.50m

Context	Classification	Description	Depth below ground surface (b.g.s) – top and bottom of deposits
900	Re-deposited topsoil	Mixed dark brown clay loam with much disturbance. Lenses of cleaner clay. Frequent bricks and stone. Overlies (901)	0.00 - 0.32m
901	Layer	Cleanish pink re-deposited clay. Overlies (902)	0.32 - 0.87m
902	Layer	Mixture of black clinker, coal and dark loam with lenses of pink clay. Overlies (903)	0.87 – 1.09m
903	Natural	Pink clay with grey mottling	1.09m+
904	Service trench	Service trench cut filled with clinker, coal and brick. Cuts (902)	0.87m+
905	Cut	?Sub-square cut filled with black ash and brick. Cuts (902)	0.87m+
906	Brick foundation	Brick footing with grey mortar. Cuts (902)	0.87m+
907	Service trench	Water pipe, cut and backfill of black clinker. Cuts (902)	0.87m+
908	Service trench	Cut and backfill of black clinker. Cuts (902)	0.87m+
909	Cut	Sub-square cut filled with black clinker. Cuts (902)	0.87m+

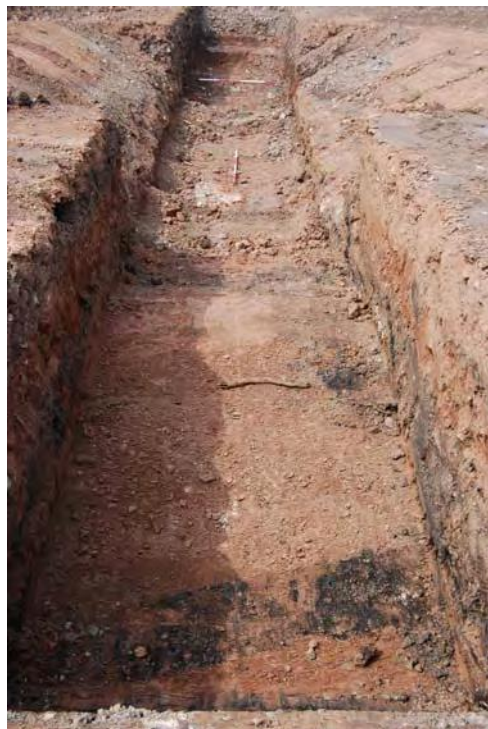
Plate 12 Trench 10 looking west

Maximum dimensions: Length: 24.10m Width: 2m Depth: 2m

Context	Classification	Description	Depth below ground surface (b.g.s) – top and bottom of deposits
1000	Re-deposited topsoil	Mixed light brown clay and darker clay loam with bricks and pebbles. Much disturbance. Overlies (1001)	0.00 - 0.35m
1001	Layer	Pink re-deposited clay with stones and brick. Overlies (1002)	0.35 - 0.90m
1002	Layer	Mixture of black clinker, coal and dark loam with concrete. Overlies (1003)	0.90 – 1.35m
1003	Natural	Pink clay with grey mottling. Only seen in east of trench.	1.35m+
1004	Brick foundation	Brick foundation cutting fill of pit (1005)	1.80m+
1005	Cut	Large cut filled with bricks, brown clay loam and clinker seen in western two thirds of trench. Cuts (1001)	0.35 – 2m+
1006	Service trench	Service trench backfilled with a mixture of (1001) and (1002). Cuts (1002)	0.90m+
1007	Service trench	Service trench backfilled with a mixture of (1001) and (1002). Cuts (1002)	0.90m+
