ARCHAEOLOGICAL
EVALUATION ADJACENT TO
DROITWICH BARGE LOCK,
VINES PARK, SALT WAY,
DROITWICH SPA,
WORCESTERSHIRE

13 October 2008
revised 30 October 2008

Project 3282
Report 1644
WSM 39895

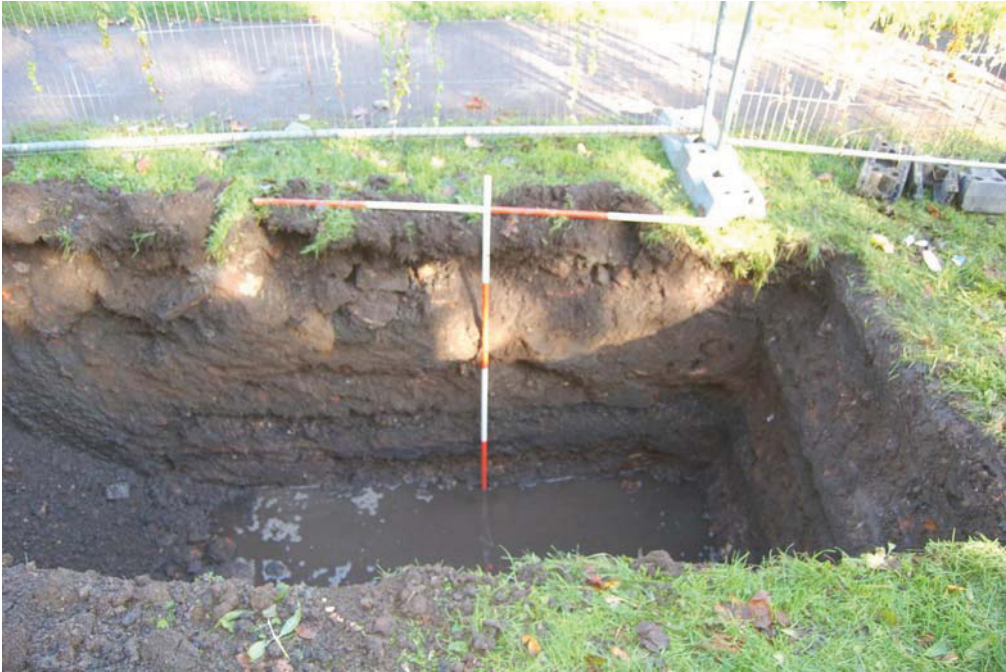
Plate 1 General view of north section of trench

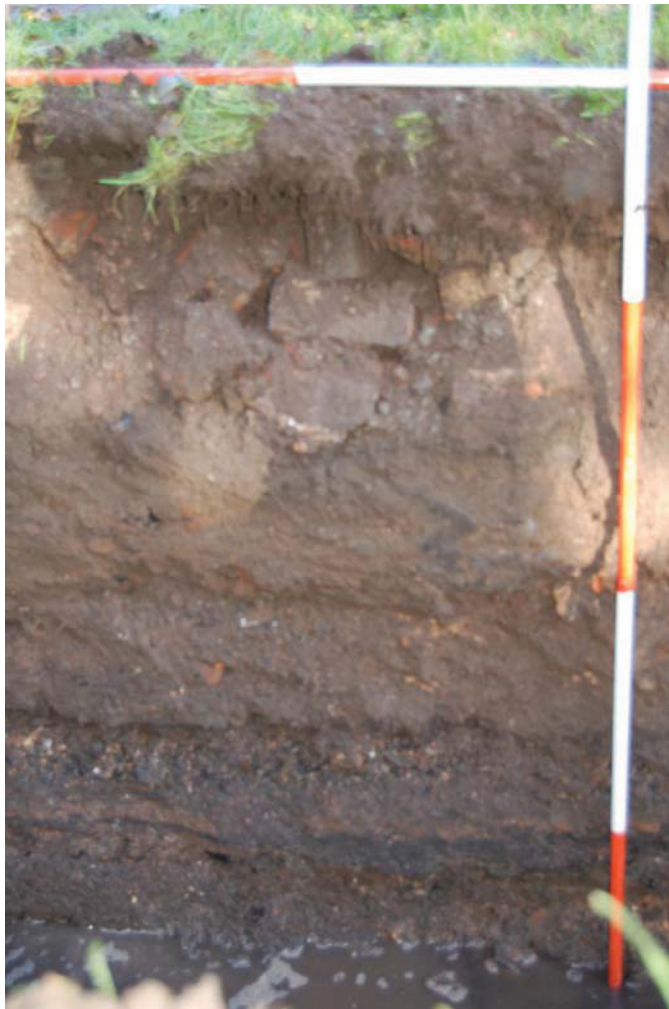
Plate 2 Close up on north section of trench

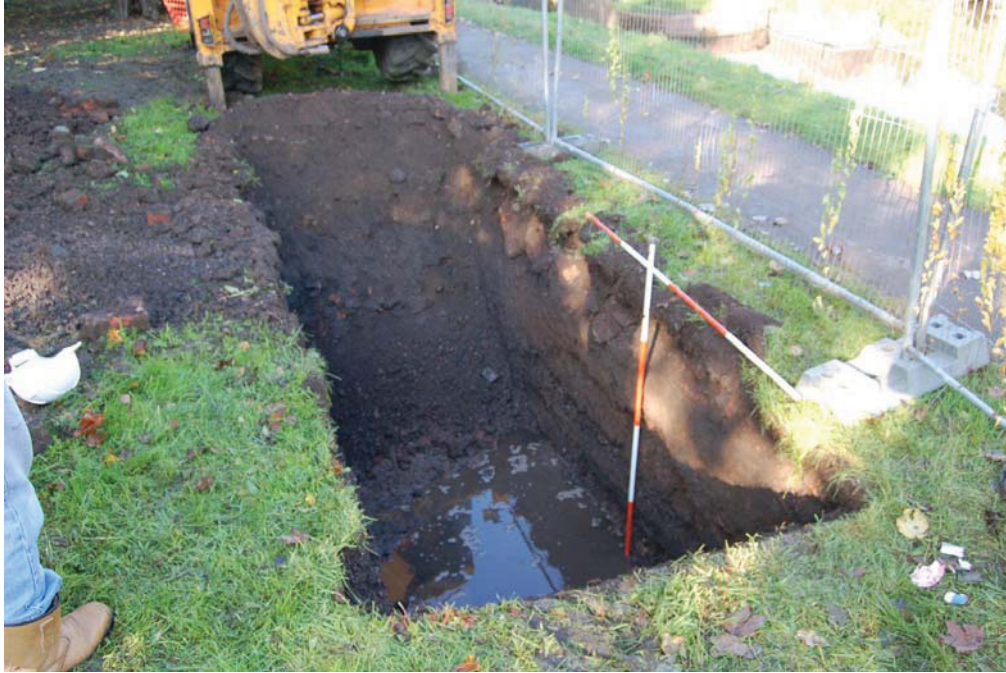
Plate 3 General view of trench, north-west

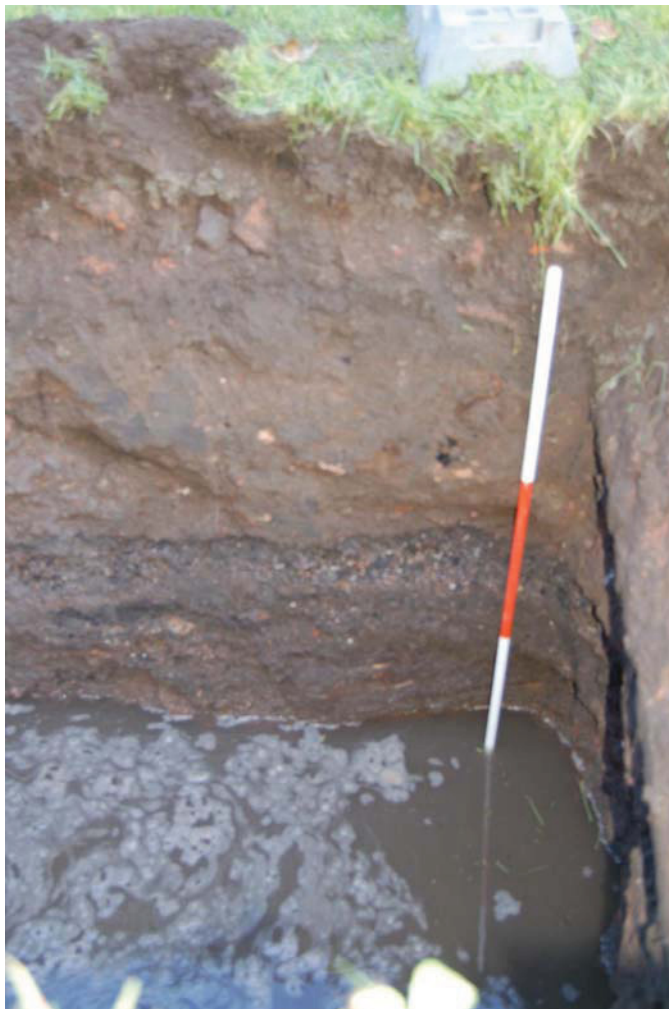
Plate 4 Close up of north-east corner of trench, brick wall 1005 at water level

A single brick structure, 1005, was noted aligned approximately west-south-west to east-north-east within the north section of the trench, continuing into the north-east corner. It comprised at least three courses of bright orangey red machine made bricks set in probable Portland cement below a horizontal roughly squared timber and lay at a depth of 1.33m below the present ground surface (27.64m AOD).

It is unclear to what the brick wall, 1005, within the north-east corner of the trench relates. It does not appear to correlate with any structures identified on the available cartographic sources. It can however be tentatively identified as of mid/late 19th century date, and may relate to the original construction of the Junction Canal in 1854.

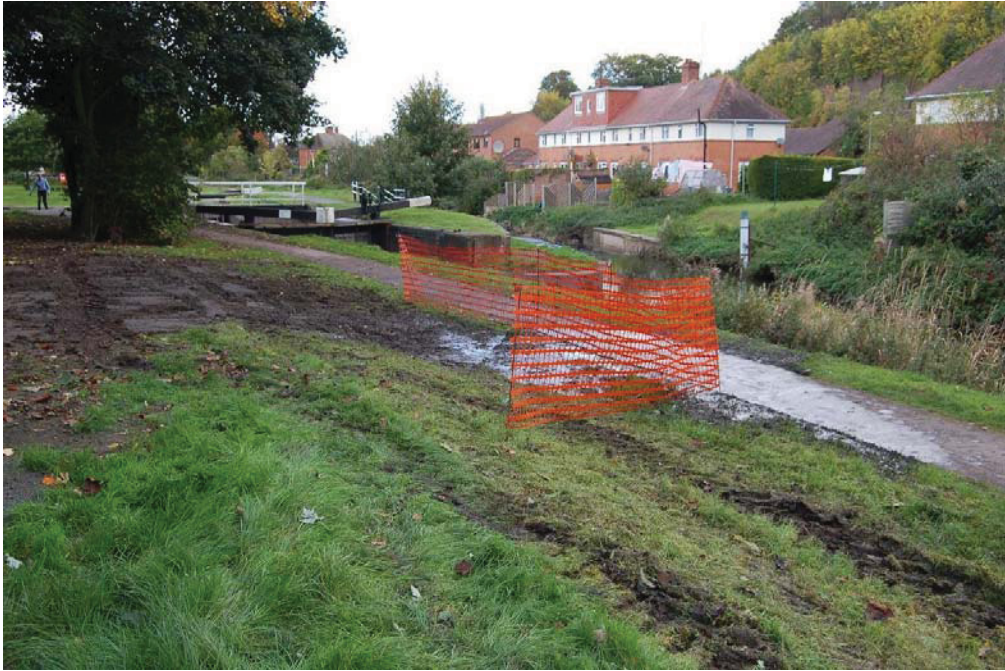
Plate 5 Trench as backfilled, view west-north-west

recording was undertaken from the surface. Deposits were recorded according to standard Service practice (CAS 1995). On completion of excavation, the trench was reinstated by replacing the excavated material.
