ARCHAEOLOGICAL WATCHING  
BRIEF,  
AT  
ST EADBURGHAS CHURCH,  
BURY END, BROADWAY,  
WORCESTERSHIRE

27 April 2009

INVESTOR IN PEOPLE  
Project 3163  
Report 1685  
WSM 38359

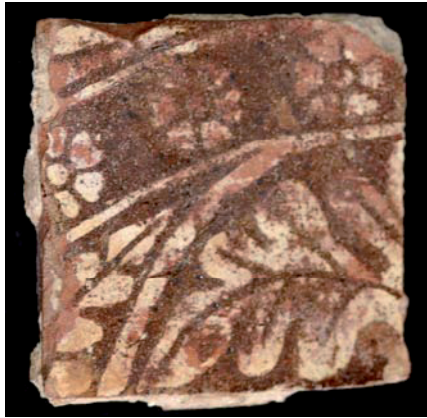
*Plate 1*  
*Decorated medieval tiles (Scale 1:3)*

Of the remaining finds from context 10003, the most significant were three decorated and glazed medieval floor tiles. These were highly fired and slightly distorted, and had hard reddish-brown fabrics, which appeared purplish-brown when glazed. Inclusions comprised ill-sorted quartz and iron-rich material.

The first of these tiles was complete, square in plan, but slightly tapering with depth, in order to facilitate removal from a mould; its size, 5x 4<sup>7</sup>/<sub>8</sub>x1<sup>1</sup>/<sub>8</sub>" (127x124x25-27mm), lay within the range measured for 15<sup>th</sup>-16<sup>th</sup> century tiles from Broadway Priory, which were also reported to have been purplish-brown in colour (Eames 1980). The decoration on the present tile was produced using a white slip, but surface-coated rather than inlaid (Plate 1). The elements of its foliate design, which included stylised six-petal flowers, were identical to design 3004 reported by Eames for tiles from Broadway Priory. This type of decoration would have been part of a multi-tile arrangement, and has been attributed to the Malvern School. This was in its ascendancy during the mid 15<sup>th</sup> century. However, the site of manufacture for the tiles previously found at Broadway Priory has not been determined.

The second tile was approximately 80% complete. Its original size would have been 5x5x1<sup>1</sup>/<sub>8</sub>" (126x127x27-28mm), i.e. similar to the one described above, and was also slightly tapered in depth. Its white slip was applied as a shallow inlay (Plate 2), using a design that featured a lion's head and mane, surrounded by curved borders and rosettes. This was practically identical to Eames' catalogued design 2928. However, it was noted that the latter, with a date range 1249-1269, was found at Meaux Abbey, in Yorkshire, and probably manufactured in that locality. Moreover, the Meaux Abbey tiles were much smaller in size (77x76x31mm) than the Broadway example. Thus, it would appear likely that the design, if not the tiles themselves, had travelled a considerable distance, and was 13<sup>th</sup> century, or later, in date.

The third tile was broken, but it was fair to assume that it had been square as well. It was slightly smaller than the first two, with dimensions 4<sup>3</sup>/<sub>4</sub> × 3<sup>1</sup>/<sub>8</sub> × 1" (121 × >80 × 25mm), and also differed by having its white slip inlaid. This design appeared to be a component of a multi-tile arrangement, based on foliate patterns. Examination of designs in Eames' catalogue and in Tileweb (2009) failed to locate a close match with this tile, although the fabric characteristics were consistent with a local source of clay having been used in its manufacture.

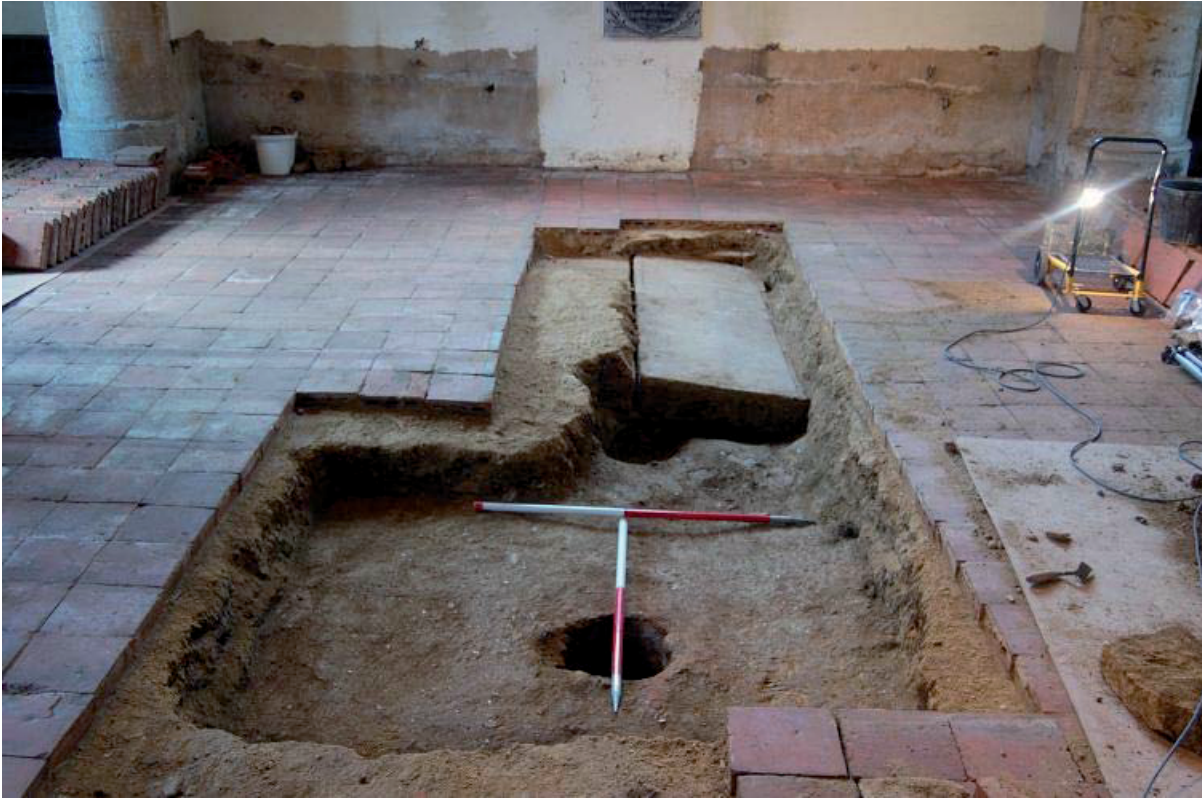
*Plate 4 General view of excavations in progress, facing west, with grave slab 10004 in the background*

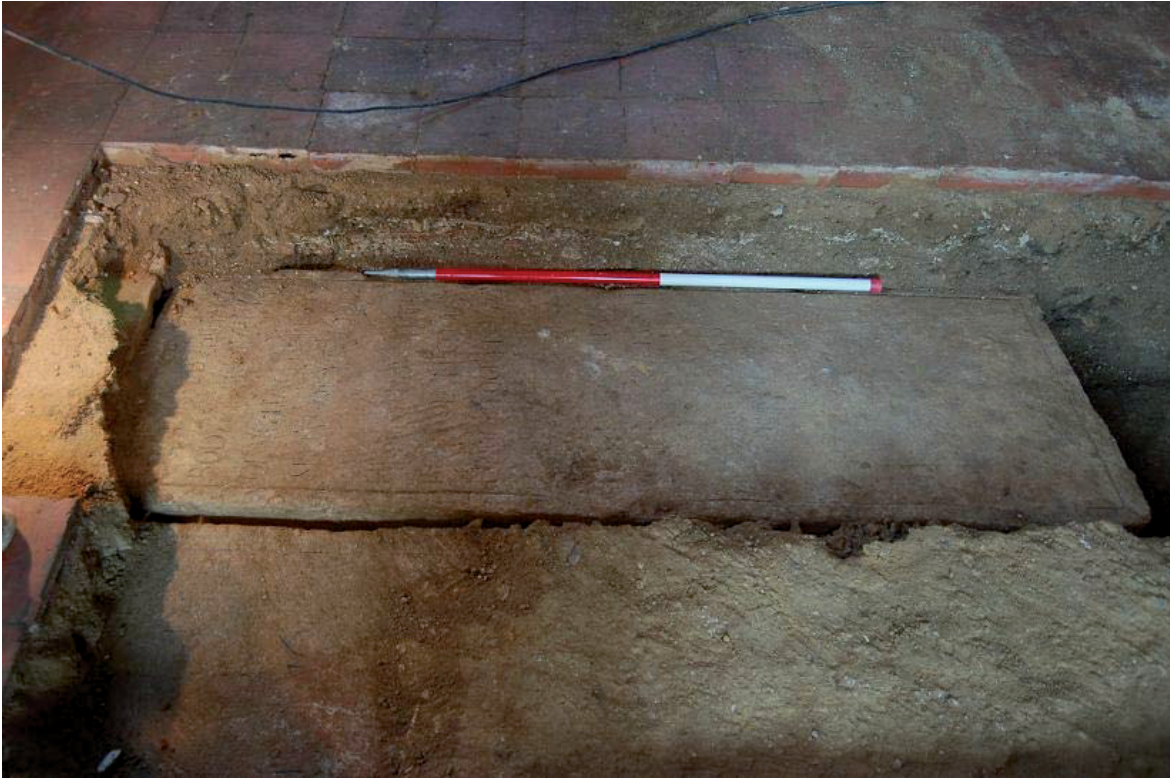
*Plate 6 Hobday grave slab 10004, dated 1622, facing north*

In the western area of the nave, grave slabs 10004 and 10005 were revealed 0.30m below the ground surface, sealed by 10002. They were carved from pale yellowish grey limestone, 2m long, 0.90m wide and 0.22m thick, with incised borders around the edges.

Unfortunately the lower portion of the inscription was almost entirely worn away and illegible.

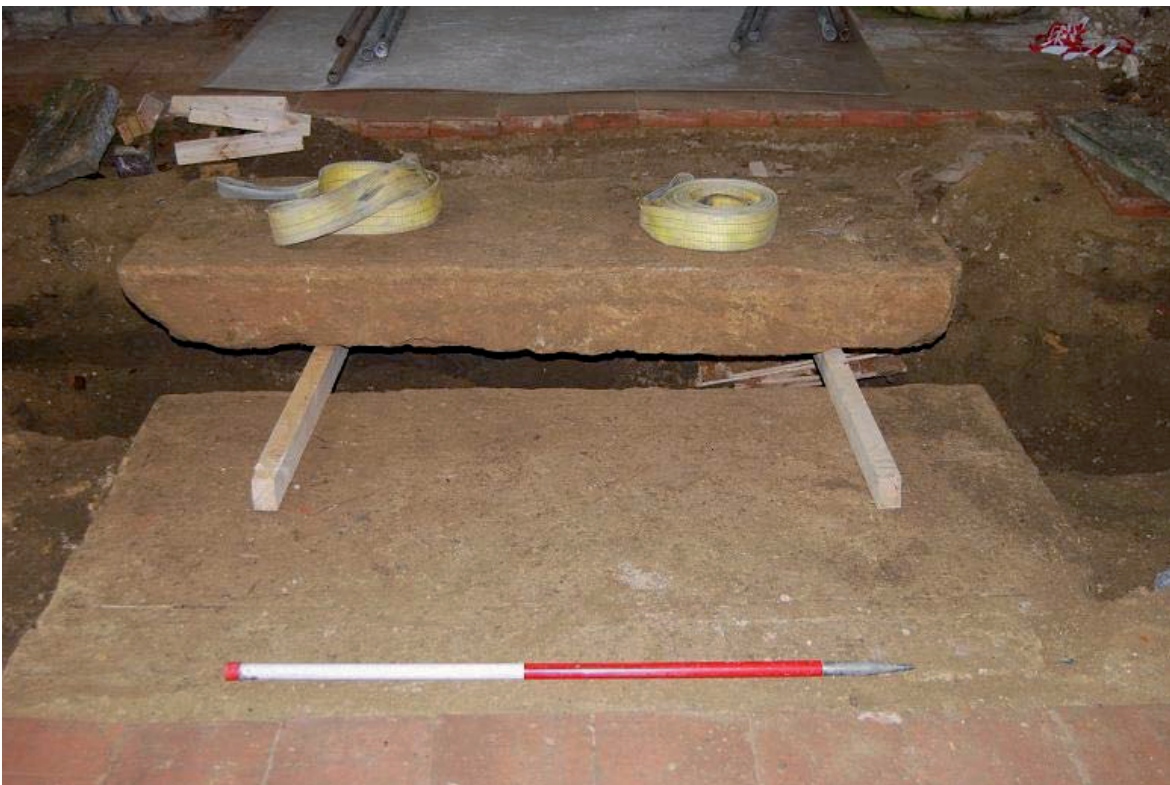
*Plate 7 Grave slabs 10004 and 10005, dated 1622 and 160\*?, facing north*

Grave slab 10005 was in poor condition, so it was not possible to decipher much beyond occasional letters and a partial date '160.'. This slab was bedded on and formed the top of a red brick vault (10011), measuring 1.90m long, 0.76m wide and more than 0.50m deep. However the full depth was not revealed during the excavation and the interior was filled with a loose brown sandy loam (similar to 10006). It is unclear if the vault contained burials.

The two grave slabs are similar in size and style with incised borders and are adjacent to each other, suggesting the two are broadly contemporary. While the inscription on 10005 was only partially legible, with a date sometime in the first decade of the 17<sup>th</sup> century date, the first inscription on the Hobday grave slab (10004) dates to 1622.

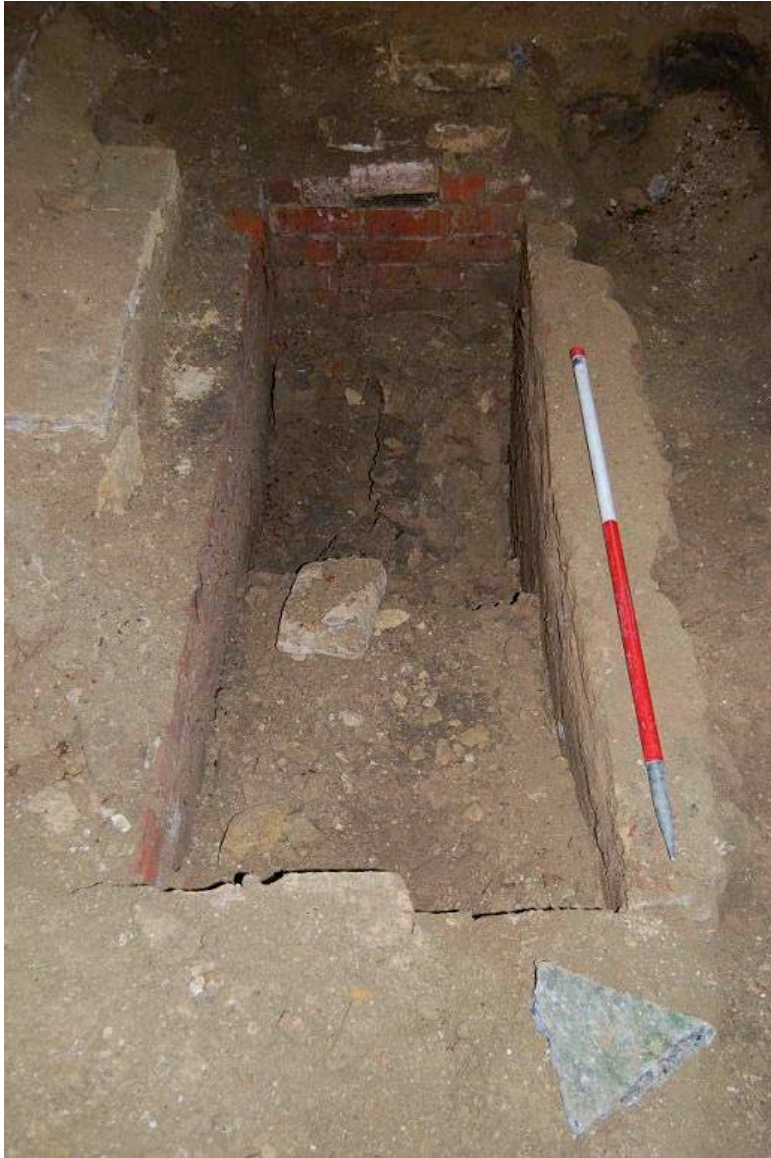
*Plate 8 Brick vault 10011, below slab 10005, dated 18<sup>th</sup> to mid 19<sup>th</sup> century, facing west*

A single intact brick was retrieved from context 10011. This was handmade and hard fired, with some cracking, and a substantial amount of poorly mixed lime mortar still adhering. Its size, 8 $\frac{7}{8}$ x4 $\frac{1}{8}$ x3" (225x105-107x75-78mm), and lack of a recessed frog indicated a probable late 18<sup>th</sup> to mid 19<sup>th</sup> century date of manufacture.

The area within the nave has been heavily disturbed during the documented alterations to the church (detailed in Section 3 above). A *terminus post quem* date of 1784-1850 was provided for the brick vault (10011) below grave slab 10005, indicating that it is not in its original position, but had in fact been reused.

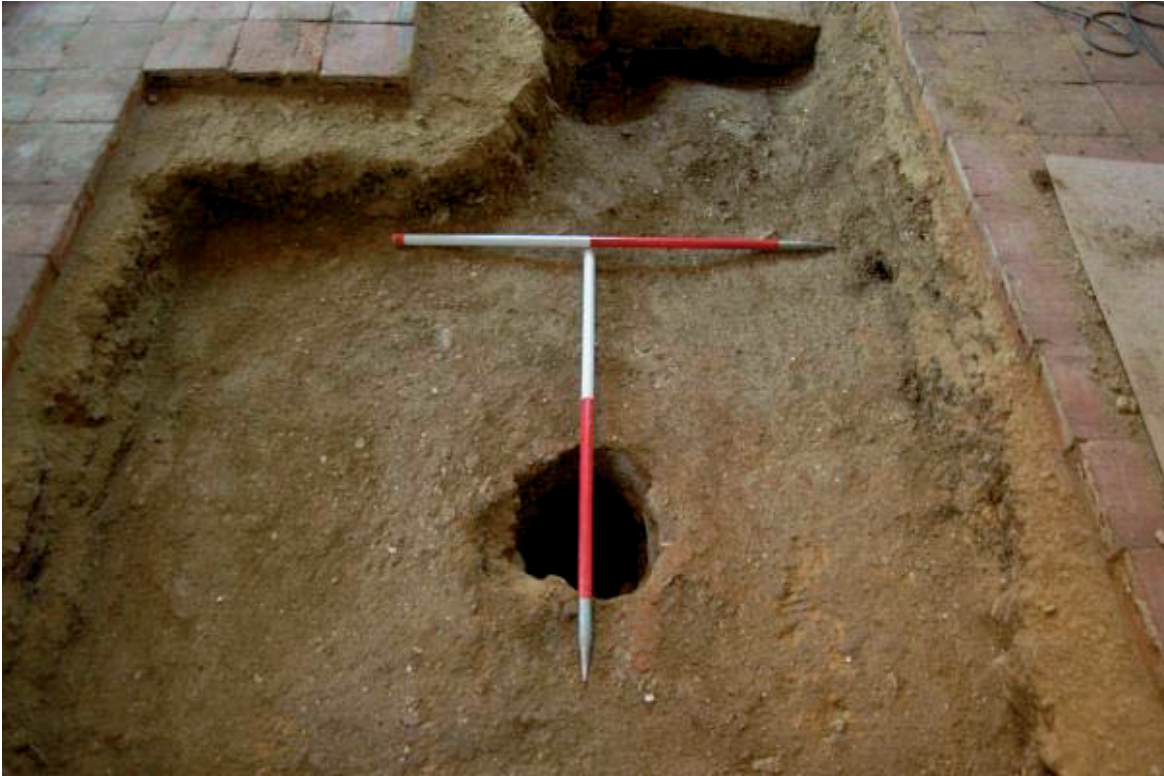
*Plate 9 Hollow 10010, facing west*

Deposit 10003 below 10002 was 0.30m below the ground surface and 0.10m deep. Located within 10003 to the east of nave was a circular hollow 10010 0.18m deep. No similar features were associated with 10010.

The circular hollow 10010 may also relate to subsidence although it is possible that it is a posthole relating to the to 19<sup>th</sup> century repairs.

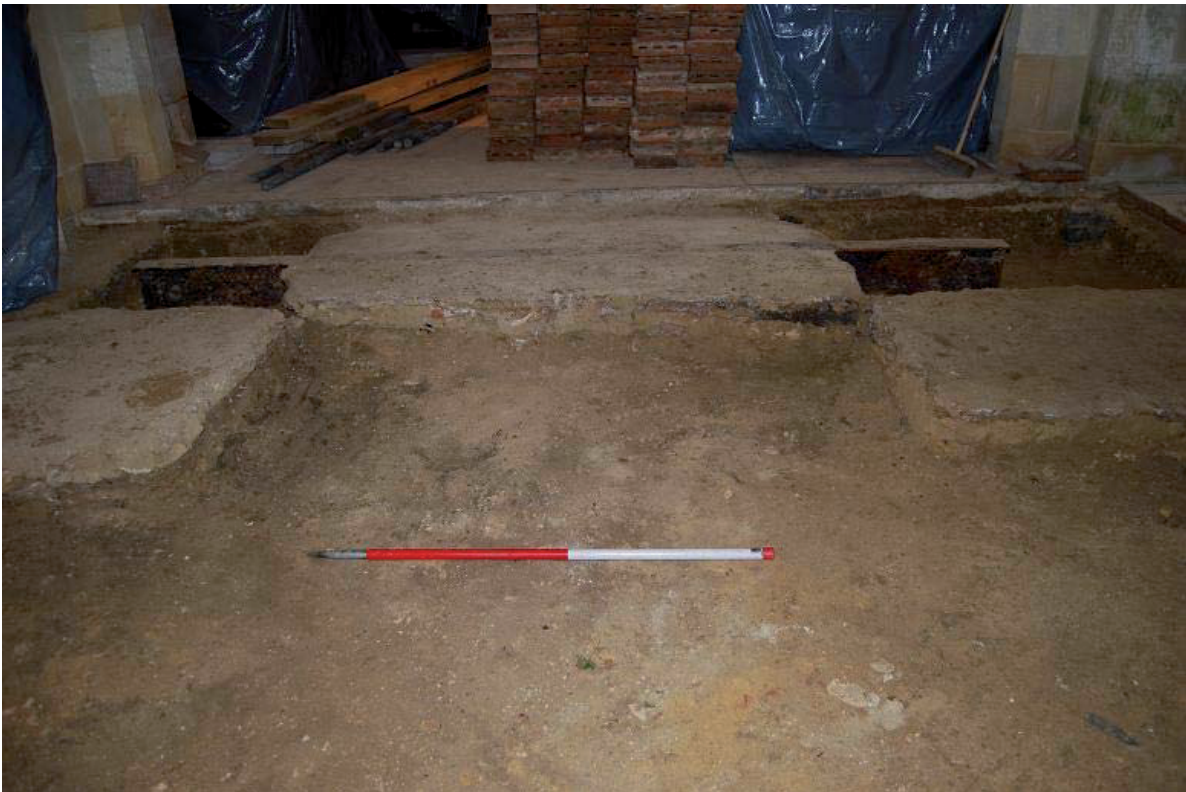
*Plate 10 Concrete bases 10012 and steel 10013, facing east*

Located at the foot of the tower, in the eastern area of the nave were concrete slabs (10012), sealed by 10002, measuring 2m long, 1m wide and 0.12m deep. A very compact dark reddish brown loam (10014) was revealed below 10003 and truncated by 10011.
