# ARCHAEOLOGICAL WATCHING BRIEF AT MERCHANT'S QUAY, THE DOCKS, GLOUCESTER

24 November 2010

Project 3477  
Report 1803

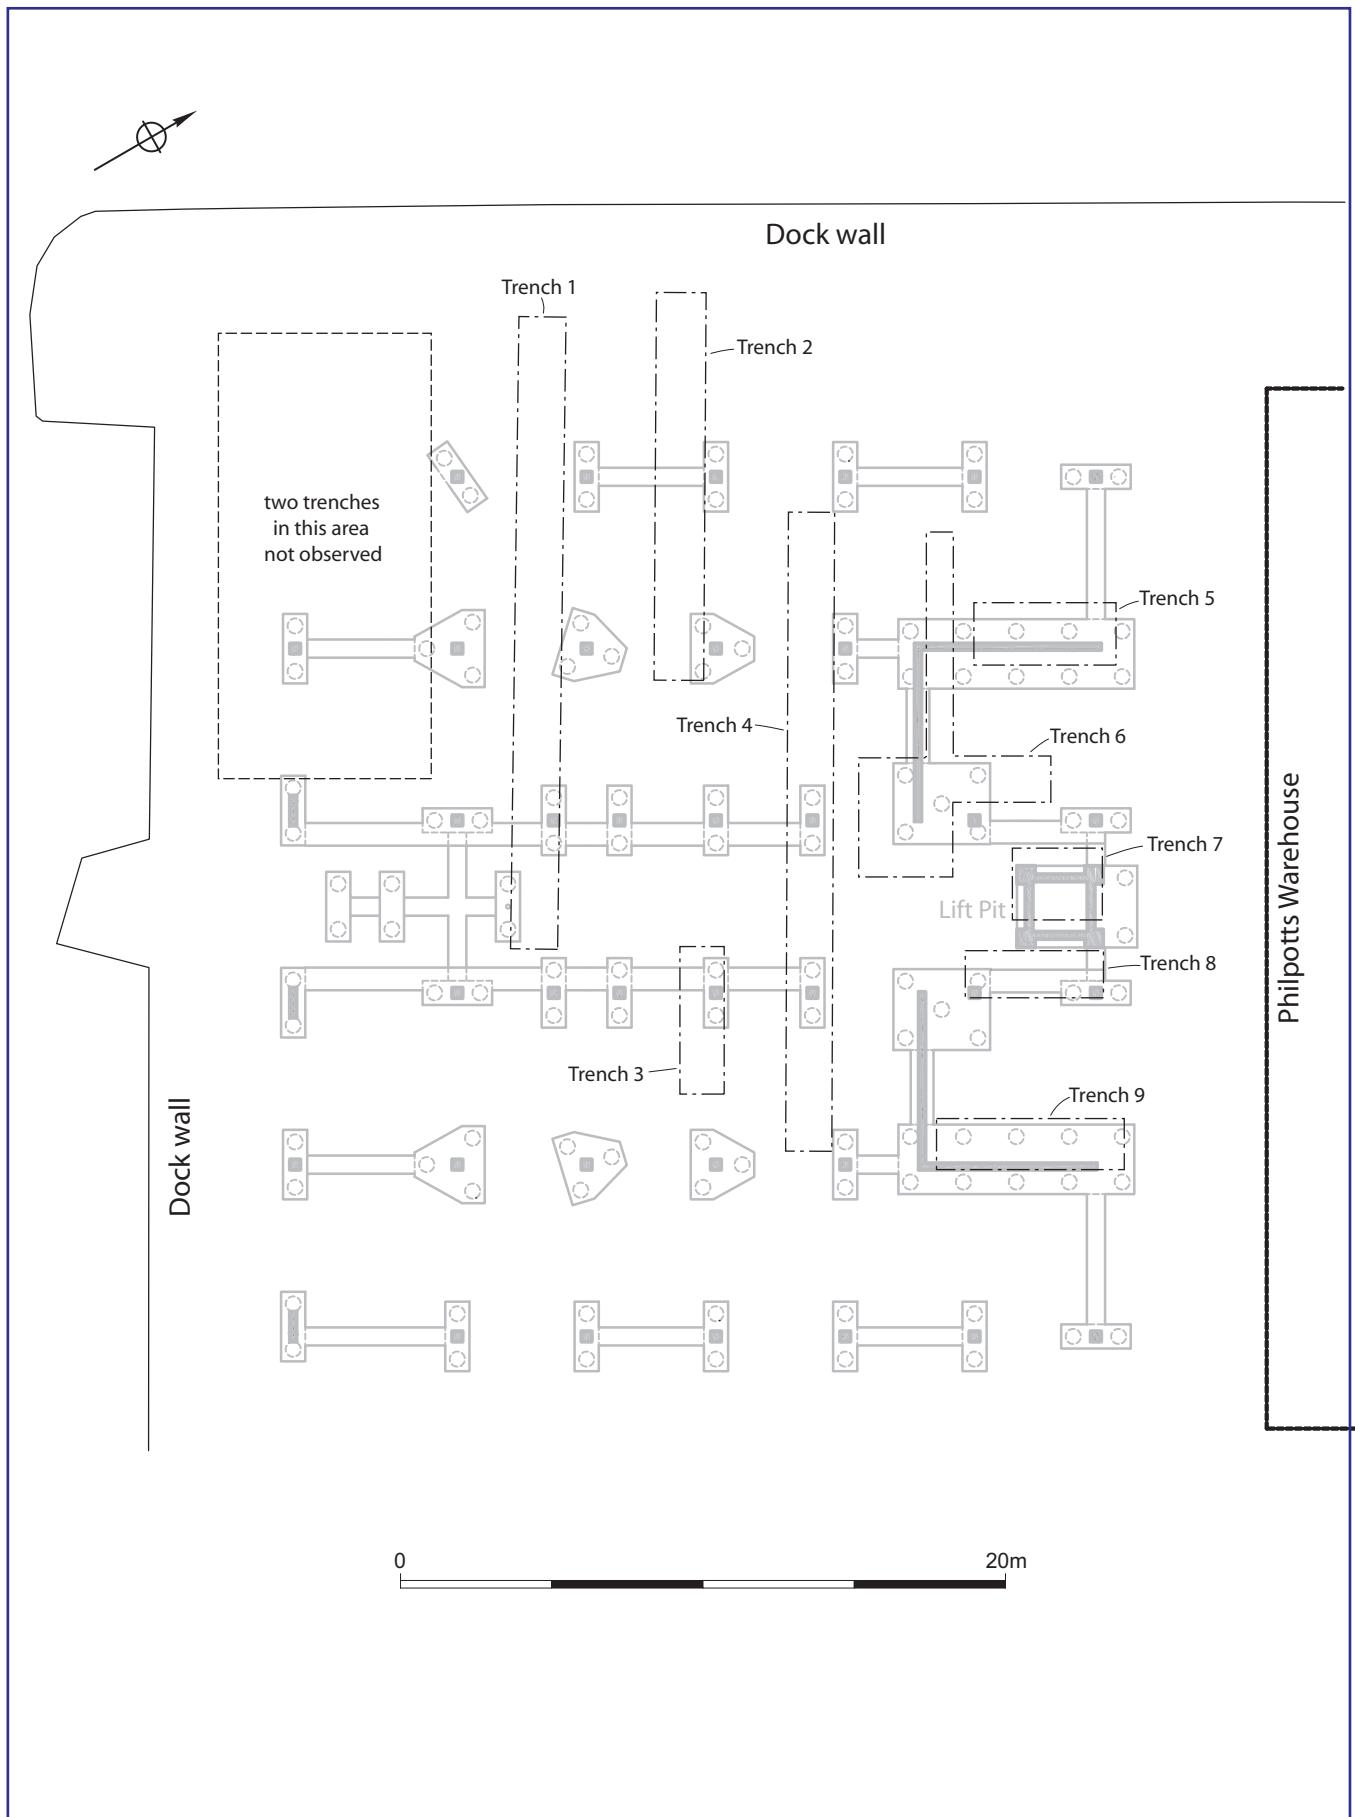
Figure 2

Location of trenches (based on Arup Dwg F02)

The excavation of nine trenches to varying depths was monitored. The trenches amounted to just over 141m<sup>2</sup> in area. Within the site area of approximately 1540m<sup>2</sup>, this represents an observed sample of 9% (Fig 2). The works were undertaken to determine the extent of hydrocarbon contamination on site. For example, Trench 6 was extended to the north-west in order to discover the source of a quantity of diesel that was flowing from a disused service pipe trench.

The trench locations are shown in Figure 2. The results of the structural analysis are presented in Appendix 1.

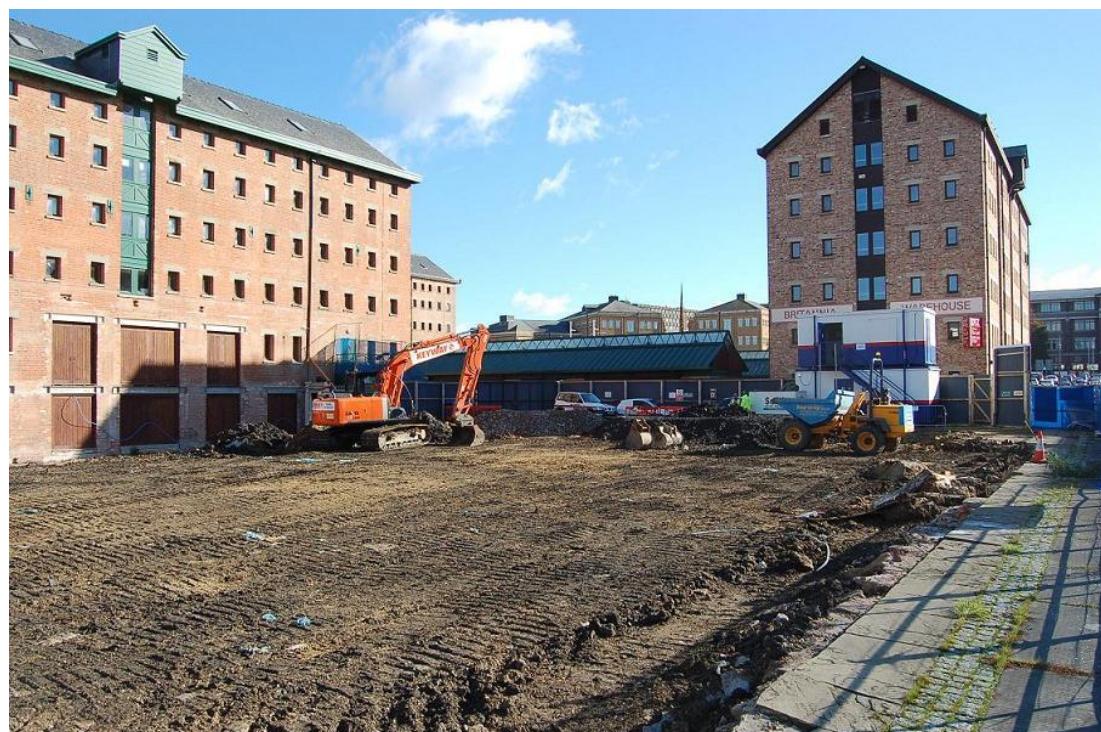
*Plate 1, General east view of the site, with Philpott's warehouse to the left*

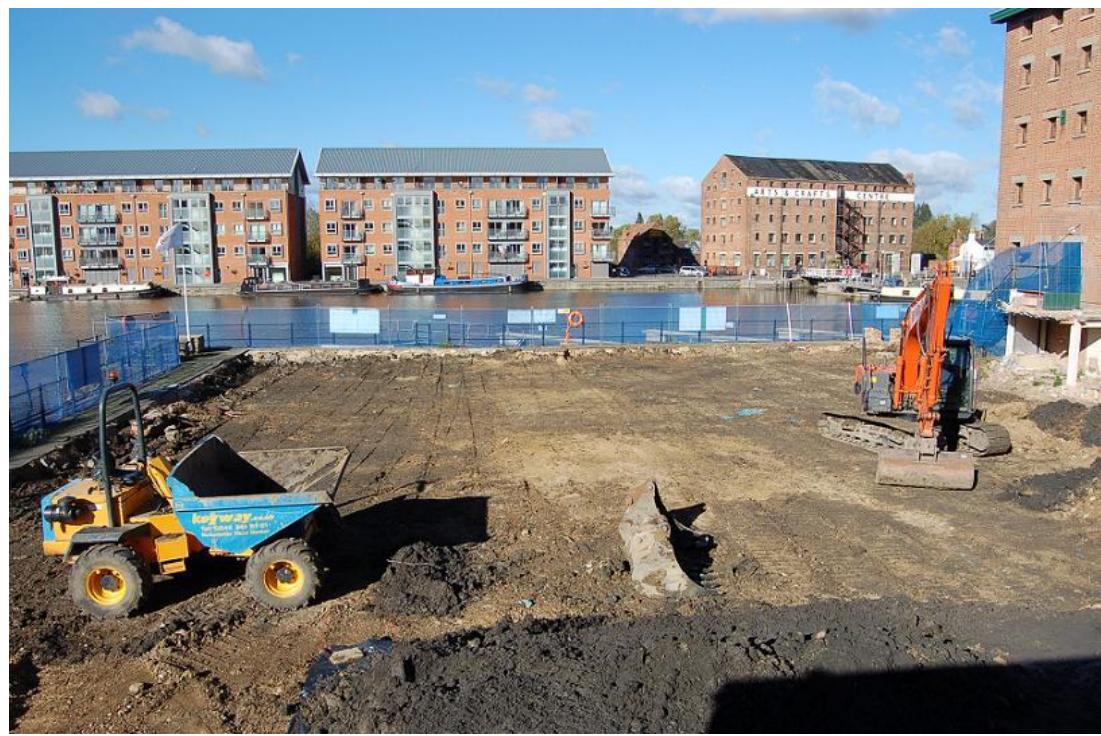
*Plate 2, General north-west view of the site, with the Main Basin in the background*

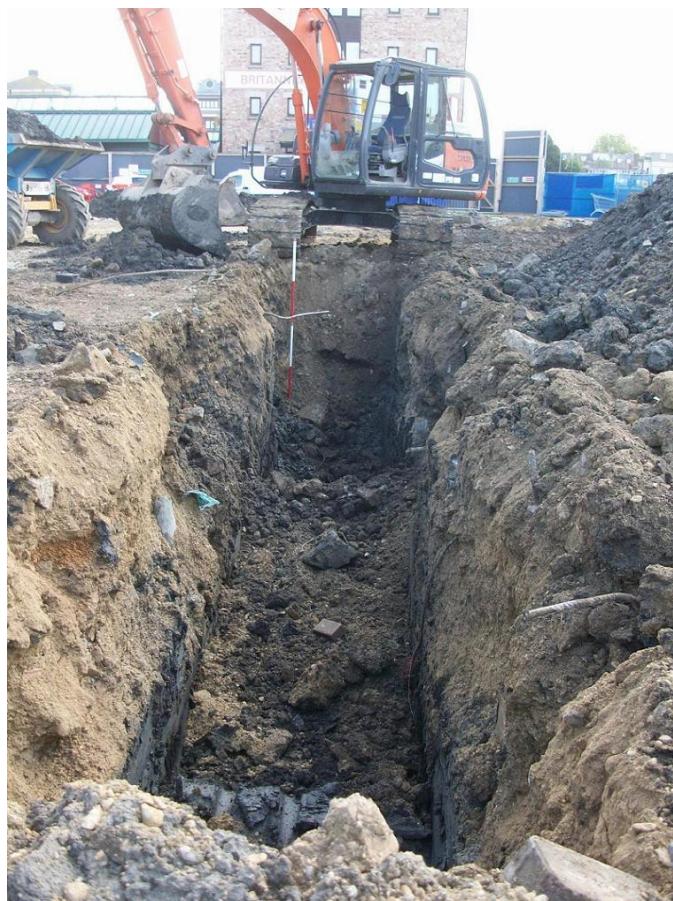
*Plate 3, Trench 1 during machining, view south-east*

| Context | Classification | Description | Depth below ground surface (b.g.s) – top and bottom of deposits |
|---|---|---|---|
| 100 | Made Ground | Mixed light yellowish brown fine sand and pebble gravel. Loose and un-cohesive, cut by frequent services and contains patches of medium orange yellow pea gravel. Includes brick and concrete rubble, iron rods and blue plastic. | 0.00-0.90m |
| 102 | Natural sand | Light grey fine sand with occasional orange grey patches. Loose throughout. | 2.34m+ |

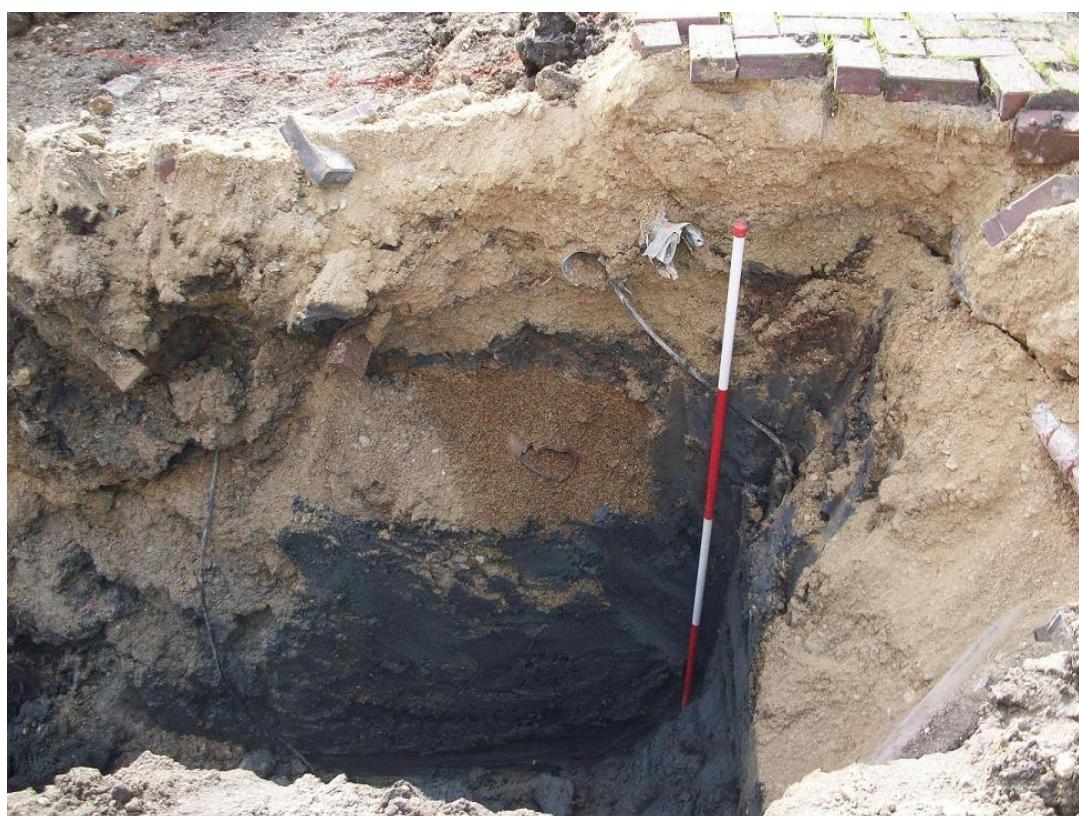
*Plate 4, Trench 2 section at north-west end of the trench, view south-west*

| Context | Classification | Description | Depth below ground surface (b.g.s) – top and bottom of deposits |
|---|---|--|---|
| 200 | Made Ground | Mixed light yellowish brown fine sand and pebble gravel. Loose and un-cohesive, cut by frequent services and contains patches of alluvial clay - probably disturbed remains of layer (201) when services put in. Includes brick and concrete rubble, iron rods and blue plastic. | 0.00-1.30m |
| 202 | Natural sand | Light grey fine sand, becomes waterlogged with depth. Loose throughout. | 2.60m+ |

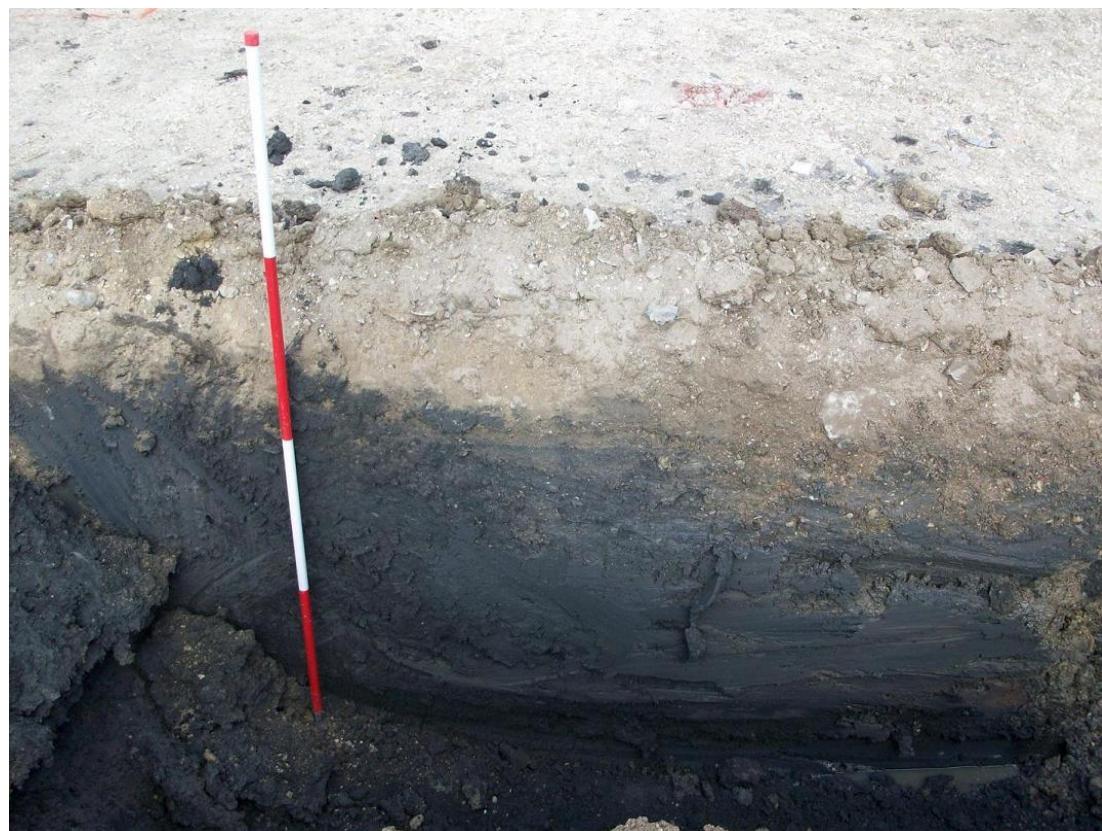
*Plate 5, Trench 3 sample section, view north-east*

| Context | Classification | Description | Depth below ground surface (b.g.s) – top and bottom of deposits |
|---|---|---|---|
| 300 | Made Ground | Mixed light yellowish brown fine sand and pebble gravel. Loose and un-cohesive, cut by frequent services and contains patches of medium orange yellow pea gravel. Includes brick and concrete rubble, iron rods and blue plastic. | 0.00-0.80m |

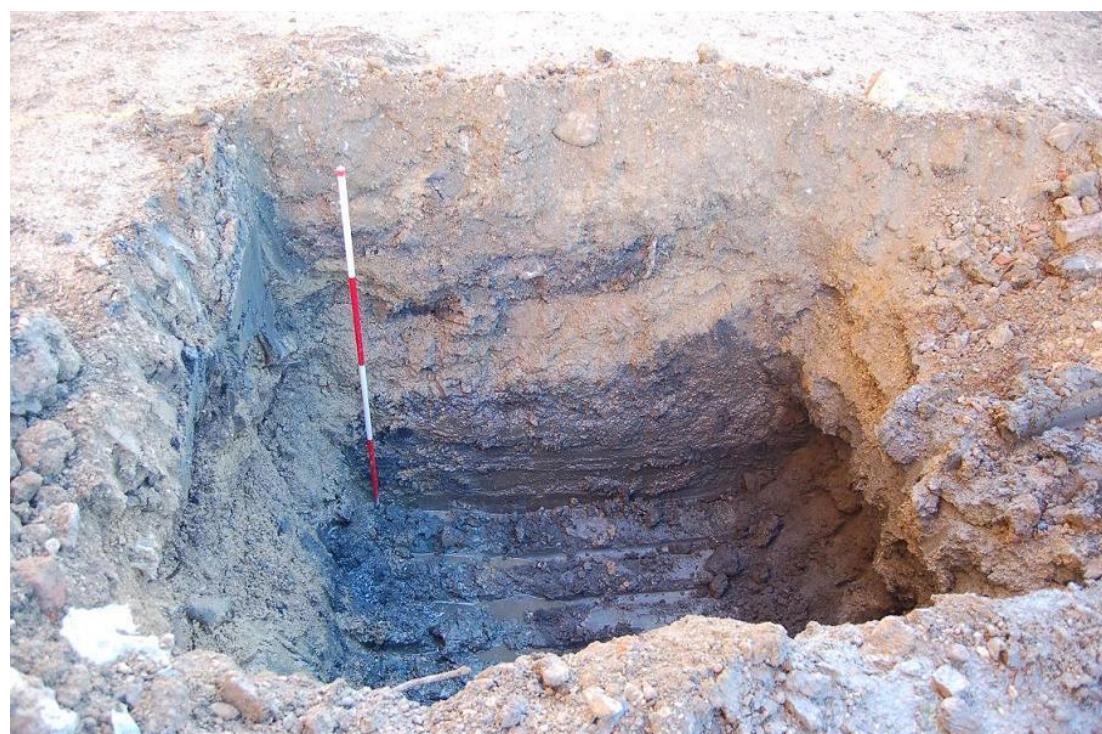
*Plate 6, Trench 7 section, view south-east*

| Context | Classification | Description | Depth below ground surface (b.g.s) – top and bottom of deposits |
|---|---|---|---|
| 702 | Natural sand | Light blue grey sand, becomes waterlogged with depth. Loose throughout. | 2.30m+ |
