ARCHAEOLOGICAL
EVALUATION
AT
HALL GREEN WORKS,
WEST BROMWICH

2nd July 2010

Project 3496
Report 1769
WMJHLCL 10

Archaeological Evaluation at Hall Green Works, West Bromwich, Metropolitan Borough of Sandwell.

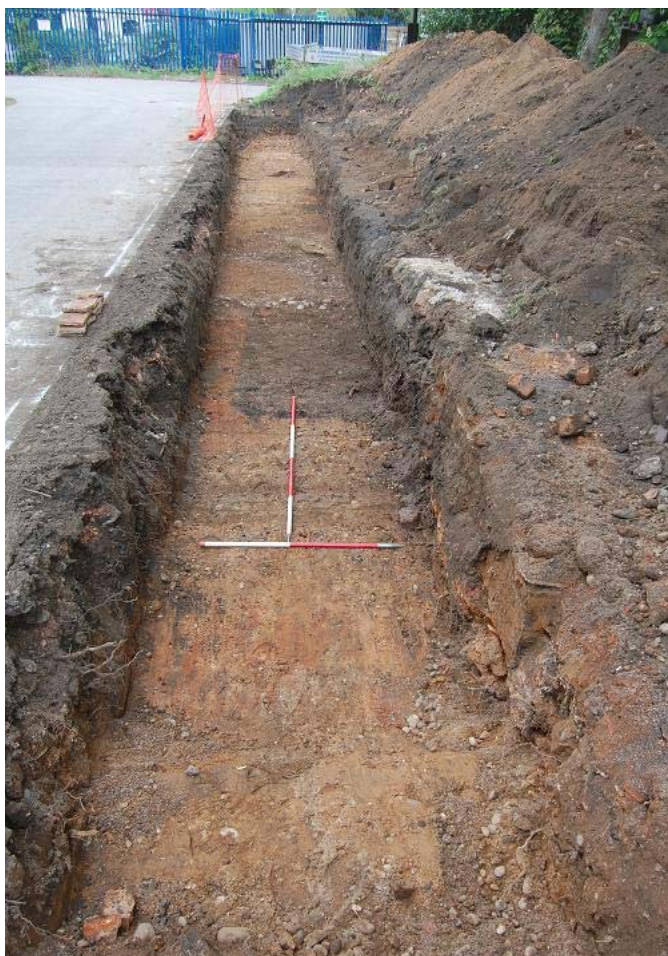
Plate 1: Trench 1, facing southwest

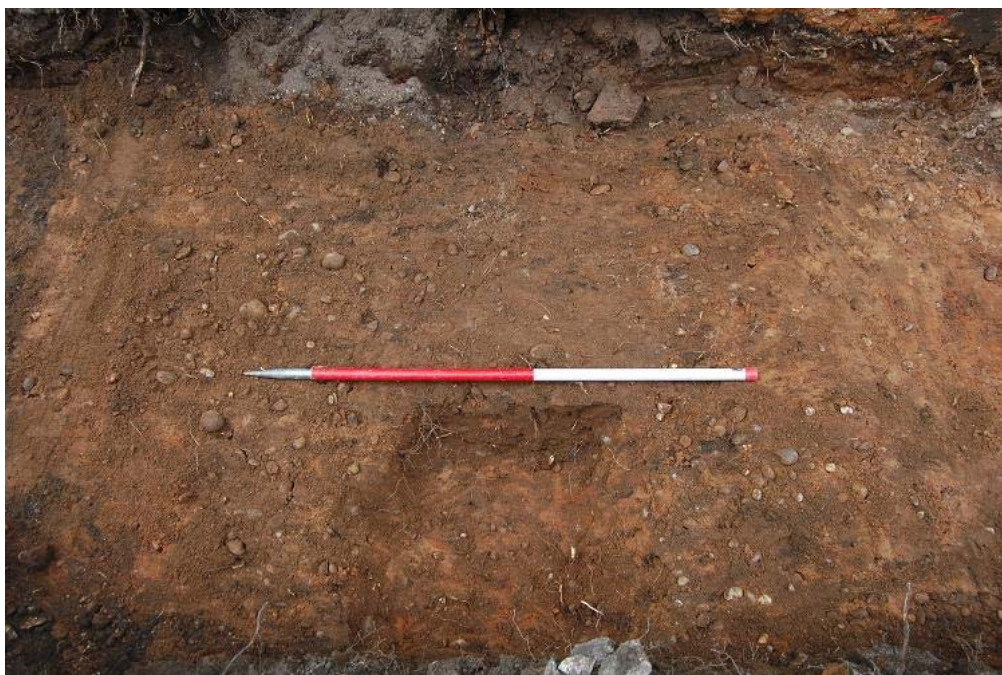
Two NW-SE ditches; [013] and [030] were seen towards the eastern end of Trench 1. Ditch [030] was seen only in section. It was 0.75m wide and 0.30m deep forming a wide 'V' profile with curved base. It would, however, originally have cut from higher; the upper reaches having been truncated. An estimate would put the original depth at 0.63m, if cutting from the top of the subsoil. Ditch [013] was similar in profile, cutting some 0.18m deeper to 137.37m AOD. It was seen to cut through the aforementioned subsoil. Neither ditch was found to contain any datable material, although a sample was taken from ditch [013] for potential finds recovery and dating. The stratigraphic relationship between the two intercutting features was unfortunately uncertain. Both ditches were filled with a homogenous silty sand. The fill of ditch [030] was slightly paler and more orange than the mid brown of [013], which may suggest that it is earlier, being closer in character to the natural.

Plate 2: Ditch [013], facing northwest

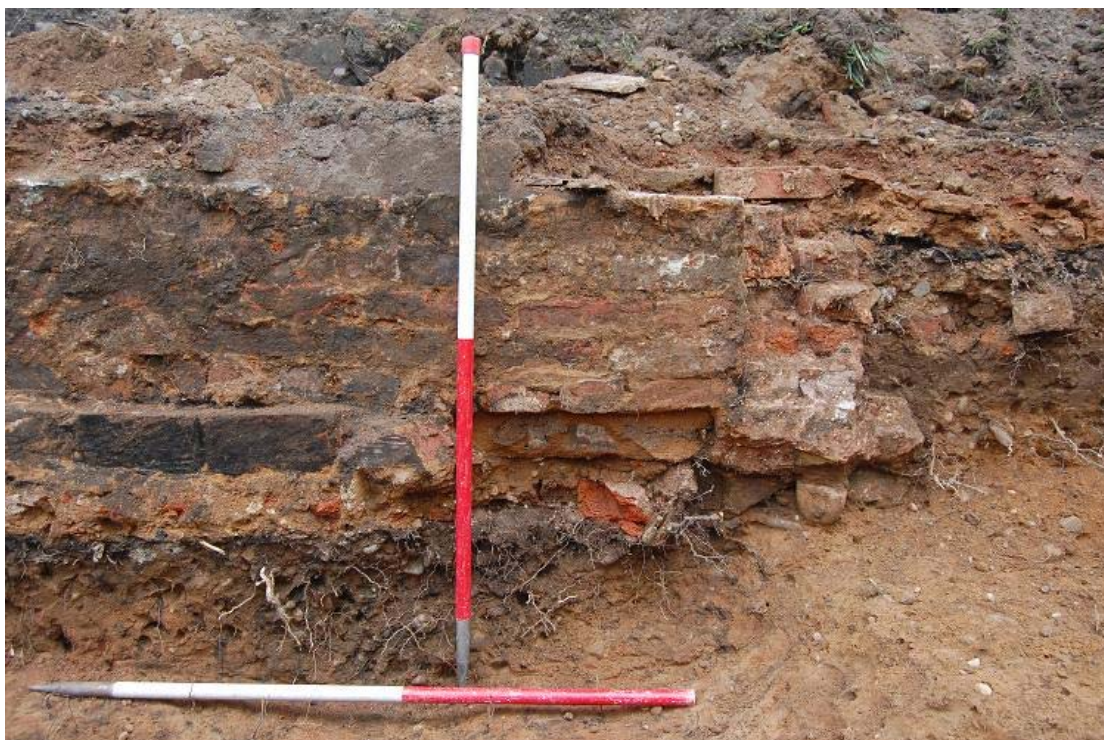
To the far east of Trench 1, a brick wall with stone foundation (023) was seen to run NW-SE. The construction cut [025] was 0.25m deep, cutting through the subsoil (026). It had a flat base and was filled predominantly with roughly squared green sandstone blocks, up to 250mm in diameter, although quartz and flint nodules were also incorporated. The central core of this material was bonded with a mottled pink lime mortar, while the peripheries were filled with (024); a greenish grey silty sand with occasional charcoal and mortar flecks. The wall (023) was stretcher built, utilising 2 types of brick; 2" unfrogged bricks probably from the C17th, and distinctive bricks as found in Hall Green House; c.1800. The wall was also bonded with mottled pink lime mortar.

The wall (023) that ran parallel to ditches [030] and [013] is of significance. The foundation (024) was built not of brick like the superstructure, but of mixed masonry; predominantly roughly squared green sandstone blocks. The only other building in West Bromwich known to have stone foundations such as these is the thirteenth century manor house 200m to the west (*G. Eyre-Morgan, pers. comm.*). A sampled brick from the wall itself was tentatively dated to the late sixteenth to early eighteenth century, but distinctive hand made bricks the same as those used to build Hall Green House, dated c.1800 were also used. This would suggest the wall to date from c.1800 onwards, but it is thought that the foundation may be earlier in origin. This supports the prediction of post medieval structures identified in the original brief (*G. Eyre-Morgan 2010*). The wall (023) and its foundation were sealed by an occupation horizon or possible earth floor, (022).

Plate 3: Wall (023) on foundation (024), with added structure (019), facing north.

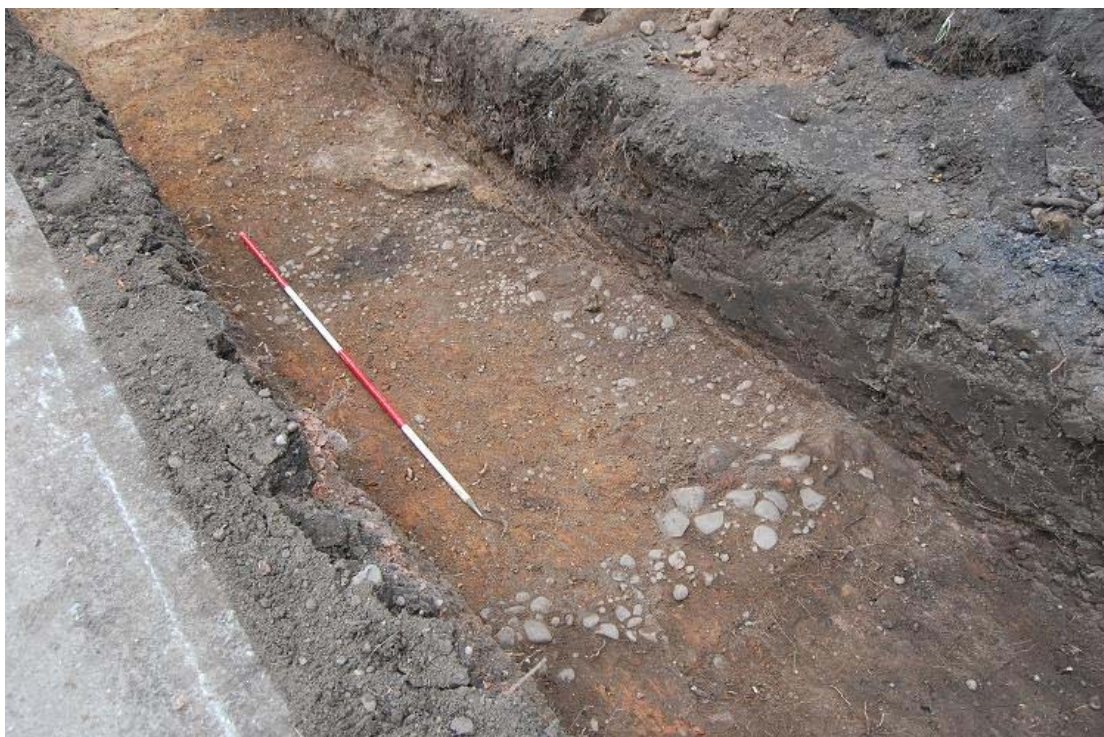
Much of the central section of Trench 1 had been horizontally truncated by a wide, flat based cut; [014]. This ground reduction had removed the natural soil horizons, including the contemporary topsoil (002), across a 12m length. A rough cobbled surface (009) was laid on its base at 137.47m AOD; very close to the 137.44m AOD level of the natural to the west of the trench, but cutting significantly down through the higher ground to the east. The cobbles were patchy and mixed with soft pale orange mortar in places.

Plate 4: Cobbled surface (009), facing west

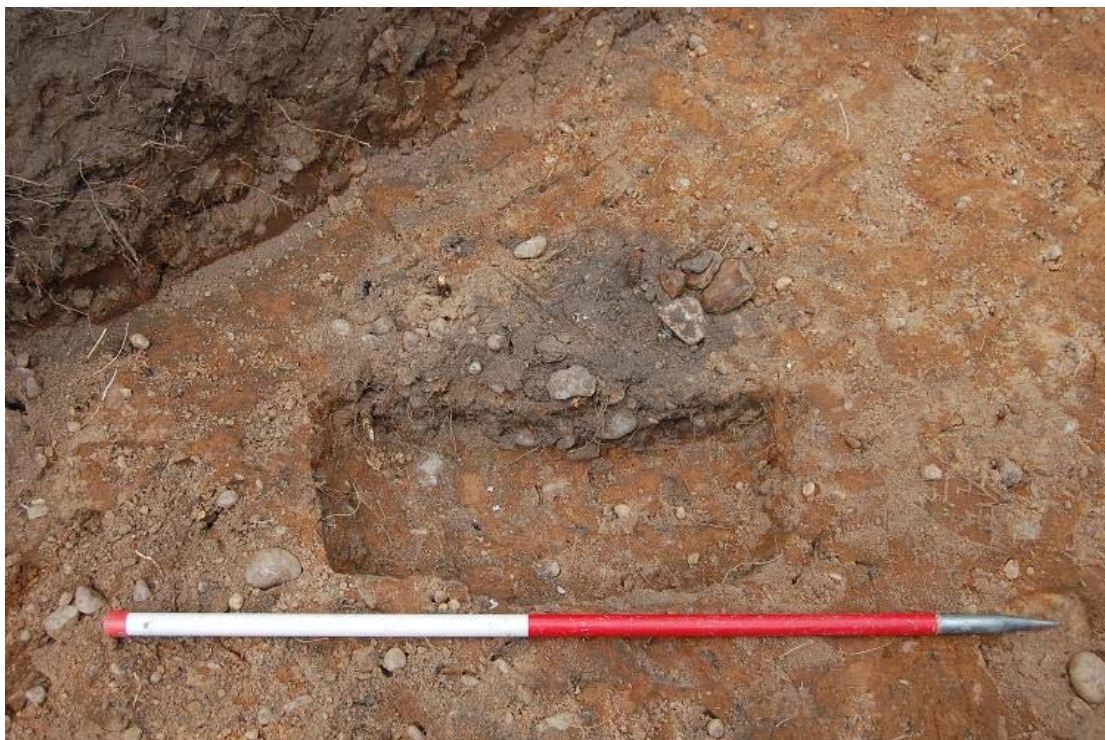
Towards the western end of Trench 1 were a cluster of small features; [006], [008] and [016], which appeared to be cut from the reduced level of [014] (rather than being truncated by it). [006] was a small square pit; 0.60m across, with a flat base. The loose fill contained coal and was clearly nineteenth century in date or later. Context [008] extended beyond the limit of excavation but appeared to be square in plan; 0.45m across. It was 0.25m deep with a flat base. The fill (007) was similar to that in [006] and contained a single large piece of green sandstone. Similarly, [016] contained one large, squared and level slab of green sandstone. The cut was less precise, 0.90m across (it was not seen fully in plan), and with a level base. The alignment of the edges, and of the sandstone, respected that of [008]. It is uncertain

Plate 5: Pit [006], facing north

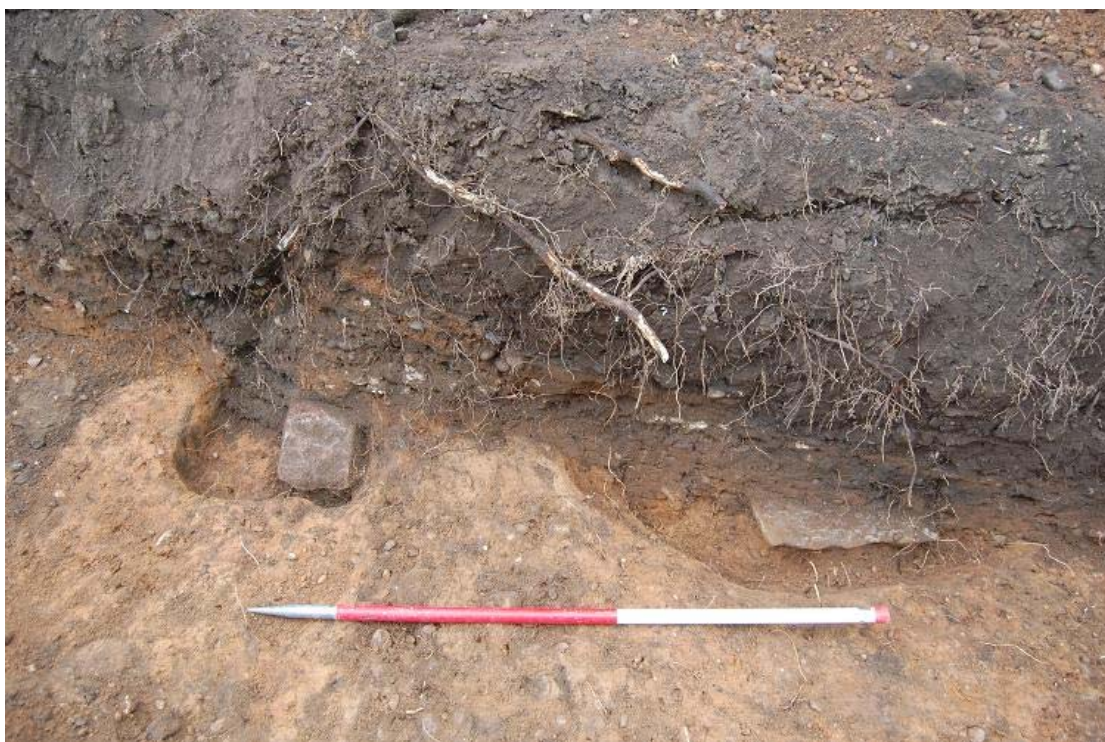
whether all three features are associated, but it would appear that [008] and [016] represent associated post pads, which would have supported posts approximately 1m apart.

Plate 6: Post pads [008] and [016], facing northwest

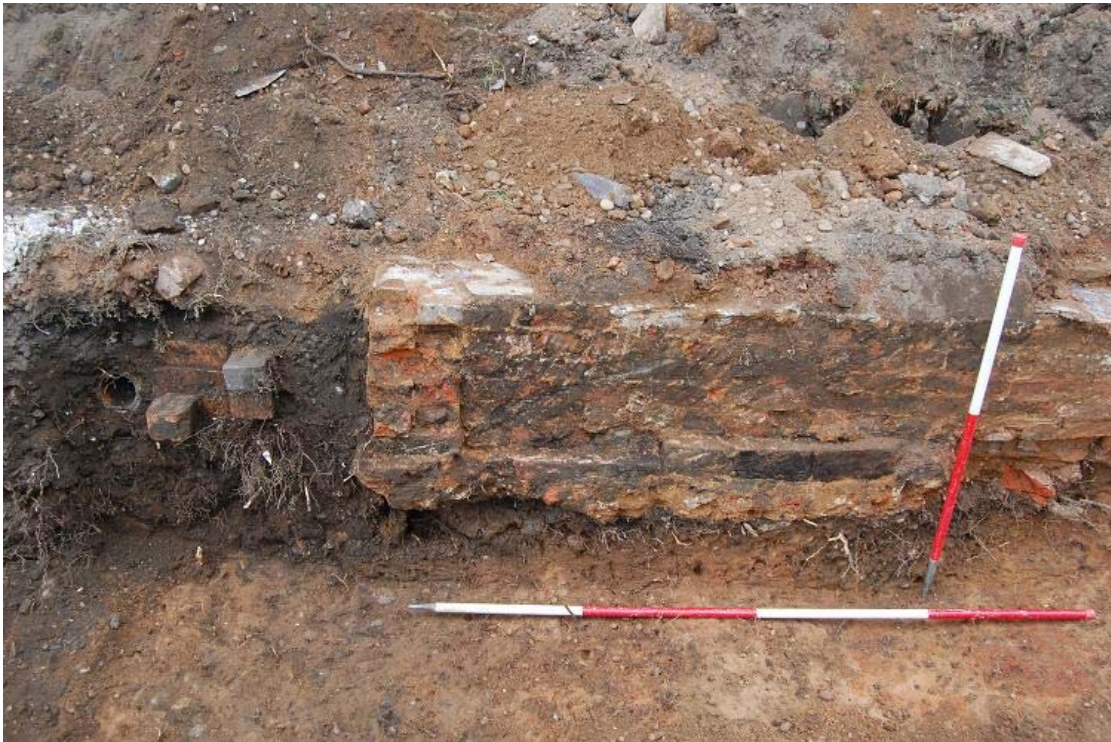
A brick structure (019) was found towards the east of Trench 1. It was seen to be relatively modern whilst machining open the trench so was removed and recorded only in section. Nevertheless, it was seen to be roughly square in plan with a brick floor resting at 138.05m and 138.12m AOD; it had a shallow step down to the west. It was approximately 1.5m wide by 2.15m long, and had been built externally against the standing remains of wall (023). It had been painted internally. The construction cut [020] respected the line of wall (023), cutting below its foundations such that the floor was level with the base of the wall. From the deposits on the other side of (023), this is suggested to have been below ground level. Immediately to the west of this brick structure was a stoneware drain set within a dark grey ash-rich sandy material. This, and a small 3-course brick structure were all assigned as (018) and interpreted as one phase of drain building; the brickwork seen in section probably indicating the position of a downpipe. The brick structure and drains are thought to be associated; probably forming a lavatory.

Plate 7: Sanitation in Trench ; possible lavatory (019) and drain (018), facing north

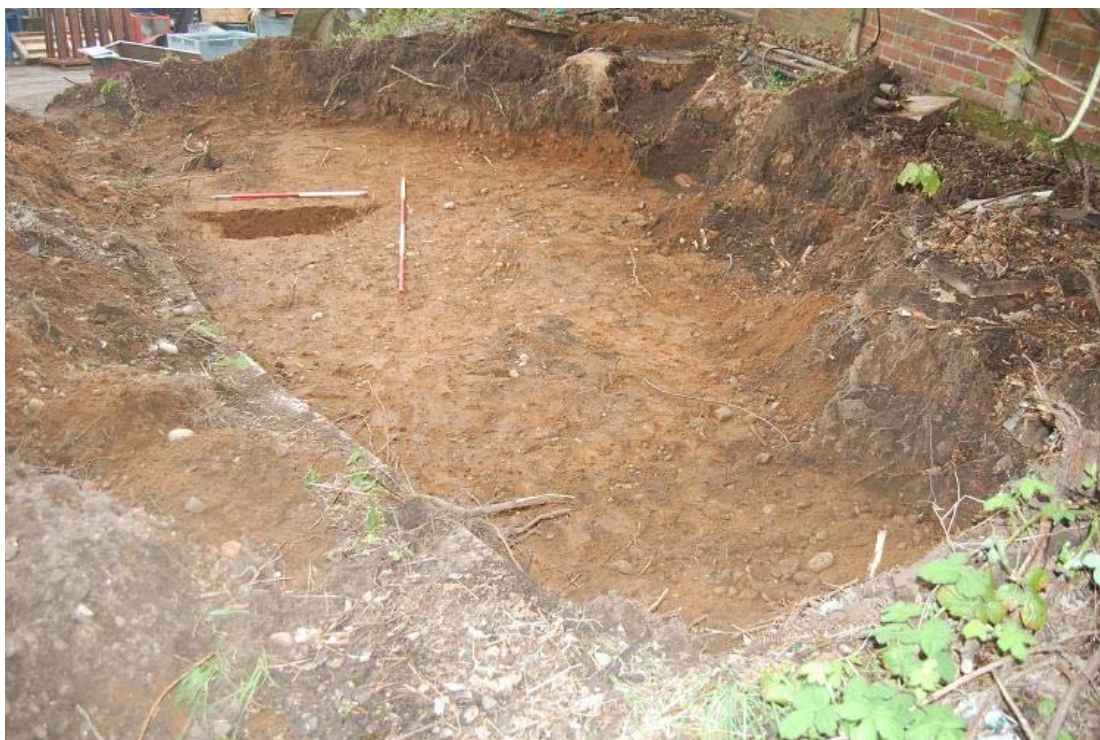
The whole of Trench 2 was later horizontally truncated by cut [039] to a level of between 138.35 and 138.68 m AOD. It is thought that a stoneware drain (033) was laid at this point; in a N-S cut [034] that extended beyond the limits of excavation. As in Trench 1, the entirety was then sealed with a dark sandy deposit (038) that had the same distinctive horizon of gravel in pink clay directly on top of the natural sand.

Plate 10: Trench 2, facing north

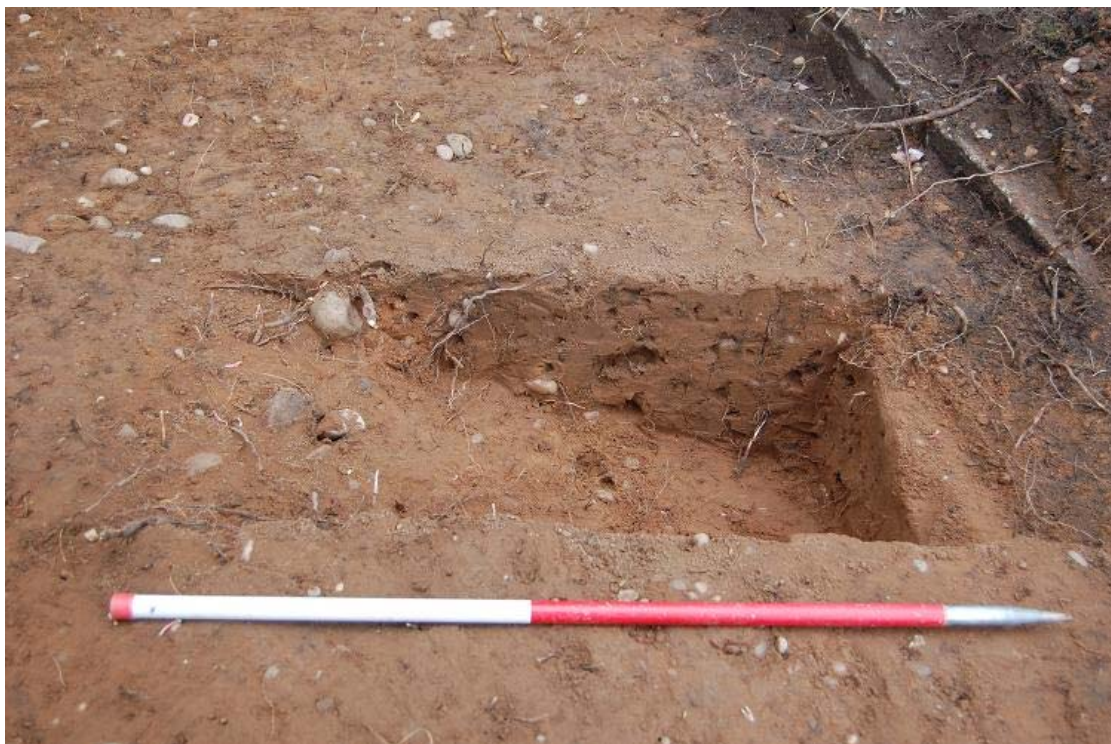
In Trench 2, a cut [036] was seen to run N-S. It had been horizontally truncated, so its original depth is unknown, and it had also been truncated by the construction of a concrete ramped path to the SW. All that remained was one side, with no base, angling down from east to west at around 25°, from 138.22m AOD. If interpreted as one side of a ditch, the feature would originally have been at least 3m wide. The unconsolidated fill (035) was only marginally more grey and silty than the natural sand (037) and did not have the feel of a naturally deposited material. The interface, however, was sharp; indicating a cut rather than perhaps the interface between natural and subsoil on steeply sloping ground. It is thought that this area was subject to terracing, and that the fill (035) is redeposited natural.

In Trench 2, two phases of wide-scale truncation were identified. The earlier episode saw the western edge of the trench removed by cut [036]; sloping down from east to west. This is thought to have been associated with the ground reduction necessary to expand J.H. Lavender's Foundry to its current footprint in the mid twentieth century. The material (035) that "filled" this cut is thought to be redeposited natural that was dumped here; possibly to build up the ground level locally for the construction of the concrete ramped path to the SW of the trench, possibly to even out an area that was landscaped back too far. A small fragment of ceramic building material and a piece of post medieval pottery were recovered from this deposit, but they served merely to confirm that the unconsolidated and otherwise clean deposit was indeed not natural.

Plate 11: Cut [036], facing south
