Burton Stone Community Centre, Evelyn Crescent, York

HISTORIC BUILDING RECORD

**Burton Stone Lane Community Centre
Evelyn Crescent
Clifton
York**

**HISTORIC BUILDING RECORDING
(PHOTOGRAPHIC & DESCRIPTIVE RECORD)**

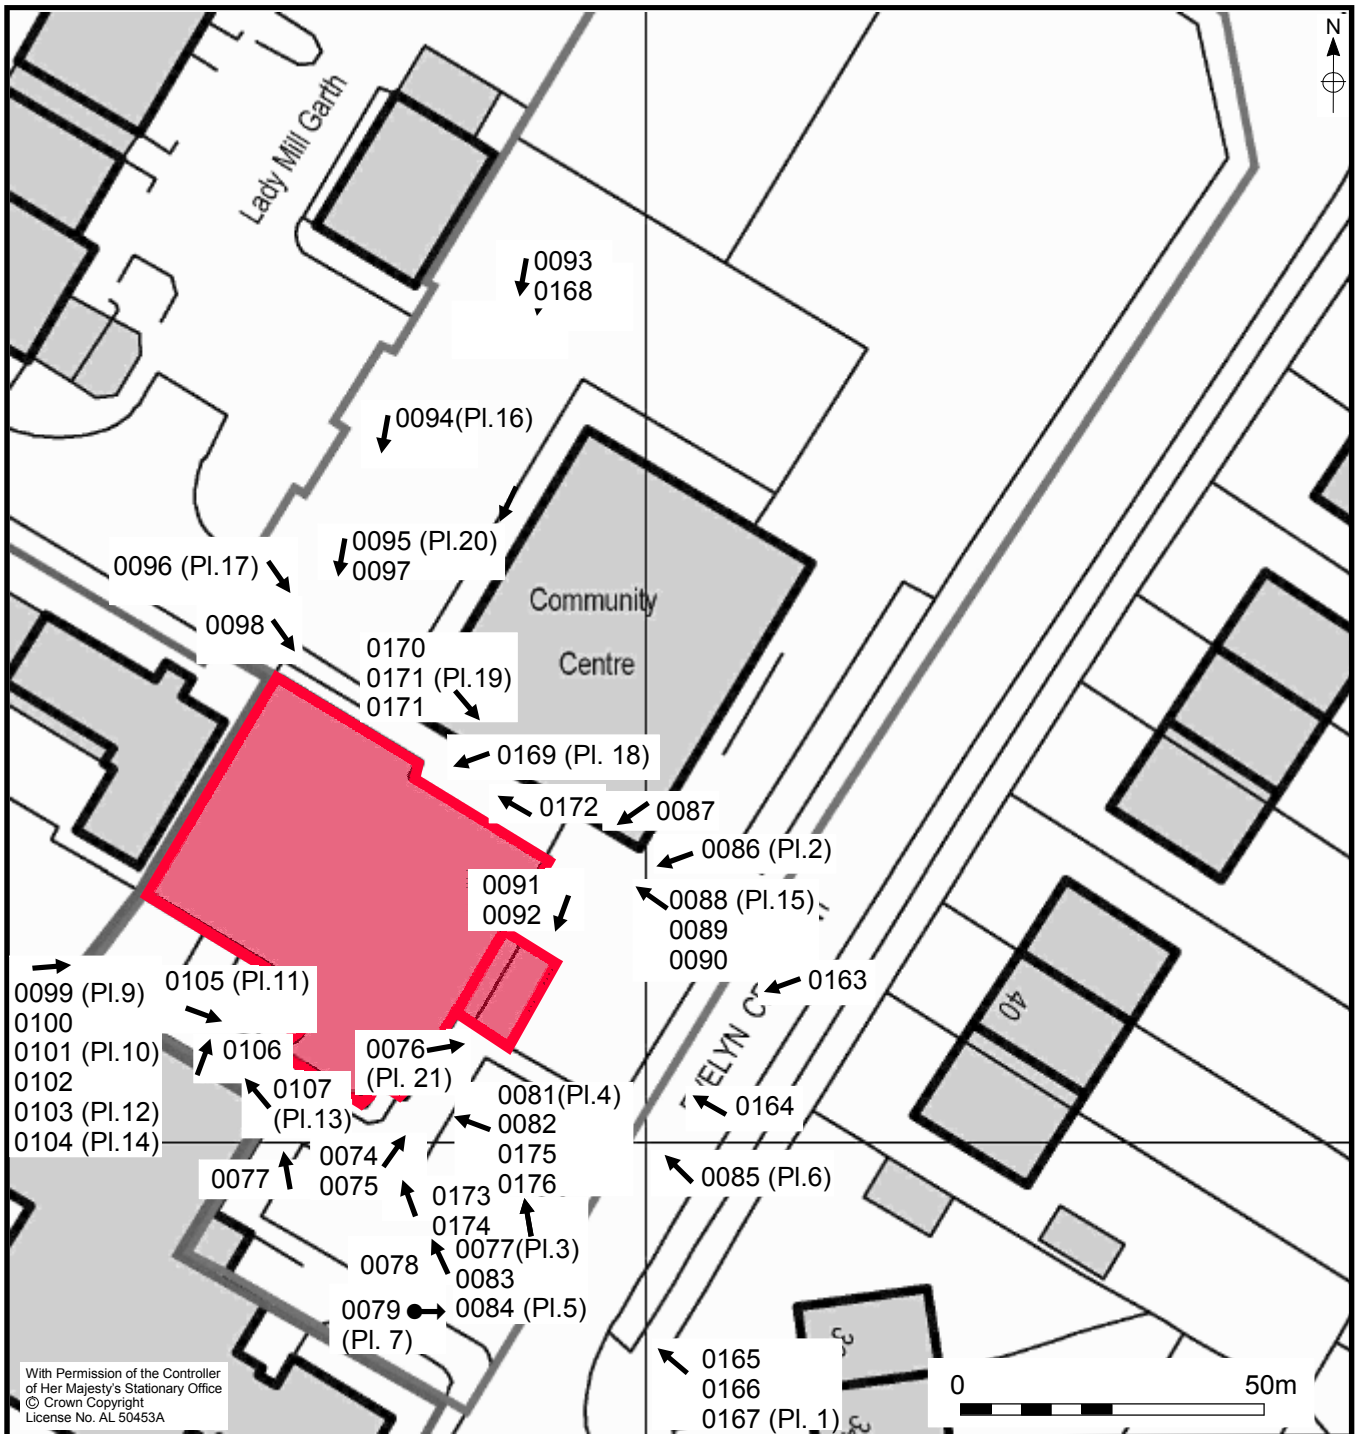
TITLE: Plan of Exterior Photographs (Plates).	
SITE: Burton Stone Lane Community Centre. Evelyn Crescent, York		FIGURE: 10.	Scale: 1:500
CLIENT: City of York Council		DRAWN BY: KCH

6.2 *Gymnasium: Exterior Description (Figs. 10-12; Pls. 1-21)*

6.2.1 The Gymnasium was a tall single brick-built structure with flat roof, semi-circular 'deck/penthouse' structure around the chimney, a lower rear (north-western) block with flat roof and a front (south-eastern), small, flat roofed structure providing access to the basement. The Gymnasium had curved corners and a south-western extension/aisle with rounded corners. The walls were constructed in brick stretcher bond and with concrete lintels, sills, frieze and string courses. The concrete frieze is above the windows and wrapped round the building from either side of the chimney on the north-eastern elevation of the main Gymnasium. The roof structure had blocked curved windows either side to the north-east and south-west. The rear central chimney was square in plan.

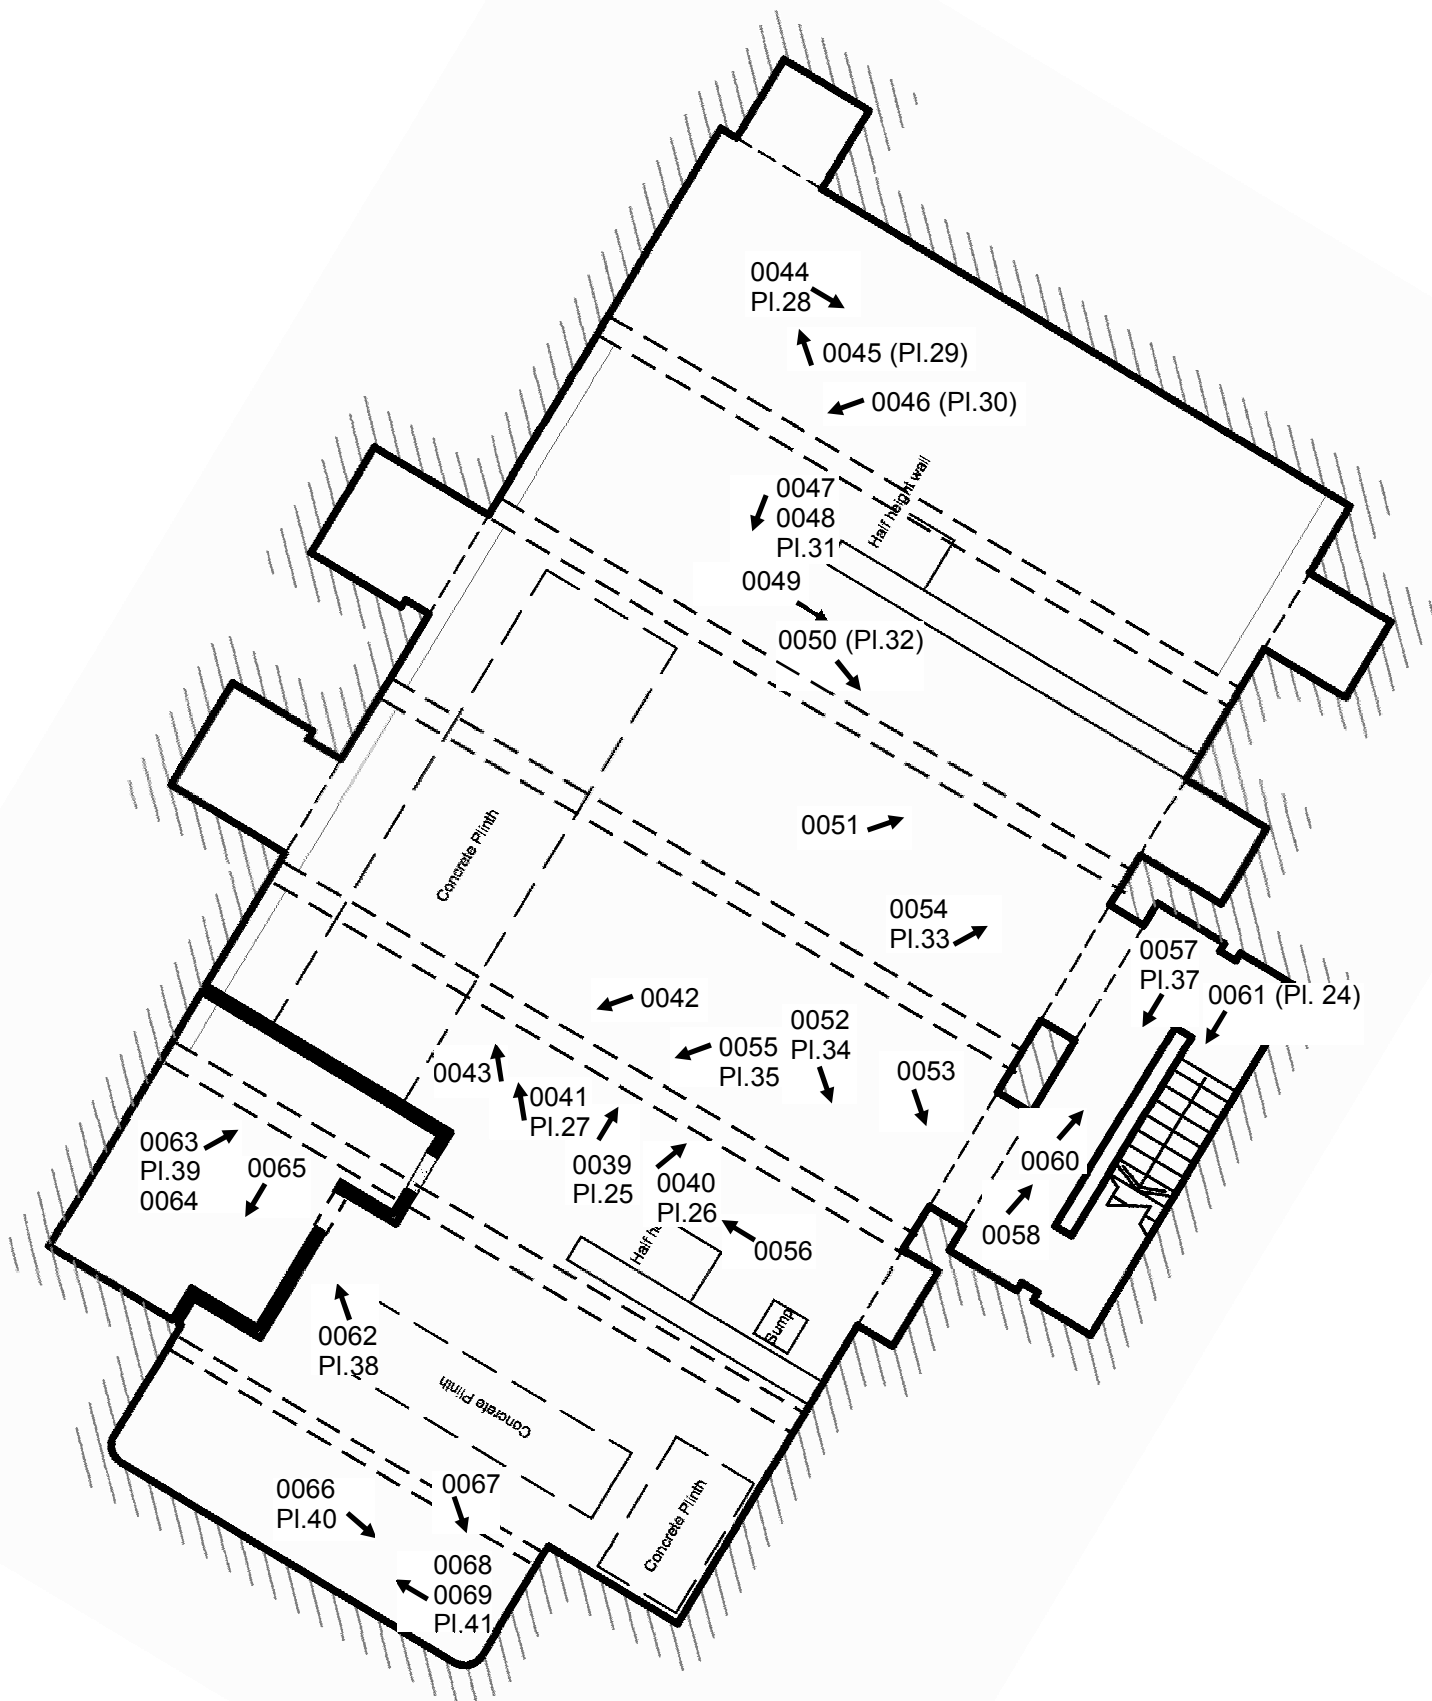
Figure 11. Basement Plan with Photograph (Plate) Locations.

6.3.1 The basement was accessed via the small building attached to the south-eastern elevation with a low wall below the central two windows of the Gymnasium. The ground floor of this structure had a toilet to the rear of the hall and stairs to access the basement (Pls. 22, 23 & 24). The low wall formerly provided illumination into the space below, as its ceiling comprised glass bricks, covered by concrete (Pl. 37). The basement was a large open space with recesses in the north-western wall, accessed from the centre south-eastern wall and a small store room in the south-

western corner (Pls 22-41). A steel frame construction was noted, evidenced by exposed steel beam ceiling joists, five by *Dorman & Long Middlesbrough* and the south-eastern joist by *Skinningrove, England*. The cellar contained the modern heating plant still in use for Marjorie Waites Court. In the northwest and south-east walls, there were four blocked coal chutes and the base of the chimney on the north-west wall. Concrete plinths survived from the previous heating plant/boilers.

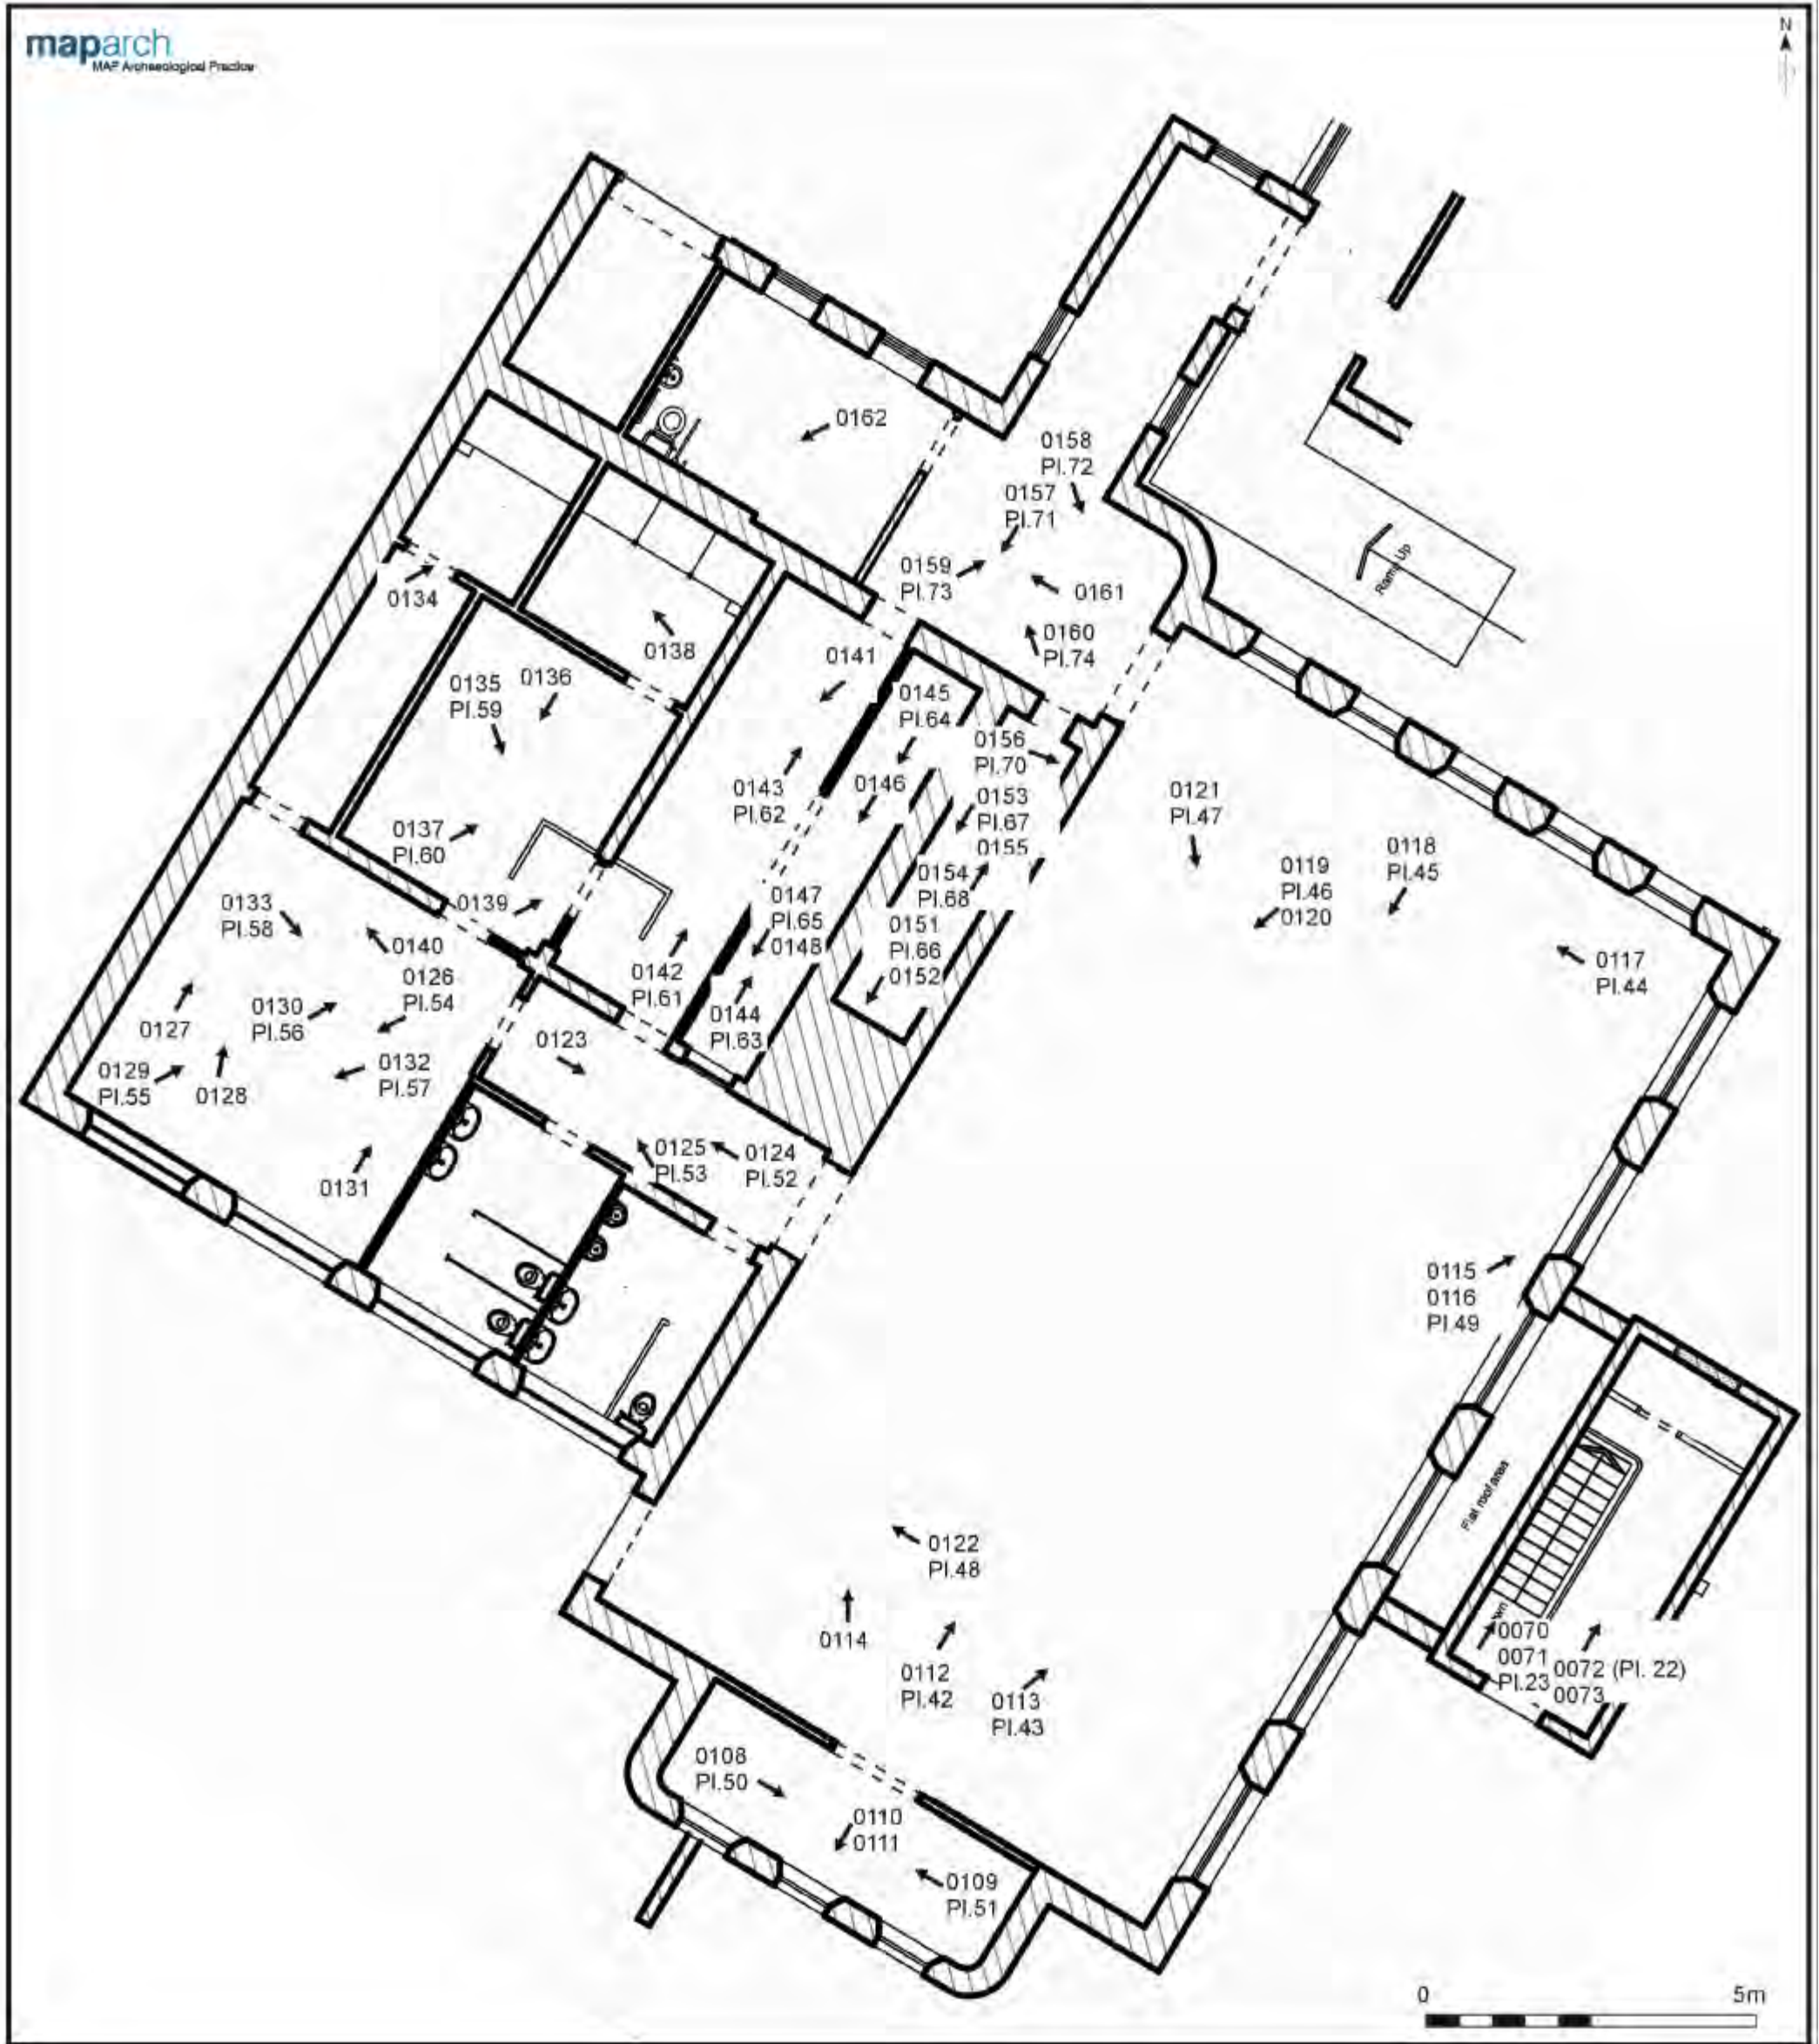
Figure 12. Ground Floor Plan with Photographs (Plate) Locations.

6.3.2 The interior of the main Gymnasium comprised a storage area, the main gymnasium, toilets, hall, changing rooms with showers, a service room with access into the roof structure and two storage rooms (Pls. 42-74). The gymnasium was accessed from the main hall to the north, with a fire-exit to the south and access to the changing rooms to the north-east and a storage area to the south west. There was a storage space to the south-west.

6.3.3 To the north-west of the main Gymnasium were two doors, the northern one provided access to the entrance hall and the southern door, access to the rear hall, toilets/changing rooms. The changing rooms contained benches and hooks, probably dating back to its original outfitting. There was an access corridor from the entrance hall to the rear hall with a storage space to the south-east. From the entrance hall, in addition to the access corridor, there was a disabled toilet to the north-west and a service room to the south-east. The service room was unplastered, with an access ladder to the roof structure and by the door had the scar of an earlier electrical fitting.

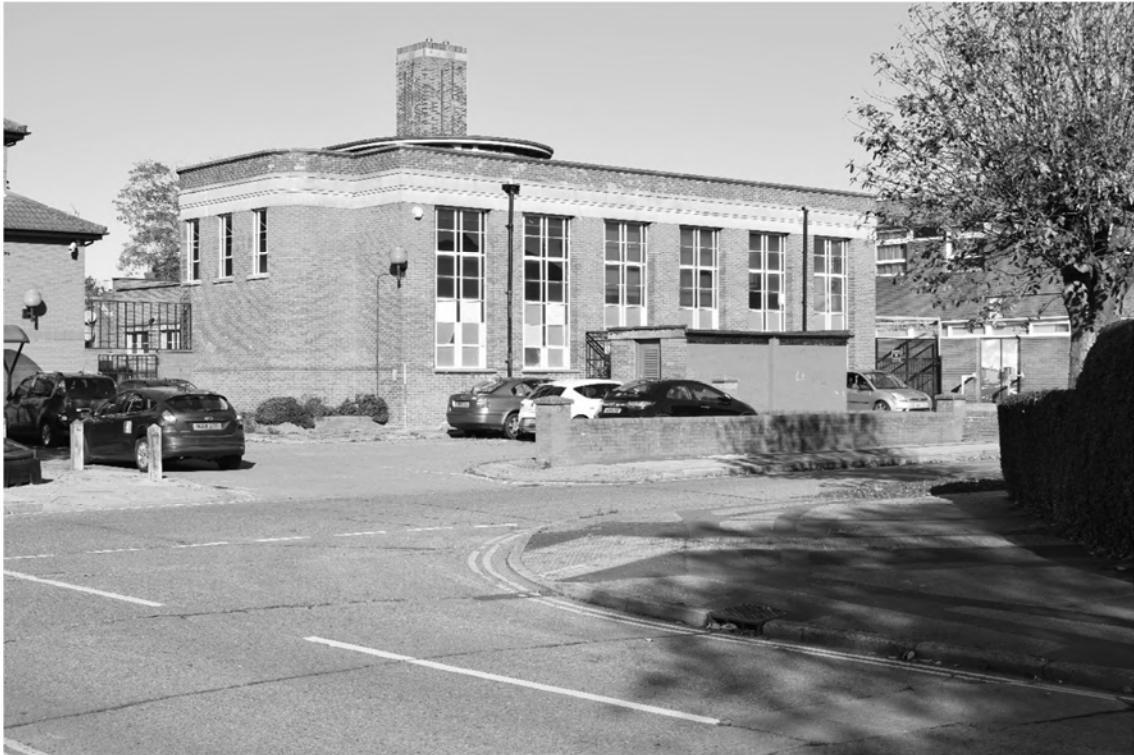
Plate 1. Gymnasium Exterior – South-east Elevation. Facing North-west.

6.2.2 The front (south-eastern) elevation had six tall metal framed windows into the Gymnasium with plain concrete frieze/lintel above (Pls. 1-8 & 15). The central small block, with access door into the basement to the south west (Pls. 5, 6 & 8), a low wall between the south-east wall of the Gymnasium and the north-west wall of the smaller building and a blocked-up window in the north-west elevation (Pl. 2).

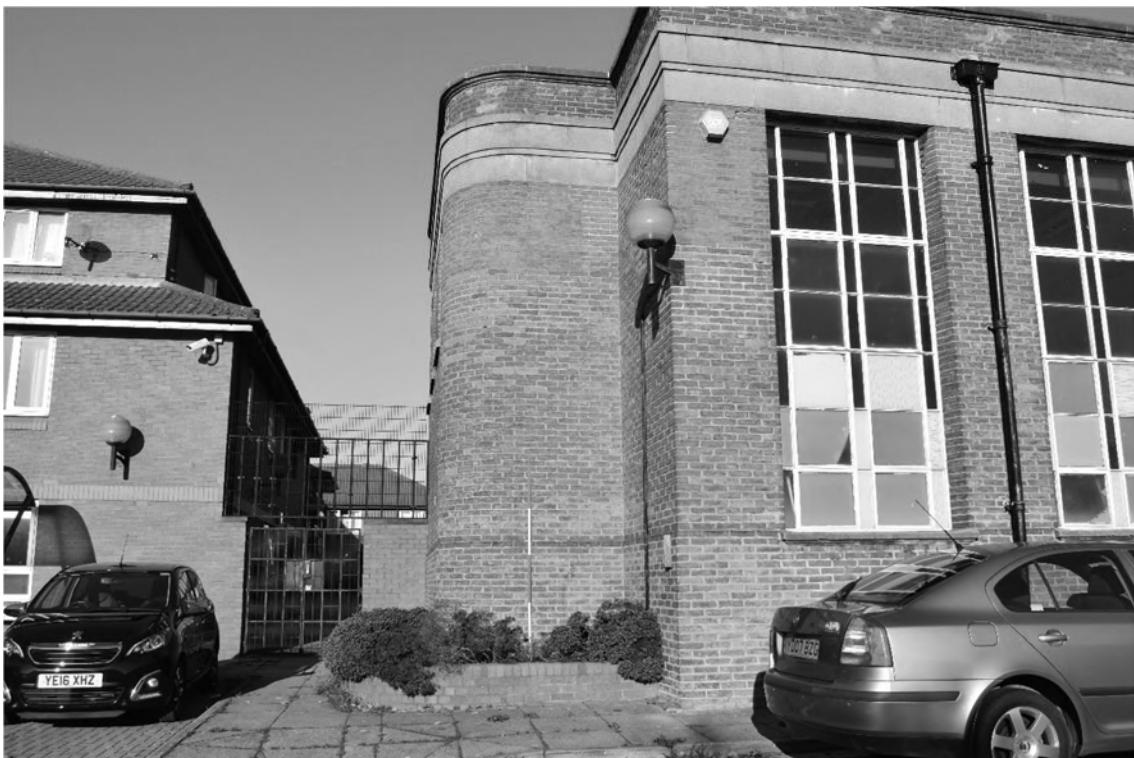
Plate 4. Gymnasium Exterior – South-east Elevation. Facing North-west.

6.2.6 Two hoppers on the rainwater down spouts were decorated with Yorkshire roses on the Gymnasium's south-east and south-west elevations (Pls. 4, 7 & 11).

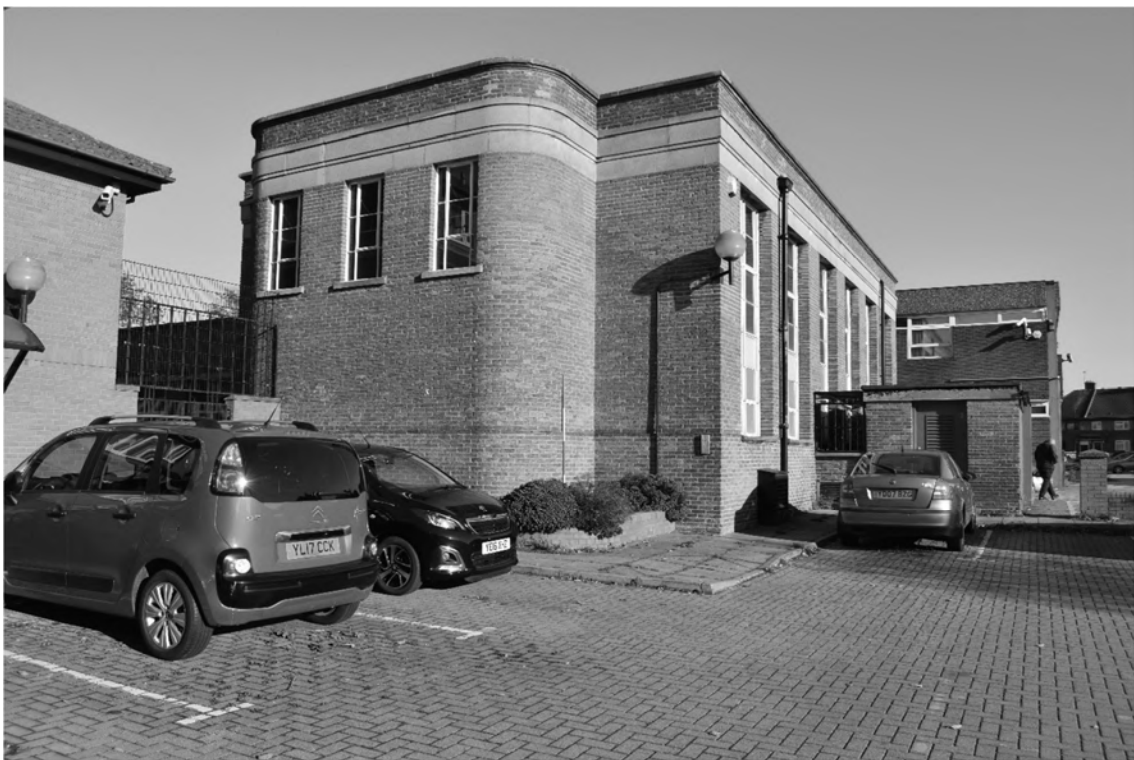
Plate 8. Gymnasium Exterior – South-west Elevation. Facing North.

6.2.3 The south-western elevation had three windows in the side projection (Pls. 8 & 11). The rear block had four wide, squat windows providing light into the changing room area (Pls. 9, 10, 12 & 13). There was a rear door into the Gymnasium in the north-western elevation from the south-eastern corner of the main Gymnasium (Pls. 9 & 10).

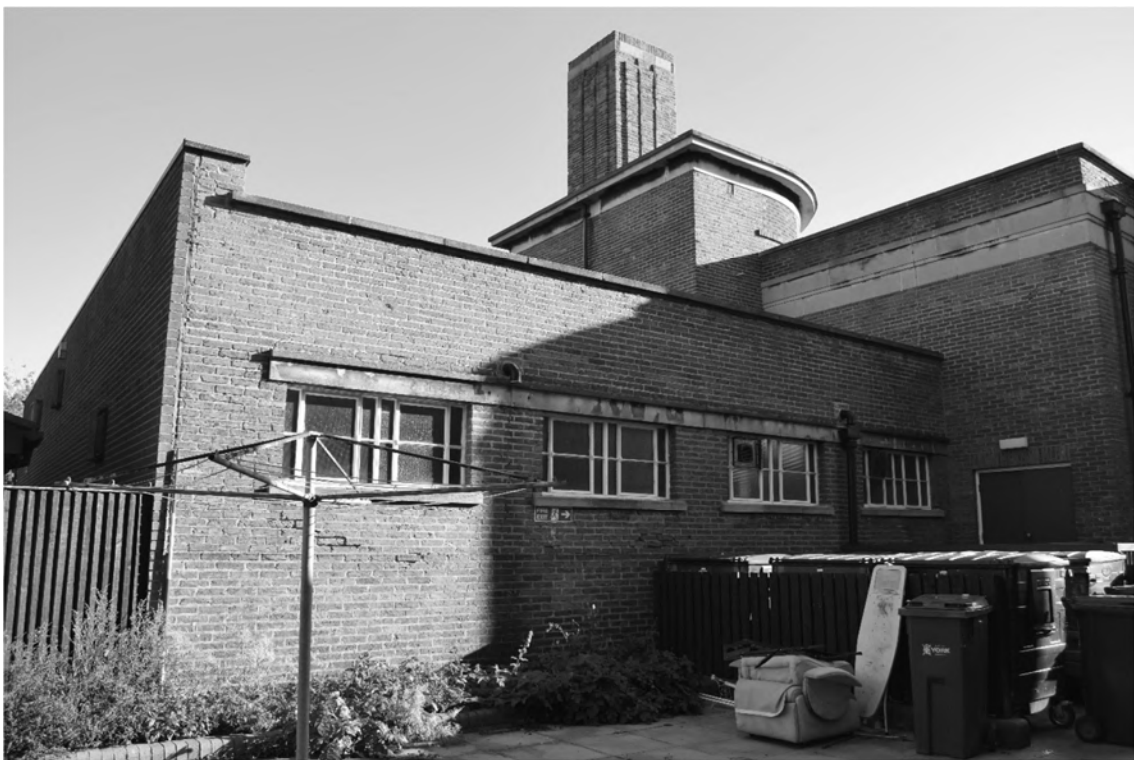
Plate 10. Gymnasium Exterior – South-west Elevation. Facing North-east.

6.2.5 The north-west wall of the rear block has been re-skinned, probably after the rest of the school buildings were demolished (Pls. 10 & 18).

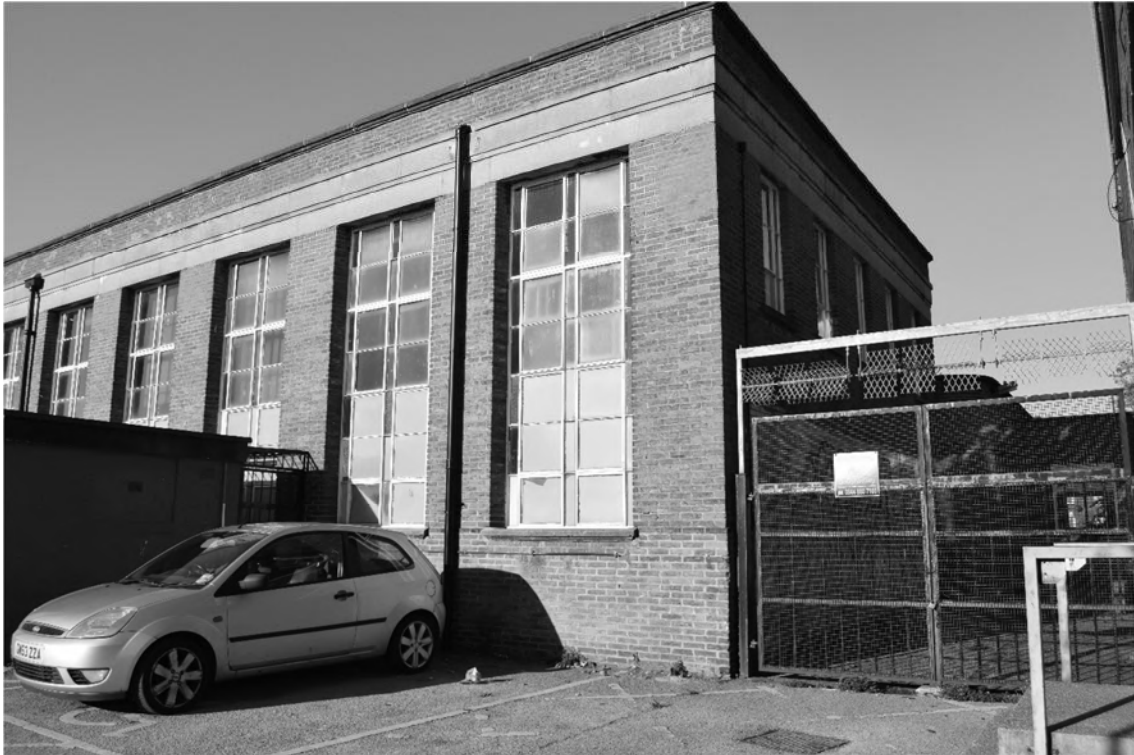
Plate 15. Gymnasium Exterior – South-east and North-east Elevations. Facing West.

6.2.4 The north-eastern elevation of the main Gymnasium has five windows (Pls. 15 & 19). There is a possible blocked door north of the curved offset wall of the rear block, partially covered by the later corridor added to join to the community centre, with concrete lintel (Pl. 18). The north-east elevation of the rear block has two small windows and a door into a rear store (Pl. 17).
