Historic Building Record

Sports Pavilion
St John Playing Fields
Hull Road
York

HISTORIC BUILDING RECORDING
(PHOTOGRAPHIC & DESCRIPTIVE RECORD)

This report has been undertaken by MAP Archaeological Practice Ltd under the instruction Keepmoat Homes, to record the Sports Pavilion at the St. John Playing Fields at Hull Road, York, prior to its demolition.

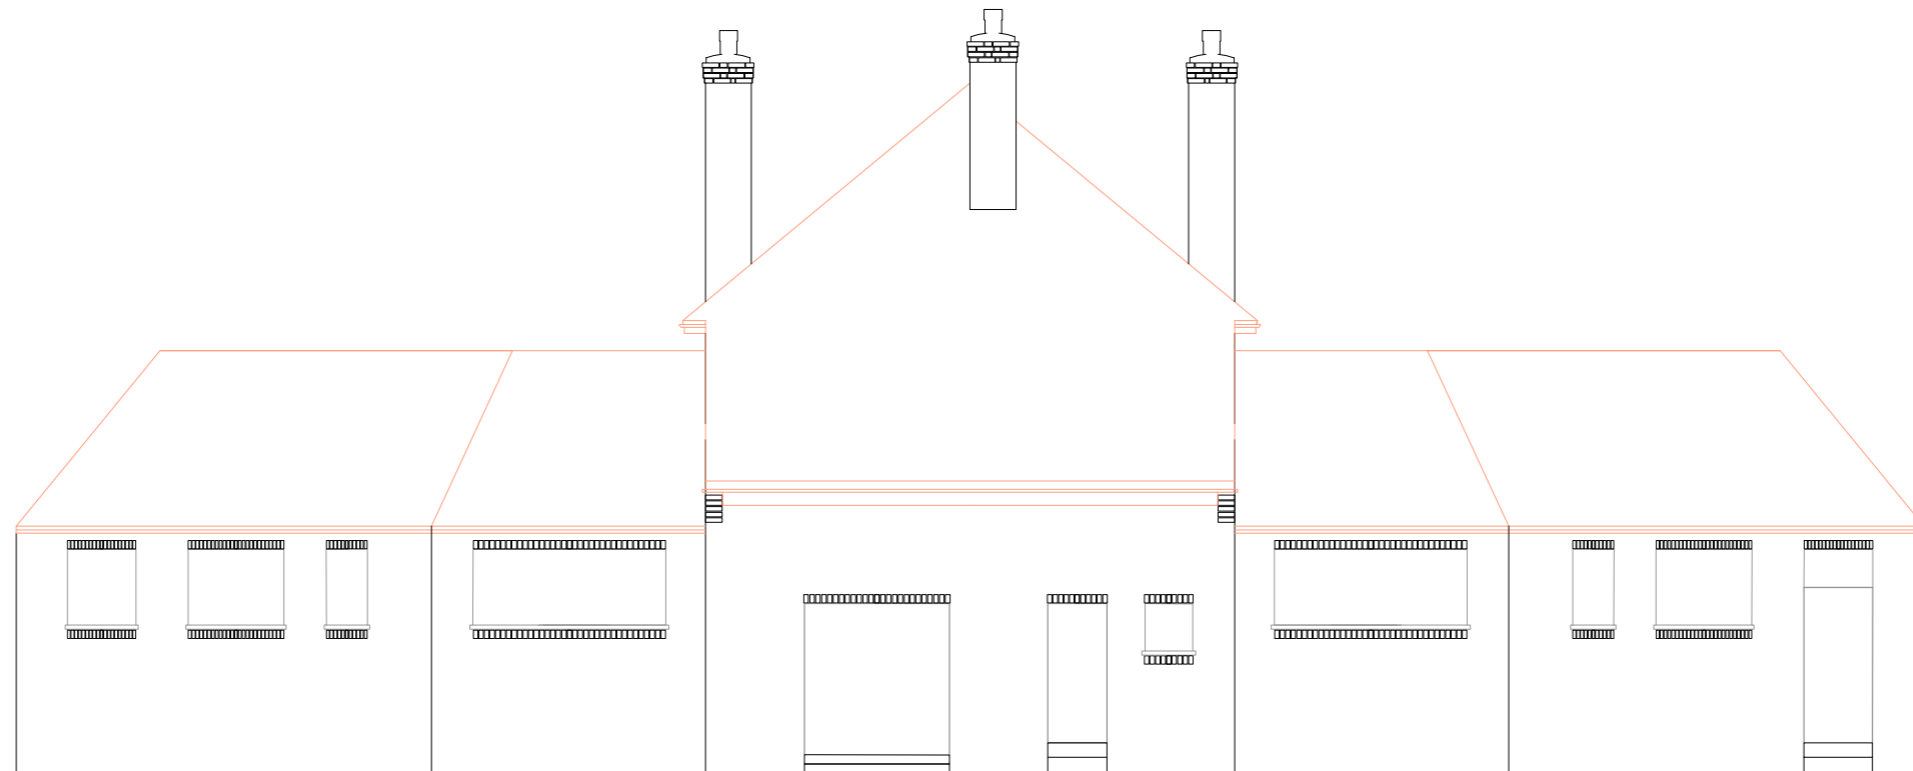
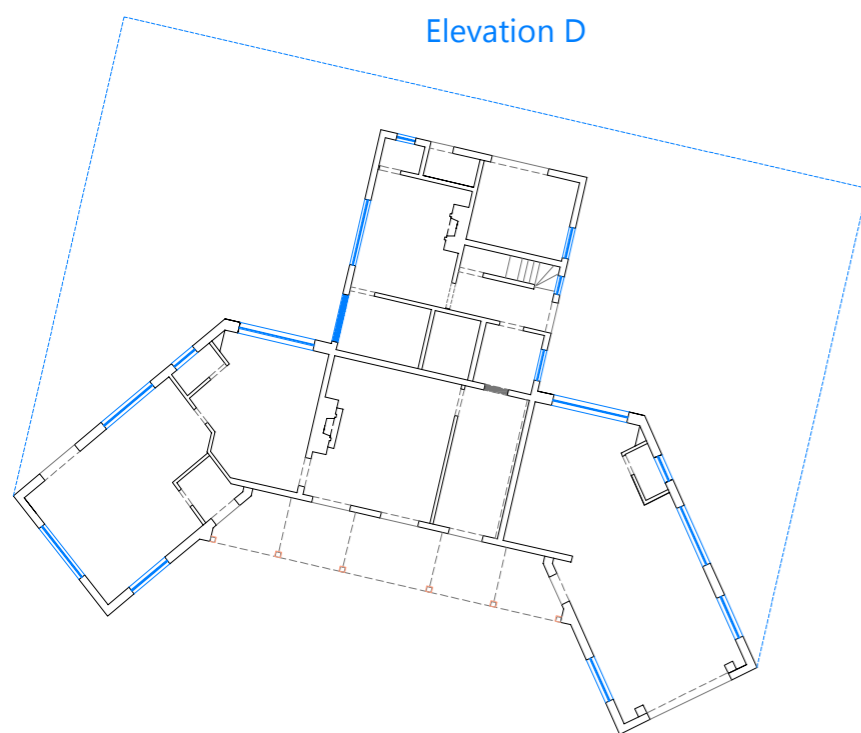
Figure 5
Elevation D
Scale: 1:100 @ A3

five single light six pane casement windows and central to the east wing was a chimney stack in the hipped roof (Fig. 6). The west elevation of the main block had a four light ten pane casement window on the ground floor and four windows on the first floor (a three light, a two light and two single light six pane casement windows) and a chimney stack central to the west wing (Fig. 6). The north elevation of the main block was a double door, a door and a small single light 4 pane window. In the centre of the hipped roof was a chimney stack (Fig. 5).

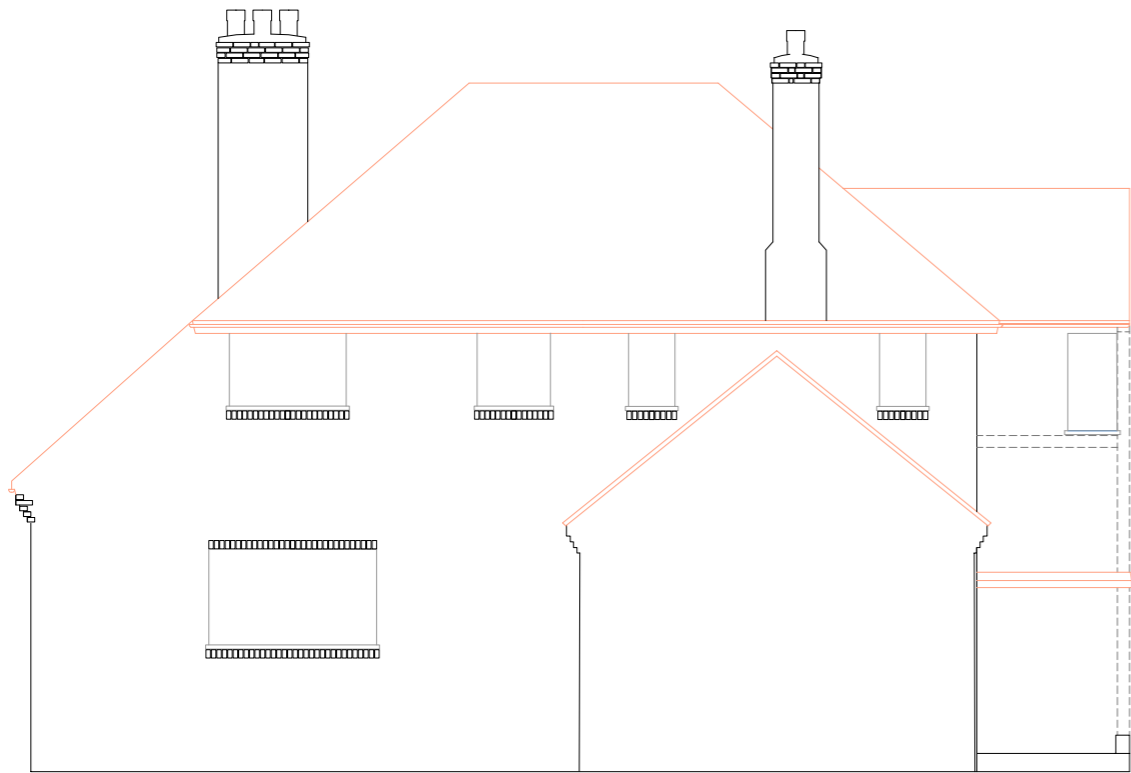
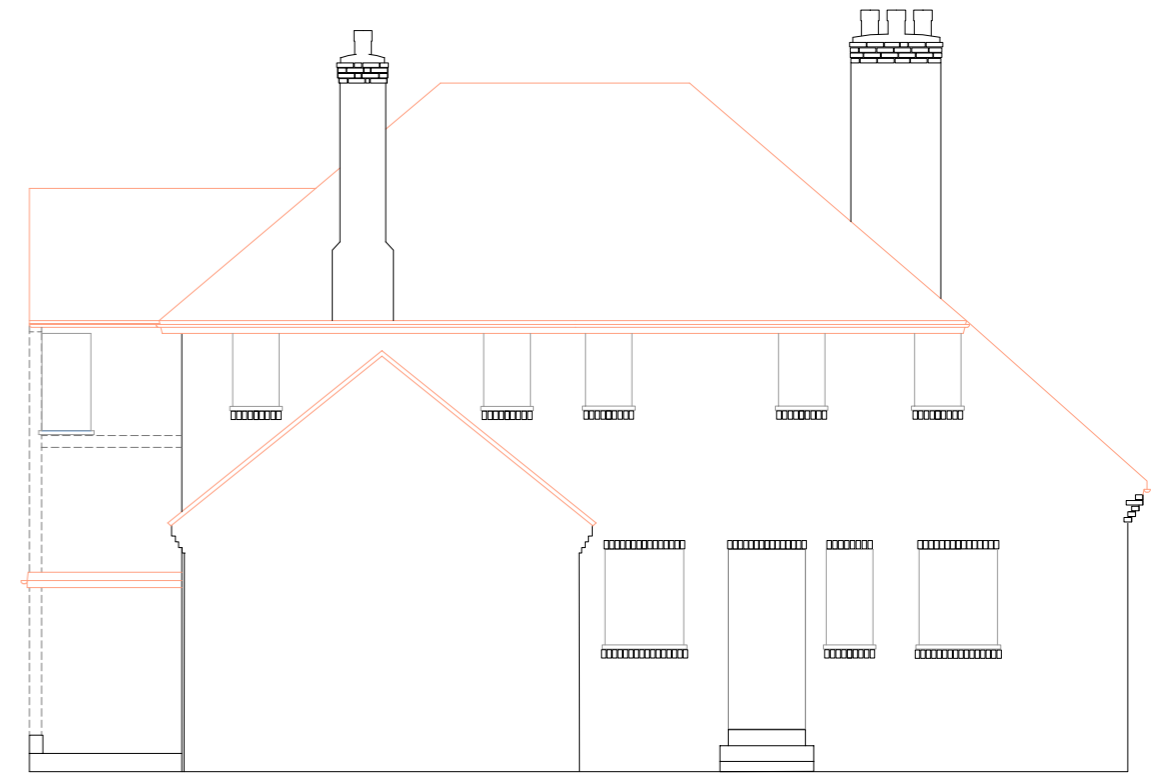
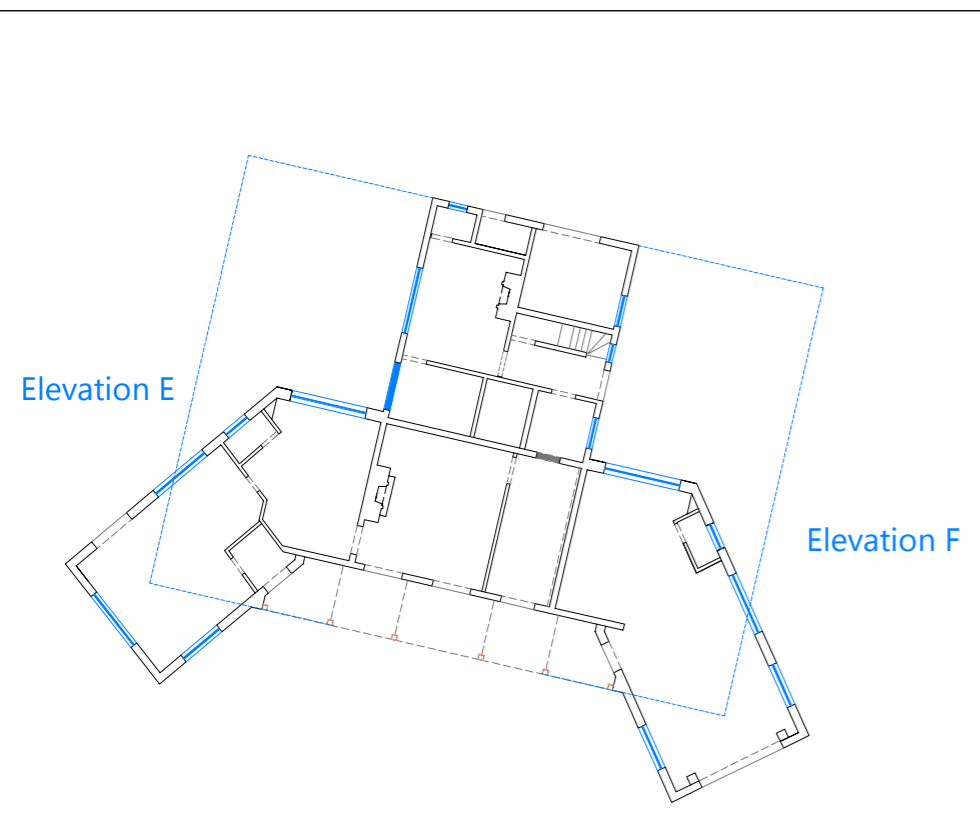
Figure 6
Elevations E&F
Scale: 1:100 @ A3

6.2.3 The east elevation of the main block had three windows and an entrance to north of the east wing: a two light six pane casement window, a security door with three pane fanlight above, a single light six pane casement window and another two light six pane casement window. On the first floor there were

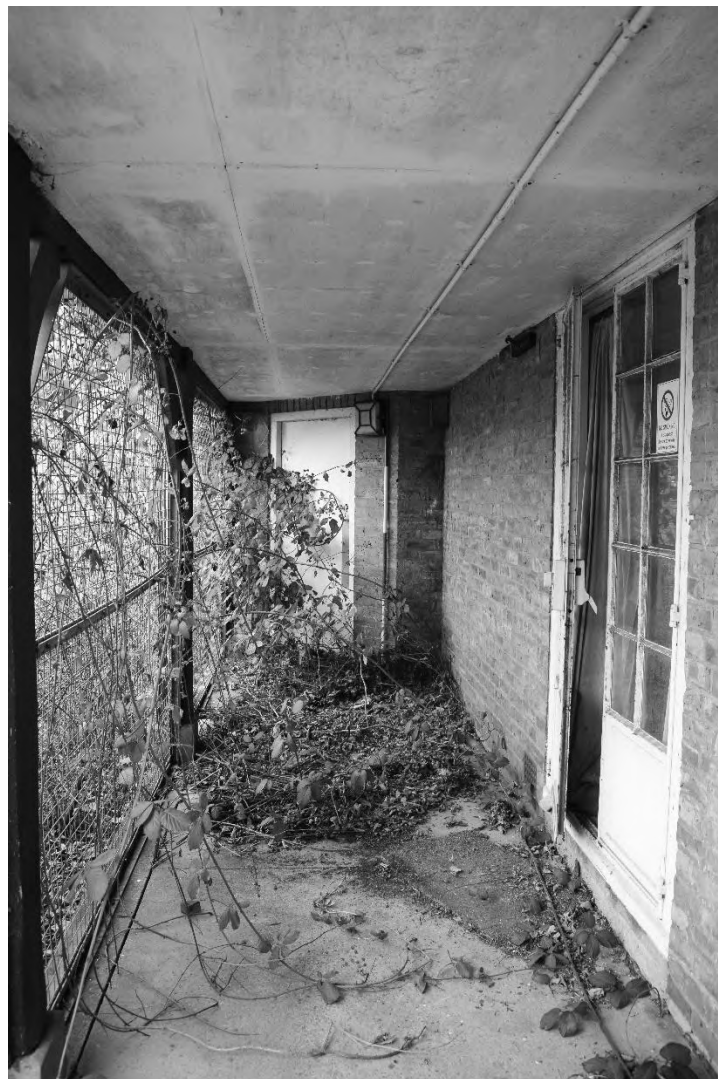
6.2.2 The south elevation has a veranda with flat roof along the ground floor frontage constructed of timber with four post and is dominated by the projecting dormer over the two central posts either side of the central door on the ground floor (Fig. 4 & Pls. 2-5). Under the gable dormer is a wrap-around observation window: five light eight pane tall windows (four opening casement windows and a fixed window in the centre) to the south and one light eight pane tall windows to the east and west. This projection was constructed in timber and with mock-Tudor style. On the ground floor there were three French doors opening onto the veranda. Above the veranda were two three pane fanlights above the east and west French doors. On the first floor there were a window to the east and west of the dormer: both two light six pane casement windows. There is a double sting course below the first floor windows.

Plate 8. Pavilion: Exterior – Veranda (DSC_0056). Facing North-west.

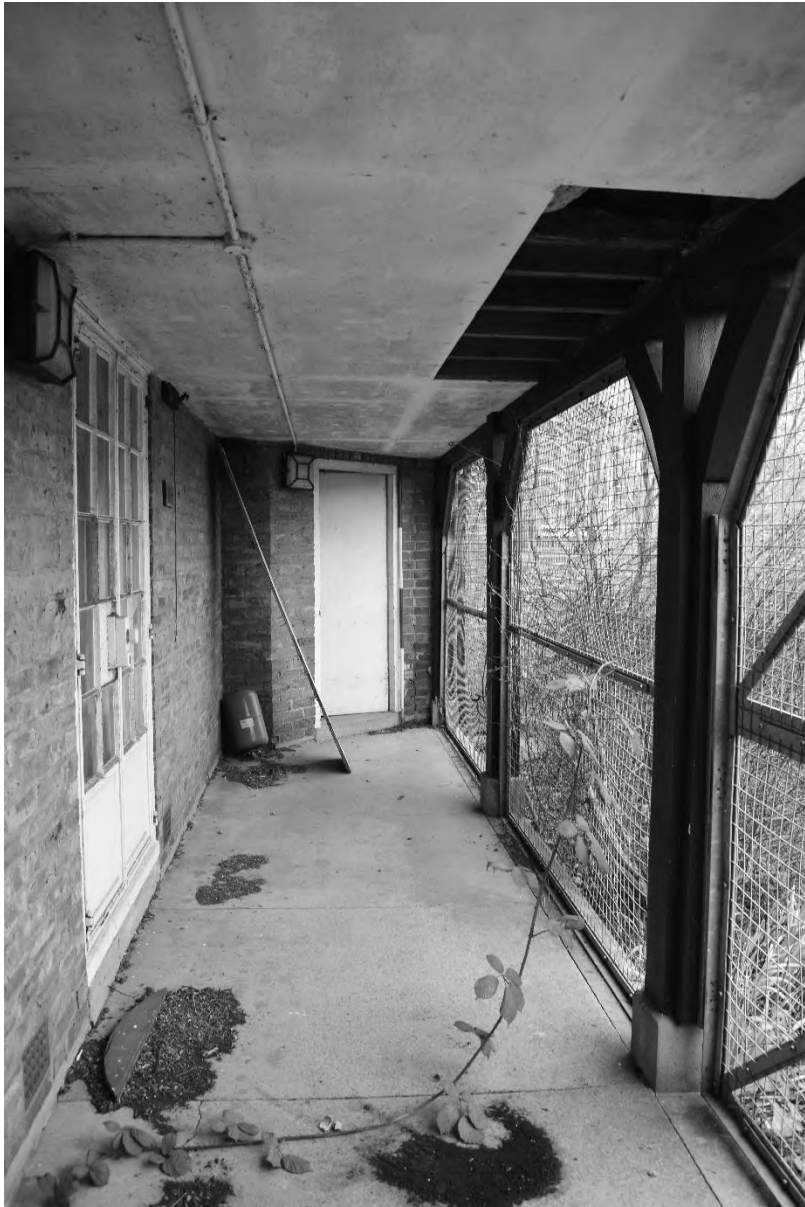
Plate 9. Pavilion: Exterior – Veranda (DSC_0057). Facing South-east.
