North Farm
Hard Lane
Harthill
Rotherham
South Yorkshire

MAP 5-08-2021

SK 4926 8122
OASIS ID: maparcha1-57021
RB2019/1474

ARCHAEOLOGICAL BUILDING RECORD

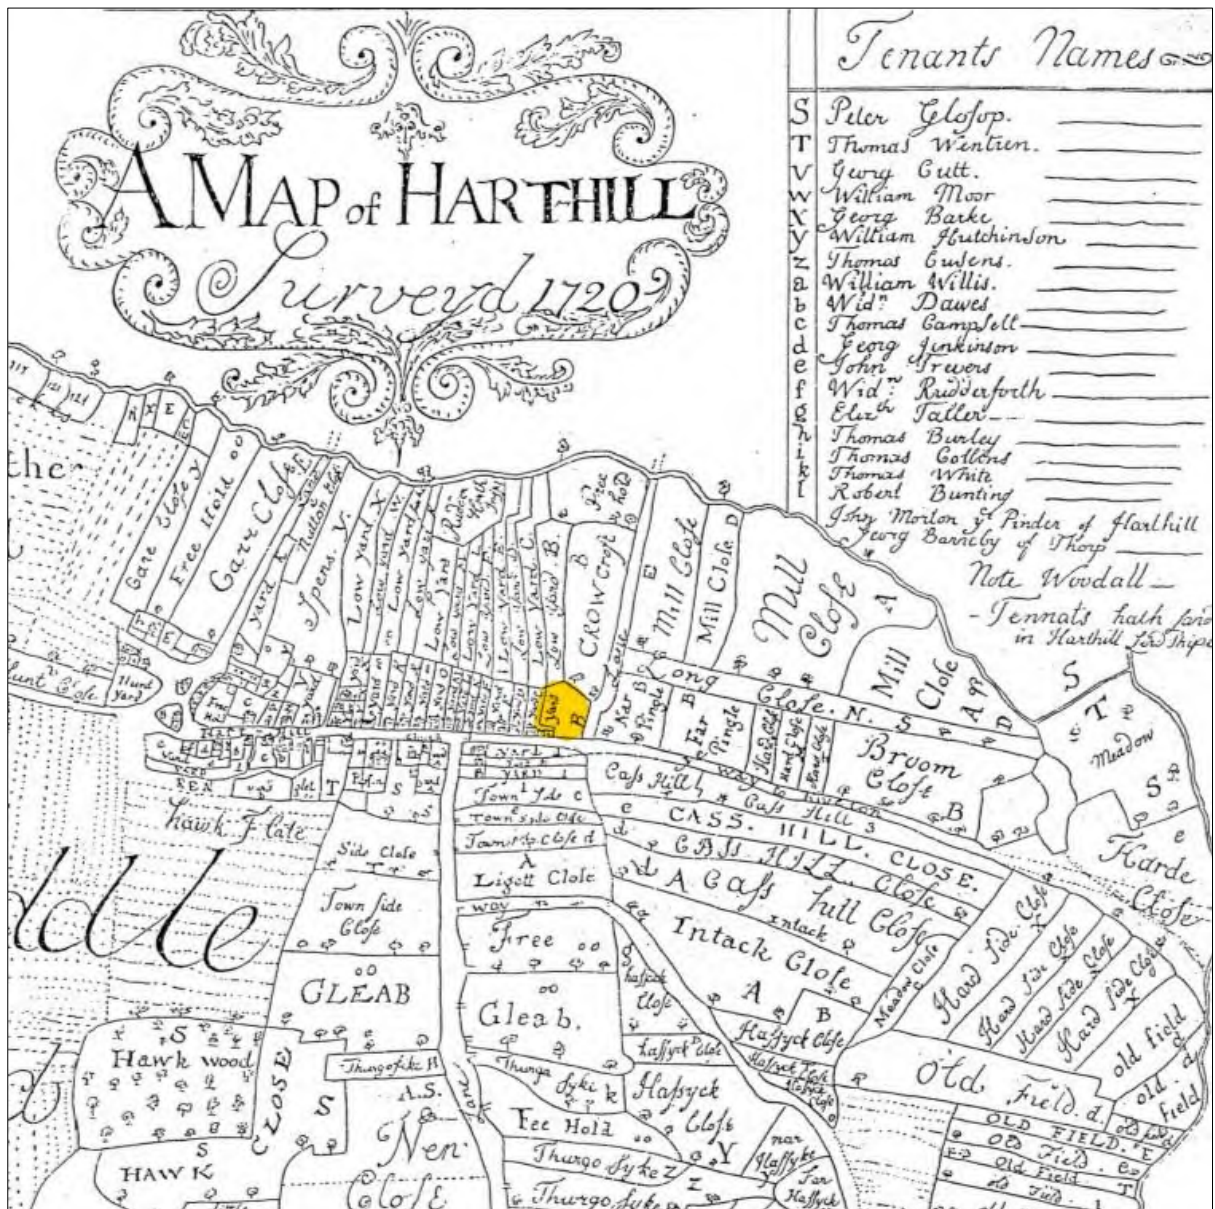
Figure 3. Extract from the 1720 map of Harthill, Survbey made under the aegis of Peregrine, Duke of Leeds.

- 3.4 A 1720 map of Harthill, the *Ducal Survey made under the aegis of Peregrine, Duke of Leeds*, depicted the village's medieval burgage plots (Fig. 3). The location of North Farm was depicted as plots, tenanted by Robert Marsh (B), called '*Crow Croft*', '*Low Yard*' and '*Yard*' (Snowden 2019, 11), with a building depicted on the street frontage.

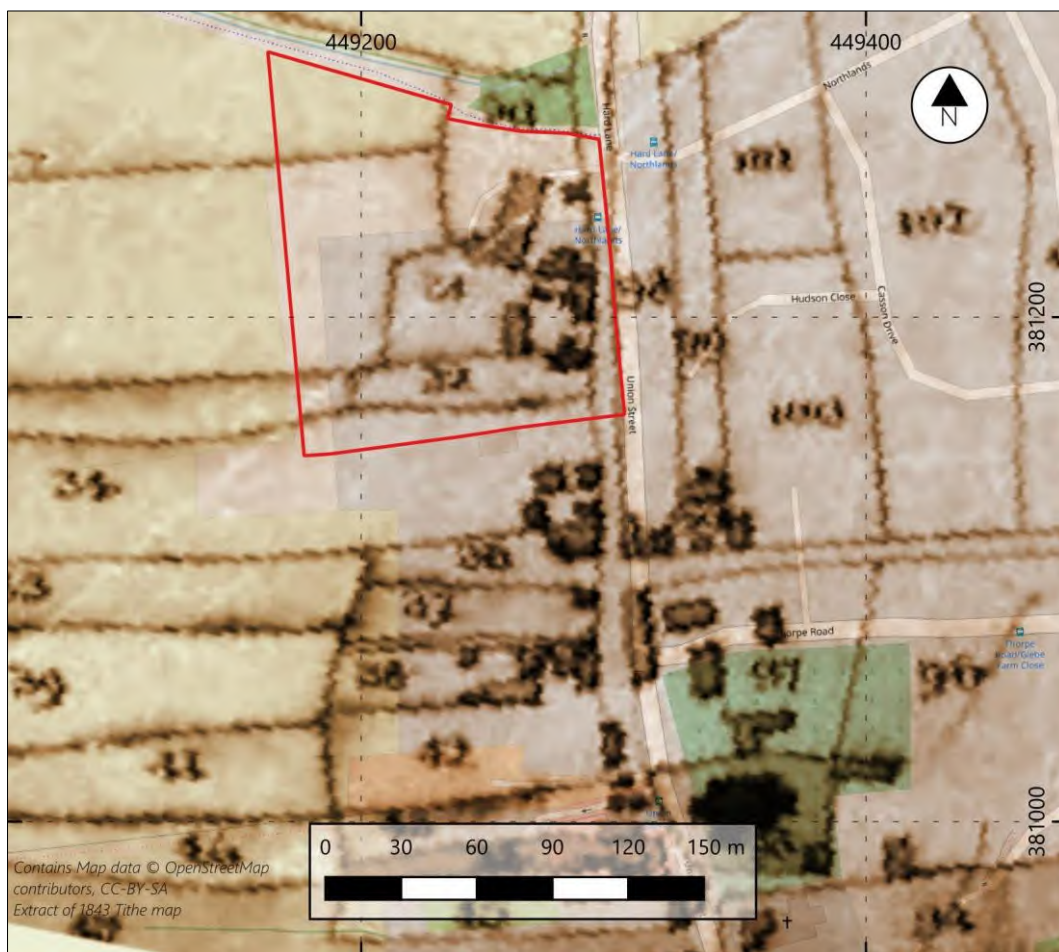
Figure 4. Extract from the 1843 Tithe map of Harthill.

- 3.5 The 1843 Tithe map of Harthill (Fig. 4) depicted North farm as Apportionments 30 & 31 (Snowden 2019, 12); with the farmhouse and attached barn (Farm Building 2) with another small building to the east and buildings set round the yard adjacent to the

road on the south of the farmhouse (possibly Farm Building 3) and the barn (west parts of Farm Buildings 4 & 5). The 1844 tithe map and apportionment of Harthill (IR 18/12583 & IR 29/43/193) stated the land was owned by the Duke of Leeds and farmed by John Glossop. John Glossop was listed on the 1851 Census as 'a farmer of 208 acres employing 4 labourers' (HO107/2122/F?).

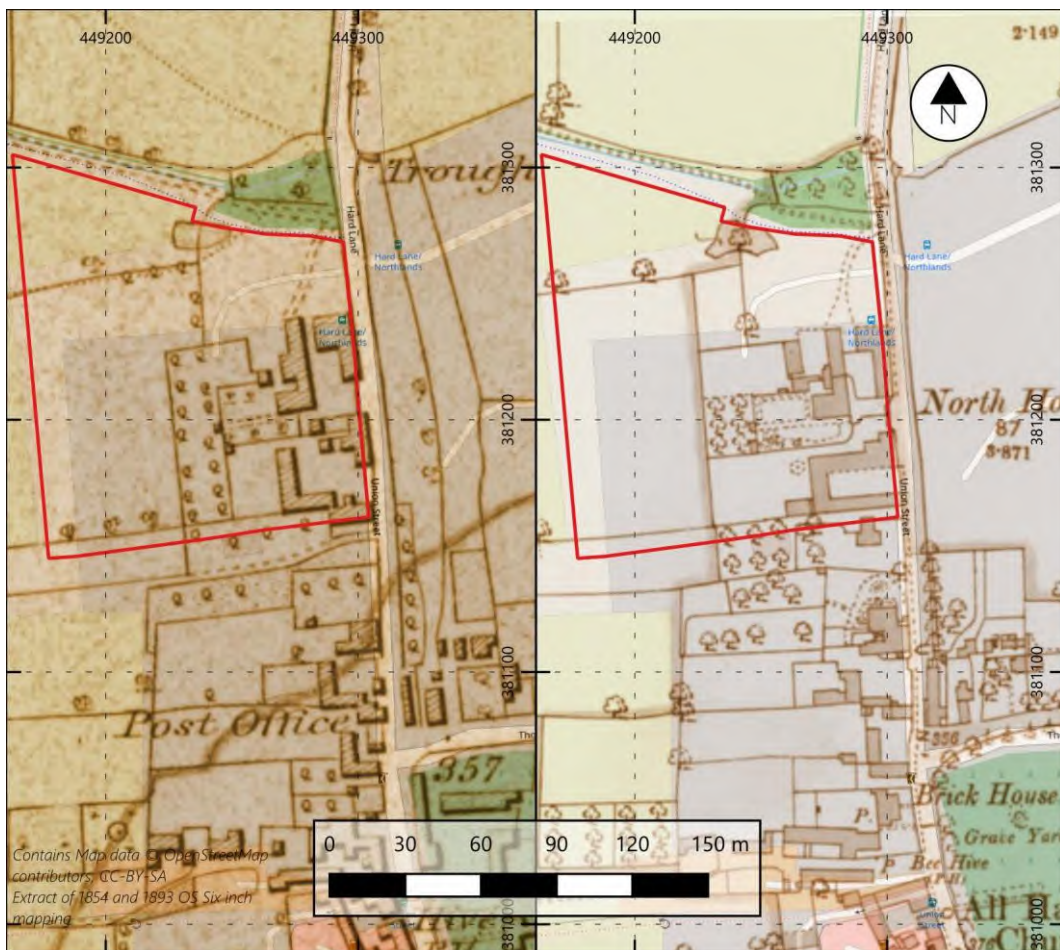
Figure 5. Extracts from the 1854 (left) and 1894 (right) first edition Ordnance Survey Maps.

- 3.6 The farmhouse and three farm buildings were depicted on the 1854 first edition 6 inch to 1 mile Ordnance Survey map are shown more clearly on the 1:10560 Ordnance Survey map, surveyed in 1851, published in 1854 (Fig. 5). The farmhouse and dairy extension with attached barn (Farm Building 2 with addition to the north),

with the L-shaped building to the east (farm Building 1), a T-shaped building on the roadside (Farm Building 3) and L-shaped building south of the farmhouse (west part of Farm Building 4 & Farm Building 5). The 1894 edition Ordnance Survey map depicted North Farm (Fig. 5) as the farmhouse with attached barn (Farm Building 2) and another building to the west and the L-shaped farm building to the east (Farm Building 1) and south farm buildings around a yard (Farm Buildings 3, 4 & 5), with an additional building west of south building (Farm Building 5).

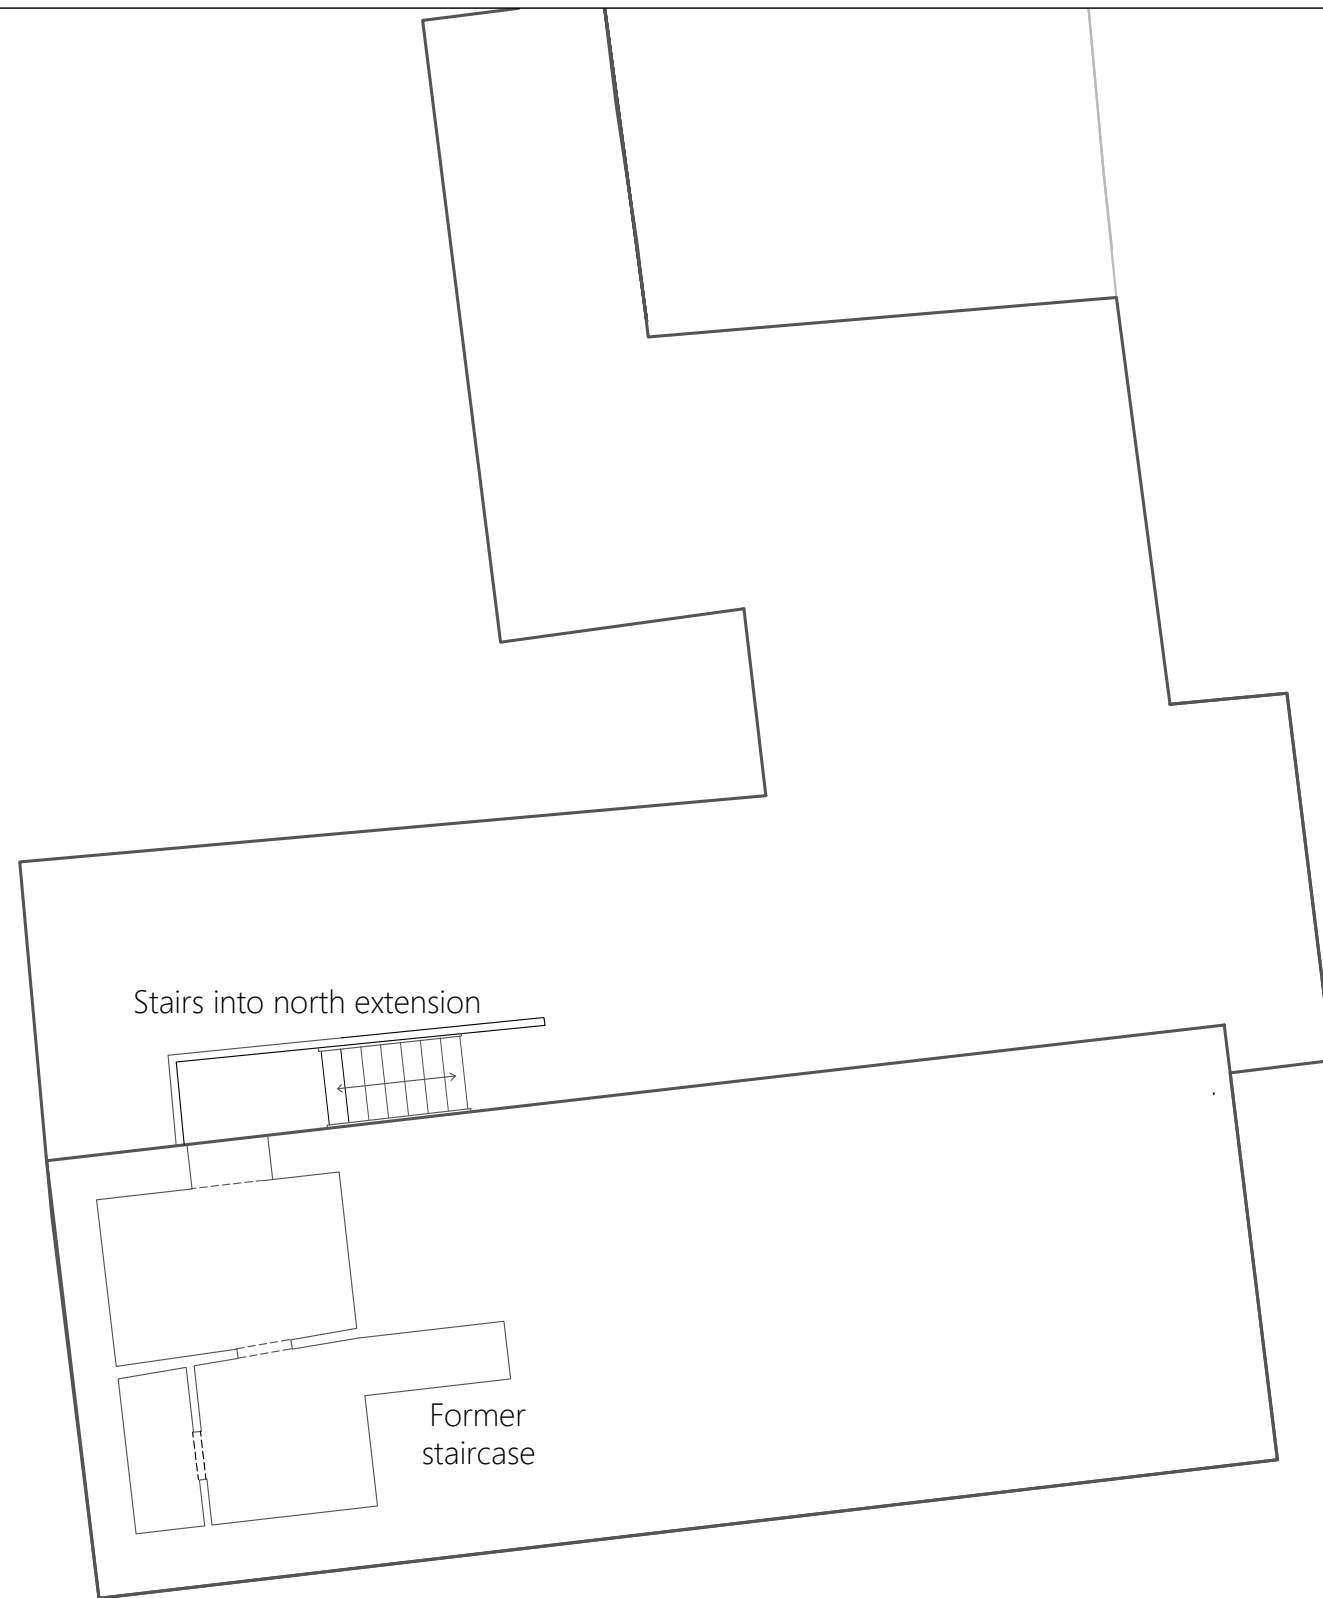
Figure 10. Farmhouse:
Basement Floorplan.

6.4.23 There was one open access into the hayloft above in the west wall, above the north window in the large, blocked opening (Pl. 27). There was a blocked access into the hayloft in the north gable (Figs. 10 & 11). The floor was in poor condition, covered in debris and vegetation and photos (Pls. 79-81) were taken from this vantage point. The roof was supported by two large principal rafter trusses with tie beam and collar (Pl. 79). The collar and rafter ties were irregular, with rough shaping above and assembly marks '||||' to the north face of the collar tie. The chamfered soffit along

FARMHOUSE
Cellar
plan
based on
drawing
by
Edward
Architecture

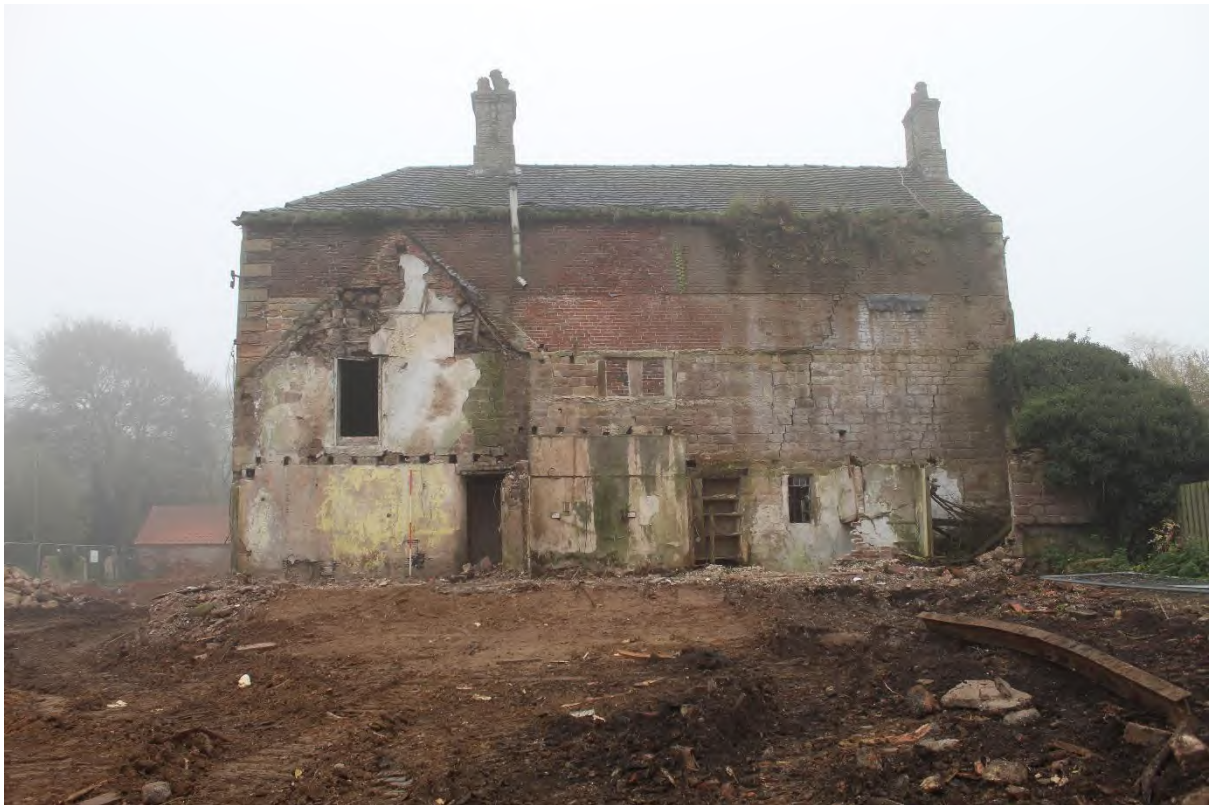
Plate 30. Farmhouse: North Elevation after partial demolition (IMG_0097). Facing South.

6.4.9 The lower half of the north elevation of the farmhouse was fenced off, as the partially collapsed northern extension was unsafe to enter (Pl. 29). The north extension was in ruins with only part of the north and west elevations surviving (Pls. 29 & 31). There was a rear entrance into the north extension flanked by windows to the east and west and two windows to the west. The north extension was photographed after the partial demolition of the extension (Pl. 30) and a window and blocked doorway on the ground floor were exposed. There were three blocked windows at first floor level within the stone-built part of the wall, which reflected the

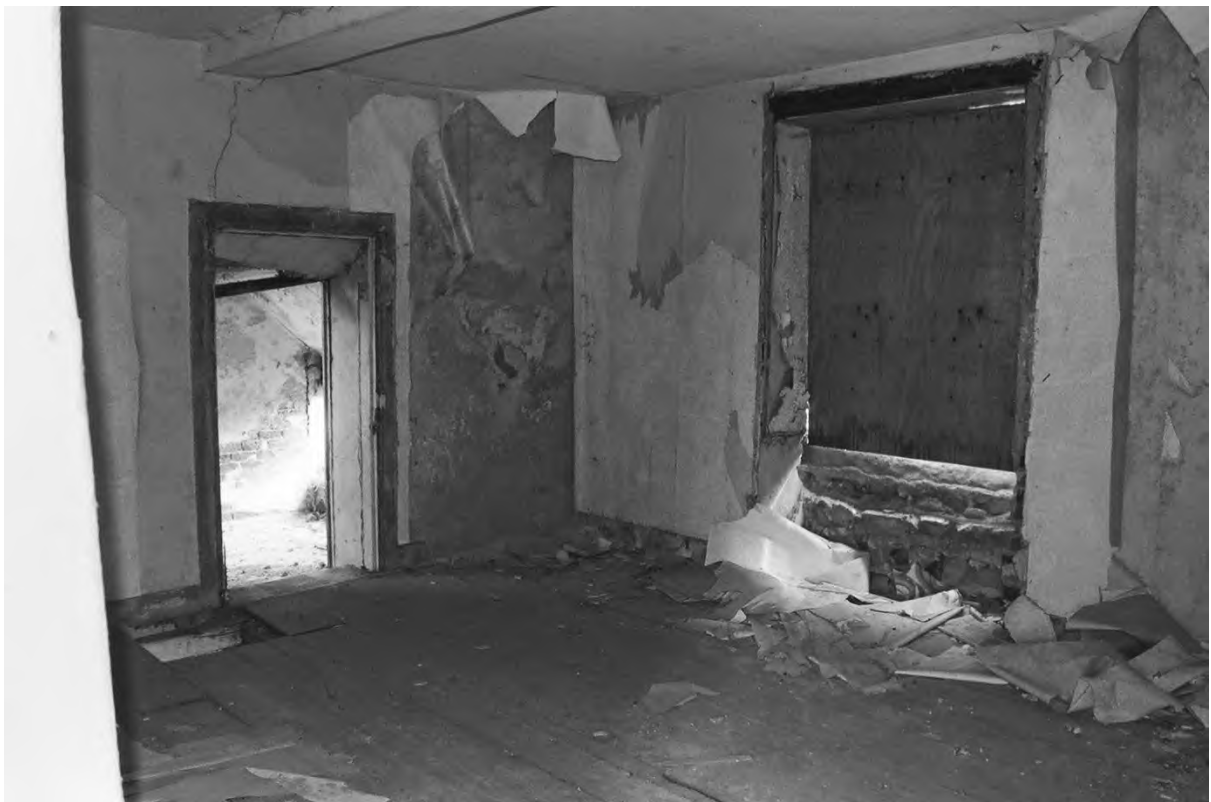
Plate 56. Farmhouse: First Floor Room 13 (Film 3/9). Facing North-east

6.4.20 The rooms and stairwell on the first floor of the main part of the farmhouse had large windows to the south and east. Rooms 11 & 13 rooms had wooden floorboards (Pls. 54 & 56). Rooms 12, 14, 15 and 16 appeared to have ash lime floors (Pls. 55 & 57-60). The landing on the main stairs between the ground and first floor had an internal double window (Pl. 53). Rooms 11 & 12 on the first floor were on either side of the stairs with a joint cupboard to the north, which has a blocked window in the north wall (Pl. 29). Room 11 had been badly damaged by water penetration (Pl. 54). There was no chimney breast or fireplace on the west wall of Room 11. There was a chimney breast and hearth were on the east wall of Room 12, but the fireplace had been removed (Pl. 55). Room 13 had access to the west to the stairs via Room 12

(Fig. 15). In Room 13, the fireplace in the west wall removed and blocked. There was a step down into the Room 14 to the north from Room 13 and a north-south aligned beam on the ceiling (Pl. 56). Room 14 had been badly damaged by water ingress with a rotten floor and there was a blocked window to the west (Pl. 57). Room 14 had access to the north into a rear hall, Room 15, which was accessed via the stairs in Room 6 on the ground floor. There was a chimney stack and a blocked window in the east wall of Room 15 (Pl. 58). There was access from this hall to Room 16 to the north, which had a window beneath the eaves and at floor level to the east (Pl. 60). The western window in Rooms 15 and 16 was by the door, which provided illumination for both rooms and had been later partially blocked western extension, with a small slit left in the gable (Pl. 49).
