Chalk and Brick Barns at Burnham Beeches Farm, Burnham Warren,
Thornton Curtis

PA/2015/0536 & PA/2015/0568

HISTORIC BUILDING RECORDING (PHOTOGRAPHIC & DESCRIPTIVE RECORD)

MAP 5.32.2017

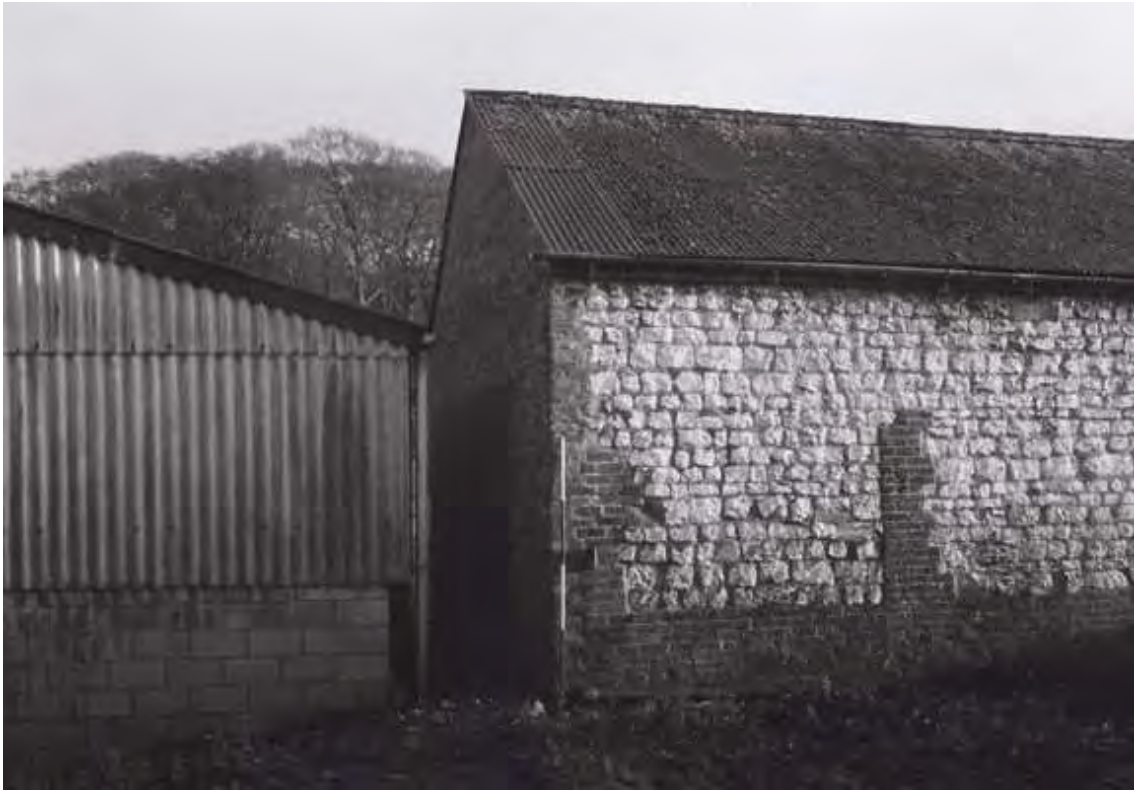
Plate 5. Chalk Barn: Exterior – North and West Elevations. Facing East.

- 6.2.2 The northern gable had been built in brick (Pl. 5), with the interior of this wall in concrete block (Pl. 16).
- 6.2.3 The southern gables of both the main barn and the extension are

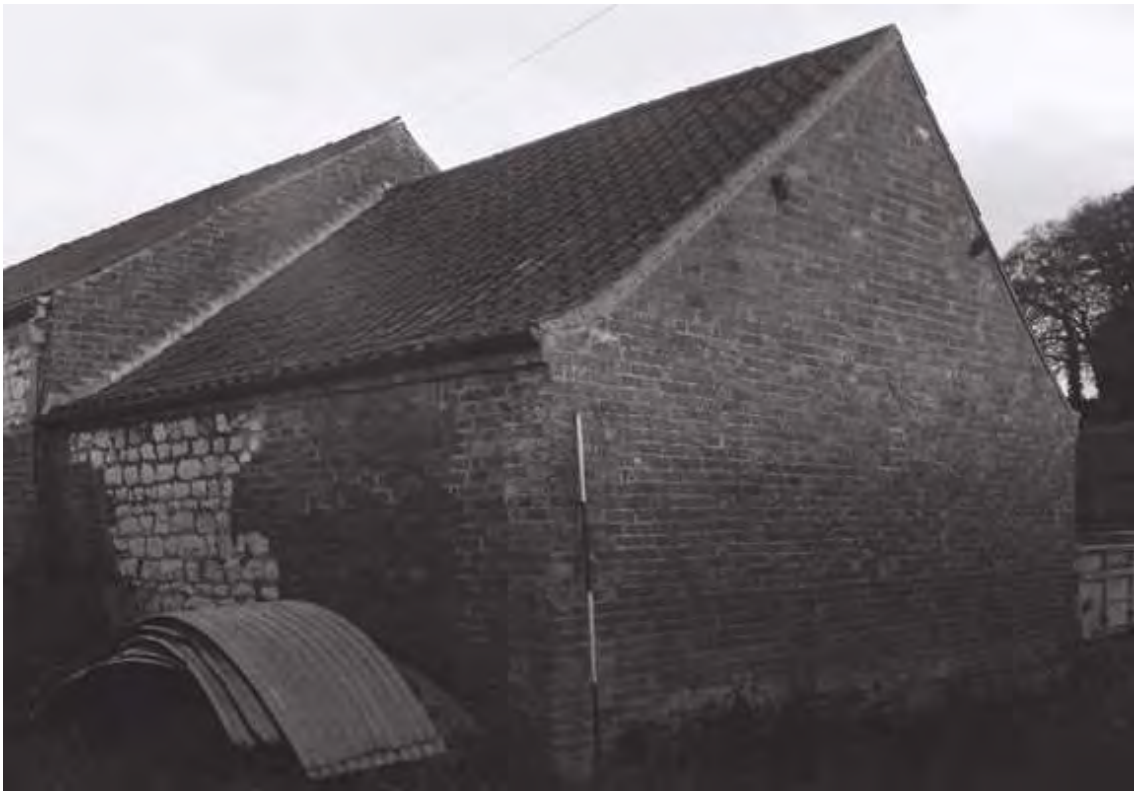
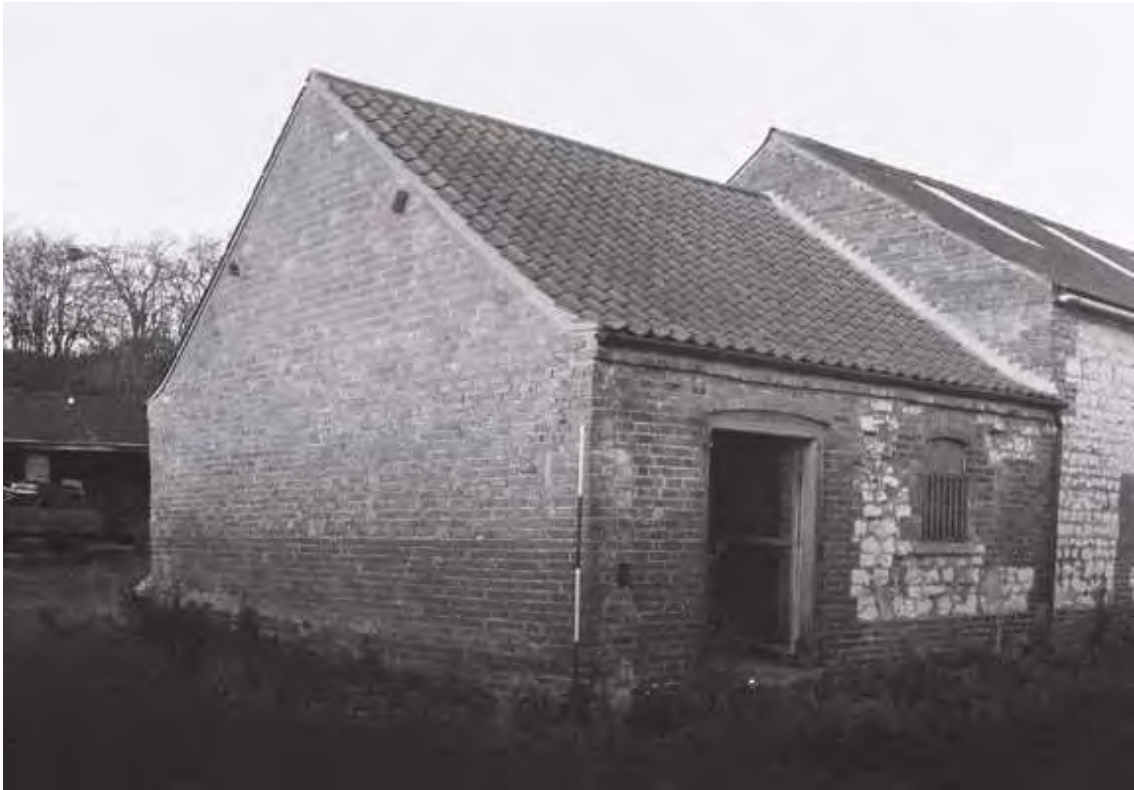
Plate 6. Chalk Barn: Exterior – West and South Elevations. Facing North-west.

constructed of brick, laid in stretcher bond (Pls. 6 & 7).

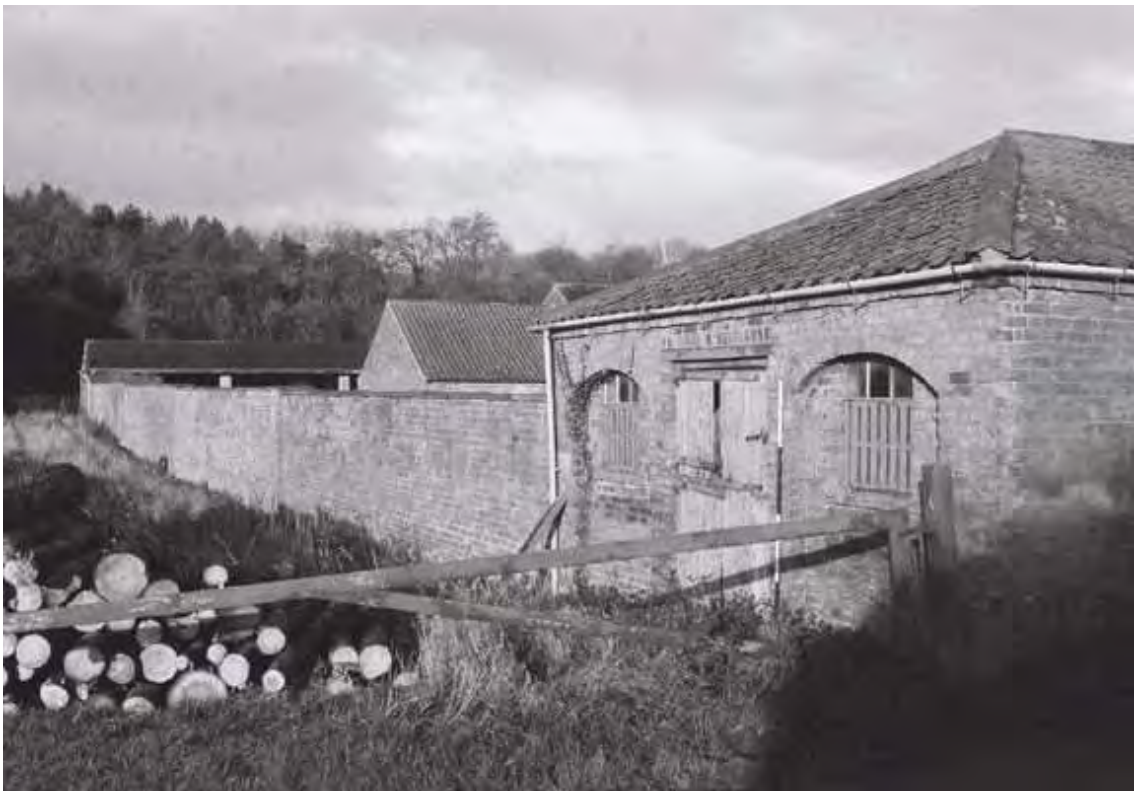
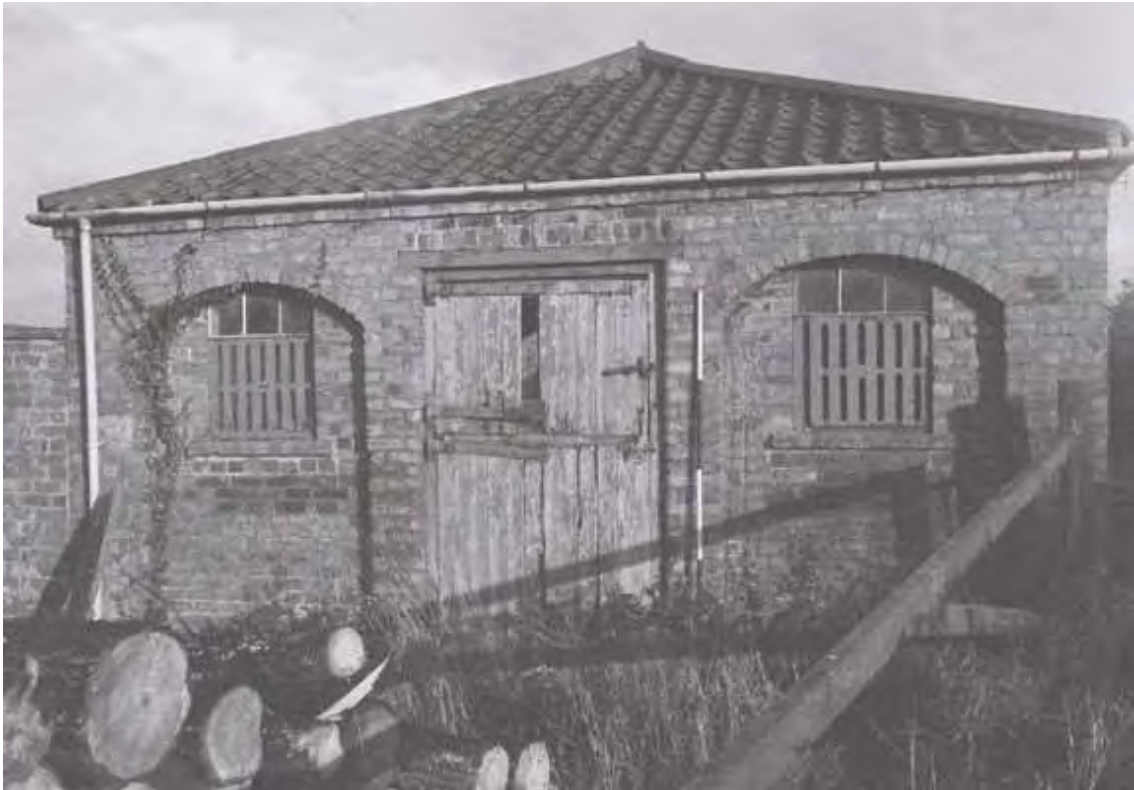
Plate 24. Brick Barn: Exterior – South Elevation. Facing North-west.

6.4.3 There is a central entrance into the south entrance with windows on either side. The windows are within arched reliefs (Pls. 24-26).

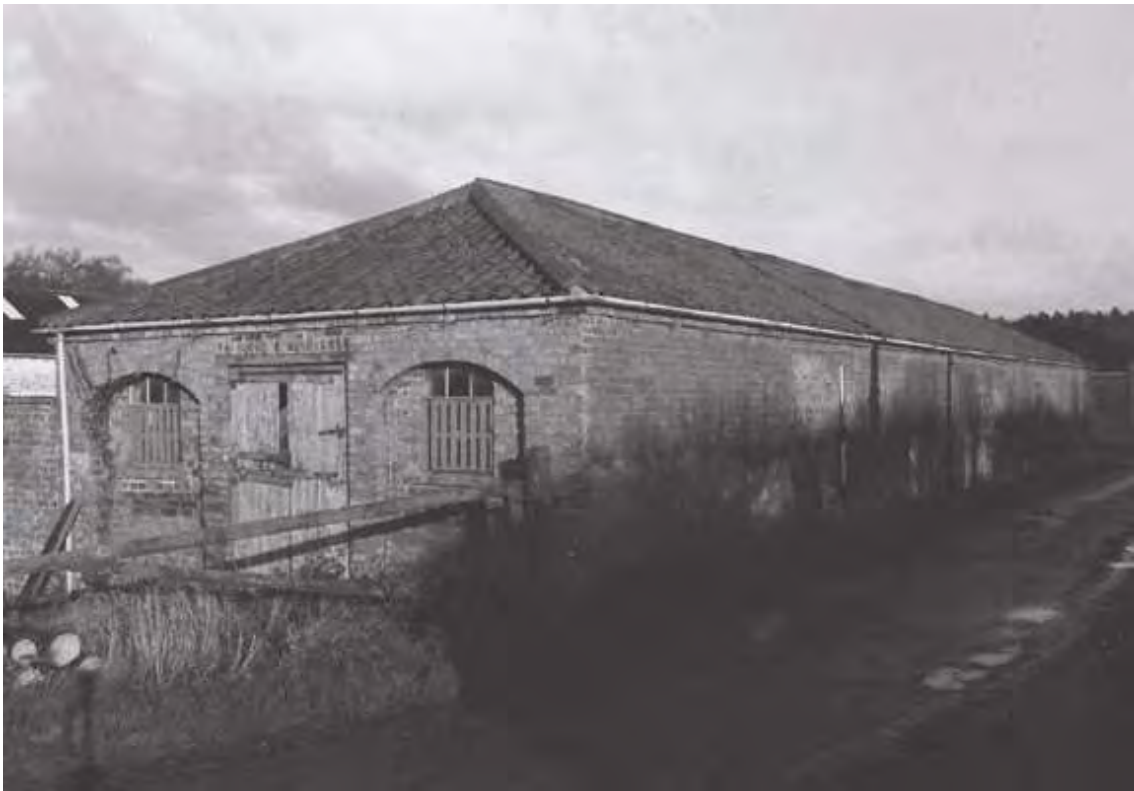
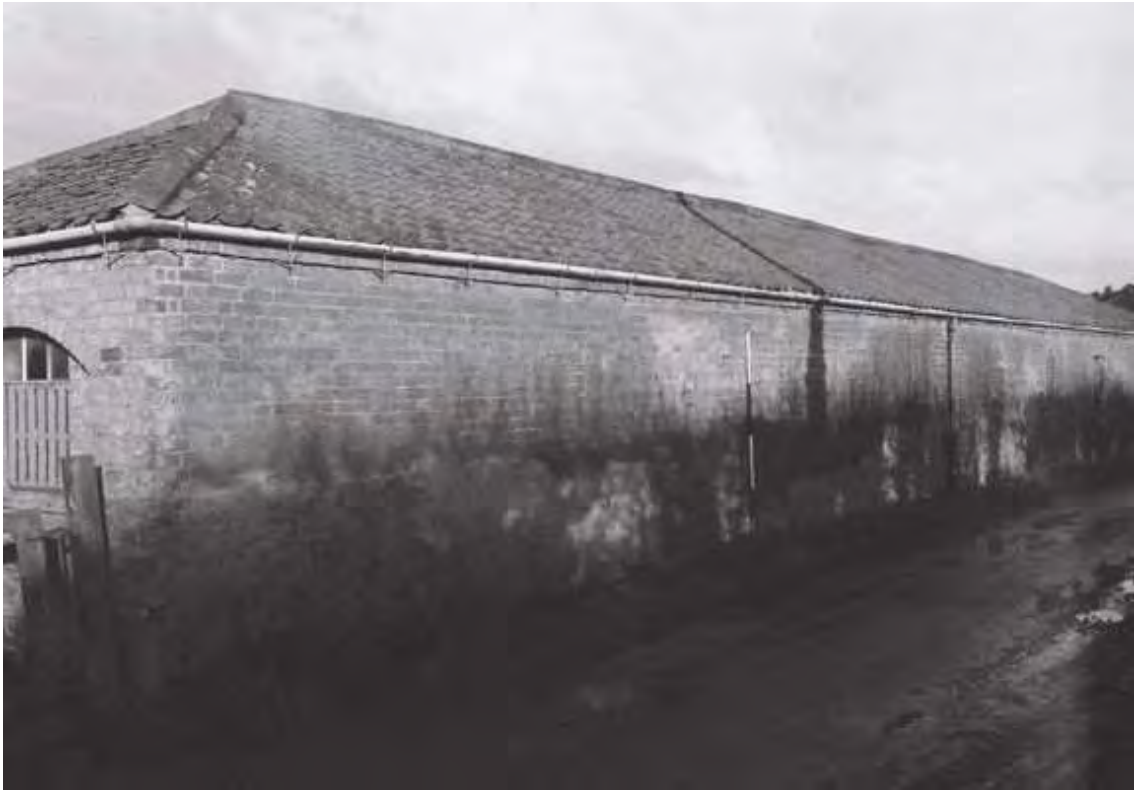
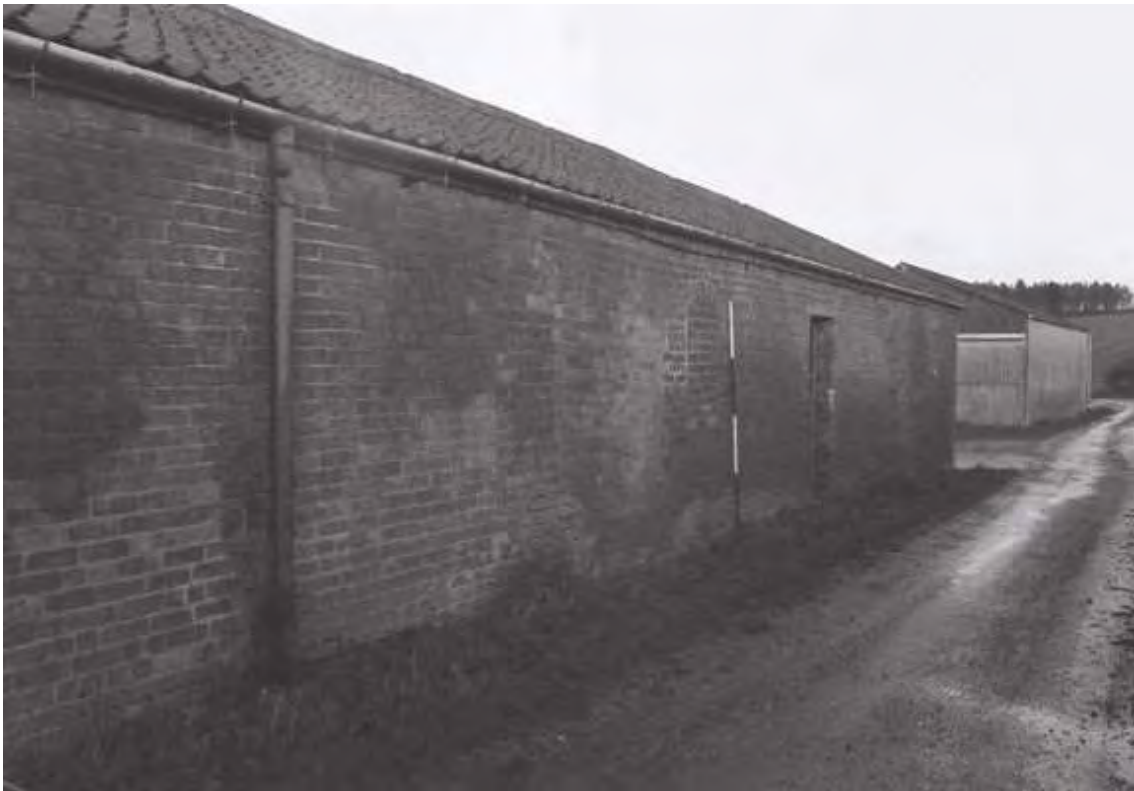
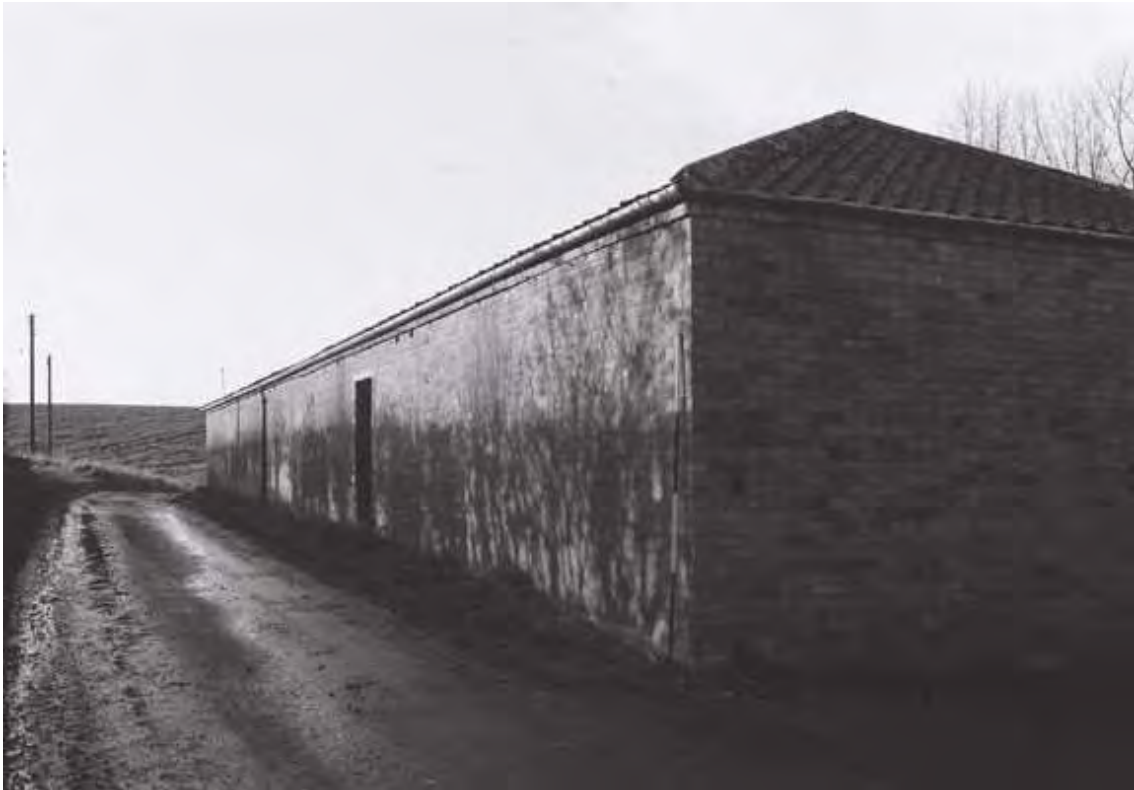
Plate 26. Brick Barn: Exterior – South and East Elevations. Facing North-west.

6.4.4 There is a single narrow door on the east elevation with pairs of blocked windows to the north and south (Pls. 26-29).

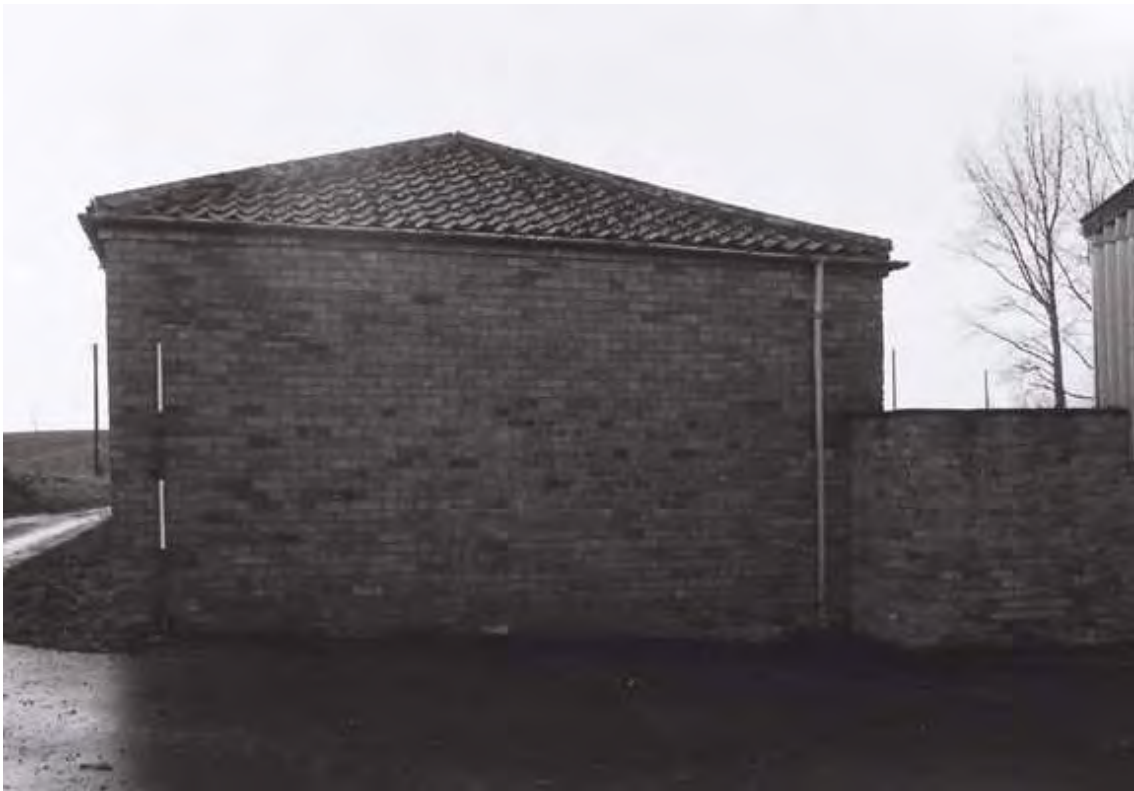
Plate 30. Brick Barn: Exterior – North Elevation. Facing South.

6.4.5 The north elevation was constructed of slightly paler brick (Pl. 30), possibly reconstructed after the replacement of the northern range, at the same time as the reconstruction of the Chalk Barn's northern elevation.

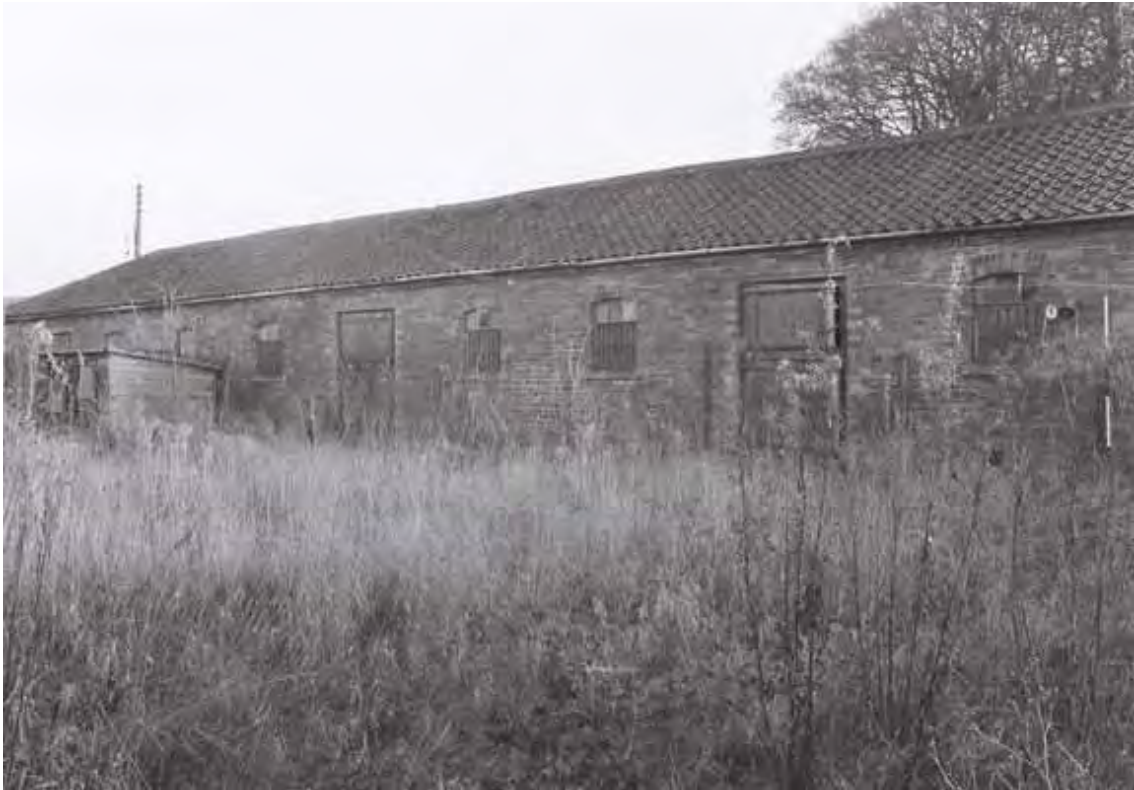
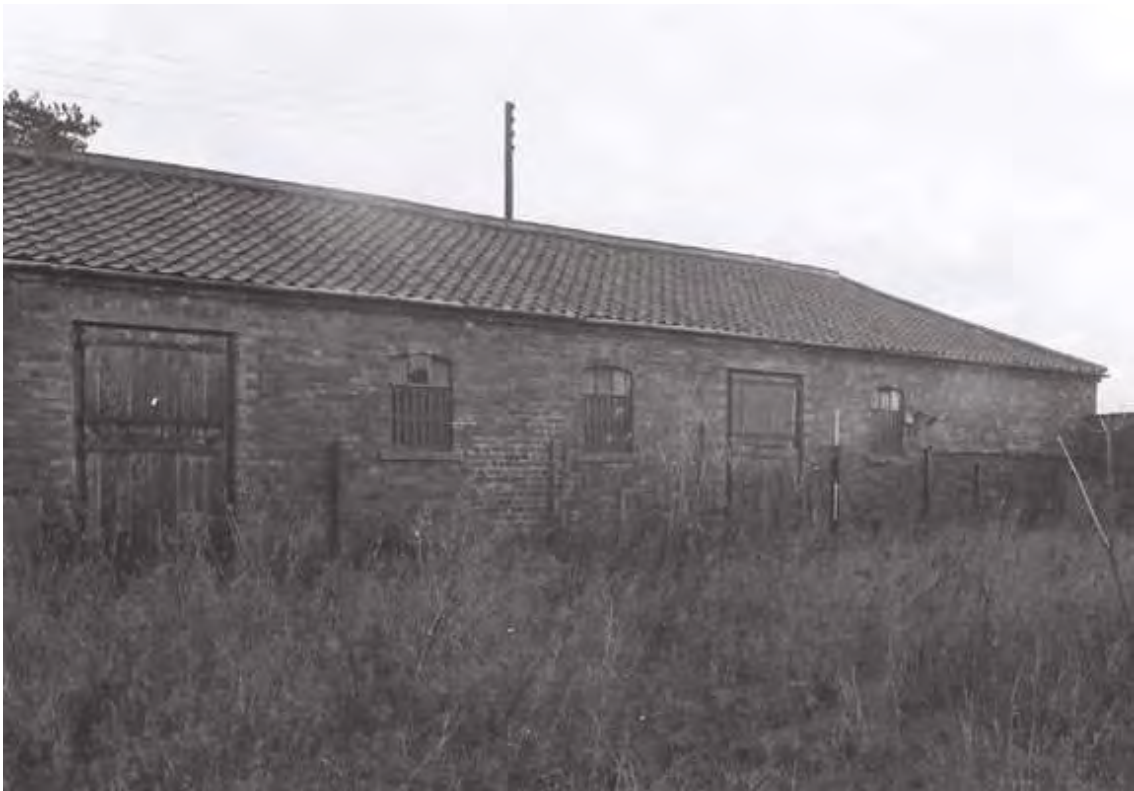
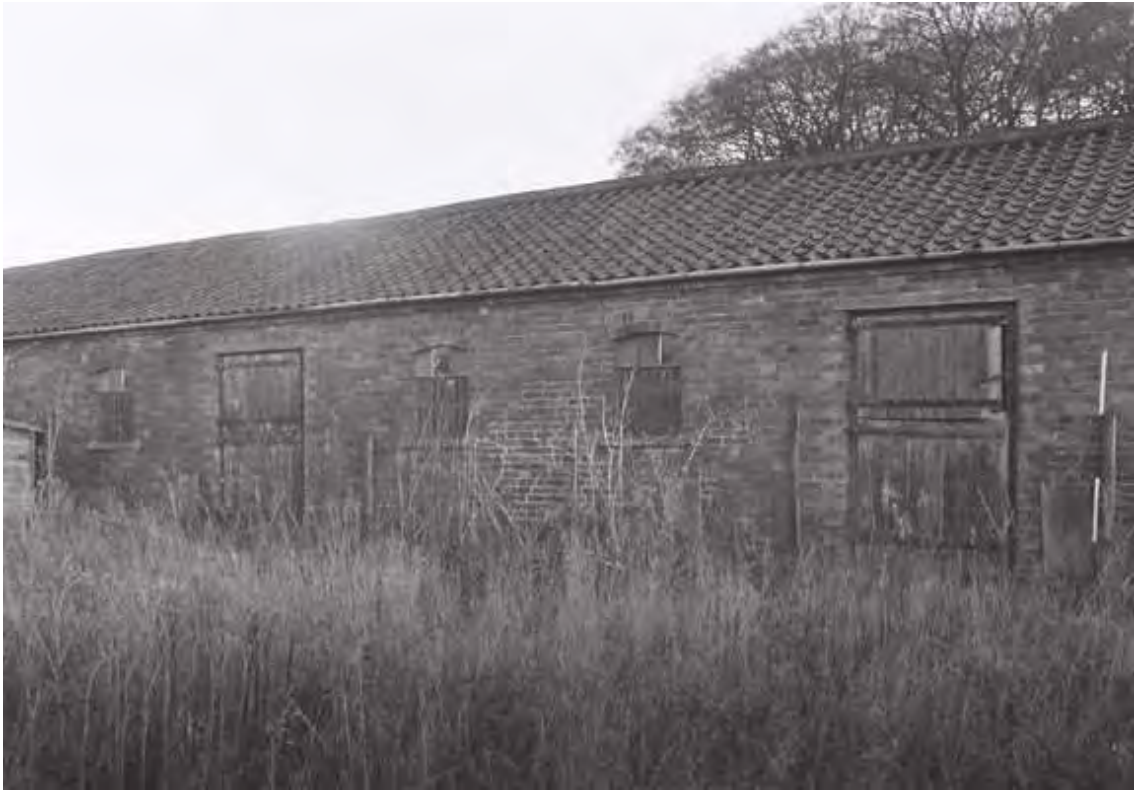
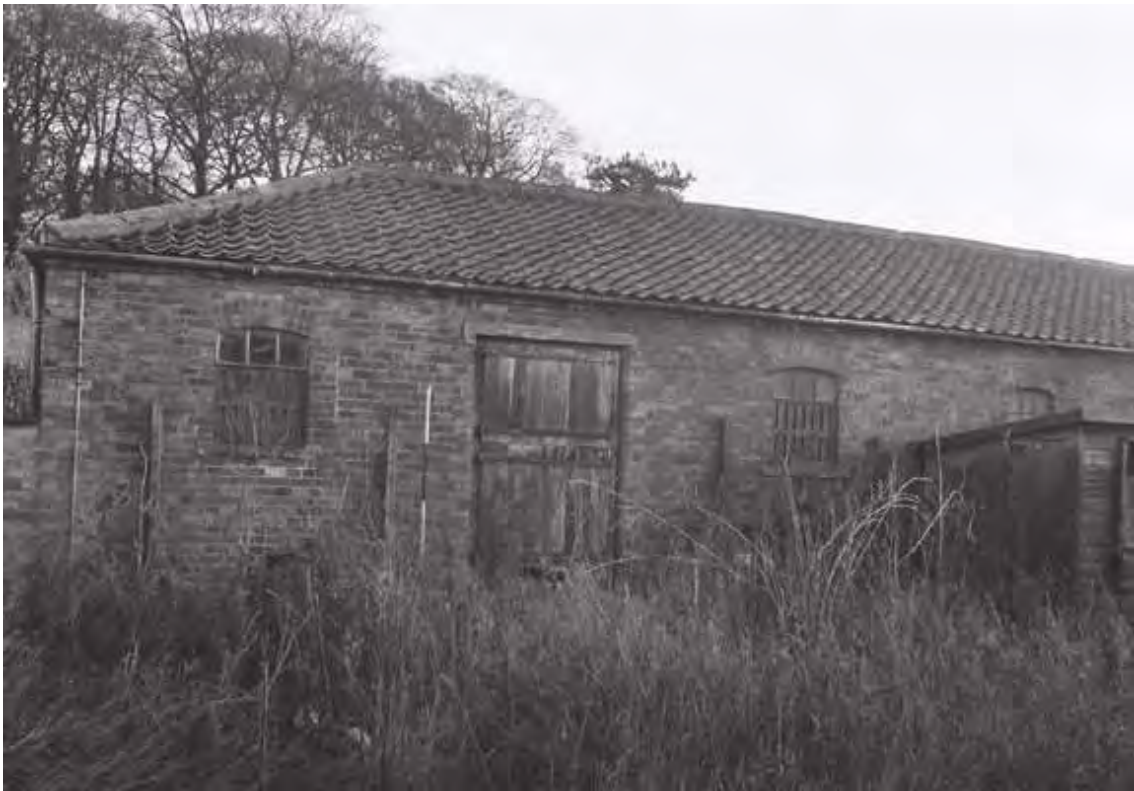
Plate 31. Brick Barn: Exterior – West Elevation. Facing North-east.

6.4.6 The west elevation faced onto a fold yard within the farm yard, separating the Brick Barn from the Chalk Barn. The West Elevation has three entrances which are (1.3m wide), for livestock. There is one window north of the north door, then three windows to the central door, two windows to the north door, which had a window to the south (Pls. 31-34).

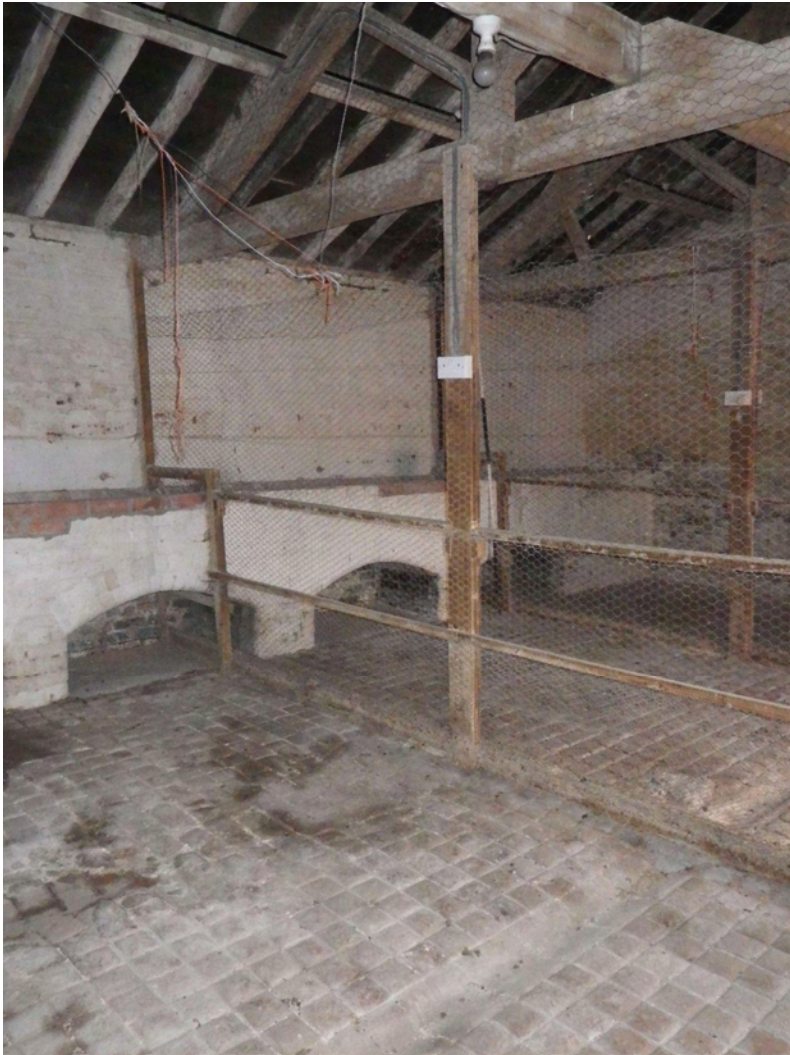
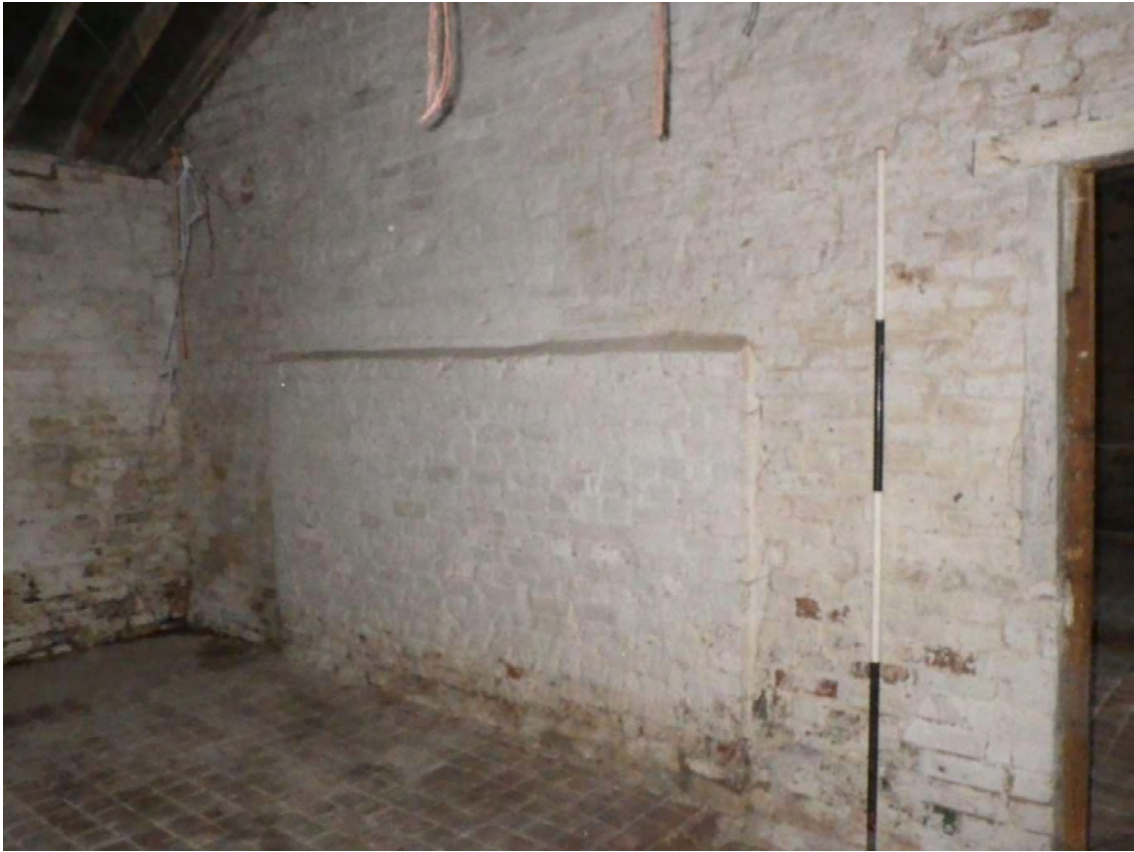
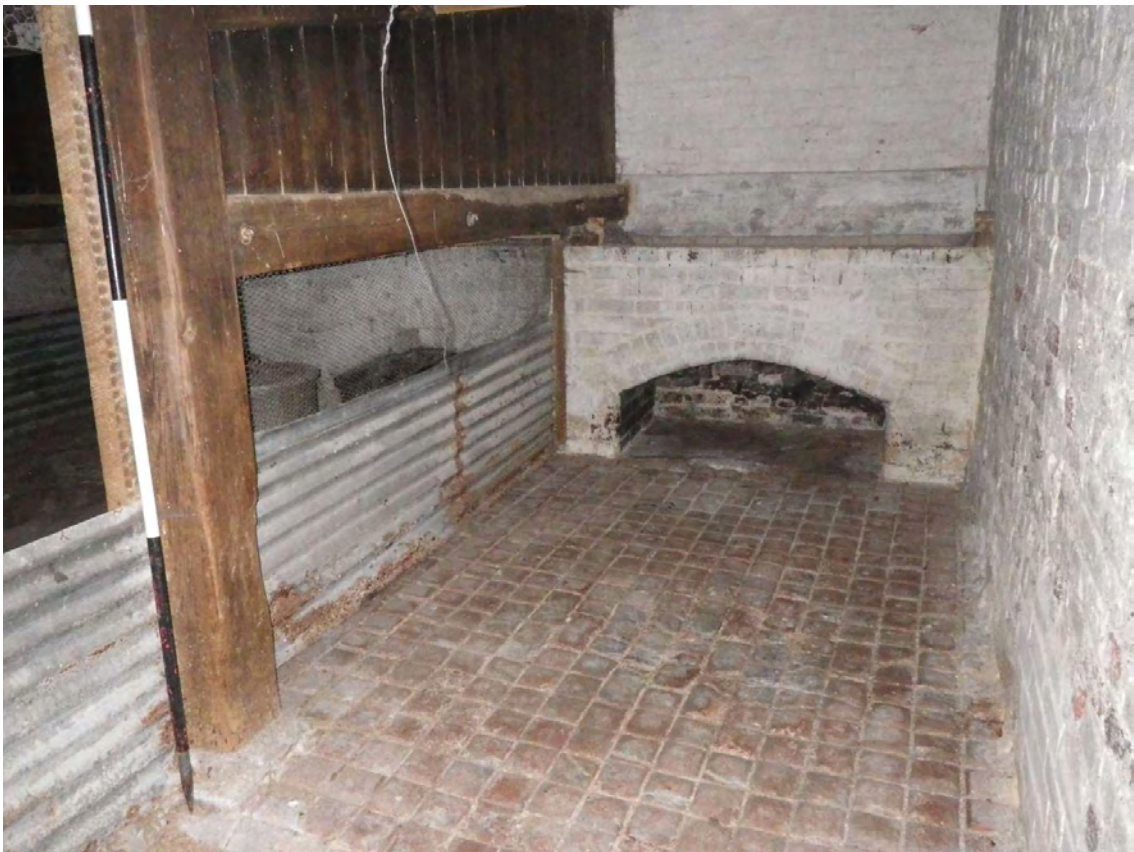
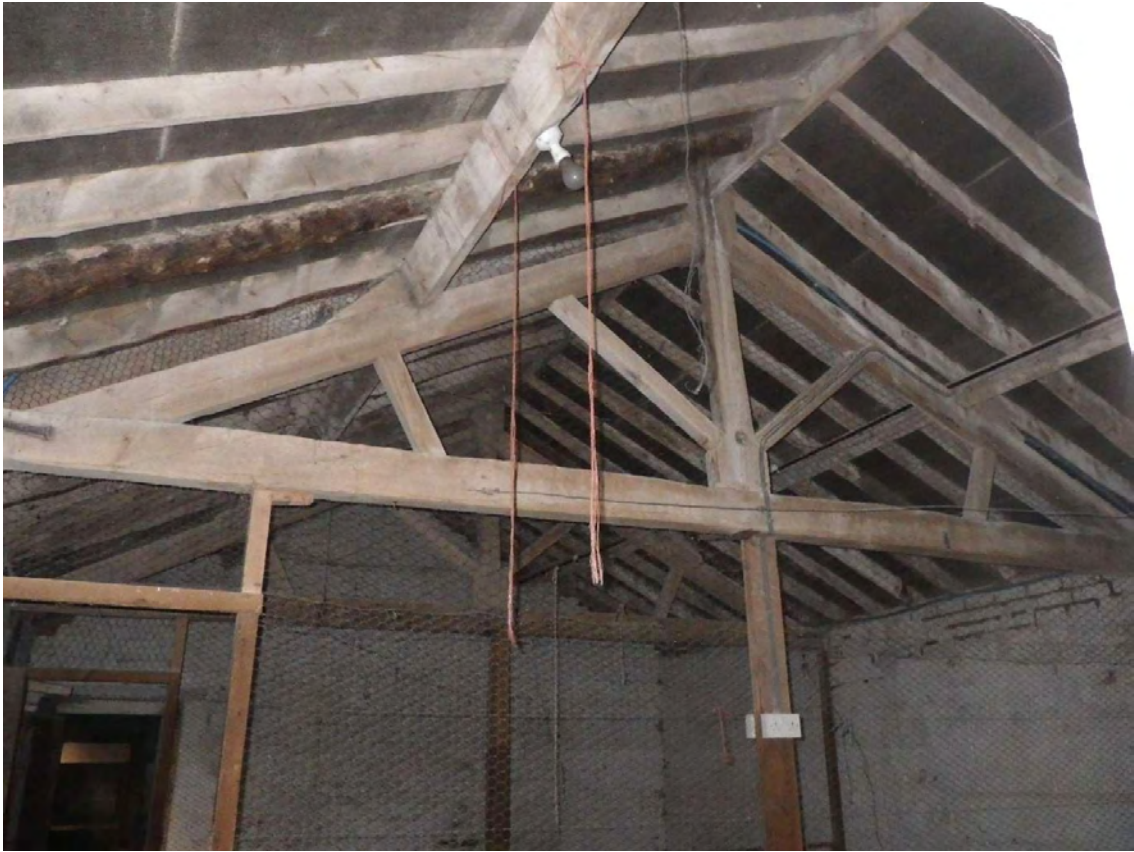
Plate 35. Brick Barn: Interior. Facing South-east.

6.5.1 The Brick barn has four internal walls, dividing the building into five rooms. There is a byre, then corridor, byre/stable, byre and a storeroom to the south. There is internal access via a series of internal doors in the walls along the west side of the rooms. The original timber stall are present in the northern room. The southern three rooms have been

subdivided with wooden frames and wire mesh. All rooms are open to the rafters with the three larger rooms with two King post trusses. The smaller storeroom to the south with a single King post truss. All the rooms have concrete floors. The northern and southern larger rooms have brick/concrete troughs along the east wall. All three larger rooms have a drain just east of the internal accessway. There was an internal blocked door between the corridor and the byre to the south, along the east wall.
