**Manor Top  
Saxby Hill  
Saxby All Saints  
North Lincolnshire**

**SE 99268 17396  
PA/2012/0326  
MAP 5.03.2015  
Historic Building Recording**

**HISTORIC BUILDING RECORDING  
(PHOTOGRAPHIC & DESCRIPTIVE RECORD)**

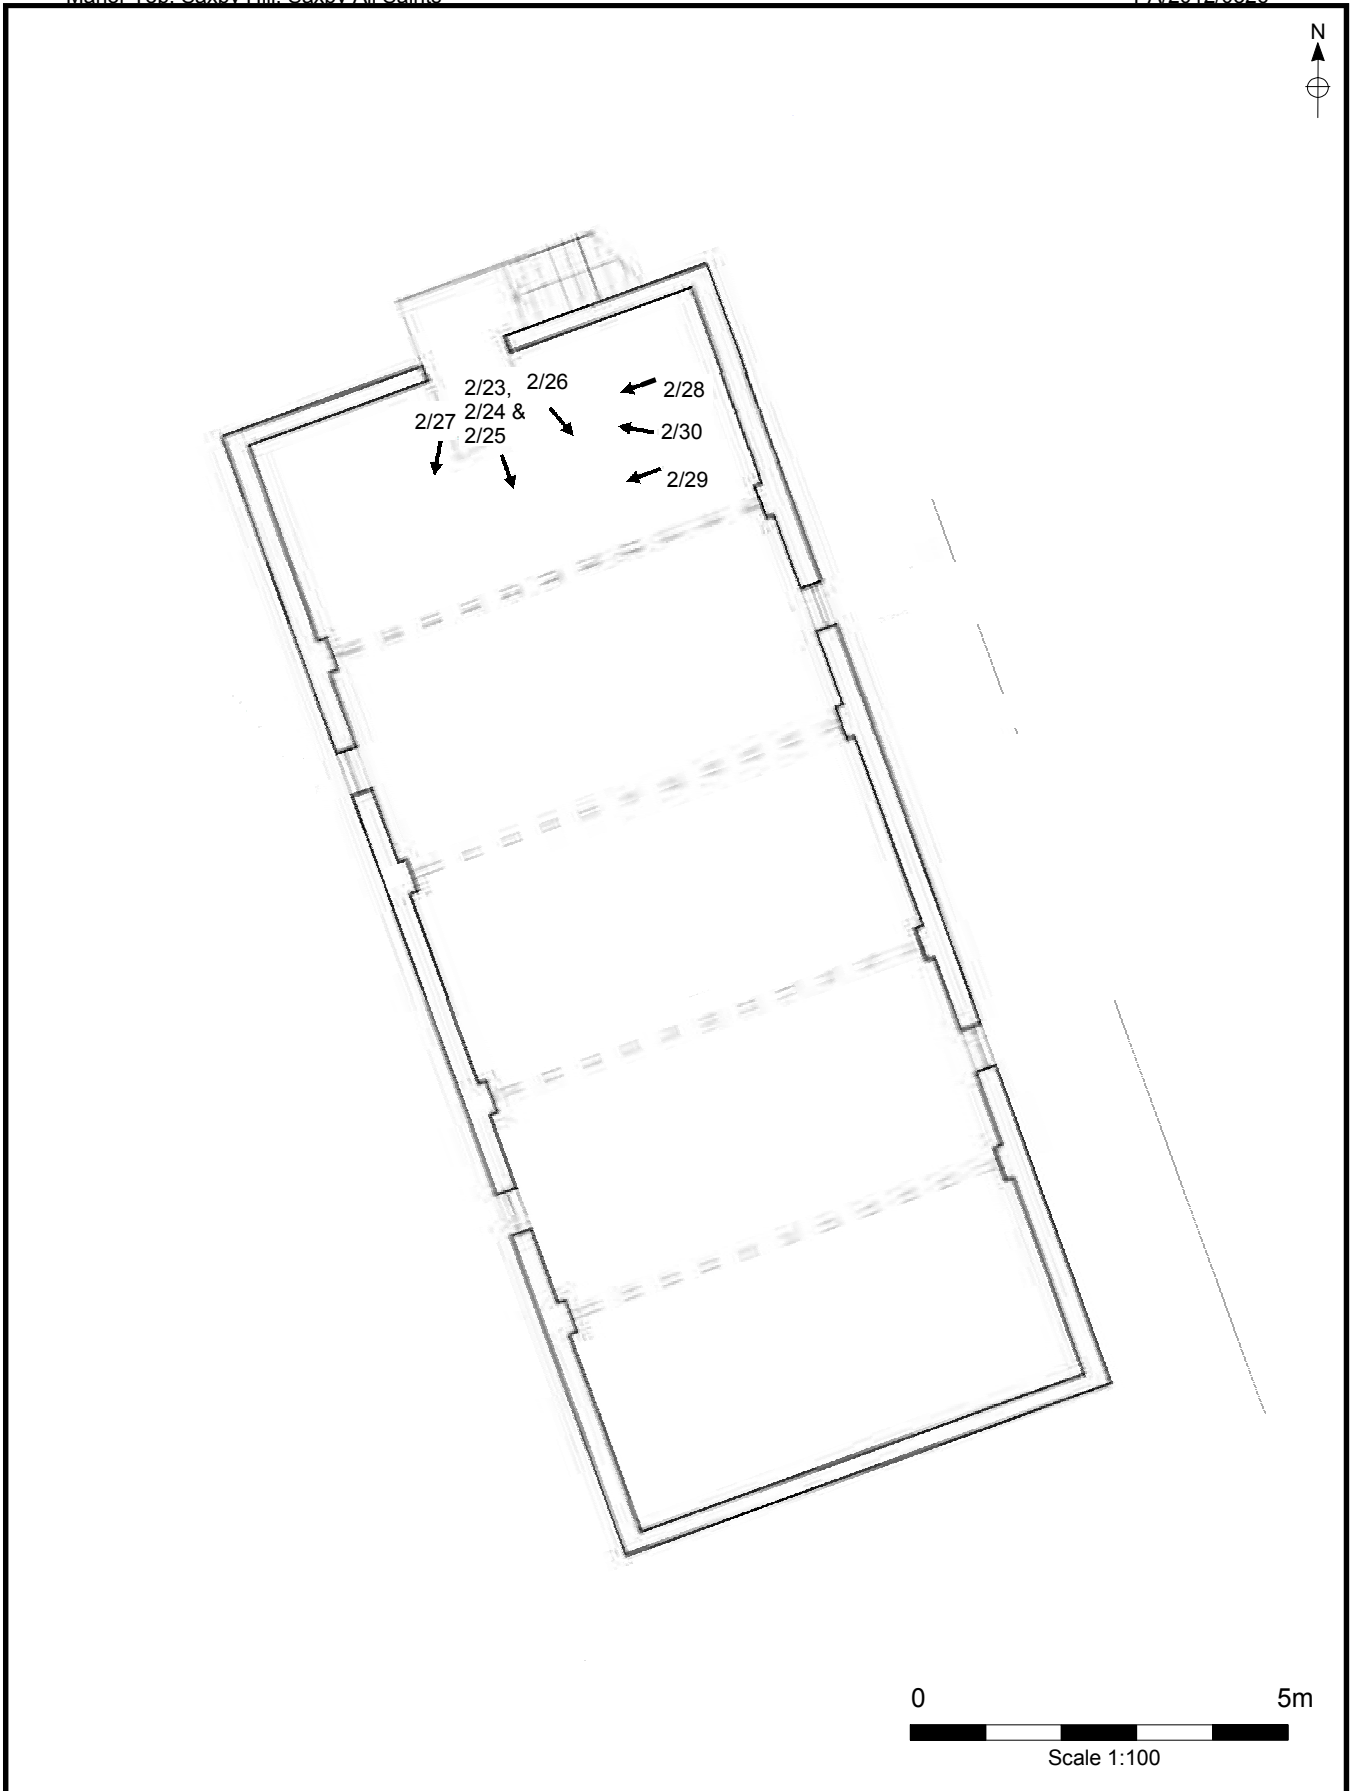
6.3.2 The first floor was in a dangerous condition and partially collapsed at the southern end of the building (Pls. 14-19). The granary was only viewed from the door because of the poor state of the floor. The roof structure was supported by four main king post trusses (Fig. 6). The planks are 17cm wide with replacement planks nearest the door. The timbers were sawn wood with iron braces and stays.

Figure 8. Cart Shed/Granary First Floor Plan.

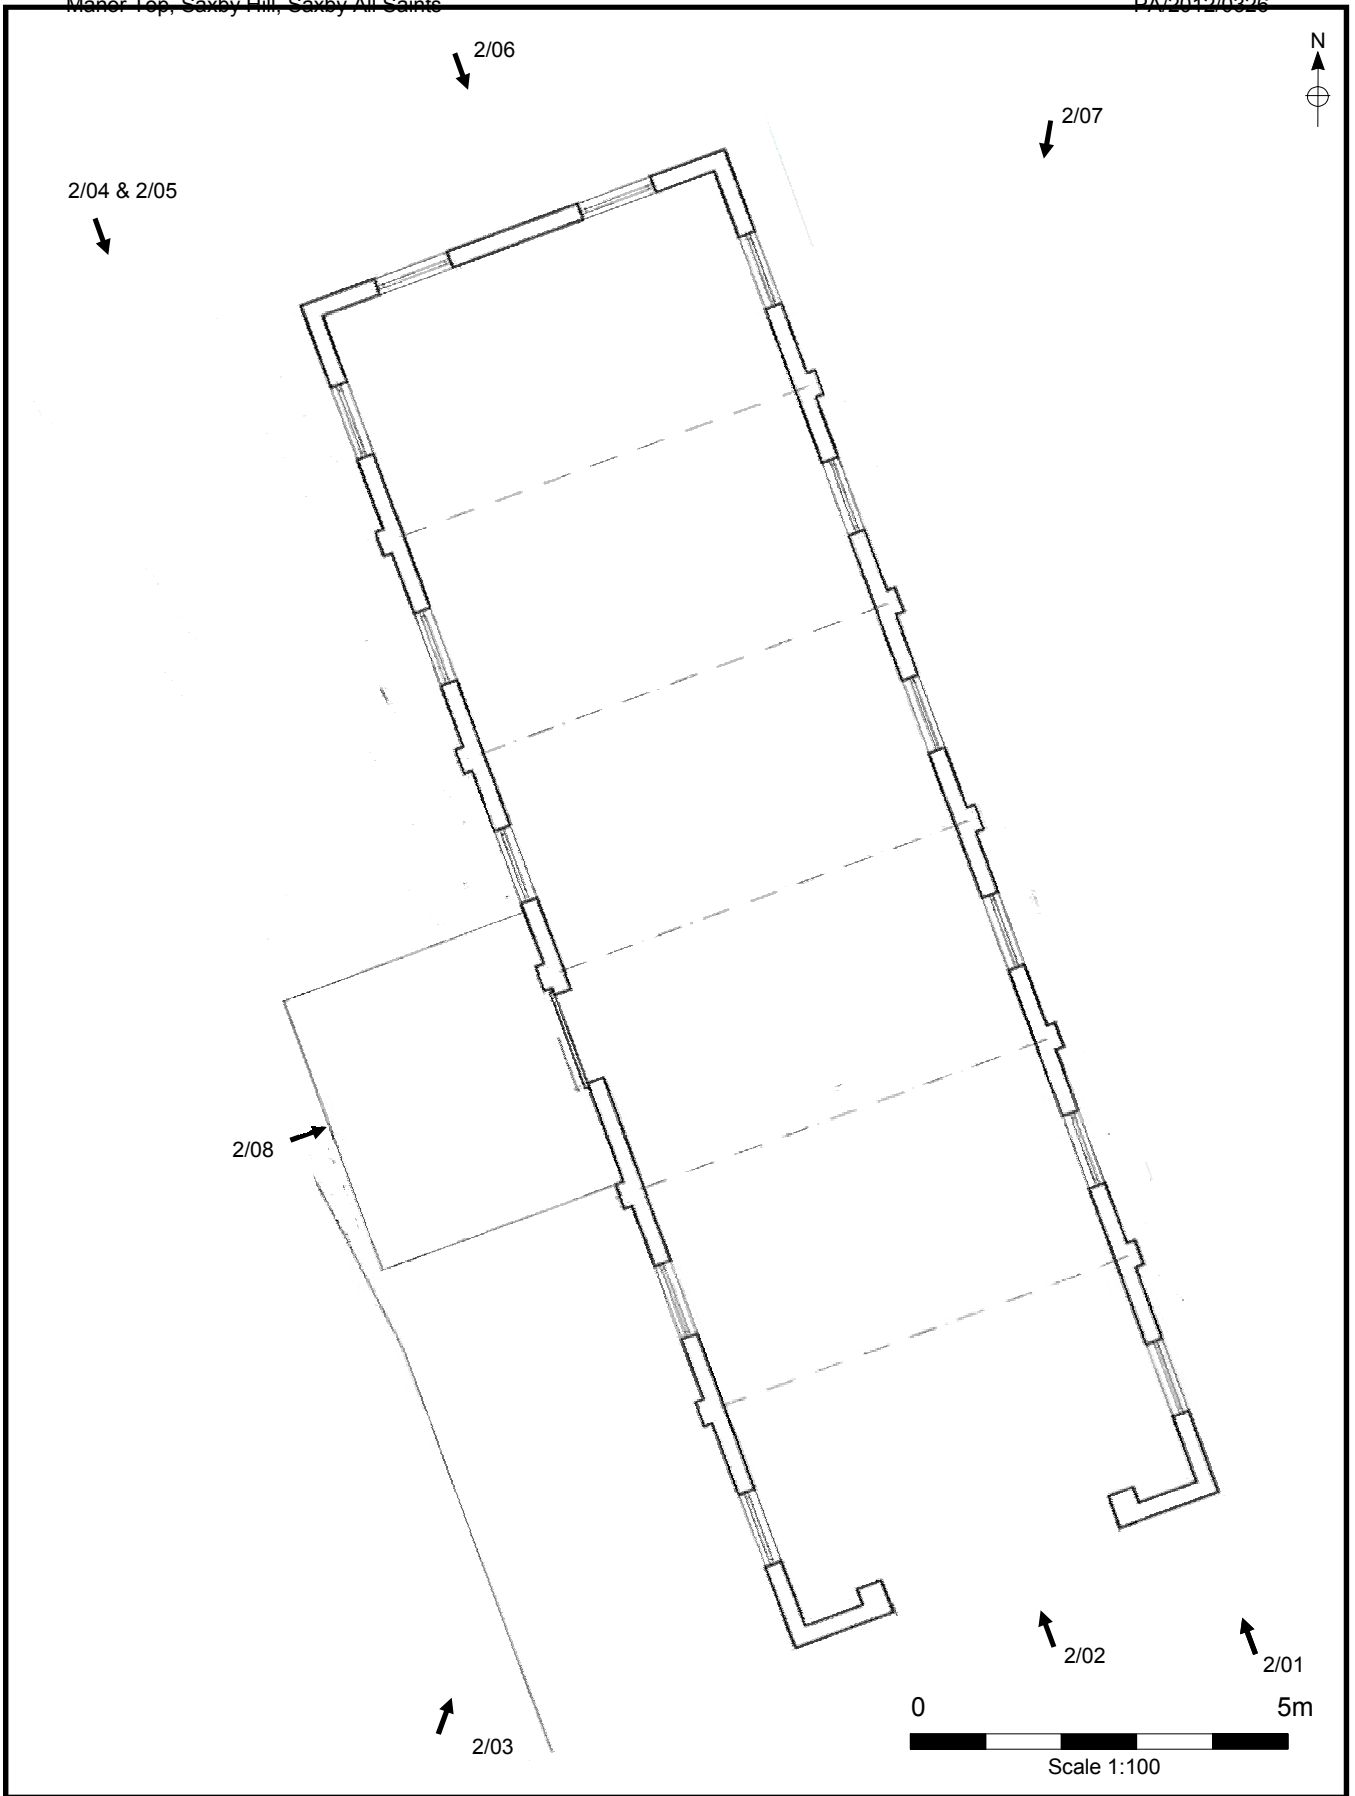
6.4.1 The store is a single storey brick built structure with low pitched gable roof covered in asbestos sheet. The building is built in header bond and thin pointed concrete mortar. The bricks are modern standard bricks (220mm long by 105mm wide by 73mm high). The building probably dates from the middle of the twentieth century fro its construction materials. There is a large double door on the southern gable for vehicle access. There is a sliding door entrance in the middle

of the western elevation and there is a large concrete plinth, in front of this door. The building is well lit with five windows on the west elevation, two on the north elevation and six windows on the east elevation. These windows are metal framed casement.

Figure 9. Store Ground Floor Plan.

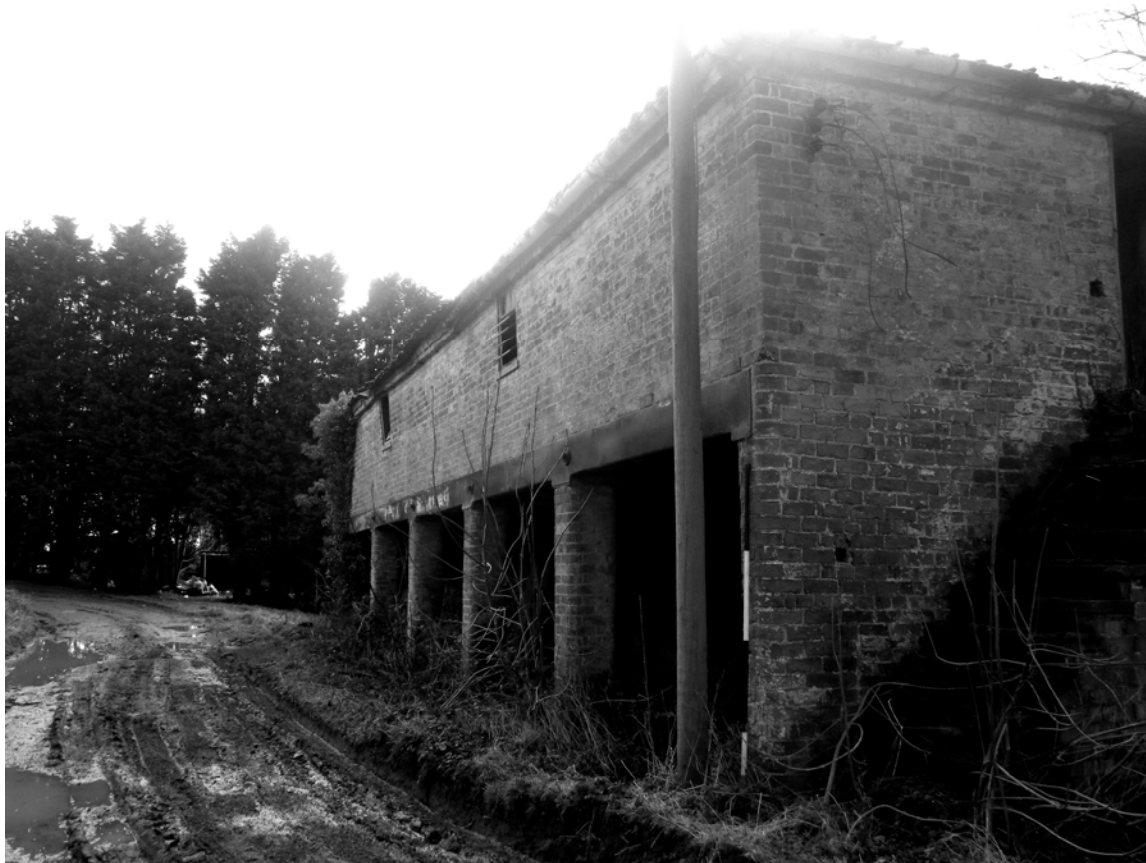
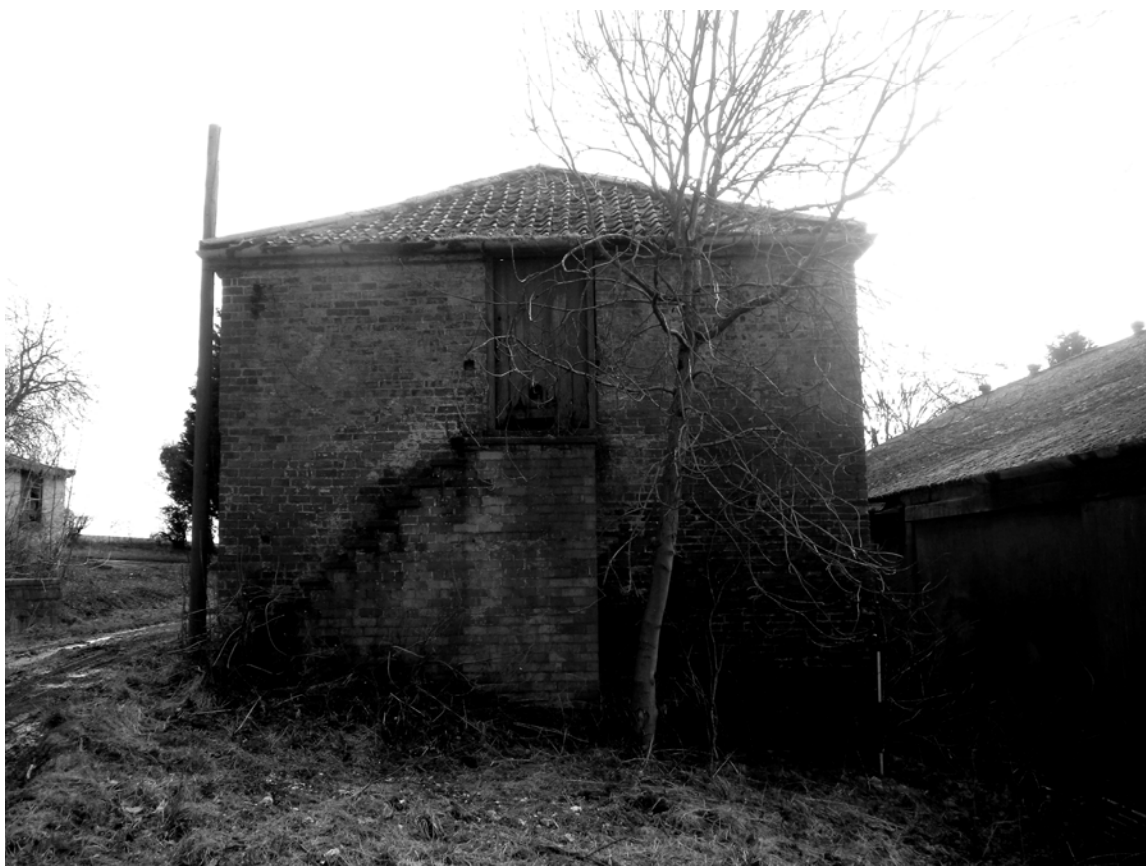
6.2.1 The Cart Shed was unused at the time of the survey and in a poor state of repair as the roof and granary floor had partially collapsed. The building was a two storey structure, constructed of local plain brick, in English Garden Wall bond with a hipped pan tile roof (Figs. 4-5; Pls. 3-4 & 10-11). The bricks measured 230mm long by 105mm wide by 75mm high. The guttering and down pipes are modern asbestos replacements. The ground floor was a cart shed, open on the eastern elevation and supported by four brick piers. The top of each pier was

Plate 3. Cart Shed Exterior: East Elevation. Facing South.

Plate 4. Cart Shed Exterior: North Elevation. Facing South.

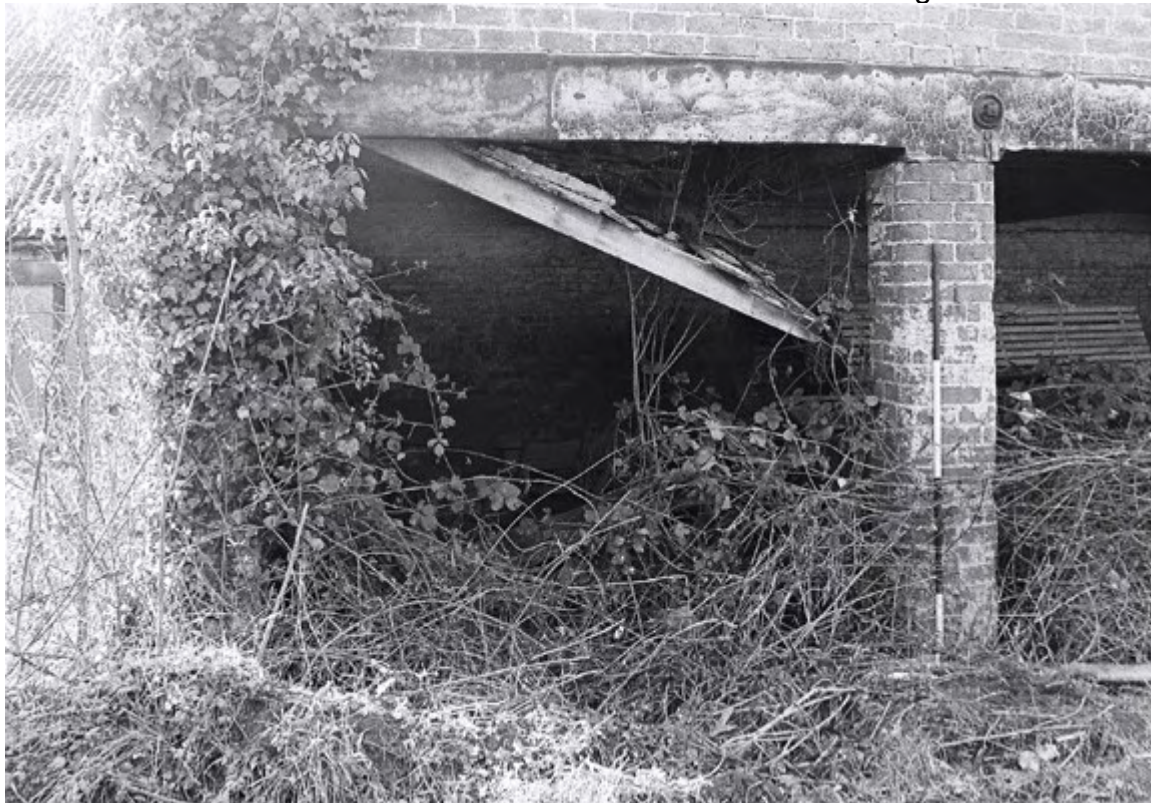
Plate 8. Cart Shed Exterior: Collapsed Floor. Facing West.

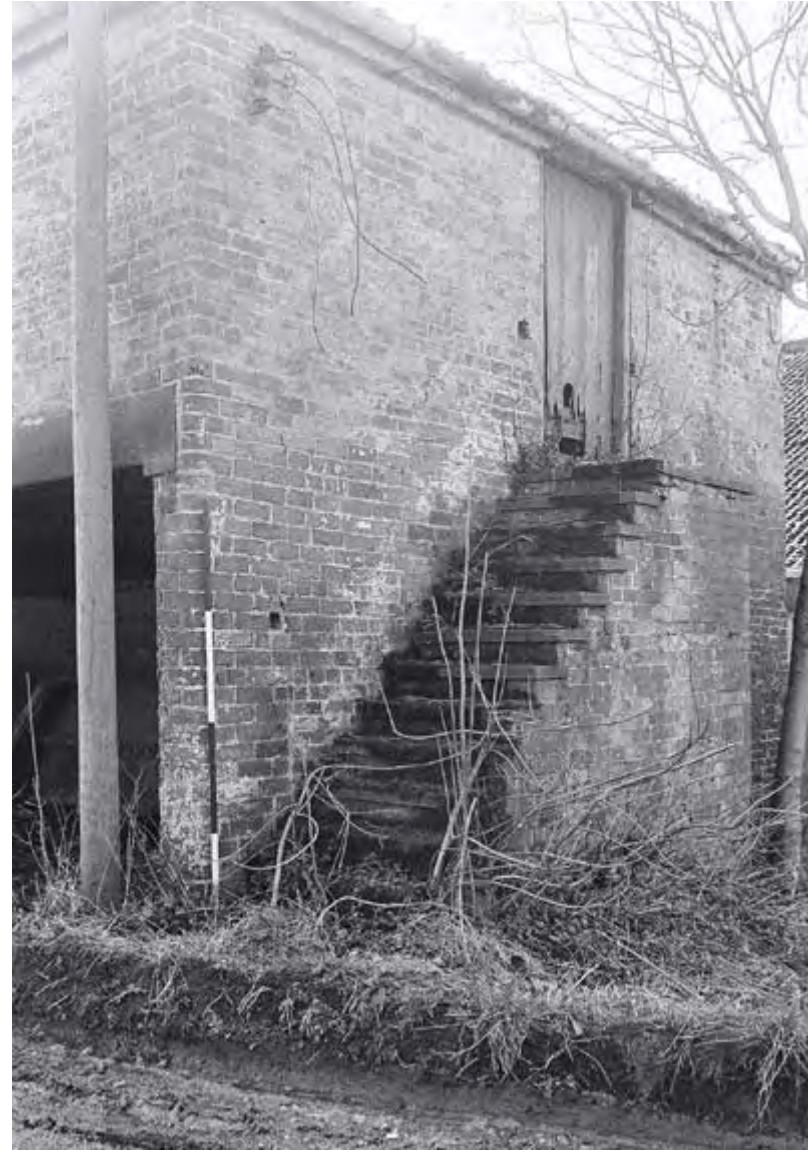
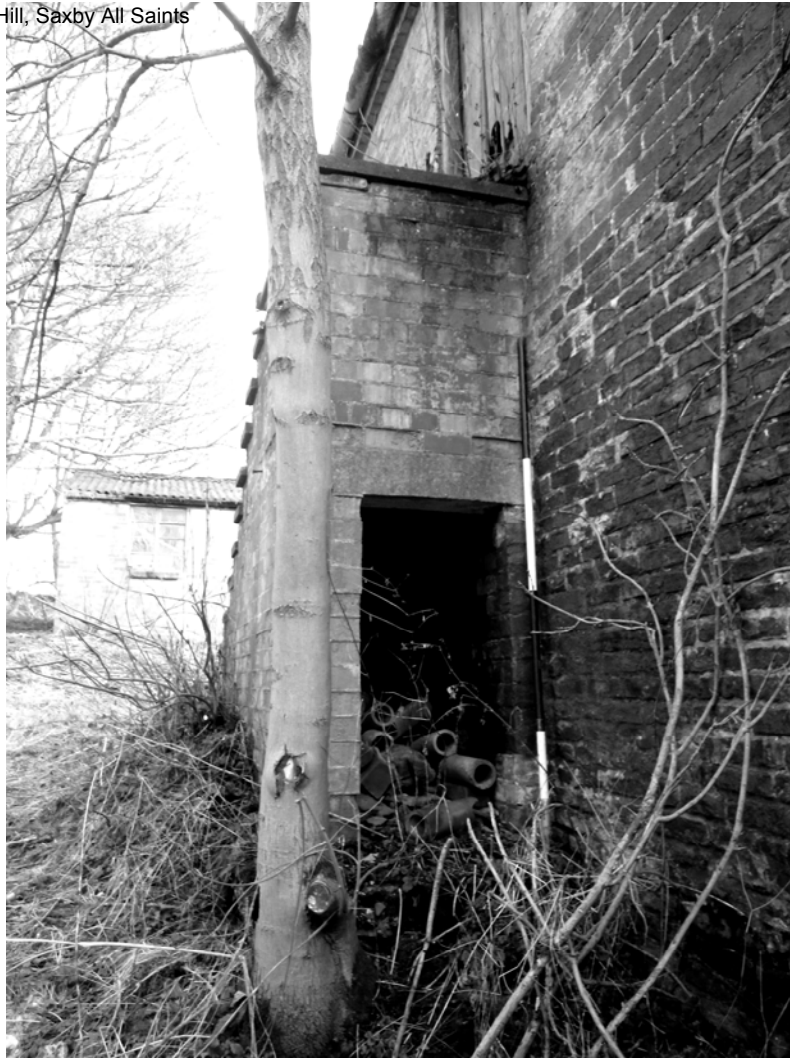
7.1 The granary over cart shed building was the only original farm building still standing within the farmyard at Manor Top, and was a typical building of a late eighteenth century improved farm. The cartshed had a granary above which was accessed via an exterior staircase. These steps had been replaced, probably at the same time as the construction of the mid-twentieth century store as the modern bricks matched. Both buildings also had asbestos down-pipes and guttering. The first floor windows were also a later replacement or insertion. There was also a building scar on the southern elevation suggesting a single storey lean-to or outbuilding had been demolished at some point in the past. There were no signs of any earlier structures within the cart shed and granary and it appears to have been a single build.

Plate 10. Cart Shed Exterior: Steps to Granary. Facing South-west.

Plate 11. Cart Shed Exterior: Rear of External Steps. Facing East.

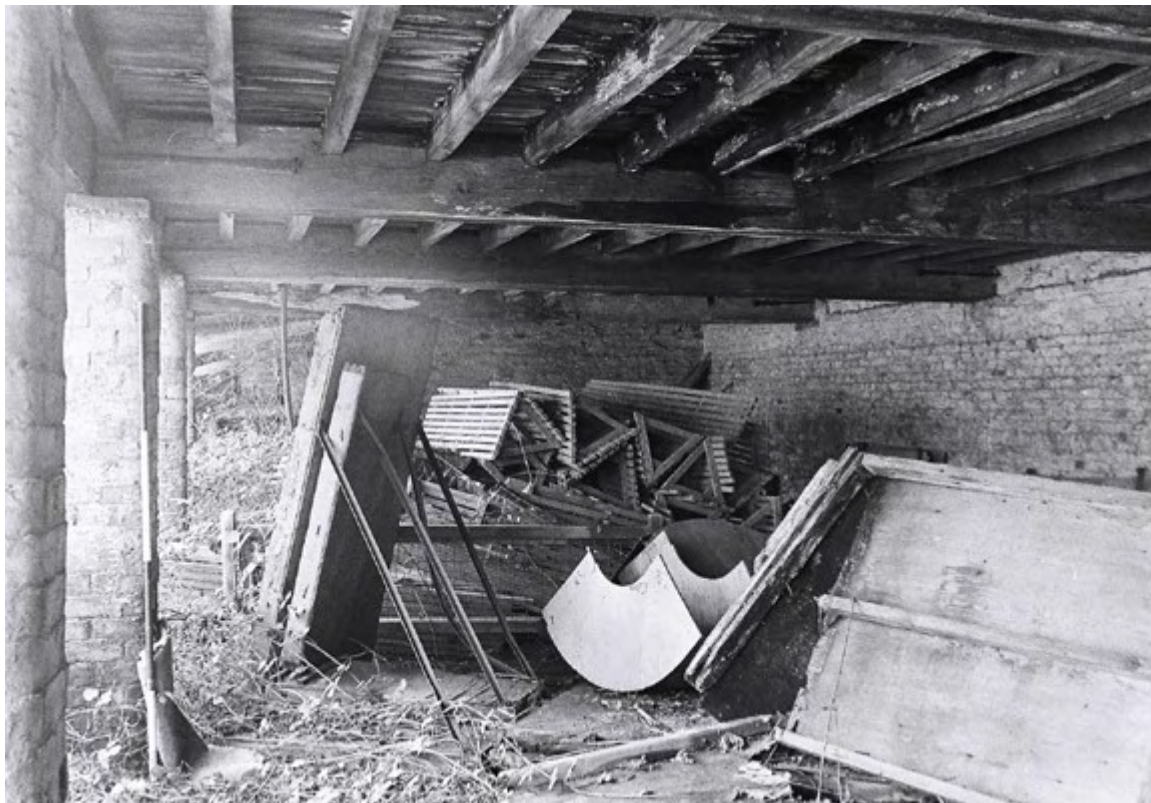
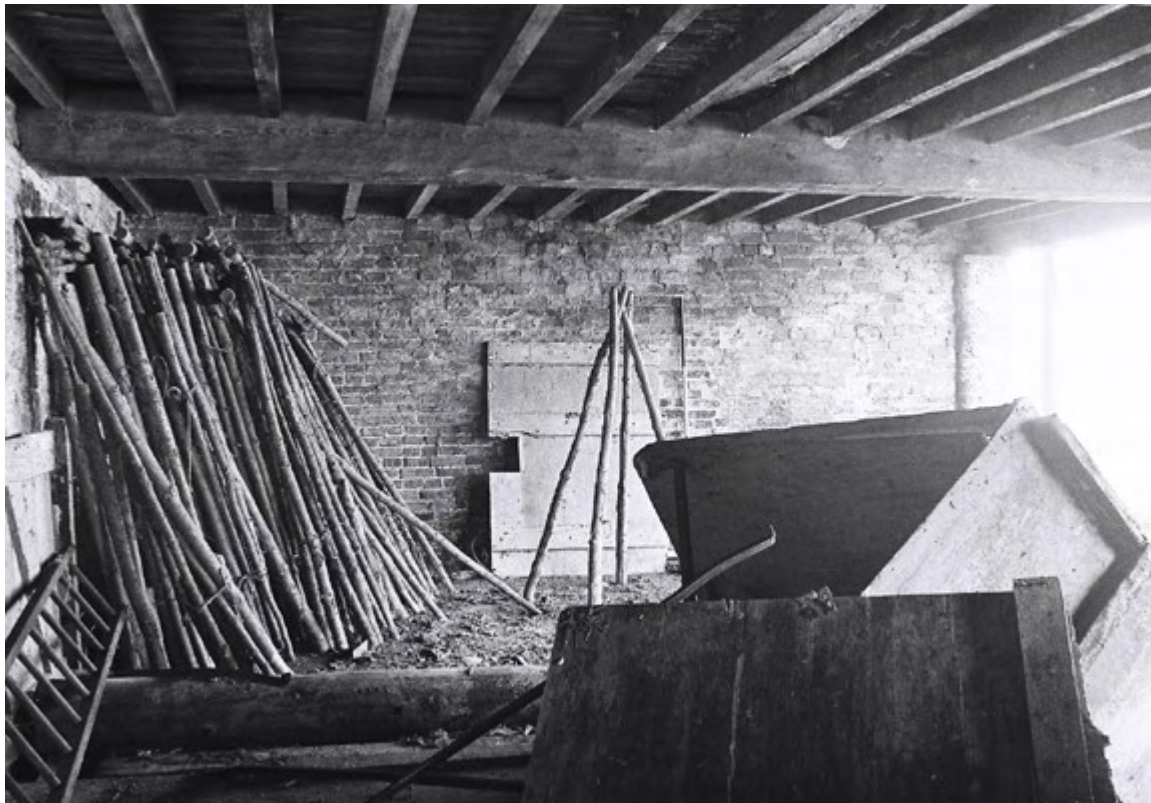
6.3.1 The ground floor of the cart shed had an earthen floor and was used as a storage area (Pls. 12 & 13). The first floor was supported by four beams. These joists appeared to be sawn timber, as the sides were smooth and had no signs of being re-used.

Plate 12. Cart Shed Interior: Ground Floor. Facing South.

Plate 13. Cart Shed Interior: Ground Floor. Facing South.

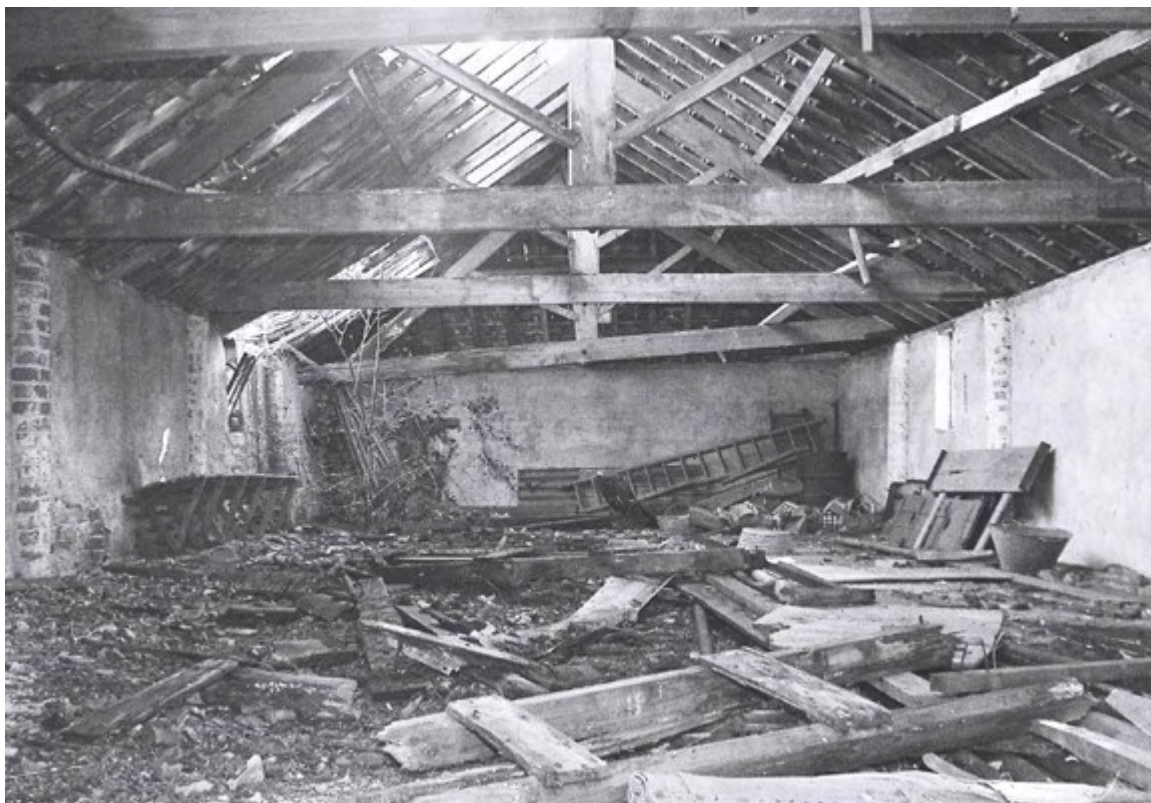
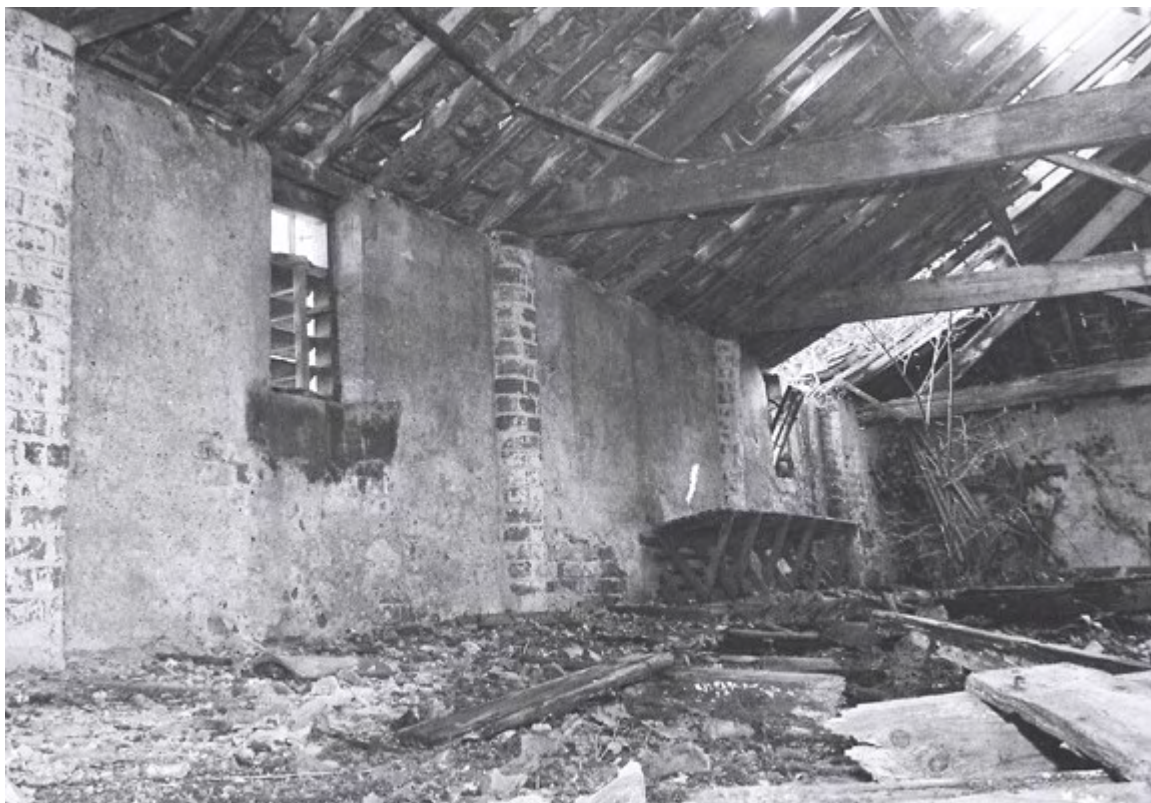
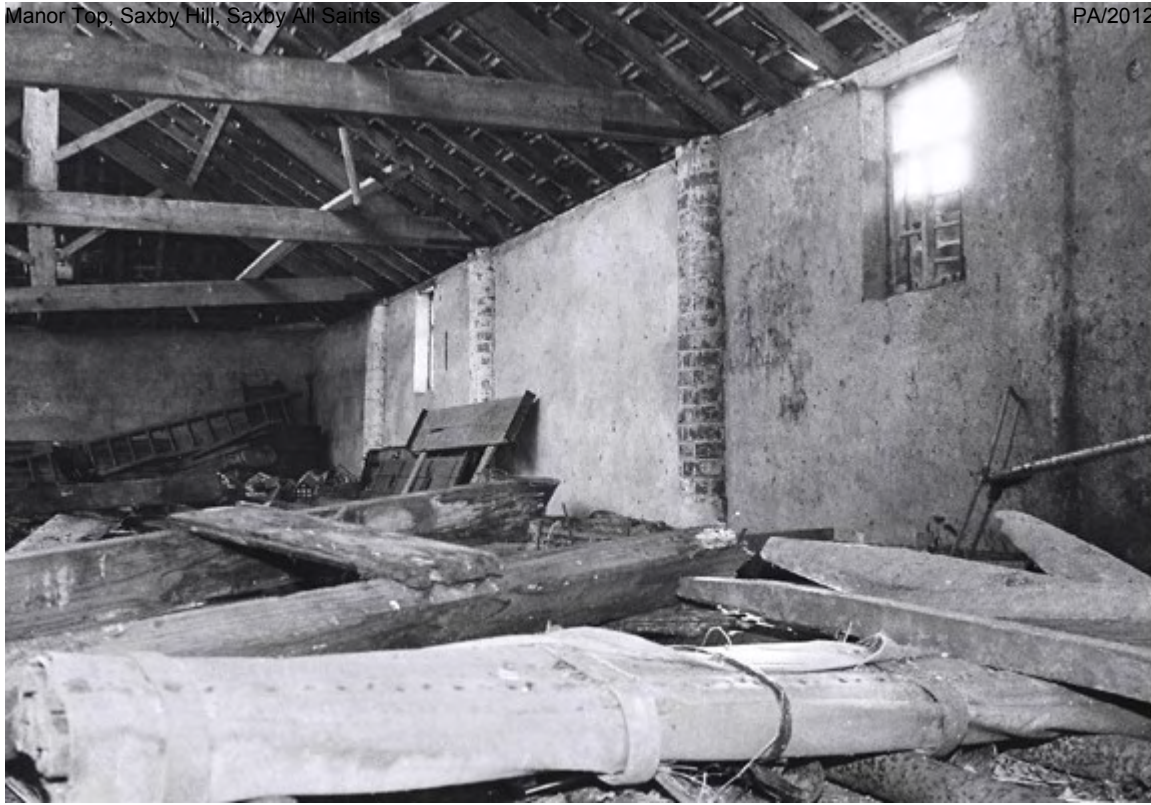
Plate 14. Cart Shed Interior: First Floor. Facing South.

Plate 16. Cart Shed Interior: First Floor. Facing South-East.

Plate 17. Cart Shed Interior: First Floor. Facing South-west.

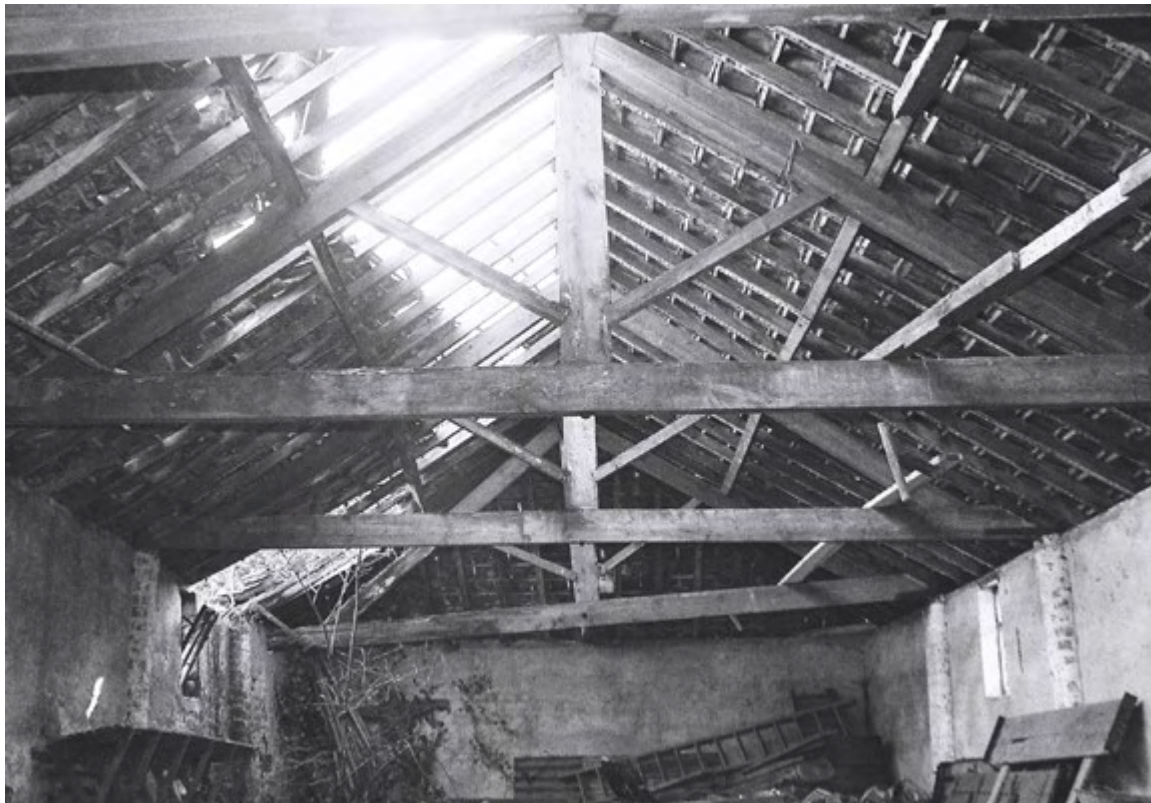
Plate 15. Cart Shed Interior: King Post Roof Truss. Facing South.

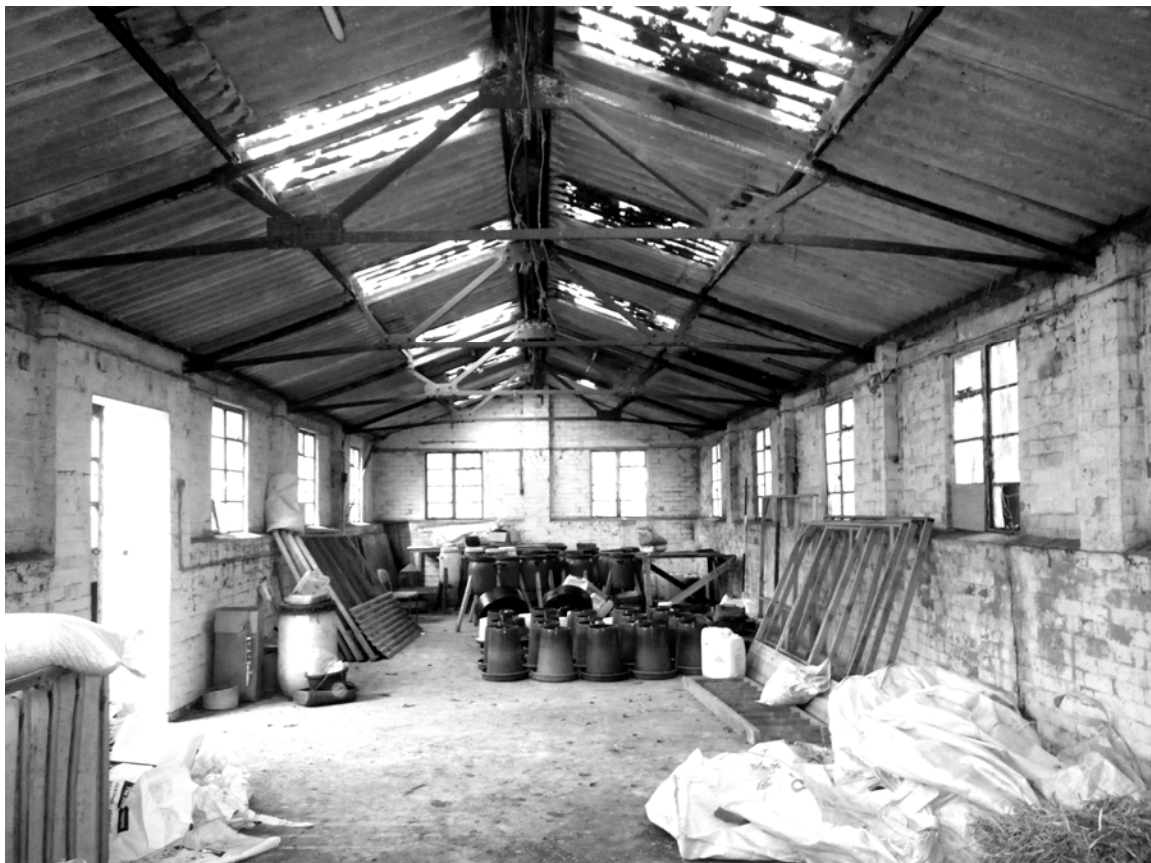
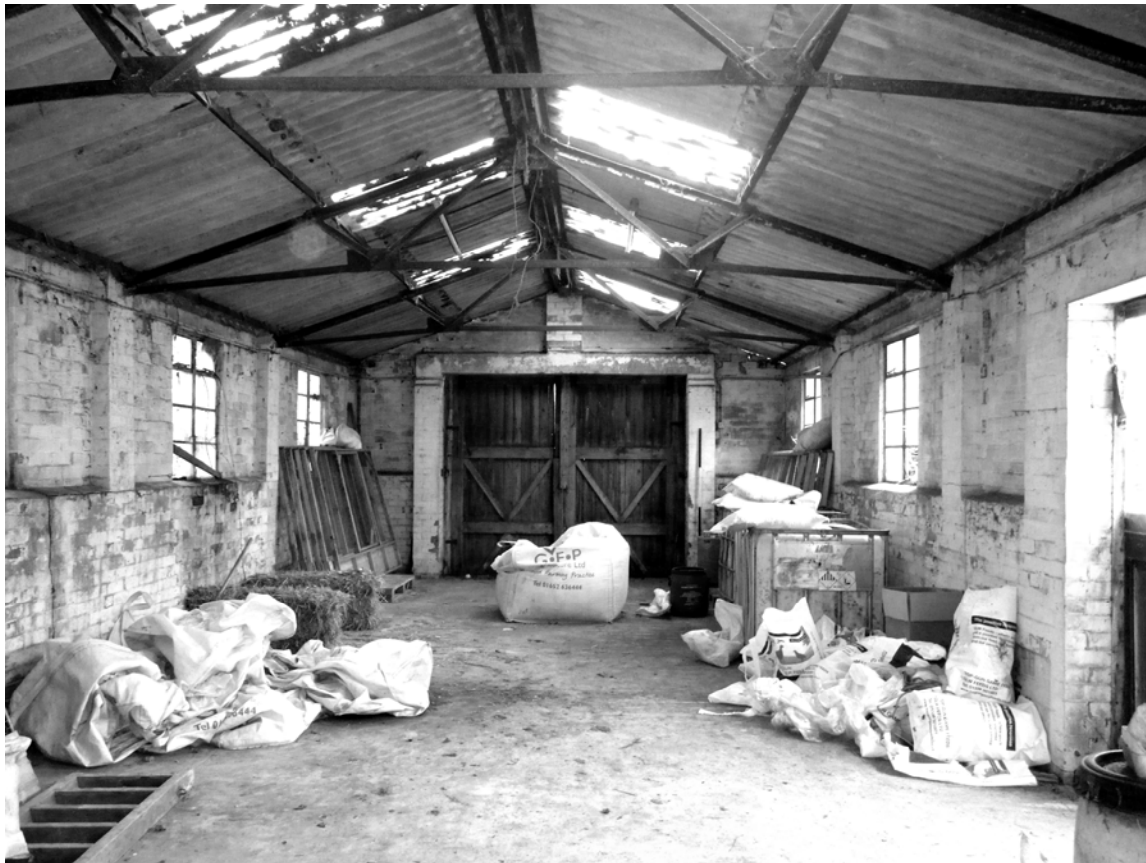
6.5.1 The interior of the store has a concrete floor and is open with five metal roof trusses with a 'W' frame (Pls. 26-27).

Plate. 26. Store Interior. Facing North.

Plate 27. Store Interior. Facing South.
