Historic Building Record

**Glebe Farm
Coleby Road
West Halton
North Lincolnshire**

**HISTORIC BUILDING RECORDING
(PHOTOGRAPHIC & DESCRIPTIVE RECORD)**

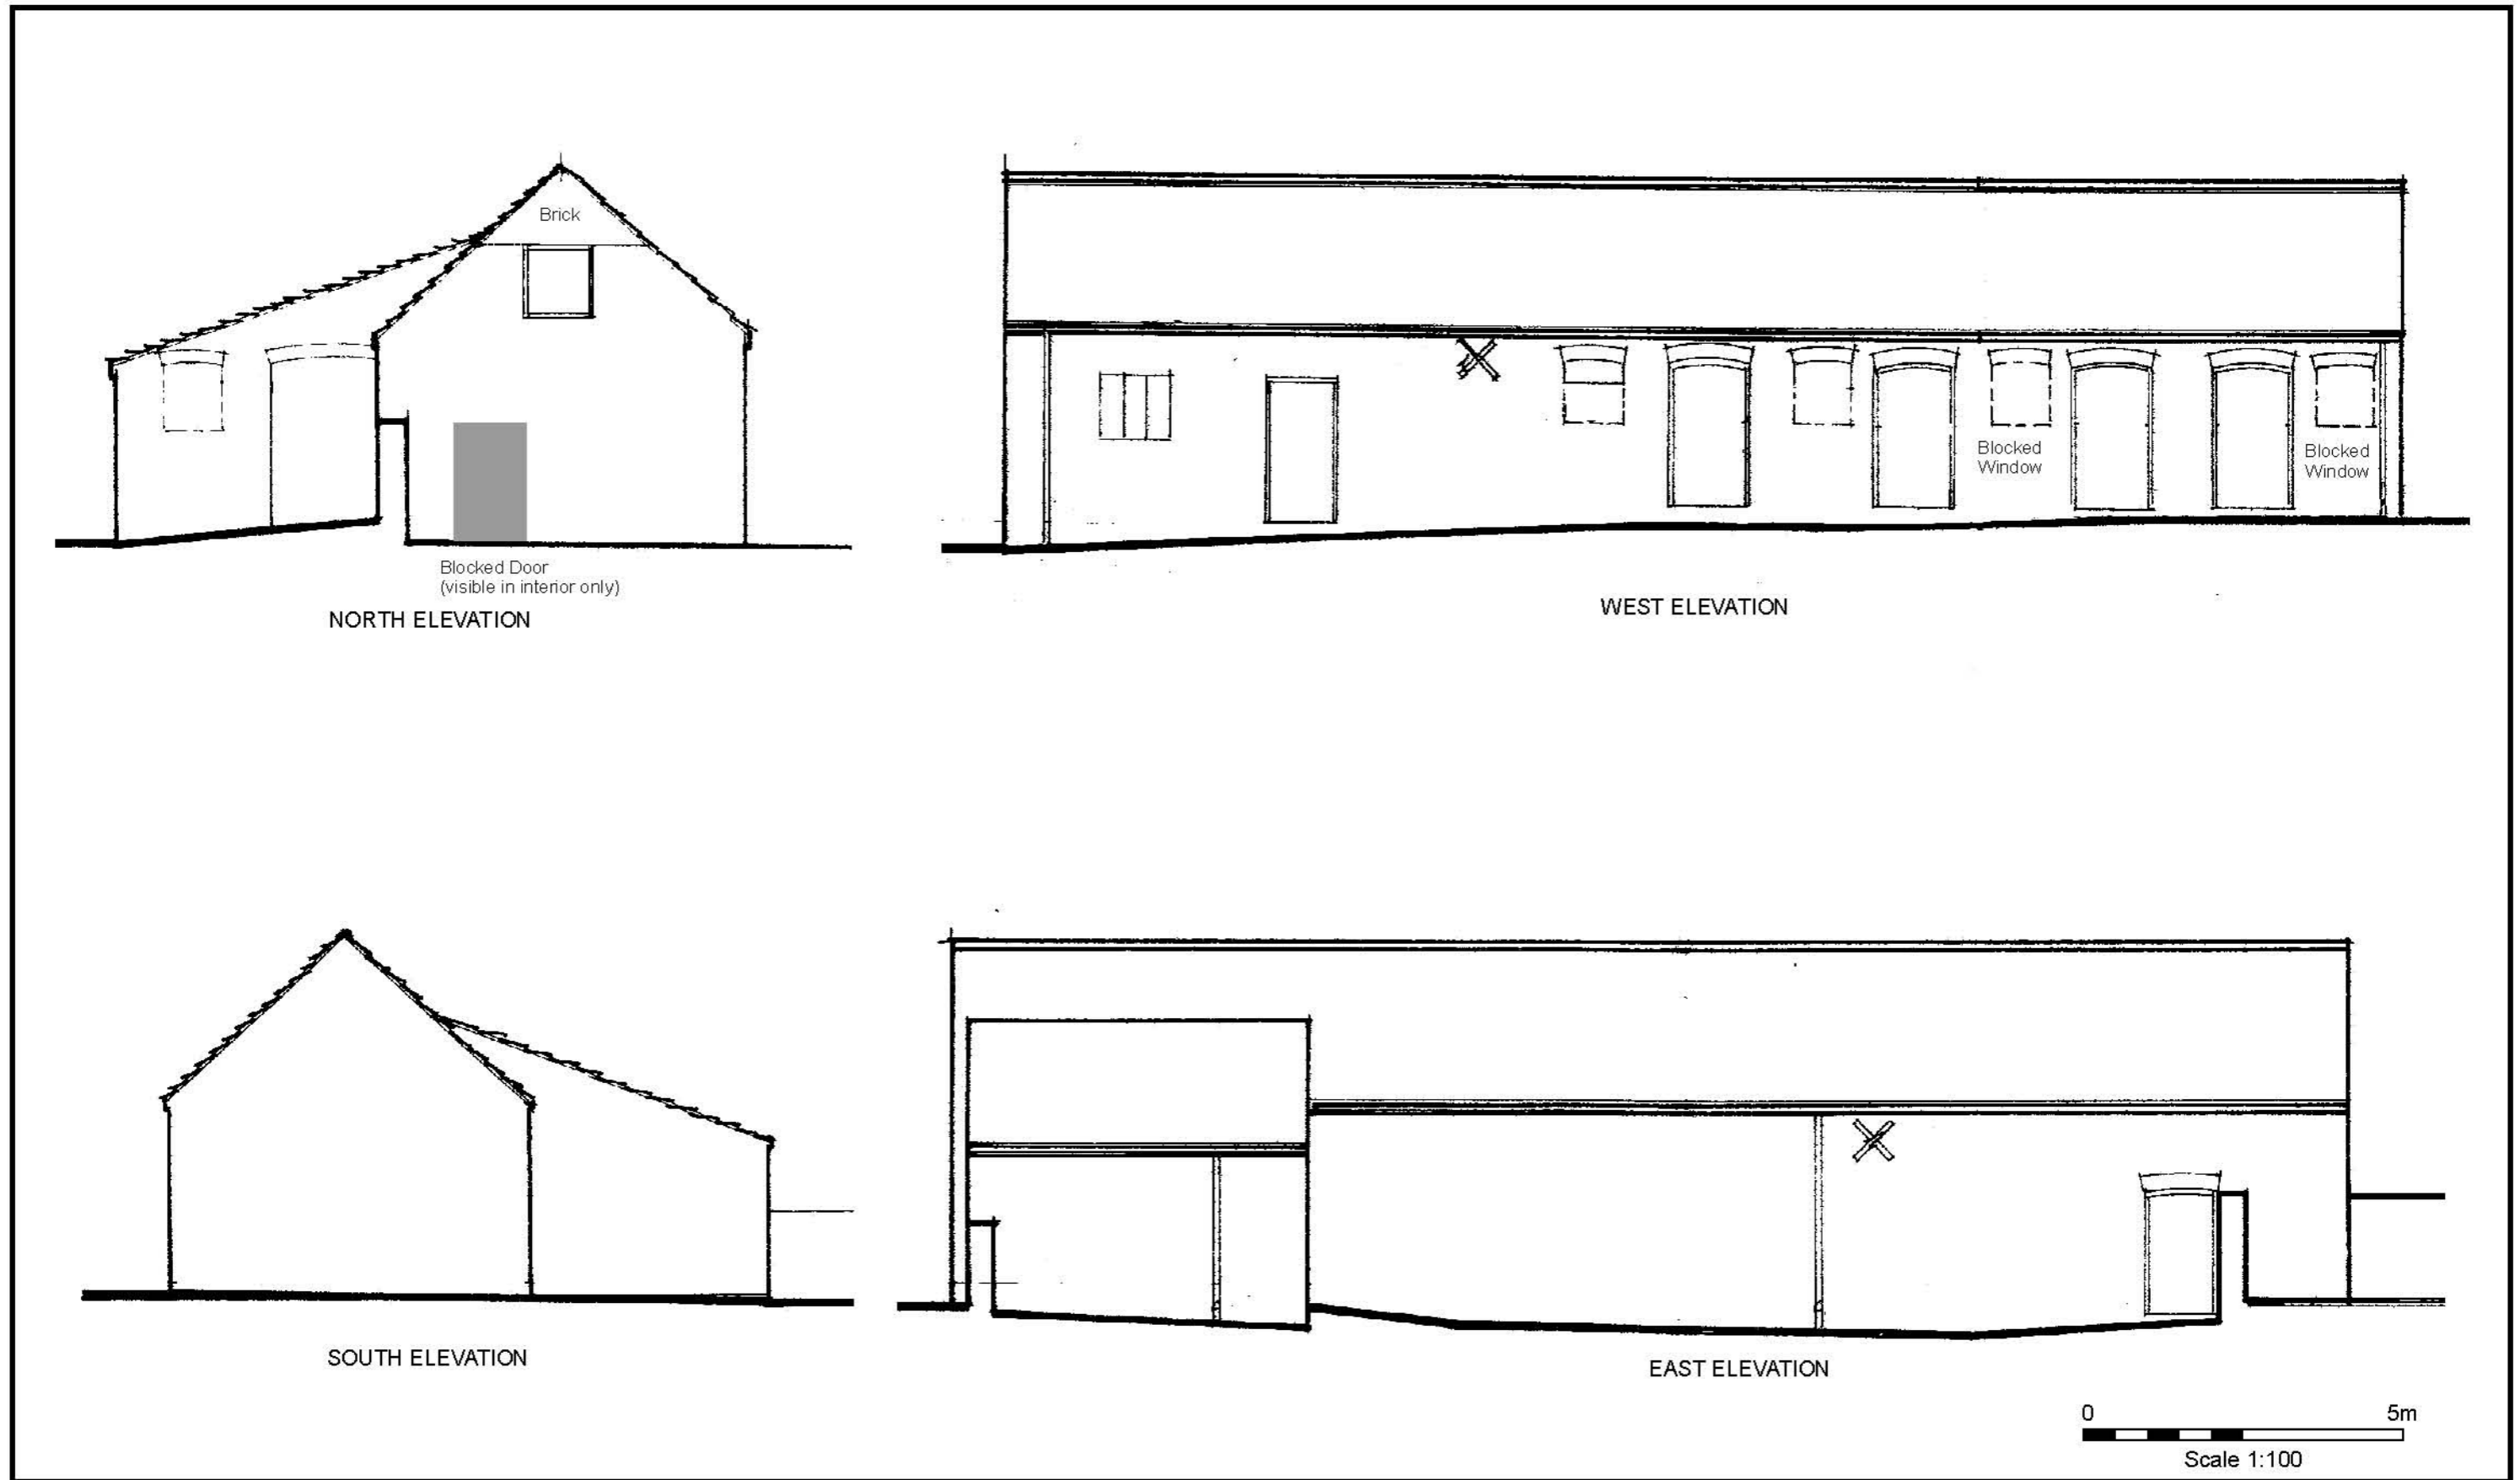
Figure 4. Building A: Elevations.

6.2.1 Building A was unused at the time of the survey and in a moderate state of repair. The building was a one storey structure, constructed of local stone rubble and plain brick lintels and surrounds, with a gabled pan tile roof. The building comprised three phases of construction. The earliest part was the northern end of the building. The north gable has a brick rebuild at its apex in English Garden Wall Bond and has entrances on the east and west elevations and a window on the west

elevation. There was a hatch in the gable to a former hayloft. To the south is a later building addition also constructed of stone rubble with brick lintels, surround and quoins on the south gable and a pantile roof. This phase of the building is split into four stables/byres. All access into this phase of the building is from the west elevation and there are windows to the north of the northern three doors and a window to the south of the southernmost door. The last phase of construction was an out-shut with cat-slide roof on the southern gable on the eastern elevation. There is an entrance on its northern side into a fold yard located east of Building A.

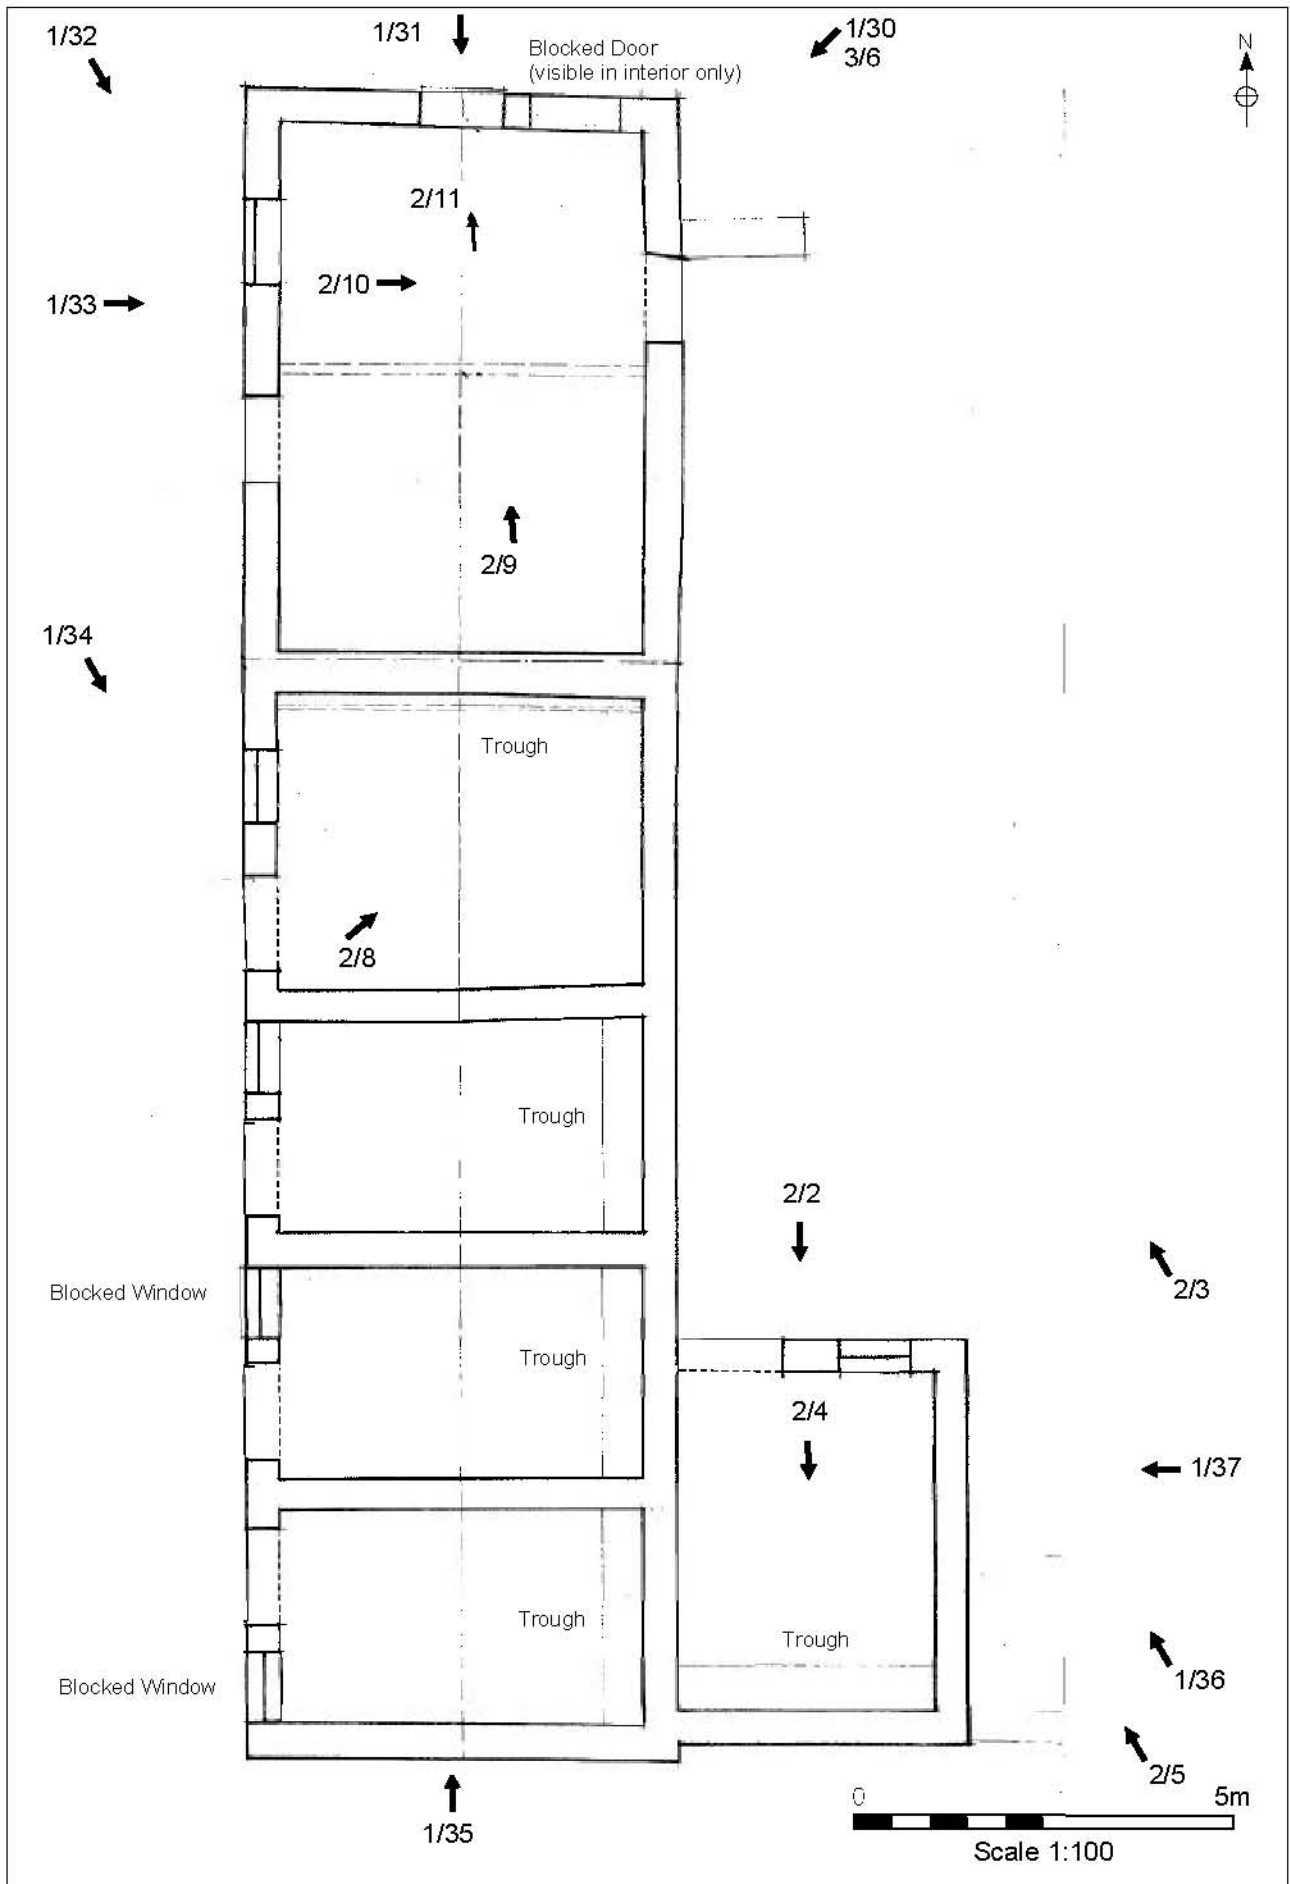
Figure 5. Building A: Plan.

6.3.1 Building A was split into six byres/stables. The earliest phase of the building had a A-frame truss. These joists appeared to be reused timber, in poor condition. There was a blocked doorway in the northern gable, only visible from the interior.

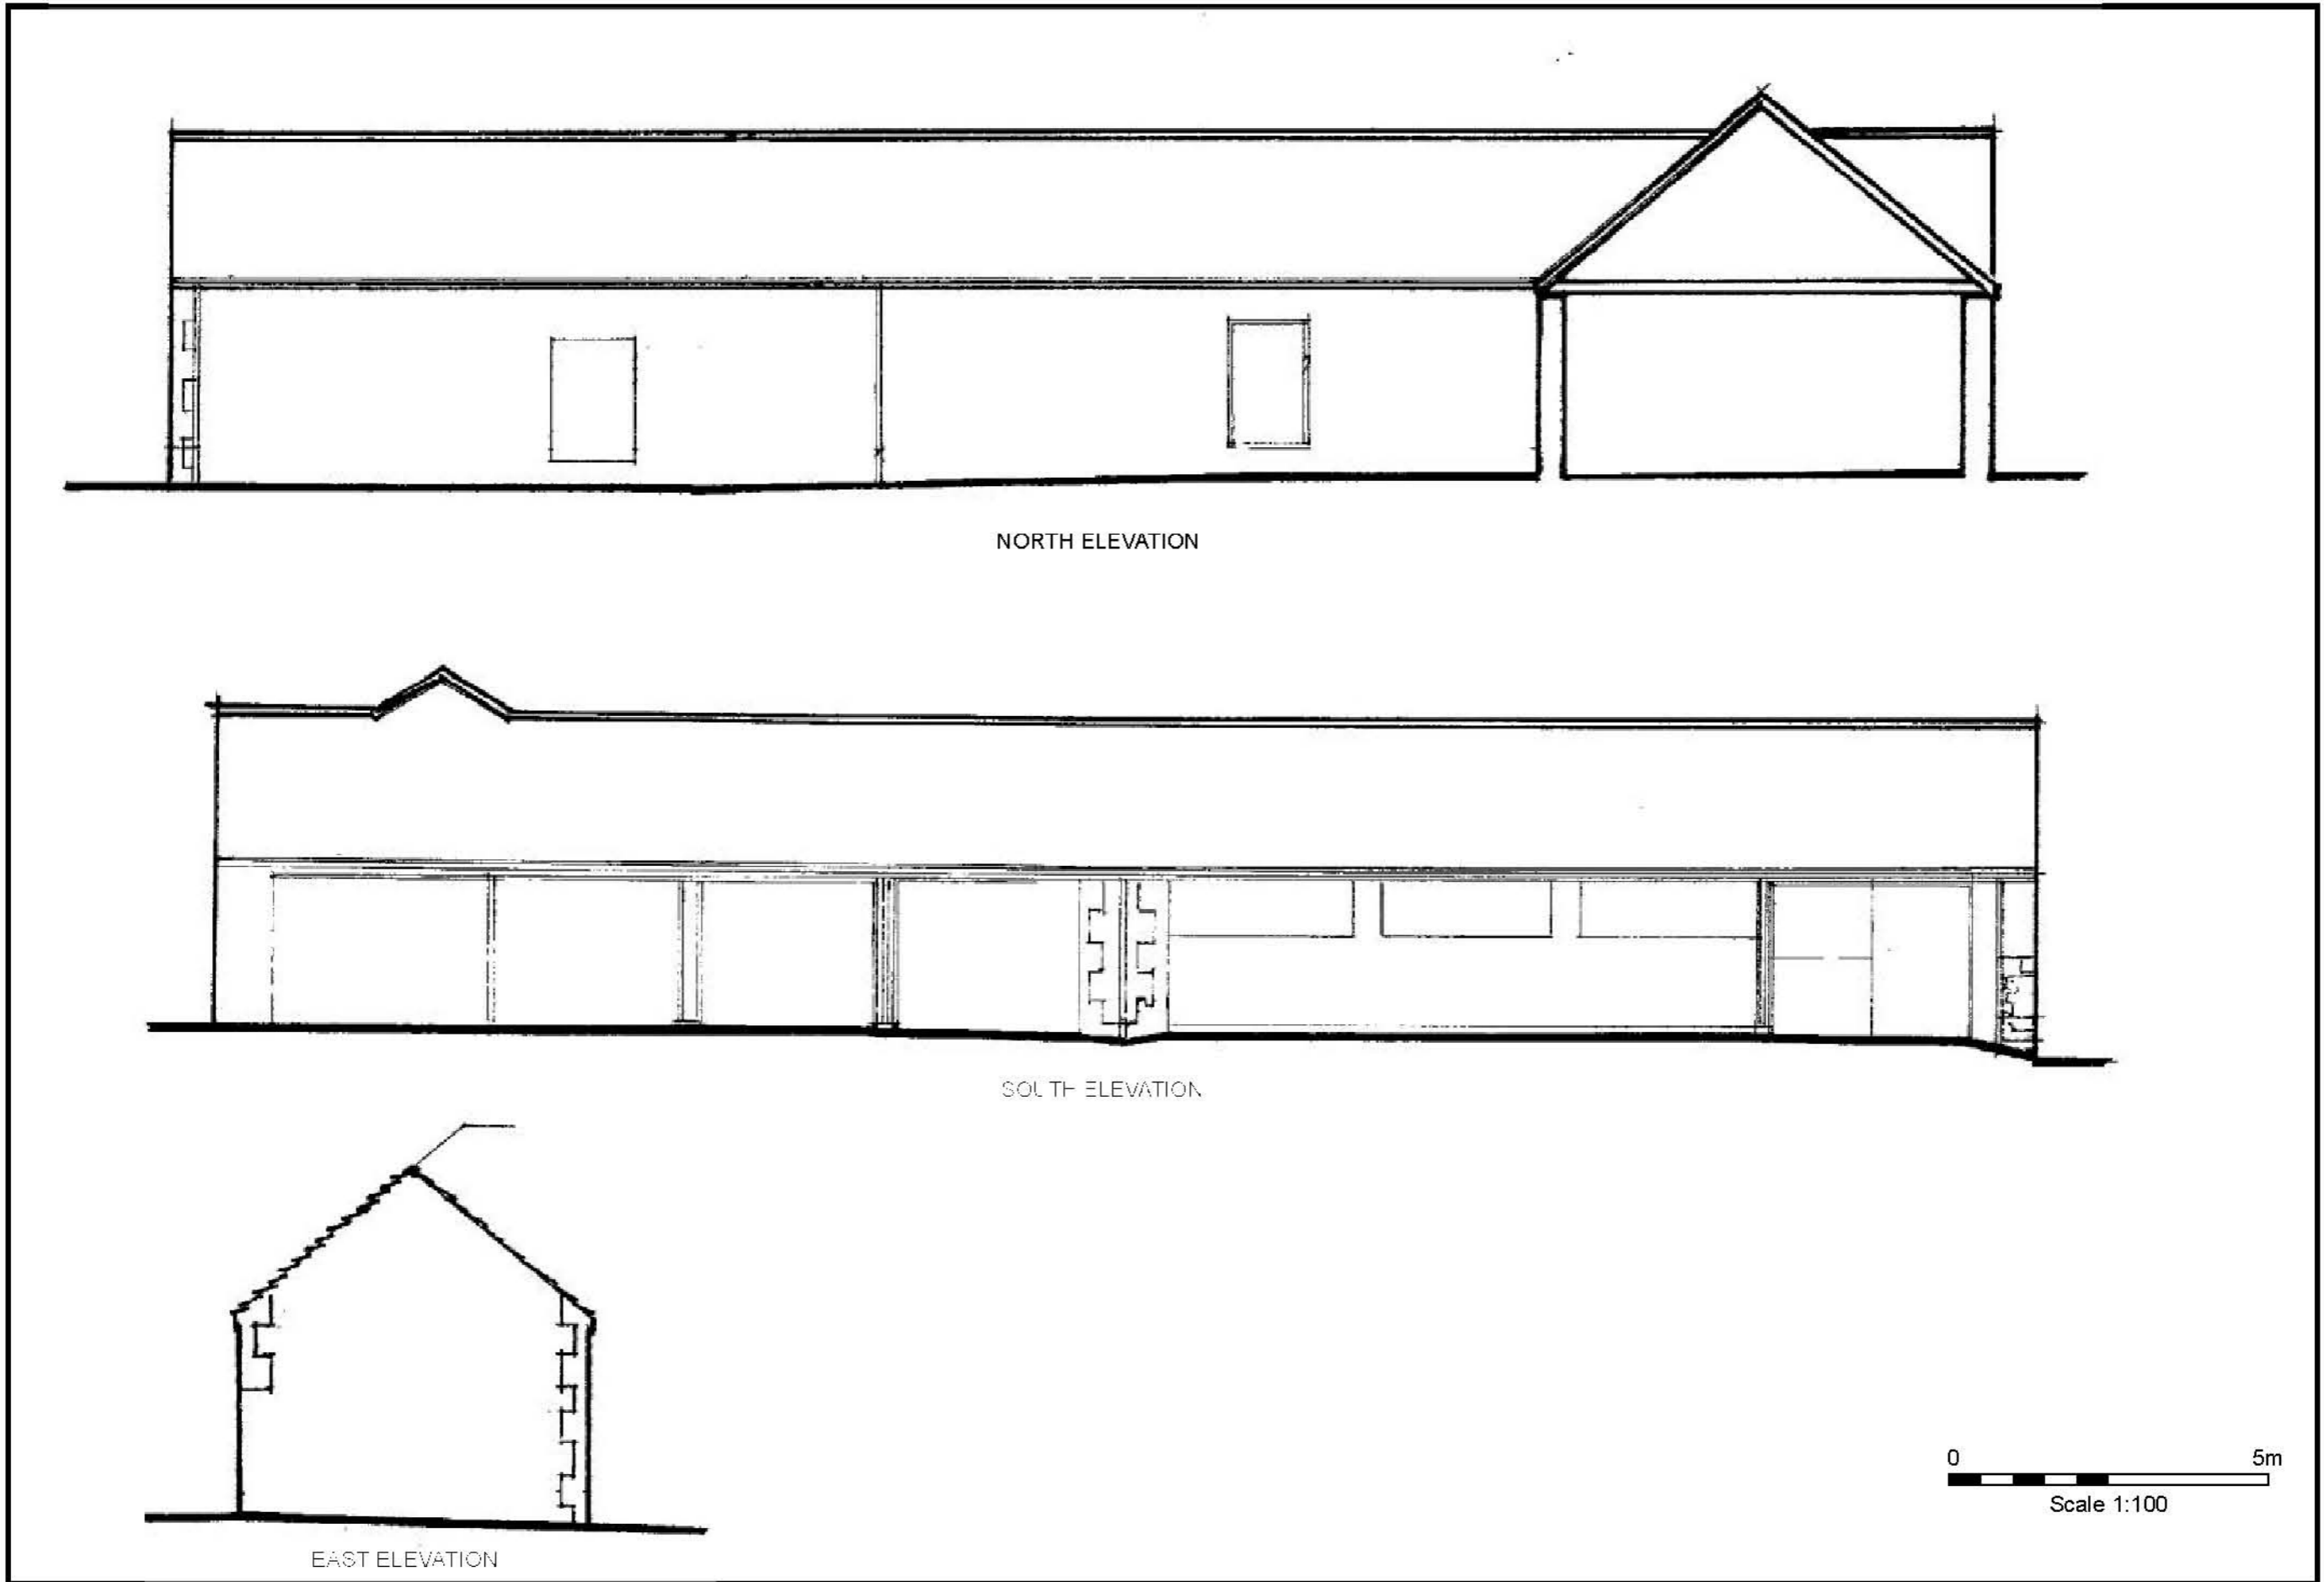
Figure 6. Building B: Elevations.

6.4.1 The store is a single storey structure constructed of stone rubble and plain brick with pantile gable roof. The building has two parts with a central partition, each with three timber posts open to the foldyard to the south and the eastern half has been enclosed with breeze blocks. The foldyard wall to the south facing Building A had a series of feed slots. At the western end of Building B is butted by Building E. A single bay at its south end is included in Building B. The northern elevation has two doors into the eastern and western parts of Building B. The eastern gable has brick quoins.

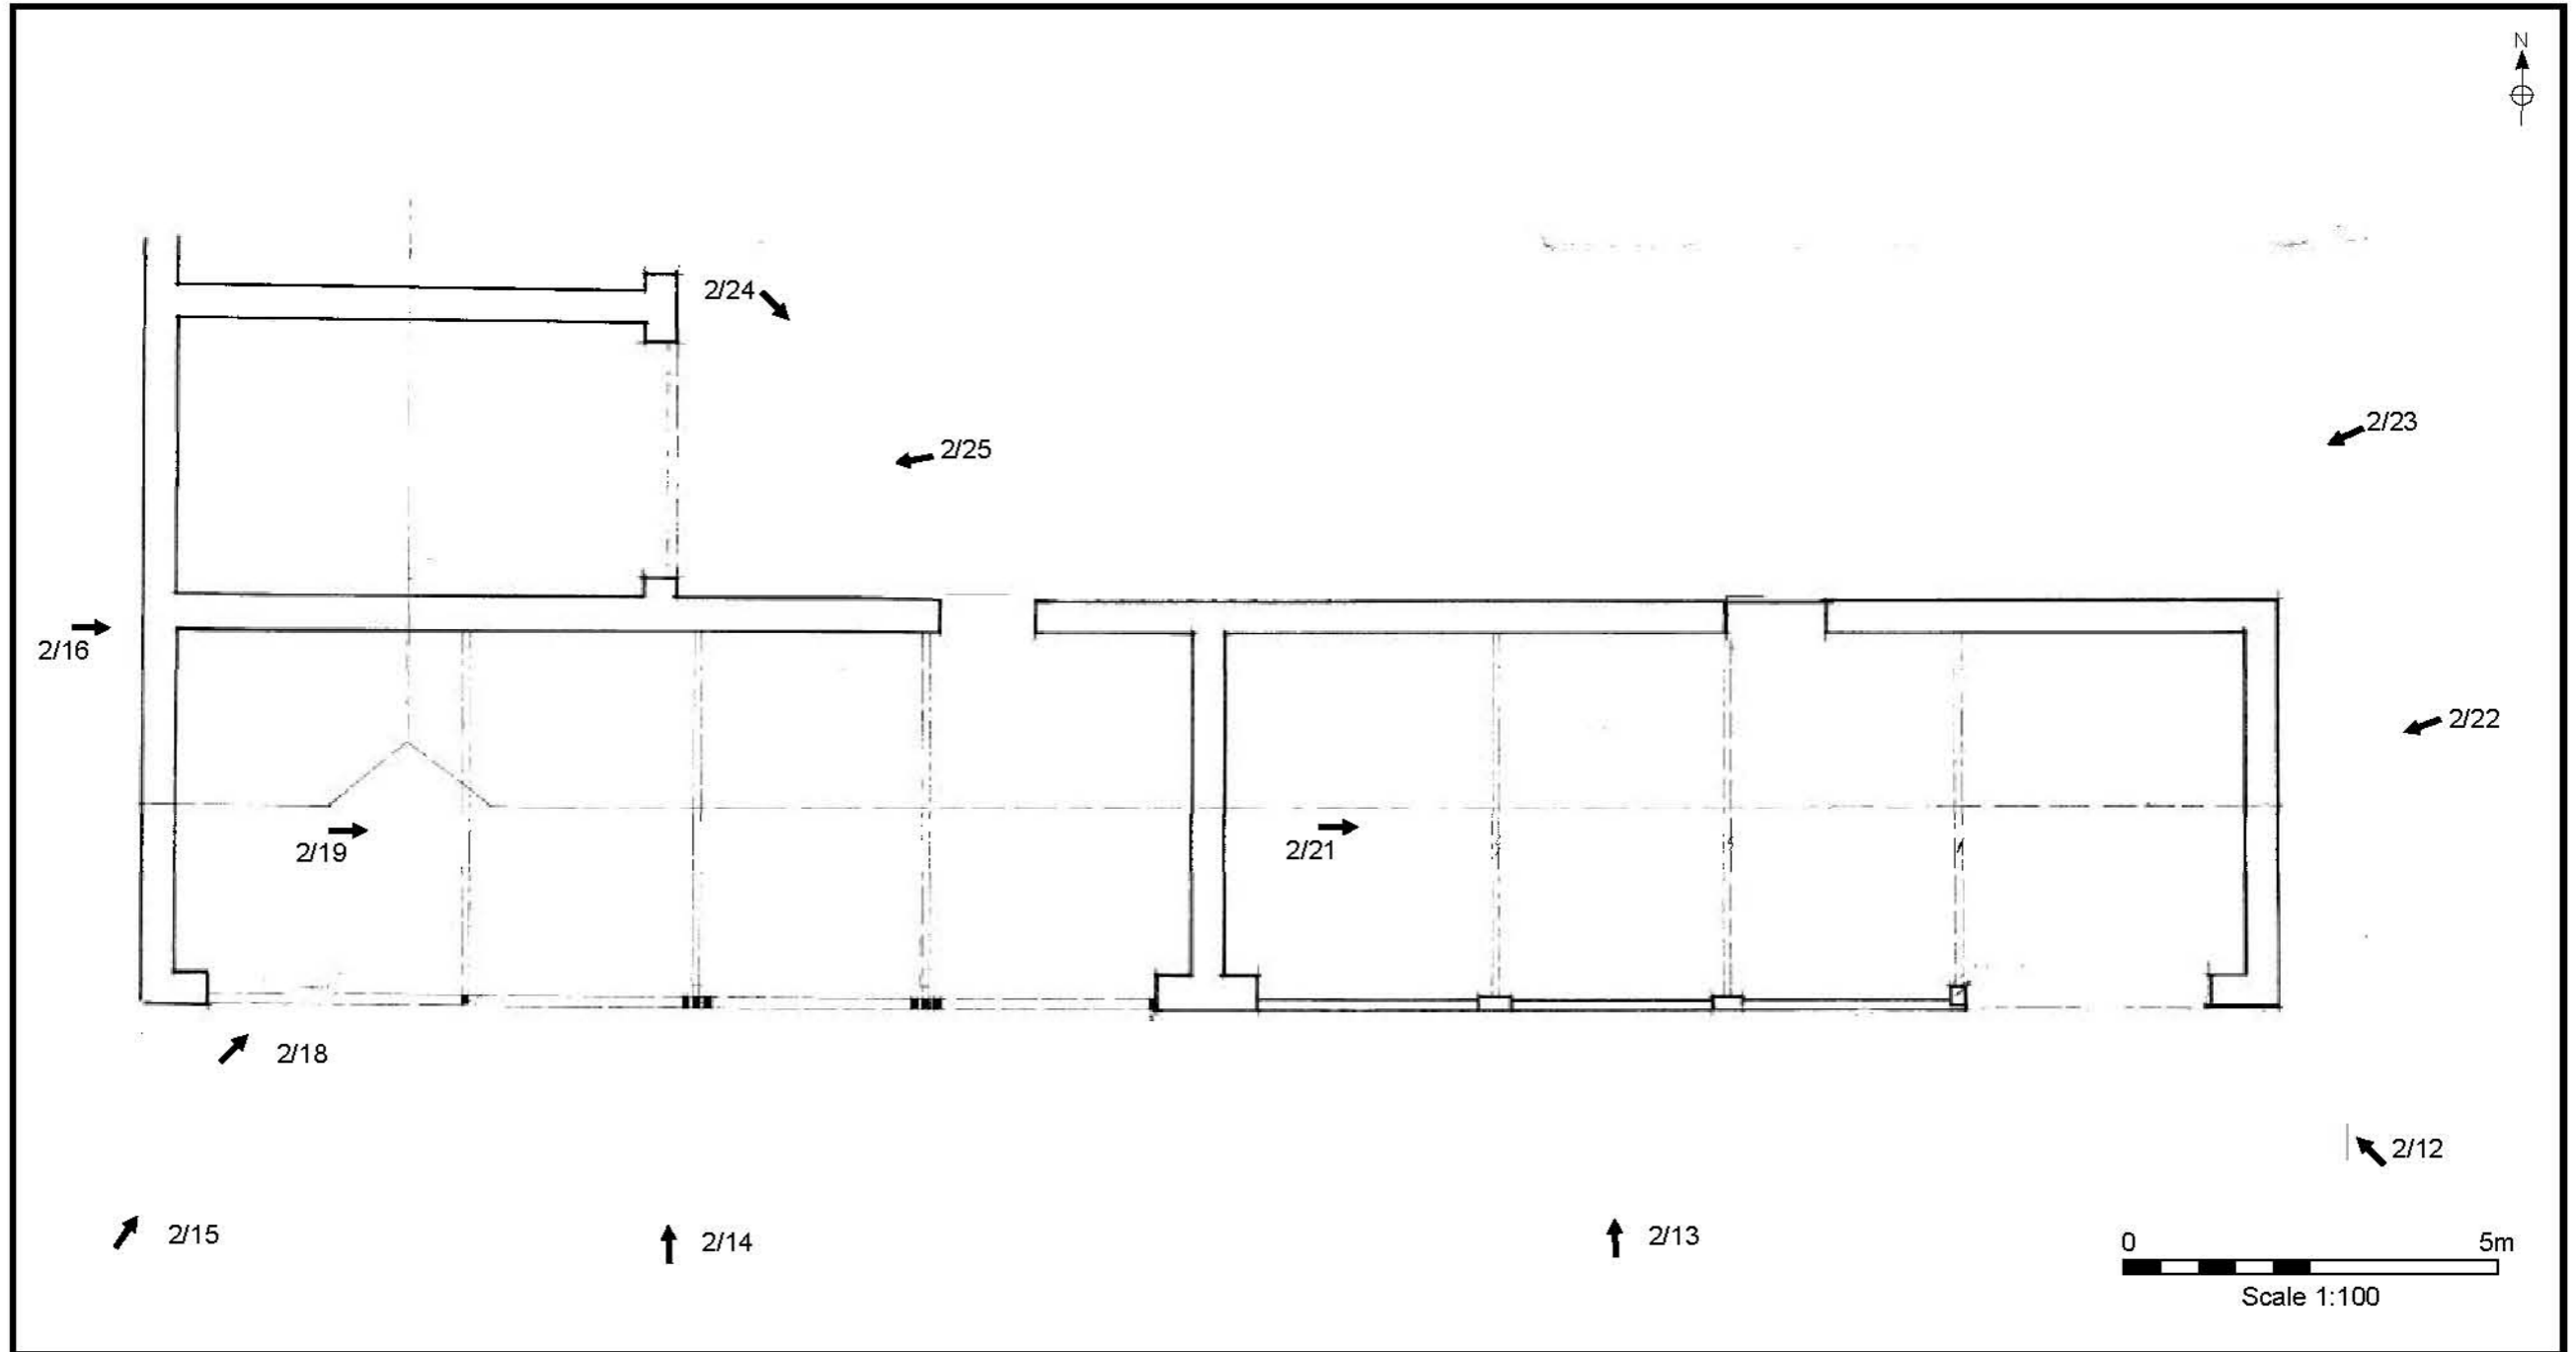
Figure 7. Building B: Plan.

6.5.1 The interior of the store has three king post trusses in both eastern and western parts of the building.

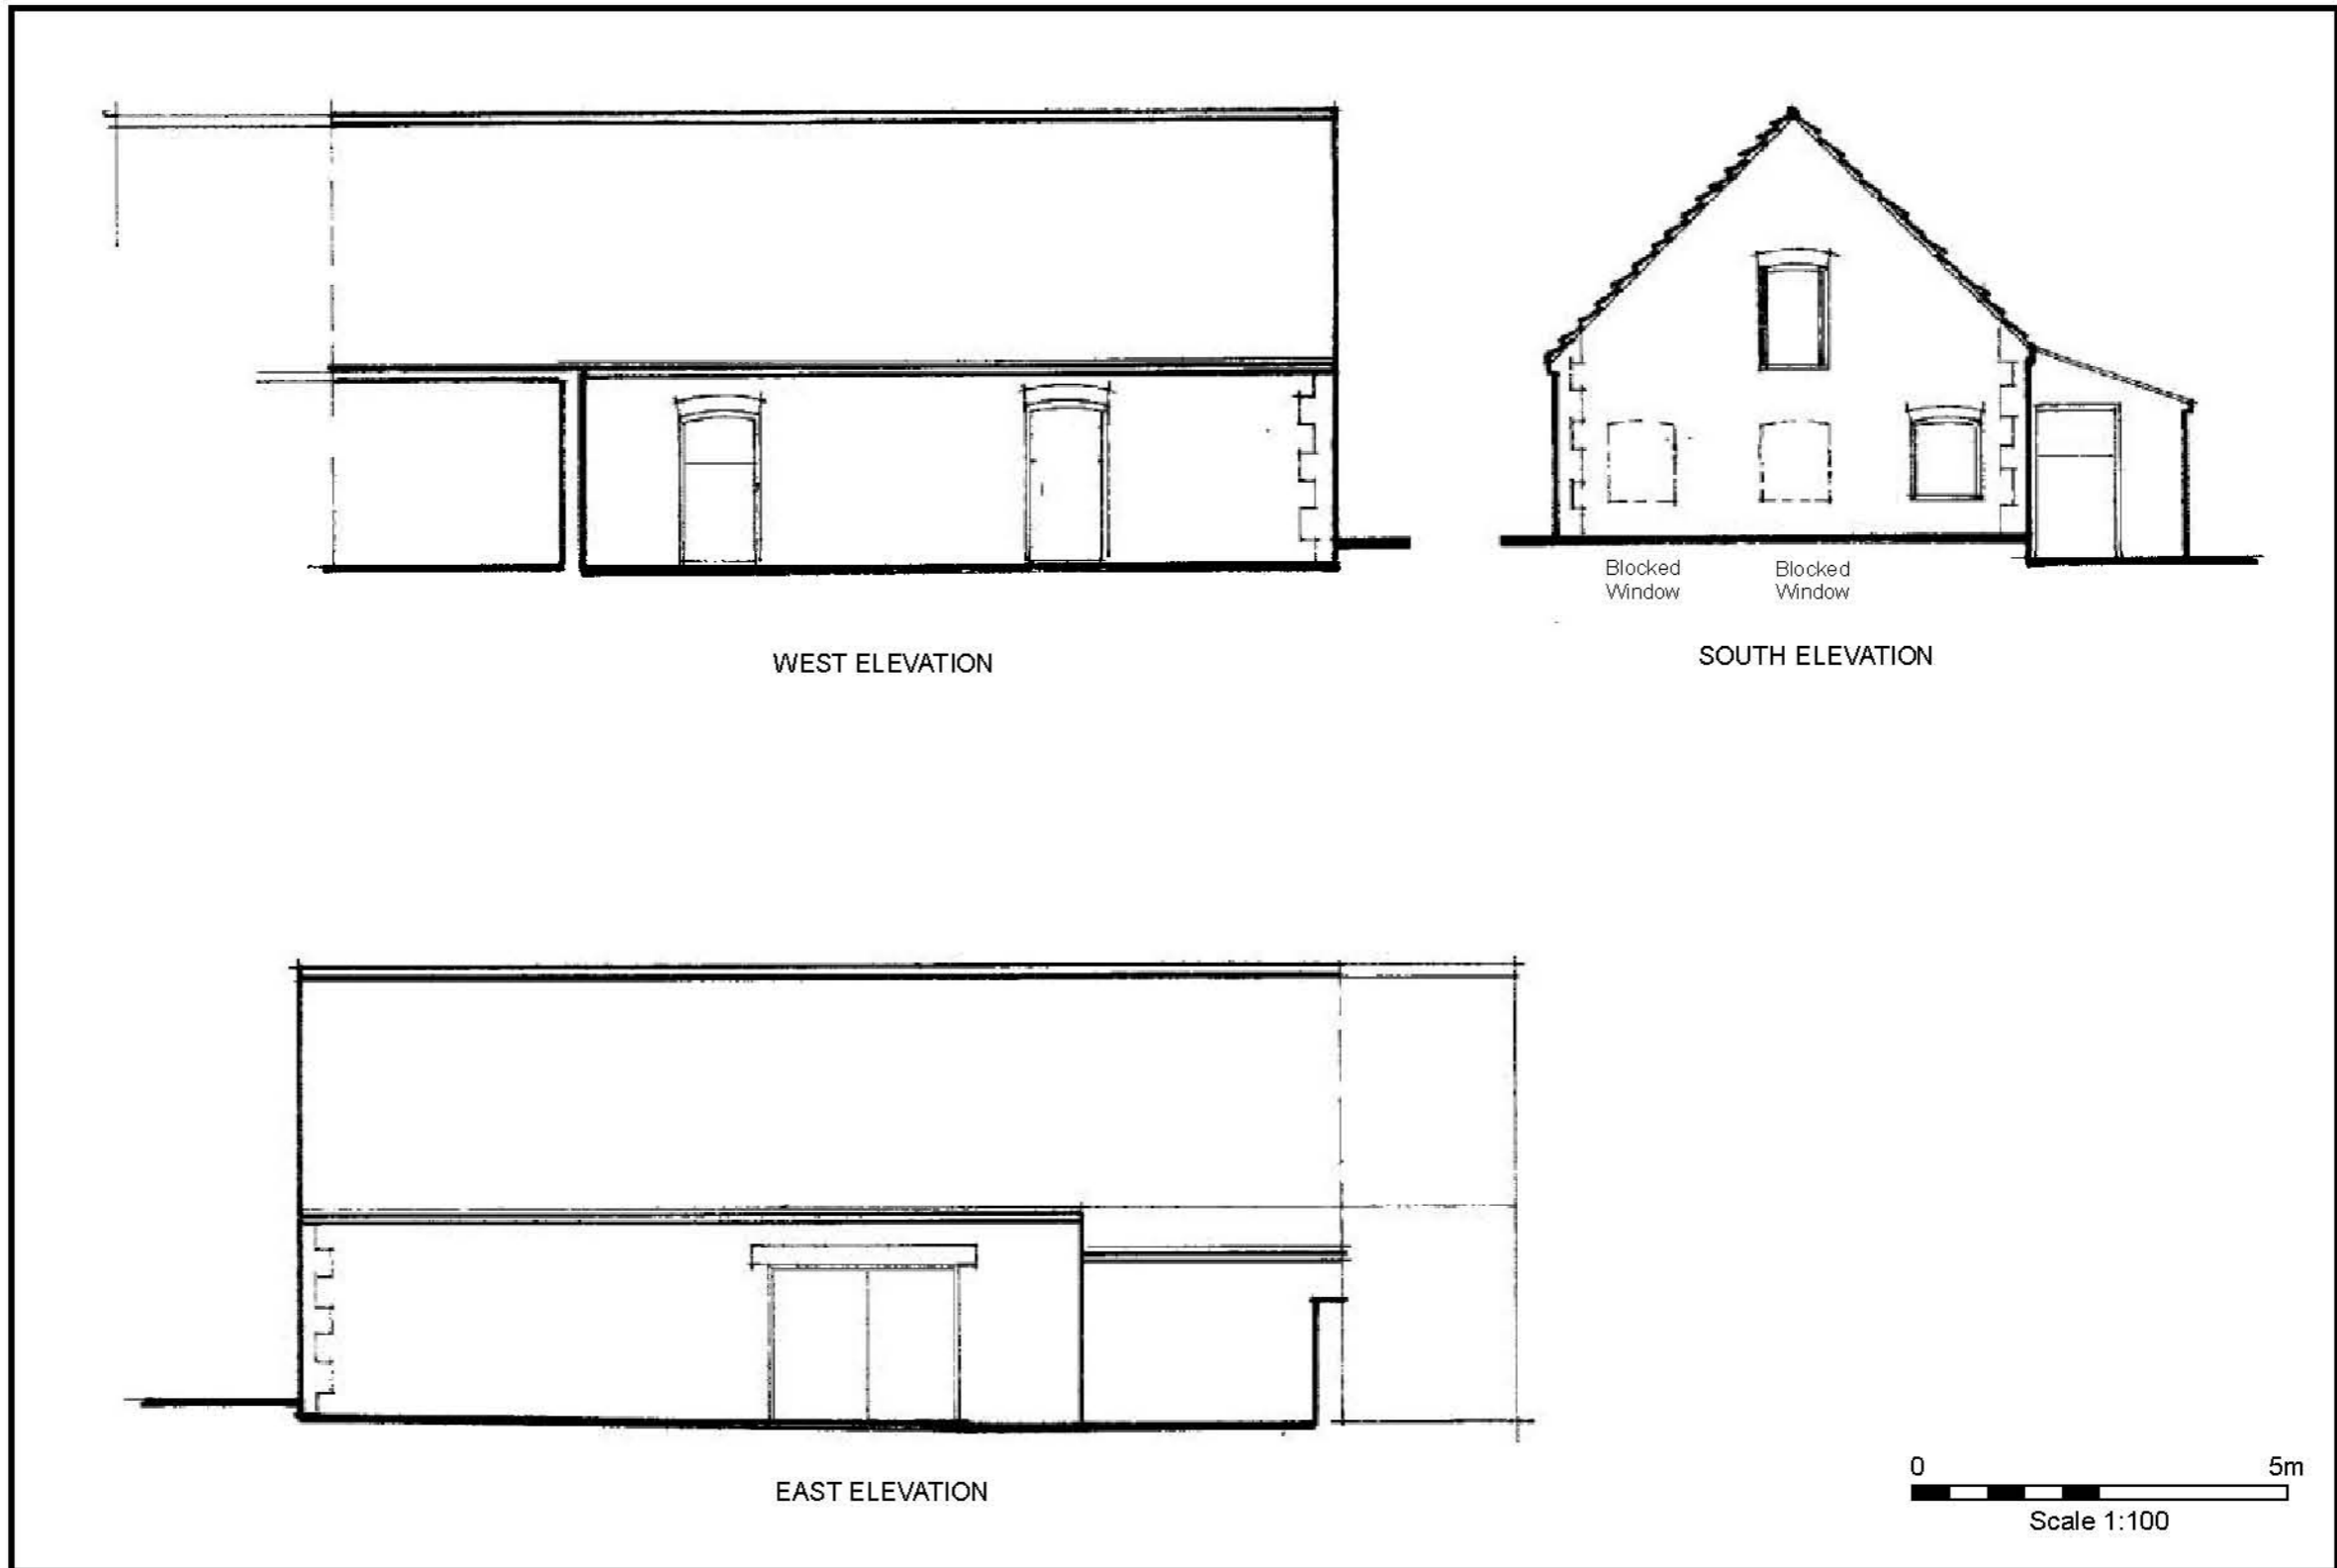
Figure 8. Building C: Elevations.

6.6.1 Building C was a one and a half storey structure, constructed of stone rubble and plain brick with a pantile gabled roof. This building continues to the north (Outside of the development area). This building has three windows on the ground floor on the south gable, two are blocked and a door in the gable apex above. The western gable has two door and the eastern gable a double door at its northern end.

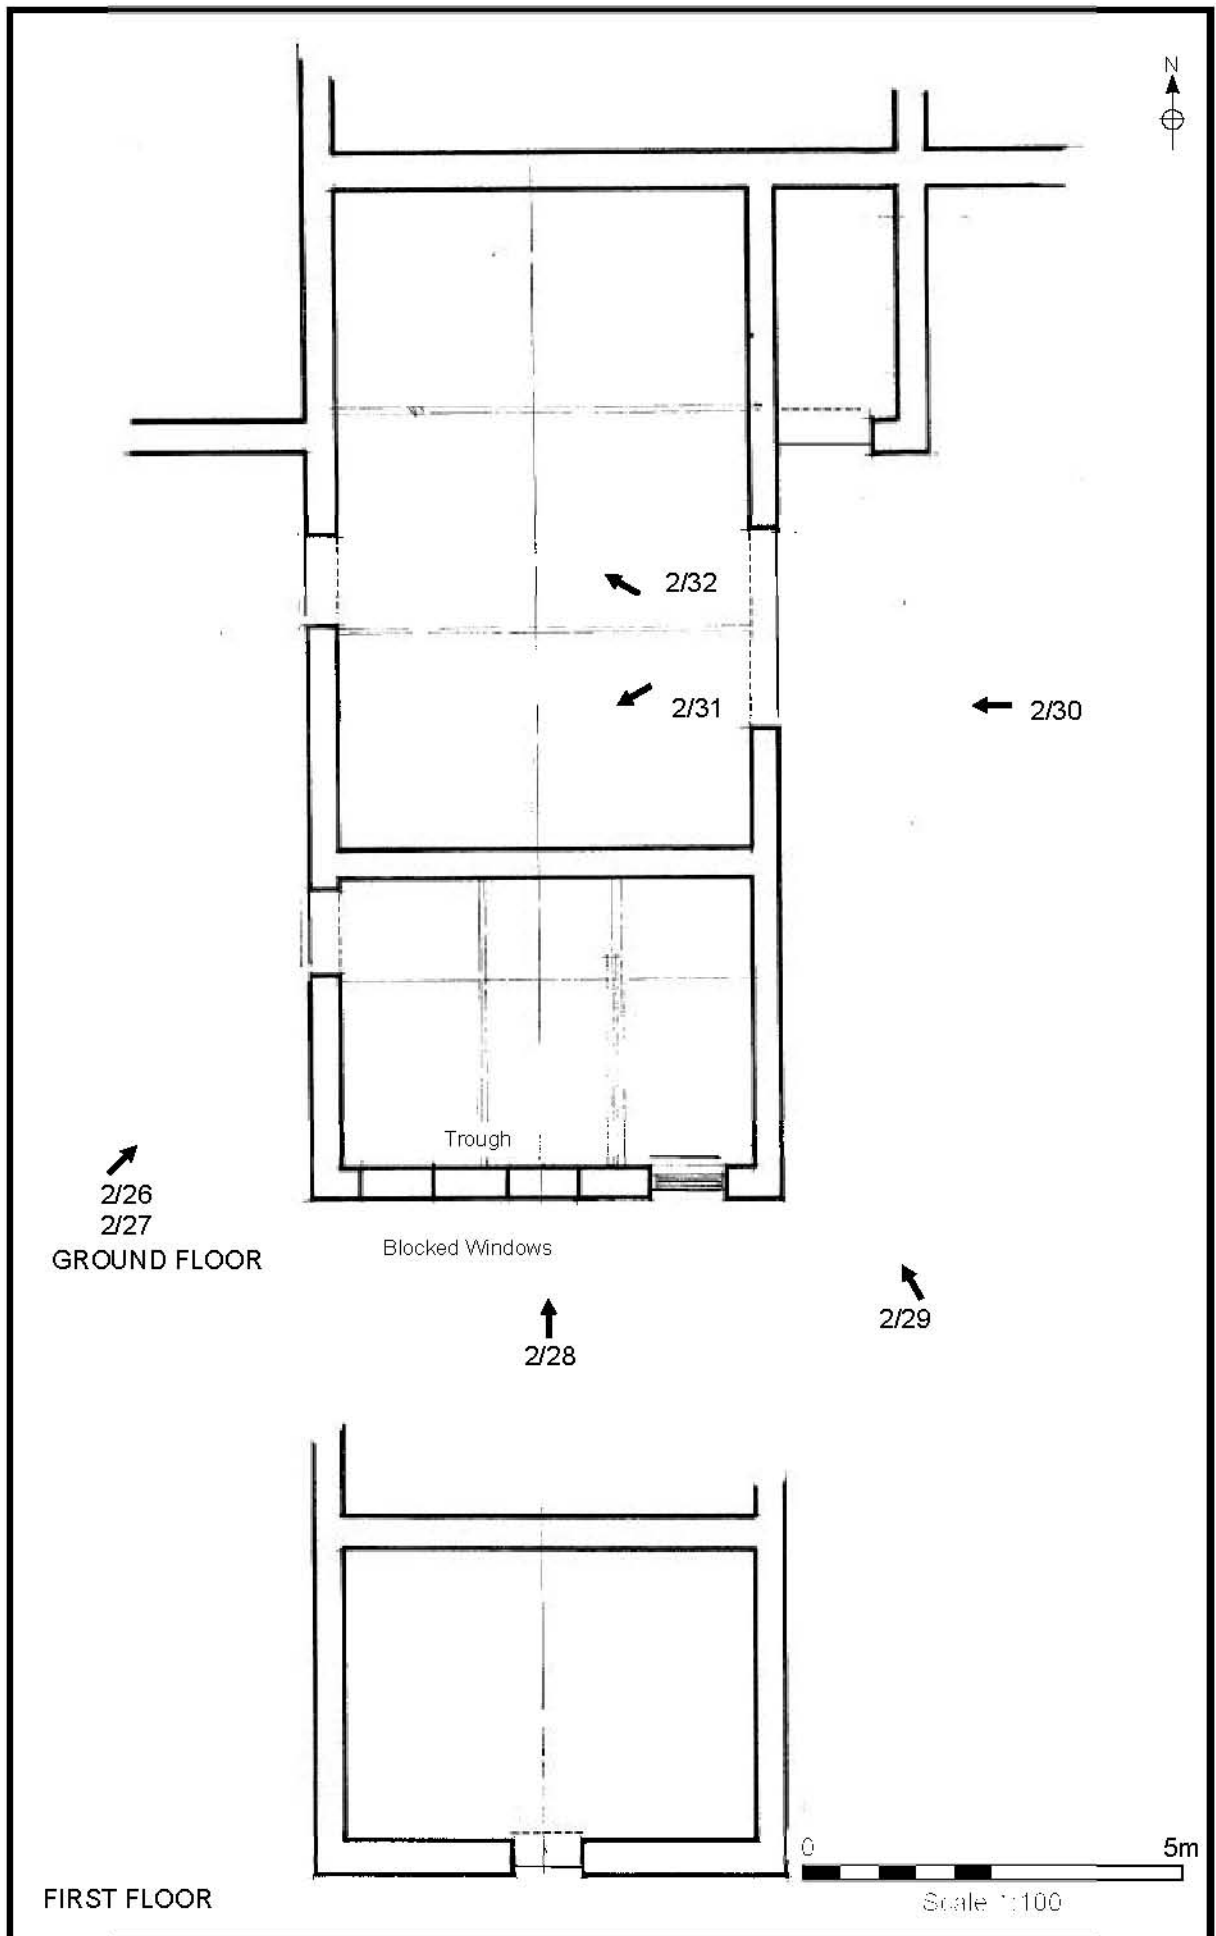
Figure 9. Building C: Plans.

6.7.1 There was no access into the first floor hayloft from the southern gable. The interior of the store had two separate areas, formerly used as a byre, now used as storage (Pls. 26-27).
