Historic Building Record

**Glebe Farm
Coleby Road
West Halton
North Lincolnshire**

**HISTORIC BUILDING RECORDING
(PHOTOGRAPHIC & DESCRIPTIVE RECORD)**

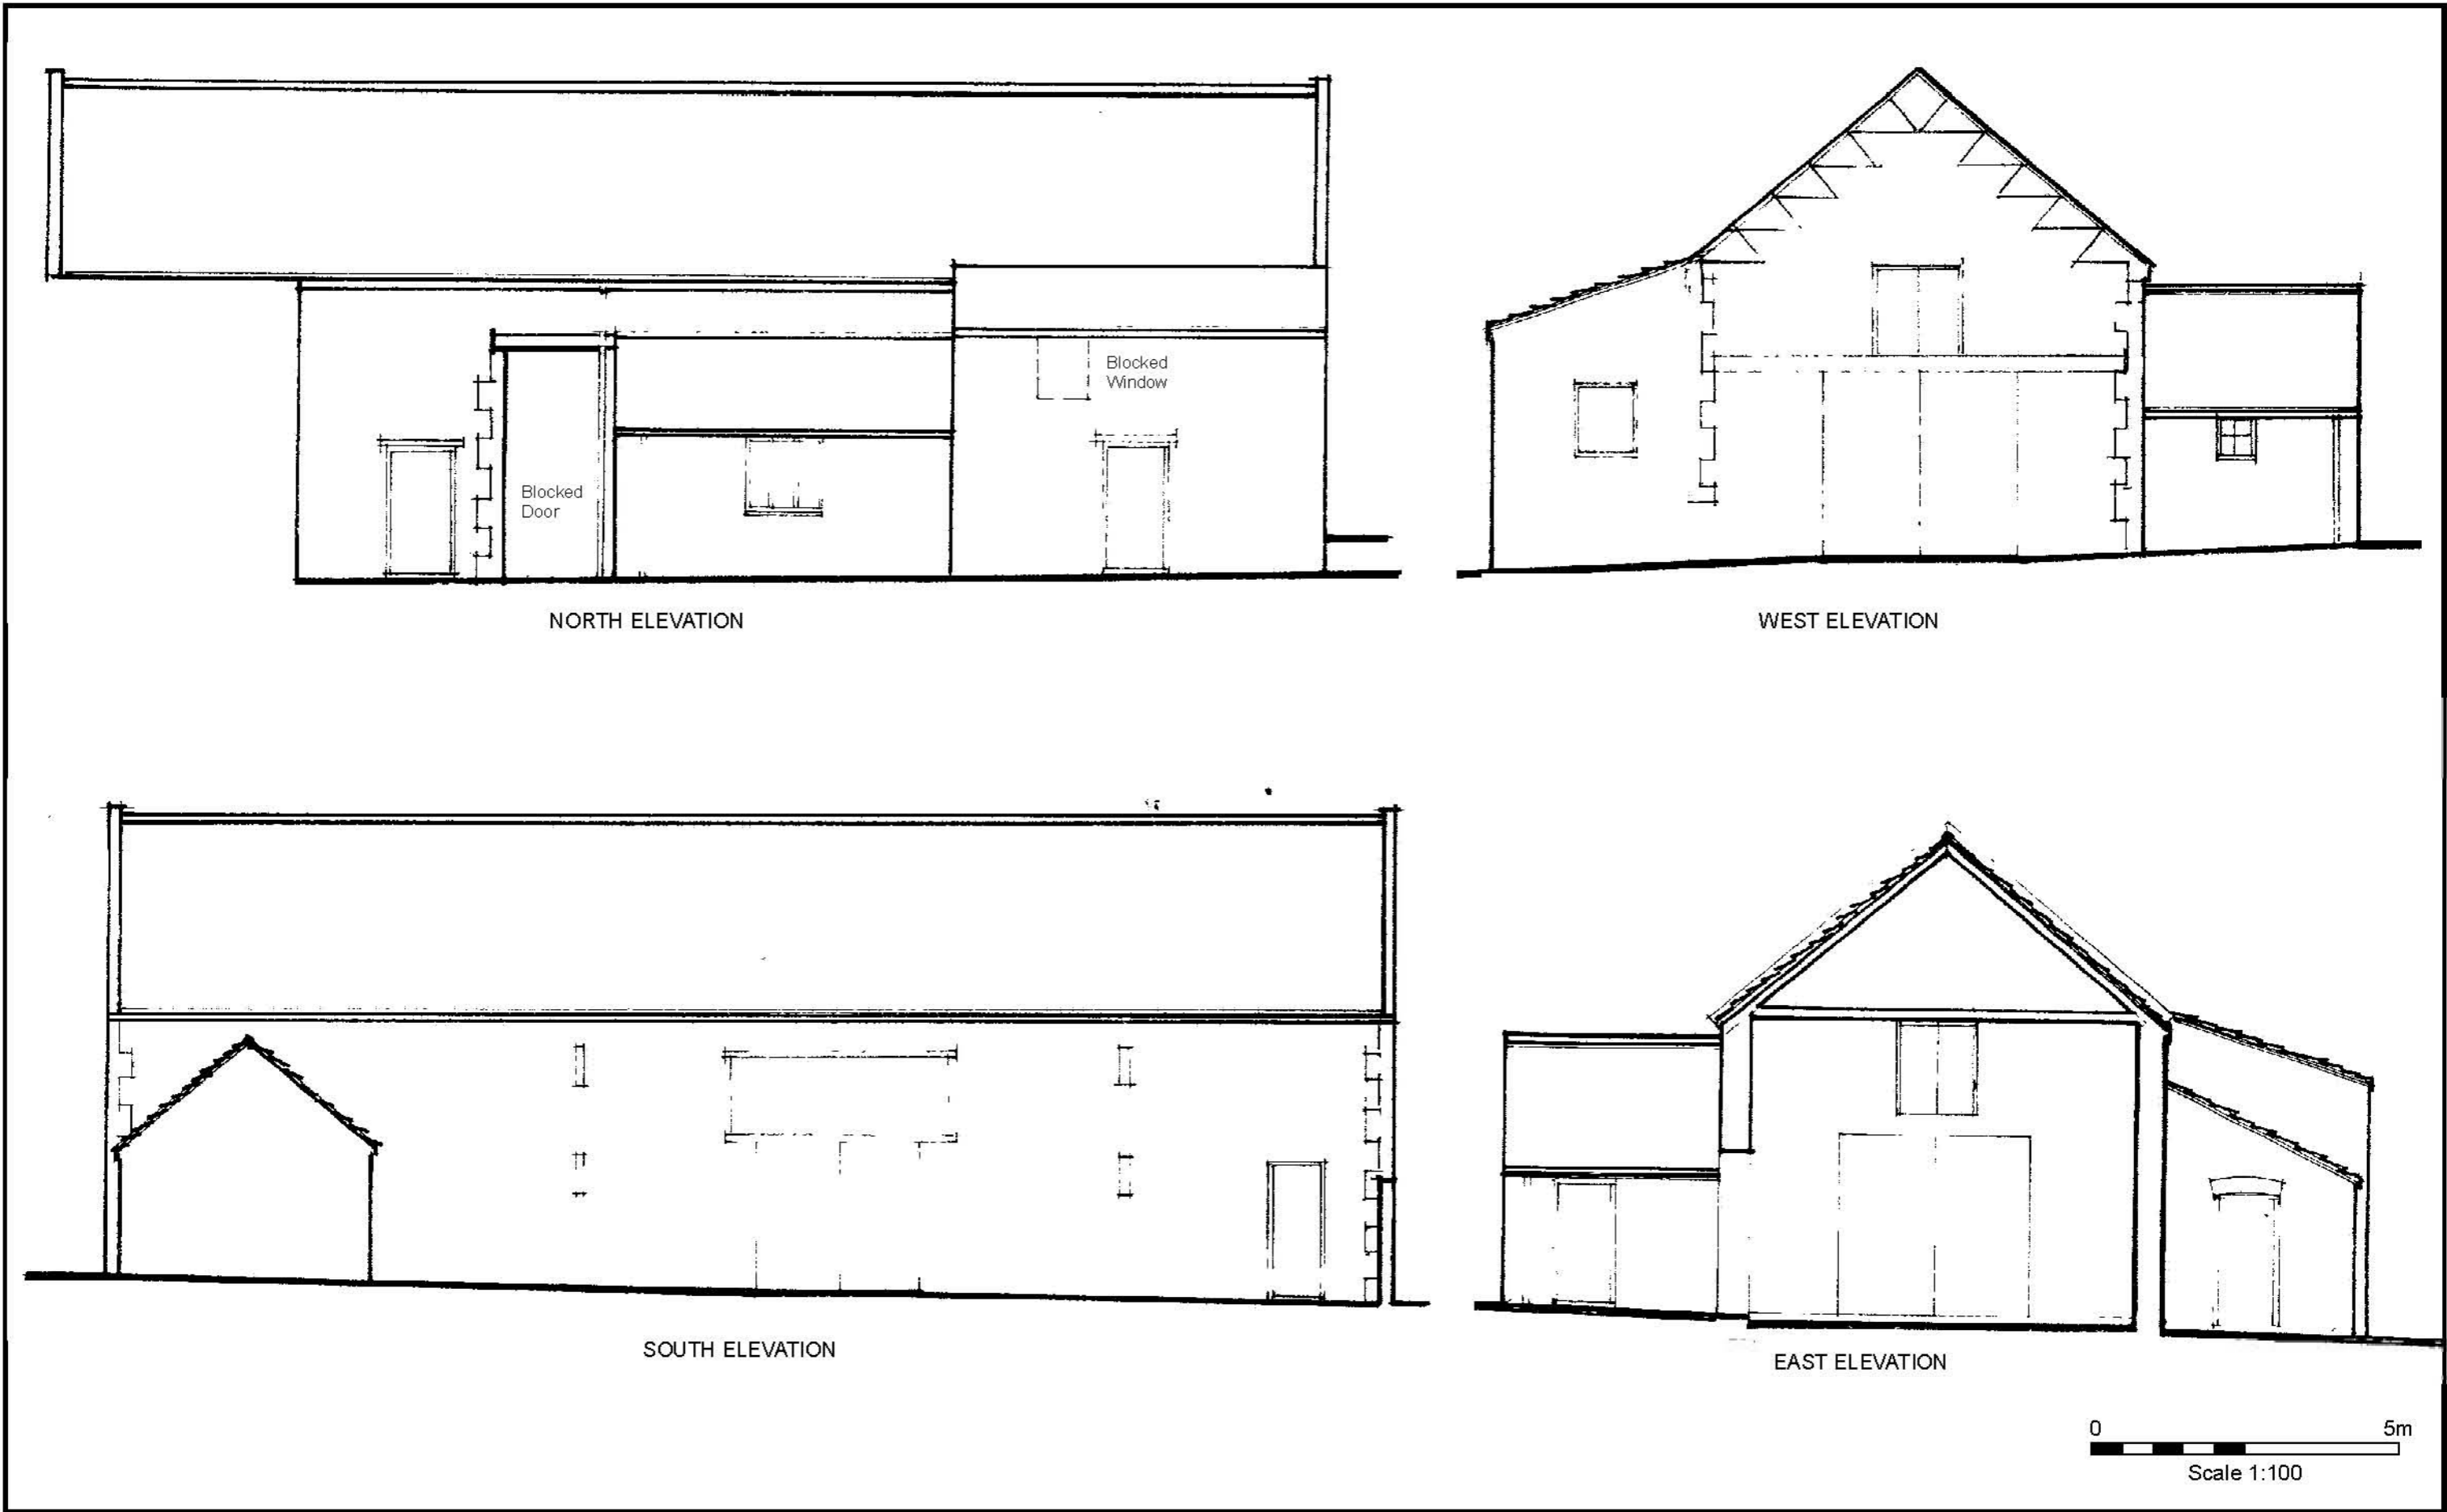
Figure 10. Building D: Elevations.

6.8.1 Building D is a large barn with three additions, two on the northern elevation and one on the southern elevation. The barn is a single storey structure constructed of stone rubble and plain brick with pantile gable roof and butts the Grade II Listed farmhouse to the east. The building was partially used for storage. The eastern addition on the northern elevation is a twentieth century single storey store, constructed of modern brick with single pitch roof, entrance in the

eastern elevation and metal framed window in the northern elevation. To the west is a one and a half storey store constructed of stone rubble with a door and blocked window in the north elevation and a window/hatch in the west elevation. The door has a sign stated the small structure as the West Halton Reading Room. The third addition has a gable roof and is on the southern elevation at the west end of the barn. This store had a window in the western elevation and a door in the eastern elevation.

6.8.2 The barn was constructed of stone with a gabled pan tile roof. The western gable had brick tumbled gable and brick quoins. The main barn building has three large doors, the main entrance to the west and in the north and south elevations (for threshing), the northern door had been blocked and the modern twentieth century store built across the blocked entrance with a smaller door into the barn inserted to the east. There was a hatch above the door in the eastern gable end.

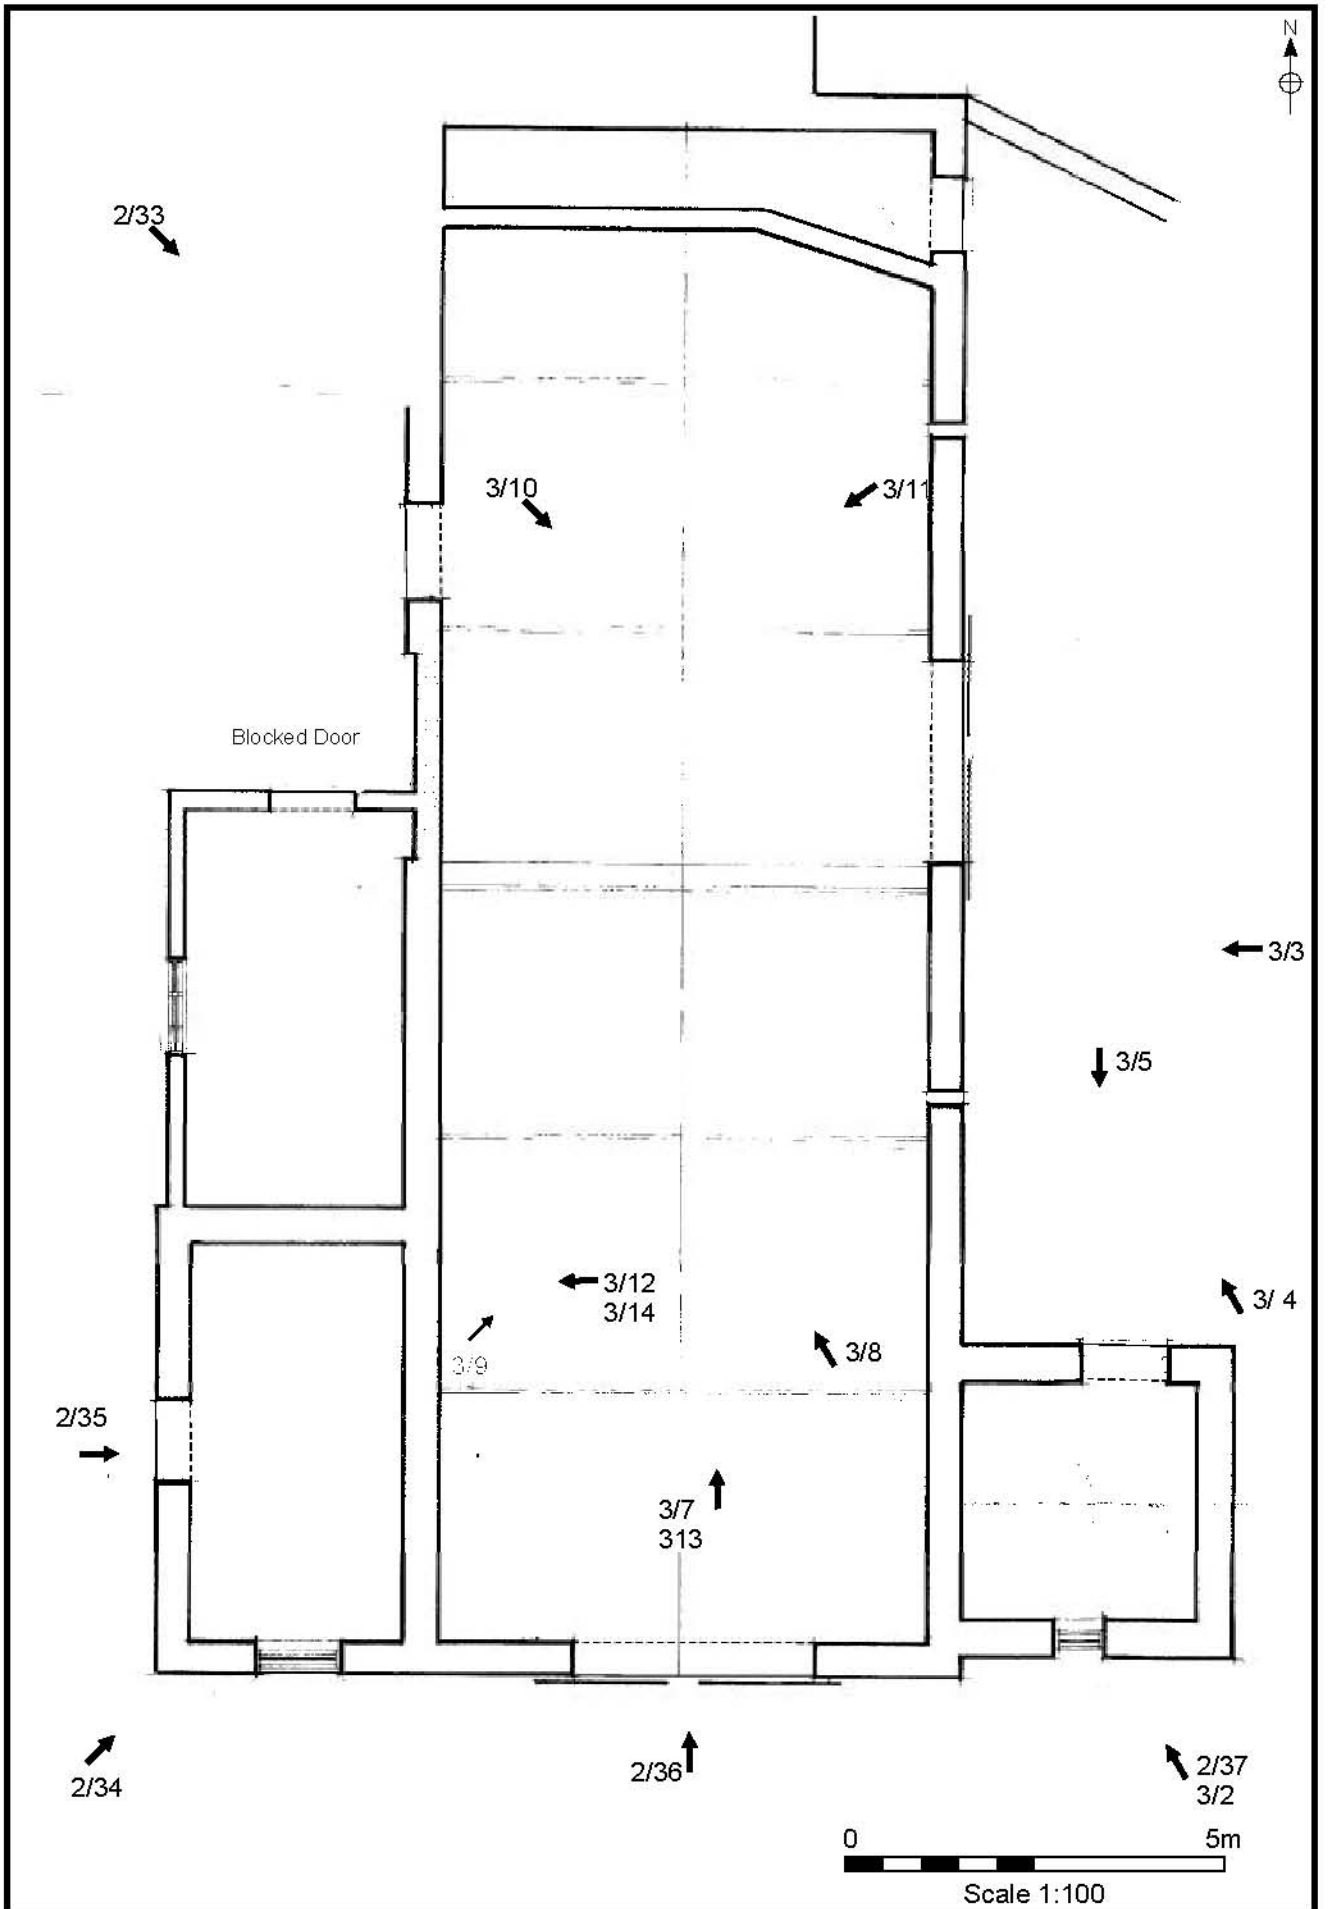
Figure 11. Building D: Plan.

6.9.1 The interior of the store has five A-frame trusses constructed of sawn timbers (Pls. 26-27). The eastern gable has had a passage inserted, constructed of brick and above it is a blocked window

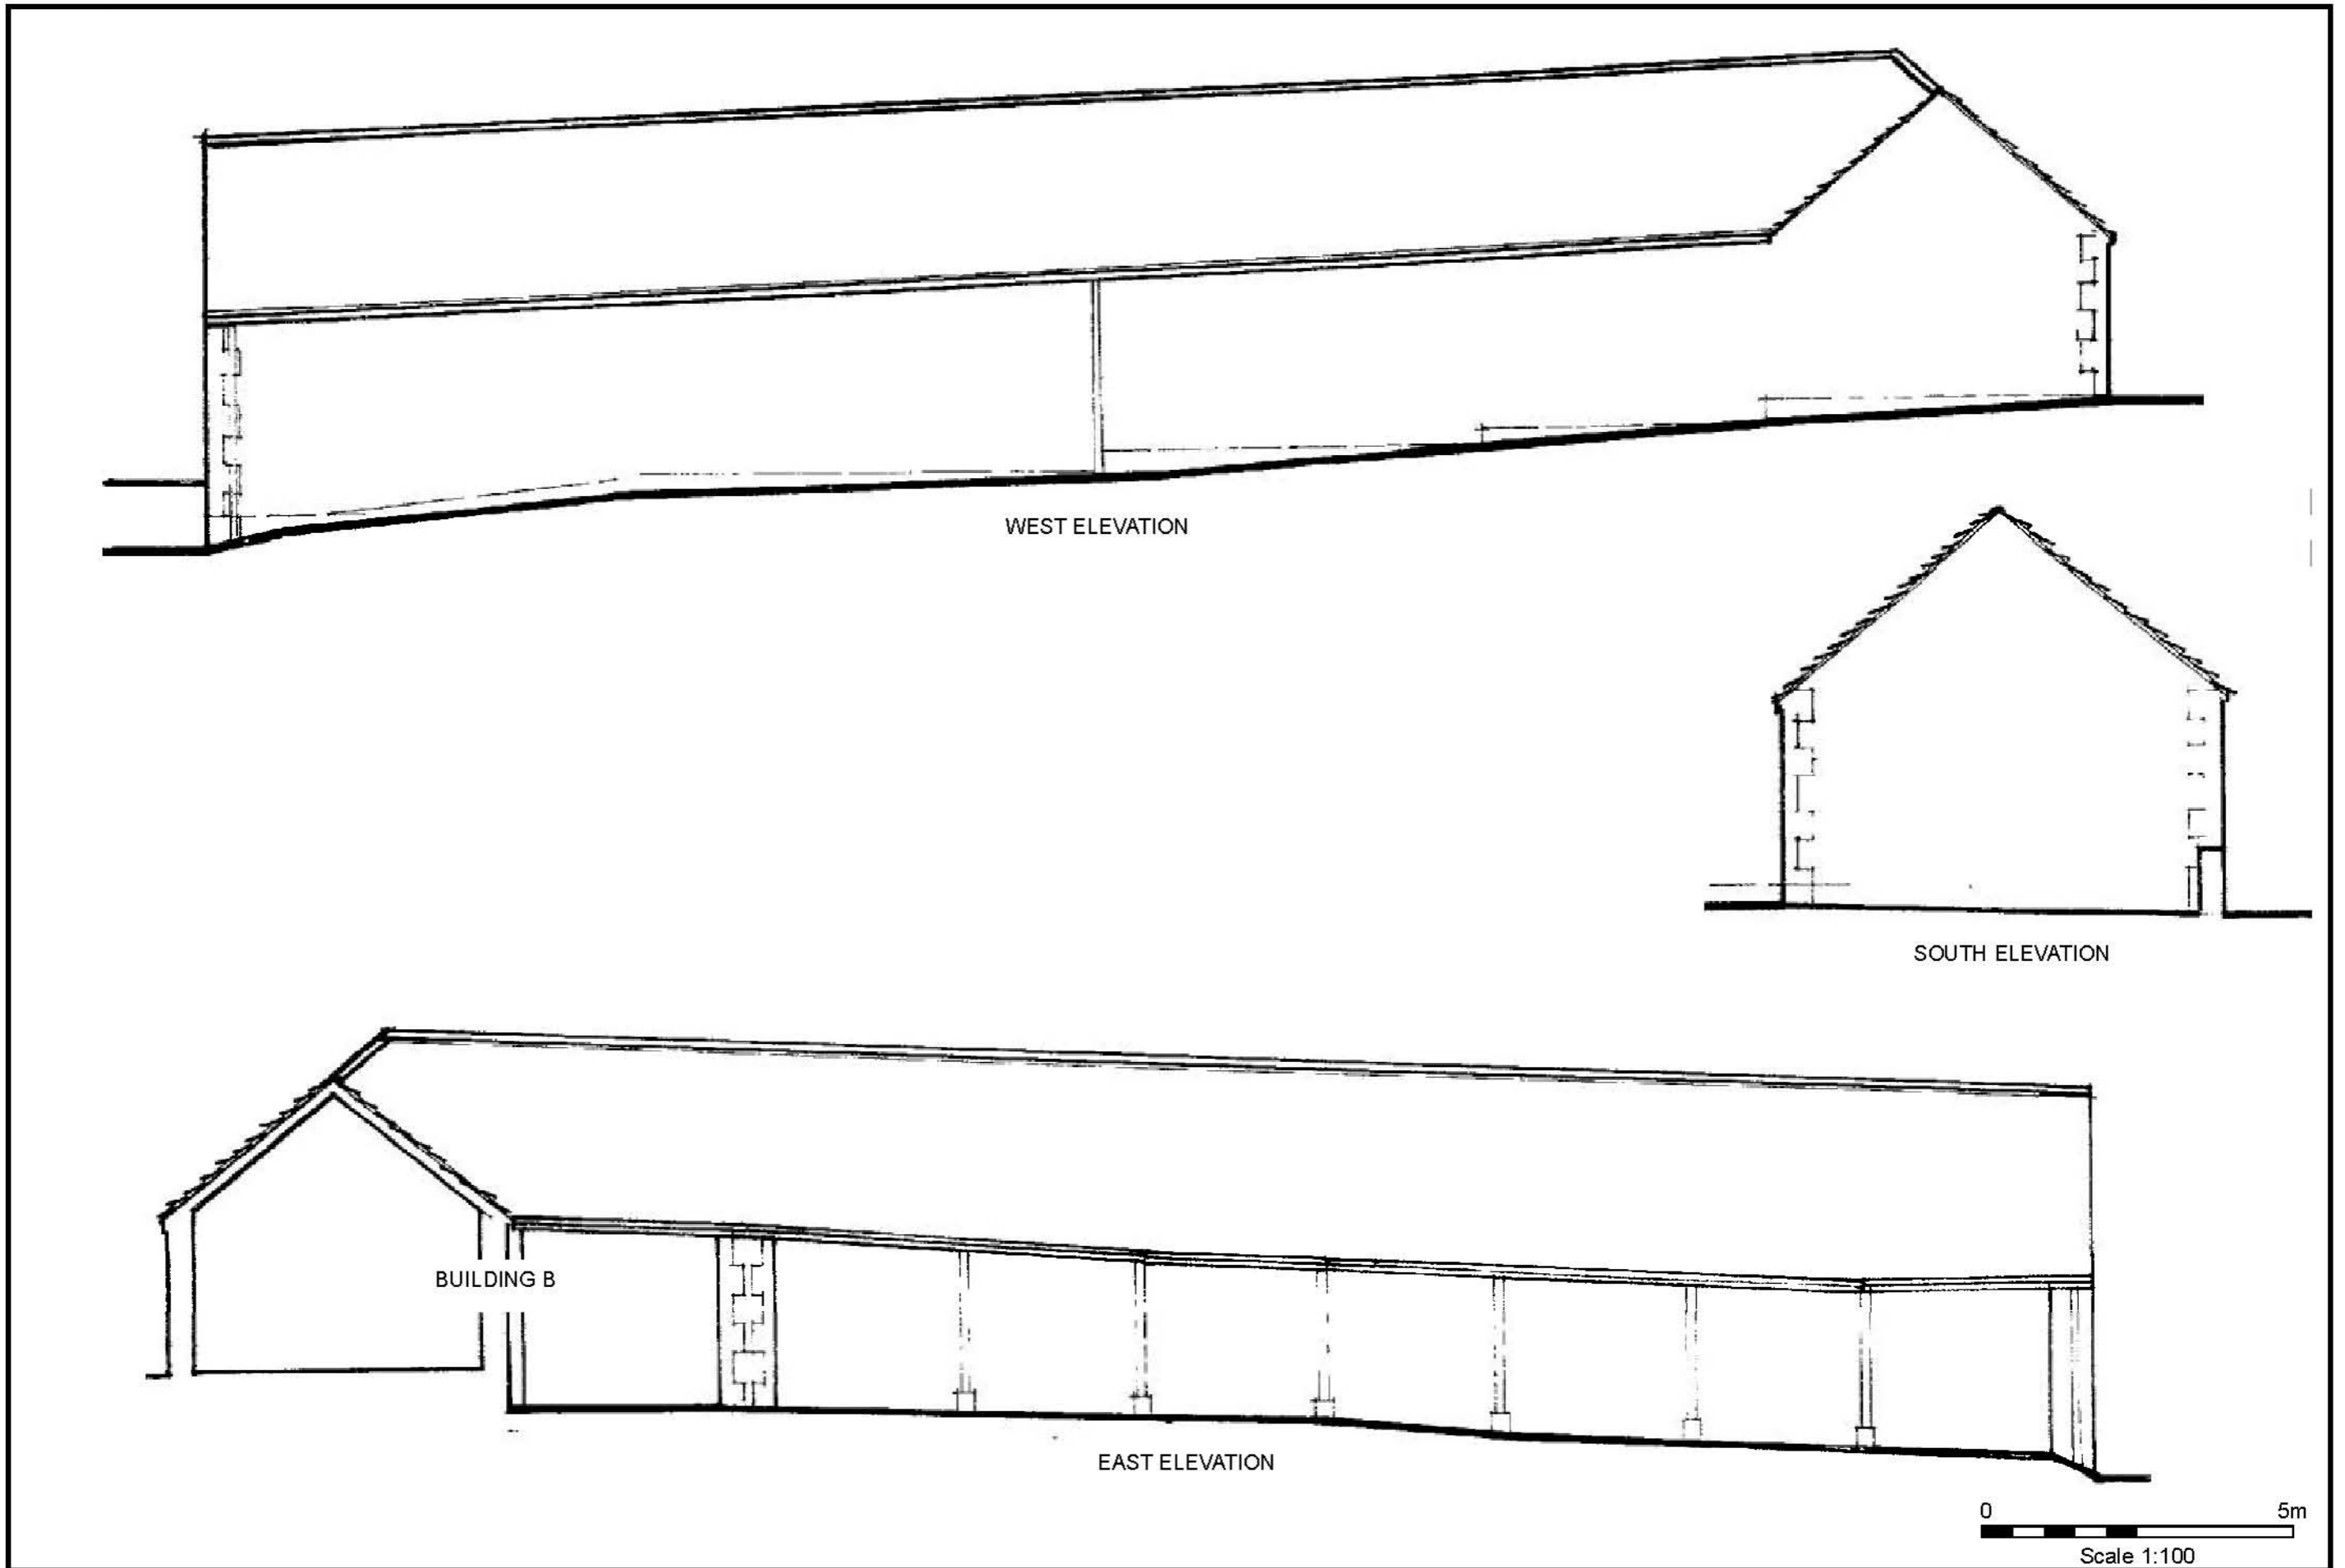
Figure 12. Building E: Elevations.

6.10.1 The store is a single storey structure constructed of stone rubble and plain brick with pantile gable roof, aligned north-south forming an L-shaped range with Building B. The building is open to the east and the main farmyard. At the western end of Building B is butted by the

south end of Building E. A single bay at its north end is included in Building B.

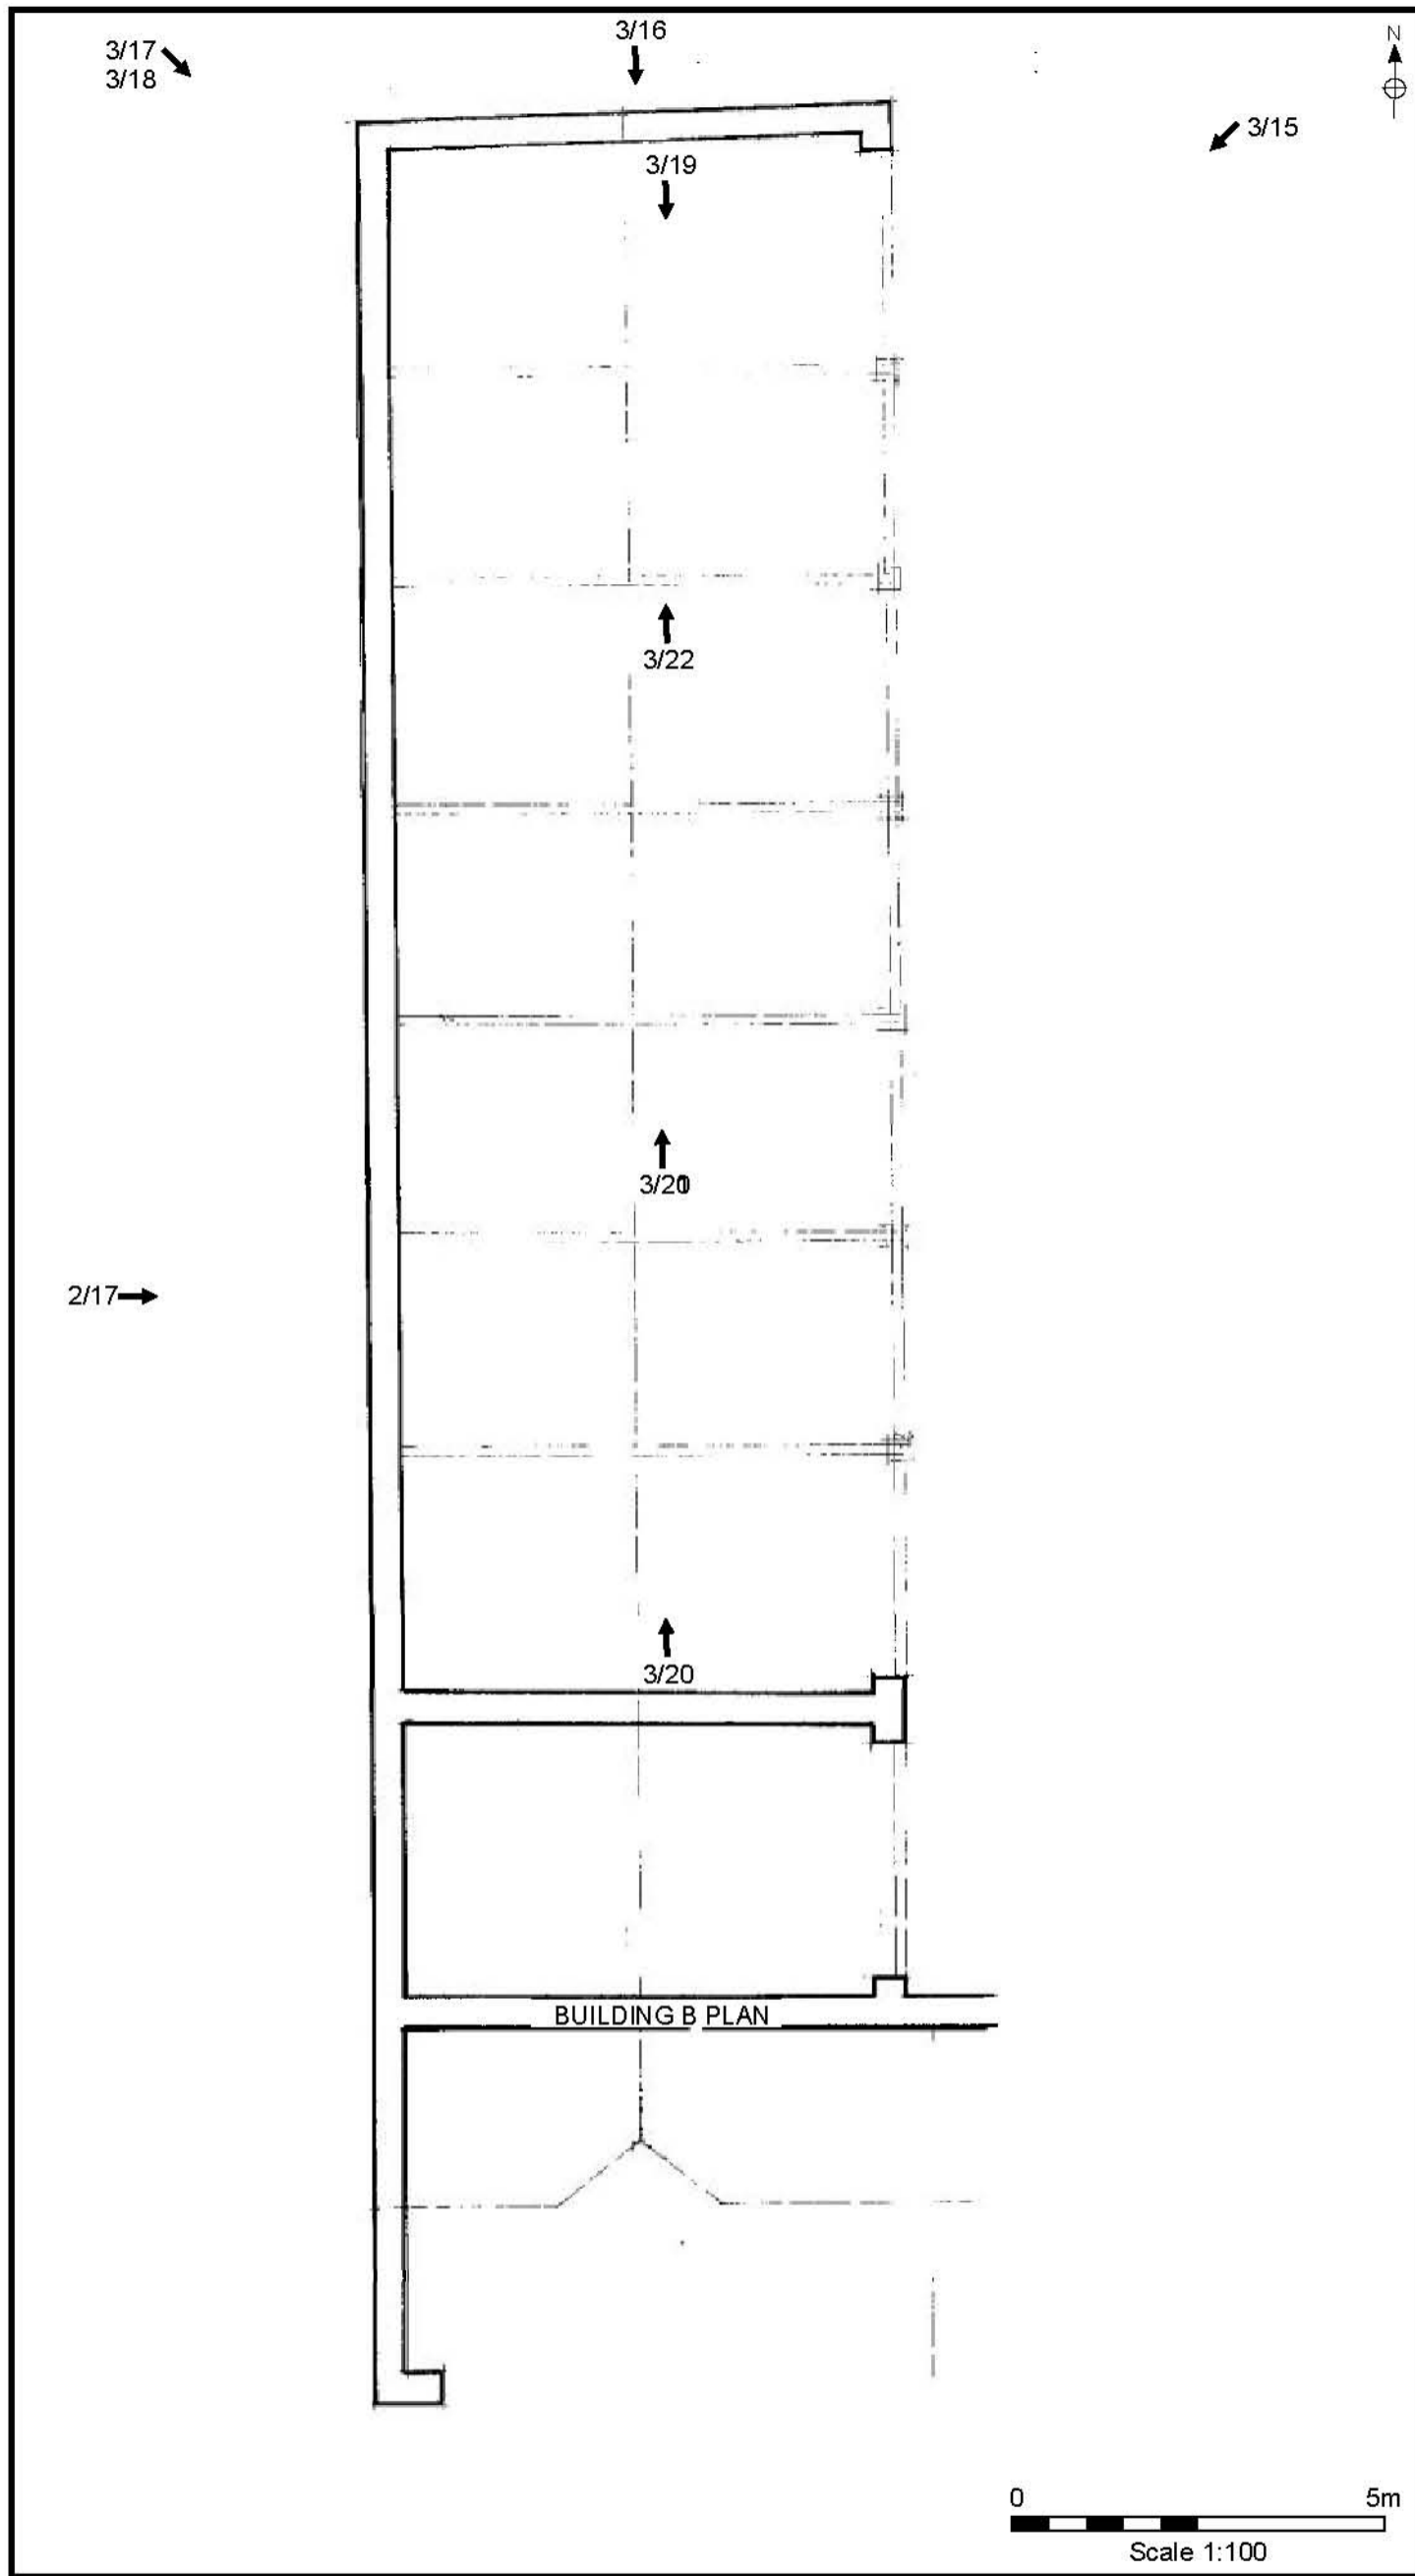
Figure 13. Building E: Plan.

6.11.1 The interior of the store has six king post trusses, similar to those in Building B suggesting that these adjoining buildings are contemporary.

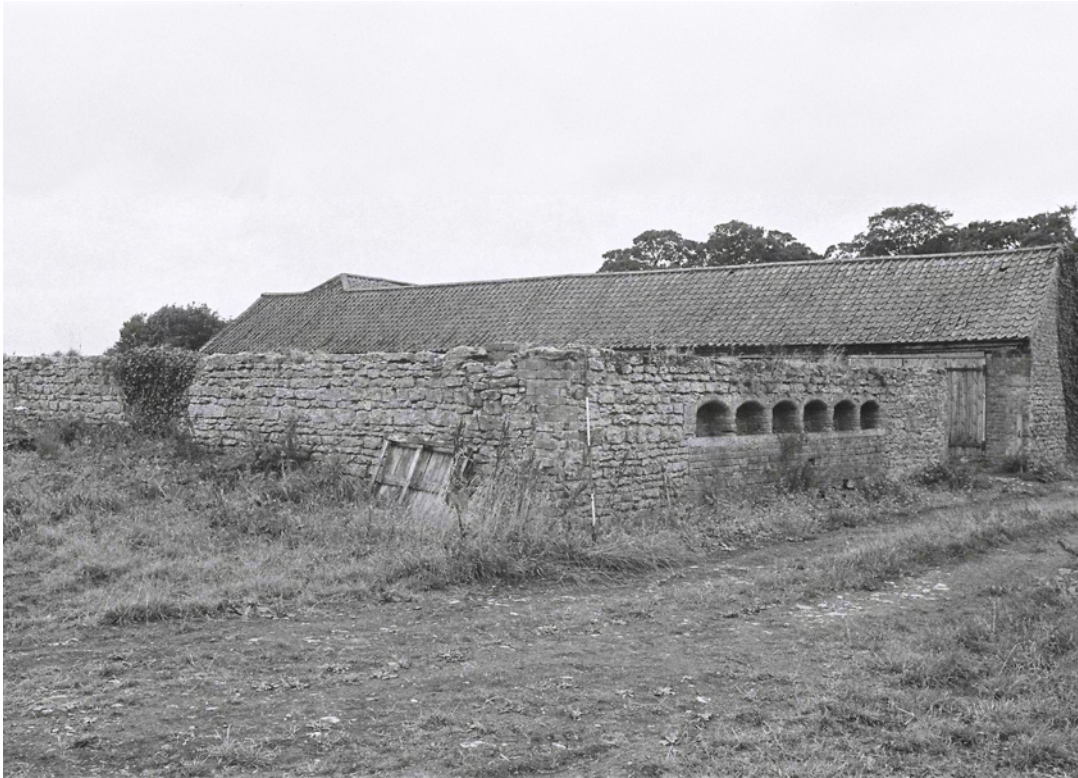
6.4.2 The eastern foldyard wall has a series of six feed slots (Pls. 23 & 24).

Plate 23. Building B Foldyard. Facing North-west.

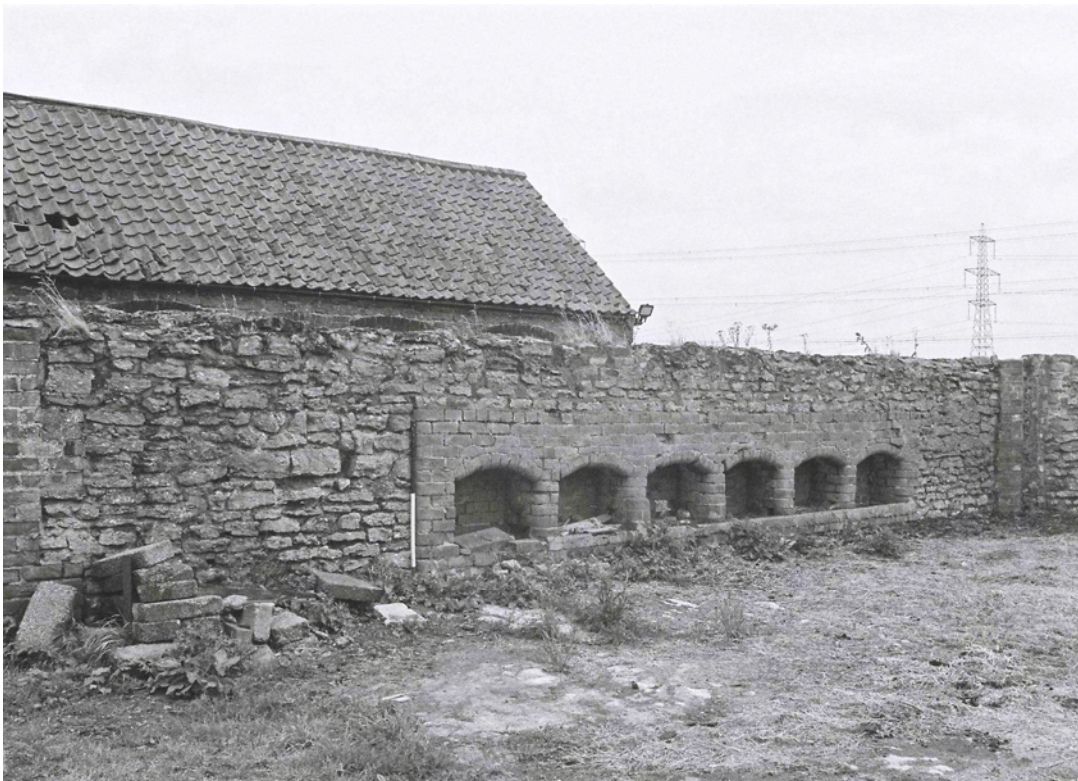
Plate 24. Building B Foldyard. Facing South-east.

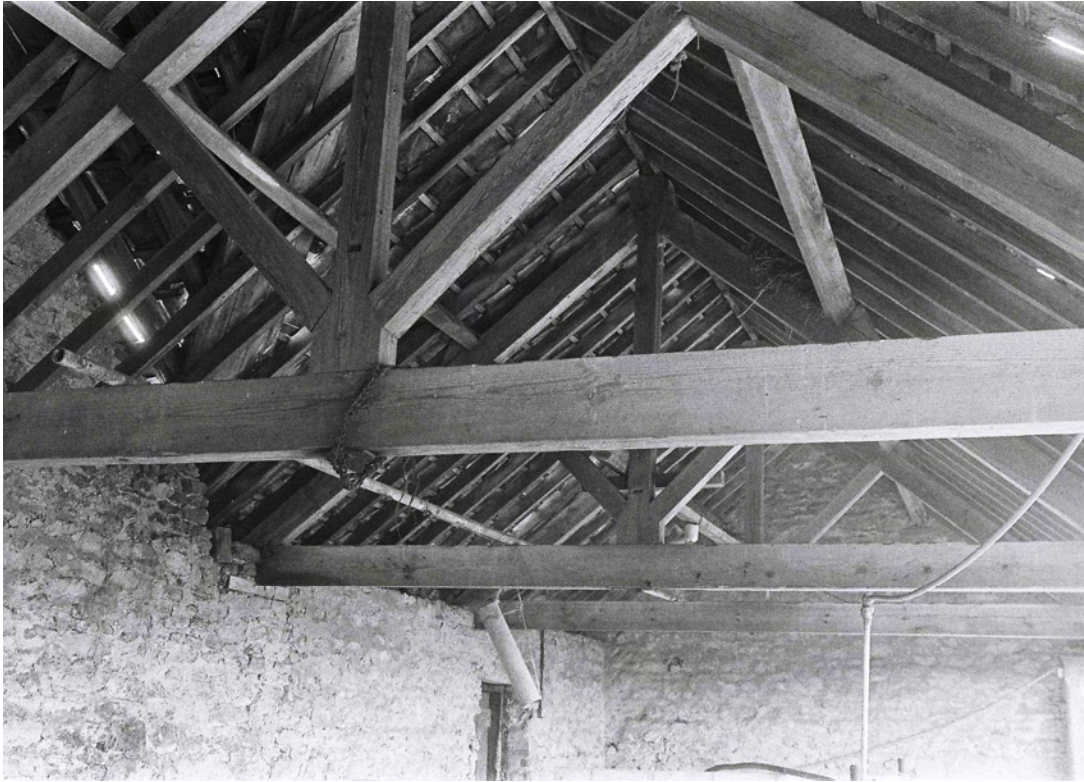
6.5.1 The interior of the store has three king post trusses in both eastern and western parts of the building.

Plate 25. Building B interior. Facing East.

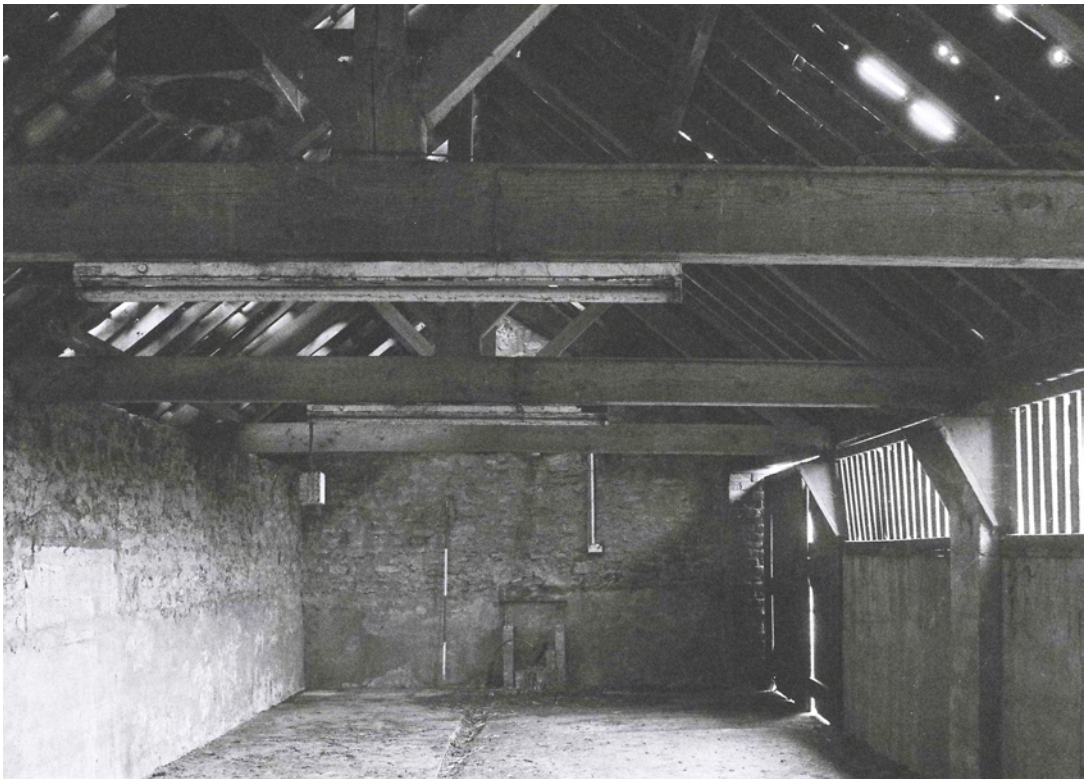
Plate 26. Building B Interior. Facing East.
