**Land to the East of School House
Main Street
Crambe
North Yorkshire**

Planning Ref.: 13/01286/FUL

Site Code: MAP 10.07.2014

Archaeological Watching Brief

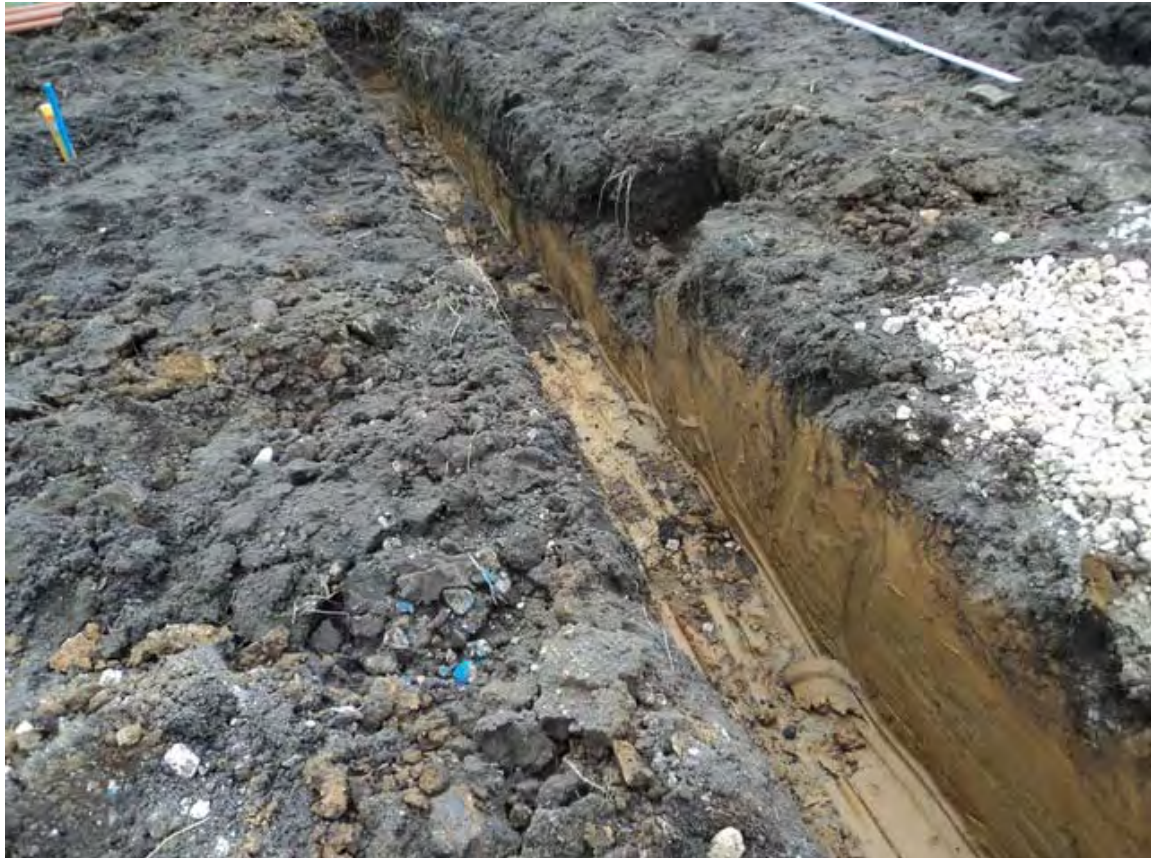
- 6.1 The foundations consisted of conventional strip footings, 0.70m wide. The depth of the footings varied from 0.70m up to a maximum depth of 0.80m (Pls. 2-4).
- 6.2 Natural deposits of yellow clay were revealed in all the foundation trenches (Pls. 3 & 4). The topsoil deposit had a maximum depth of 0.55m and consisted of a dark grey-brown clay sand containing frequent demolition/rubble material. Only 0.10m of topsoil remained in the northern foundation trench.
- 6.3 No archaeological features, deposit or finds were revealed during the Watching Brief.

Plate 2. Southern Foundation Trench. Facing South-west.

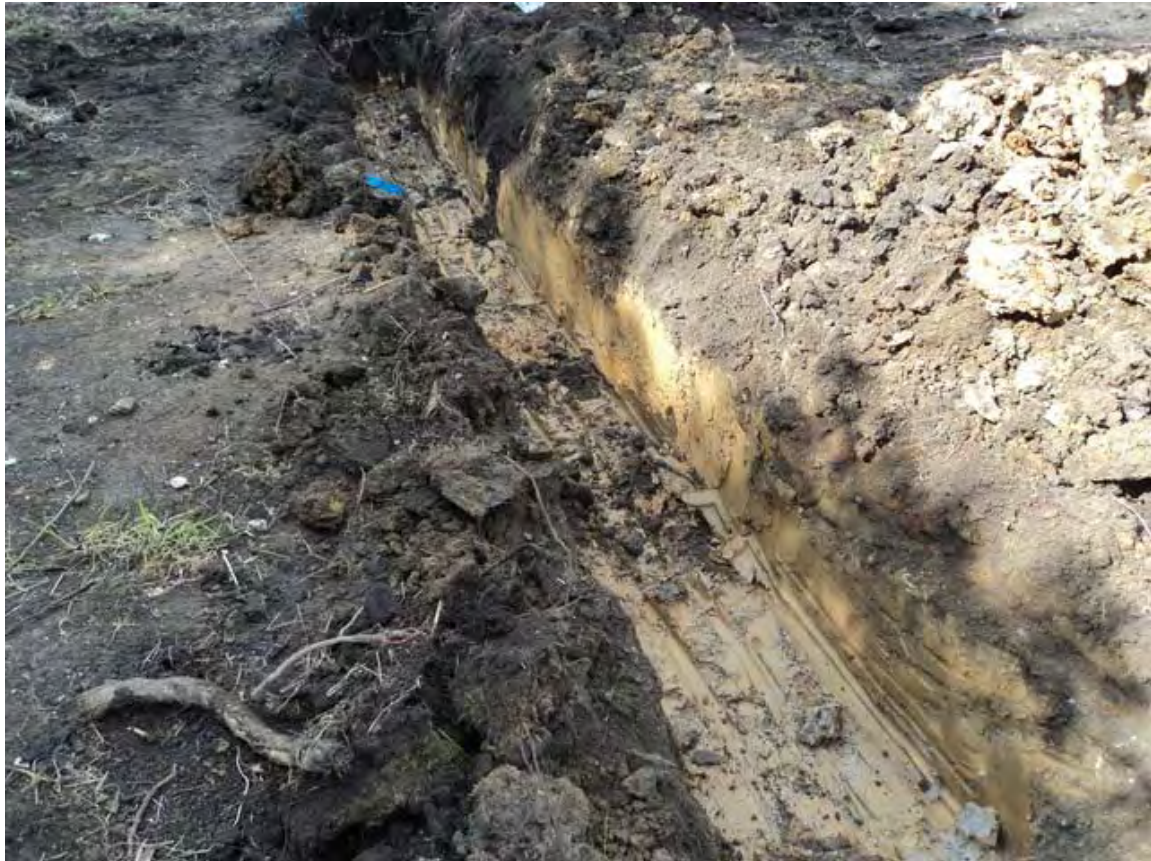
Plate 3. Western Foundation Trench. Facing North.

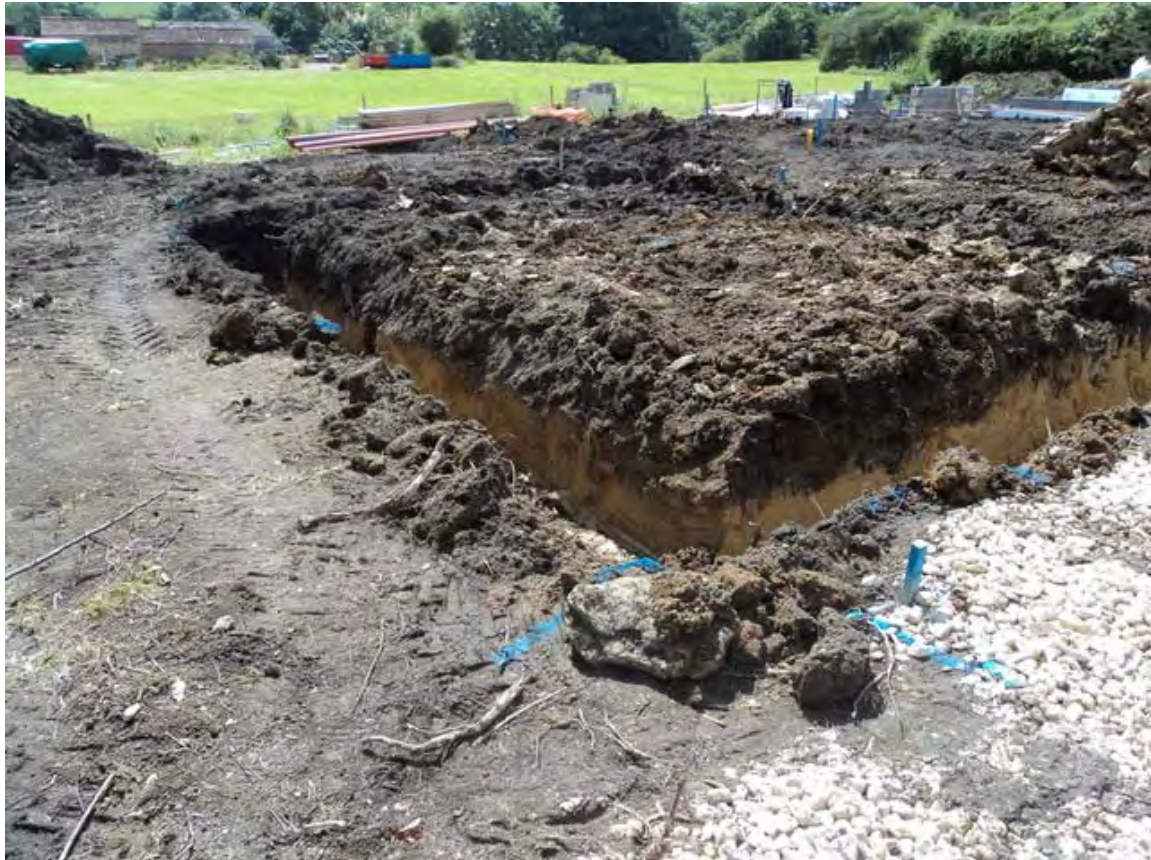
Plate 4. Overall View after Excavation. Facing South-west.
