**Land North of Manor House Farm  
Long Hill  
Helperthorpe  
North Yorkshire**

**SE 94800 71222  
NY 12/00201/FUL & APP/Y2736/A/12/2179101  
MAP 10.31.2013**

**Archaeological Strip and Record**

**Archaeological Strip and Record Report**

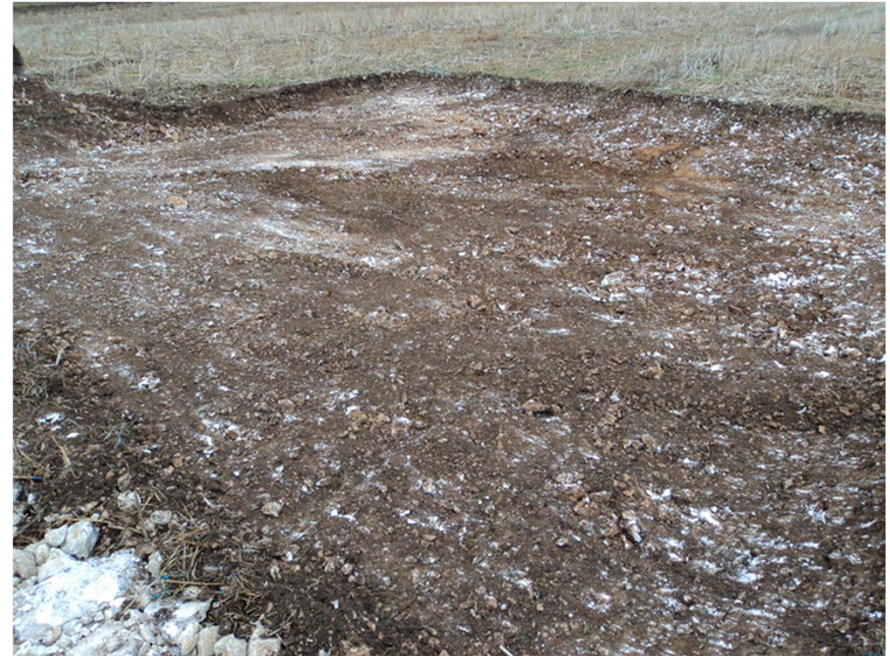
6.1 Natural deposits of hard compact chalk were encountered at the location of the wind turbine. A dark brown loamy clay topsoil deposit (001) lay directly above the natural chalk. The topsoil deposit had a maximum depth of 0.16m (Pls. 2 & 3).

Plate 2. Wind Turbine Base after Topsoil Strip. Facing North-west.

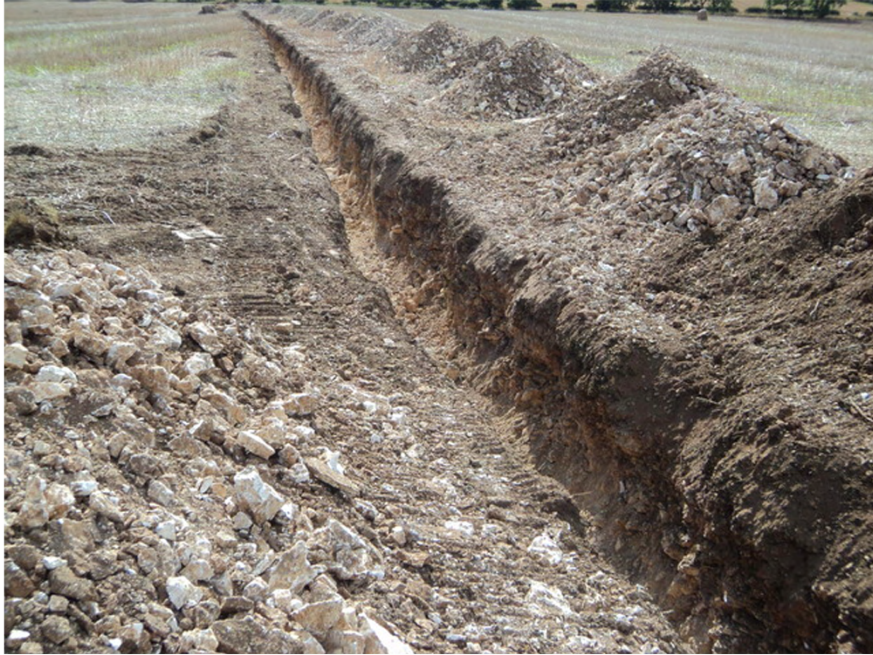
Helperthorpe allowing for connection to the client's meter located within Manor House farm itself (Pl. 3).

Plate 3. Cable Trench. Facing South-east.

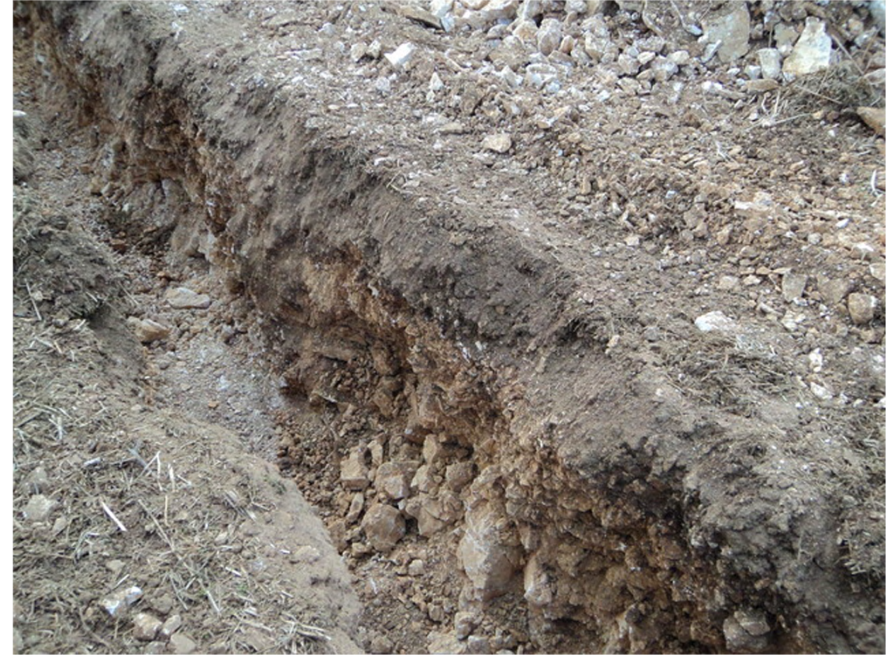
6.2 The cable trench was excavated to an average depth of 0.90m. Stratigraphy consisted of a loamy topsoil (001), which sealed the natural chalk (Pl. 4).

6.3 No archaeological features, deposit or finds were present in either the wind turbine base or cable trench.

Plate 4. Section through Cable Trench. Facing South.
