**Broachdale Farm
Sheep Rake Lane
Kilham
East Yorkshire**

**Archaeological Strip and Record and
Archaeological Watching Brief**

**MAP 10.34.2011
Planning Ref. DC/11/01637/PLF**

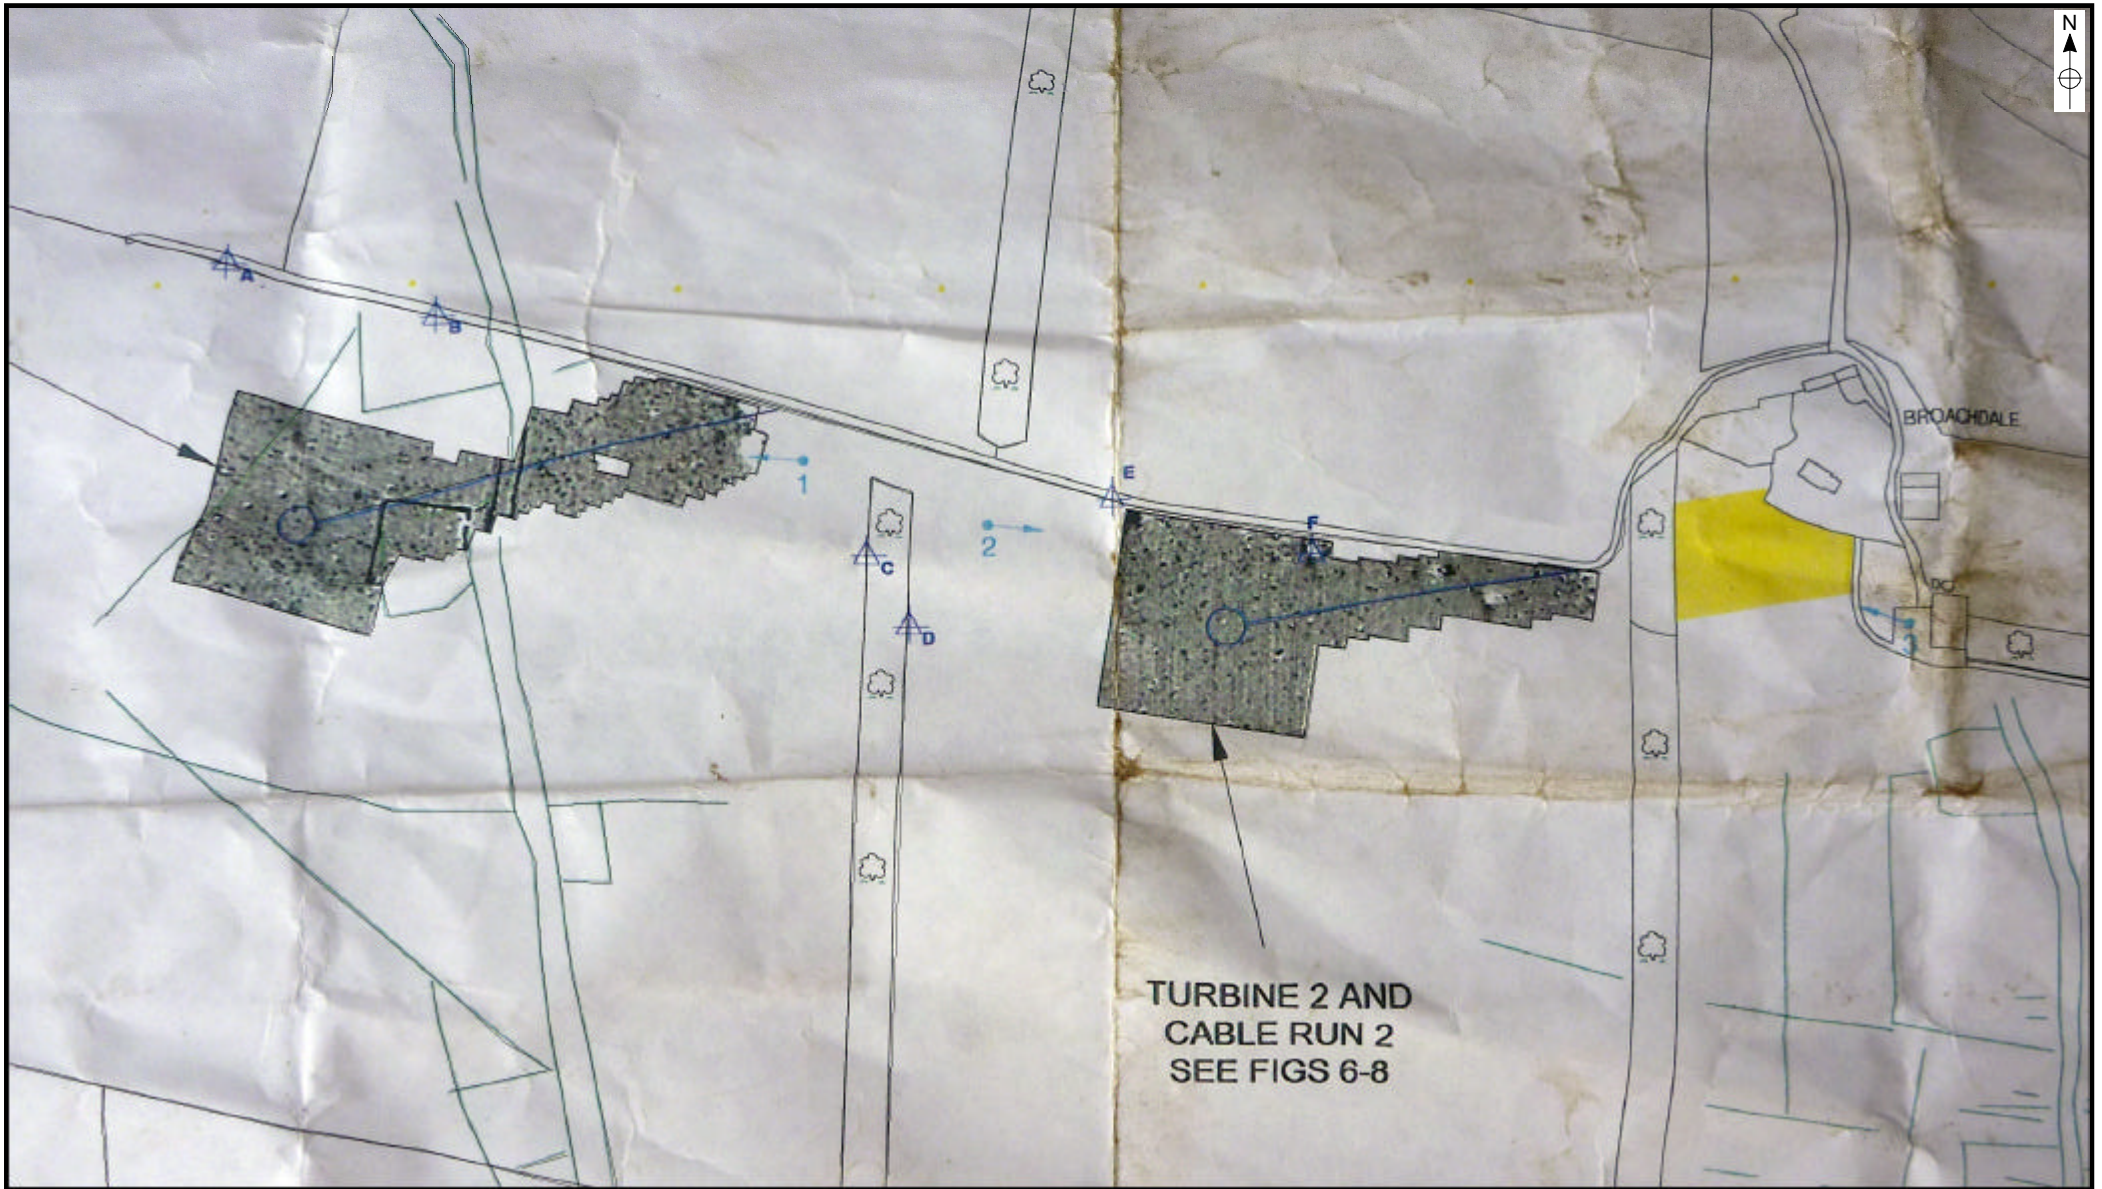
Figure 3. Detail from the WYAS Geophysical Survey Results

- 4.2 A Geophysical Survey was carried out by WYAS Archaeological Services in August 2011 and covered approximately three hectares. The survey covered areas of one hectare centered on each proposed turbine location and a 20m wide corridor along the route of the cable runs and has identified anomalies locating a square enclosure, drove-way and field boundary adjacent to the proposed location of Turbine 1, confirming and enhancing the crop data. No

anomalies of archaeological potential were identified in the area around the proposed location of Turbine 2 (WYAS 2011).

8.2 Prior to excavation, both of these sources had indicated that archaeological features would be effected by excavations for the turbine base and cable run. The location of Turbine 1 was slightly modified and by doing so the excavations avoided the square enclosure (WYAS 2011 – Fig. 3). It was not

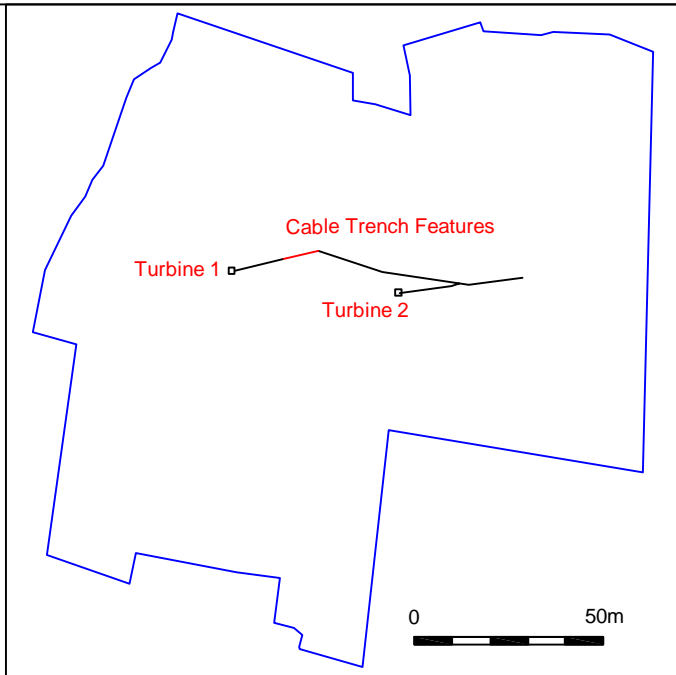
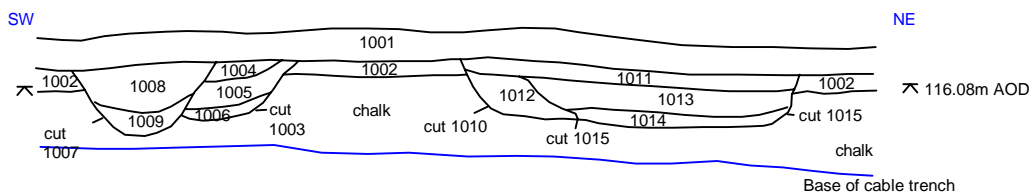
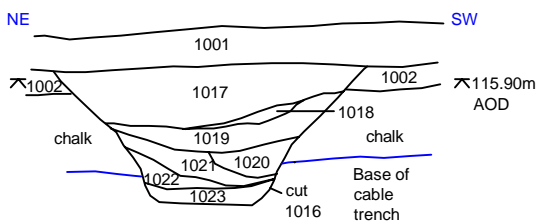
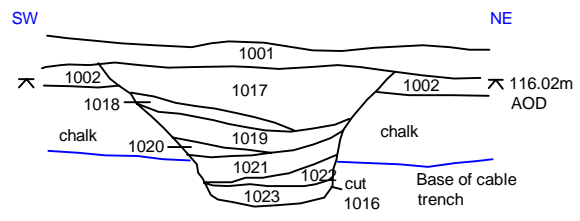
Features in Cable Trench north-east of Turbine 1

- 7.1.1 The strip of the turbine base revealed no archaeological features. A deposit of sandy loam topsoil, measuring 0.33m in depth, lay directly over the frost fractured chalk (Pl. 3).
- 7.1.2 Excavation of the cable trench for Turbine 1 revealed two linear features (1003/1007 & 10016 as defined by the previous geophysical survey – WYAS 2011) and a possible third (1010/1015).
- 7.1.3 *Turbine 1 Cable Trench: Linear 1003/1007* (Fig. 4 : Pl. 6)
Linear 1003 was a north-south aligned ditch which had been re-cut by ditch 1007, when the earlier ditch 1003 had fully silted up. Ditch 1003 was in

excess of 0.80m in width and was 0.40m in depth with a flat bottomed and U-shaped profile. Its western edge had been removed by the ditch re-cut 1007. The fills of Ditch 1003 were three silty clays with varying amounts of chalk fragments and gravel inclusions (1004-1006). The primary fill (1006) of the feature was sampled for environmental evidence, and proved to be sterile, producing only modern straw fragments and snail shell.

Linear re-cut 1007 was 0.94m in width and 0.44m in depth with a U-shaped profile. The features contained two fills (1008 & 1009) silty clays with varying amounts of chalk inclusions. The primary fill of Ditch 1007 (1009) was sampled for environmental evidence and was also sterile apart from modern material.

Feature 1010/1015 was located 1.4m to the east of Ditch 1003/1007. As with Ditch 1003/1007 this feature appeared to have been re-cut. The earliest feature (1010) was in excess 2.2m in width and 0.26m in depth with a steep sided edge (80°) and flat base. Feature 1010 was filled with a silty clay (1012), when this had silted up naturally to a depth of 0.16m. Re-cut feature (1015) was cut through Deposit 1012. Feature 1015 measured 1.8m wide and was 0.26m deep feature with a very shallow 'U' shaped profile, with primary and secondary fills of silty clay (1013 & 1014) with high proportions of chalk inclusions. The final deposition episode in Features 1010 and 1015 was a 0.12m deep deposit of silty clay (1011). No finds were recovered from these features but an environmental sample was taken from fill (1014). The flot from the environmental sample contained modern material plus one tiny sliver of charcoal measuring <0.2cm, which was not identifiable.

Linear 1016 measured 2m in width and 0.90m in depth with a 'V' shaped flat-bottomed profile. The feature contained seven distinct fills of sandy clays with varying amounts of inclusions of fractured chalk (1017–1023).

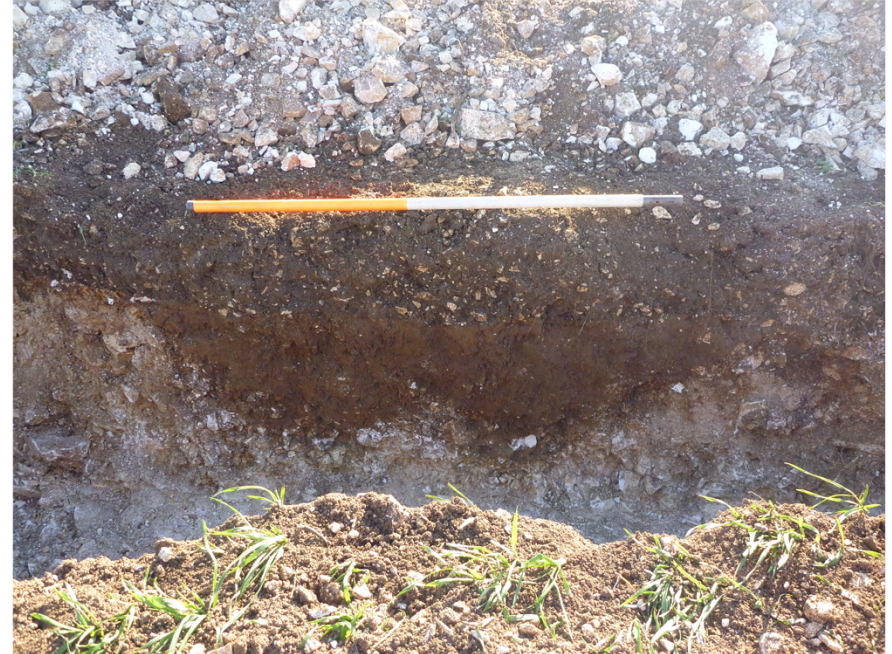
Plate 6. Linear 1003 /1007 north facing section. Facing South.

No finds were recovered from either of the ditches.

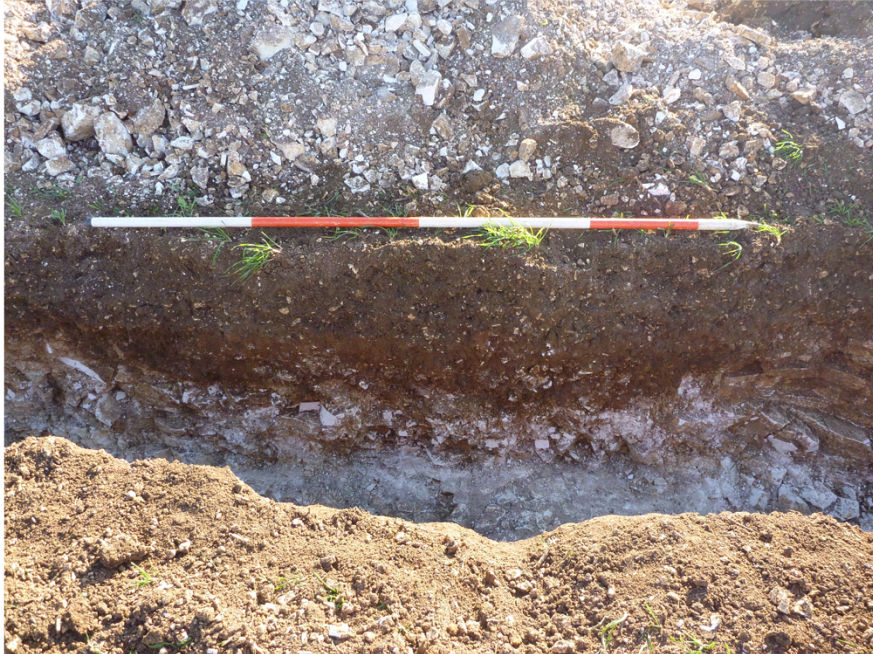
Plate 7. Linear 1010/1015 north facing section. Facing South.

As only a 0.50m wide transect was excavated of this feature it is impossible to determine whether the feature represents a ditch akin to 1003/1007 and 1016 or represented a large pit.

The Geophysical Survey of this area of the cable trench does show an isolated anomaly situated between the ditches, which may equate to Feature 1010/1015.

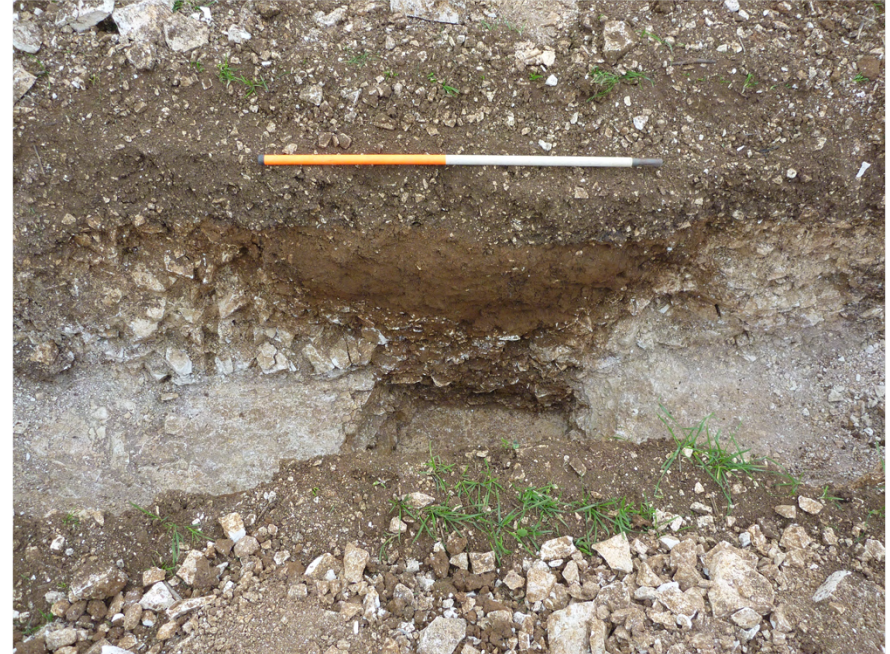
Plate 8. Linear 1016 south facing section. Facing North.

Finds from the ditch were restricted to fragments of skull and a leg bone from a sheep (Appendices 2 & 6). The bone was in a very poor state of preservation. The environmental sample from deposit 1023, the primary fill of linear cut (1016), also produced some very scarce trace fragments of wood charcoal <0.2cm in size, which are probably not that significant (Appendix 7).

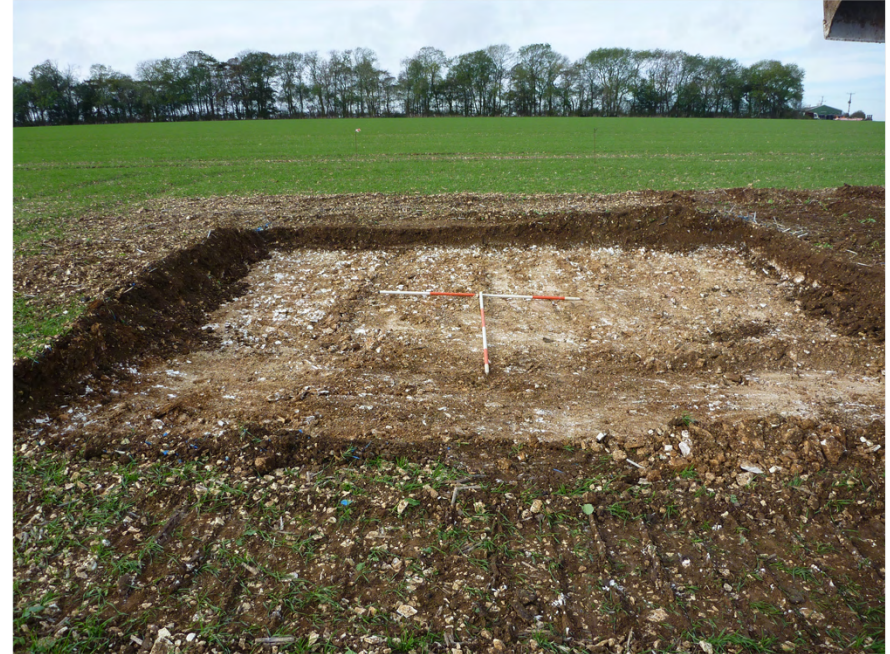
Plate 10. Site of Turbine 2 after topsoil strip. Facing West.

7.2.1 Excavation of the plot for the Turbine 2 and the cable run showed no evidence of any archaeological activity. As with Turbine 1 structural base the subsoil had been removed by ploughing leaving only a 0.30m deep deposit of topsoil (2000) over the natural frost fractured chalk (Pls. 10 & 11).

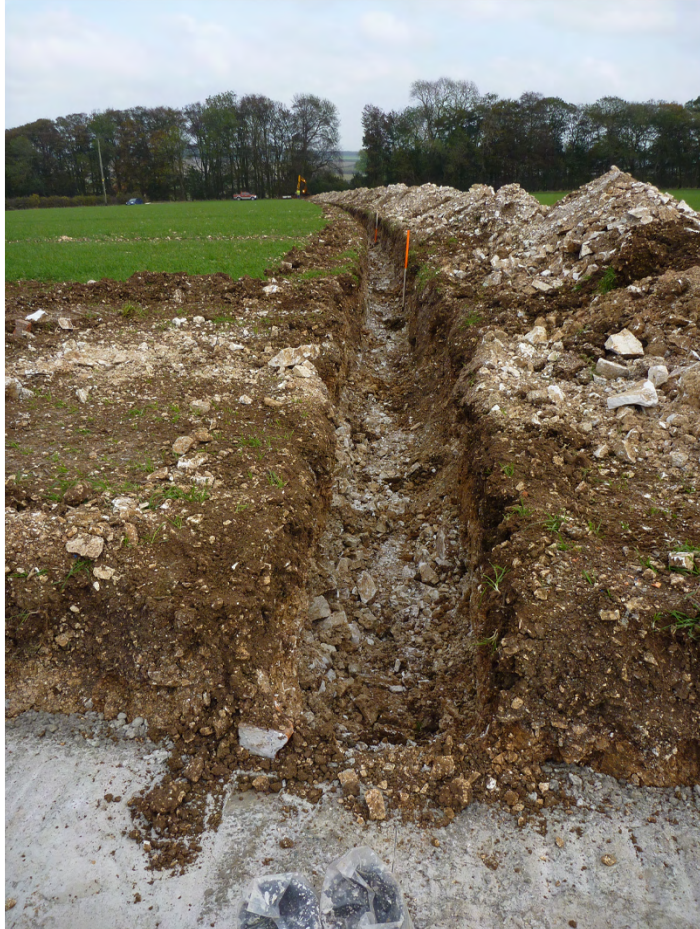
Plate 13. Turbine 2 section of cable run - north facing section. Facing South.

7.2.2 In the cable trench, down slope of the turbine base deposits of subsoil were recorded (Pl. 13).

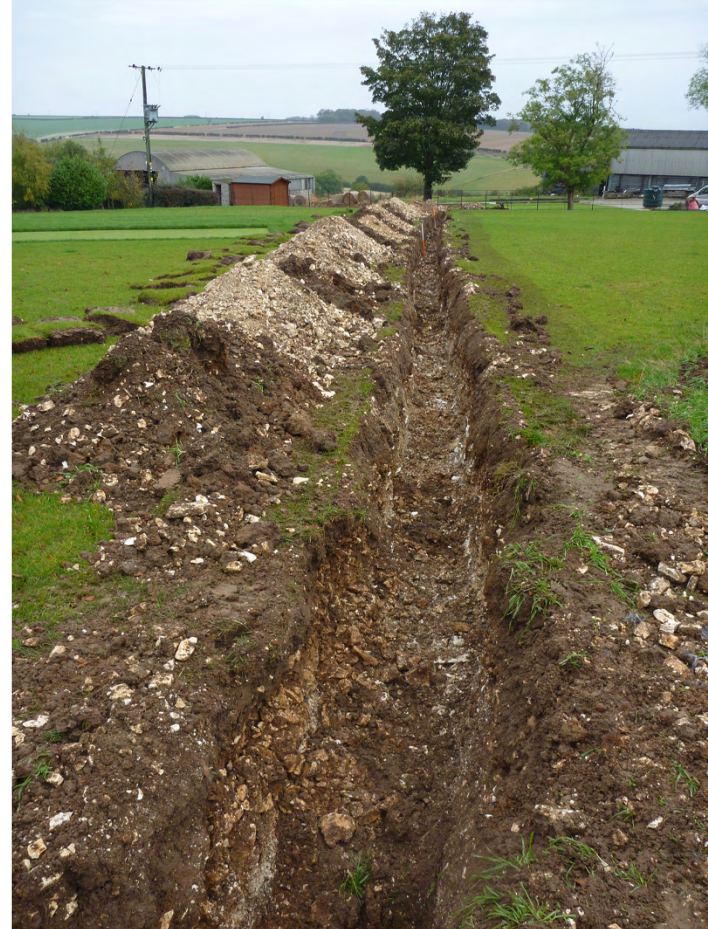
Plate 16. Turbine 2 cable route to transformer after excavation. Facing North.

cable trenches were in the main 0.90m deep and up to 0.50m wide (Pls. 4, 5, & 12-15). The exception being the section adjacent to the farm road, which was 0.50m deep (P. 16).
