**Manor Farmstead
Church Street
Greasbrough
South Yorkshire**

**SK 4201 9571
Archaeological Assessment and
Building Appraisal**

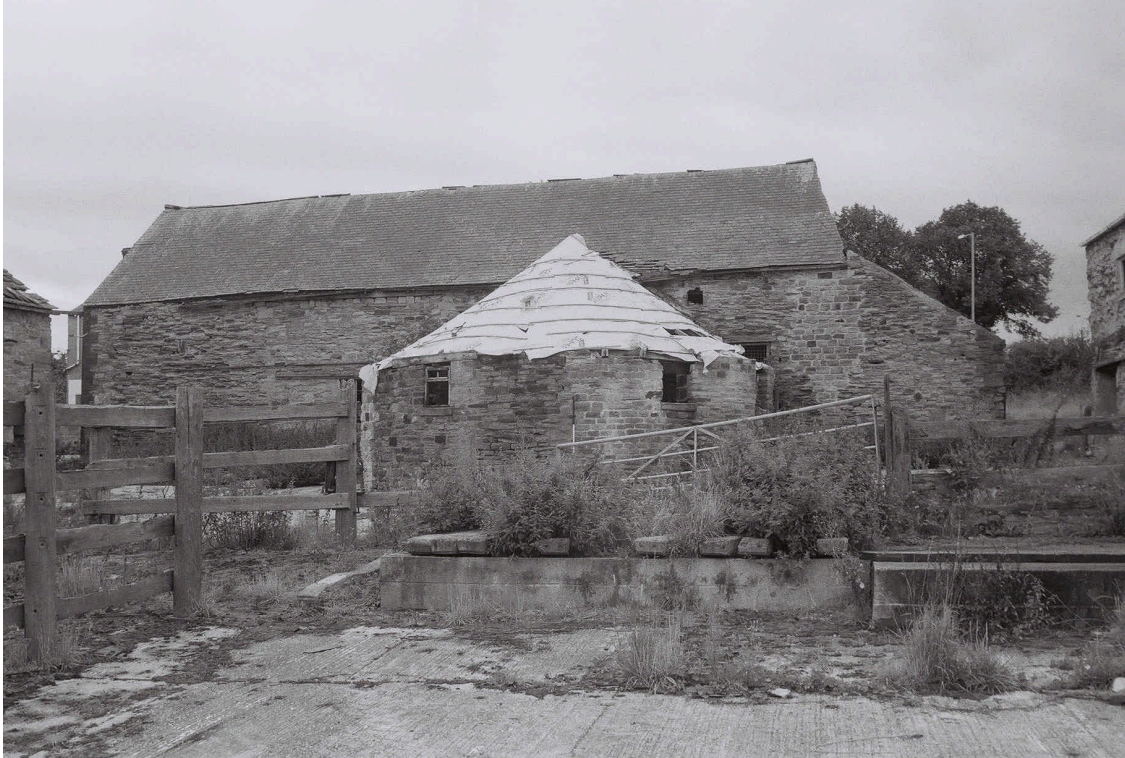
Barn with horse-engine house now grain store and cowhouses with hayloft. Timber-framed core probably early C17, encased and horse-engine house added C18 - early C19, Internal timber framing, rubble sandstone, stone slate roof replaced by Welsh slate on north side of barn. Partly 2 storeys, 4 bays (internal) with horse-engine house on farmyard side to north. Farmyard side: block-bonded brick quoins to left end. Apsidal horse-engine house to right with most of its original wall openings infilled except for some casements; door into cowhouse from engine-house flanked by casements; horizontal-sliding door to left. Opposite side: wide entrance to right of centre has re-used oak lintel; 2 casements to left with loading hatch over. Left return: rebuilt in C20 brickwork, 2 buttresses. Right return: lean-to addition; gable wall of barn collapsing inwards, slit vents. Interior: wallposts to 3 principal rafter trusses, some braces to the tie beams, original wall plates, raking struts to principals, renewed purlins. No framing in gable walls, wallpost at junction with engine house removed, 2 others shortened and underbuilt.

Plate 11. South Barn and Horse Engine House: North Elevation. Facing South.

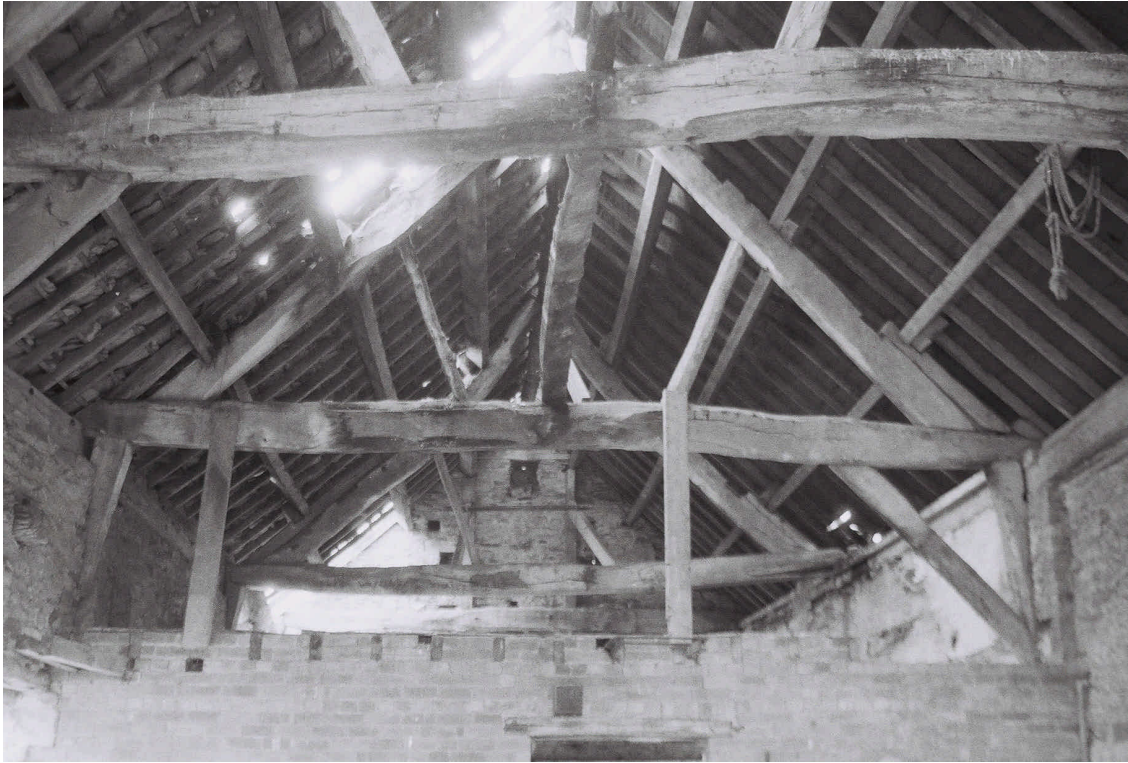
7.3.5 The Listed Building description states the barn has a “timber-framed core probably early C17, encased and horse-engine house added C18 - early C19”. The barn has three roof trusses, of cruck design. There was a truss in the west gable but not in the east gable. The barn was split internally into two by a single storey brick partition in front of the central roof truss. To the west of the partition the barn was two storeys high, with cow house below and granary/feed store above. The floorboards were rotten and the floor joists in poor condition. The cowhouse has built in mangers along the south wall and the north side of the partition wall. The floor was concrete in the cowhouse. The western truss has been modified to allow the insertion of the door into the horse engine house, and the north crick has been removed. The east of the barn is open to the roof with a partially removed stone slab, threshing floor. Part of this area has scars for floor joists on the north wall.

Plate 17. South Barn: Interior. Facing West.

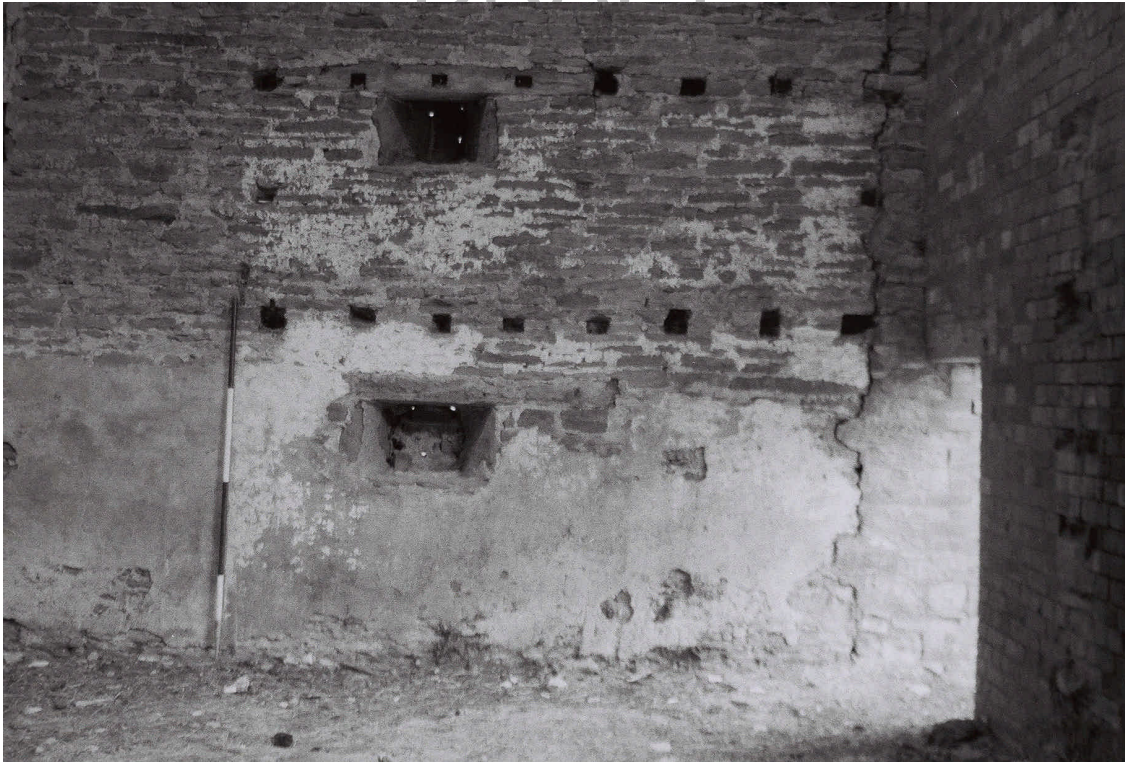
Plate 18. South Barn: Interior. Facing North.

8.3.3 The stone floor of the barn has already been damaged by vandals. This is possibly the original threshing floor of the barn, and should be either protected

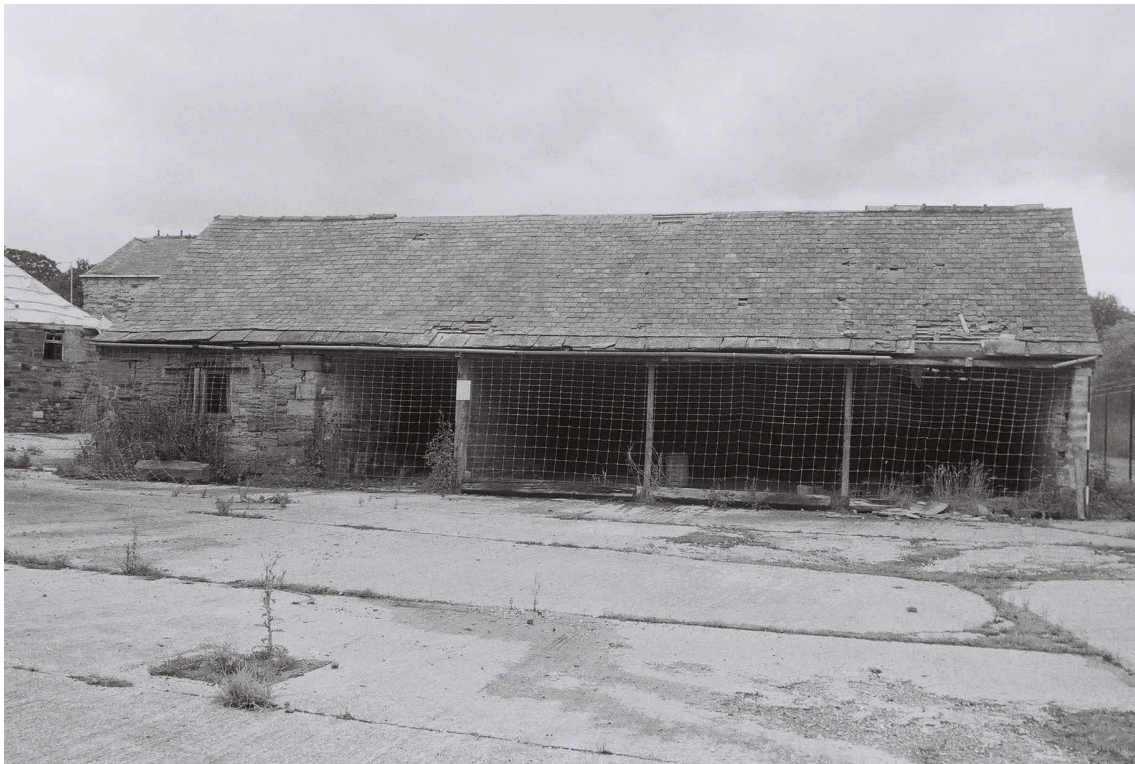
7.5.1 A brick built four bay cartshed with stable at the south end was fenced off due to its dangerous condition. It was a single storey structure with gable slate roof. The cartshed had cast iron pillars supporting the lintel.

Plate 32. East Cartshed: East Elevation. Facing West.

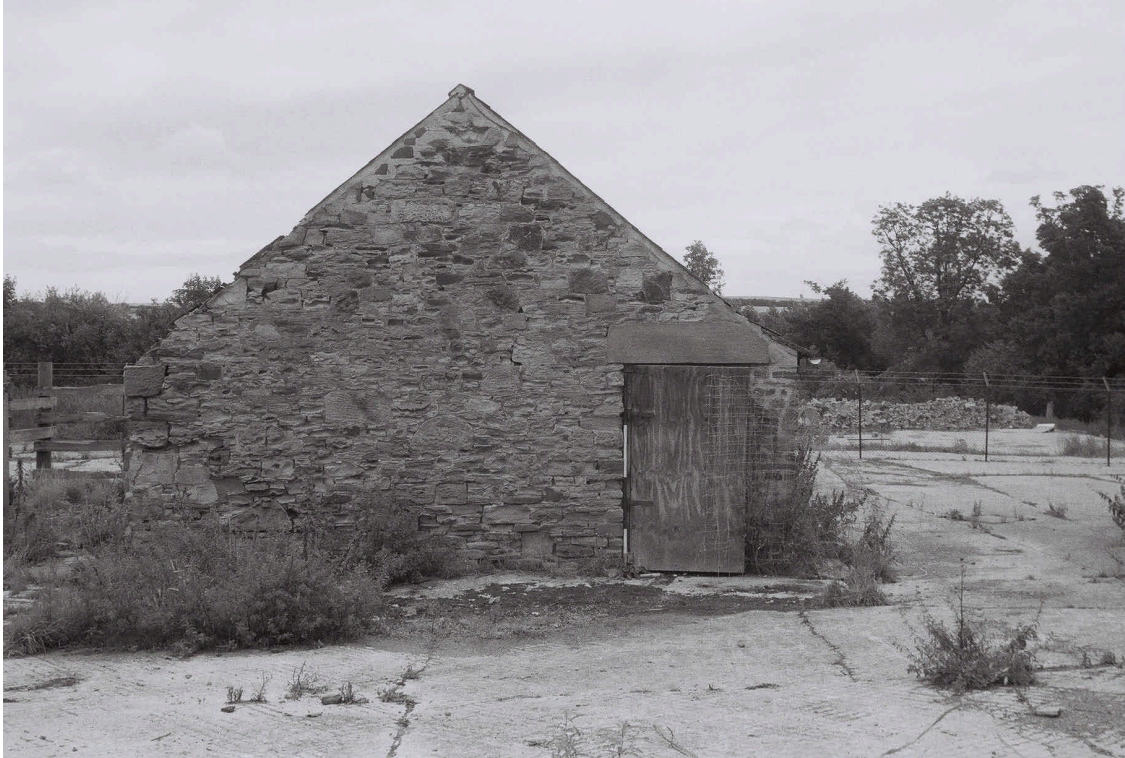
Plate 33. East Cartshed: South Elevation. Facing North.

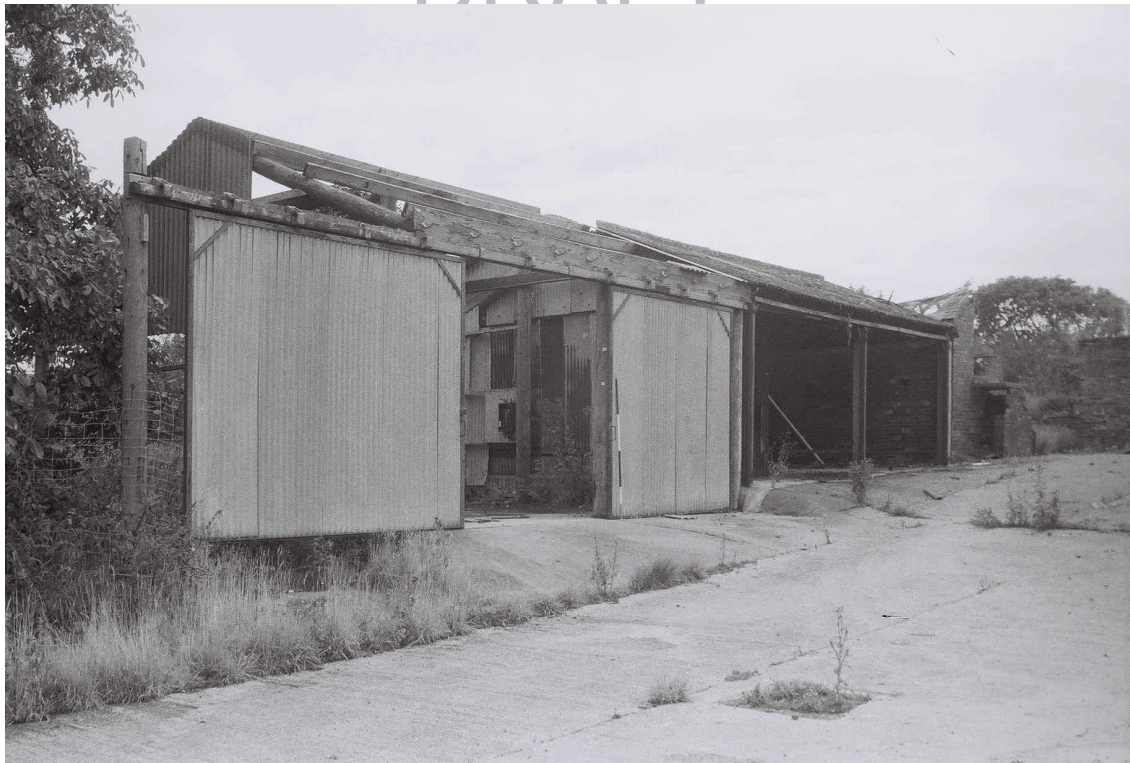
7.7.1 The other buildings on site include an early twentieth century brick built pig sty with feed store above, and three late twentieth century steel frame barns and a milking sheds. These structures were all in a poor condition.

Plate 42. Modern Barns. Facing South-east.

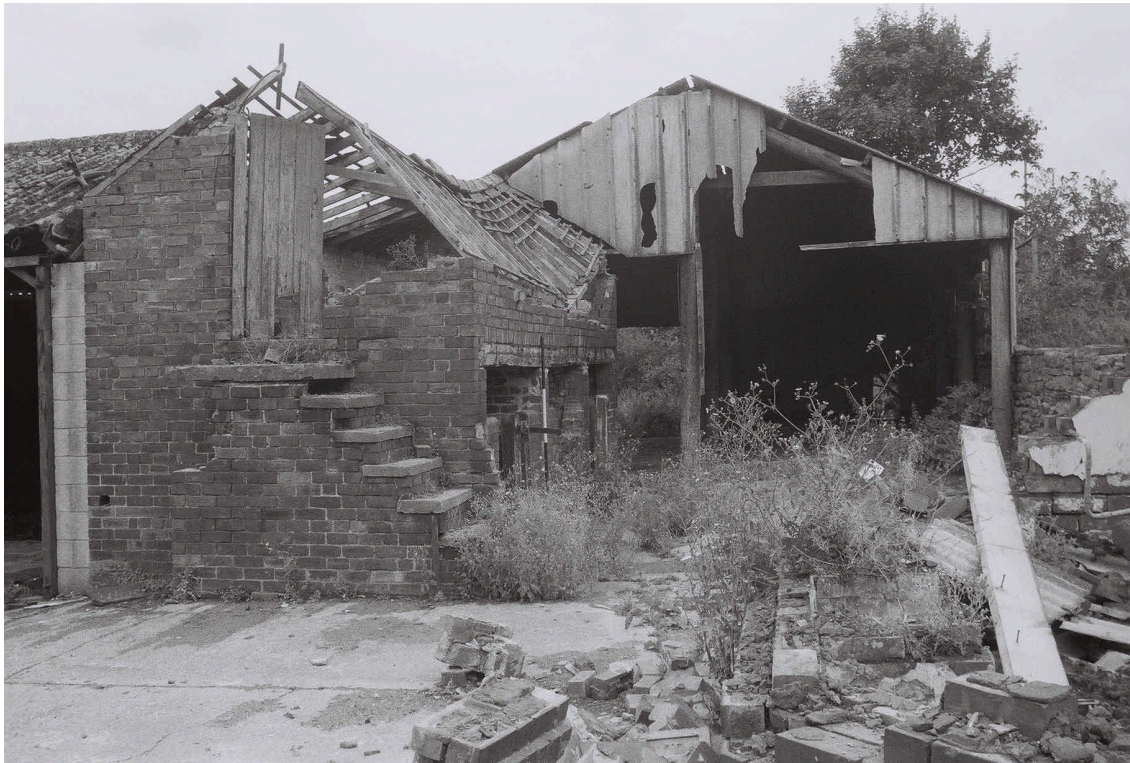
Plate 43. Modern Pig Stys and Barn. Facing East.
