**Baysdale Abbey
Westerdale
North Yorkshire
SE 5485 8588
Archaeological Watching Brief
(NYM2006/0950/FL)**

March 2009

Archaeological Watching Brief

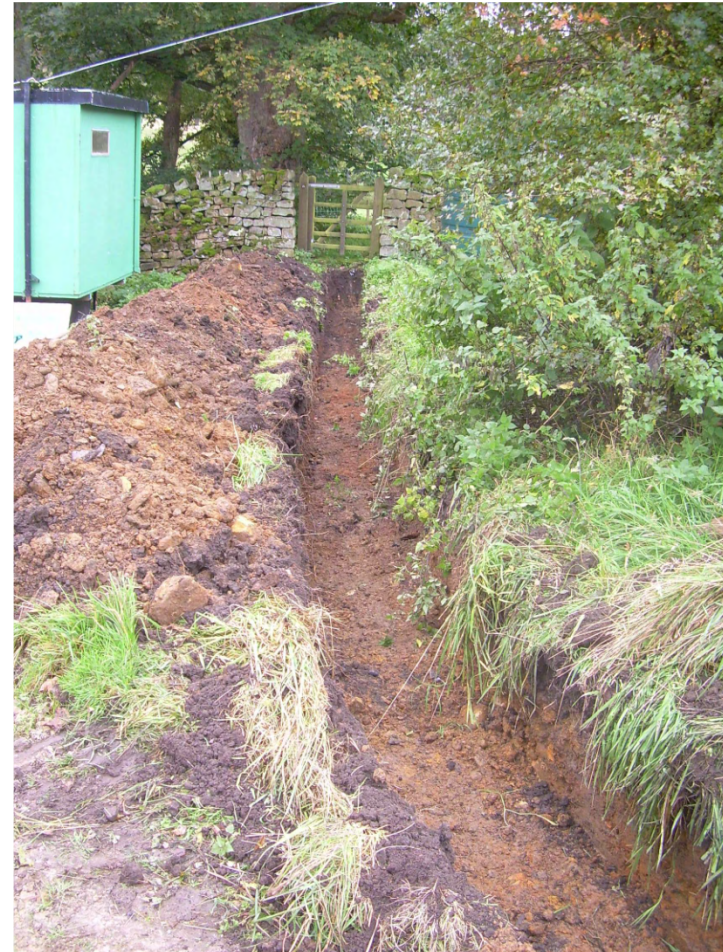
Plate 4. View of water pipe trench. Facing South.

- 5.1 The groundworks associated with the development involved the excavation of a series of narrow trenches to accommodate new drains and services.

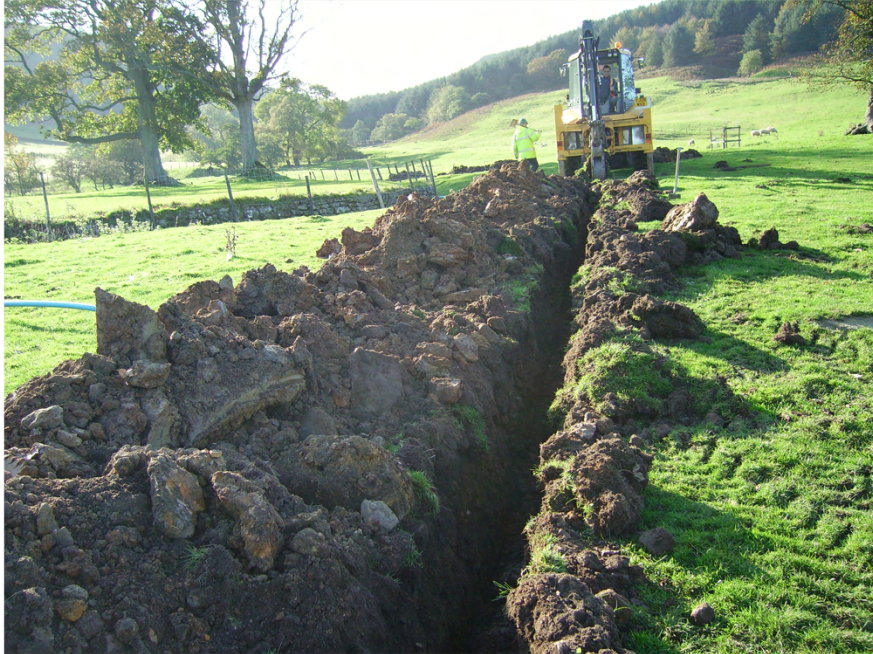
Plate 7. Trench through Field 0062. Facing South-west.

- 6.4 The rubble present within the field to the west of the farm-house could relate to the demolition of structures in the immediate vicinity, or perhaps the creation of a landscape associated with the construction the farm-house itself, and which included the excavation of a ha-ha. Post-medieval material was again present in the rubble at this location.
