INTERIM REPORT ON ARCHAEOLOGICAL FIELDWORK AT CASTELPORZIANO

31 March- 28 April 2009

Amanda Claridge
Classics Royal Holloway University of London

1. 'Sea-wall' Site CPS F2, near Tor Paterno (Figs 1-5)

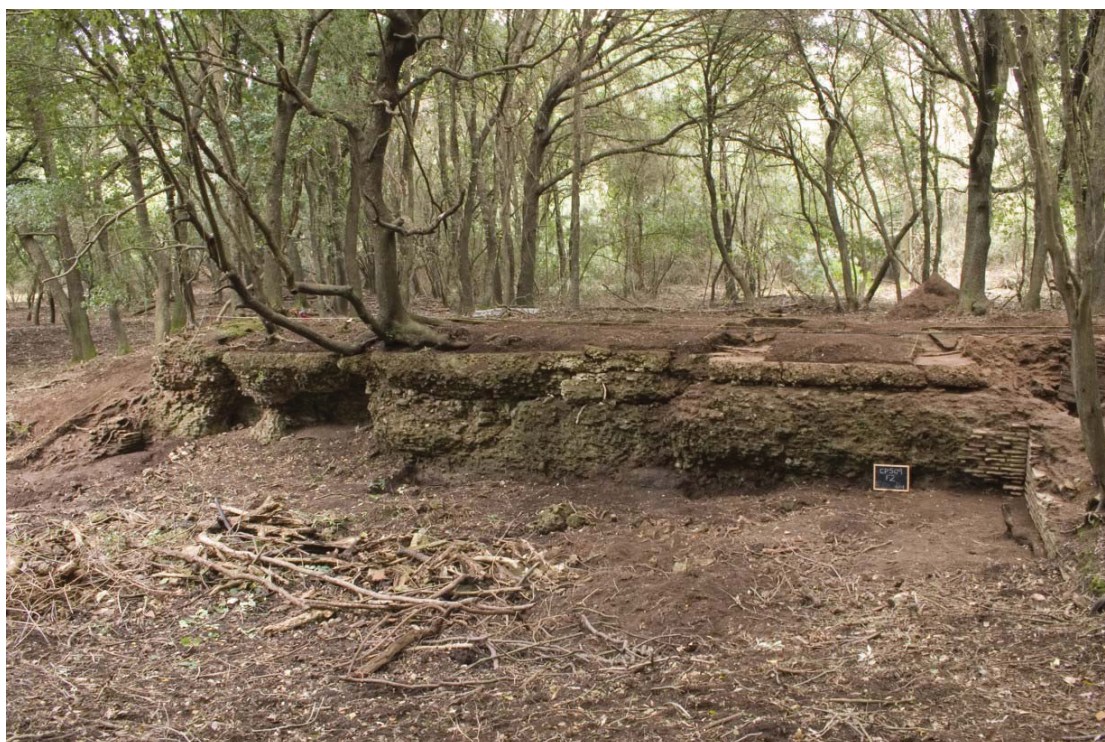
Fig. 1 'Sea Wall' near Tor Paterno, western sector (CPS F2W). General view of seaward side, from south (Photo no. 6077)

The topsoil was removed at three points (trenches 1-3), in the middle and at both ends respectively (Figs 1-2 Photo nos: 6077 and 6046). Revealed in plan (Fig. 3) the *cocciopesto* proved to be the floor of an elongated tank, measuring (internally) 1.5 x 12.80 m., with chamfered inner corners. Fragments of the *cocciopesto* lining of the north (inland) side of the tank (3), 10 cms thick, outcrop on the surface for most of its length (visible in Fig. 2). A short section of the wall which once supported it, now robbed to below the floor level, was exposed in trench 1 (2), c. 60-65 cms thick, with the remnants of a thin layer of coarse grey plaster on the north side (5). Trench 2 clipped the south face of the same wall, which seems to have continued beyond the

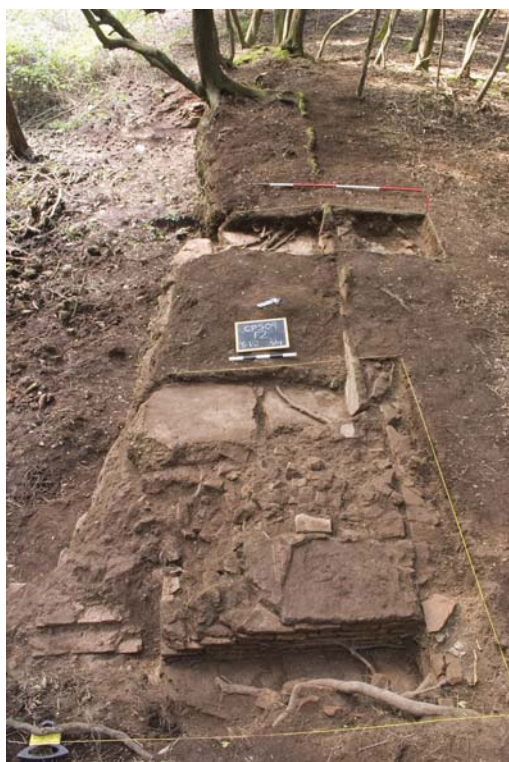
Fig. 2 'Sea Wall' near Tor Paterno, western sector (CPS F2W) Top of wall viewed from east. Trench 2 in foreground (Photo no. 6046)

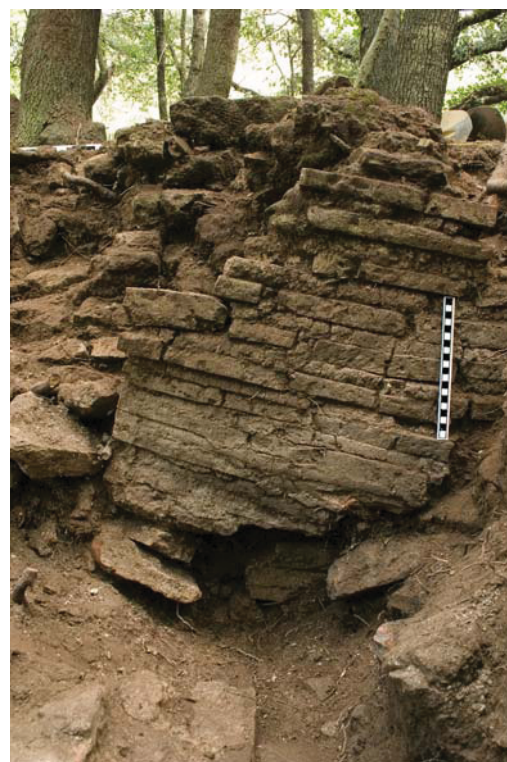
Fig. 3 'Sea Wall' near Tor Paterno. Brickwork on south face of walling [7]. Scale=20 cms

Built against the east side of (6), occupying the angle between it and wall (2), is a shorter block of brick-faced walling (7) which bears the imprint of two bipedales on its upper surface. The structure continues on a lower level (8), which also bears the imprints of two bipedales. Thirteen courses of brickwork are visible on the south face

of (7), which has cracked and is falling away (Fig. 3). The bottom 4-5 courses are rougher and less regular, probably foundations; the proportion of mortar to brick and the medley of re-used bricks in the rest suggest a similar date to wall (9). It is possible that (7) and (8) represent a set of steps to access (6) and the east end of the tank. Alternatively, if the impression (noted above) of a ramp leading up to this point is not deceptive, then (7) could be a bench or door jamb and (8) the threshold of a wide doorway. Unfortunately, tree roots made it impracticable to extend trench 2 any further to the east and the question had to be left open. Traces of *cocciopesto* lining are visible on the top of the adjacent length of 'sea-wall' (F2E), suggesting that it too bore a similar tank.

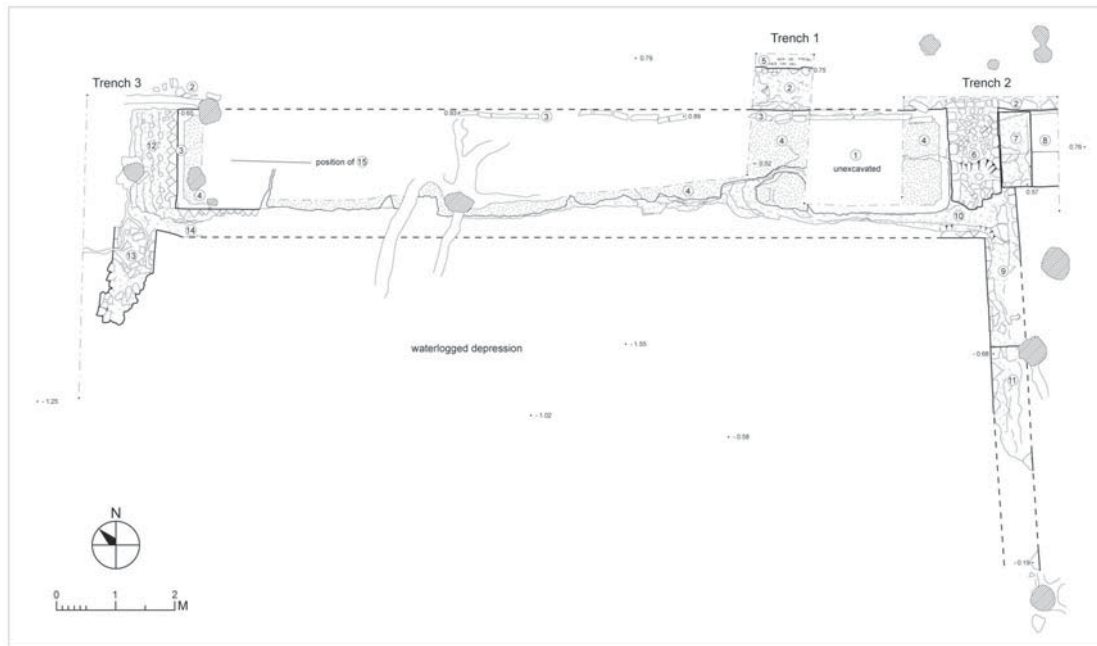
Fig. 4. 'Sea Wall' near Tor Paterno. General site plan.

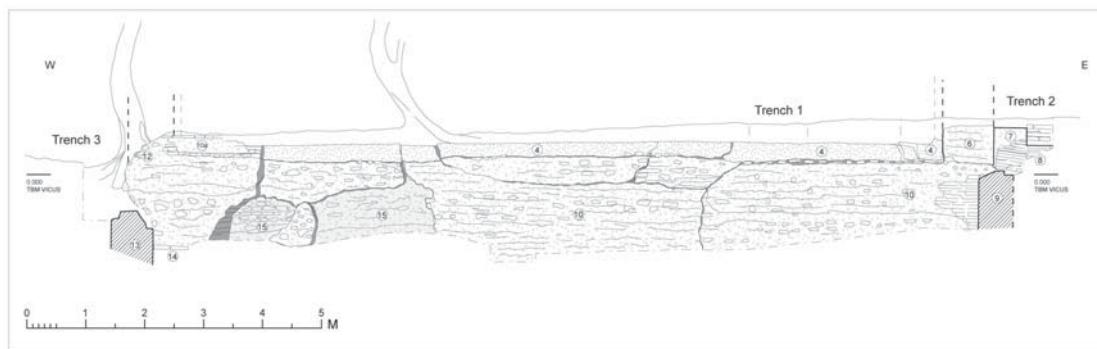
Fig. 5. 'Sea Wall' at Tor Paterno. Seaward elevation.

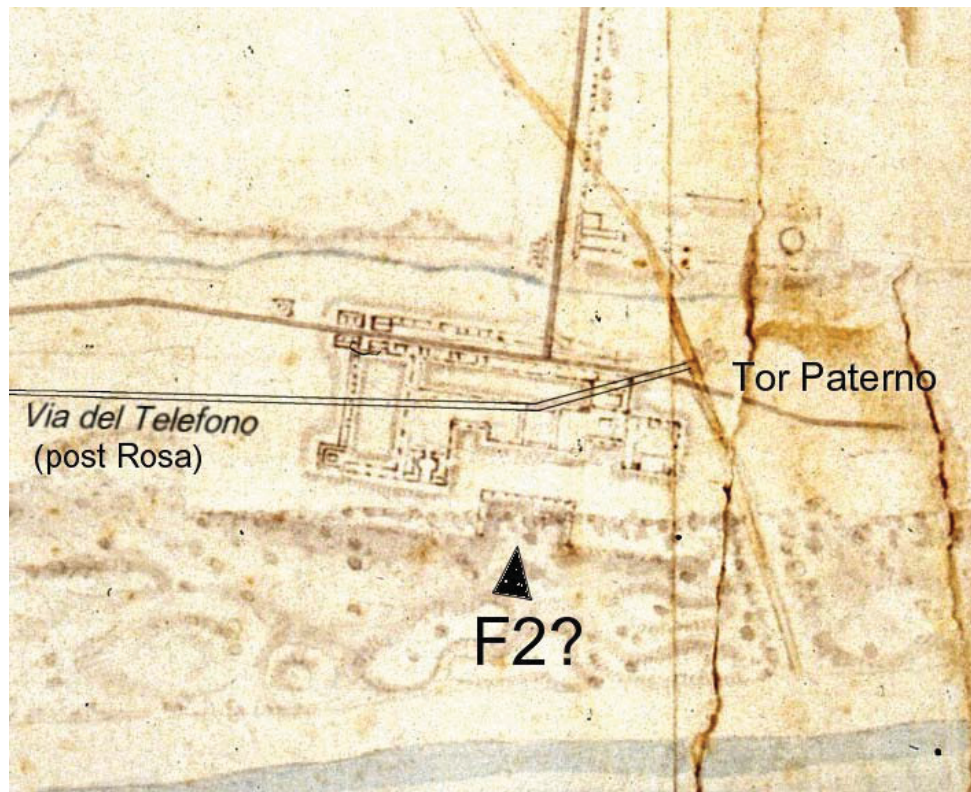
Fig. 7. Pietro Rosa, Archaeological map of Latium c. 1870 (detail)

Pietro Rosa's archaeological map of Latium (c.1865) includes a quite detailed plan of the villa at Tor Paterno (Fig. 7) which shows a platform extending from the villa, along the sea front, and containing a large rectangular re-entrant in the seaward edge. Although Rosa's re-entrant is much larger, measuring. c.140 m. wide and 66 m. deep, and there is nothing like it visible on site today, the position of its rear wall coincides with that of our site F2, beside which the ground steps back in a wide curve. It is possible that Rosa saw traces of similar walling to the west (at present densely overgrown with brambles) and joined them together. His plan not only simplifies (it was drawn at a scale of 1:20000) but also attempts to restore the evidence. Much is recognisable but much is definitely invented, based on what even in his day were widely scattered elements. He may not have seen the eastern half of our site F2 at all; it could be a quite recent excavation, perhaps at the same time as the baths F3 (which do not appear on his map either).

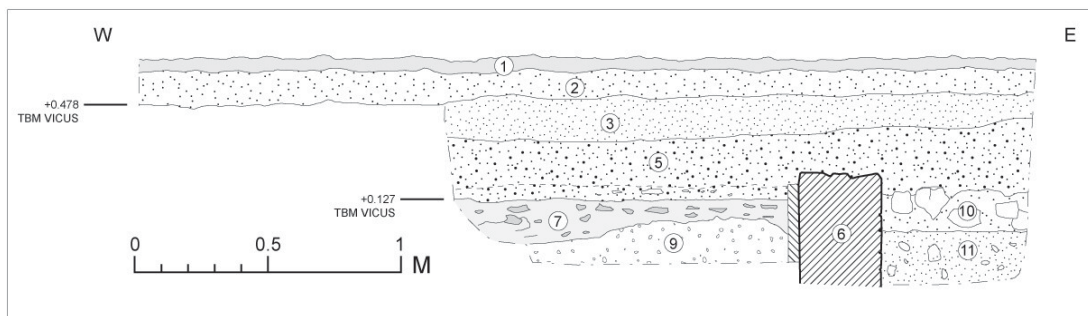
Fig. 10. Vicus, West of Y-Z, Mag. Test trench 1. E-W Section.

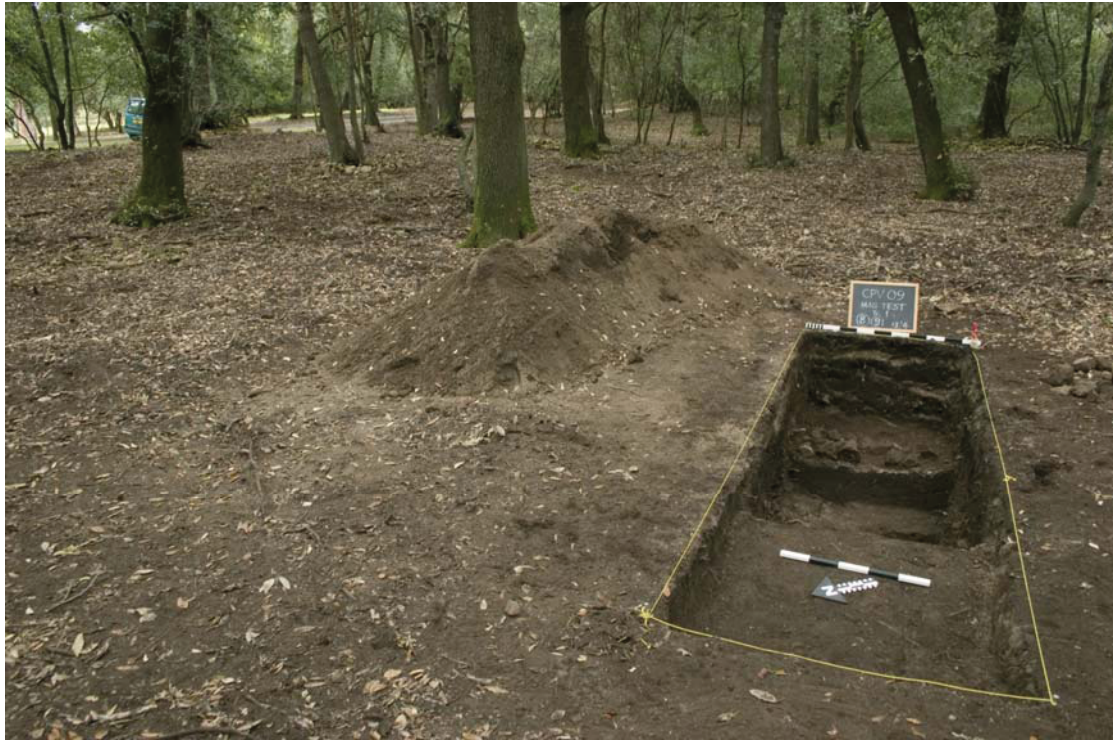
Fig. 11. Vicus, West of Y-Z, Mag. Test trench 1, from west.

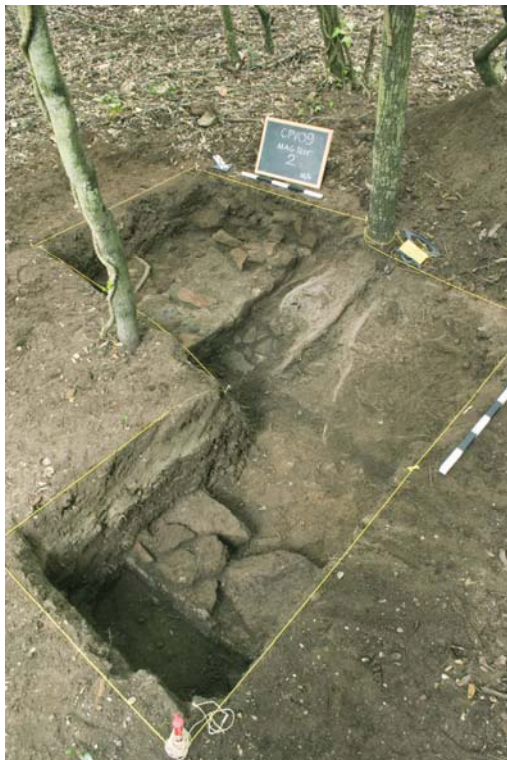
Fig. 12. Vicus. North of building Z
Mag. Test trench 2. View from NW
(photo no 6202)

The trench tested two strong linear anomalies, seemingly two walls meeting a right angle, registered by the 2009 magnetometer survey to the north of the outcropping bath building (Z), close to the edge of the Via del Telefono (79 m west of the west wall of Baths A). The spot is occupied by two trees, which the excavation had to work around, but walls were found in both the positions predicted. The larger, running N-S (2) lies c. 30 cms below the surface and is 45 cms wide, with a core of amphora and tile aggregate in grey pozzolanic cement, faced with well-cut tufa reticulate cubes at the south end and brick to the north end. The brick facing may have been combined with tufa blocks (tufelli, numbers of which were found loose in the fill), and formed a pier or jamb beside a doorway (marked by the reticulate facing). Abutting the east side of the wall is a level surface of concreted rubble tufa (3), faced with tufelli on the north, probably a step outside the doorway; in the angle between the two is the body of an amphora surrounded by small lumps of tufa (5). The second wall (6), running E-W, c. 36-38 cms wide and 40 cms below the surface, is composed of large blocks of tufa, irregular in size and shape, with an infilling of smaller pieces, bonded with clay. Although the north side forms a fairly straight edge, which has been faced with grey mortar, there is no sign of a similar finish on the south side.

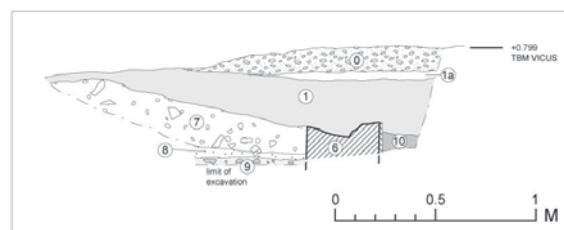
Fig. 15. Vicus, north of Z. Mag. Test trench 2
N-S section (west side of trench).
