**A Geophysical Survey and Archaeological Evaluation at
Brighton Racecourse, Brighton, East Sussex
for
Northern Racing Ltd
and
Brighton & Sussex University Hospitals NHS Trust**

Project Number CBAS0109

By
Clive Meaton &
Chris Butler MIFA

March 2010

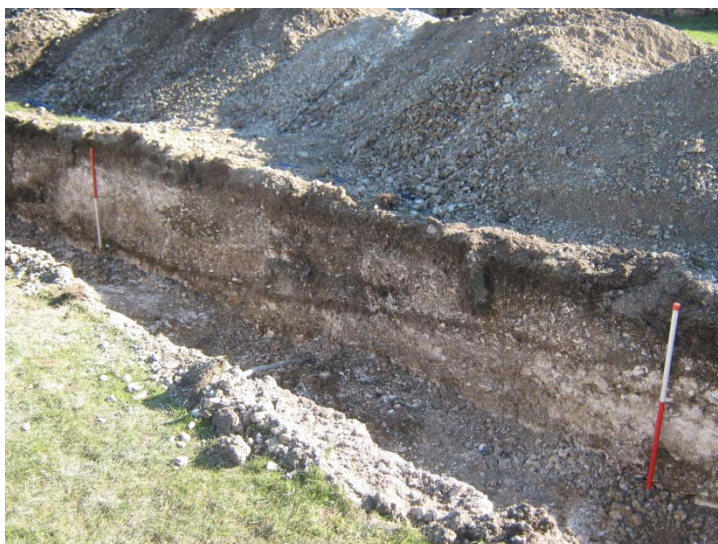
Plate 1: Tr.1 Buried Soil in NW Facing Section

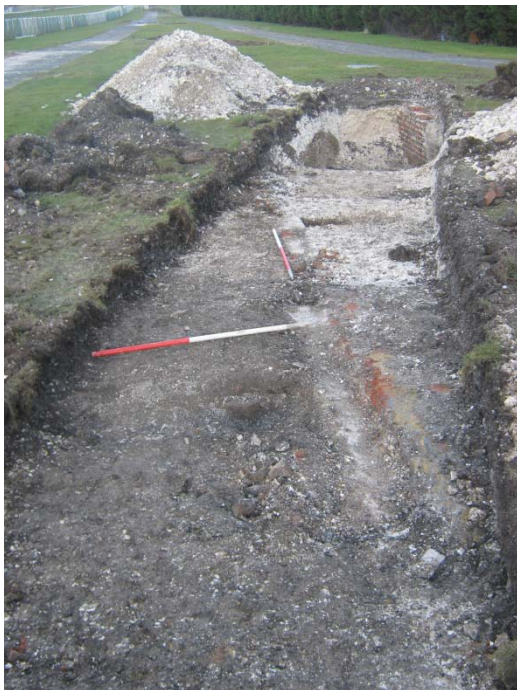
Plate 6: Tr.6 Looking N. at [84] & [85]

Context **83** was recorded overlying Wall **85**, but in an uncertain relationship with the chalky made ground (Context **81**) which sealed Wall **84**. Context **83** was c.50mm thick where investigated and comprised a mixed mid greyish brown silty clay containing chalk flecking/nodules to 40mm (10%) and building demolition material, CBM/concrete/mortar (20%). What appeared to be large pieces of asbestos were also noted in Context **83**.

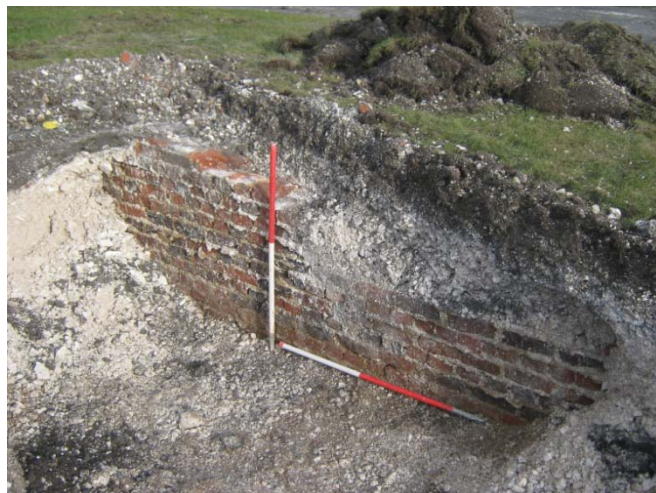
Plate 8: Tr.6 West Facing Wall [84]

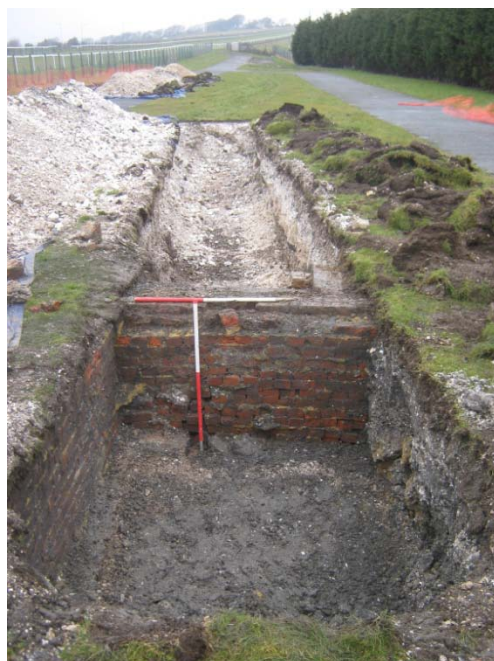
Plate 11: Tr.9 Looking NE at [55] & [56]

At the southwest end of the trench, 2 structures were revealed. Context **55** was a north south aligned wall, only exposed in the southeast facing section of Trench 9. It lay immediately beneath the top soil (Context **34**) and formed ten courses of red brick laid predominantly in a Header bond with a friable brownish yellow sandy mortar. The brick themselves were of the same dimensions found in Trench 6, being 220mm long by 110mm wide and 70mm thick. The exposed face was cleanly finished and presumably related to a lower level internal facing wall. The ten brick courses were laid onto a footing approximately 100mm thick, which comprised a very hard grey concrete with sub rounded gravel aggregate to 30mm (50%). The exposed length of Wall **55** was c.2.4m and clearly continued to the south, however on its northern end it was bonded with another wall line (Wall **56a**) which ran perpendicular to Wall **55** on an east-west alignment, continuing into both trench baulks.

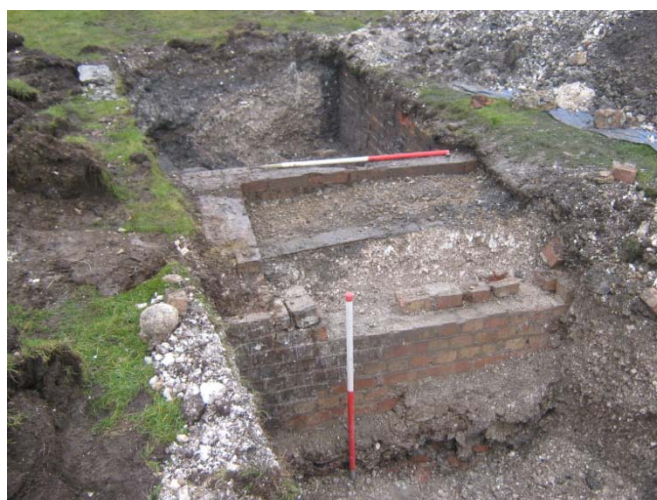
Plate 12: Tr.9 Looking SW at [56] & [55]

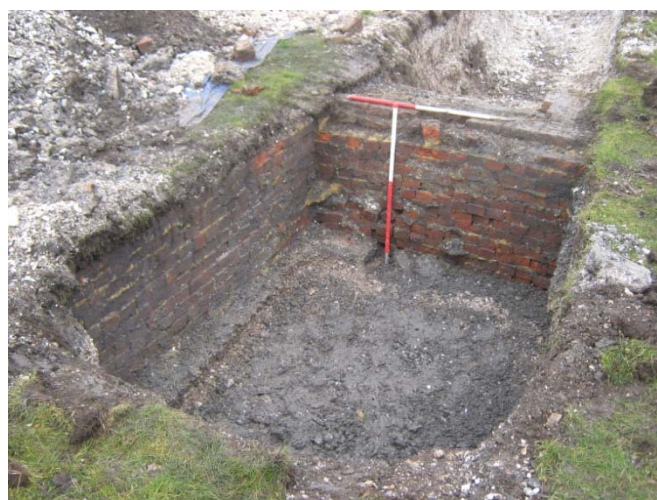
Plate 13: Tr.9 Looking NW at [55] & [56]

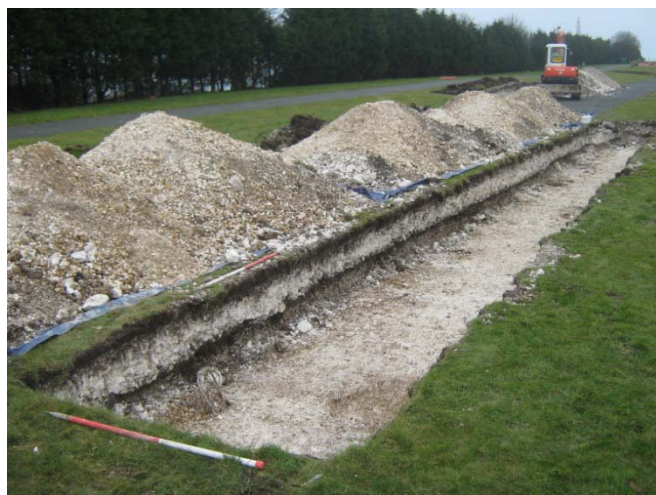
Plate 14: Tr.10 NW Facing Baulk with Buried Soil

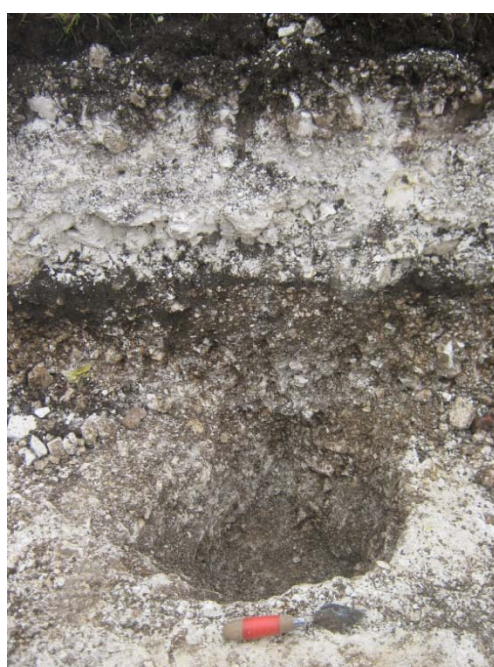
Plate 15: Tr.10 Excavated Post Hole [50]

To the southwest, located roughly mid trench another slightly larger post hole (Cut **50**) was excavated. Cut **50** was c.500mm in diameter and up to 300mm deep with steep sides and a slightly rounded base. Its primary fill (Fill **52**) was up to 300mm thick and formed a loose mid yellowish brown sandy silty clay containing very frequent chalk nodules to 20mm. Above Fill **52**, Fill **51** was recorded. This was a friable dark brown silty sandy clay with frequent chalk and sub angular flint nodules to 20mm. Fill **51** was interpreted as a possible post pipe.

The post hole cut was 100% excavated, and a 10 litre soil sample taken. Fill **52** produced a small sherd of pot and small piece of glass. Fill **51** contained a few small fragments of bone, and further small fragments were found in the soil sample. Approximately 3m to the southwest another small sub circular feature was recorded. Cut **53** was c.300mm in diameter and c.180mm deep, with steep sides and a flat base. It was filled by Fill **54**; a friable dark yellowish brown sandy silty clay containing frequent sub angular flint pieces to 20mm and frequent chalk nodules to 20mm.
