Archaeological Watching Brief
at
Land at Burtenshaw Lane,
Market Street,
Hailsham,
East Sussex

WD/2009/2657

Project No. CBAS0110

March 2011

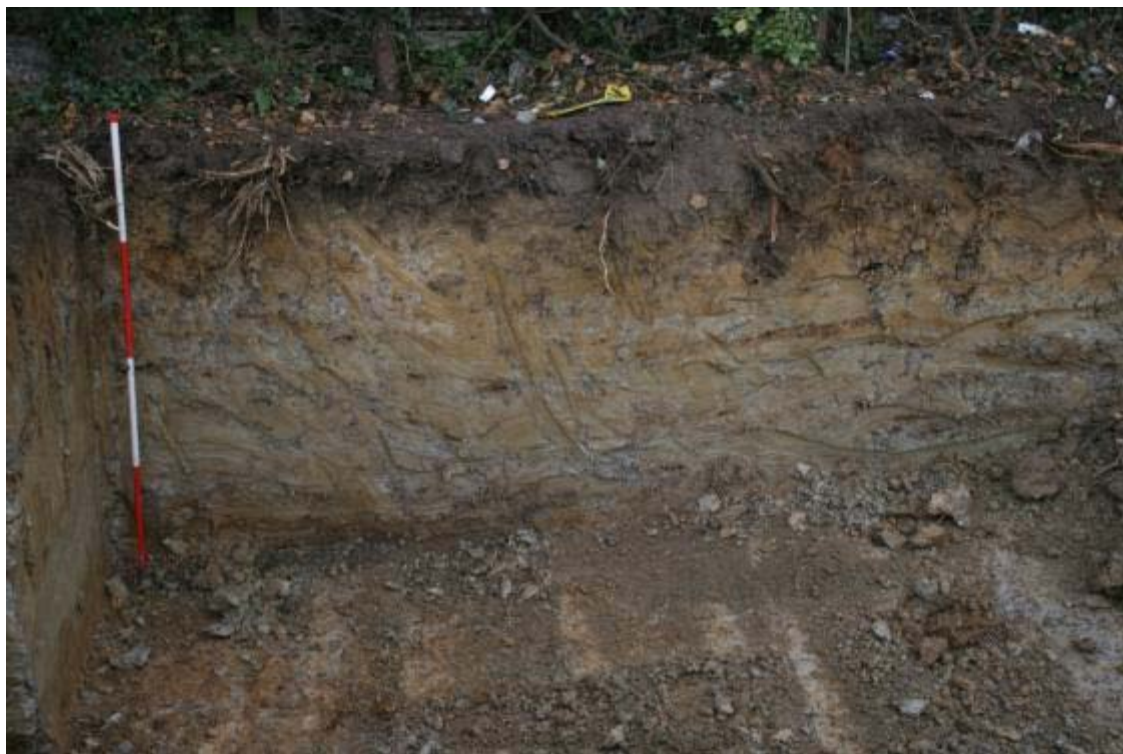
Fig. 7: Land at Burtenshaw Lane, Market Street, Hailsham: Photograph of road and water storage facility excavation

- 3.2** The following day work commenced on the excavations for the road and a watching brief was maintained over the next two days while the foundations for the road were excavated by a 360° 8 tonne digger with a 1m wide toothless bucket. This covered an area some 20m in length x 4m wide with a square 1.4m wide at the northern end tacked on. The trench was 2m in depth from the original ground surface and cut well into the natural to form a surface water storage system (Fig 0).

- 4.1** The topsoil from the new access road (Context **1**) was a very disturbed sandy-loam with some small pieces of concrete comprising approximately 1% of the total make-up, along with ceramic building material (CBM) (<1%), mortar (<1%) and flint pebbles up to 20mm in size (<1%). There was evidence of heavy bioturbation from the trees on the eastern boundary of the site. A sheet of Terram membrane was exposed in the eastern road section and had been laid between the topsoil and subsoil suggesting that the topsoil in this area is re-deposited and relatively recent. The membrane was only present in this eastern section and immediately adjacent to it, and was not found anywhere else on site.

- 4.2** The subsoil (Context **2**) in this area was a friable, mid brownish-grey, silty-clay. Inclusions amounted to flint pebbles at <1% and was up to 300mm thick in places. There was also evidence in the subsoil of heavy root bioturbation from the trees on the eastern boundary.

- 4.3** Below Context **2** lay the natural Wealden Clay (Context **3**). This was a firm orange-yellow clay with patches of light grey which became more pronounced at a depth of 2m.

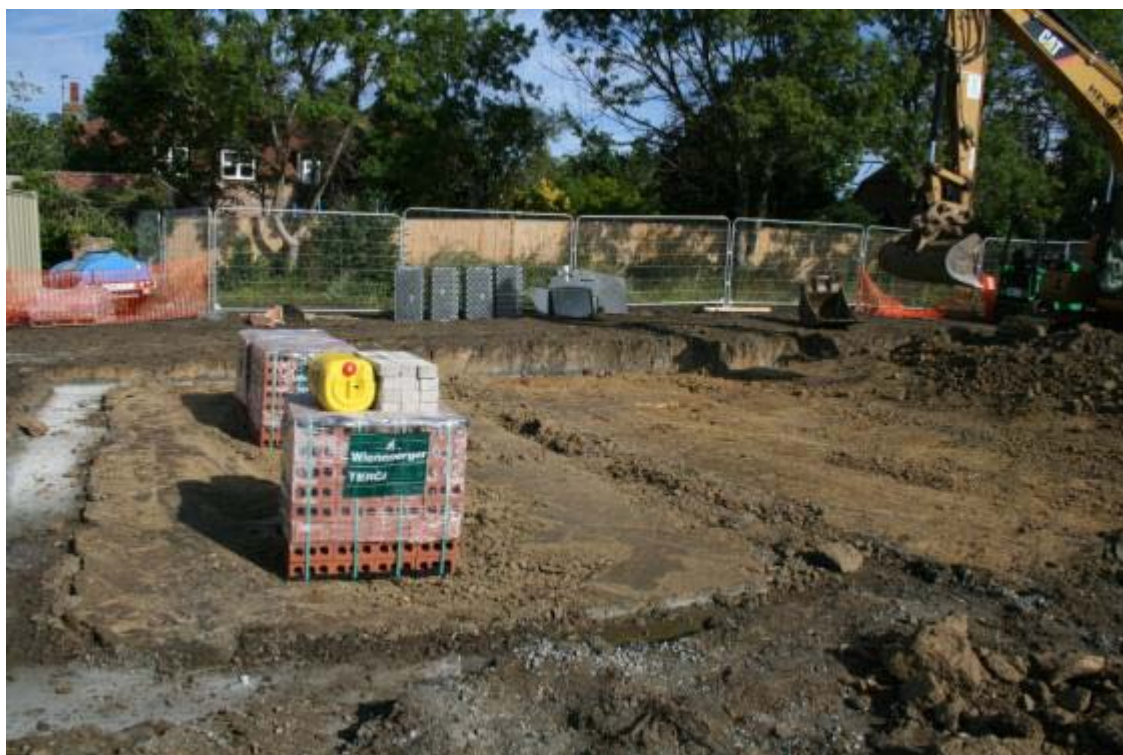
Fig. 8: Land at Burtenshaw Lane, Market Street, Hailsham: Photograph of house foundation excavation

- 3.3** Excavation then commenced on the footings using a 600mm toothless bucket and associated service trenches for the housing plots on the 9th August, starting with the middle plot. Work then carried on sporadically over the next 5 weeks, with the footings for the western plot and the associated drains runs, followed by the eastern plot and finally some landscaping and drain runs. A watching brief was maintained while all the footings and service trenches were excavated (Fig. 0).

- 4.4** Context **4** was a topsoil deposit from the footing of the South-West building plot (plots 1-3) that only survived at the southern end of the footings to a depth of 300mm. This was a loose, brownish-grey, sandy-loam with irregular flint pebbles at <1%, CBM and pot at 1% and chalk flecks and pieces up to 40mm at 1%.

- 4.5** Below Context **4** lay the subsoil (Context **5**) with which it shared a very irregular and diffuse interface. Like Context **4** this context only survived at the southern end, having already disappeared from the northern edge of the footings. While still a silty-clay like its counterpart (Context **2**) it differs slightly in colour, being a brownish-orange and with irregular flint pebbles up to 40mm at <1% and chalk flecks also at <1%. This deposit was 400mm in depth.

- 4.6** Again, below Context **5** lay the natural Wealden Clay (Context **6**). This was, like Context **3**, an orange-yellow clay and was excavated to a depth of between 0.5m to 1.1m.

- 4.8** The footings for the middle plot were excavated to a width of 600mm and a depth of 2m and 2.7m. A very mixed and disturbed mid grey-brown silty-loam topsoil (Context **9**) was present to a depth of 200mm and had modern rubbish trampled into it. The subsoil (Context **10**) was a mid grey-brown silty clay which was some 300mm in depth and contained Post Medieval land drains which were back filled with chalk and just cut into the top of the natural (Context **11**).
