**An Archaeological Evaluation Excavation
at
The Granary, Chiddingly Place,
Chiddingly, East Sussex.
(WD/2009/2626)**

Project No. CBAS0117

by
Keith Butler PIFA

September 2010

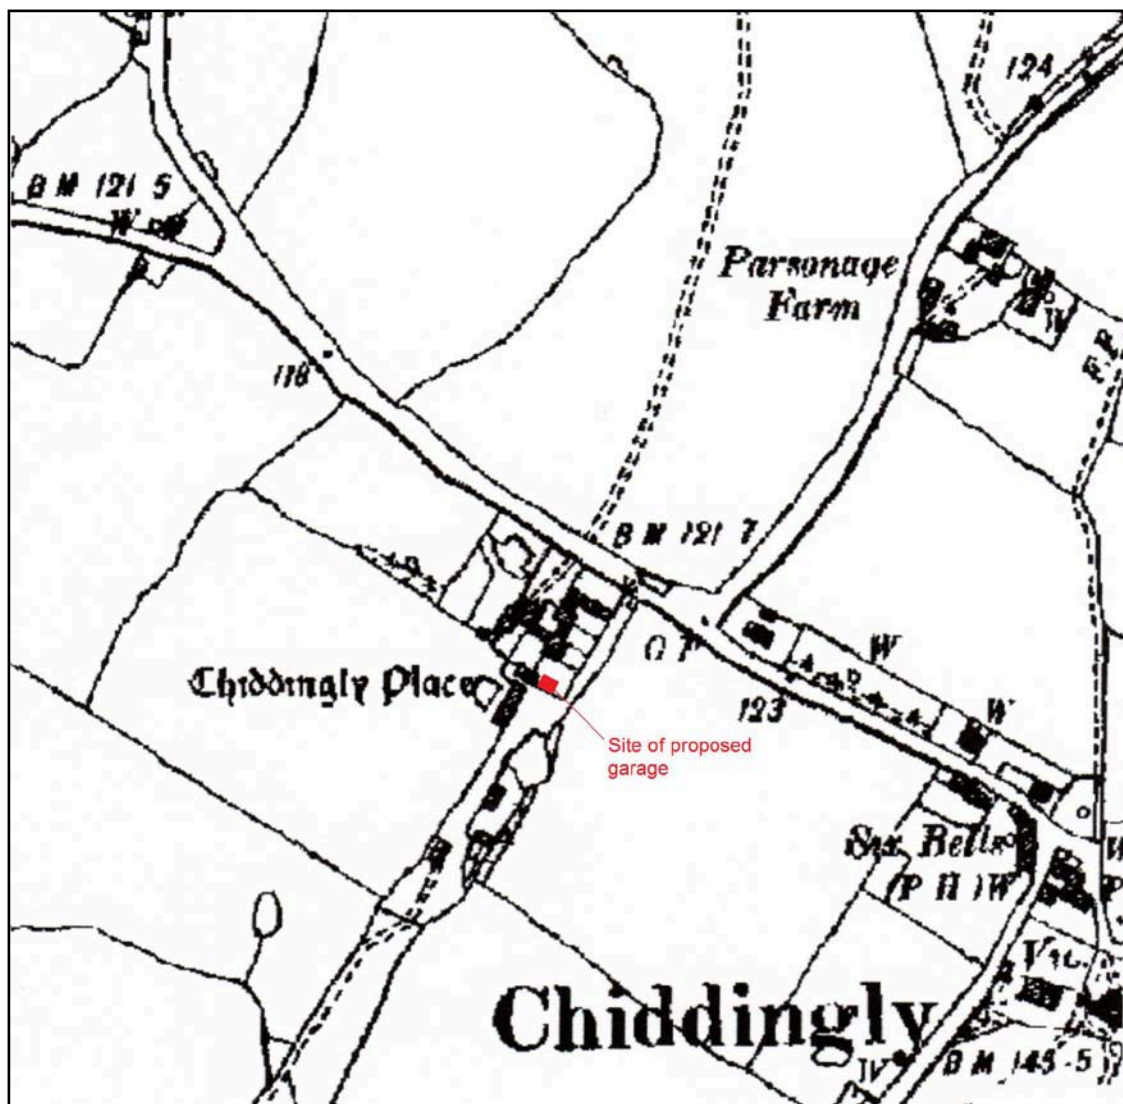
Fig. 3: The Granary, Chiddingly Place: 2nd Edition OS Map (1899)

- 2.11** The 1st Edition OS map shows a similar layout, although a number of the buildings have been extended, and this situation remains largely unchanged through the later 19th (Fig. 3) and early 20th century maps.

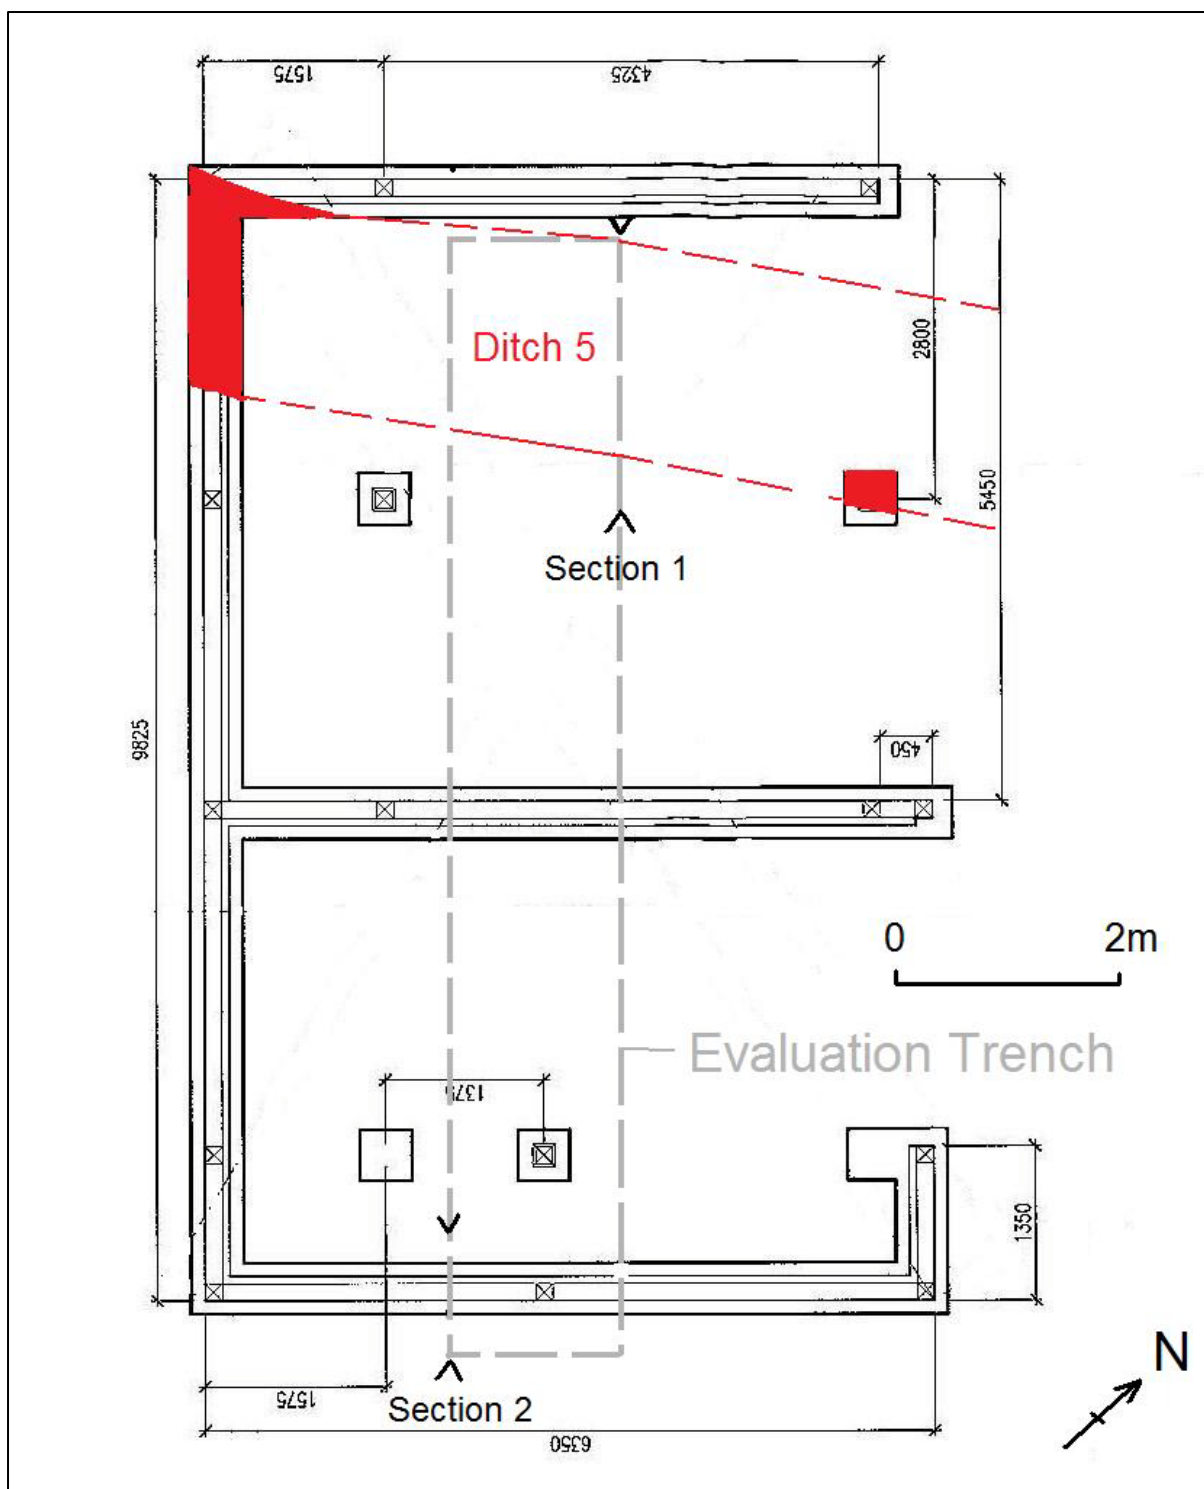
Fig. 5: The Granary, Chiddingly Place: Site plan showing garage footings, location of evaluation trench and Ditch 5.

- 3.4** On the 18th March 2010 a watching brief was maintained on the excavation of the 'E' shaped trench for the footings of the garage (Fig. 0). The trench was 500mm in width and had a depth of 1.5m at the western end with the eastern end being shallower at 1.2m at the eastern end. Three pits 1m square were also excavated for posts.

- 4.12** The only archaeological feature noted was Ditch **5** which was recorded in the south-western corner of the footings and in one of the three pits (Fig. 0). The ditch was seen to have a total width of 1.9m at the top and was 700mm deep, with the same two fills as before, although the secondary fill (Context **6**) appeared to be much shallower than previously recorded, whilst the majority of the fill comprised the much darker Context **7**.

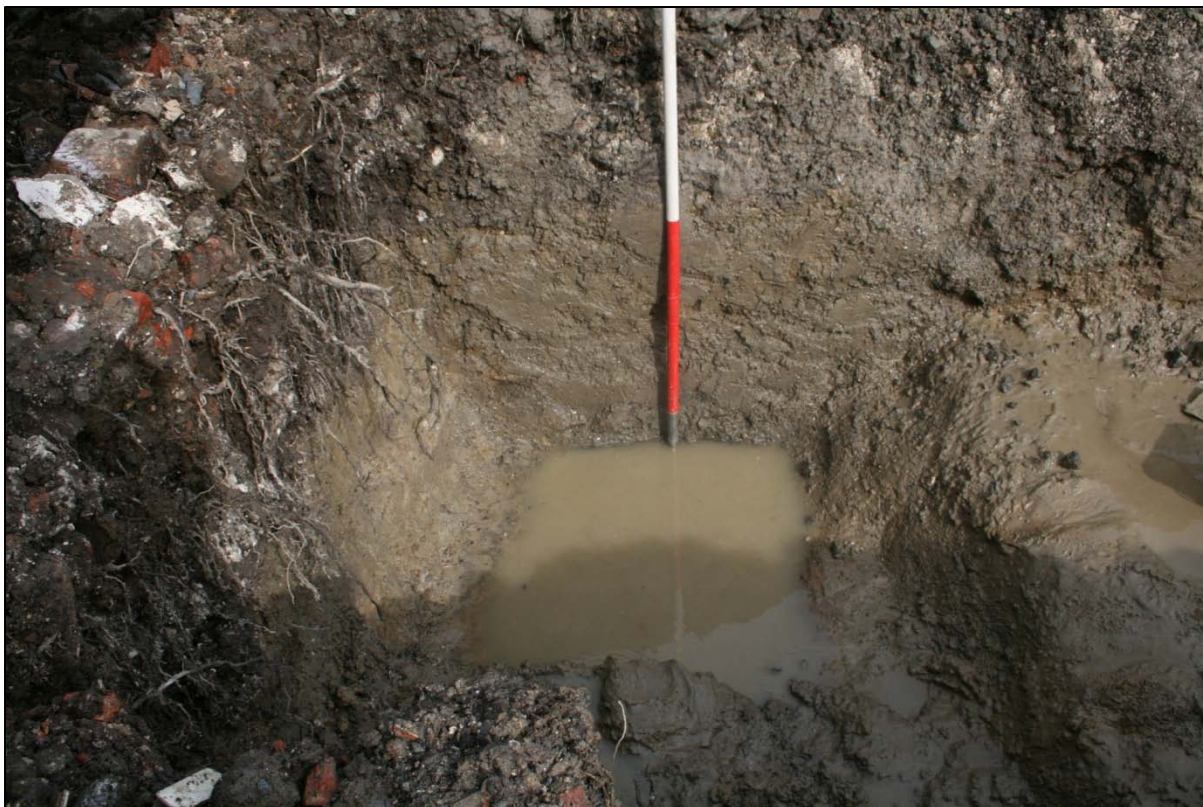
Fig. 7: The Granary, Chiddingly Place: Photograph of Ditch 5 section

- 4.8** The ditch was 'U' shaped with a gradual break of slope at the top, with sides which were steeply sloping on the west side, with the eastern side being slightly more gradual. The break of slope at the bottom was rounded, with the bottom of the ditch being slightly dished.

- 4.9** Context **6** was the upper fill of Ditch **5**, and was a mid brown silty clay. The consistence of the fill was firm; however both this fill and the primary fill (Context **7**) were both water-logged due to the spring which was constantly running into the trench from the eastern corner of the trench. Context **6** had a depth of up to 650mm, and inclusions of ironstone pieces up to 30mm (<1%), chalk pieces up to 40mm (<1%), flint pieces up to 30mm (<1%), sub angular flint pieces up to 30mm (<1%) and sandstone pieces up to 50mm (<1%).

- 4.10** Context **7** was below Context **6** and was the primary fill of Ditch **5**. This was a very dark brown silty clay with gravels. This fill having a depth of up to 100mm and inclusions of manganese pieces (5%). As mentioned above this layer was waterlogged but had a firm consistence. All artefacts recovered from the primary and upper fill of the ditch were given the Context **6** as due to the waterlogged conditions it proved impossible to see exactly which fill they came from. The artefacts recovered comprised ceramic building material, other types of building material and bone, which suggested a mid/late 17th century to mid 18th century date for the infilling of the ditch.

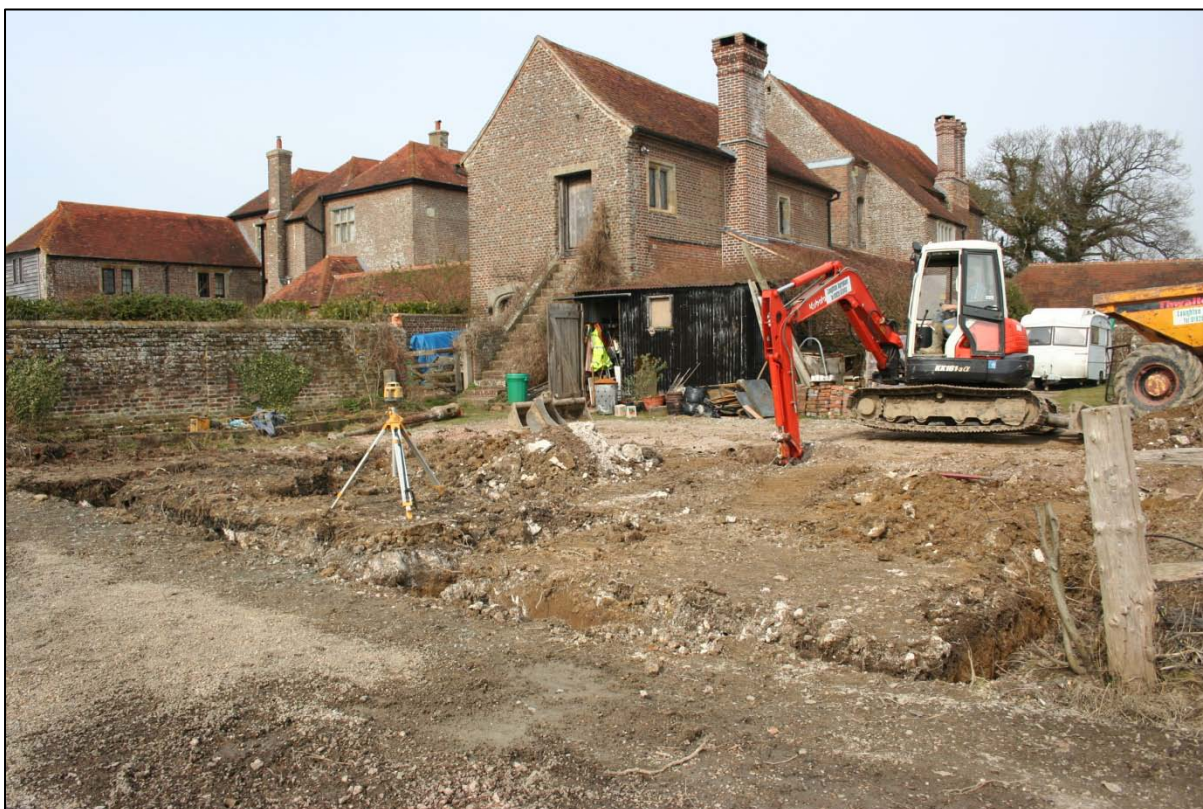
Fig. 8: The Granary, Chiddingly Place: Watching brief

- 4.11** During the subsequent watching brief on the excavation of the 'E' shaped footings of the garage, the same layers as had been found in the evaluation were noted; a thin layer of topsoil (Context **8**) above the layer of chalk (Context **2**), above Context **3** and then the natural (Context **4**).
