## **A Standing Building Survey and Evaluation Excavation at 190, High Street, Lewes, East Sussex**

Project No. CBAS0118

Chris Butler MIFA & Keith Butler PIFA

June 2010

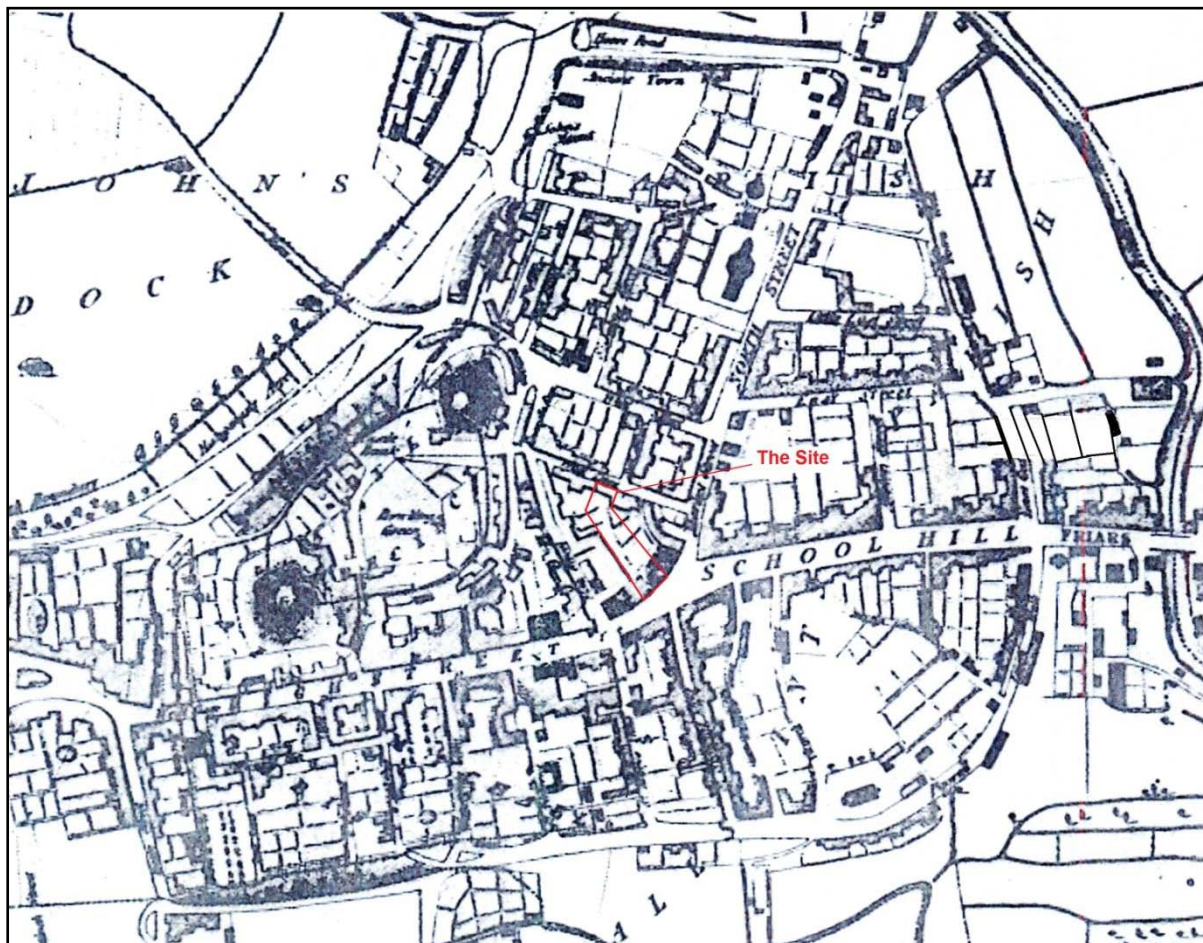
Fig. 7: 190 High Street, Lewes: Map of Lewes by J. Marchant dated 1824

- 2.13** James Edwards' map of Lewes dated 1799 shows a similar situation, as that of the map of Lee & Baker, 1799 referred to above. A map of Lewes by J. Marchant dated 1824 also shows the same situation (Fig. 7). On all of these maps the property boundaries appear to follow the current outline, although the 1824 map hints that it was divided into two properties at that time, and this may reflect earlier boundaries that were not shown on the previous maps.

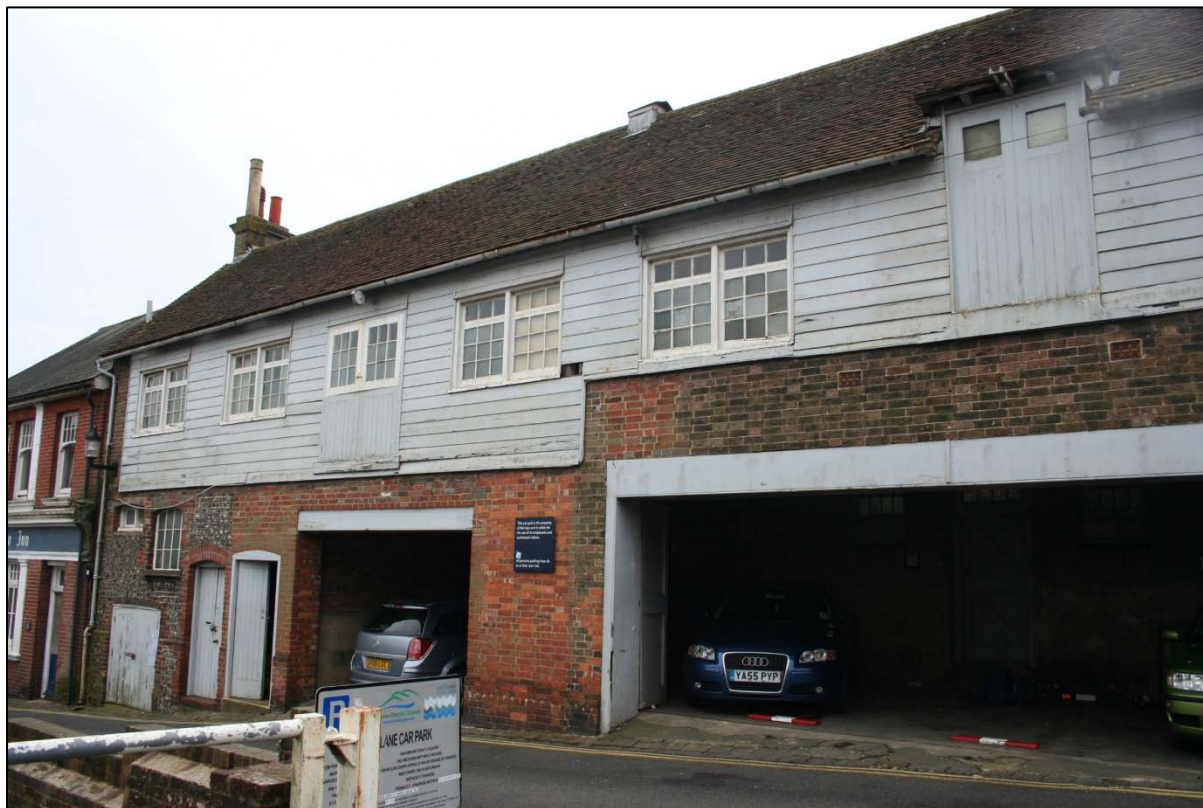
The wall of the north frontage comprises a brick built ground floor with horizontal weatherboarding above (Fig. 16). The weatherboarding is painted light grey and is sixteen planks deep at its eastern end, each overlapping the one below. This reduces to ten planks half way along the building, where it steps up above the entrance to the second garage at the western end of the building. A small plank of weatherboard has fallen off just before it steps up to reveal possible wooden studding behind.

Fig. 16: 190 High Street, Lewes: North elevation of outbuilding

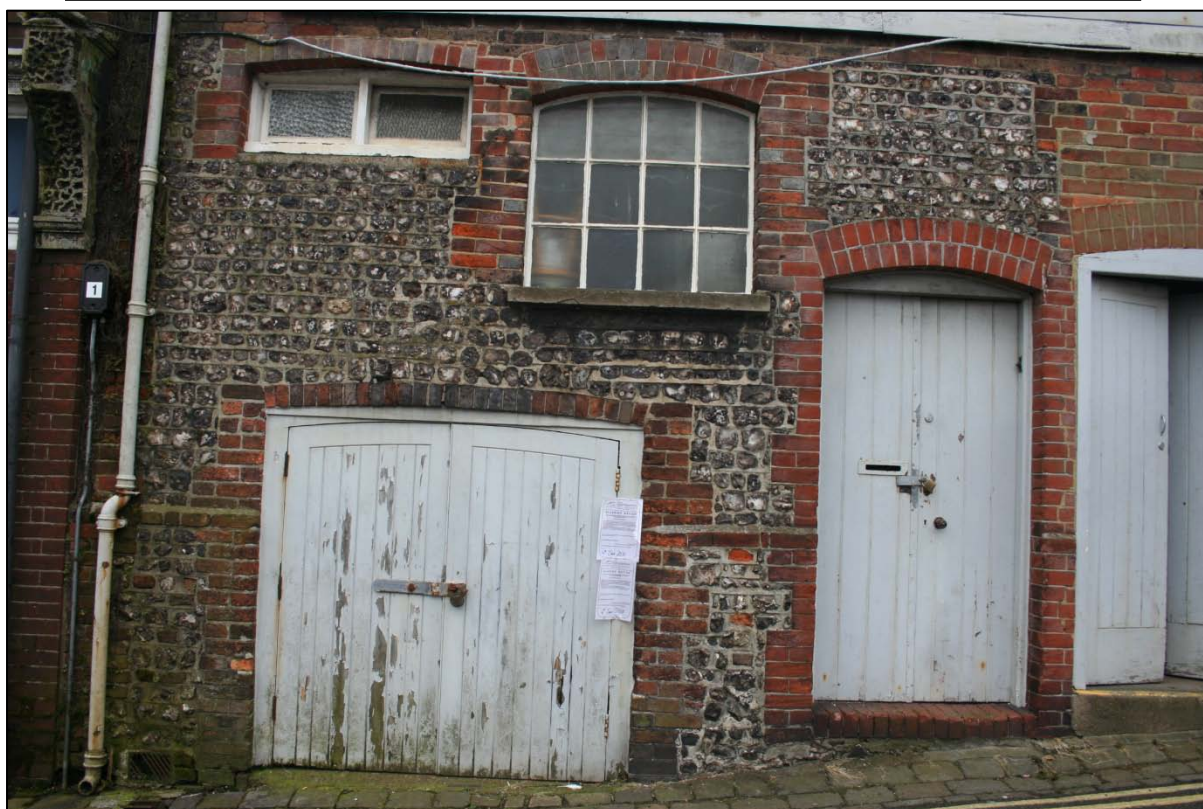
At the eastern end of the building the wall around the entrances to the cellar/basement and the interior of the building is of flint construction (Fig. 17). The flint is knapped/faced and laid in regular courses with a small number of bricks incorporated into the wall at a lower level, with the flintwork bonded with a mid grey mortar. The windows and doorway have brick surrounds. There is also a string course of bricks running through the flintwork at approximately a metre above ground level.

Fig. 17: 190 High Street, Lewes: East end ground floor, north elevation of outbuilding

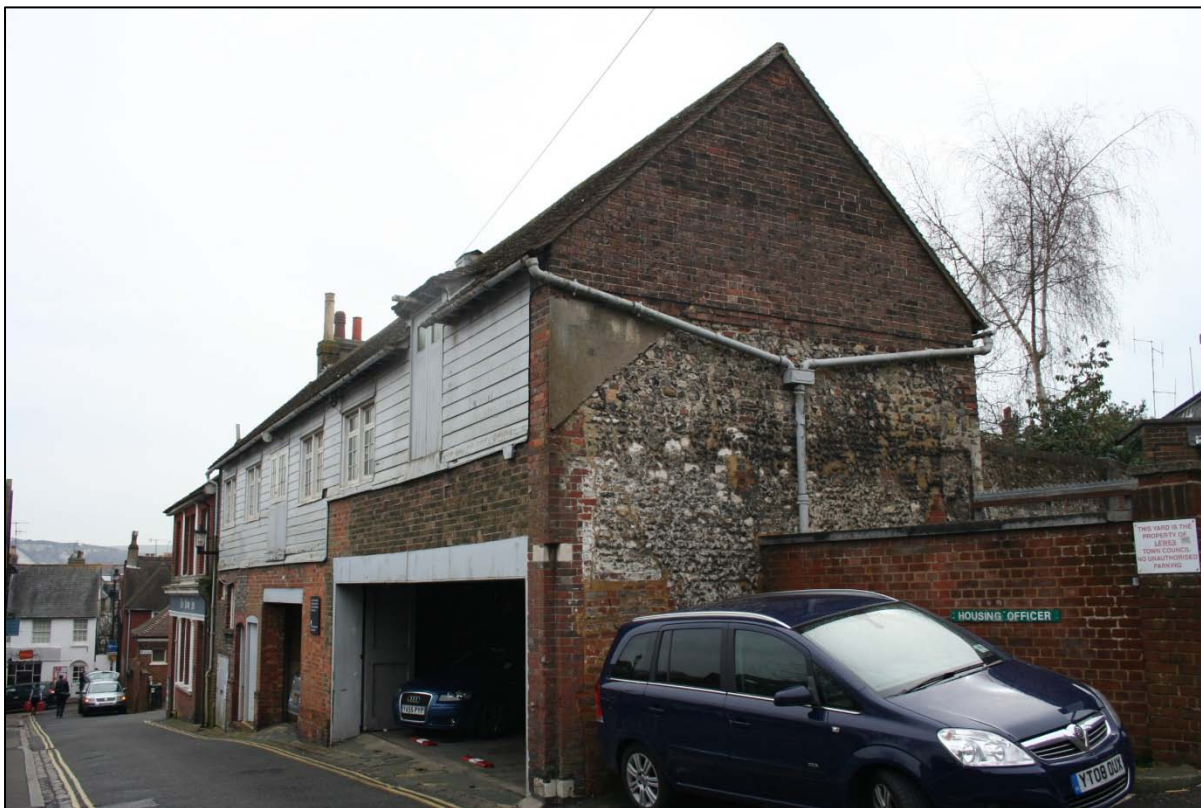
Fig. 18: 190 High Street, Lewes: West elevation of outbuilding & view east along Market Lane

The flint wall has been repaired in brick in various places, some of which appear to be of a recent date. The drain pipes from the guttering along the north and south side of the building run across the west wall, meeting in the middle, where they drain in to a rectangular header tank. This has in its centre a plain lozenge decoration which may originally have had an inscription, although this could not be confirmed. There are no current windows or doors in this wall.

Below in the bottom north-west corner of the wall is an area of brick repairs to the flint work which is blocking up a doorway, connected to the removed building, shown on the 1929 plan. A recent brick wall runs westwards from the centre of the west wall.

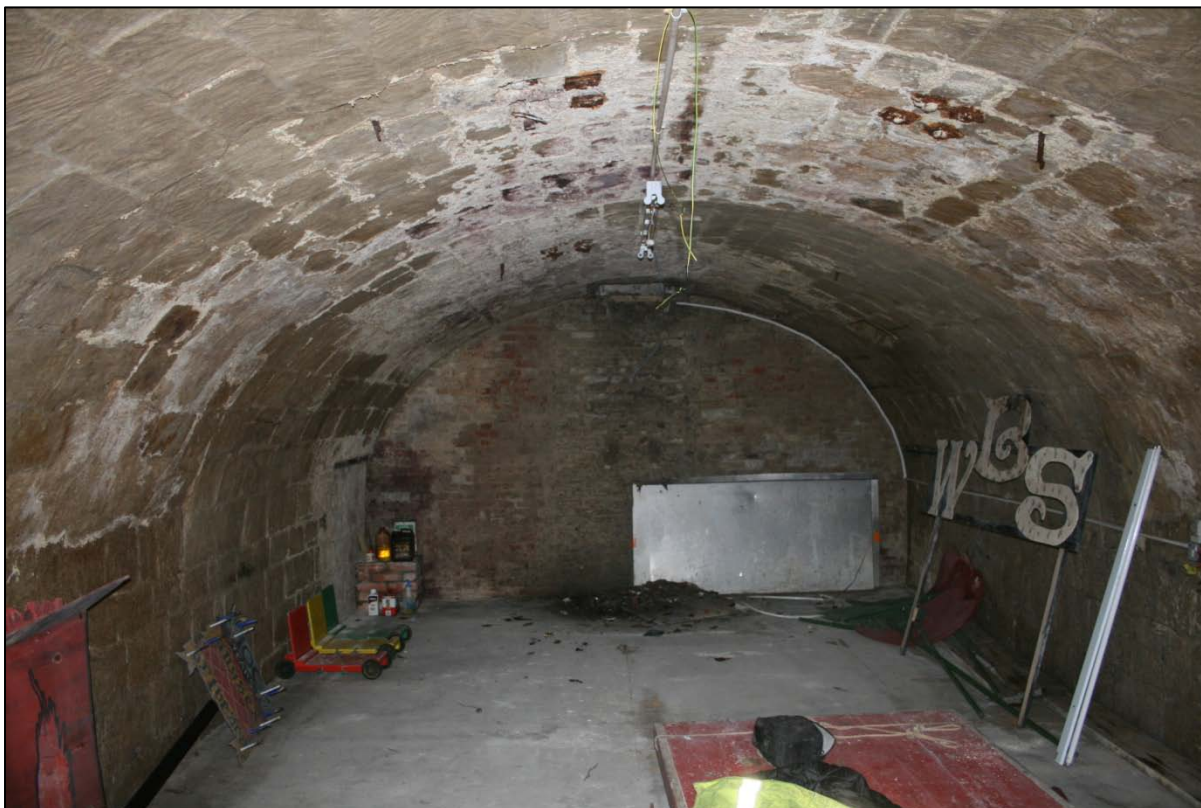
Fig. 20: 190 High Street, Lewes: Cellar/Basement

The cellar measures 19.2m in length (east to west) with a width of 4.6m, and runs the whole length of the building. The shape of the cellar is barrel vaulted, with a height at its highest point of 2.6m (Fig. 20). It is built of clunch blocks, with a floor of concrete construction. The blocks have been faced with the largest being approximately 600mm by 260mm, although most are slightly smaller in size. The eastern wall of the cellar is constructed of the same type of clunch blocks as the walls, but the western end wall is constructed of brick, perhaps suggesting that it originally extended further in this direction.

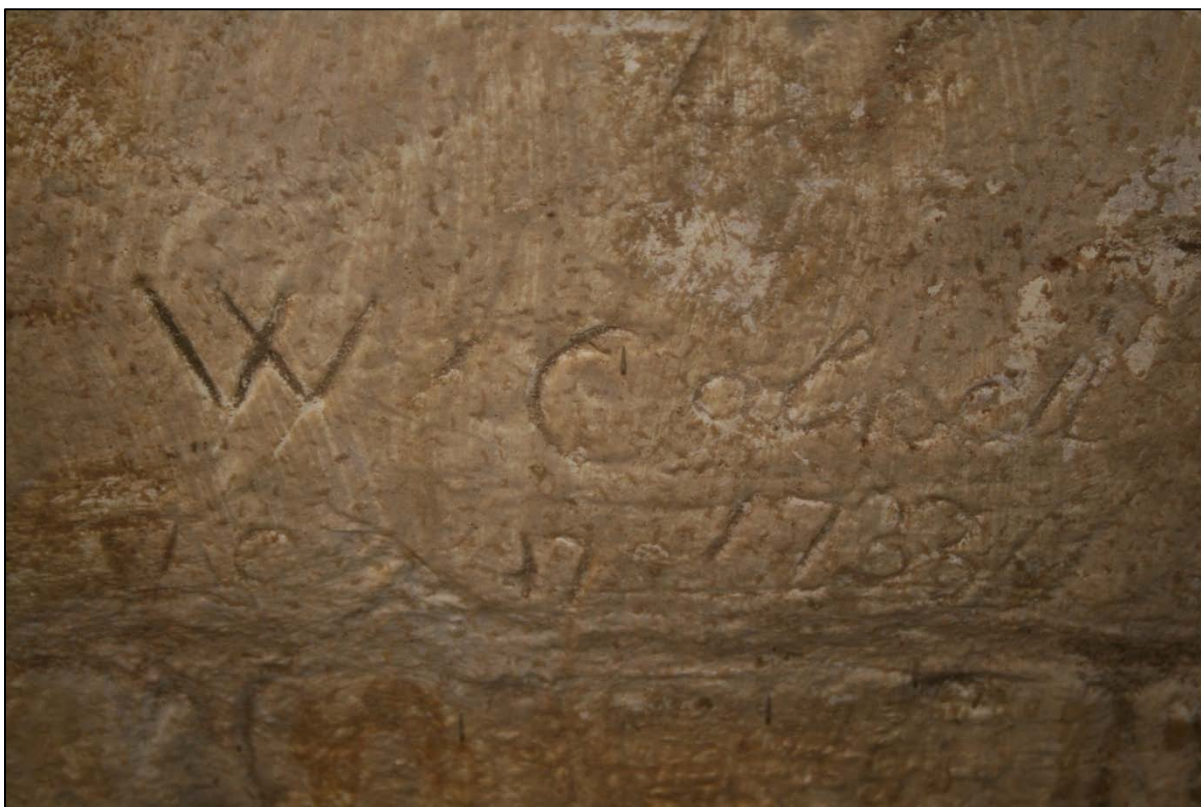
Graffiti was noted on both the north and south walls of the cellar. The majority was on the south wall, with the oldest being 'W x Cabrell' which had a date of 1736 below the name (Fig. 21). Other graffiti had dates ranging from 1948 up to 1960. On the north wall the only graffiti seen was the date '1941'. There is a strong possibility that there is more graffiti on the walls but these could not be seen due to the very poor lighting available during the survey.

Fig. 21: 190 High Street, Lewes: Graffiti in the cellar

- 8.3** It is recommended that before any building work is carried out, the cellar should be investigated further with a full measured survey and preparation of drawings, together with an in depth recording of the graffiti. It would also be considered prudent to undertake an archaeological watching brief during the groundworks connected with the new development.

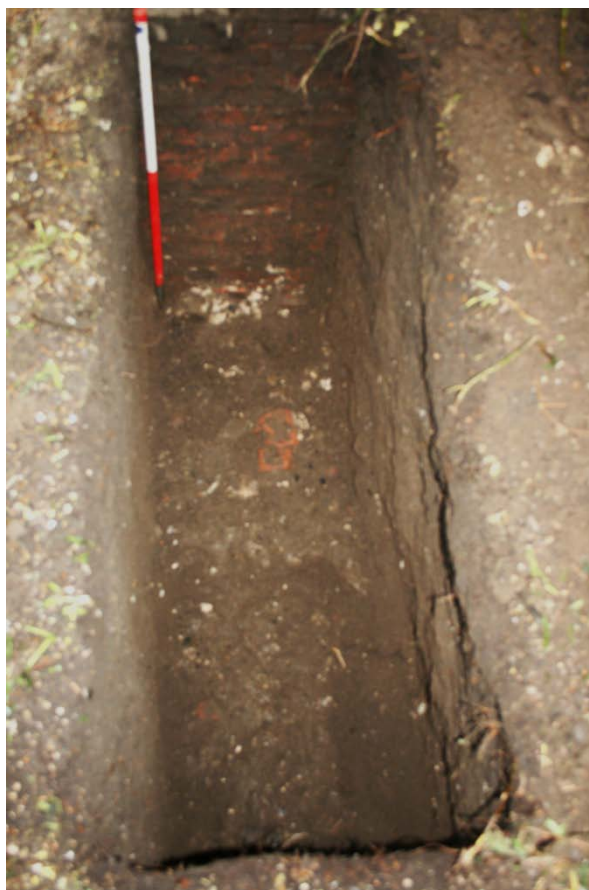
- 5.12** During the cleaning up of Trench A for recording it was noted that the foundations of the outbuilding had a depth of 1m, and below this was a layer of tiles and mortar (Fig. 22).

Fig. 22: 190 High Street, Lewes: Trench A
