A Standing Building Survey of 1, Crown Cottages, Cootham, Nr. Storrington, West Sussex.

Project No. CBAS0120

by
Keith Butler PIFA

May 2010

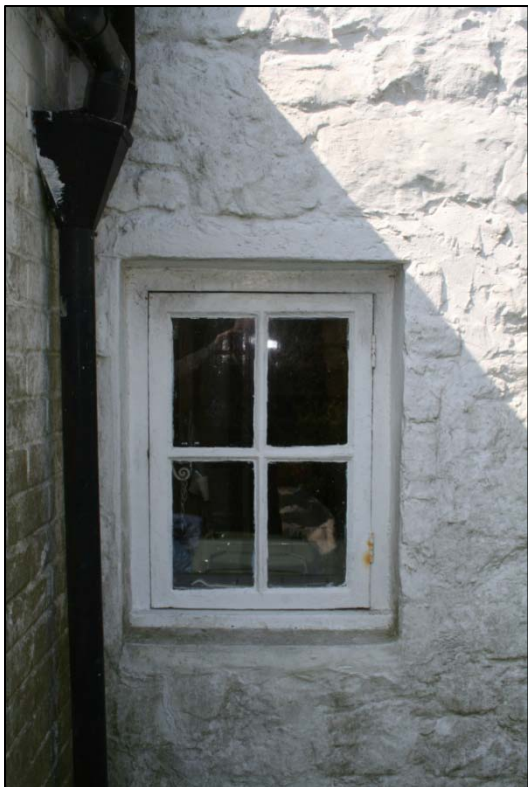
There is a small wooden framed casement window with four panes of glass positioned above the sink, which appears to have been inserted later, with a small wooden window sill between the window and the sink. To the south of the entrance door to the kitchen is the staircase. On the south wall is the entrance to the modern extension by a wooden door with two panels below and six panes of glass above.

Fig. 8: Crown Cottages: Inset window in the south wall of the kitchen

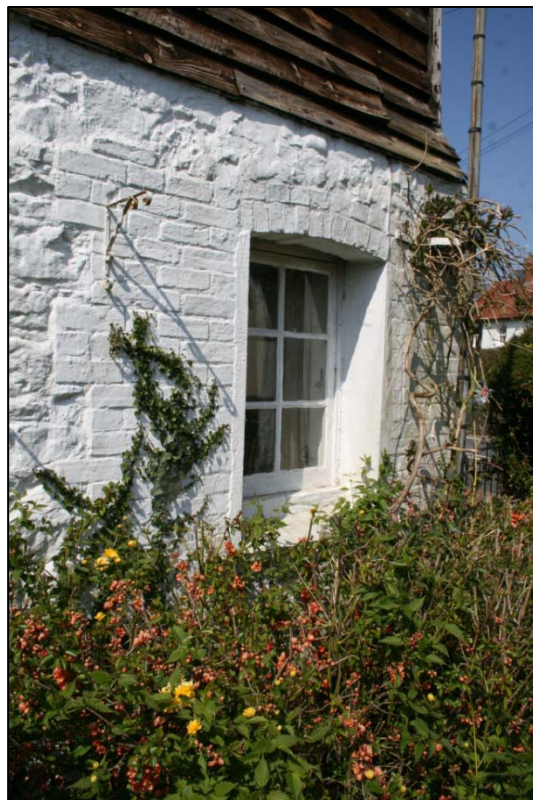
The ground floor window to the north is again a single wooden framed casement window with six panes of glass. This window is recessed into the wall, and having a brick built arched window head. An area around the window, to the south, up to the north corner of the western elevation has been rebuilt in brick; this surrounds the window to just above the top of the window head.

- 5.3** At the northern end of the eastern wall the area around and above the window is of a different build to the rest of the wall. Except for the window head and surround of the window on the ground floor of the northern elevation, this is the only area of the building that is built of brick instead of the stone used in the rest of the building. It is possible that this may represent the blocking of an earlier door or window and insertion of a new window, although it was not possible to confirm this.

Fig. 9: Crown Cottages: Possible inserted window and brick surround

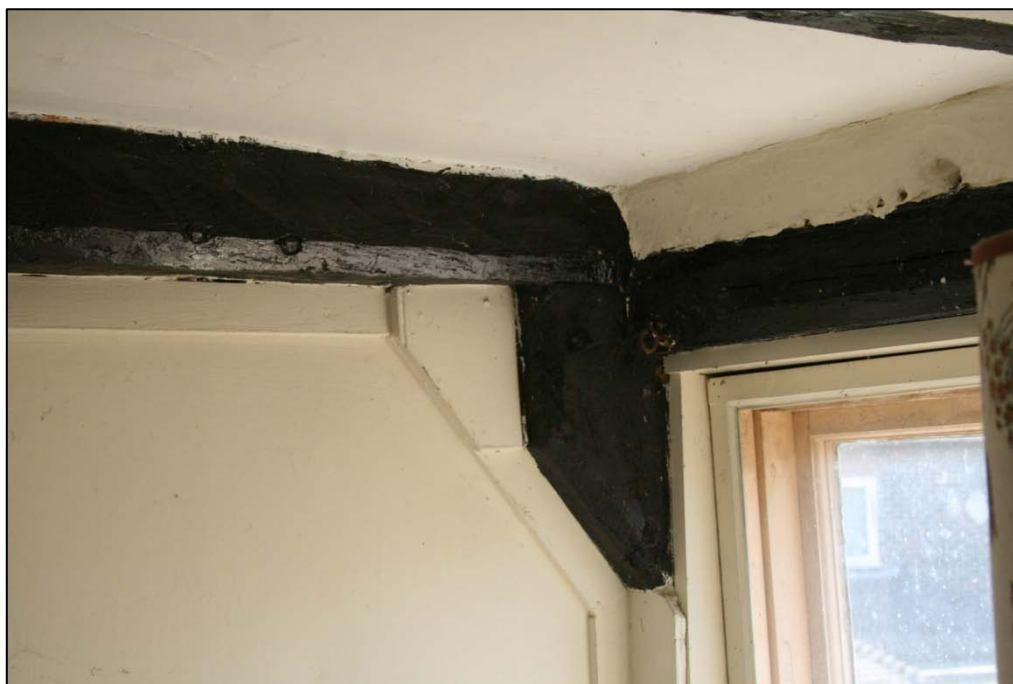
There is a wooden beam running across the top of the eastern wall of the landing, running in a north-south direction where it joins on to what appears to be the jowled head of a post. The wall plate can be seen running above the window and cut into the top of the southern corner of the jowled head, which is only exposed in the area above the window before it is obscured by the wooden planking.

Fig. 10: Crown Cottages: Exposed beam and wall plate on the landing
