A Desk-based Assessment for Churchwood Primary School, Hollington, Hastings, East Sussex

> by Chris Butler

December 2008

Summary

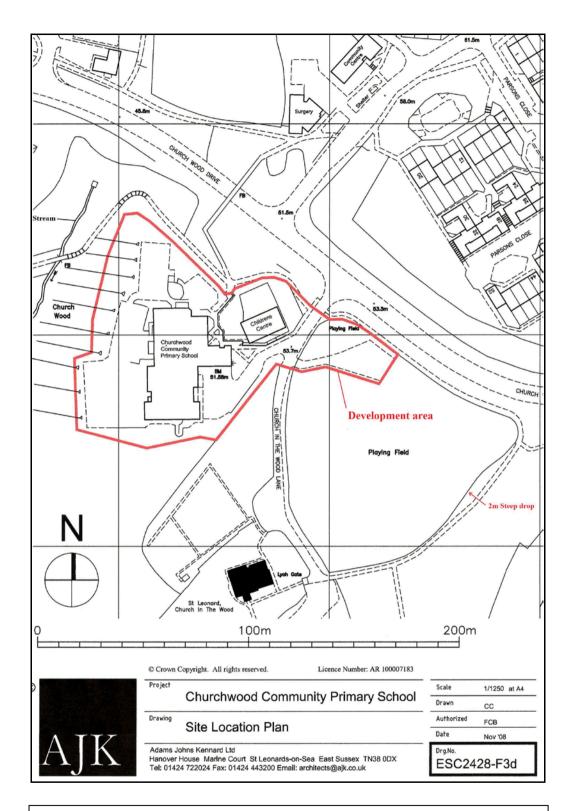
Fig. 4: Churchwood School: Site Plan also showing features noted on site visit (Adapted from AJK drawing)

- 3.5 A site visit was undertaken on the 12th December 2008. This confirmed that the site (Fig. 4) comprises an access road from Church in the Wood Lane to the front of the original 1975 school building, and which continues down to a small car park. On the north side of the building are tarmac paths with planted raised borders leading to steps down to a play area with a climbing frame and two small trees, with a bank on its north side. The ground drops again to another level with steps down onto a large tarmac playground, which extends across the back (west side) of the school.

- 3.6 At the south end of the playground there is a concrete retaining wall, and access ramps and steps up to a gate which leads through to the car park. Steep banks rise up on the south side of the site where the school has been terraced into the slope. On the west edge of the playground, the ground drops away steeply into the woods, with the school perimeter fence situated part way down the slope, and the ground finally falls away into the stream at the bottom of the slope.

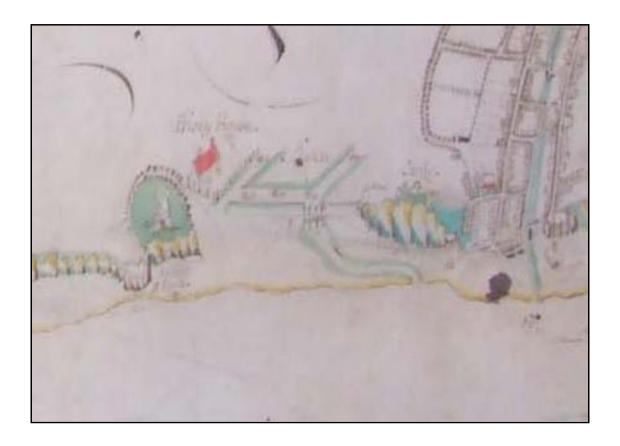
Fig. 5: Samuel Cant's map of Hastings dated to 1746/8 2003.53.208 Courtesy of Hastings Museum and Art Gallery

- 4.9.6 Samuel Cant's map of Hastings dated to 1746/8⁴⁷ shows Church Wood with the church placed within the wood, but little other detail around it apart from Priory House just to the north-east of the wood (Fig. 5).

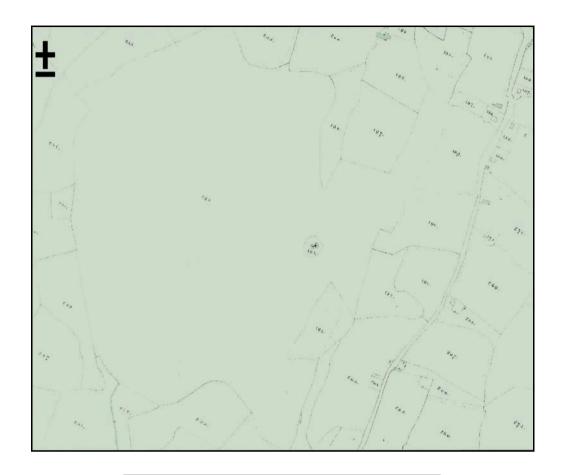
Fig. 6: Hollington Tithe Map 1843 Reproduced from copy provided by ESCC

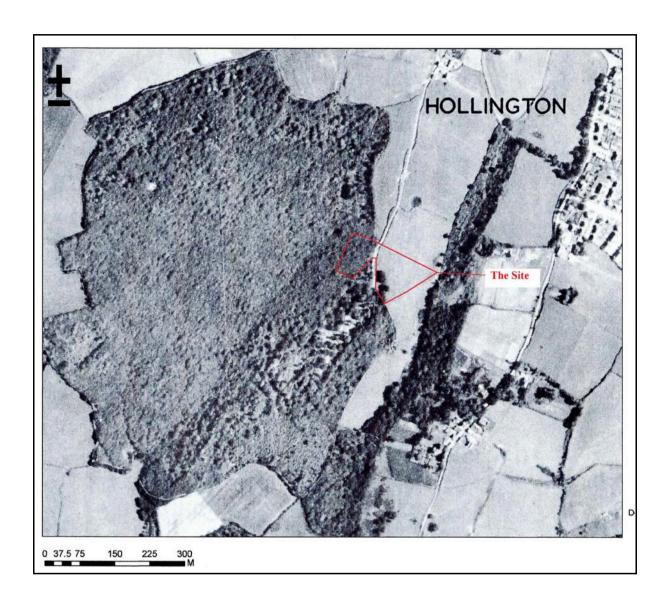
Fig. 11: Churchwood School: 1947 Aerial Photograph
(Adapted from photograph provided by ESCC)

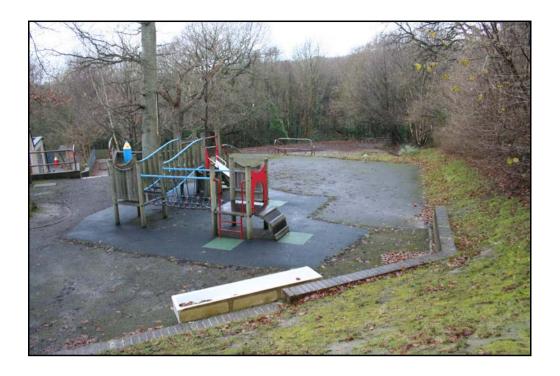
Fig. 12: Churchwood School: NW side of school showing the terracing into the slope at different levels

- 1.3 The site is located at around 53m OD on its east side (Church in the Wood Lane) and has been terraced into the west facing slope dropping some 2m to the level of the current school buildings and further down to the level of the playgrounds on its west side. The ground level then drops down to around 44m OD from the west edge of the property to a stream which flows from north to south through Church Wood.

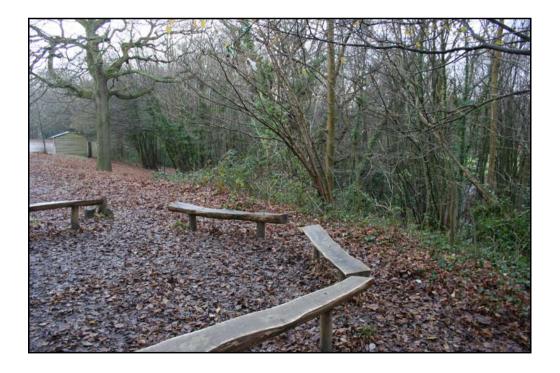
Fig. 13: Churchwood School: West side of school, showing slope to stream at edge of playground

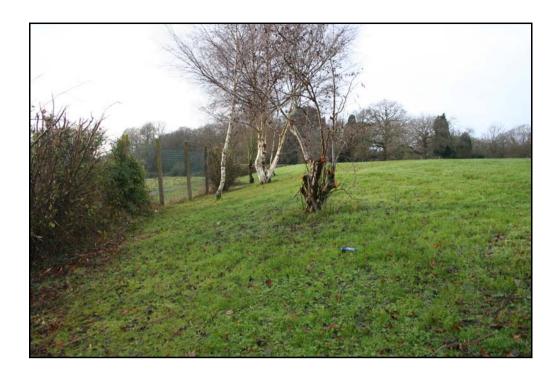
Fig. 14: Churchwood School: Playing field showing effect of in-fill at east end

- 3.8 On the east side of Church in the Wood Lane is the playing field surrounded by a tall metal fence. The field slopes down to the south, and falls away rapidly on the south-east and south sides where there is a drop of some 2m to the hedge, and beyond that scrub and open rough grassland. A number of mature trees are located in the south-east corner of the field, whilst in the north-west corner of the field there is a raised area recently planted with trees, and along the northern boundary a low bank; these appear to be the result of levelling off of this part of the field.

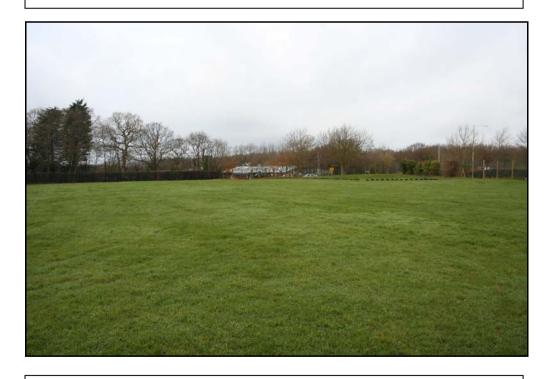
Fig. 15: Churchwood School: Playing field looking west towards proposed car parking area

- **1.6** The existing Churchwood Primary School was originally opened in 1975 to replace an earlier school built in the late 19th century, due to the redevelopment of the Hollington area. It has been proposed that new accommodation be built on the site with a new car park that will be located in the north-west corner of the playing field.
