A Desk-based Assessment on The Stade, Hastings, East Sussex

by
Chris Butler

December 2008

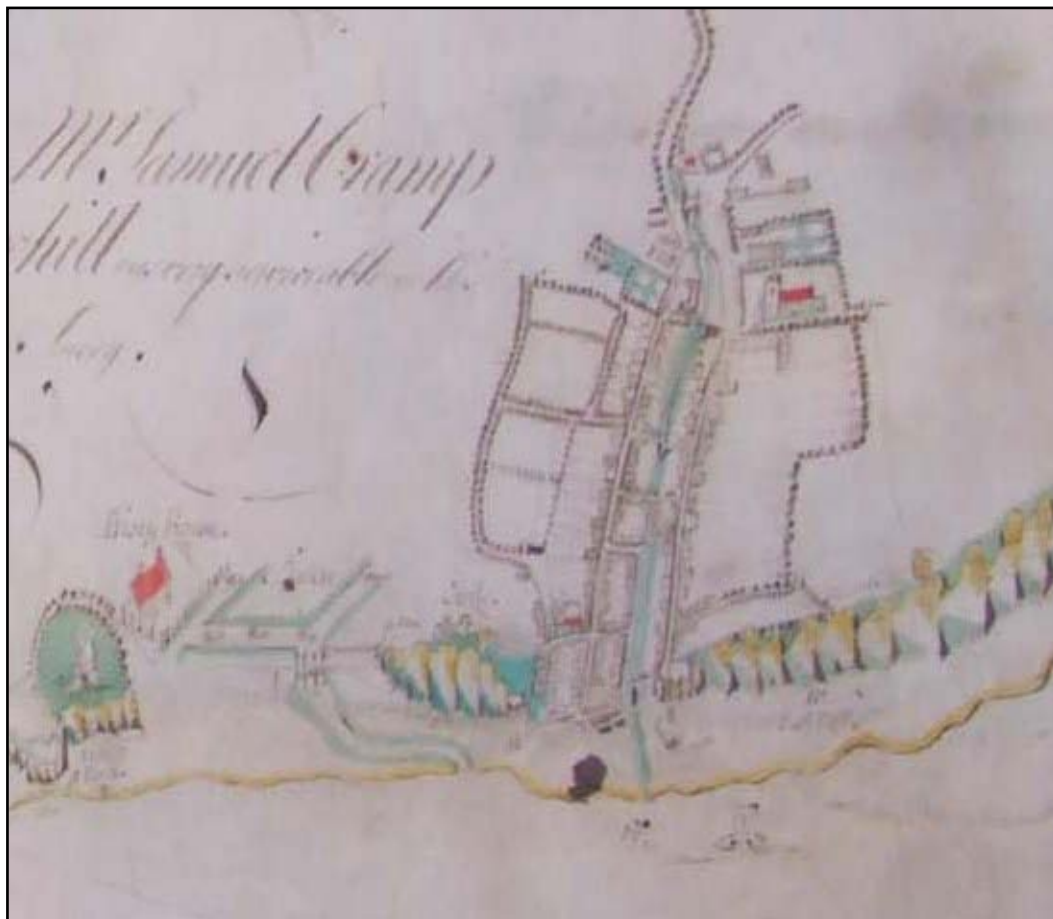
Fig. 10: Samuel Cant's map of Hastings dated to 1746/8
2003.53.208 Courtesy of Hastings Museum and Art Gallery

- 5.1 The earliest map evidence comes from Samuel Cant's map of Hastings dated to 1746/8⁷⁸ (Fig. 10). This clearly shows the Bourne running through Old Town and the Watergate, then cutting through the Stade and entering the sea. It also appears to show a large building just to the east of the Bourne on the beach.

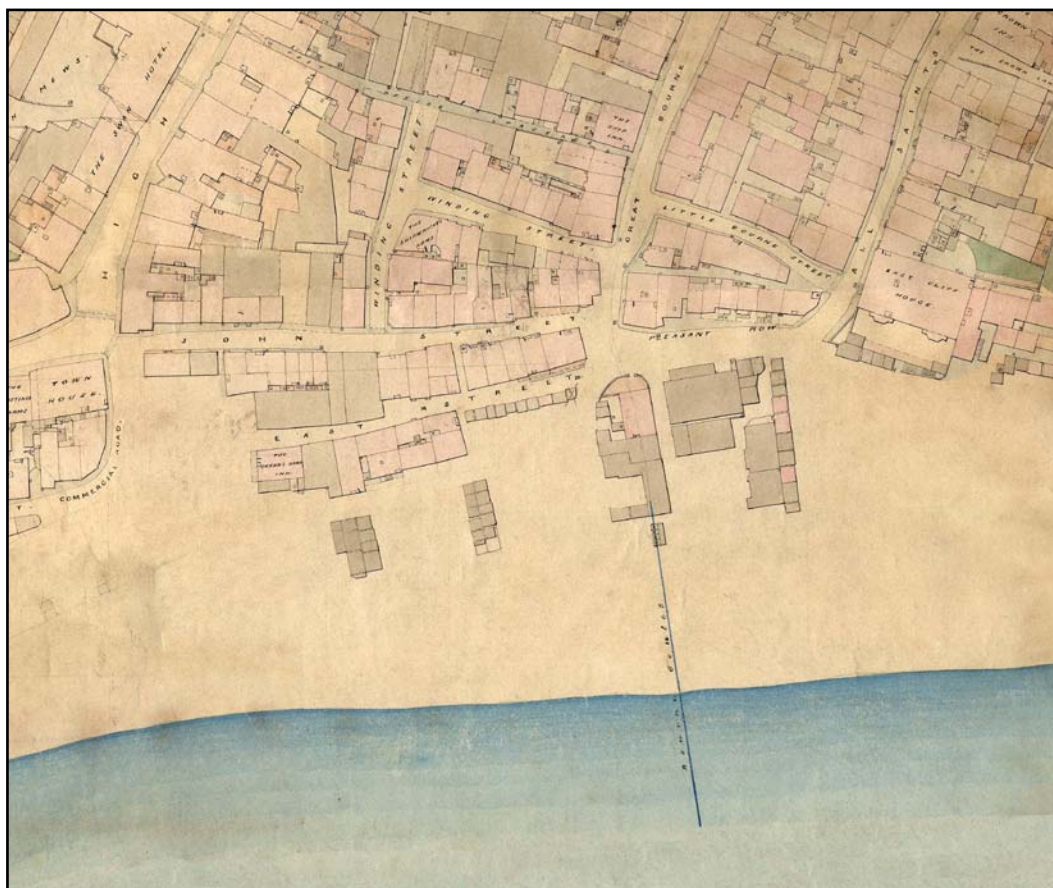
Fig. 12: William Gant's 'Survey of Hastings' of 1852
2003.53.237 Courtesy of Hastings Museum and Art Gallery

- 5.3 William Gant's 'Survey of Hastings' of 1852 (Fig. 12) provides the next map evidence for the Stade (the St. Clements Tithe map does not extend as far south as the Stade). The neatly drawn map⁸⁰ clearly shows the net shops arranged in lines and some larger buildings south of Pleasant Row. The Bourne is shown emerging from beneath a group of buildings (the same group of buildings referred to 4.9.16 above), and a small latrine building is positioned over the stream to its south.

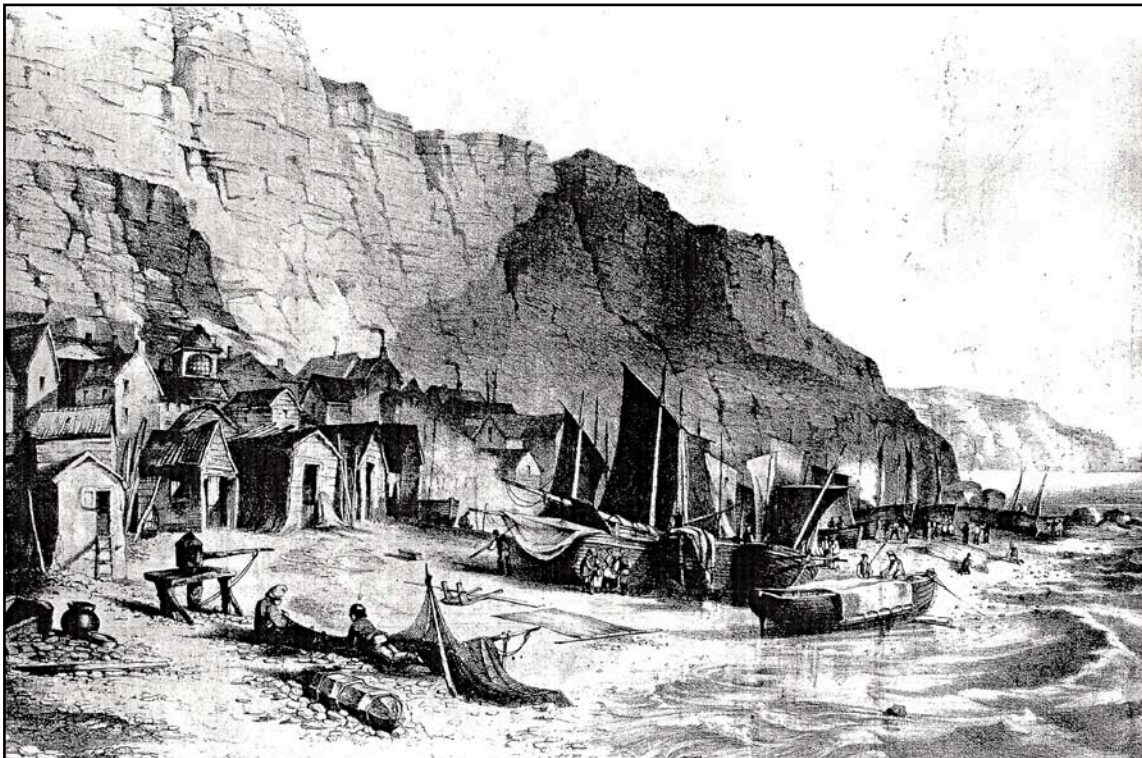
Fig. 19: The Stade: Print from a sketch by John Fairlie 1849
Courtesy of Hastings Museum and Art Gallery

- 5.8** A number of 19th century prints of the Stade were reviewed, all of which show a similar image; a relatively narrow shingle beach with numerous net shops (Fig. 18) on its upper part, fishing boats pulled up onto the beach (Fig. 19) or ships loading and unloading cargos (Fig. 20).

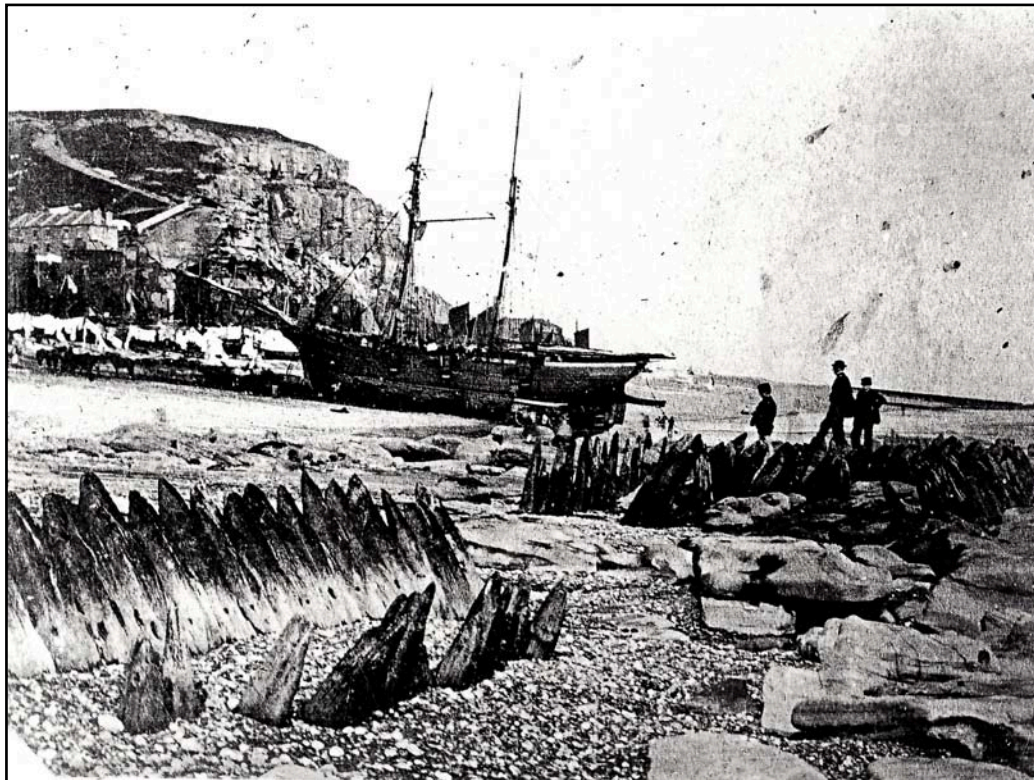
Fig. 21: The Stade: Timbers from the Elizabethan harbour exposed after a storm c.1880
990.18.423 Courtesy of Hastings Museum and Art Gallery

- 4.9.3 The wooden remains of this pier have been re-exposed on a number of occasions since. The remains were described as “very large pieces of timber covered by enormous rocks, which formed the foundation of the pier, and three or four rows of piles (Fig. 21)³⁹. In March 1821 rows of piles were revealed close to the Parade⁴⁰. They were also exposed off East Parade after the 1870 storm, until reburied by the shingle beach. During work to extend the Parade in 1931, a line of timber piles was discovered opposite the west end of George Street⁴¹. They headed in a south-easterly direction from the west end of where the boating lake is now situated.

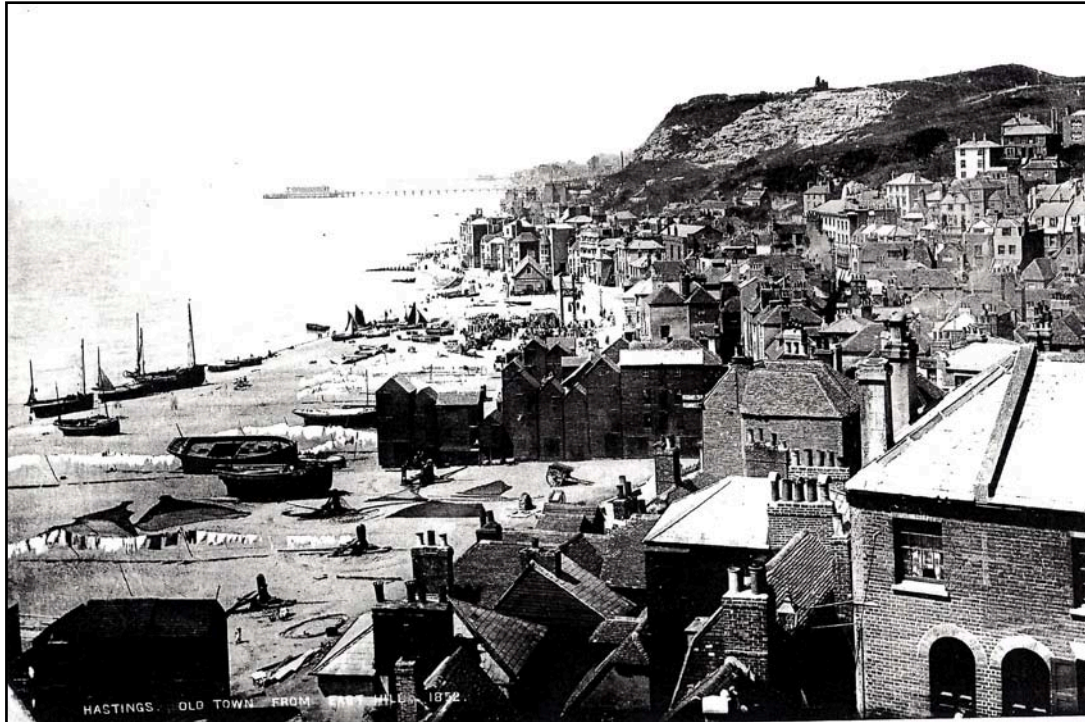
Fig. 22: The Stade: Taken from East Hill, probably later 1880's
990.18.427 Courtesy of Hastings Museum and Art Gallery

- 5.9** Numerous photographs dating from the later 19th century through to the 1980's were inspected, and a representative sample is included in this report to illustrate the changes that have taken place over that period. The earliest photograph is claimed to be dated to 1852, but this date, must be wrong as it shows the pier which was not opened until 1872 and the lifeboat house which was not built until 1882, so it must post date that (Fig. 22). Taken from East Hill it clearly shows the large cluster of net shops in the centre of the Stade.

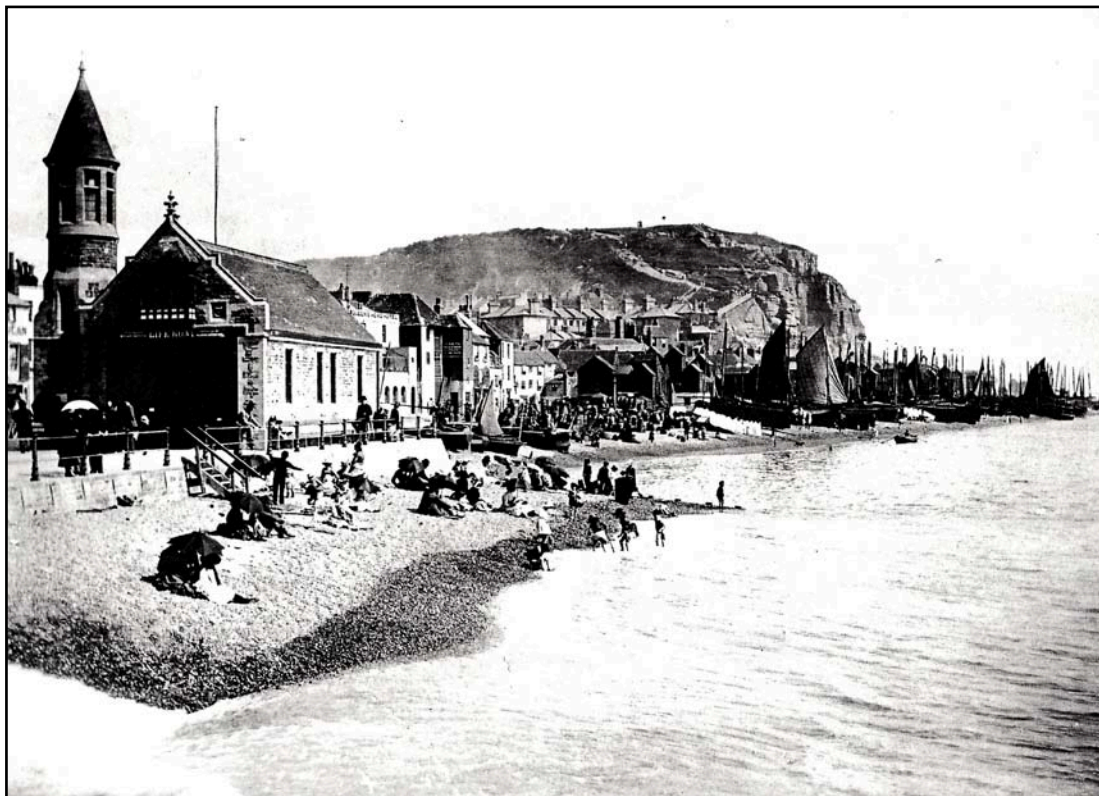
Fig. 23: The Stade: Photograph taken c.1890 from the west across the Stade
990.18.342 Courtesy of Hastings Museum and Art Gallery

- 5.10** A photograph taken *c.*1890 from the west with the lifeboat house in the foreground, shows how little beach there was at this time on the Stade (Fig. 23). The fishing fleet is beached and the cluster of net houses in the centre of the Stade can be seen.

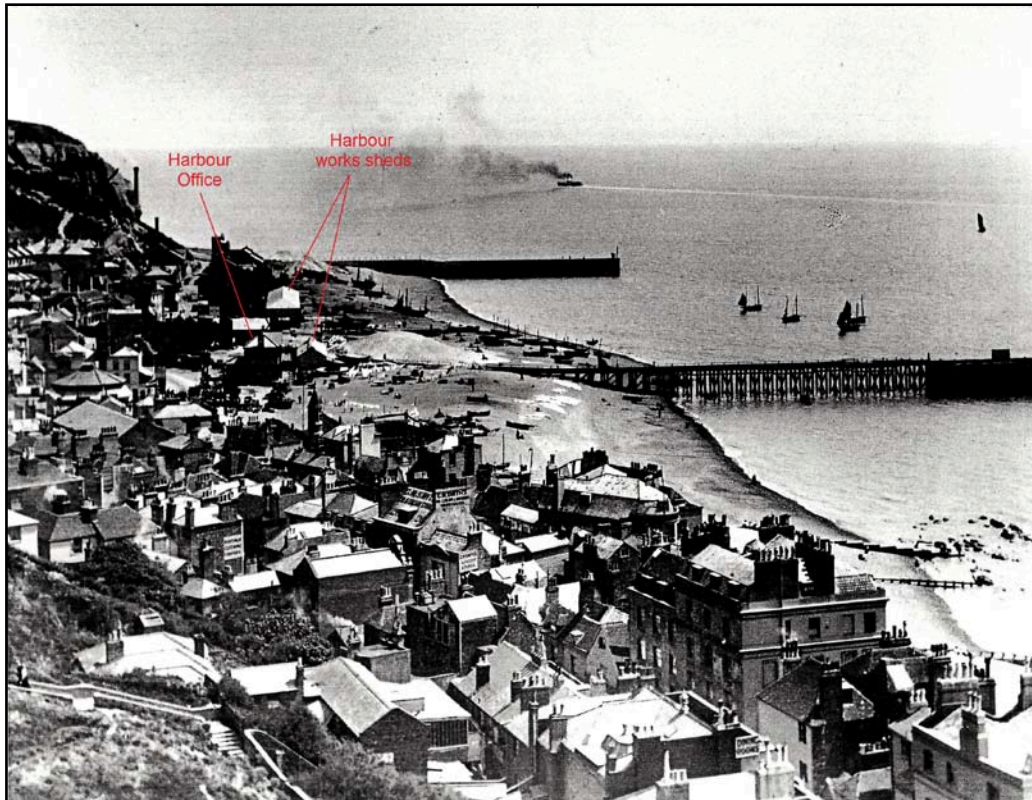
Fig. 24: The Stade: 1897/8 showing the harbour arm under construction
000.62.79 Courtesy of Hastings Museum and Art Gallery

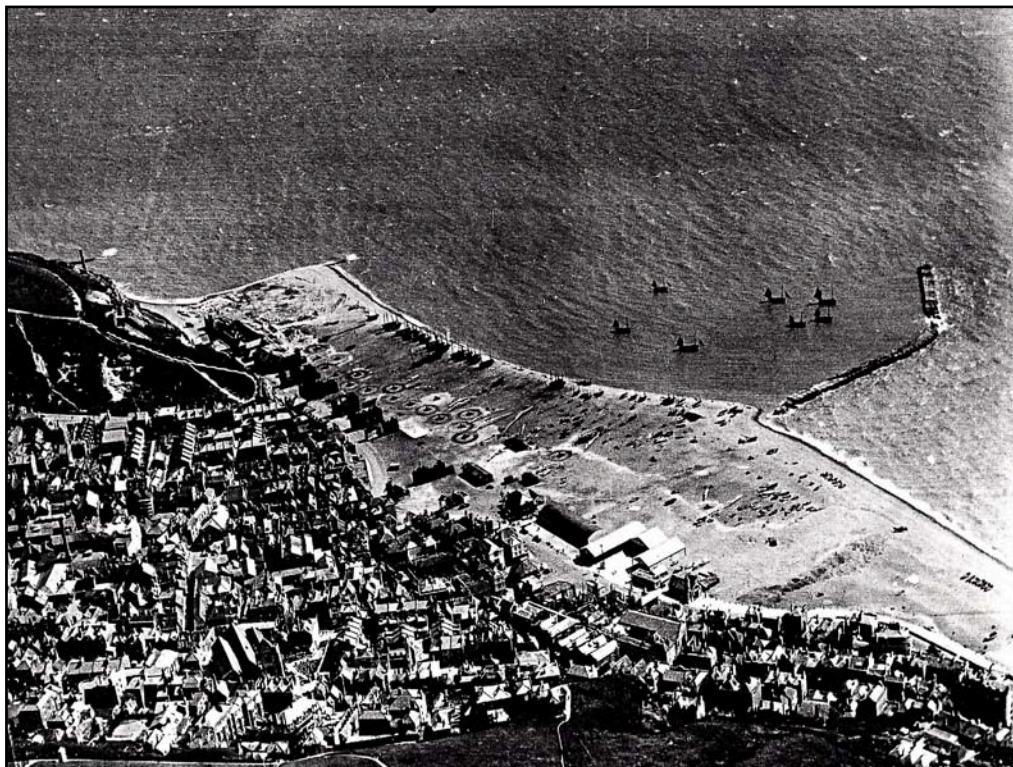
Fig. 25: The Stade: Aerial photograph c.1927-33
990.18.447 Courtesy of Hastings Museum and Art Gallery

- 5.12** An aerial photograph taken from the north-west across the Stade *c.*1927-33 (pre 1933 when the boating lake was built) shows how the shingle beach has accumulated, covering over a substantial part of the harbour arm (Fig. 25). The circular walkways for the horse capstans can be seen on the Stade, together with rows of net shops. The wholesale fishmarket and adjacent buildings can be seen in the foreground. A second aerial photograph of similar date (Fig. 26) shows the same scene from offshore; note the lack of net shops in the central part of the Stade, and no bus stop.

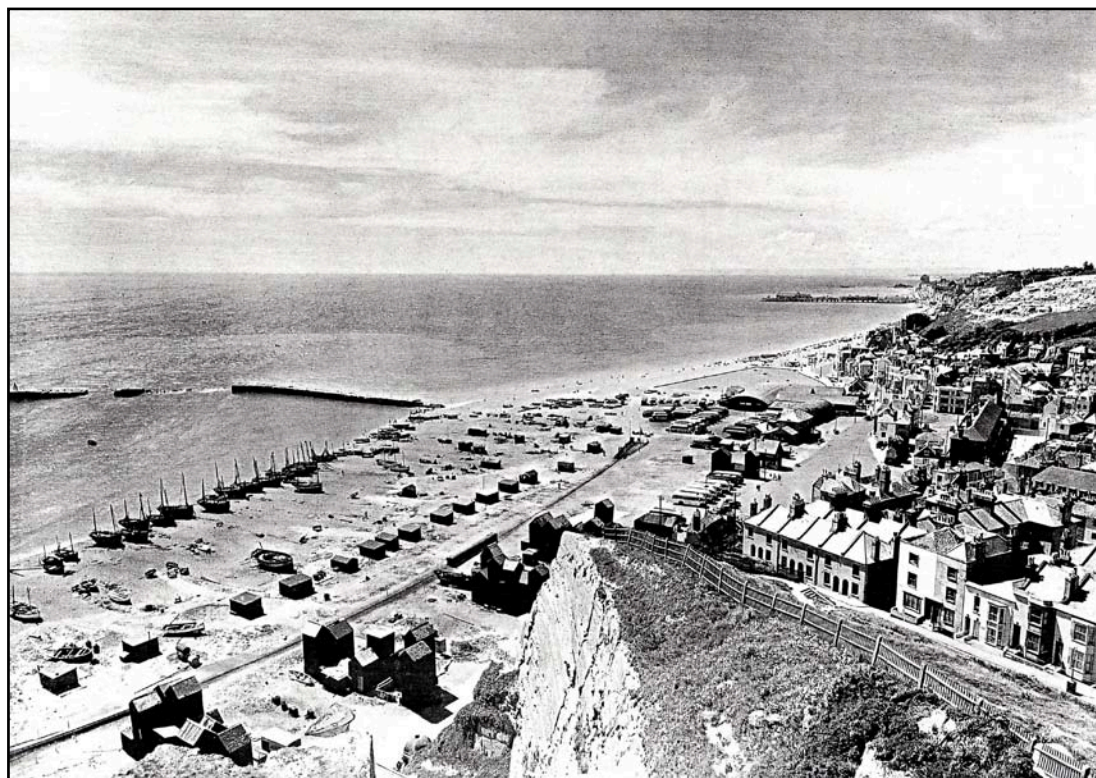
Fig. 27: The Stade: Photograph taken from East Hill in the 1950's
990.18.152 Courtesy of Hastings Museum and Art Gallery

- 5.13** Two photographs from the 1950's demonstrate the changes that have taken place since the 1930's and before the redevelopment of the Stade. The first was taken from East Hill (Fig. 27) and shows the winch sheds, net shops and coach park. The building now used as Tom's Cabin and the

adjacent brick kiosk are both present here, but no bus stop. The second is an aerial photograph taken in 1958 (Fig. 28) showing Rock-a-Nore and the Stade, and although largely unchanged from the previous photograph it shows a number of new buildings.

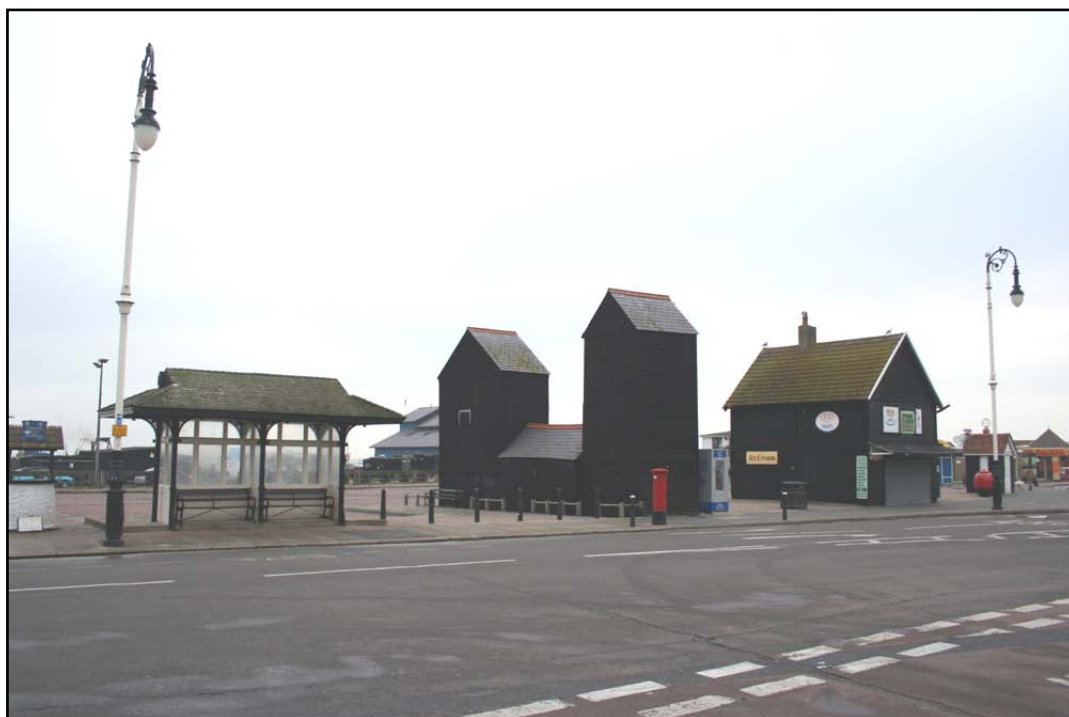
Fig. 30: The Stade: The bus shelter, net shops and Tom's Cabin.

3.6 On the street frontage of Rock-a-Nore Road is a c.1900 bus shelter (DES845) sitting on a raised concrete plinth, which is a Listed Building, and adjacent to this is a circular well structure; probably modern. To the west of this is a raised paved area with three further net shops, a wooden building with tiled roof, Tom's Cabin, (shown on 4th Edition OS map?), Second World War sea mine, and a small brick built kiosk.

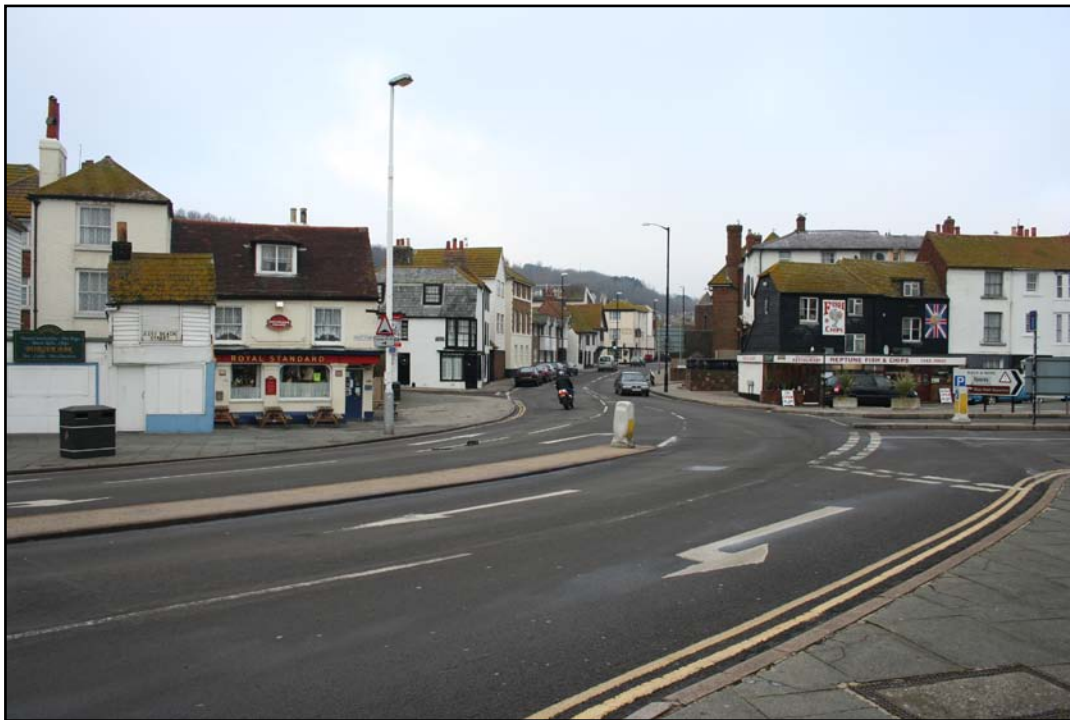
Fig. 32: The Stade: Looking north along Bourne Street. The area immediately in front of the camera was covered with net shops in the 19th century, and the Bourne Stream ran through here to reach the sea.
