An Archaeological Watching Brief at Highfield Junior School, Eastbourne, East Sussex

(EB/3010/3018/3019/CC)

CBAS0226

September 2011

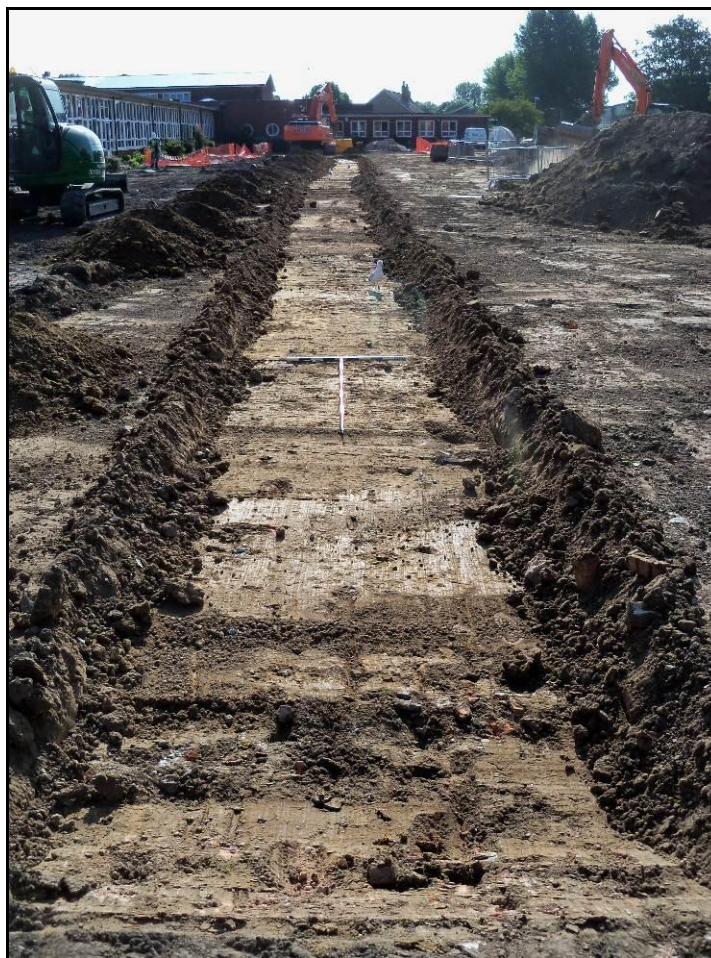
Plate 1:
Highfield
Junior School,
Eastbourne:
Trench 1
looking east

4.1.1 The topsoil (Context **100**), retained at the very west end of Trench 1 only, was a friable mid brown clayey silt that contained no obvious inclusions.

4.1.2 A made ground (Context **101**) was recorded to the west end of the trench, beneath the predominantly striped topsoil (Context **100**). This was a friable pale to mid orange-brown or brownish-orange sandy silt that contained occasional to frequent small areas of mid reddish orange or pale pink sand, frequent areas of small flints (a few cm³ in size maximum) and occasional areas of crush with brick fragments.

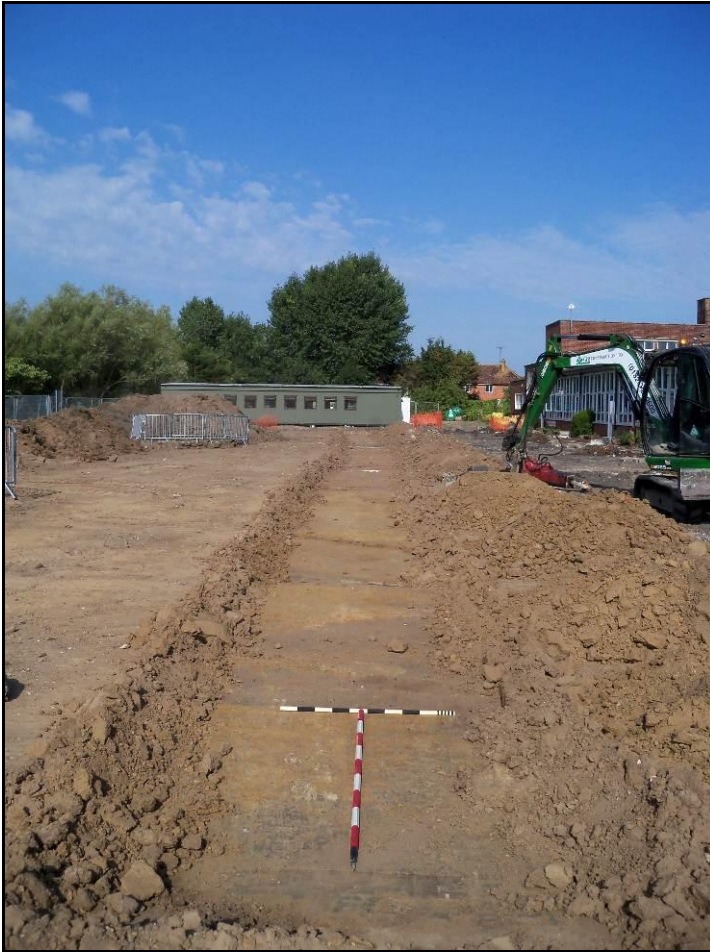
Plate 3: Highfield Junior School,
Eastbourne: Trench 1 looking west

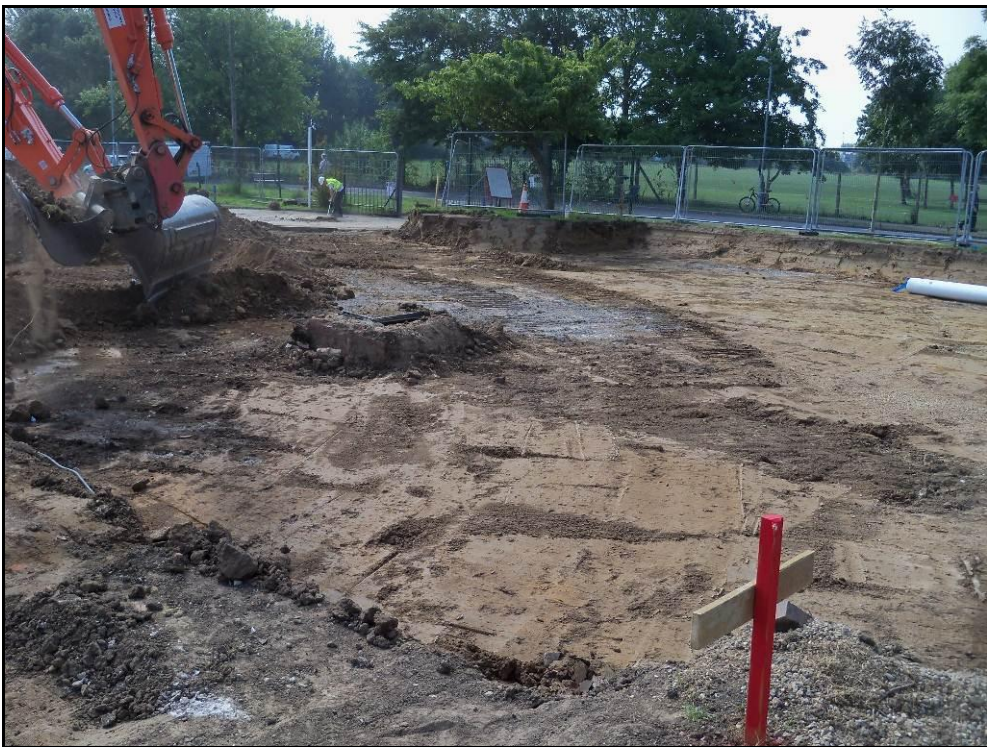
4.2.1 Outside Trench 1, two further contexts were recorded. A pale to mid greyish brown silt with no obvious inclusions was recorded to the immediate south of the trench, at its west end only (Context **107**). Further south, this layer led into a clean silty clay that comprised occasional sandstone inclusions (Context **108**). This was predominately mid brownish-orange or orange-brown in colour but was also mottled a mid greyish-brown and a pale yellow-brown. Large areas of chalk within it reveal this context to have been highly disturbed in places. Context **107** underlay the made ground of Context **101** whilst Context **108** lay beneath the topsoil (Context **100**). No finds were retrieved from either context.

Plate 4: Highfield Junior School, Eastbourne: Southwest corner of site
after ground reduction, looking southeast

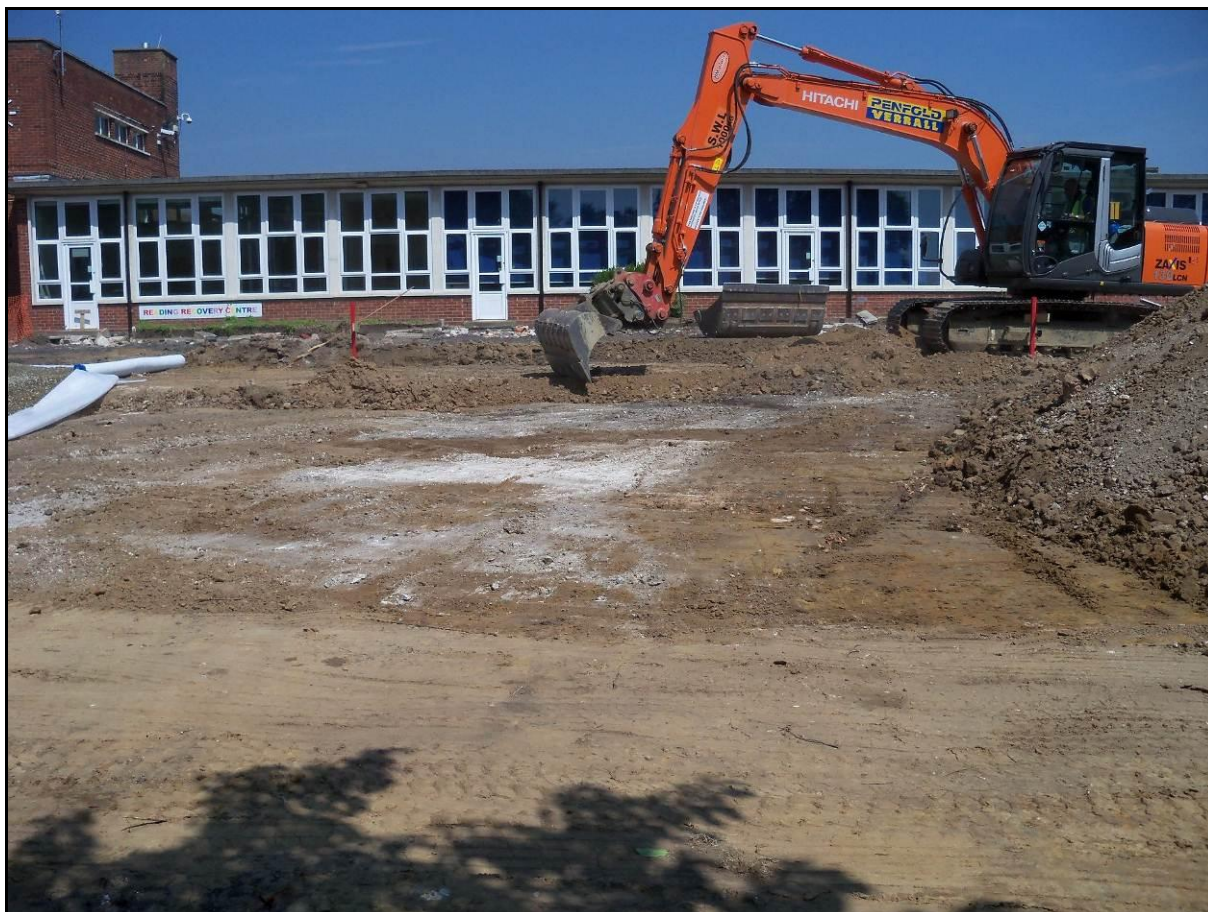
Plate 5: Highfield Junior School, Eastbourne: West side of site after ground reduction, looking north
