An Archaeological Evaluation at Edgmond Chapel, Church Street, Old Town, Eastbourne, East Sussex

Project No. CBAS0296

by
Dr Caroline Russell

May 2012

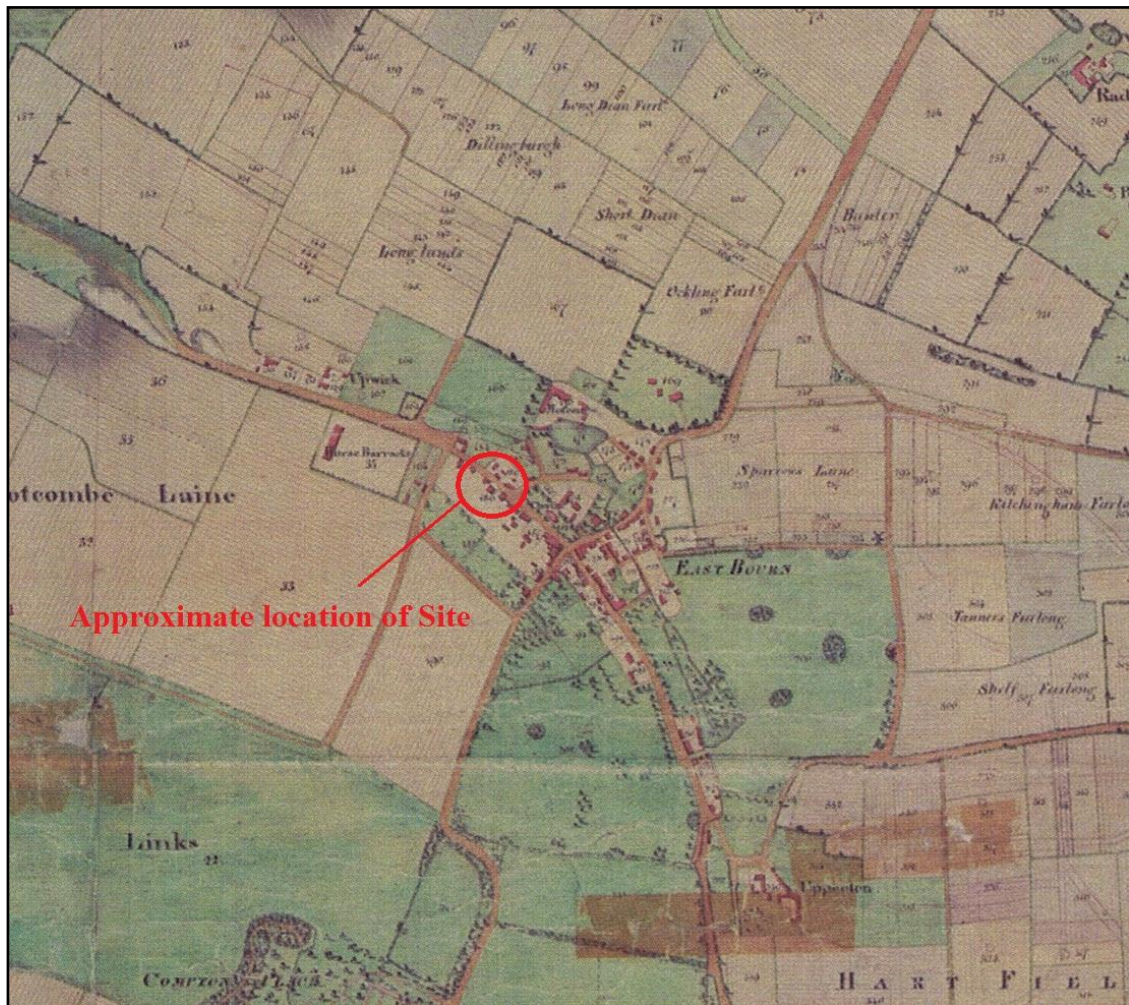
Fig. 6: Edgmond Chapel, Eastbourne: Figg Map of 1816
(Copyright ESRO GIL/3/17/1)

- 2.4.2 The Yeakell and Gardner map of 1778-1783²⁴ (not reproduced) shows that a building may yet again have stood within the site.
- 2.4.3 An 1801 map of the property owned by the Duke of Cavendish (Fig. 5) reveals at least three buildings to have been built within the site, with one standing slightly back from Church Street. Figg's map of 1816 (Fig. 6) seems to depict a similar arrangement of buildings.

- 2.4.5 A second plot in the site fronts Church Street and this is not numbered, which may suggest that the only building within this plot was government owned. This is the building seen on the earlier 19th century maps (Figs. 5 and 6) to be set back from the road, and which can be identified as Edgmond Chapel. The third 'plot' in the site is also not numbered. It lies to the back of Plot 86 and may be an associated garden.

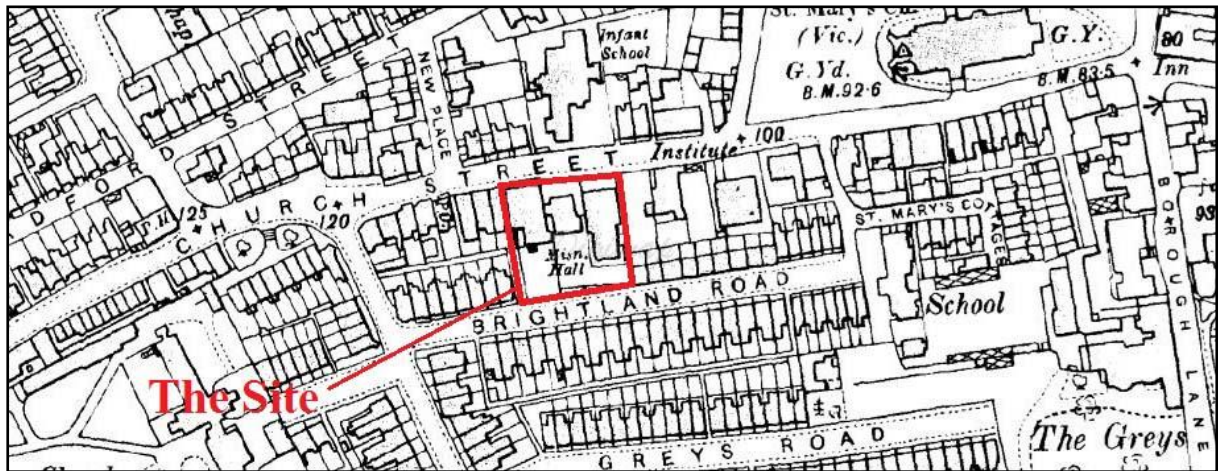
Fig. 9: Edgmond Chapel, Eastbourne: 3rd Edition OS Map, 1910

- 2.4.9 The site changed little between 1899 and 1930, as revealed by the 3rd and 4th Edition OS maps of 1910 and 1930 (only the 3rd Edition has been reproduced, Fig. 9). A building had been built between 1899 and 1910 to the rear of the site. By 1959 (Fig. 10), the Mission Hall had become known as Edgmond Hall and two new buildings had been built behind Edgmond Hall and Edgmond Lodge (No. 41 Church Street).

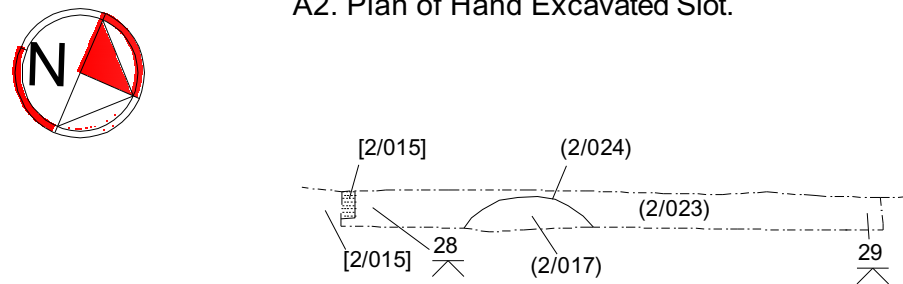
Fig.14

A2. Plan of Hand Excavated Slot.

Edmond Chapel Eastbourne - Trenches 1 & 2. Plans.

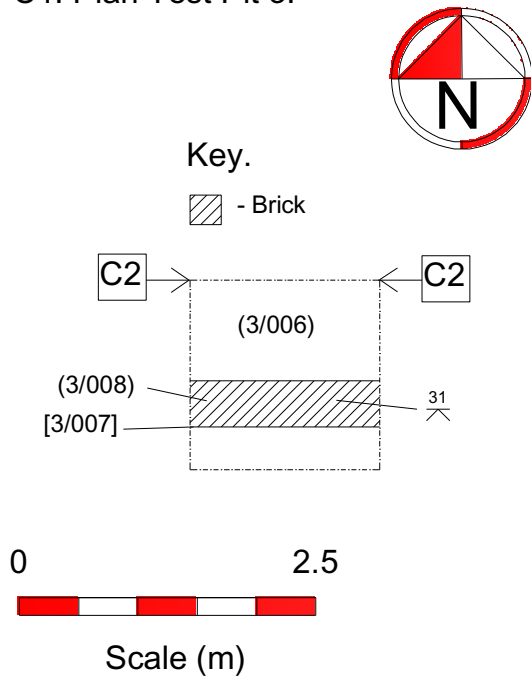
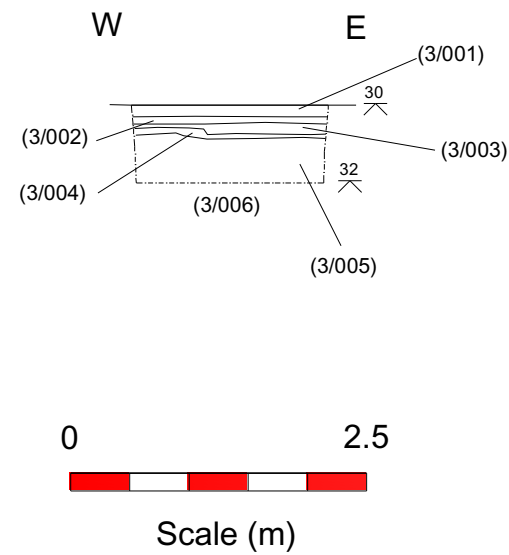
Fig.16

C1. Plan Test Pit 3.

C2. South-Facing Section of Test Pit 3.

Edmond Chapel Eastbourne - Test Pit 3 Plan & Section.

- 4.3.1 Test Pit 3 was excavated to a maximum depth of 830mm below the ground surface. Tarmac (Context **3/001**), 90mm thick, overlay an off-white MOT (Context **3/002**) that contained extremely frequent flint pebbles (under 40mm³) in a sandy concrete-like matrix. The MOT was 50mm thick and rested over a loose mid orange-brown sand (Context **3/003**) with frequent flint pebbles (under 40mm³). This layer of made ground, 90mm thick, lay over an earlier tarmac-like surface (Context **3/004**) which was 40mm thick. Beneath it was a layer of made ground and / or a demolition layer (Context **3/005**), 400mm thick, similar to that recorded in Trenches 1 and 2 (Contexts **1/003** and **2/003** respectively). It comprised chalk inclusions (up to 50mm x 45mm x 40mm), unfaced flint nodules (up to 120mm x 80mm x 50mm), large red brick fragments and pieces of mortar set in a mixed matrix, part of which was a pale whitish / greyish brown sandy mortar.

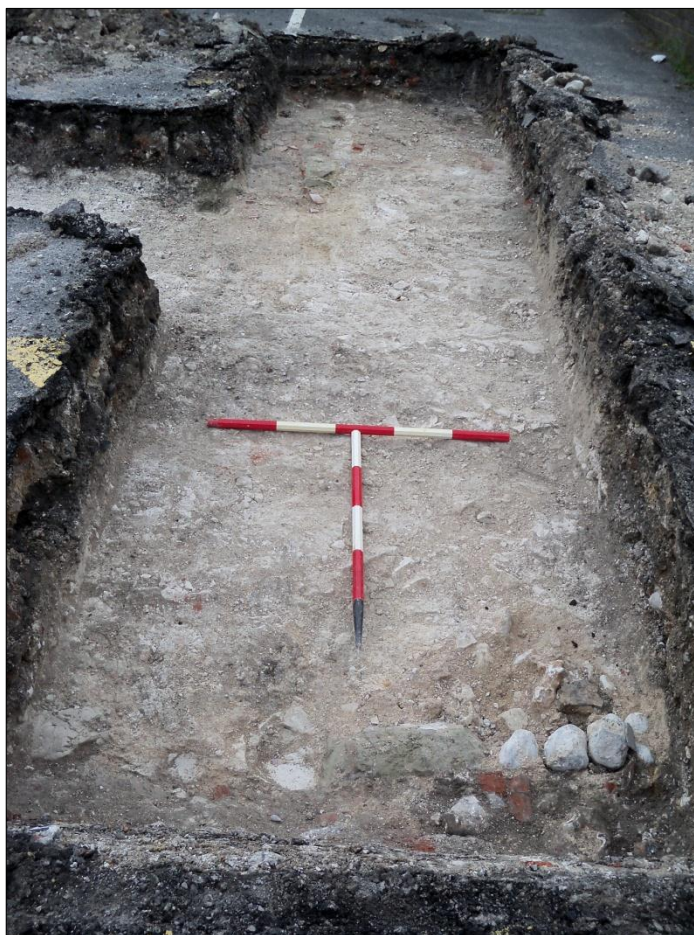
Plate 1: Edgmond Chapel, Eastbourne: Trench 1, looking west

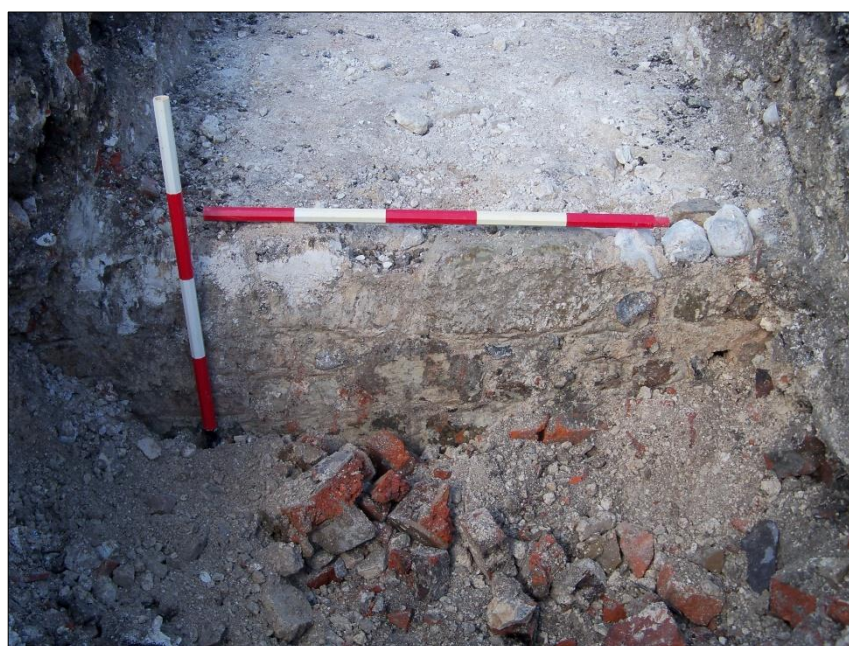
Plate 2: Edgmond Chapel, Eastbourne: Cellar wall 1/006 in
Trench 1, looking west

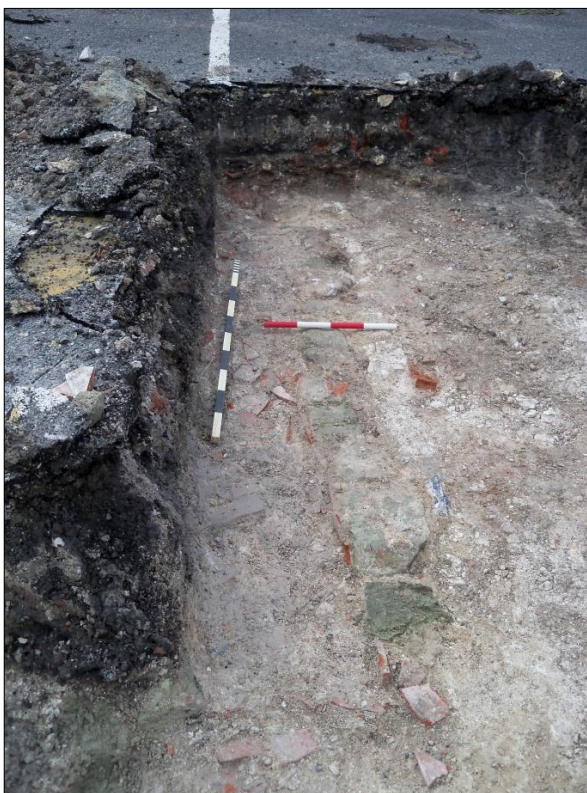
Plate 3: Edgmond Chapel, Eastbourne:
Wall 1/008 in Trench 1, looking west

- 4.1.6 Between the two skins of walling, red tiling was seen to line the greensand blocks exposed in plan. A considerable number of tiles were also found within the infill (Context **1/009**), which was a pale off-white sandy mortar. The tiles are interpreted as the possible remains of a drain. A hand-excavated slot through Context **1/009** revealed that it had a depth of 210mm (i.e. the depth of the foundation stones of the wall). Below Context **1/009** was a clay deposit of the same colour (Context **1/010**), which showed that the wall had been built on top of earlier layers and not the natural.

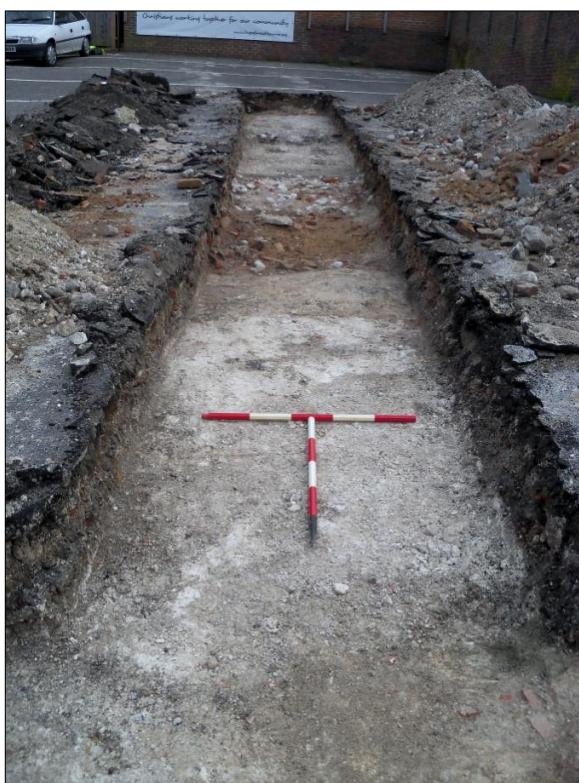
Plate 4: Edgmond Chapel, Eastbourne:
Trench 2, looking south

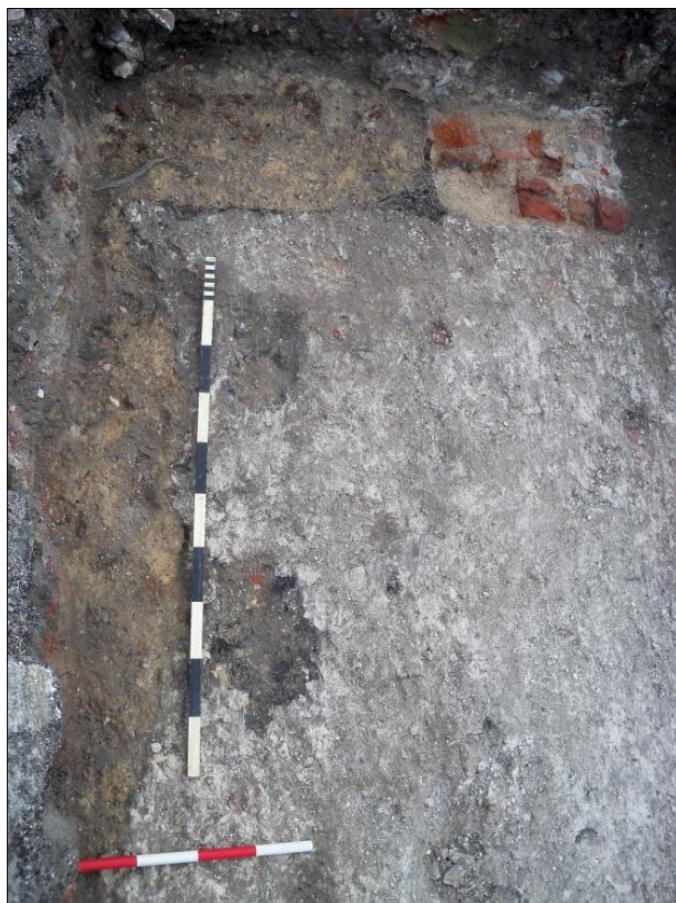
Plate 5: Edmond Chapel, Eastbourne:
Walls 2/010 and 2/011 in Trench 2, looking south

- 4.2.5 The floor beside wall **2/011** had two adjacent dark stains. The smaller circular stain was associated with a small patch of burning. Neither of these potential features had any depth to them. A slot in the floor, 550mm long and aligned north to south beside wall **2/013**, was *c.*50mm deep and therefore looked slightly more convincing as an archaeological feature; it was not however recorded as one.

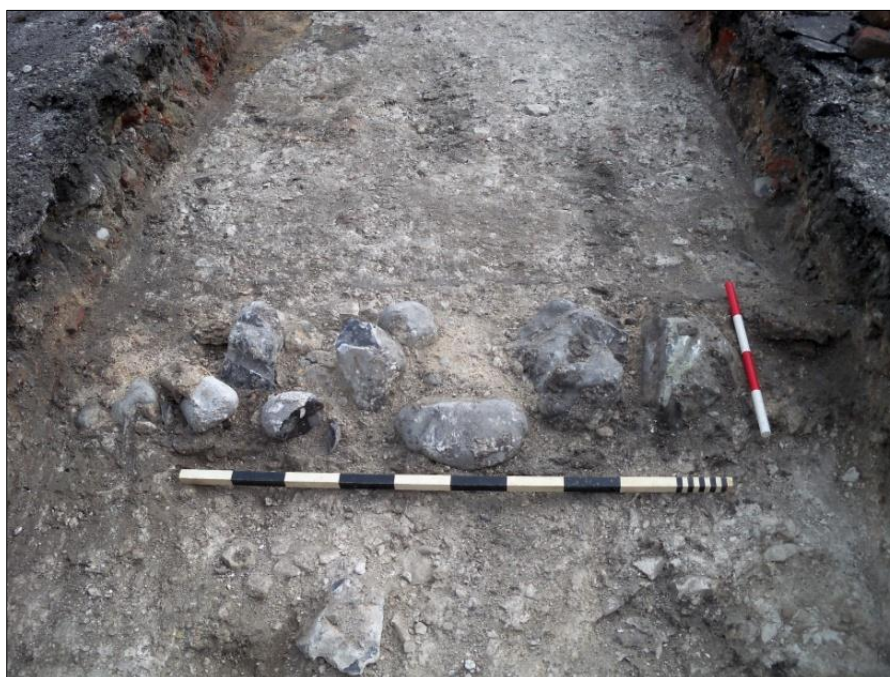
Plate 6: Edmond Chapel, Eastbourne:
Wall 2/013 in Trench 2, looking south

- 4.2.6 Wall **2/013** (with cut **2/012**) lay 2.35m downhill from the west-east alignment of walls **2/010** and **2/011**. It too ran this direction across the width of Trench 2. It was 430mm wide and was built largely of unfaced flint nodules but also had the occasional piece of roughly hewn sandstone. The flints used in this wall were large, up to 290mm x 230mm, as was the only piece of sandstone observed, which measured 350mm x 190mm. The deposit of Context **2/005** rested over the surviving top of this wall.

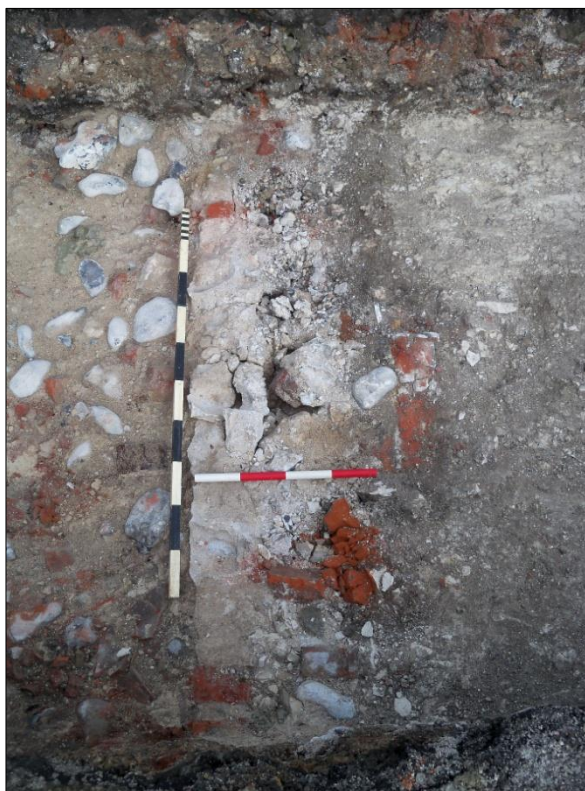
Plate 7: Edgmond Chapel, Eastbourne: Wall 2/015 in Trench 2, looking east

- 4.2.9 Wall **2/015** (with cut **2/014**) was 590mm wide. It had two skins of walling; red bricks were used for the inner skin of walling uphill, unfaced flint nodules were used for the outer face skin of walling downhill, and a mix of red bricks, flints and chalk were used for the rubble infill which also appeared mortared. Nearly all the brickwork had disappeared, and no flints were found in situ although their imprints were seen in the mortar.

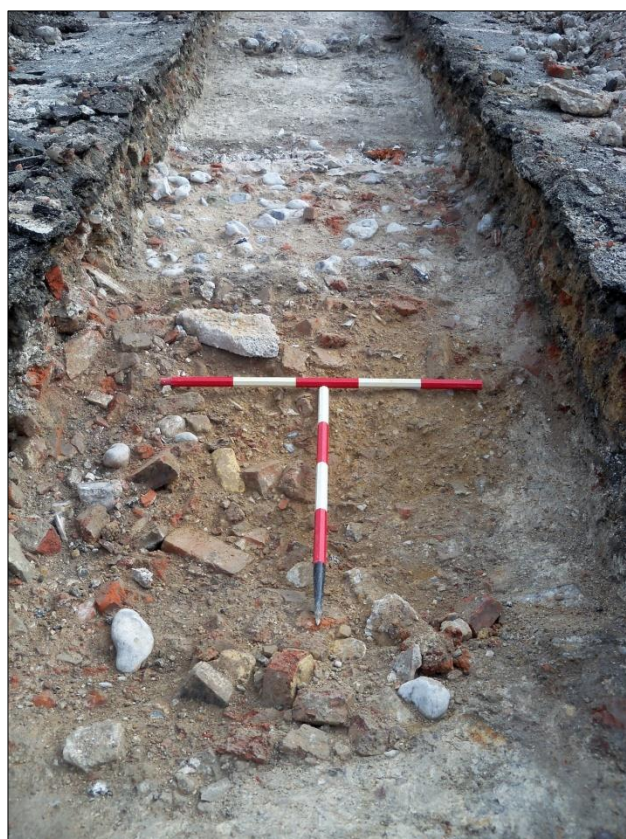
Plate 8: Edgmond Chapel, Eastbourne:
Wall collapse (2/016), well backfill (2/017) and mortar floor (2/006) in Trench 2, looking south

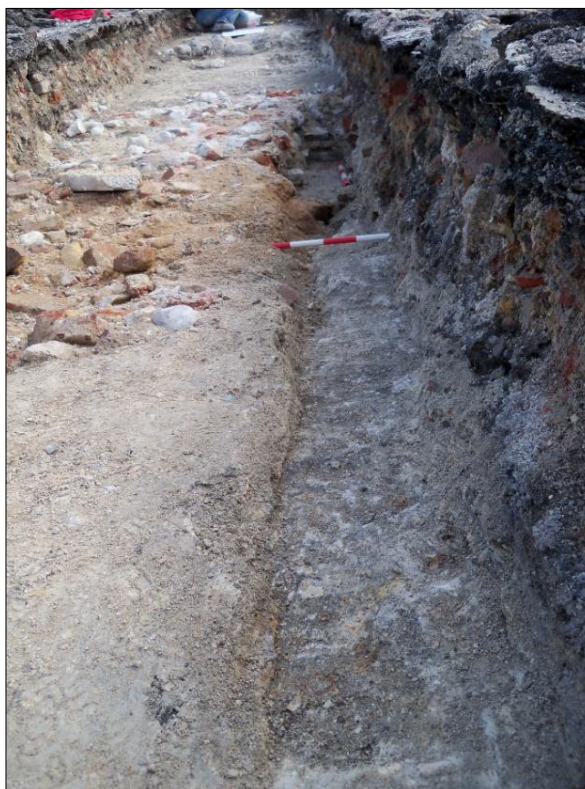
Plate 9: Edgmond Chapel, Eastbourne: Excavated slot in Trench 2 showing depth of deposits over the chalk natural (2/023), looking south

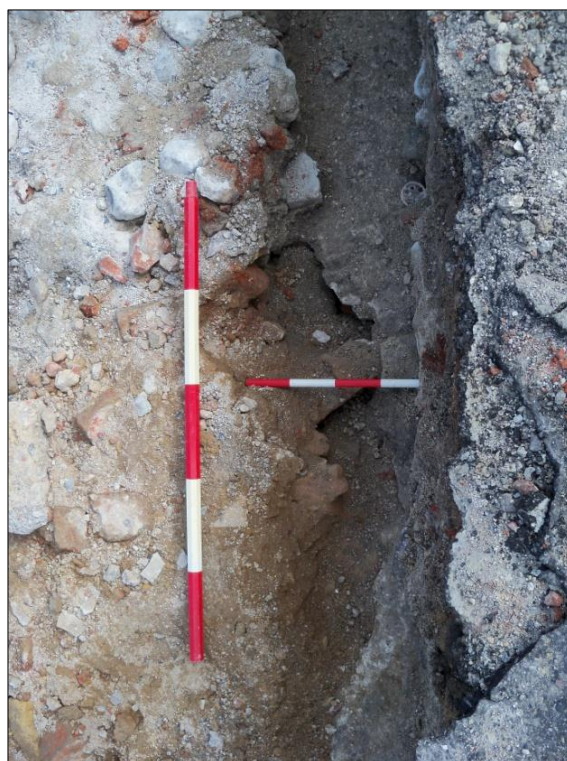
Plate 10: Edgmond Chapel, Eastbourne:
Exposed western edge of well (2/024) in excavated slot in Trench 2, looking south

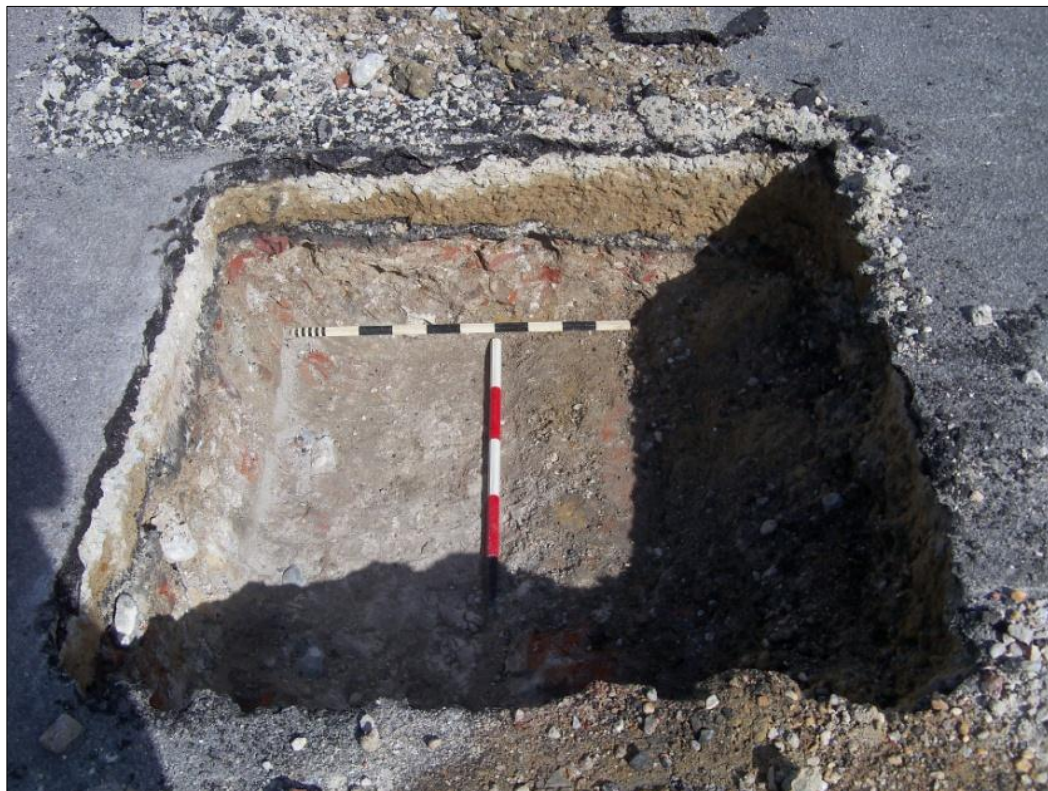
Plate 11: Edgmond Chapel, Eastbourne:
Wall 3/008 in Test Pit 3, looking east

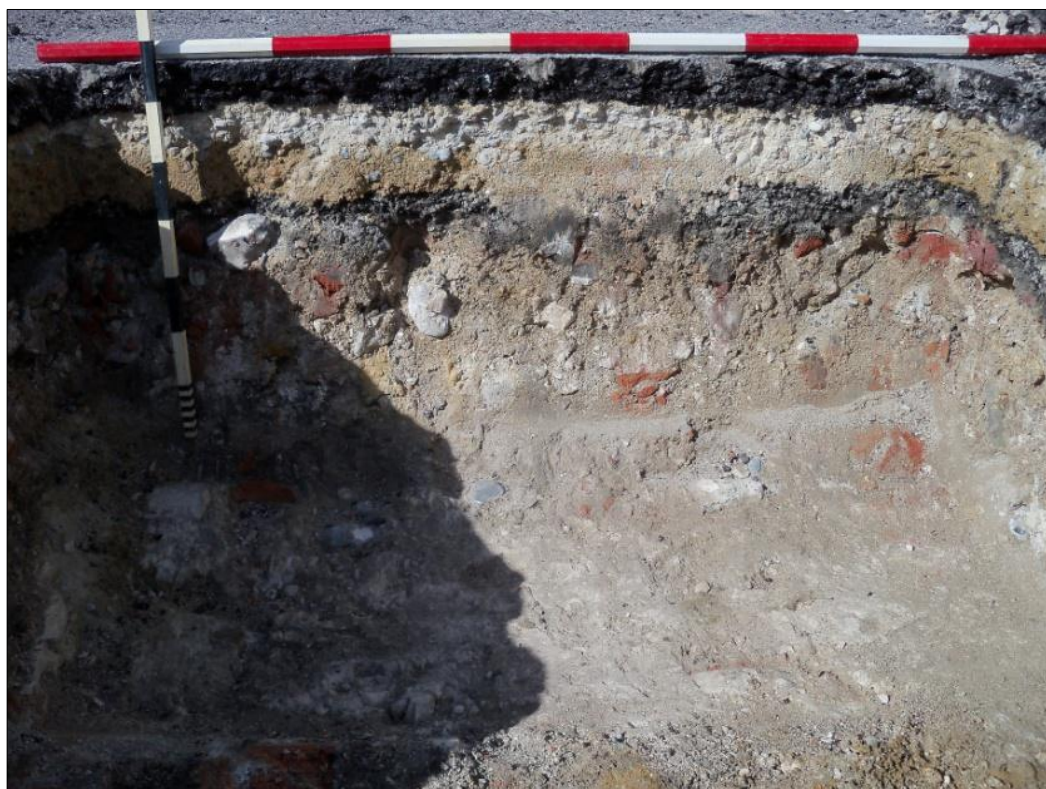
Plate 12: Edgmond Chapel, Eastbourne:
South-facing section of Test Pit 3

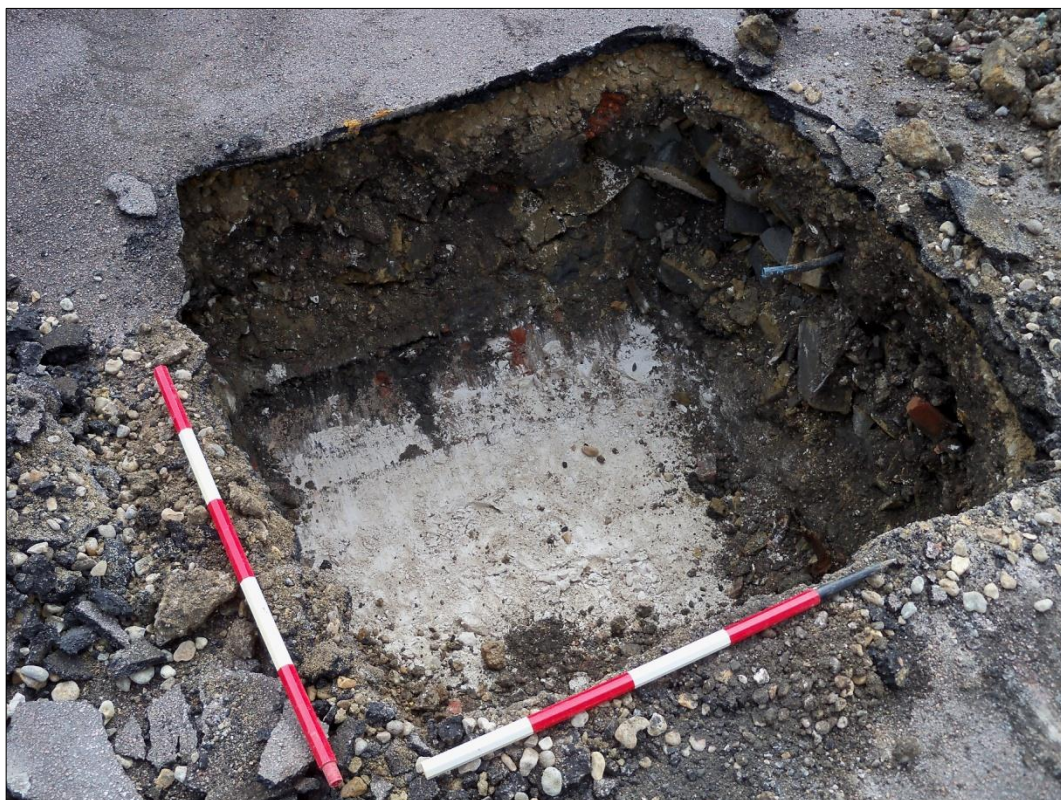
Plate 13: Edmond Chapel, Eastbourne: Test Pit 4, looking southwest

4.4 Test Pit 4 (Plates 13 and 14)

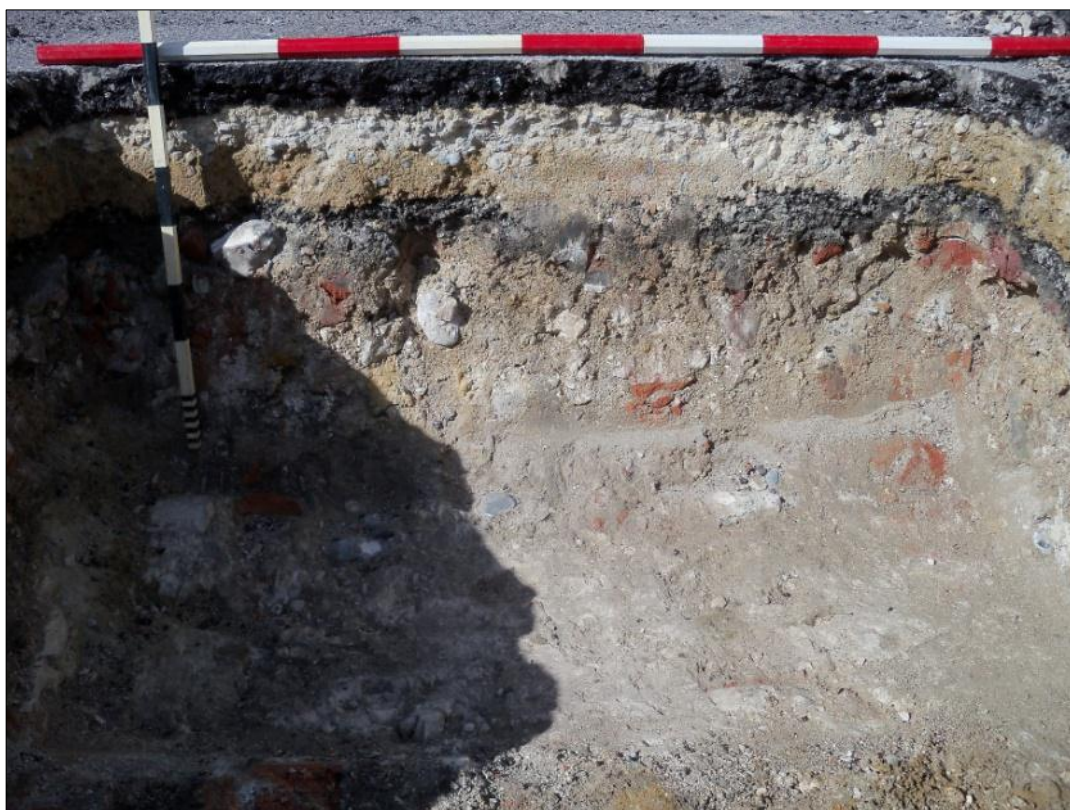
Plate 14: Edmond Chapel, Eastbourne: North-facing section of Test Pit 4
