**An Archaeological Watching Brief
at
Methersham Farm, Beckley,
East Sussex.**

Project No. CBAS0147

TQ 8645 2693

August 2011

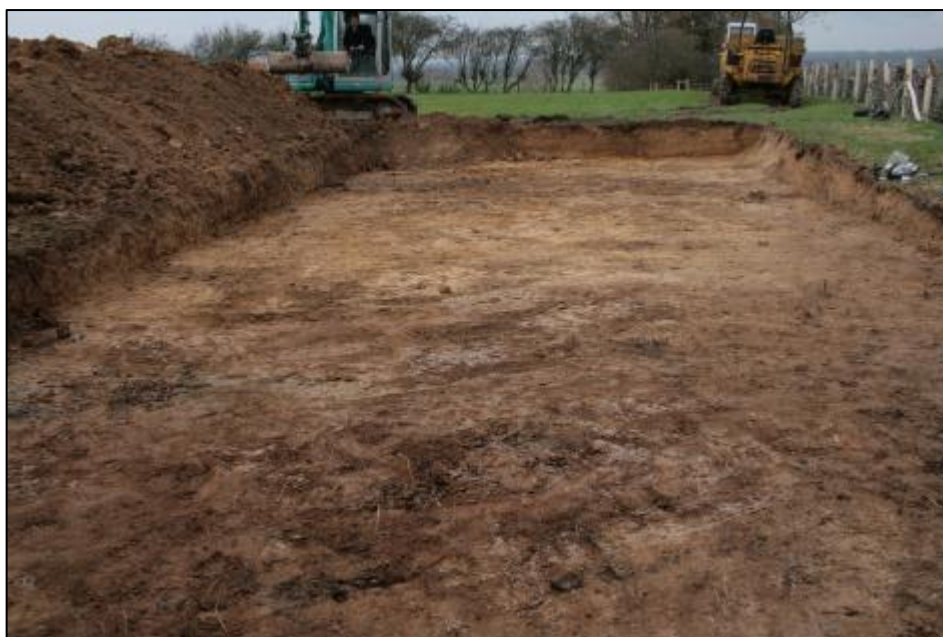
- 3.2** The area to be reduced measured 16.5m north to south by 8.0m east to west; this was marked out in spray paint and string lines by the contractor. The depth of the reduction was 600mm at the northern end of the reduction, and graded up to a depth of 350mm at its southern end. The reduction was carried out using a 7 tonne 360° tracked digger with a 1.5m toothless bucket. The spoil removed in this process was piled up on the side of the trench.

- 4.1** In the area of the reduction there were two layers. Context **1** was a dark to mid brown topsoil of silty clay loam with a loose consistence. The layer was up to 100mm thick, and had inclusions of rooting (1%) and small pebbles (<1%). In the north-west corner of the area of reduction the topsoil had been the site of a recent bonfire. In this area the topsoil was a very dark brown with added inclusions of charcoal flecks and small pieces of burnt wood (Context **3**). No artefacts were recovered from these contexts.

- 4.2** Below Contexts **1** & **3** was Context **2**, a subsoil of an orange-buff coloured silty clay with patches of mid to dark grey. This deposit continued below the level of impact, so its full depth was not determined. It had inclusions of sandstone pieces up to 70mm (<1%), there were also two pieces of laminated sandstone up to 600mm, ironstone pieces up to 110mm (1%), rooting (1%) and pebbles (<1%). Artefacts recovered from this deposit were of pottery, ceramic building material, metal and glass.

Fig. 7: Methersham Farm, Beckley: Photograph showing reduction over new site of stables

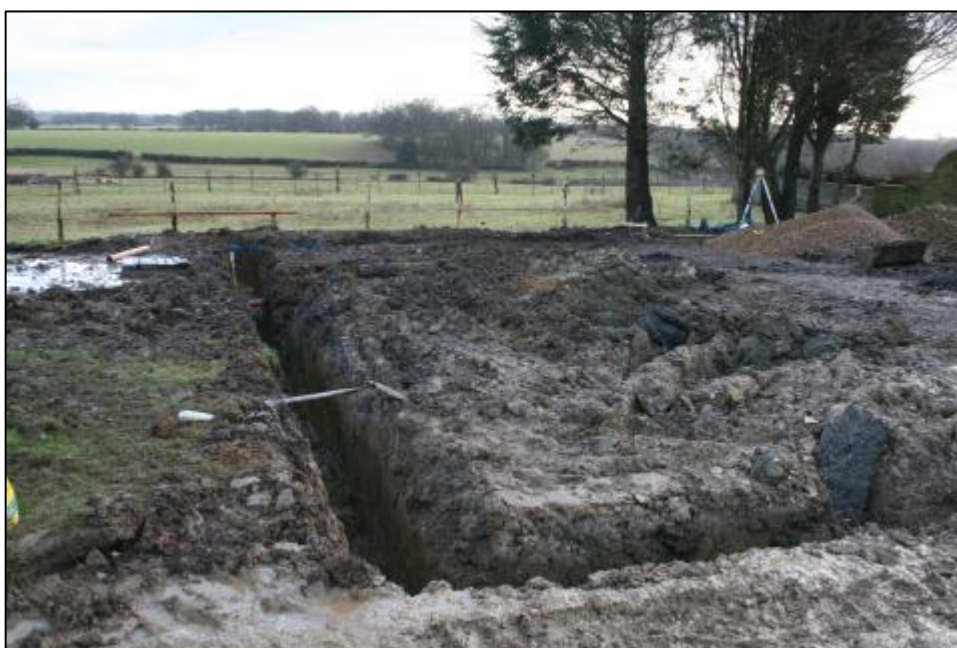
- 4.3** In the footings there were three layers; Context **4** was a layer of topsoil contaminated with demolition rubble, with a thickness of up to 350mm. This was a dark brown coloured silty clay loam with a loose consistence, and having inclusions of pebbles (2%), pieces of tarmac (2%) and moderate rooting (5%). There were no artefacts recovered from this layer.

- 4.4** Below Context **4** was Context **5**, a layer of mid orange-brown subsoil with a depth of up to 500mm, of silty clay. This had a friable consistence with inclusions of pieces of sandstone up to 40mm (1%). Also incorporated into this layer were large sections of concrete foundations, of the demolished barn that stood in this area before the stables had been constructed. There were no artefacts recovered from this layer.

- 4.5** Below Context **5** was Context **6**, which was the natural silty clay. The silty clay was an orangey buff colour with patches of grey. This layer had a firm consistence, and contained no inclusions. This layer was not fully excavated as it continued below the depth of the excavated footing trenches.

Fig. 8: Methersham Farm, Beckley: Photograph showing excavation of footings
