An Archaeological Evaluation at 59, High Street, Hastings, East Sussex.

Project Number CBAS0173

by
Keith Butler PIfA

January 2011

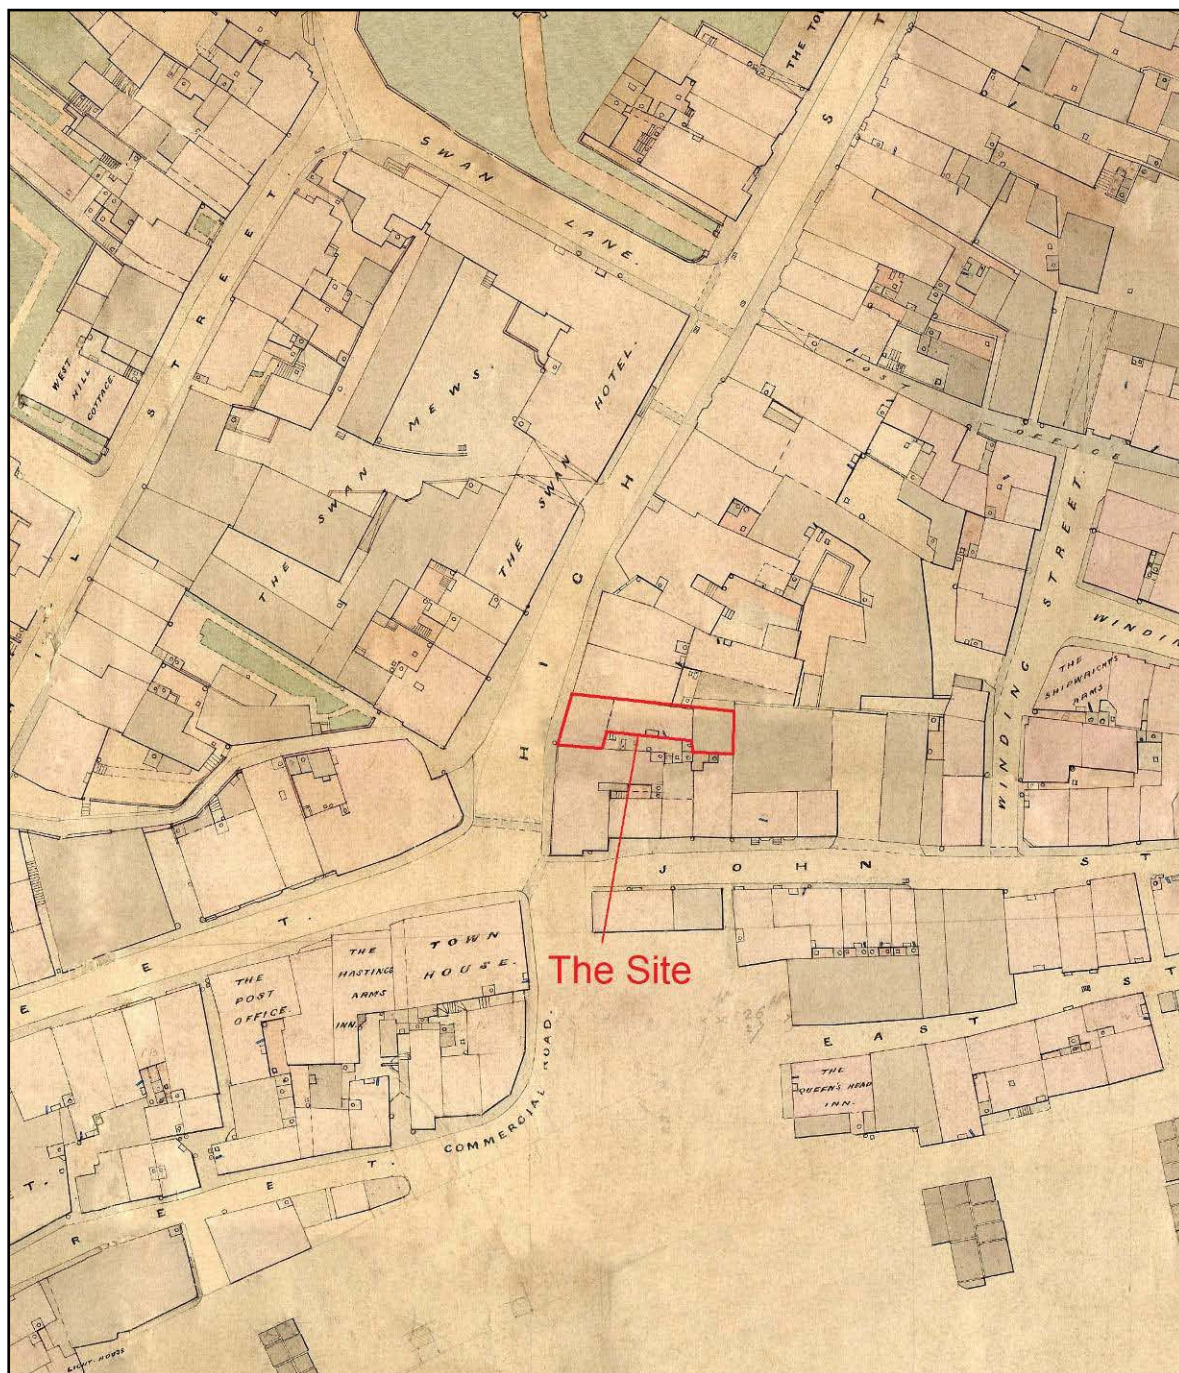
Fig. 4: 59 High Street, Hastings: William Gant's 'Survey of Hastings' of 1852
(Reproduced with permission of Hastings Museum)

- 2.14** William Gant's 'Survey of Hastings' of 1852 provides the next map evidence (Fig. 4). The buildings are shown in great detail, with a building fronting onto the High Street, an addition to its rear, and a small area of garden at the east end of the site.

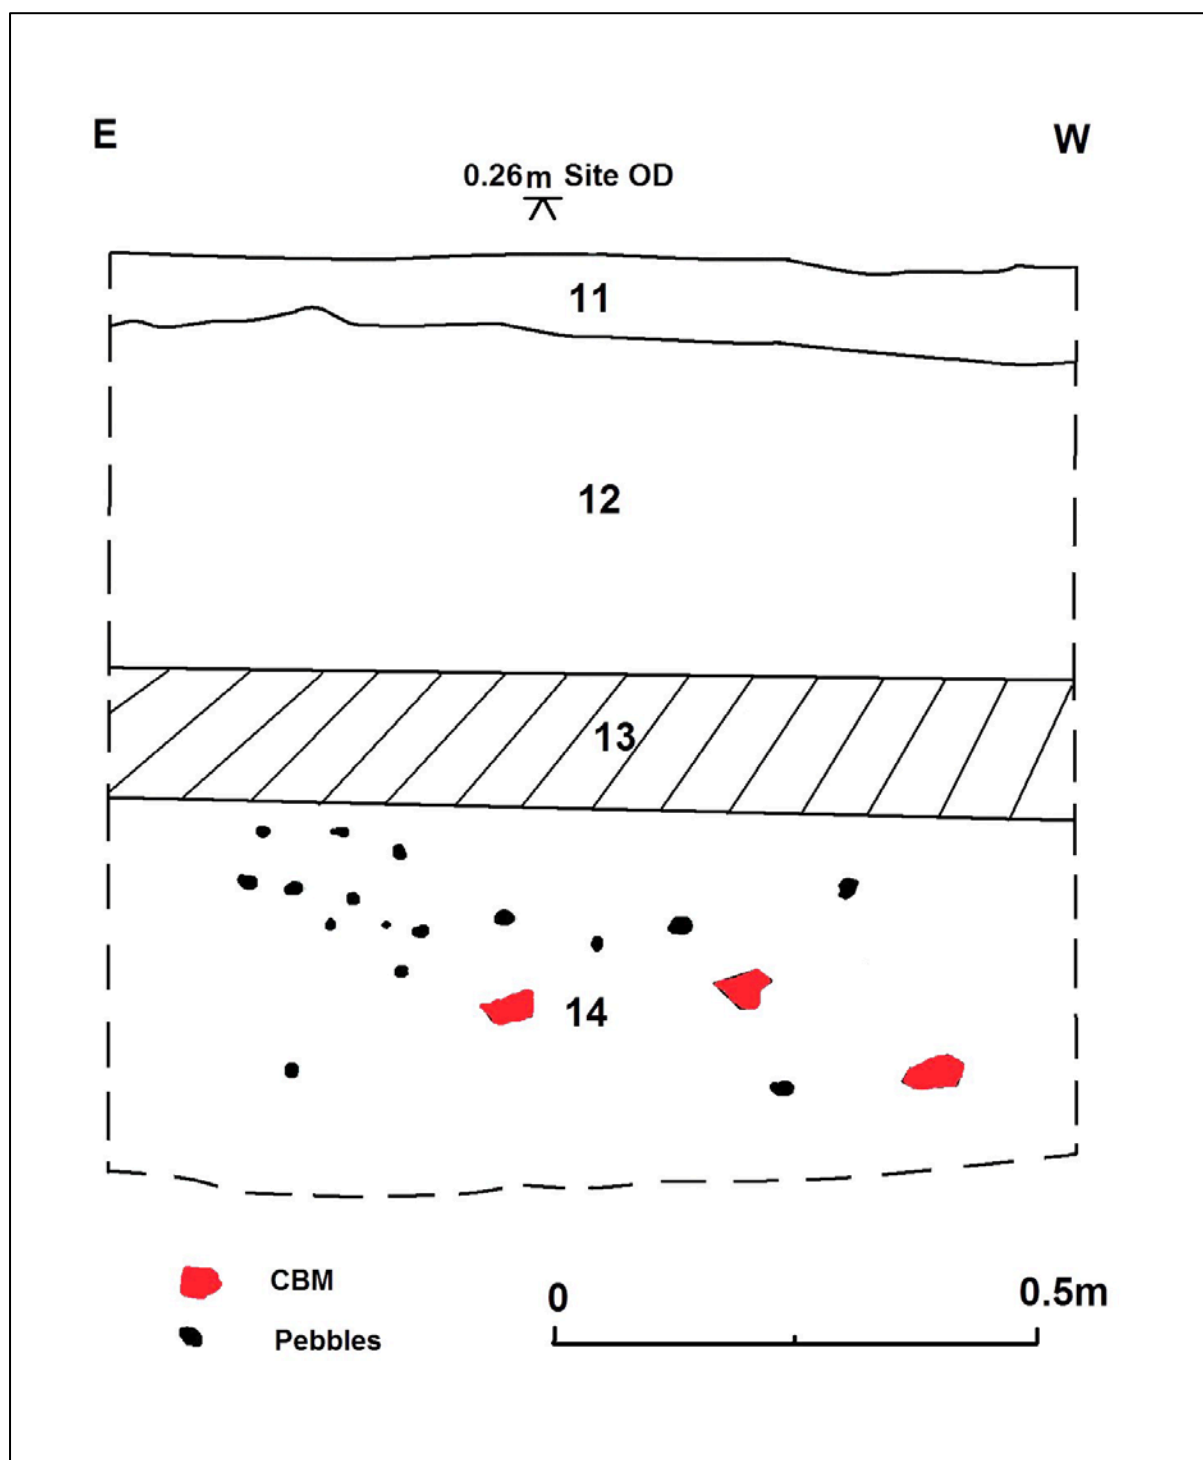
Fig. 7: 59 High Street, Hastings: Representative Section of Trench B showing the modern made ground (12), concrete floor (13) and in-situ deposit (14) preserved below the floor

- 4.7** In Trench **B** the top deposit was Context **11** and was the same as Contexts **1** and **4**. It was a dark brown silty clay loam with patches of orange sand with a loose consistence. The deposit had a depth of up to 150mm, with inclusions of ceramic building material (1%) and pebbles up to 40mm (1%).

- 4.8** Context **12** was below Context **11**, and was a light greyish-brown mixed sandy and silty clay, with a loose consistence with many voids. This deposit had a thickness of 360mm at the southern end of trench above the concrete floor (Context **13**), and a depth of up to approximately 960mm at the northern end of the trench. This deposit had inclusions of ceramic building material (40%), mortar (10%) and MOT (5%). This deposit also included lengths of modern scaffolding planks and poles and a hot water heater, and was clearly very recent in date.

- 4.9** Context **13** was below Context **12** in the southern end of Trench B, and was the same concrete floor as was discovered in both of the other trenches. However, in this trench the concrete floor had been broken up and was absent in the northern part of the trench, where the earlier HAARG trench had been excavated.

- 4.10** Context **14** was a deposit below the concrete floor (Context **13**) in the southern end of Trench B. This layer was not excavated as it was sealed by the concrete floor, and only recorded from the north facing section (Fig. 7). This was a deposit of firm mid brown silty clay, with inclusions of ceramic building material (1%) and pebbles (2%). No artefacts were recovered from this deposit.

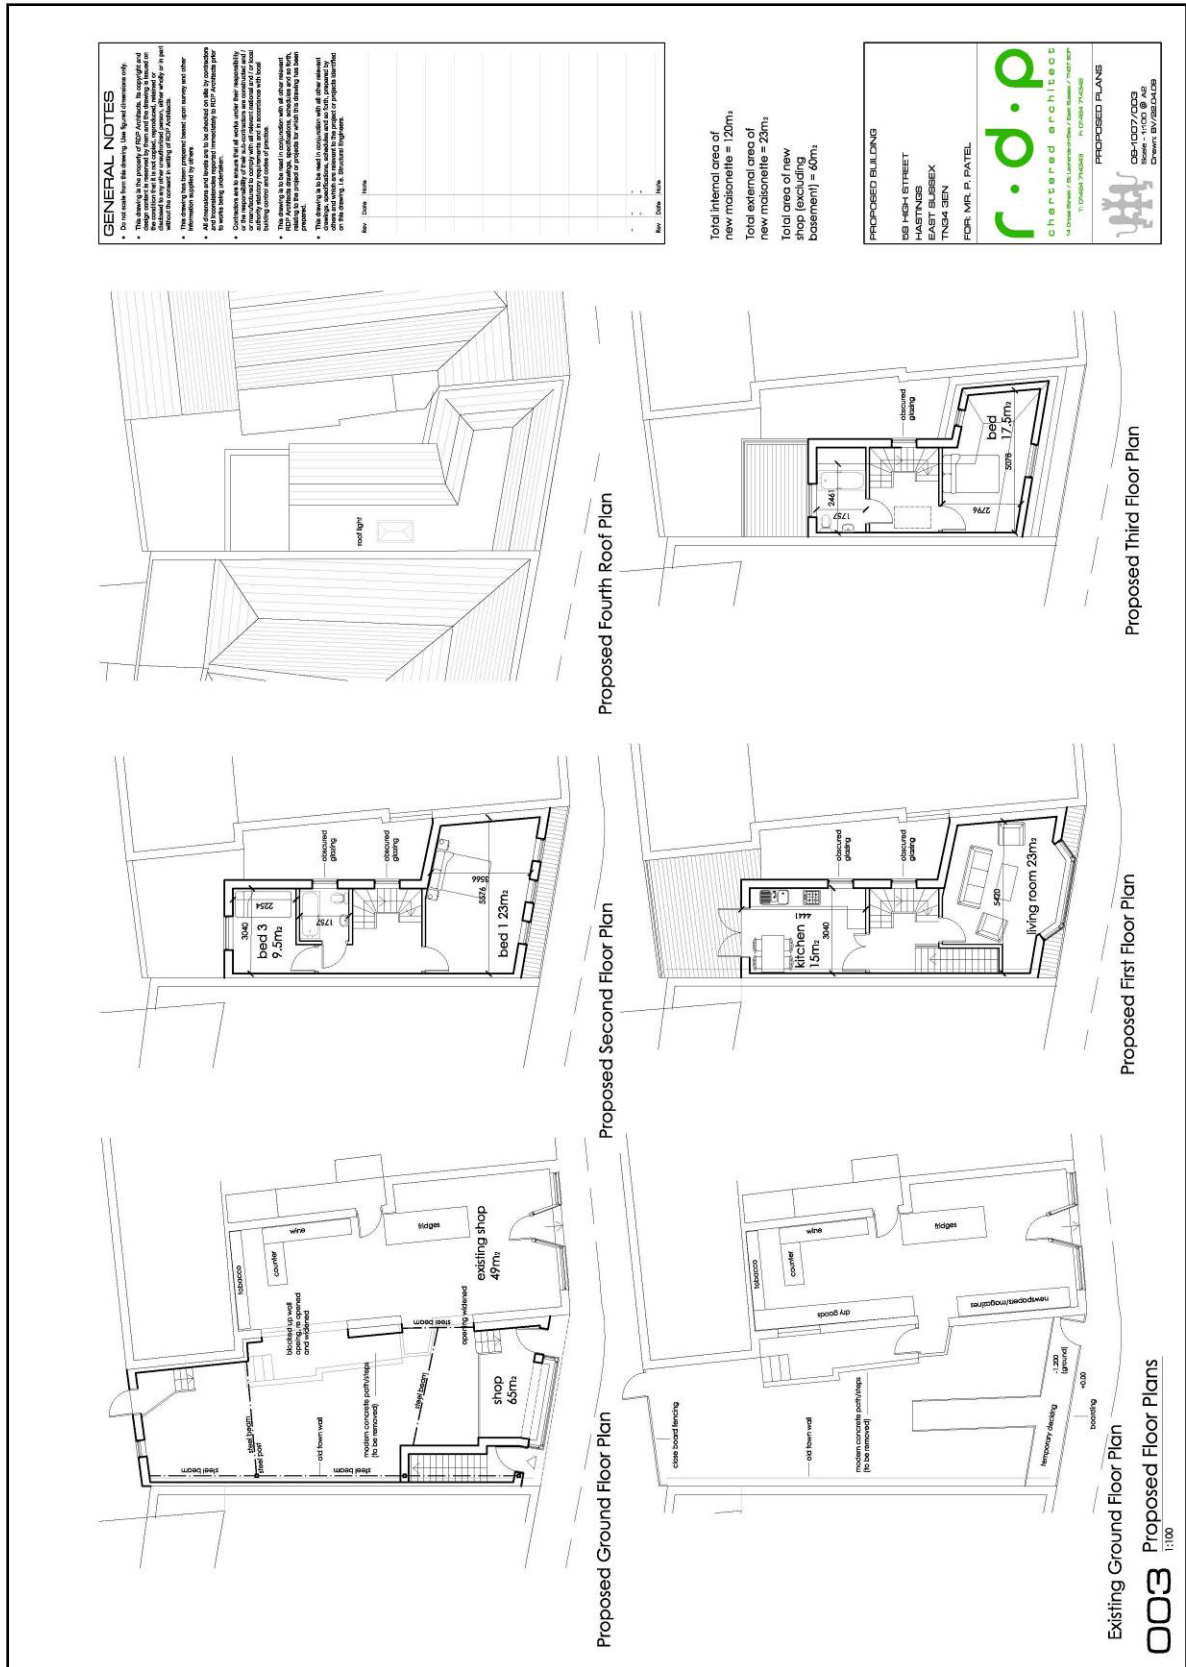
Fig. 9: 59 High Street, Hastings: Development plans
(Adapted from architects drawing)

- 7.3** The building design (Figs. 9 & 10) shows that although the proposed building floor level will be at or above current ground level, the foundations will have a below ground impact around the outside of the building footprint, and at the north-west corner, that is likely to be to a depth of c. 1m. This will therefore have an impact on all of the potential archaeological remains noted above.

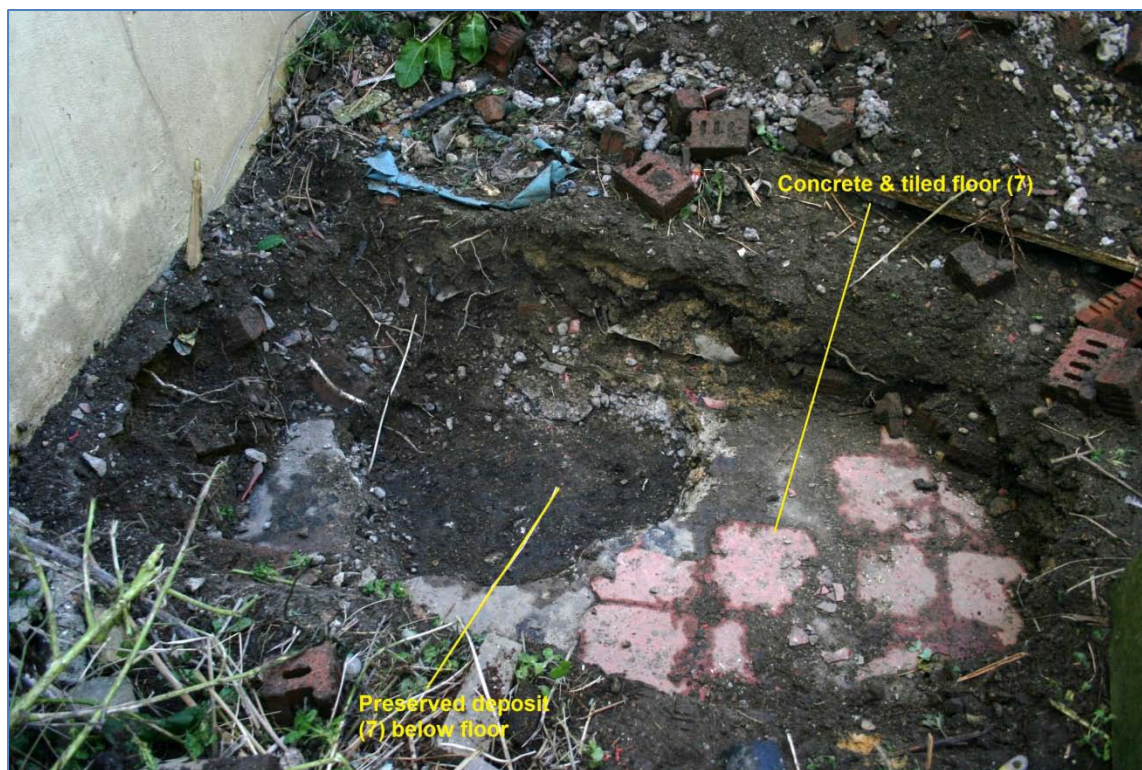
Fig. 11: 59 High Street, Hastings: Photograph Trench A

- 4.1 In Trench A the top layer (Context 4) was a layer of dark brown silty clay loam with a loose consistence and a depth of 130mm. The inclusions were of ceramic building material (1%), large plastic bags (1%), and rooting (<1%). No artefacts were recovered from this deposit, which was the same layer of made ground as Context 1 in Trench C.

- 4.2 Context 5 was below Context 4, and comprised two courses of red bricks, 140mm deep. The bricks measured 212 to 220mm (stretchers), 100mm to 103mm (headers), with a thickness of 65mm to 70mm. One side of the stretcher face was grooved, with six holes in their flat surfaces. No bonding material was present. The bricks are of a 20th century date.

- 4.3 The bricks were above Context 6, which was a concrete floor, 130mm thick, with a red linoleum tiled surface. Below Context 6 was Context 7, which was a 250mm thick deposit of dark greyish-brown silty clay with a firm consistence. The inclusions were of ceramic building material (2%), charcoal (1%), and rooting (<1%). Finds from this context were 19th century date.

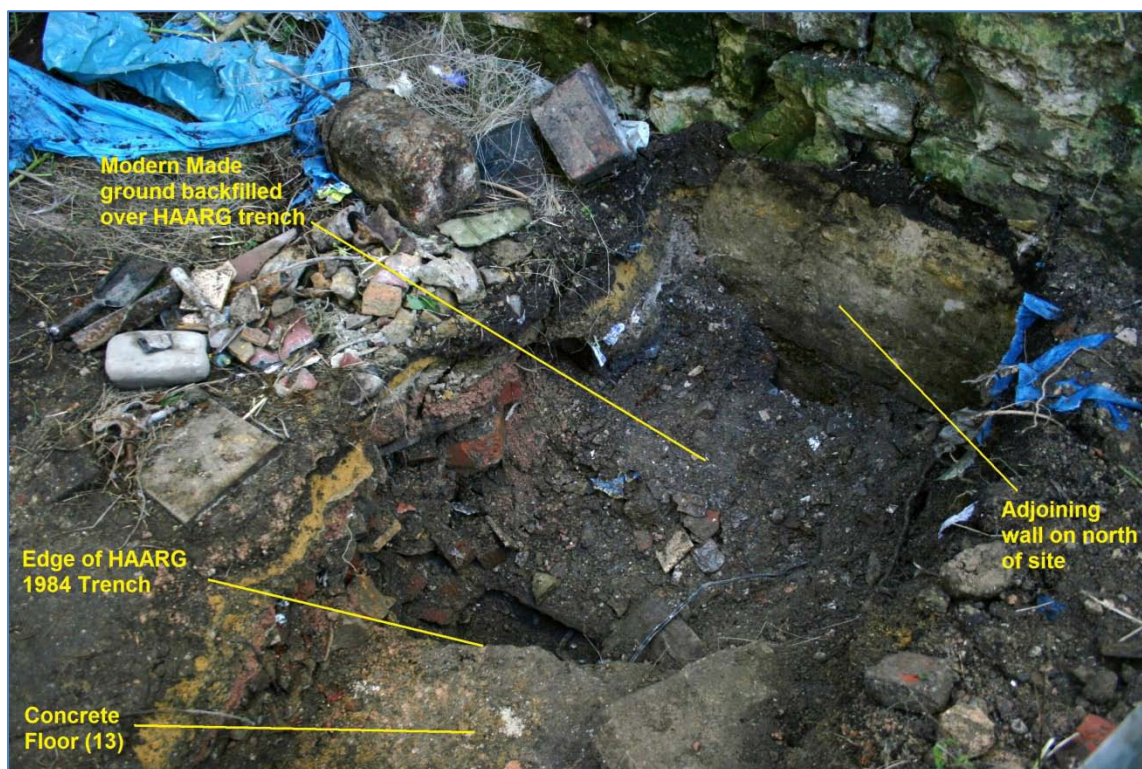
Fig. 12: 59 High Street, Hastings: Photograph Trench B

- 4.11** Once the modern deposit (Context **12**) had been removed, it was possible to determine the edge of the HAARG trench, excavated in 1984, in the base of the trench (Fig. 12). However, due to the obstructions and unstable nature of the ground, it was not possible to expose and record any of the features noted during the HAARG excavation.
