## Archaeological Watching Brief at Alciston Church, Alciston, East Sussex

Project No. CBAS0141

by David Atkin

October 2012

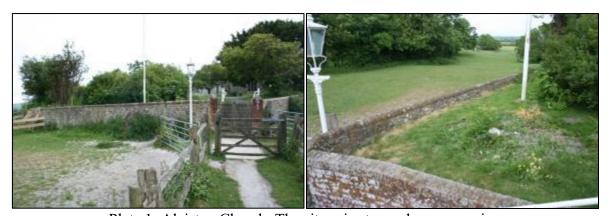
Plate 1: Alciston Church: The site prior to work commencing

- 2.21 On the south side of the wall within the churchyard, the area of the work (Plate 1) is grassed, with a number of small trees (one now removed) and shrubs set back from the wall, together with a flag pole and some paving slabs. The ground slopes gently down to the wall, and is only some 0.3m below the top of the wall. There are no obvious graves or structures in this area, the nearest being a short distance outside the area of proposed works, and are of 20<sup>th</sup> century date.

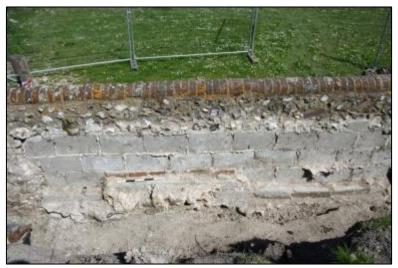
Plate 2: Alciston Church: Modern repairs to wall

- **4.4** Context **4** was the modern repair to the wall and consisted of flint with brickwork capping with lime mortar and sand and cement render. It incorporated modern breeze blocks at its base (Plate 2).

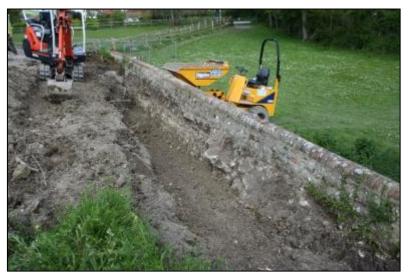
Plate 3: Alciston Church: Excavation for the French Drain

- 4.6 Context 6 was a soft to firm, silty-clay, light to mid grey deposit very similar to Gault clay. It was directly underneath Context 2. It contained inclusions of very occasional chalk pieces up to 20mm in size at <1%, CBM at 1% and charcoal at <1%. This deposit was approximately 300mm in depth to the limit of excavation and was encountered approximately 1.3m below the present ground surface within the graveyard.
- 4.7 Context 7 was assigned to an incomplete child's skeleton that appeared to sit immediately above Context 6 and within Context 2. No grave cut could be ascertained. It was orientated east-west and only part of the skull and a few other bones were recovered (See 5.4 below). A single sherd of medieval pot was recovered from the immediate area to the left of the shoulder.

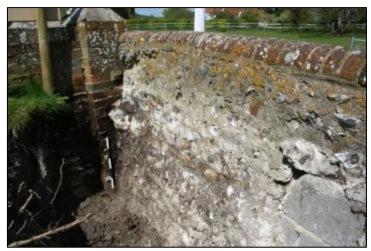
Plate 4: Alciston Church: Different phases of wall construction

- 4.9 Context 9 was assigned to the earliest phase of the flint wall surrounding the churchyard. The wall was approximately 700mm in height with the thinner later 19<sup>th</sup> century wall (Context 10) sitting directly on-top. The early wall was constructed of un-knapped flint nodules with lime mortar used as a bonding agent and showed signs of repair. A sample of mortar was taken (Sample 1).

4.10 Context 10 was assigned to the later phase of the surrounding flint wall. It was up to 1m in height and was constructed of flint nodules bonded with a lime mortar and had knapped flints incorporated into its facing (Plate 4). A sample of mortar was taken (Sample 2). The wall had a rounded brick capping along its length bonded with a light grey concrete which had also extended down the upper surfaces of the wall. The wall showed some signs of later repair with modern bricks having been inserted on the inside, and there was an area of brick repair at the bend in the wall (Fig. 9).

- 6.5 It seems likely that the wall around the churchyard has at least four phases. The first being the lower original build, of unknown date. The later flint rebuild is likely to have taken place in the 19<sup>th</sup> century, with the subsequent lowering in height and capping with brick taking place at the end of the 19<sup>th</sup> or in the early 20<sup>th</sup> century. The brick buttresses may also have been added at this time. The latest repairs, represented by the breeze block infill dates to the 1960's.
- 6.6 The methodology adopted for this evaluation proved to be satisfactory, and the confidence rating should be considered to be reliable.

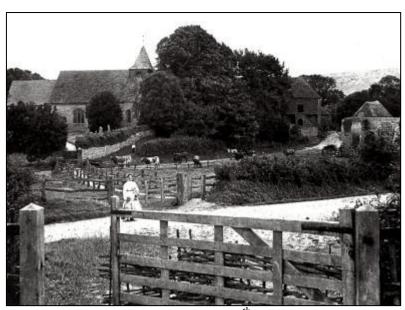
Plate 5: Alciston Church: Late 19<sup>th</sup> century photograph

- 6.4 The origin of the wall itself is also open to debate. That work was carried in the 19<sup>th</sup> century is clear from the brick inclusions within the later build. The earlier wall may be of a medieval date, but apart from the differences within the lime mortar and the later inclusions, there is little to tell them apart. A photograph (Plate 5) of the church in the later 19<sup>th</sup> century shows the walls to have been much taller than they are today, although the current gate and steps are present.

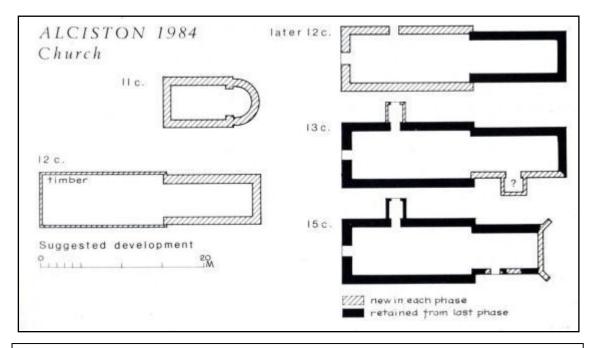
Fig. 4: Alciston Church, Alciston: Development of the Church

- 2.11 The earliest part of Alciston church is the eastern apse (Fig. 4), found during the 1984 excavation<sup>20</sup>, which dates to a pre-conquest church. The earliest part of the current church is a window in the north wall of the chancel which dates to the 12<sup>th</sup> century. The south wall of the church was rebuilt in the 13<sup>th</sup> century, and the porch was added at the same time (although rebuilt in 1951). The final phase of Medieval building is represented by the east wall of the chancel which has a 15<sup>th</sup> century window<sup>21</sup>. The church was drastically 'restored' in 1853<sup>22</sup>.

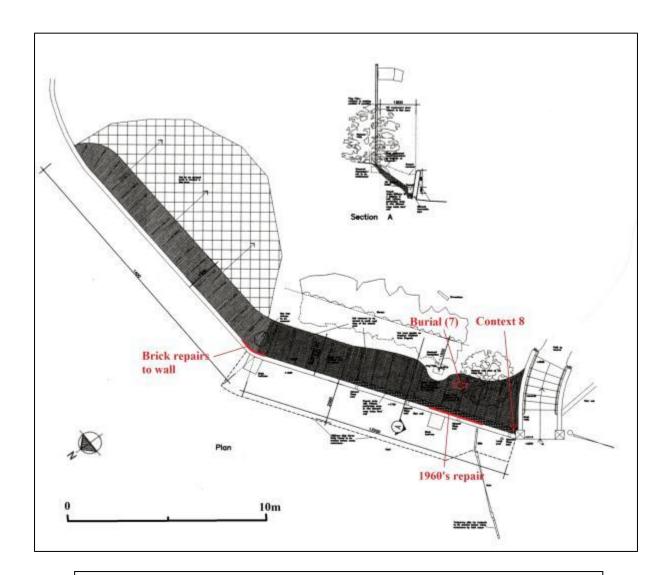
Fig. 9: Alciston Church, Alciston: Plan of the area monitored

- 3.2 The groundworks for the landscaping were excavated in shallow spits by 3 tonne ditching machine using a flat-bladed 600mm ditching bucket and by hand, under archaeological supervision. The soil adjacent to the wall for the French drain was excavated by hand so as not to cause any damage to the wall. The area excavated for the landscaping and the French drain was approximately 1m inside the north wall on its south side and ran for approximately 12m from the north-west entrance to the east before following the wall and turning south-east for a further 12m (Fig. 9). Excavation ceased at approximately 1.3m below the current ground level.
